Highlander Environmental Corp.

RP # 774

Re: Assessment and Closure Report for the Pogo Producing Company (Arch Petroleum), West Dollarhide Devonian Unit, Well #113, Section 4, Township 25 South, Range 38 East, Unit C, (Flow-line Spill Located in Section 33, Township 24 South, Range 38 East), Lea County, New Mexico.

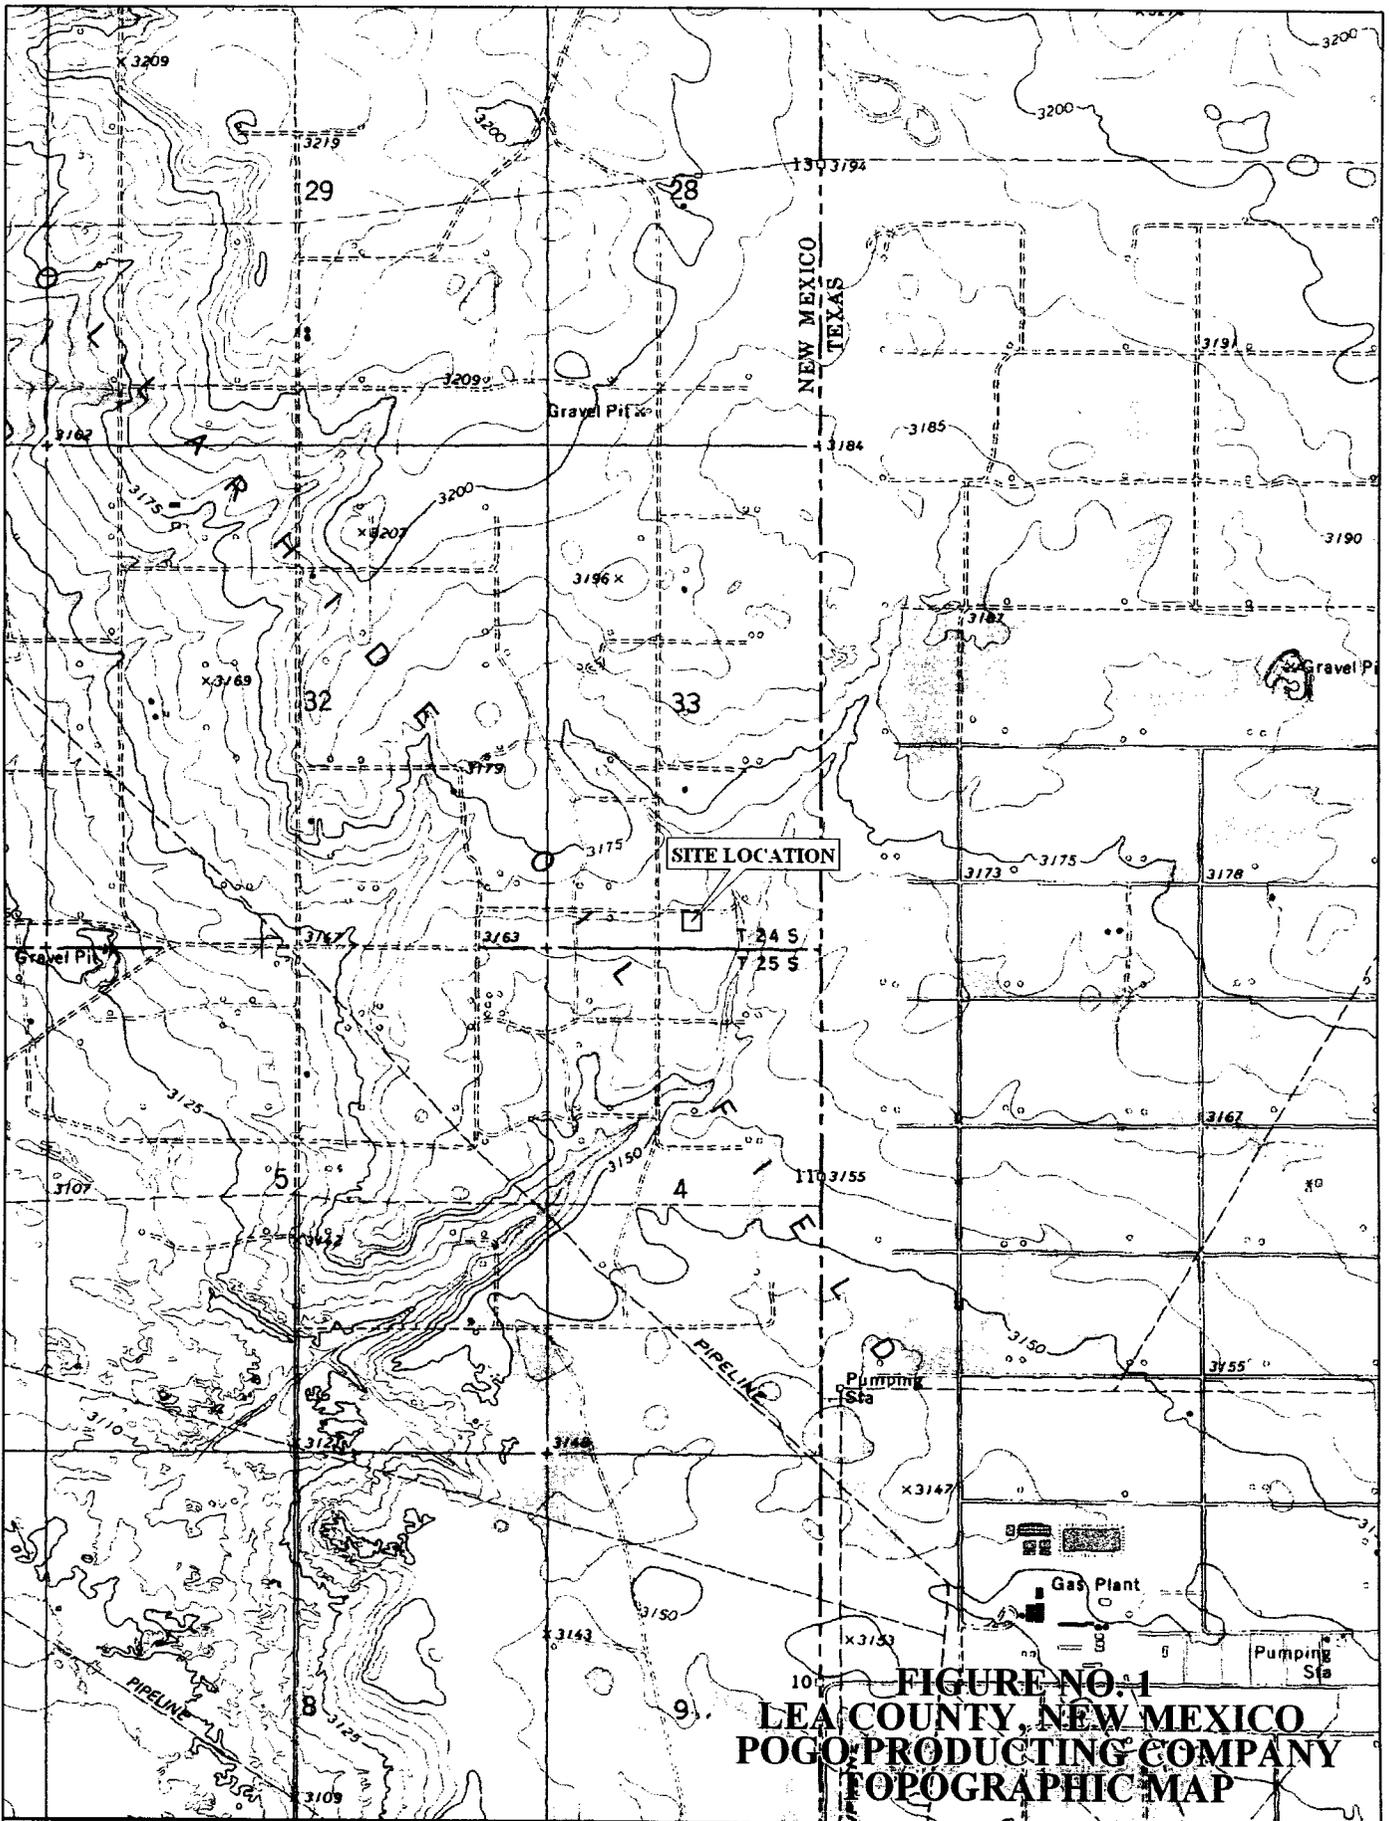
**FIGURE NO. 1
LEA COUNTY, NEW MEXICO
POGO PRODUCING COMPANY
TOPOGRAPHIC MAP**

Highlander Environmental Corp. (Highlander) was contacted by Pogo Producing Company (Pogo) to assess a spill from a pumping well located on the West Dollarhide Devonian Unit, located in Section 4, Township 25 South, Range 38 East, Lea County, New Mexico (Site). The spill site coordinates are N 32° 10' 07.7", W 103° 04' 08.5". The State of New Mexico C-141 (Initial and Final) is included in Appendix A. The Site is shown on Figure 1.
