Final Site Investigation Report
& Abatement Completion Report:
Bertha Barber EME E-5 Junction Box

RE: Final Site Investigation Report & Abatement Completion Report:
Bertha Barber EME E-5 Junction Box
NMOCD Case No.: 1R0427-91

RICE OPERATING COMPANY
JUNCTION BOX CLOSURE REPORT

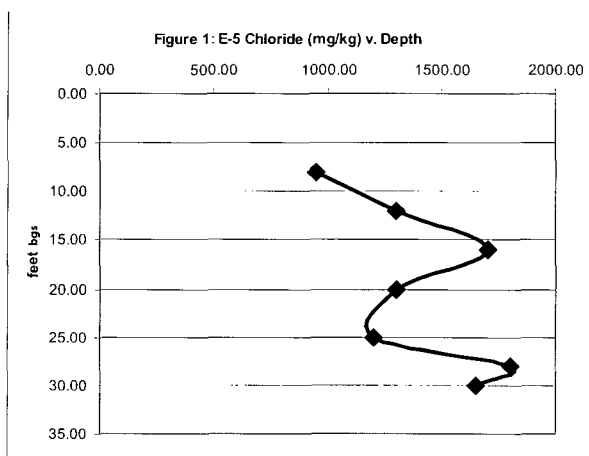
Figure 1: Chloride Concentrations in the Vadose Zone, 2002

Past operations at the site released brine and caused chloride to enter ground water. Soil samples show chloride concentrations are relatively constant from the junction box to ground water, which is 30–40 feet below ground surface (see Figure 1). This chloride signature suggests that saturated or near-saturated flow existed during past operations. Nevertheless, this information does not suggest a large mass of chloride entered ground water and caused measurable impairment.

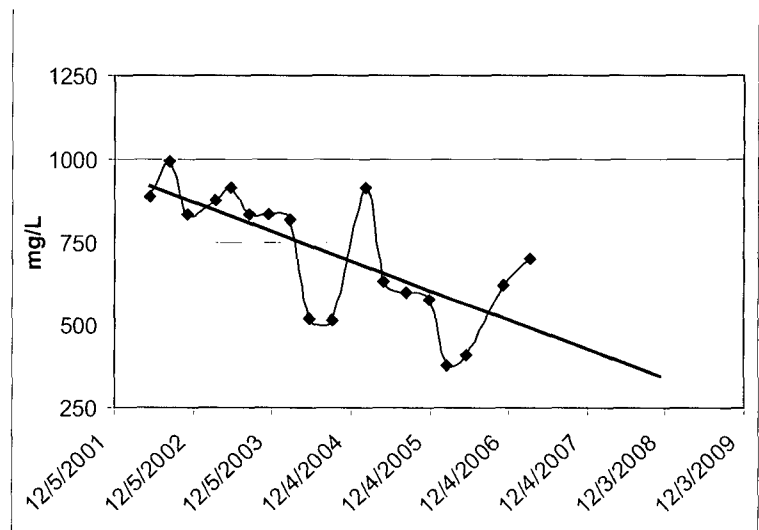
Natural restoration (dilution and dispersion) will mitigate the impact to ground water caused by up-gradient sources by about 2009. Figure 2 shows the chloride concentrations in MW-1 over time after deleting the spurious results discussed above. Figure 2 shows the calculated trendline that predicts ground water impacted by up gradient sources in the area will meet WQCC Standards (250 mg/L chloride) by about 2009.

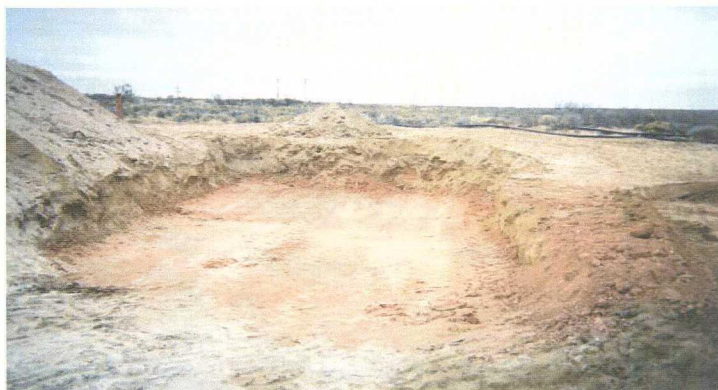
Figure 3. Installation of approved ET Barrier, December 2006.

The evapotranspiration (ET) barrier installed by ROC in December, 2006, will sequester chloride in the vadose zone, eliminating any threat to fresh water, public health or the environment. Extensive studies by the EPA, Sandia National

Consultants in conformance with the specifications. Compaction documentation for the ET barrier are also included in Appendix E. The site was seeded on April 10, 2007.

In accordance with the NMOCD-approved plan, ROC installed and documented (see Appendix E) the ET infiltration barrier in December, 2006. The site was seeded in April and is expected to return to natural productive capacity. ROC now respectfully requests closure of the regulatory file associated with the E-5 site.

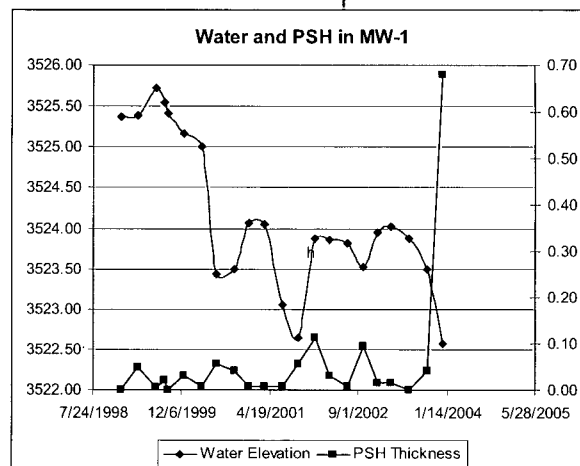
Figure 1. Water and PSH in MW-1.

In 2003, BBC International observed phase-separated hydrocarbons in MW-1. As shown in Figure 1, PSH in MW-1 is not uncommon. No other wells exhibited PSH in 2003. As Table 1 shows, before 2003 PSH occurred more than once in wells MW-2, MW-4, MW-5, MW-7, MW-9 and MW-10. Generally, the PSH thickness in these other wells was less than 0.01 foot from 2001-2003.

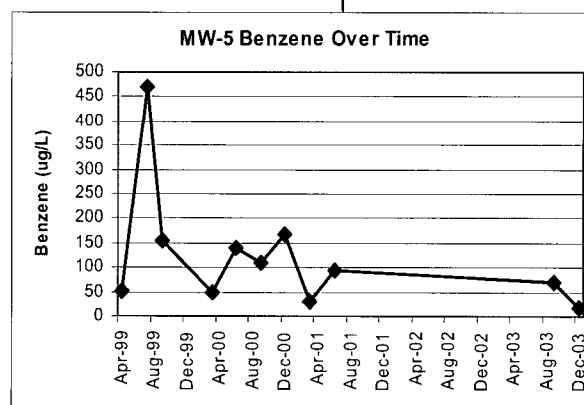
Figure 2. Benzene over time in MW-5.

The chemical analyses are summarized in Tables 2, 3 and 4 along with historical results from each well. In 2003, only MW-5 exhibited benzene above laboratory detection limits. Figure 2 shows the chemical trend in this well over time. Figure 3 compares the benzene concentrations in MW-5 with those observed in MW-4. Samples from MW-4 have not detected benzene since March 5, 2003. Forecasting the benzene concentration decline suggests that MW-5 will meet WQCC standards by 2008. We hypothesize that benzene concentrations in MW-5 will now decline at a faster rate because recent benzene concentrations are relatively low. If we observe a decline similar to that observed in MW-4, we may witness MW-5 at or below 10 ppm benzene by 2006.

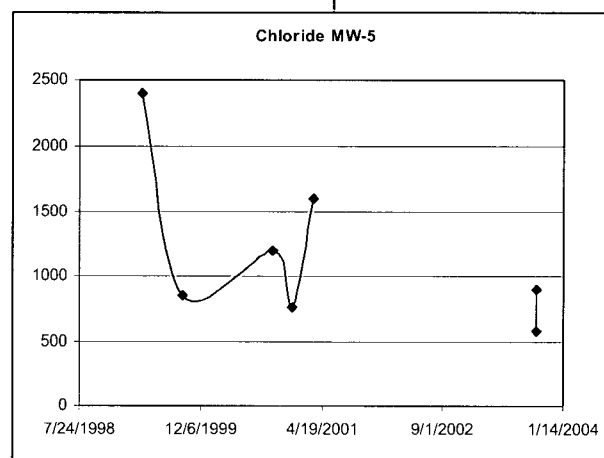
Figure 4. Chloride in MW-5 over time.

Total Dissolved Solids (TDS) and chloride are above WQCC standards in several wells, including the up gradient livestock well. The regional background TDS concentration in the area of the Bertha Barber site appears to be about 1600 ppm (see livestock well analyses in Table 3) and background chloride is about 650 ppm. Several monitoring wells exhibit chloride concentrations materially higher than background (see Plate 5). Figure 4 shows chloride concentration over time for MW-5. Like several other wells, chloride is decreasing with time due to natural dilution and dispersion. The most recent analysis (2003) suggests that MW-5 is very close to background conditions. Some wells show chloride and TDS concentrations increasing over time.

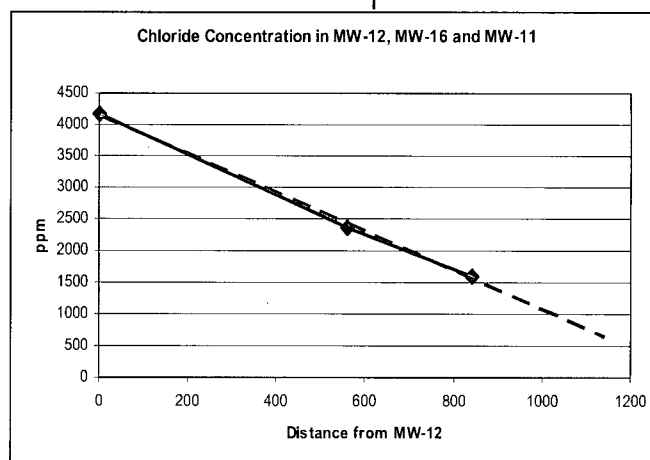
Figure 5. Chloride in MW-12, MW-16, MW-11.

We hypothesize that past discharges to the former evaporation pit caused localized impairment of ground water quality. Dilution and dispersion are mitigating the effect of these past releases and causing the TDS and chloride concentrations at MW-12 to decrease over time. Simple forecasting of the concentration decline at MW-12 suggests that this area will be at background concentrations in less than 10 years. We hypothesize that the zone of ground water impairment is not expanding but has reached a "dynamic equilibrium" and the relatively stable TDS and chloride concentrations at MW-11. Examination of the chloride and TDS data from MW-12, MW-16 and MW-11 suggest that background water quality exists about 1200 feet down gradient from MW-12 (Figure 5). Continued monitoring of MW-11 should show a decline of TDS and chloride over the next 10 years. Aerial photographic evidence shows that discharges to this pit have not occurred since 1975 or earlier. Therefore, an equilibrium condition as hypothesized above appears valid.

7. MW-12, MW-16, and MW-11 are within a zone of ground water impairment caused by past discharges to an evaporation pit (closed before 1975). The extent of this localized zone is about 1200 feet by 500 feet.

8. Natural processes have limited the extent of the zone of impairment identified by MW-12, MW-16 and MW-11 and these processes will cause this zone to reach background water quality in about 10 years.

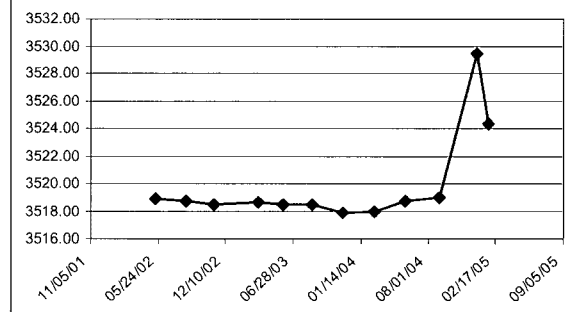
Figure 1: Hydrograph E-5 MW-1

Figure 1 is a hydrograph of the E-5 monitoring well of Rice Operating Company, which is gauged quarterly. In the area of the Bertha Barber site, water levels rose more than 10 feet. Other wells in the area also showed a rise in the water table elevation, but generally less than the 10 feet observed at the E-5 Bertha Barber site.

This rise in the ground water elevation shown in Figure 1 was a stress to the hydrogeologic system, similar to a pumping or injection well. When conducting a pumping test to determine aquifer property, one applies a

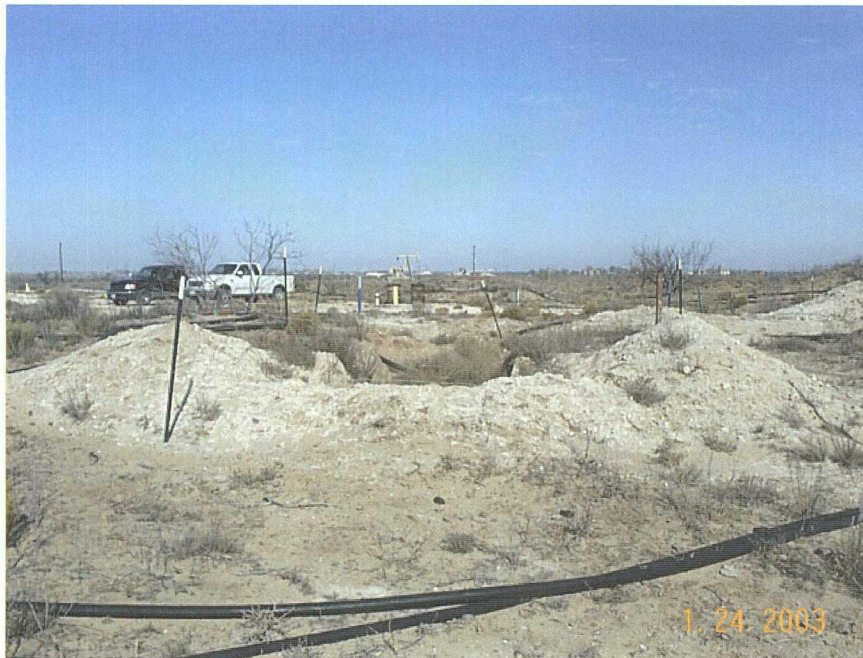
Figure 1: E-5 site prior to installation of ET Barrier

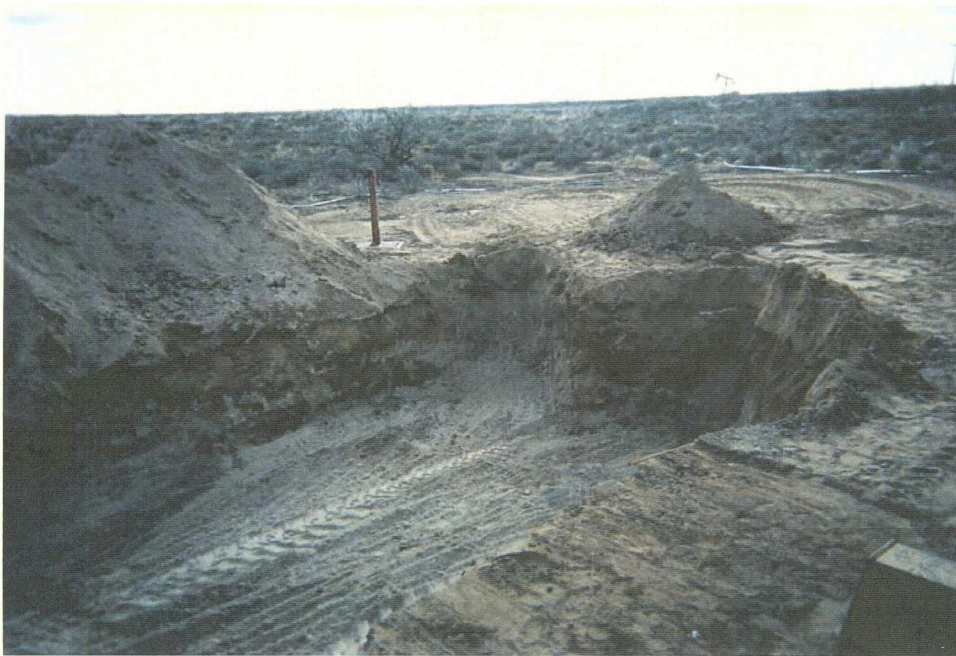
Figure 2: Excavation of site in preparation for ET Barrier, December 2006

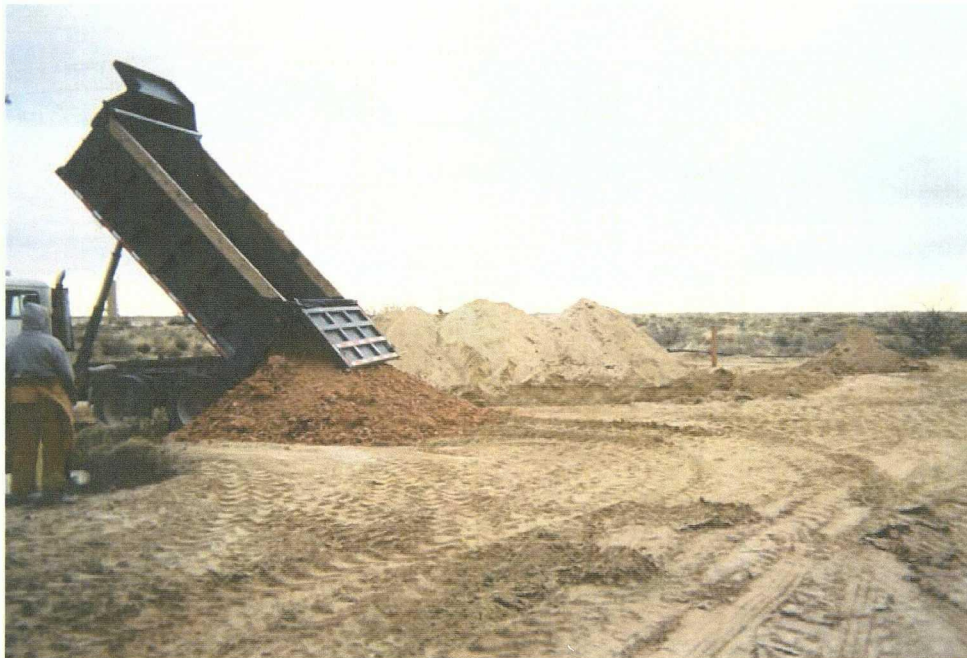
Figure 3: Delivery of red clay

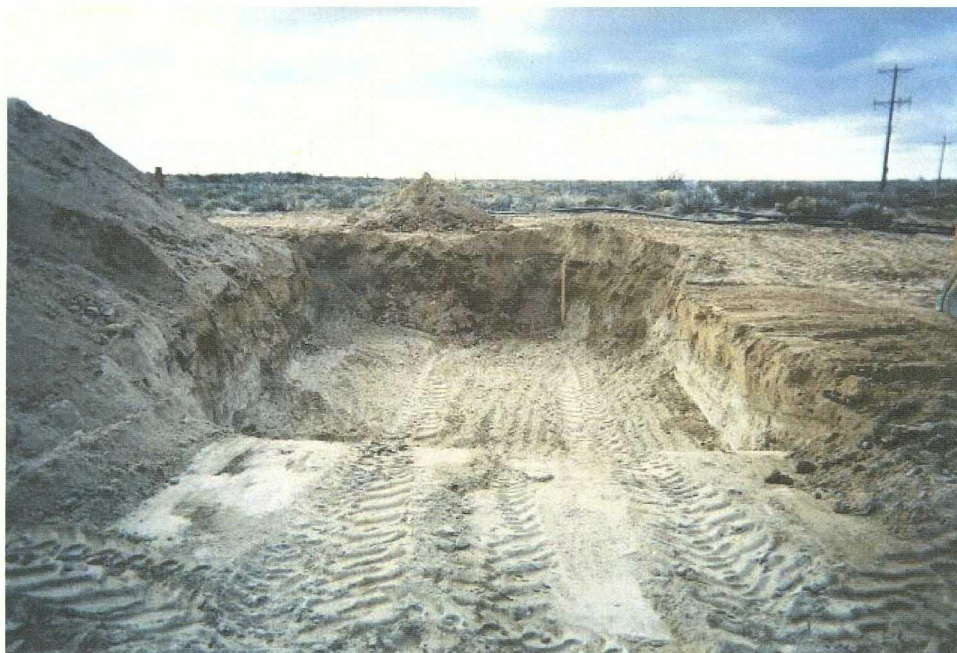
Figure 4: Preparation for installation of ET barrier

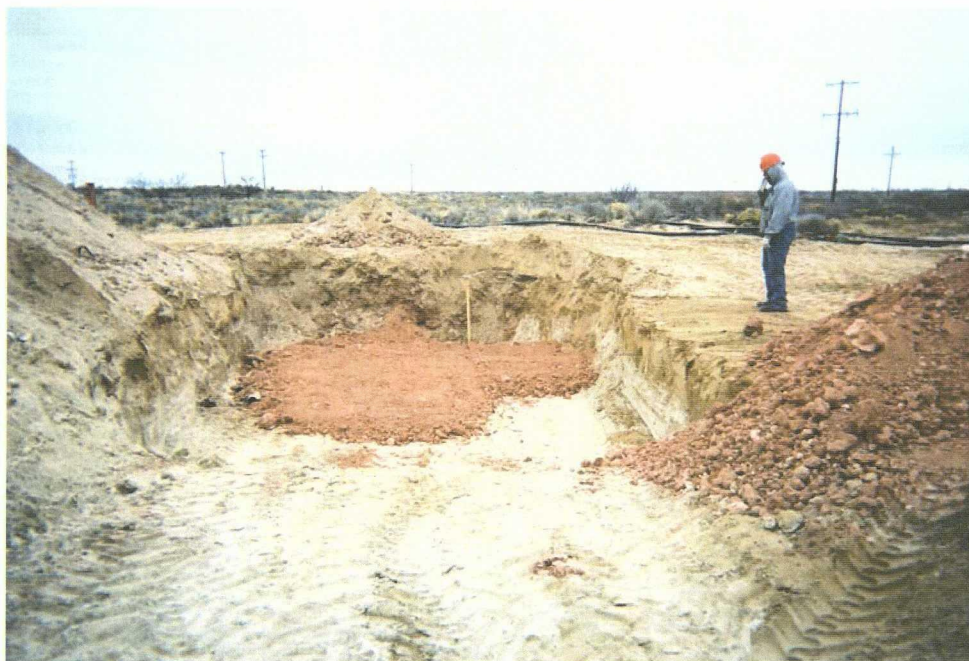
Figure 5: Placement of first clay lift on prepared surface

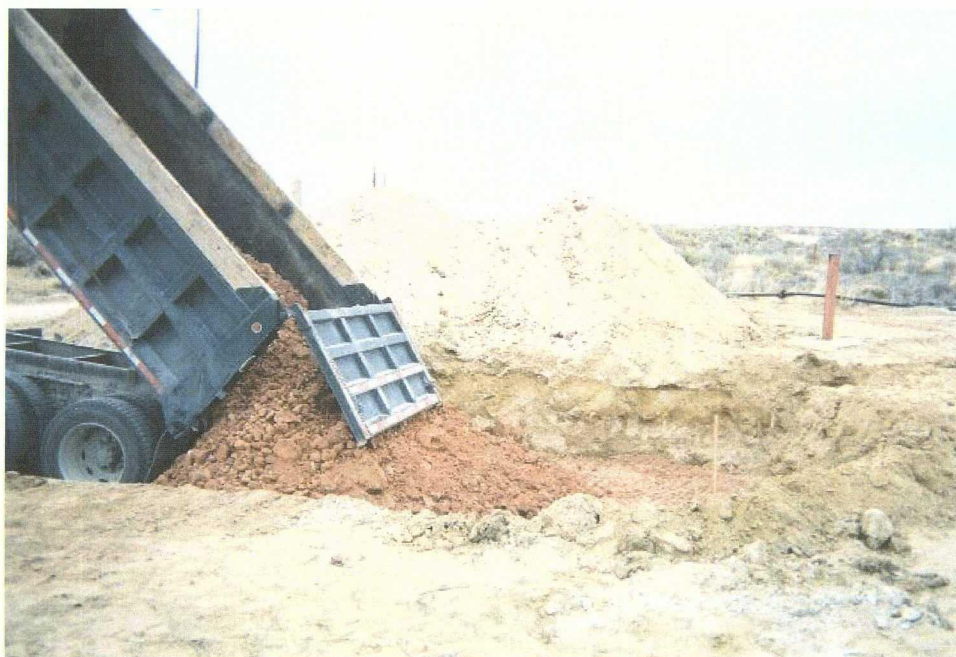
Figure 6: Delivery of clay for second lift

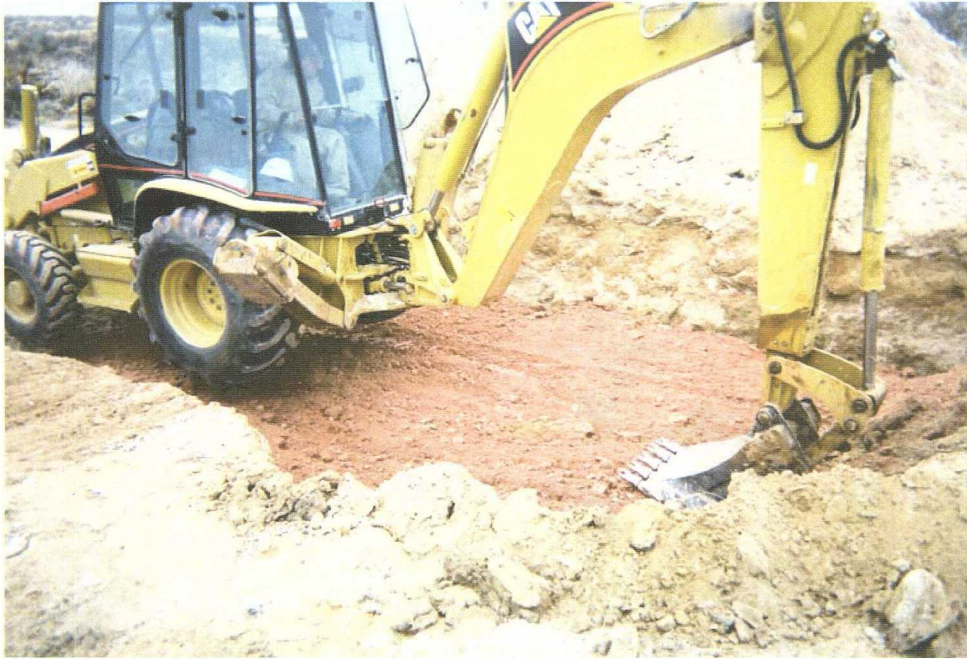
Figure 7: Compaction of clay layer

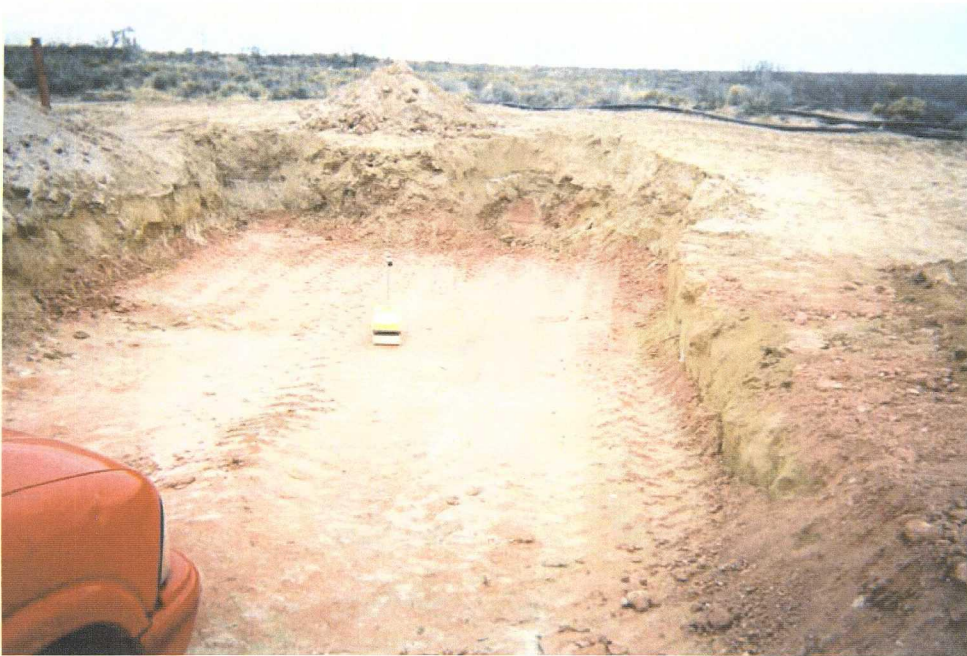
Figure 8: Density testing of clay lift

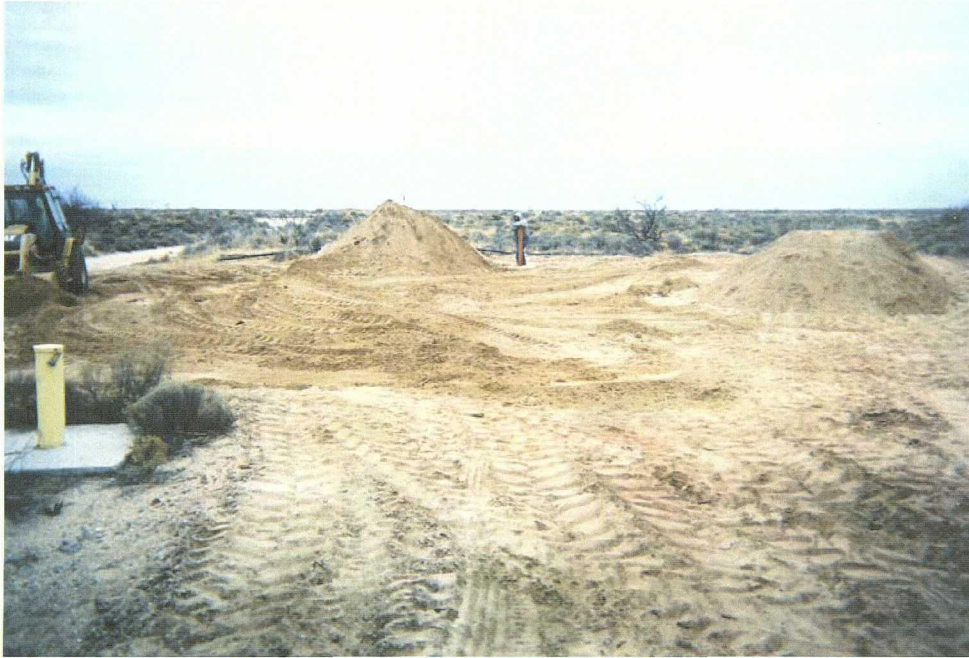
Figure 9: Placing topsoil over compacted clay

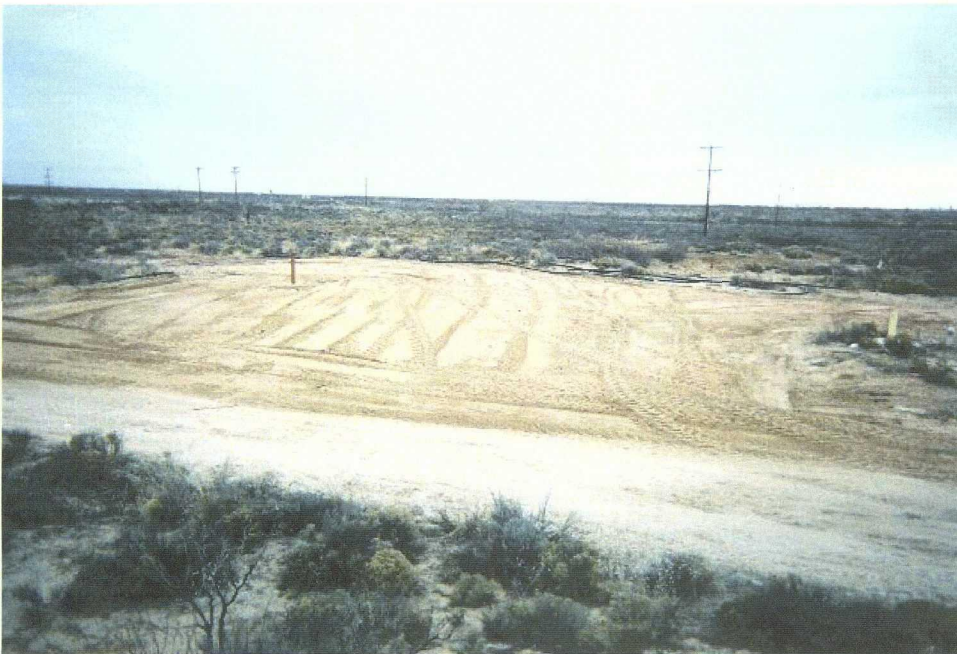
Figure 10: Final grade of topsoil, December 2006

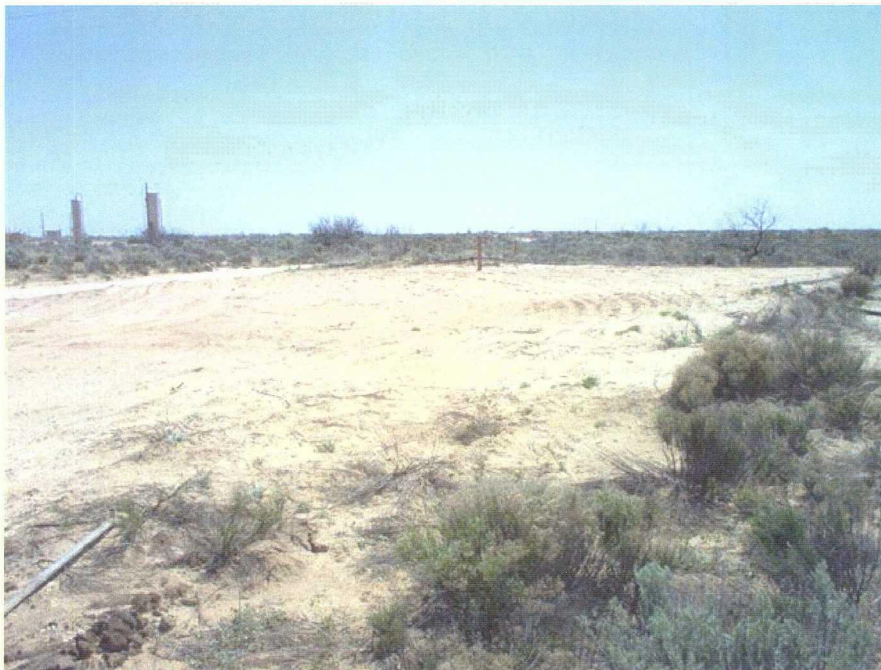
Figure 11. Site prior to seeding, April 10, 2007

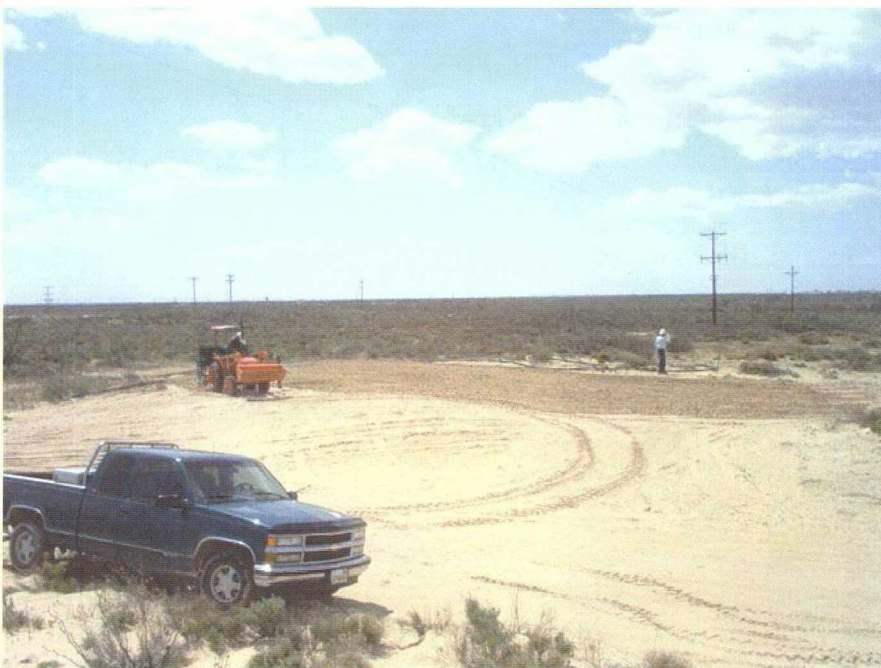
Figure 12. Seeding Site

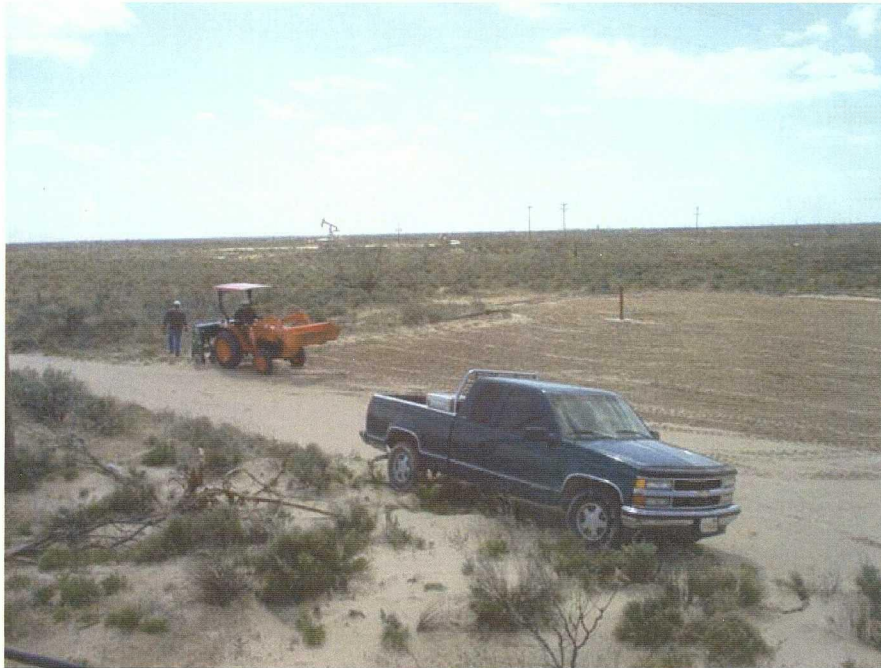
Figure 13. Seeding Site

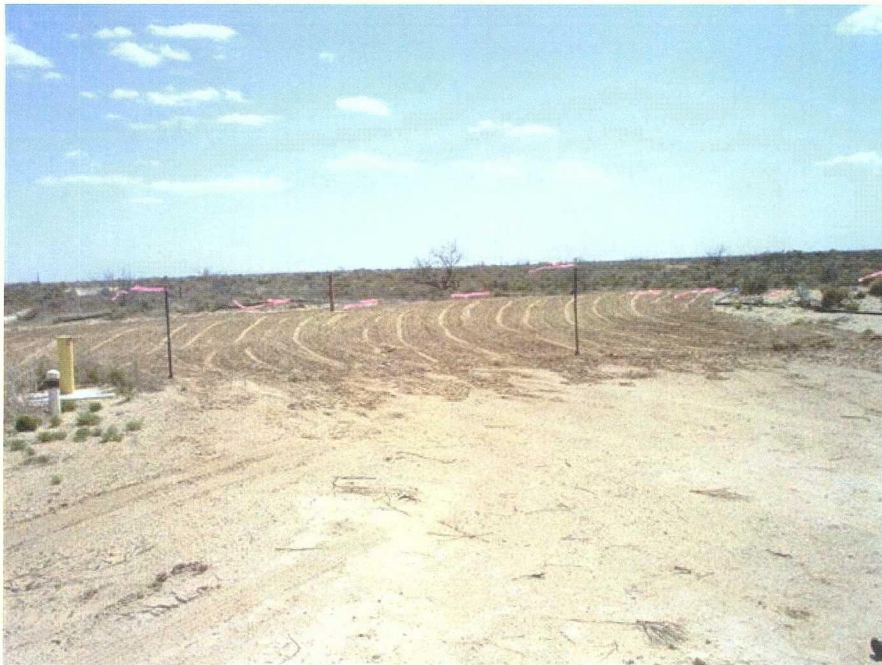
Figure 14. Seeded site, April 10, 2007.
