BO Jet G-26-1

# Final Report

# Closure

RICE OPERATING COMPANY  
JUNCTION BOX FINAL REPORT

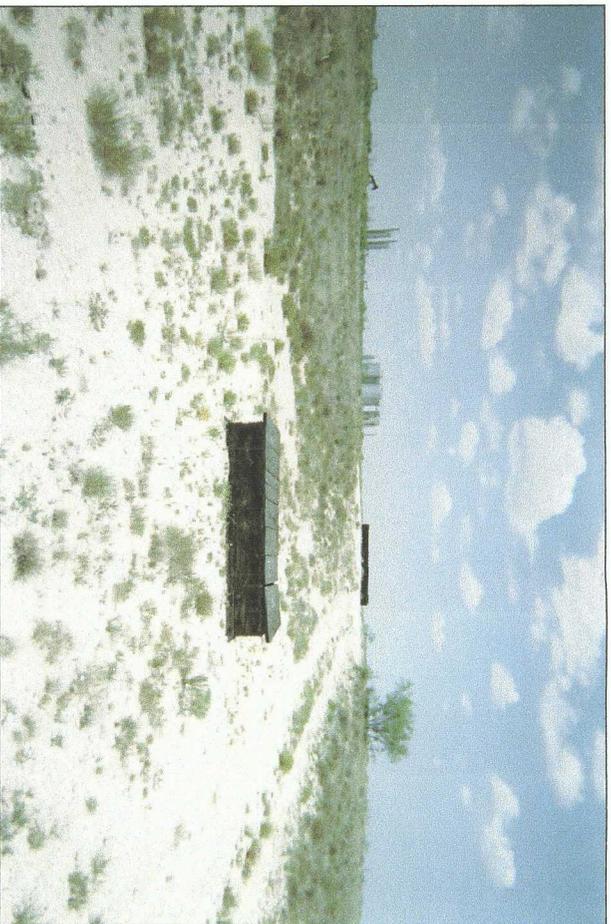
7/23/2003

undisturbed junction box

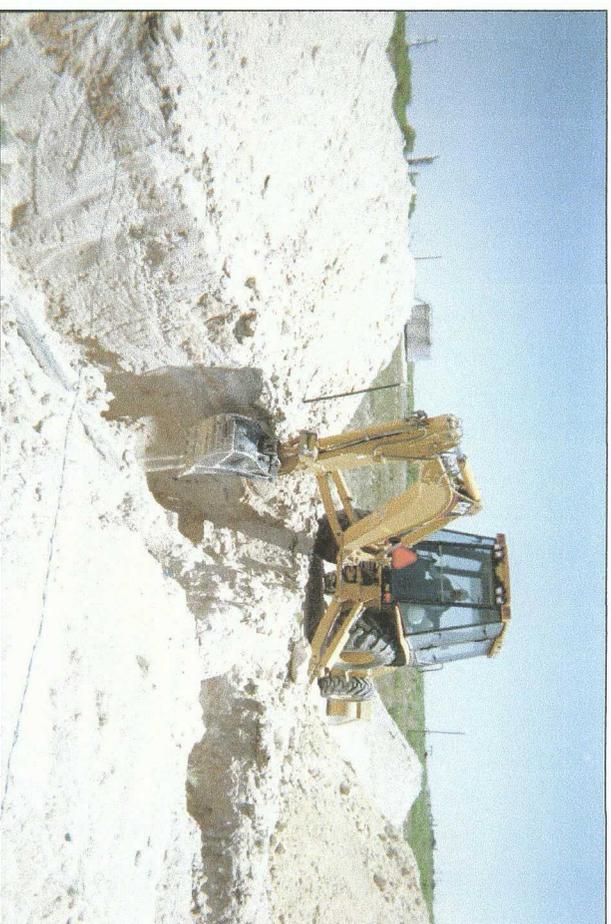
May 2006

delineation trenches

This junction box was eliminated with the pipeline replacement/upgrade program. After the junction box was removed, the site was delineated using a backhoe to collect soil samples at regular intervals. The samples were field tested for VOCs using a PID and yielded very low concentrations. Chloride concentrations were also generally low. Composite samples from the 30 x 30 x 12-ft-deep excavation for laboratory analysis. Lab results confirmed the chloride field tests and NMOCD TPH guideline concentrations were met. The excavated soil was blended on site and then backfilled into the excavation and contoured to the surrounding terrain. The disturbed surface was seeded on 8/31/2006 with a blend of native vegetation and is expected to return to productive capacity at a normal rate.

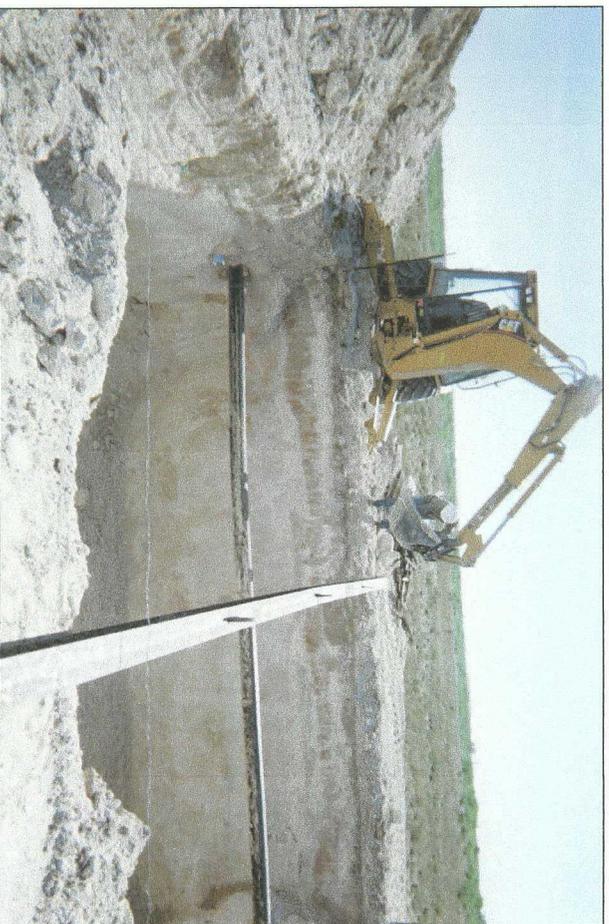
5/19/2006

collecting samples from final 30 x 30 x 12 ft excavation

5-point composite sample of bottom and 4-point composite sample of excavation sidewalls. TPH and chloride laboratory test results completed by using an approved laboratory and testing procedures pursuant to NMOCD guidelines.

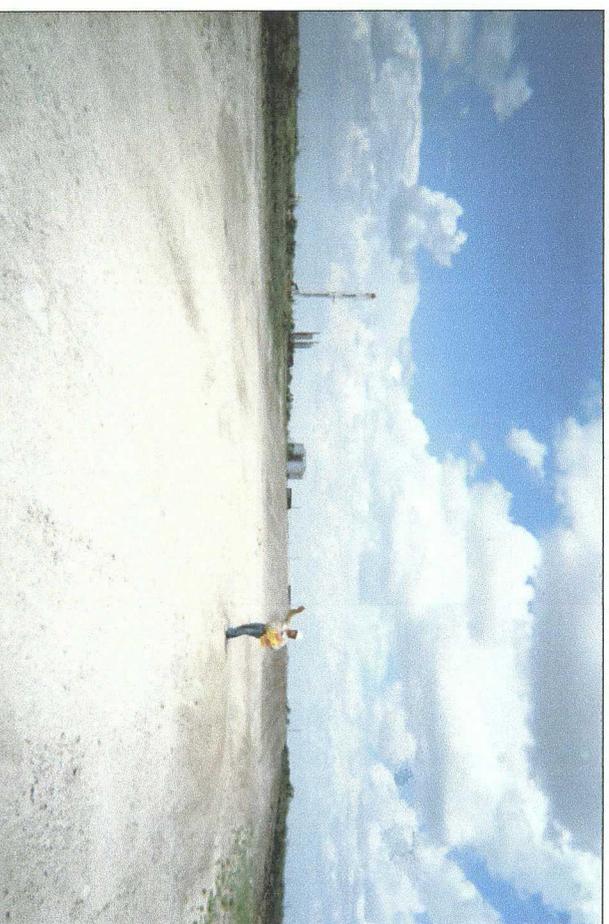
8/31/2006

seeding disturbed surface at backfilled site
