Release Notification and Corrective Action

Name of Company: Targa Midstream Services L P	Contact: Tim Jordan or Ralph England
Address: PO Box 1689 Lovington, NM 88260	Telephone No. (575) 396-3221
Facility Name: Saunders Plant	Facility Type: Gas Processing Plant

Type of Release: Natural Gas and Produced Liquid	Volume of Release: Approximately 14.15 mcf of raw gas and unknown amount of Produced liquid.	Volume Recovered: 0
Source of Release: Hole in 4" Pipeline with 14 psig of pressure passing about 70mcf of natural gas with containing 2500ppm of H2S. Line has been taken out of service.	Date and Hour of Occurrence: Not sure	Date and Hour of Discovery 05/05/09 Line monitor aircraft discovered leak
Was Immediate Notice Given? <input type="checkbox"/> Yes <input checked="" type="checkbox"/> No <input type="checkbox"/> Not Required	If YES, To Whom?	
By Whom?	Date and Hour	
Was a Watercourse Reached? <input type="checkbox"/> Yes <input checked="" type="checkbox"/> No	If YES, Volume Impacting the Watercourse.

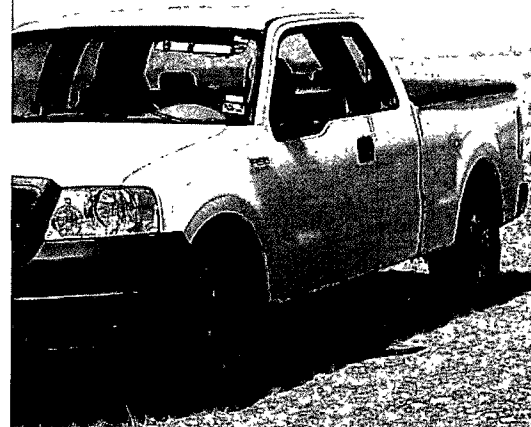
West

06/08/2009

Targa has excavated the contaminated area from leak to include runoff. Contaminated soil has been hauled to an approved landfarm. Targa purchased soil from Landowner to fill excavation after approval to close.

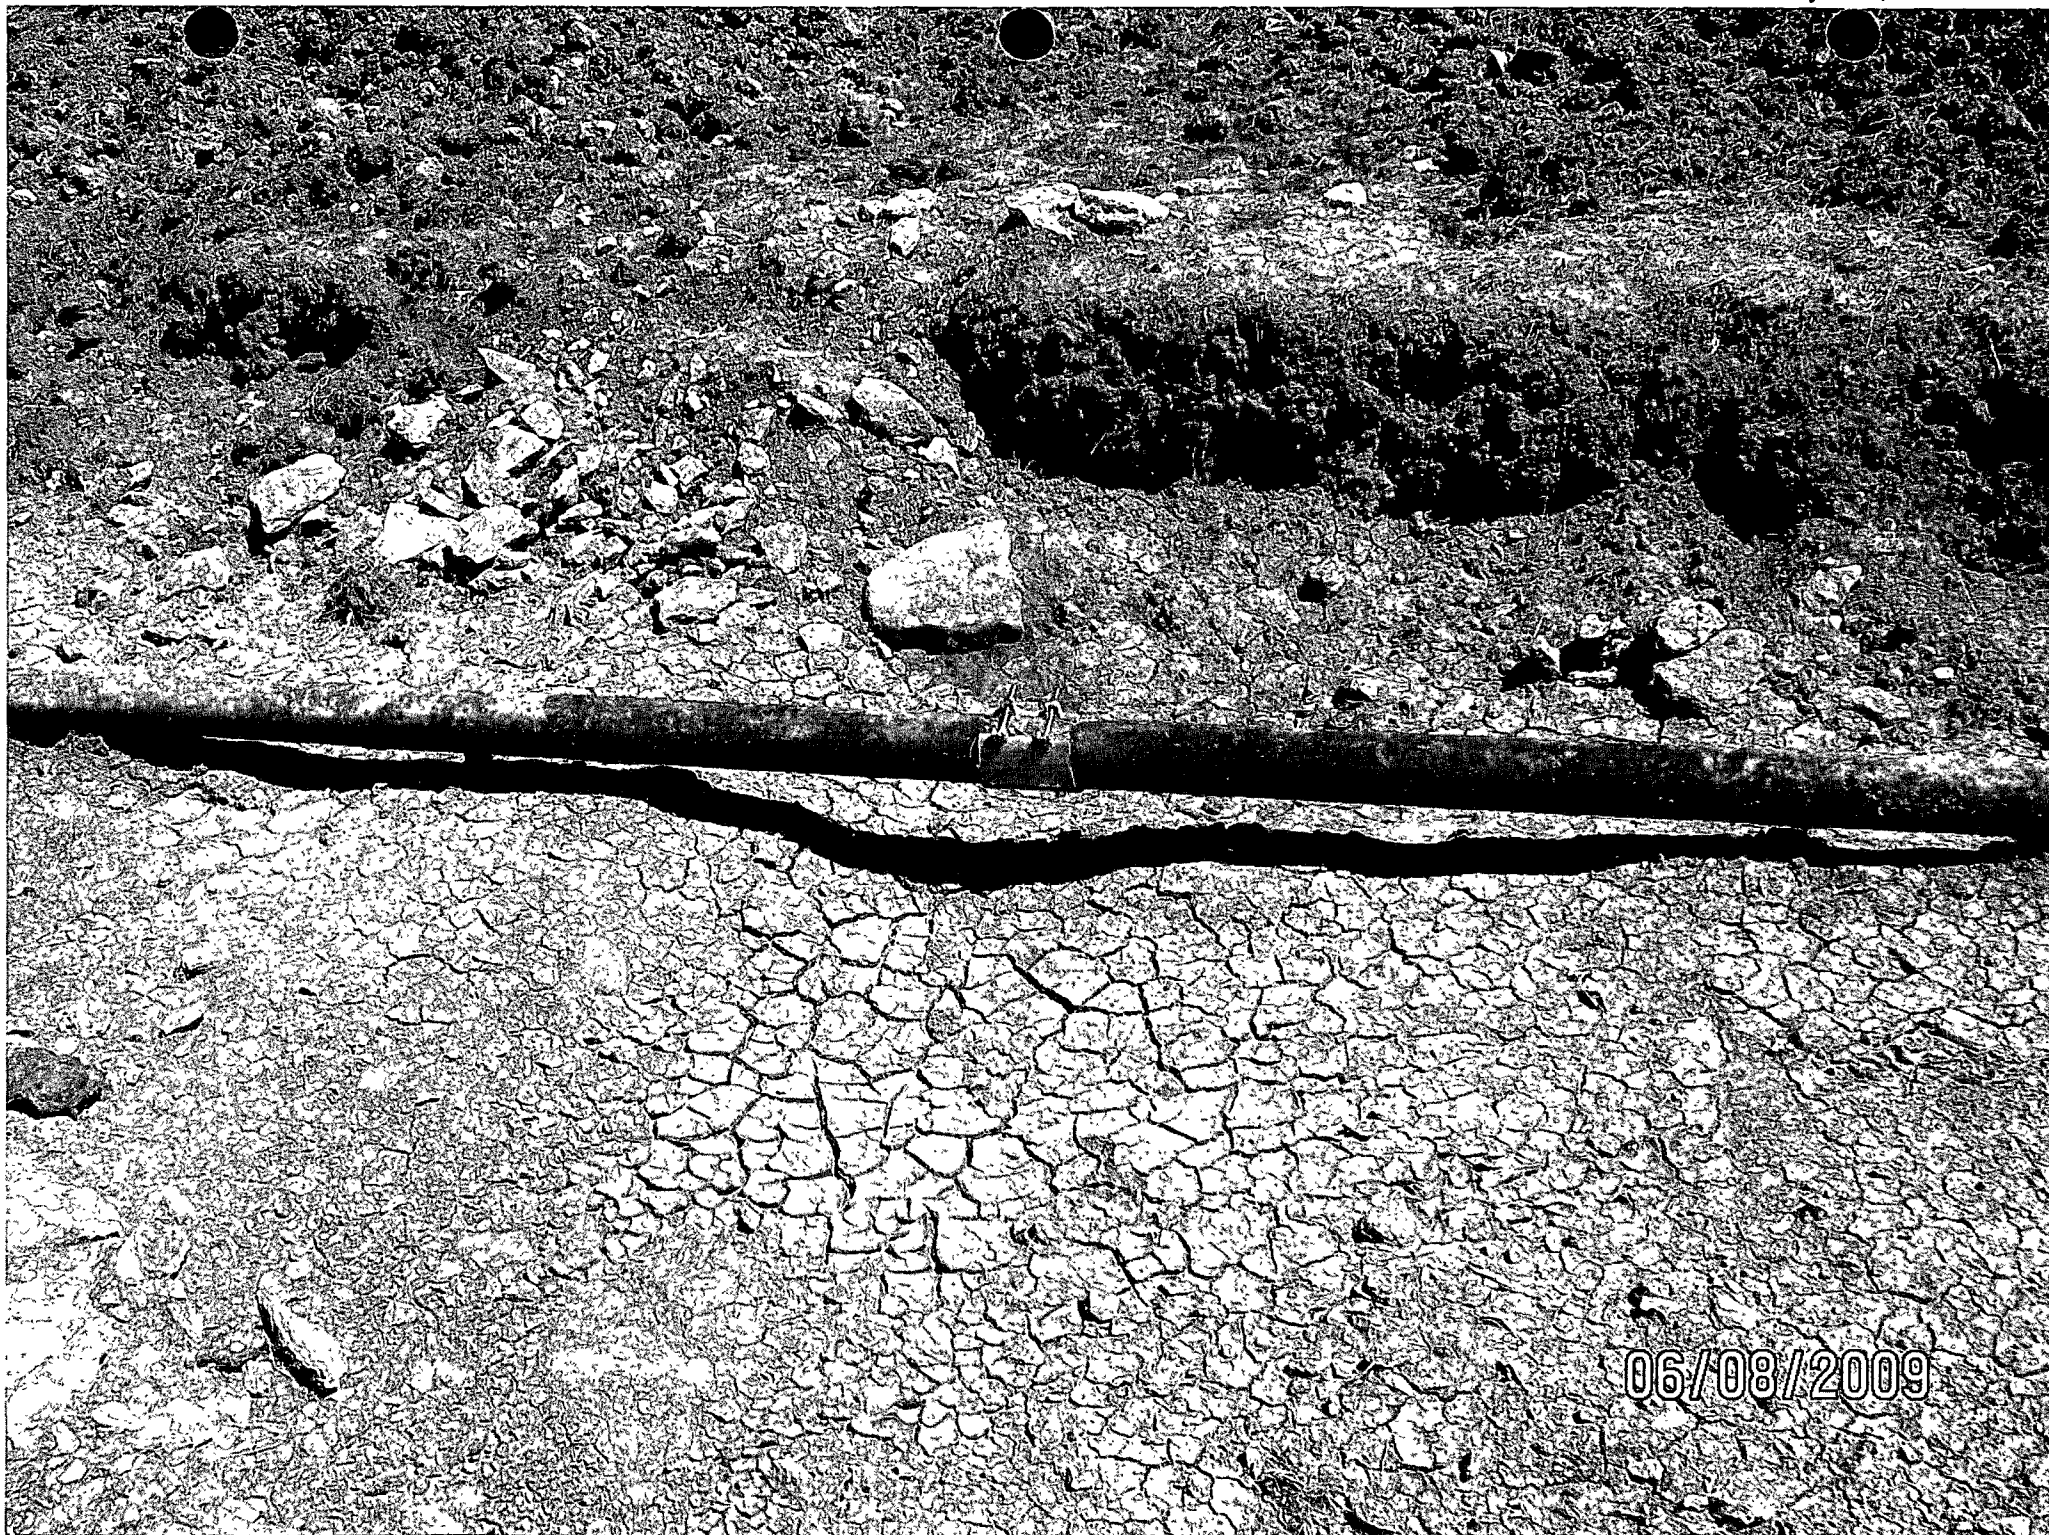
West

06/08/2009

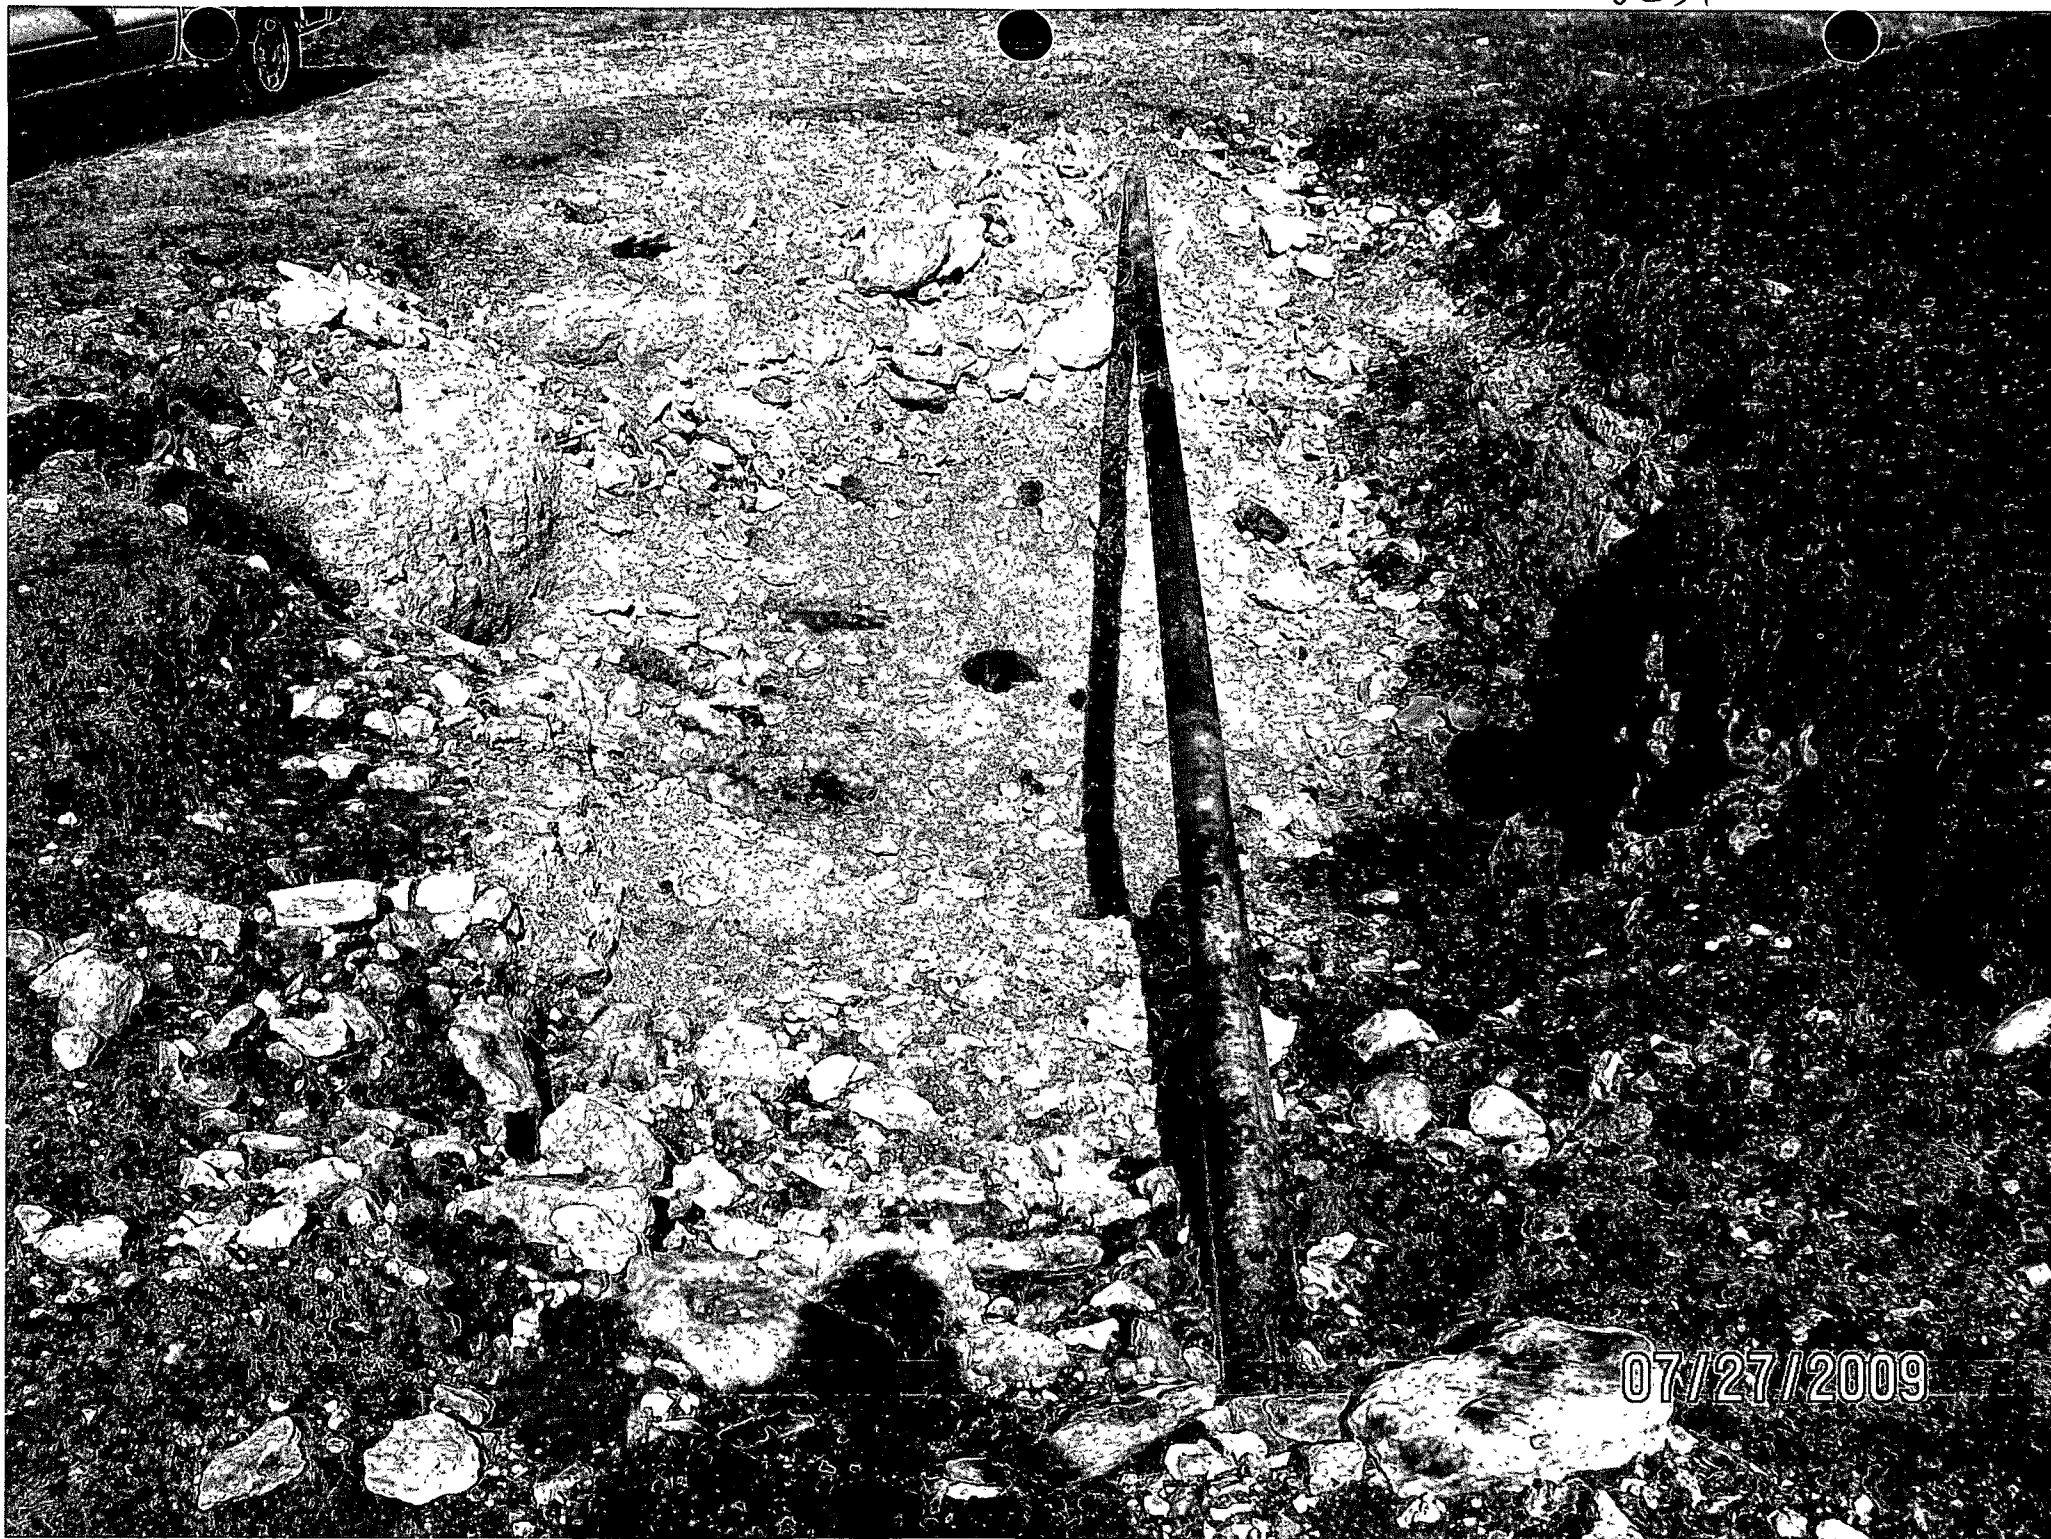
West

07/27/2009

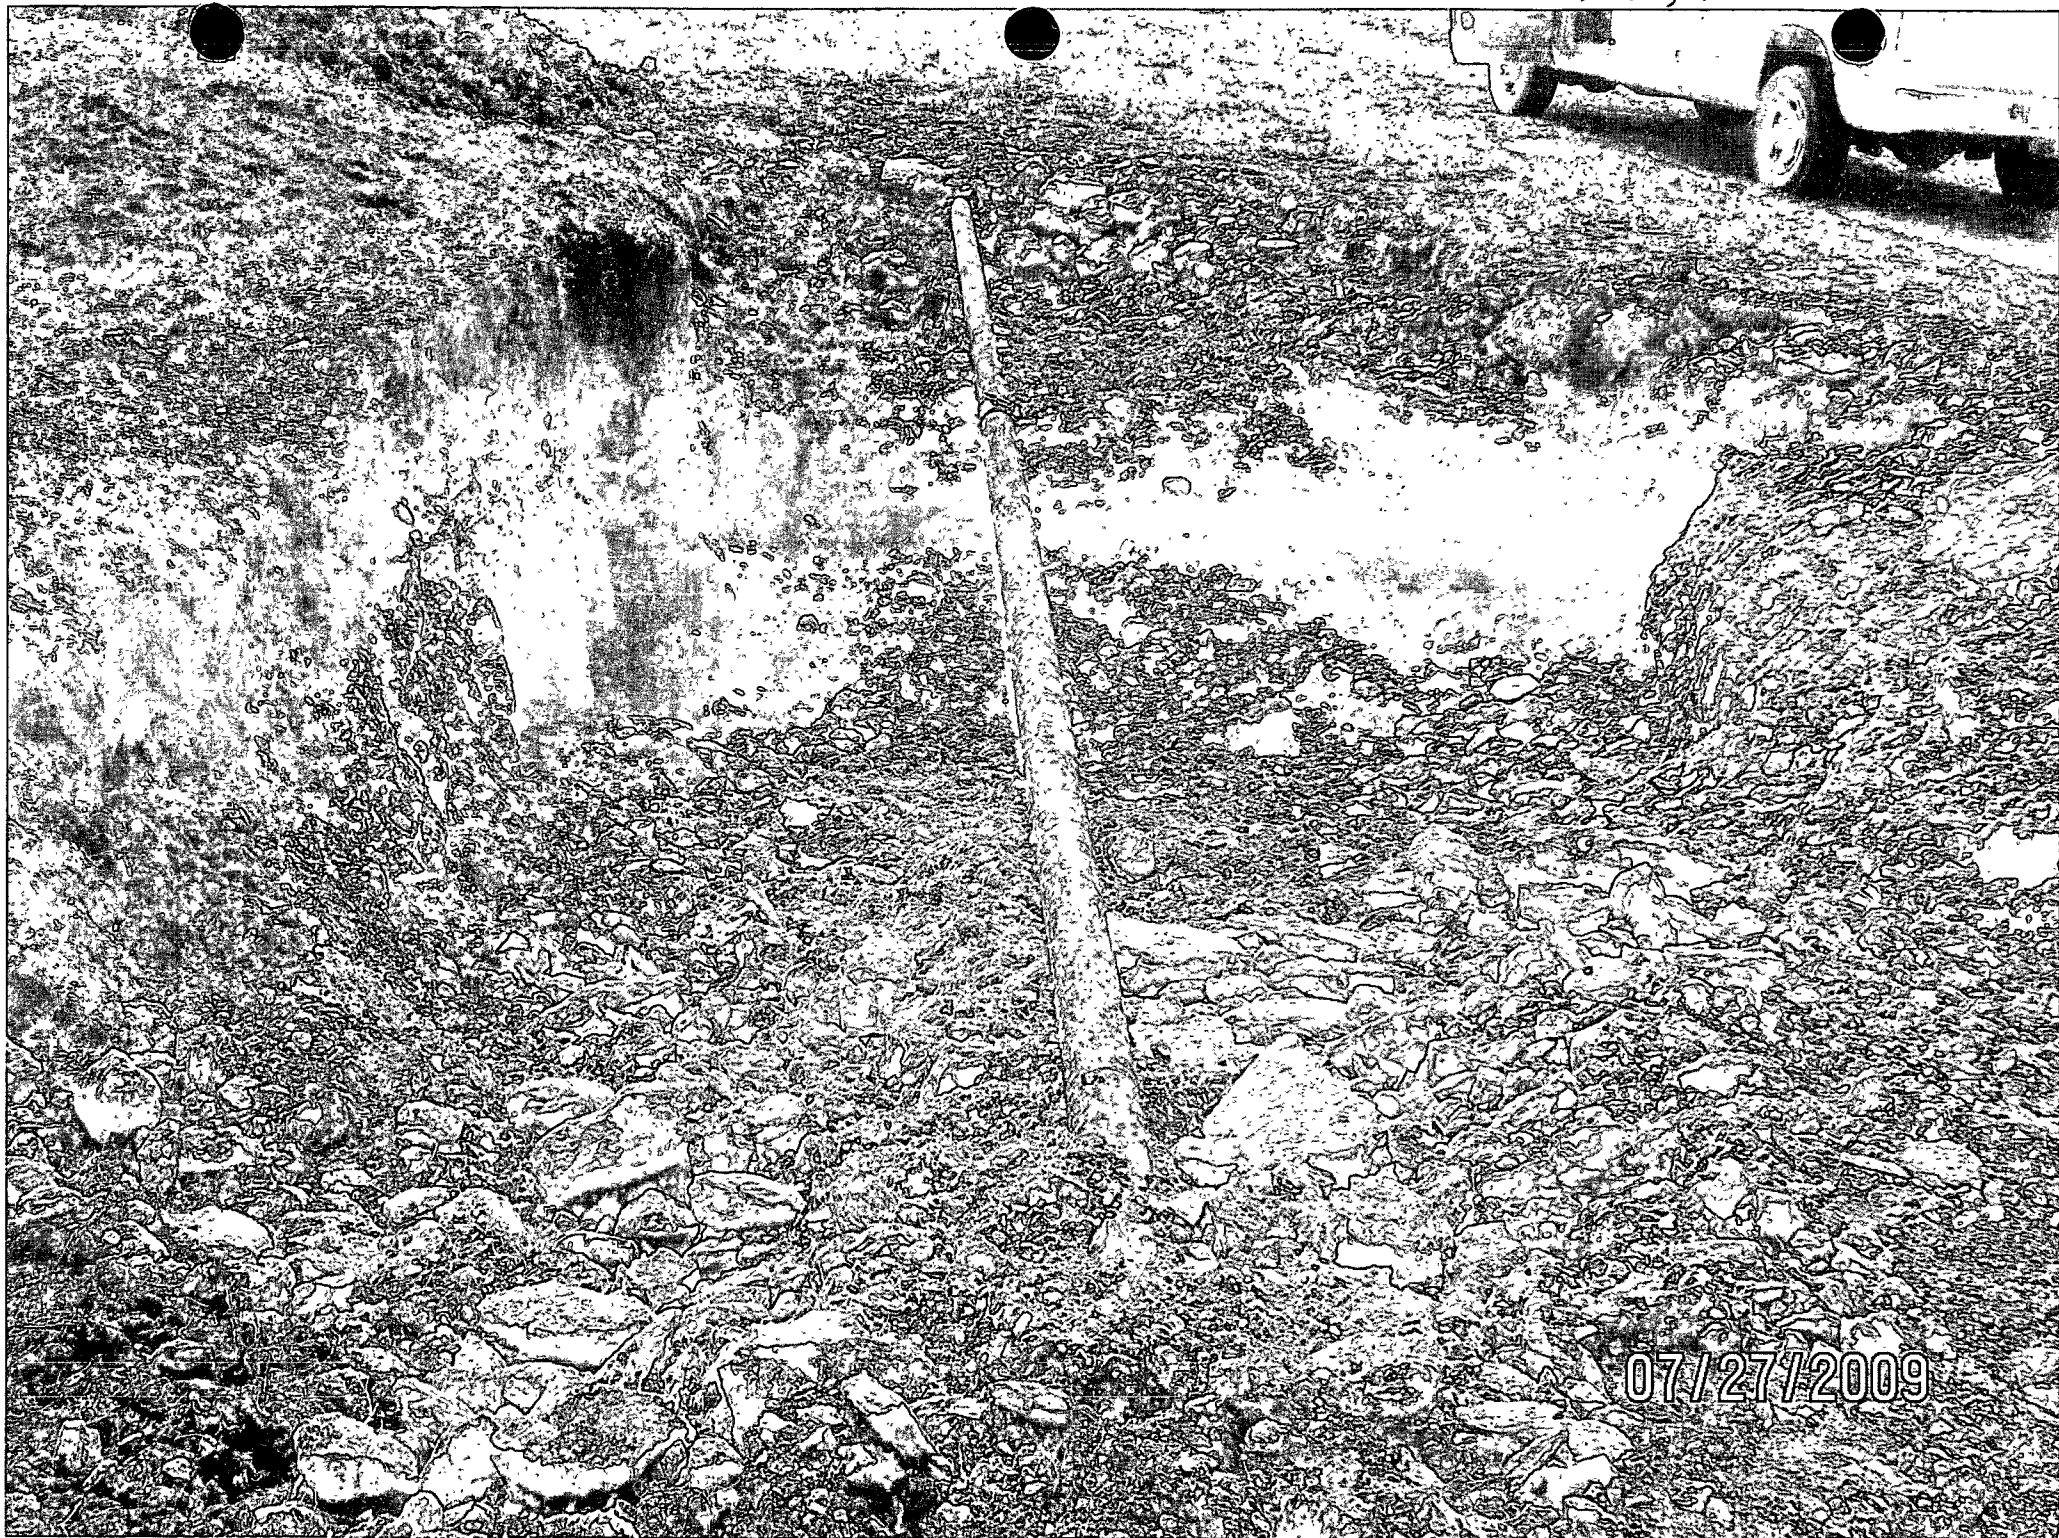
West

07/27/2009
