#### RICE OPERATING COMPANY JUNCTION BOX FINAL REPORT

# BD Jct. P-1

# BD Jct. P-1 unit 'P', Sec. 1, T22S, R36E

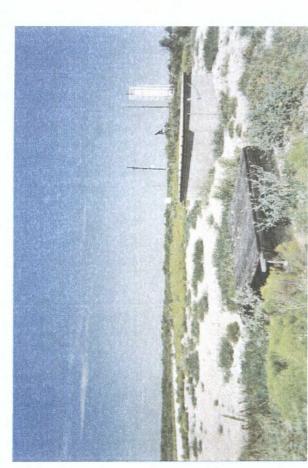
8/7/2007

undisturbed junction box in foreground with new, water tight box in background

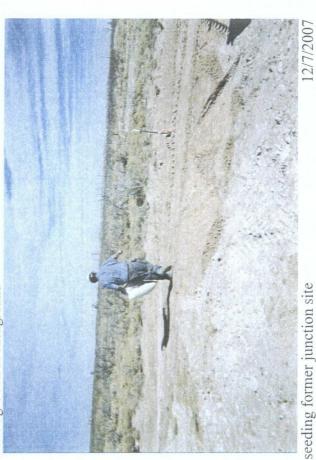
Unit P, Section 1, T22S, R36E

seeding former junction site

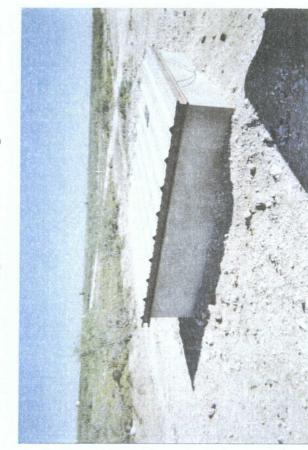
10/17/2006

new, water tight junction box 30' north of former

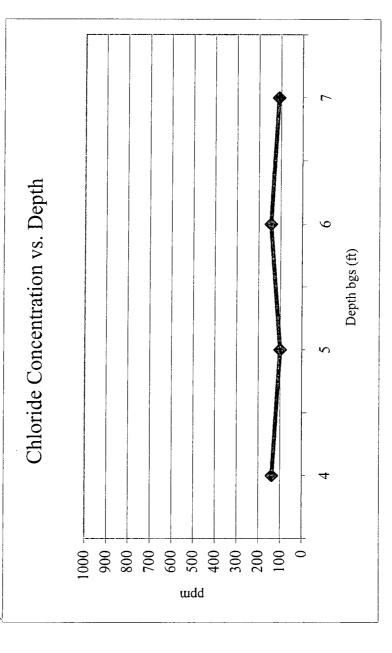
Backhoe samples at junction (source)

[Cl] ppm	137	100	144	109
Depth bgs (ft)	4	5	9	7

Groundwater = 130 ft
