Release Notification and Corrective Action

Name of Company: Judah Oil, LLC <i>245872</i>		Contact: Blaise Campanella	X Initial Report <input type="checkbox"/> Final Report
Address: PO Box 568, Artesia, NM 88211-0568		Telephone No.: 575-748-5488	NMOCD 2RP No.: <i>634</i>
Facility Name: Ford State No. 1		Facility Type: Oil	API No.: 30-015-22512
Surface Owner: State		Mineral Owner:	State Lease No.: E4205

Re: Ford State No. 1 Polyline Discharge *Corrective Action Plan*

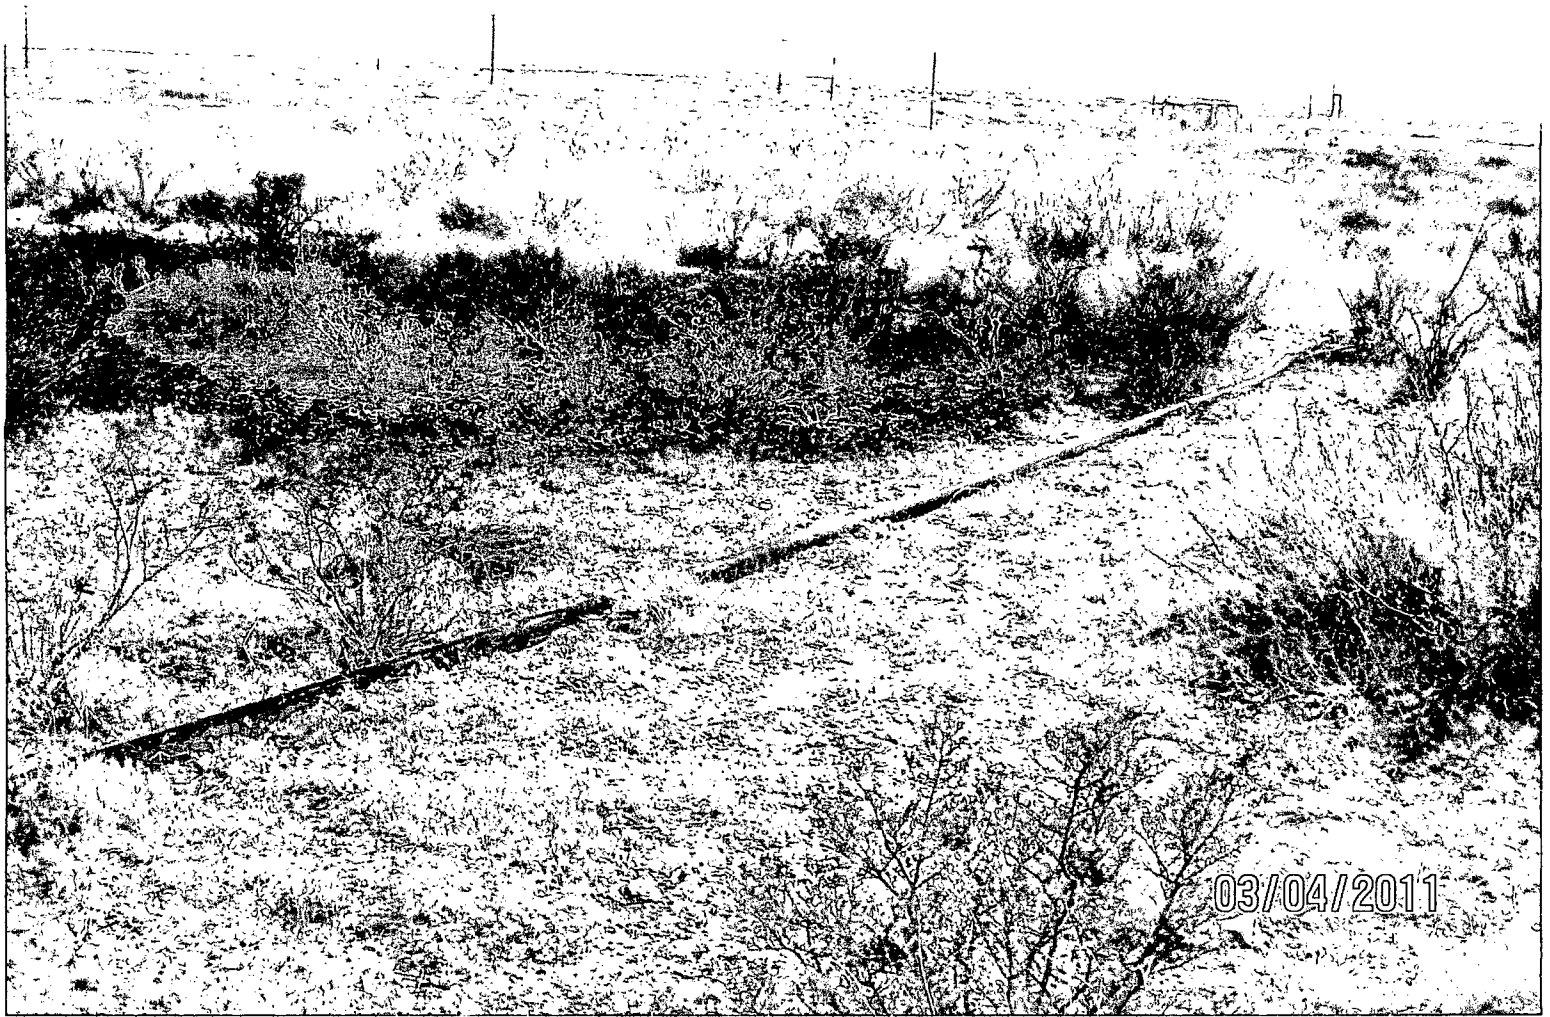
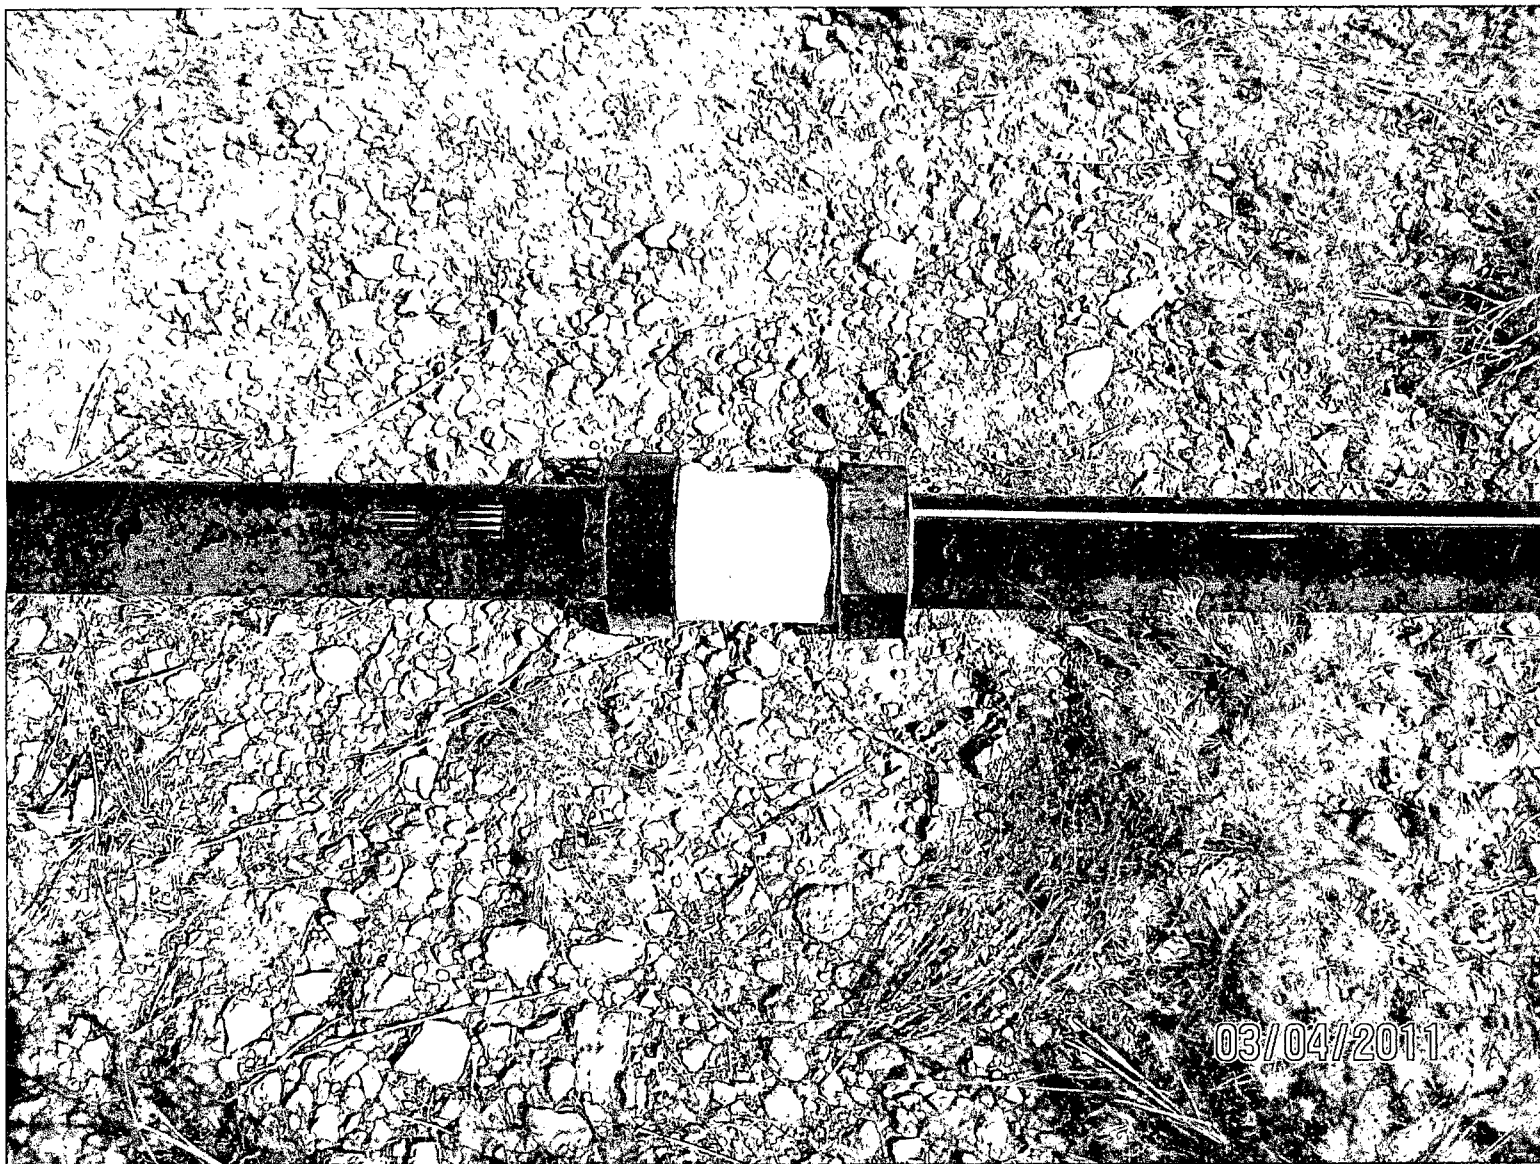
Judah Oil, LLC (Judah) herewith notifies the New Mexico Oil Conservation Division (NMOCD) that a hydrocarbon and produced water discharge occurred at the Ford State No. 1 which was discovered on 18 February 2011 by the pumper. The point of discharge occurred at a split that developed in the flowline running from the well to the remote tank battery when a geological survey crew drove across it.

Due to the fact that this point of discharge was approximately 640 feet from the Ford State No. 1 location and approximately 852 feet from the remote tank battery hidden in a dense grassy field exhibiting dull, straw-like winter killed vegetation supported within a noticeably undulating terrain, the discharge was not found immediately (photos enclosed). Production data indicates the discharge probably began on 4 February 2011 but remained unknown to the operator because the pumper apparently was not verifying or back checking his daily well production figures or he would have noticed something was wrong. When the monthly production figures reached Judah Oil's company office and the discrepancy was revealed, the pumper was severely reprimanded both for not notifying the office immediately and for repairing the flowline on 22 February 2011 and still not telling the office! However, the well was put back on line at this time.

Subsequently, Judah Oil has taken immediate proactive steps to remove the contaminated soils to an authorized disposal facility as soon as possible. Samples will be taken and following that, the NMOCD shall be notified of the soil chloride levels such that discernment may be employed in

implementing the *Corrective Action Plan* as quickly as possible. Following excavation, confirmation samples will be taken to verify compliance with NMOCD standards. Should you have questions, please call (575-748-5488).
