## CLOSURE

## RICE OPERATING COMPANY JUNCTION BOX FINAL REPORT

## **EME I-29-2 EOL**

# Unit I, Section 29, T19S, R37E

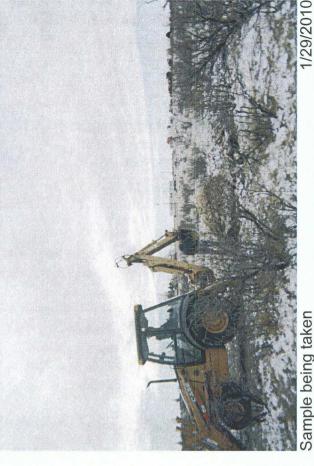
Sample being taken

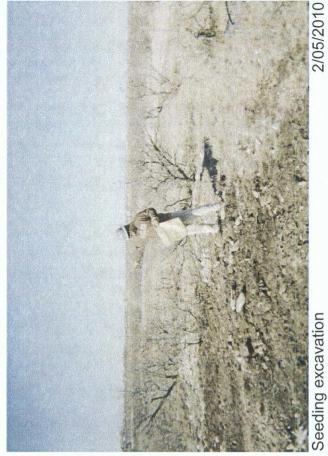
2/05/2010

Backfilling excavation

confirmed low concentrations of chloride and organics. The excavated soil was returned to the excavation to ground surface and contoured

to the surrounding area. On 2/05/2010, site was seeded with a blend of native vegetation and is expected to return to a productive capacity

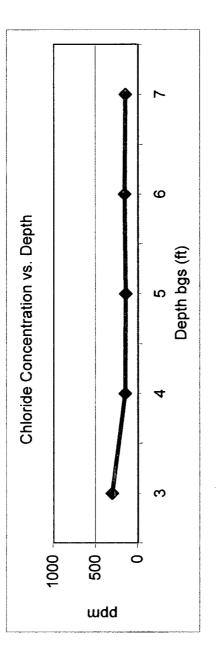
CHLORIDE CONCENTRATION CURVE

Backhoe samples at the junction (source)

| [CI] ppm | 301 | 146 | 141 | 154 | 145 |
| Depth bgs (ft) | З | 4 | 5 | 9 | 7 |
