OCD CASE NOS.  
15219 AND 15231

BOPCO  
Exhibit # 18

Poker Lake Unit  
Eddy County, New Mexico

Delaware Mountain Group  
Fracture Orientation Map

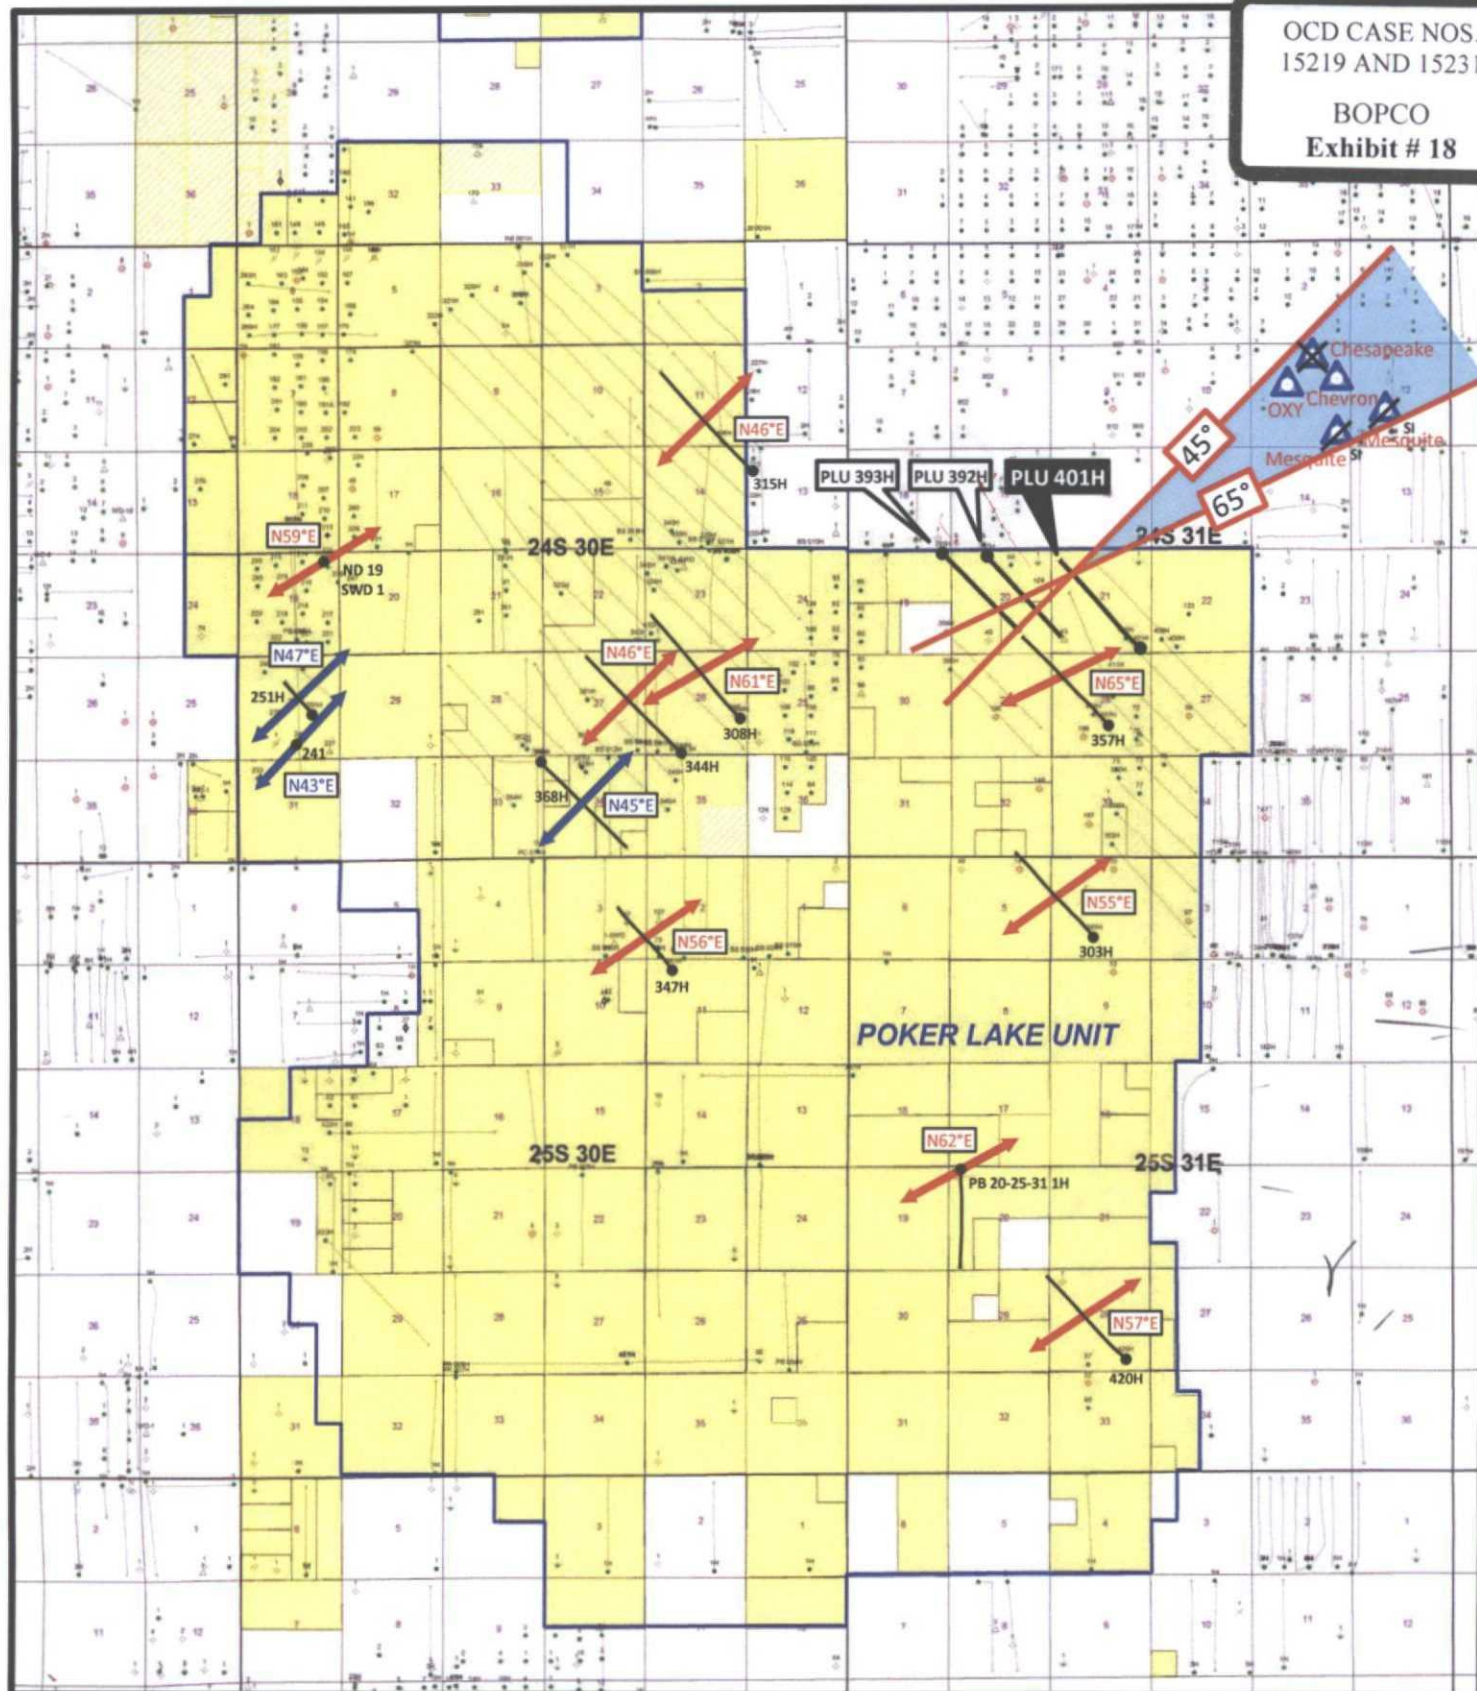
### Fracture Propagation Direction

FMI Data

Microseismic Data

Horizontal Well with Fracture Direction Data
