Corbin; Bone Spring, South Pool (Pool Code: 13160) Structure Map (Top 2nd Bone Spring Subsea)

Eland State 32-18S-33E #123H

BEFORE THE OIL CONVERSION
DIVISION
Santa Fe, New Mexico
Exhibit No. 9
Submitted by: MATADOR PRODUCTION
Hearing Date: January 21, 2016

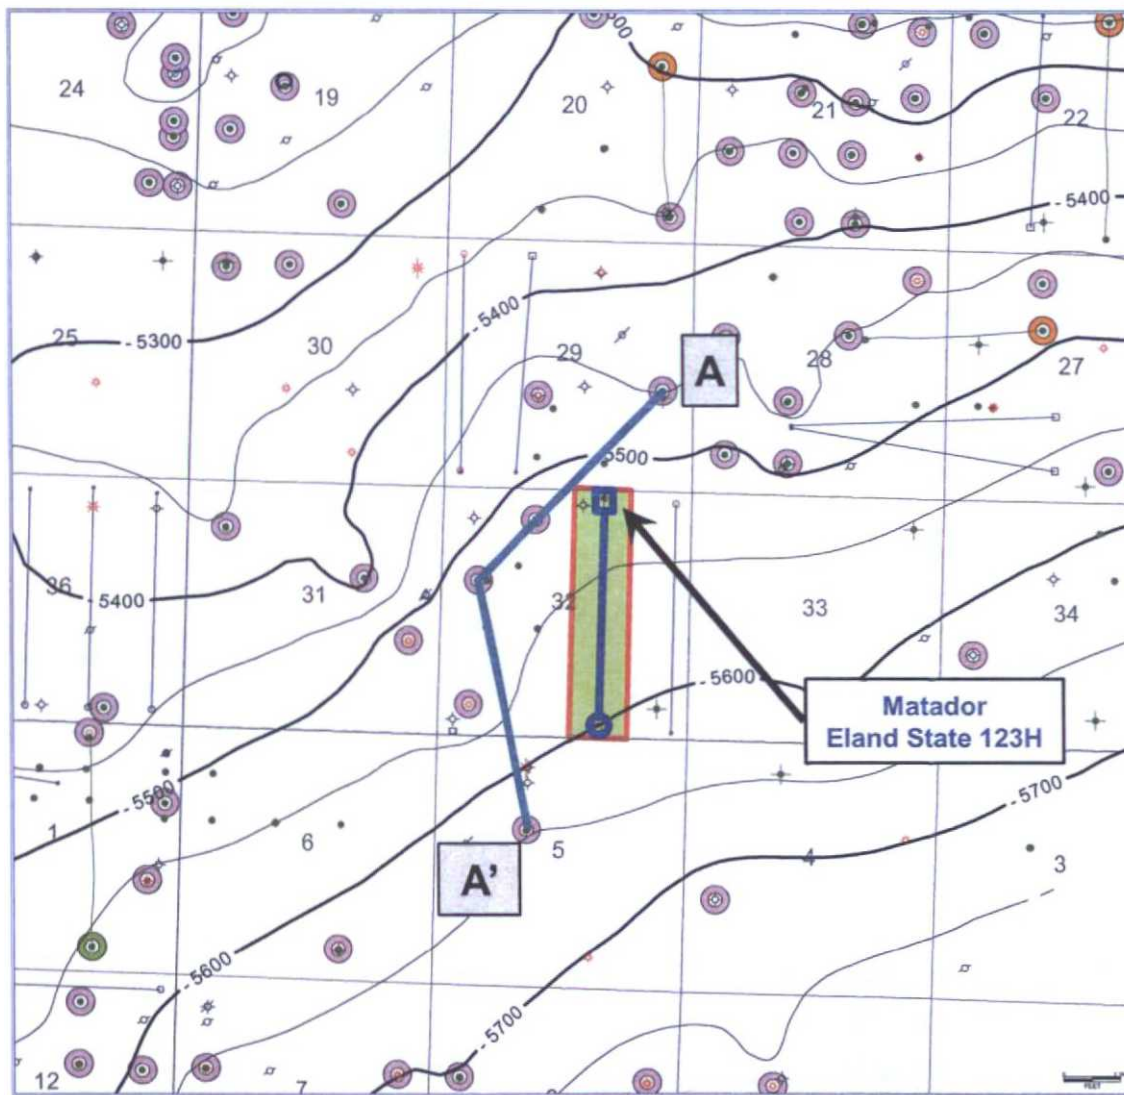
C.I. = 50'
