E K QUEEN FIELD

Lea County, New Mexico

Seely Oil Company

CENTRAL E.K. QUEEN UNIT  
Lea County, New Mexico

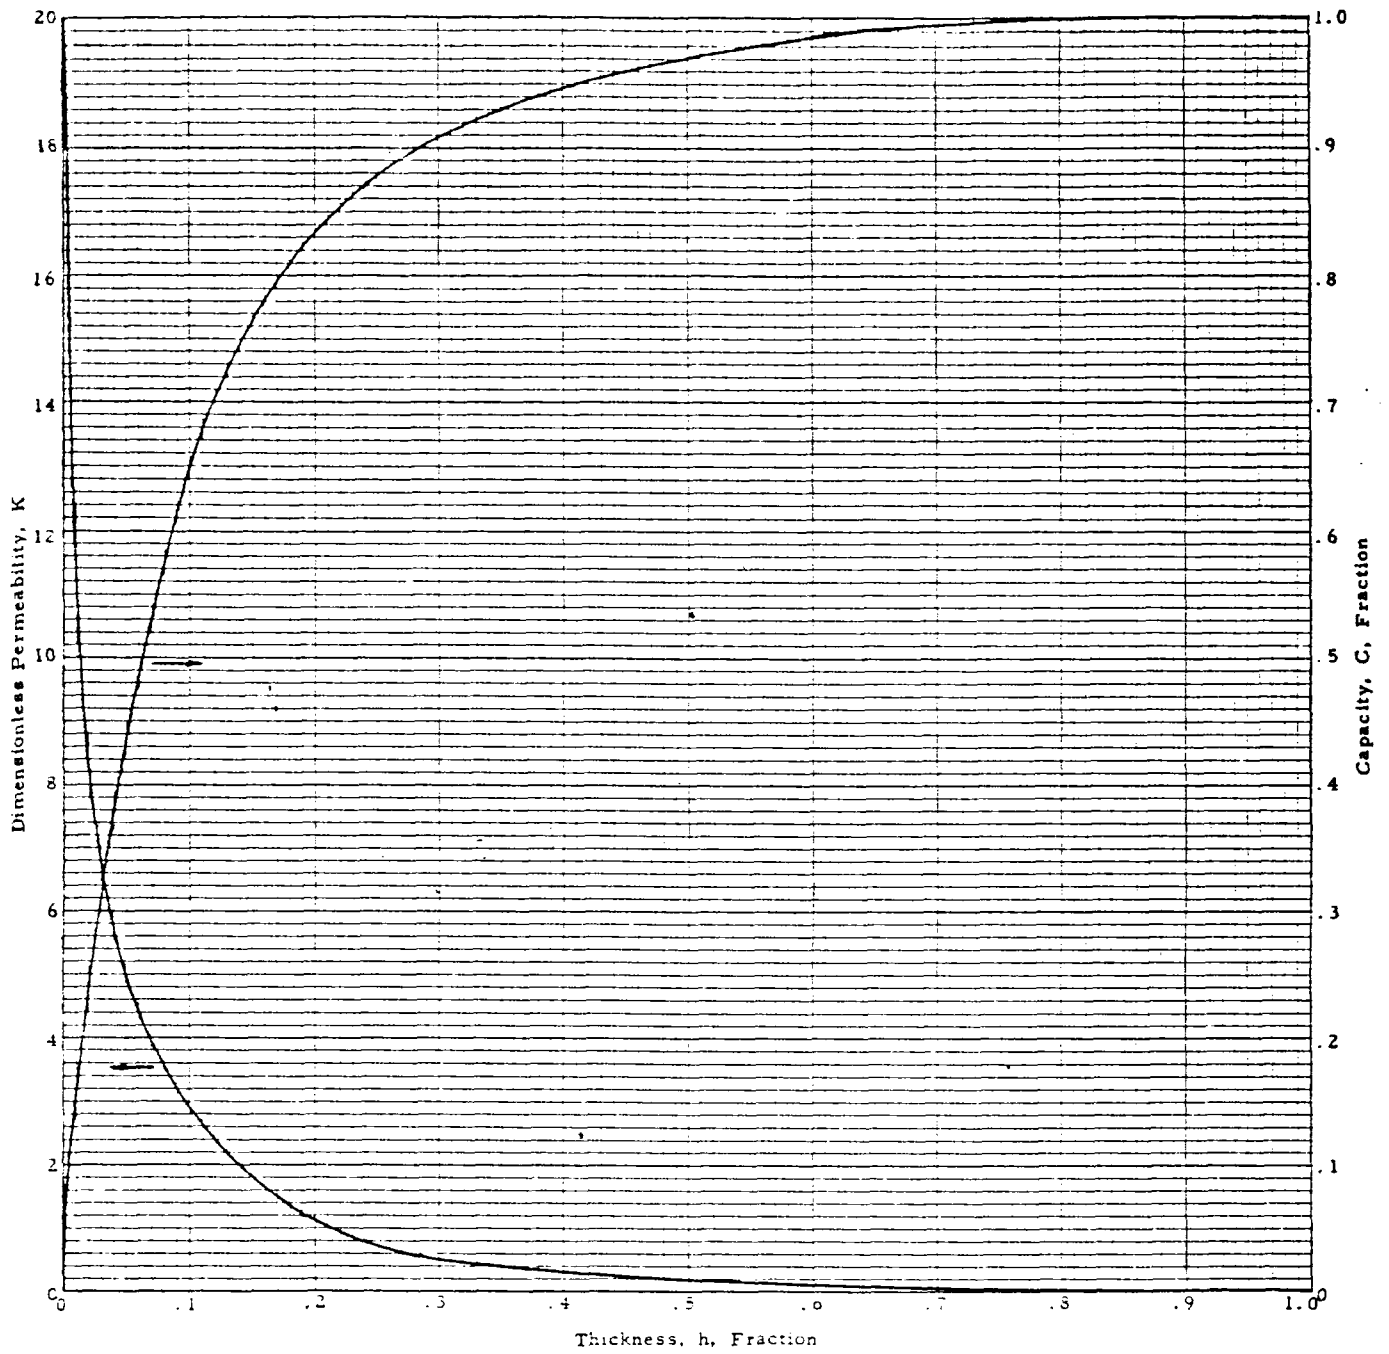
FIGURE 10

PERMEABILITY-CAPACITY DISTRIBUTION

Queen Reservoir

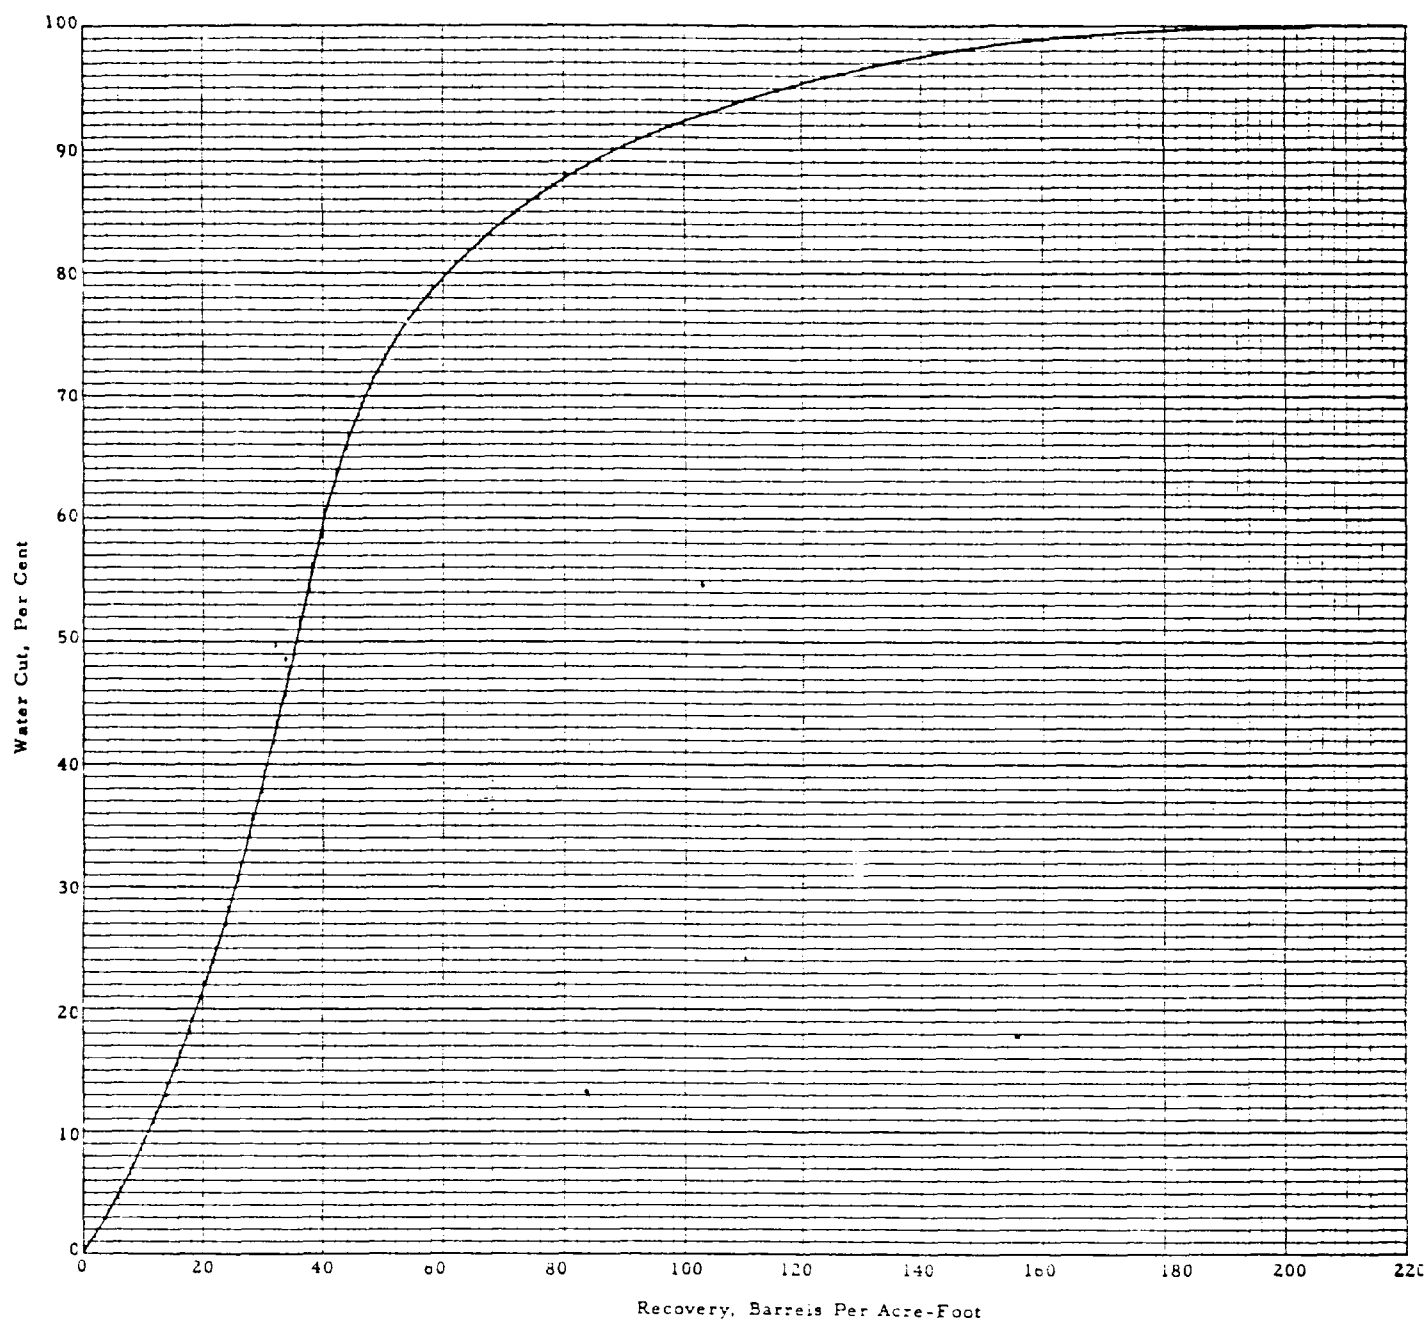
FIGURE 11

WATER CUT - RECOVERY RELATIONSHIP

Queen Reservoir

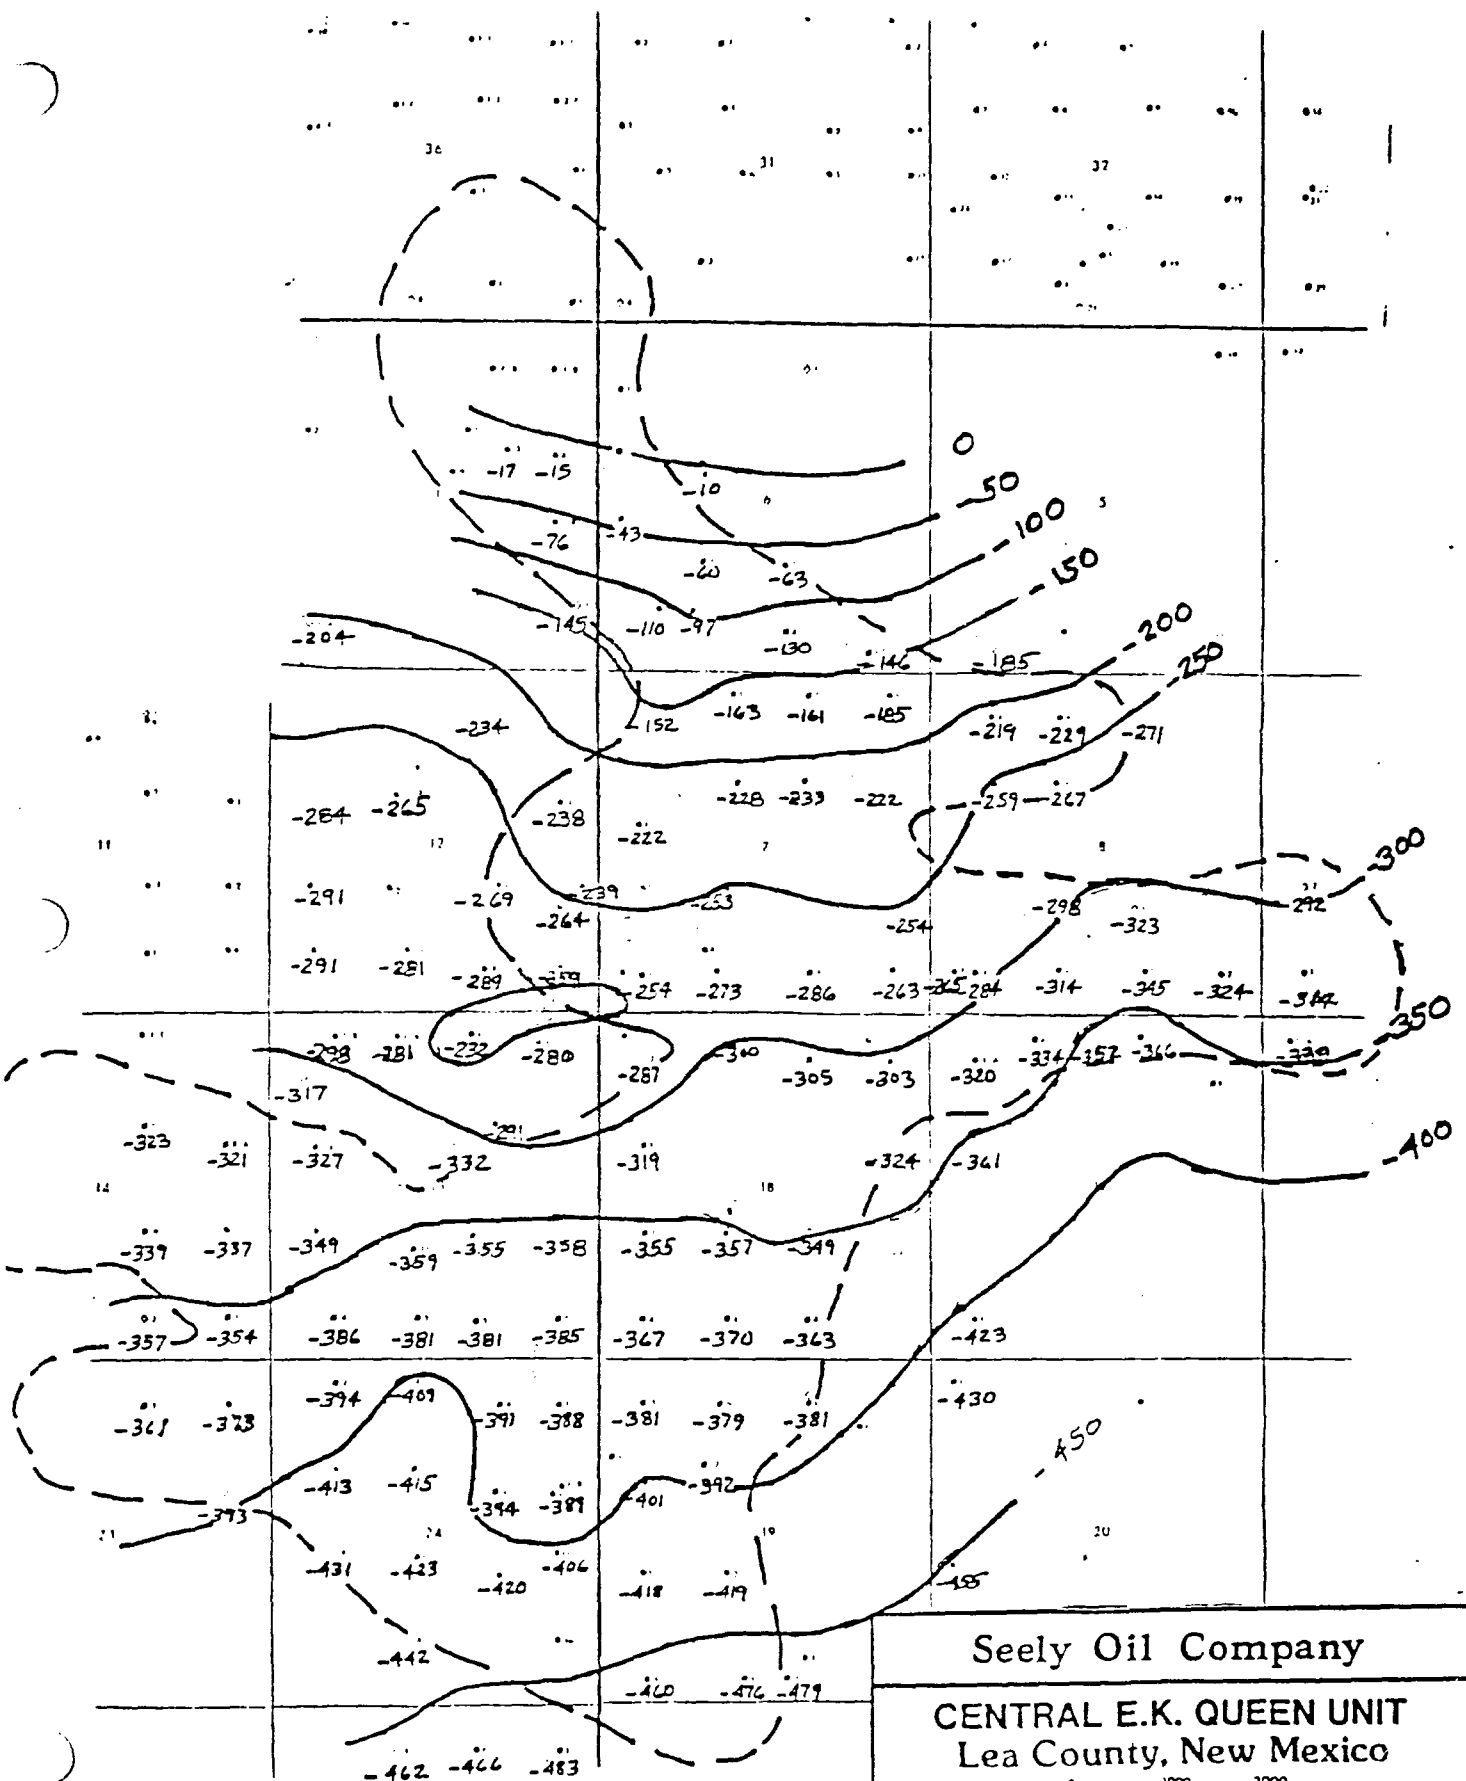
FIGURE 8

Structure Map  
Contoured on Top of  
Queen Formation
