HALLWOOD PETROLEUM, INC.  
CASE NO. 10728 5-6-93  
MONTAYA #27-1 (FC)  
T32N-R13W, Sec 27: SE SE  
SAN JUAN COUNTY, NEW MEXICO

# HALLWOOD "LAPLATA AREA" COAL WELLS

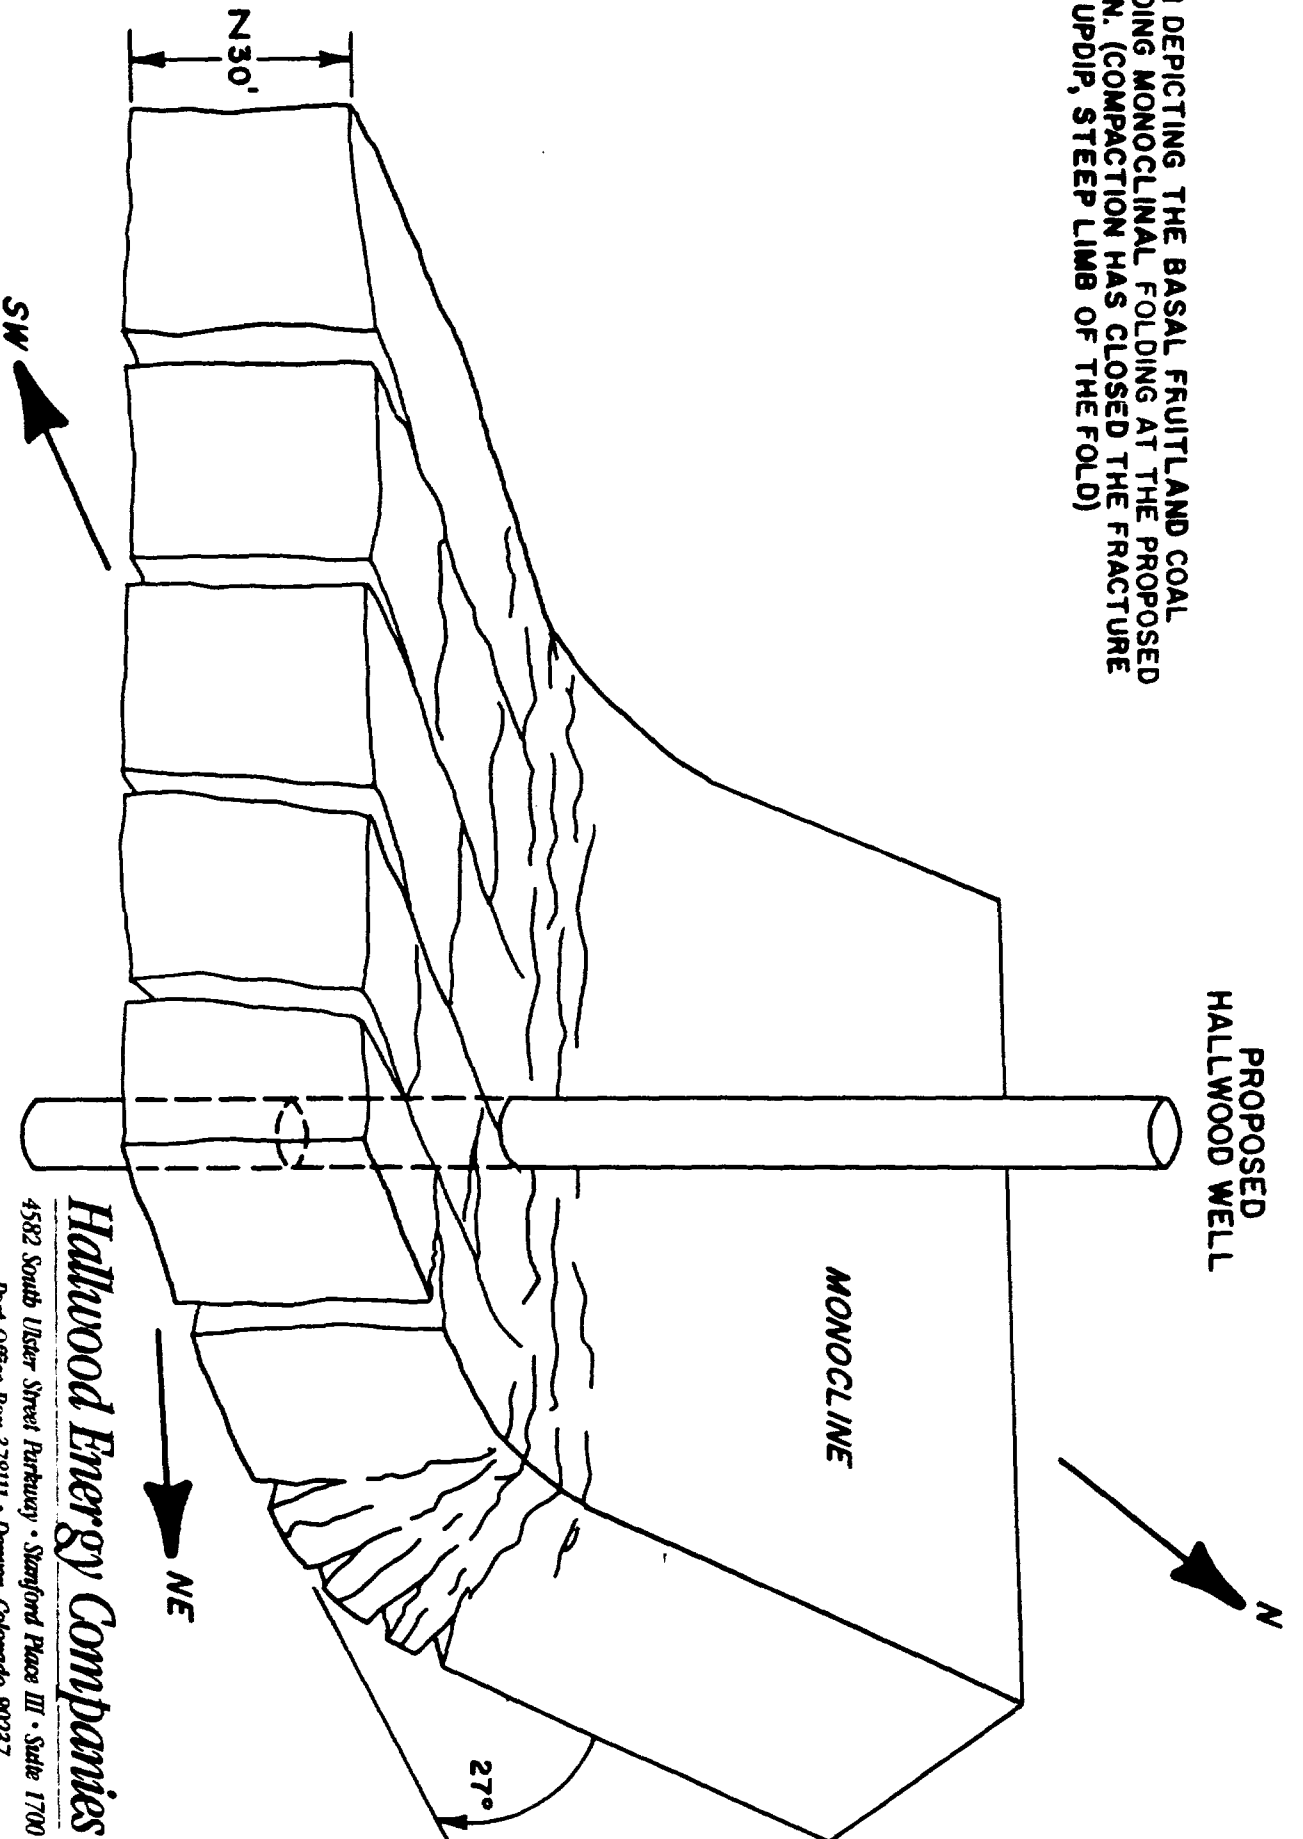
EXHIBIT 2

DIAGRAM DEPICTING THE BASAL FRUITLAND COAL UNDERGOING MONOCLINAL FOLDING AT THE PROPOSED LOCATION. (COMPACTION HAS CLOSED THE FRACTURE ON THE UPDIP, STEEP LIMB OF THE FOLD)
