BEFORE EXAMINER CATANACH

CASE NO.

# Chaco 4, Fracture Dimensions

# CHACO #4 PETCOM 11

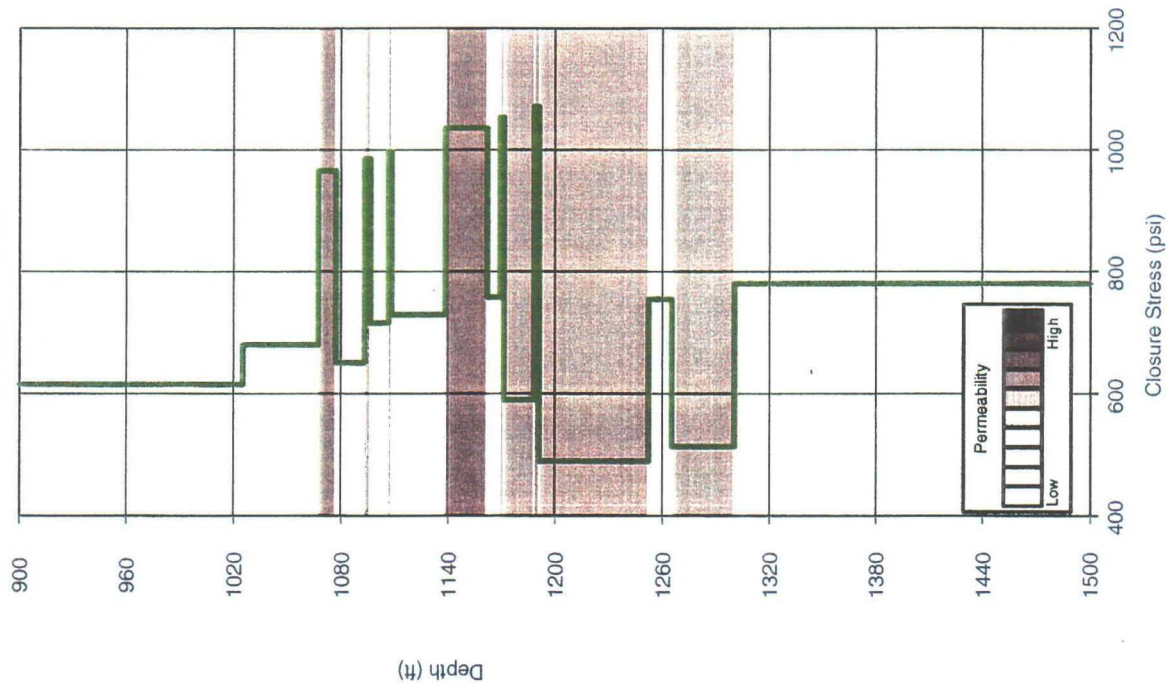
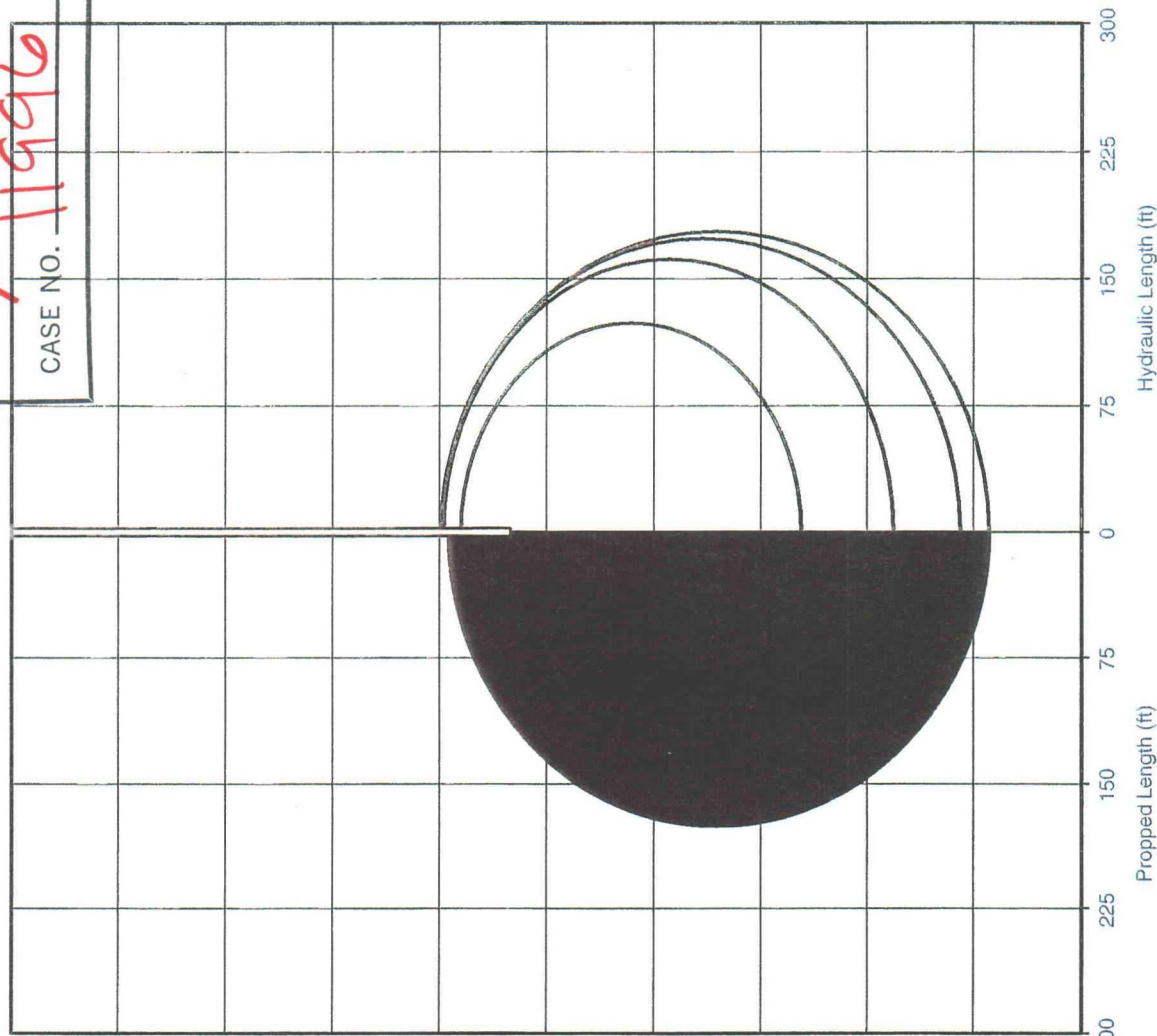
Stress Profile

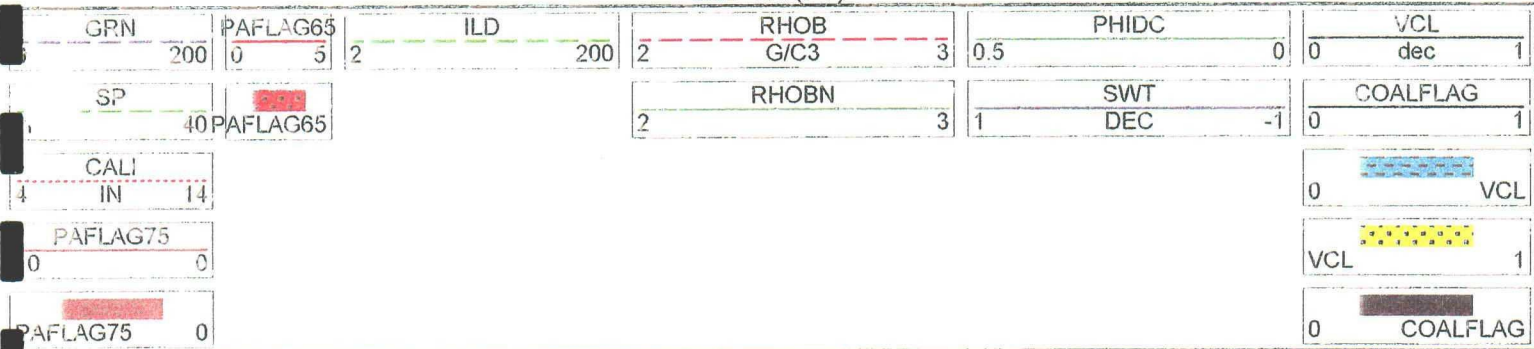
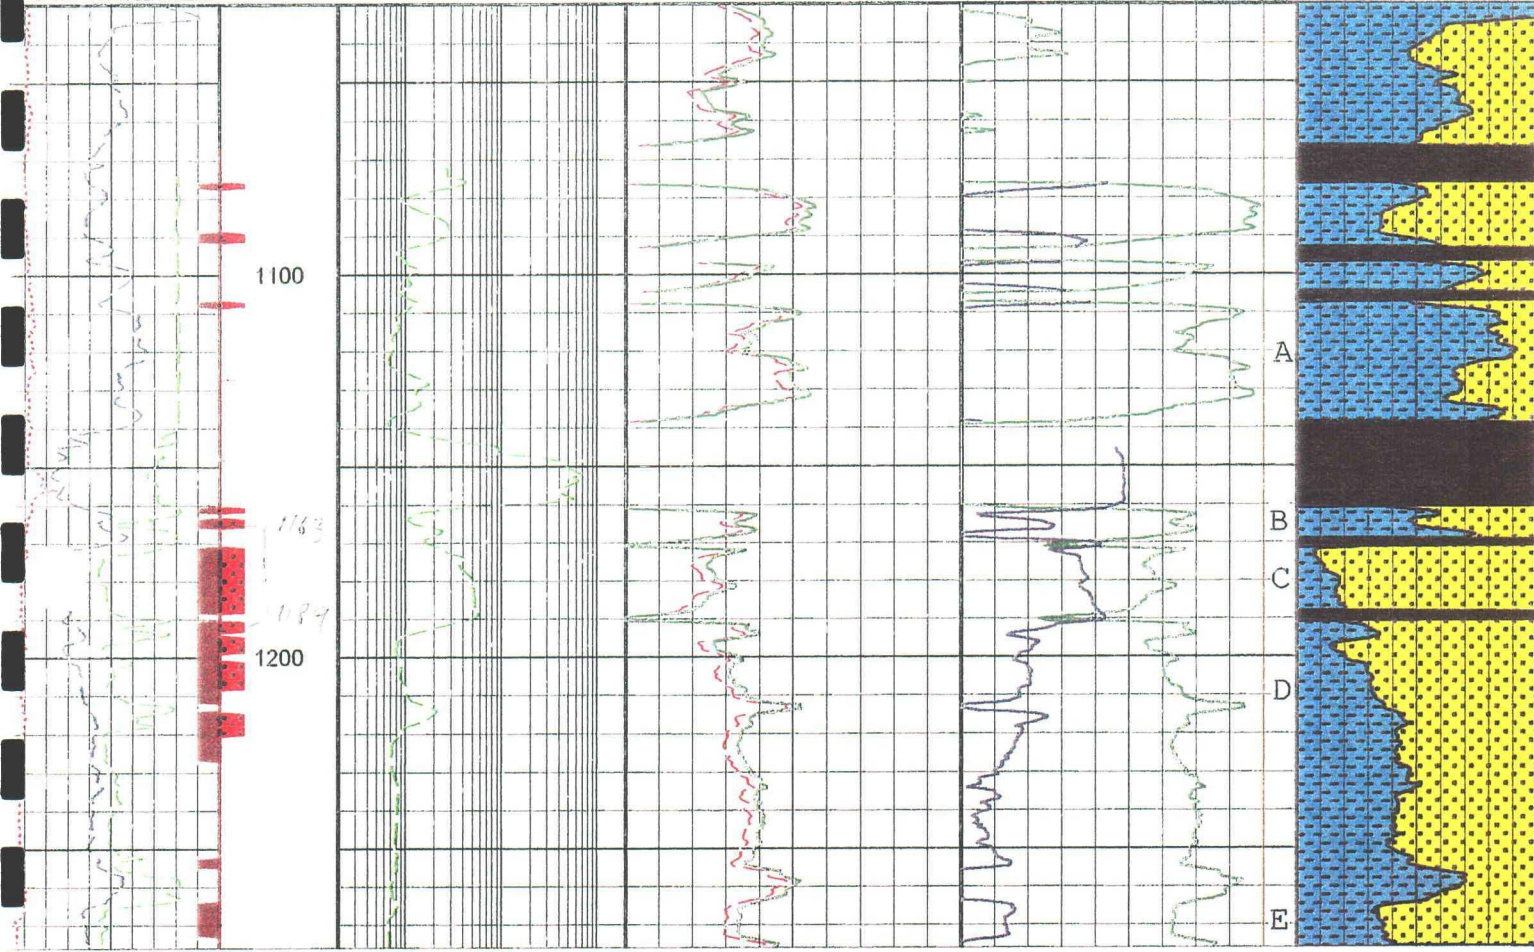
3 Jun 1998 @ 14:45

DEPTH (FT)
