Plug & Abandon  
REPORT

**RE: Plug and Abandon Report of MW-1  
Rice Operating Company – Hobbs SWD System  
Hobbs M-4 vent (1R428-76): UL/M sec. 4 T19S R38E**

## Plugging Report

**Hobbs M-4 vent (1R428-76)**  
**Unit Letter M, Section 4, T-19-S, R-38-E**

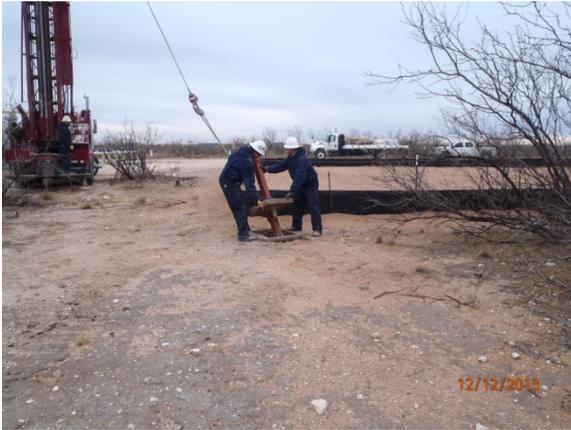
Pulling MW-1, facing west 12/12/13

On December 12<sup>th</sup>, 2013, RECS personnel were on site to supervise the plugging and abandonment of MW-1 according to the Termination Request submitted to NMOCD on November 19<sup>th</sup>, 2013 and approved on November 27<sup>th</sup>, 2013. The well was plugged with a 1-3% bentonite/concrete slurry and a three foot concrete cap.

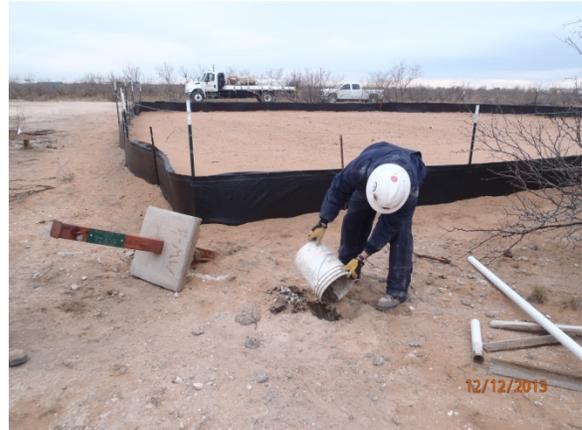
Plugging MW-1 with a 1-3% bentonite-concrete slurry and a 3 ft concrete cap, facing west 12/12/13

Client	Rice Operating
Contractor	HCI Drilling
Date Completed	12/12/2013
Site	Hobbs M-4 Vent
Well ID	MW-1
Casing Diameter	2"
Well Depth	39'
Casing Material	PVC
Plugging Material	Portland/Bentonite Slurry
Slurry Interval	3'-39'
Cement Interval	0'-3'

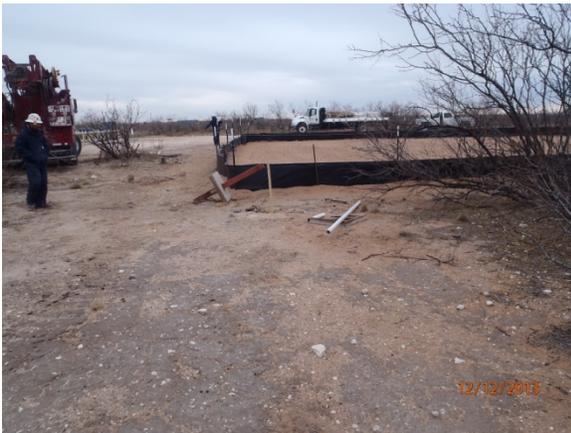
MW-1 plugged and abandoned, facing west 12/12/13

ROC acknowledges they have met the requirements in accordance of 19.15.29 NMAC (Part 29; formally Rule 16), and the remediation plan (1R428-76) is terminated in accordance with 19.15.29 NMAC and no further action is required.
