**GW - 004**

**2013 AGWMR**

**VOL 5 OF 5**

*North Eunice Gas Plant  
Lea County, New Mexico*

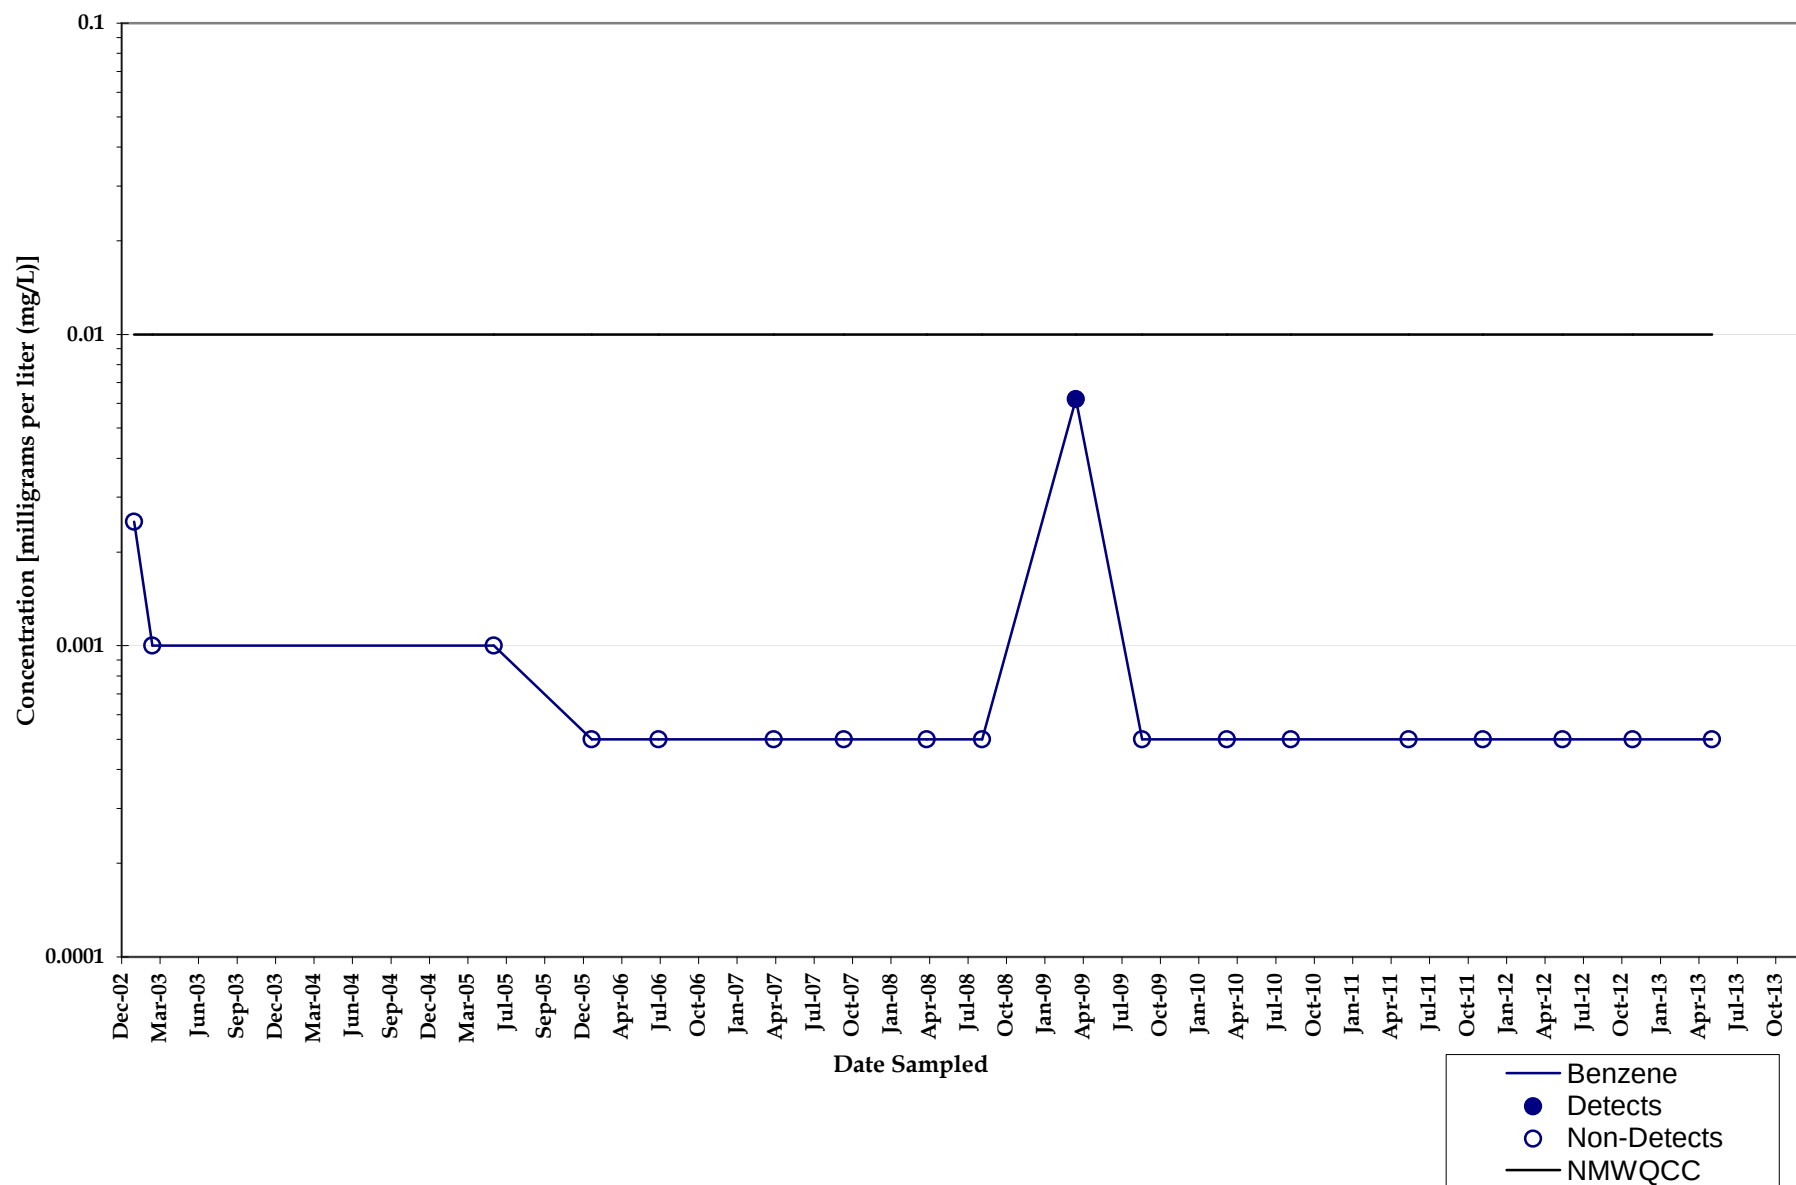
## Benzene Concentrations Monitoring Well MW057SA

Note: Non-detect analyses plotted at the method detection limit or half the reporting limit (RL). Detections denoted by symbol and detection values greater than the RL denoted by shaded symbol.

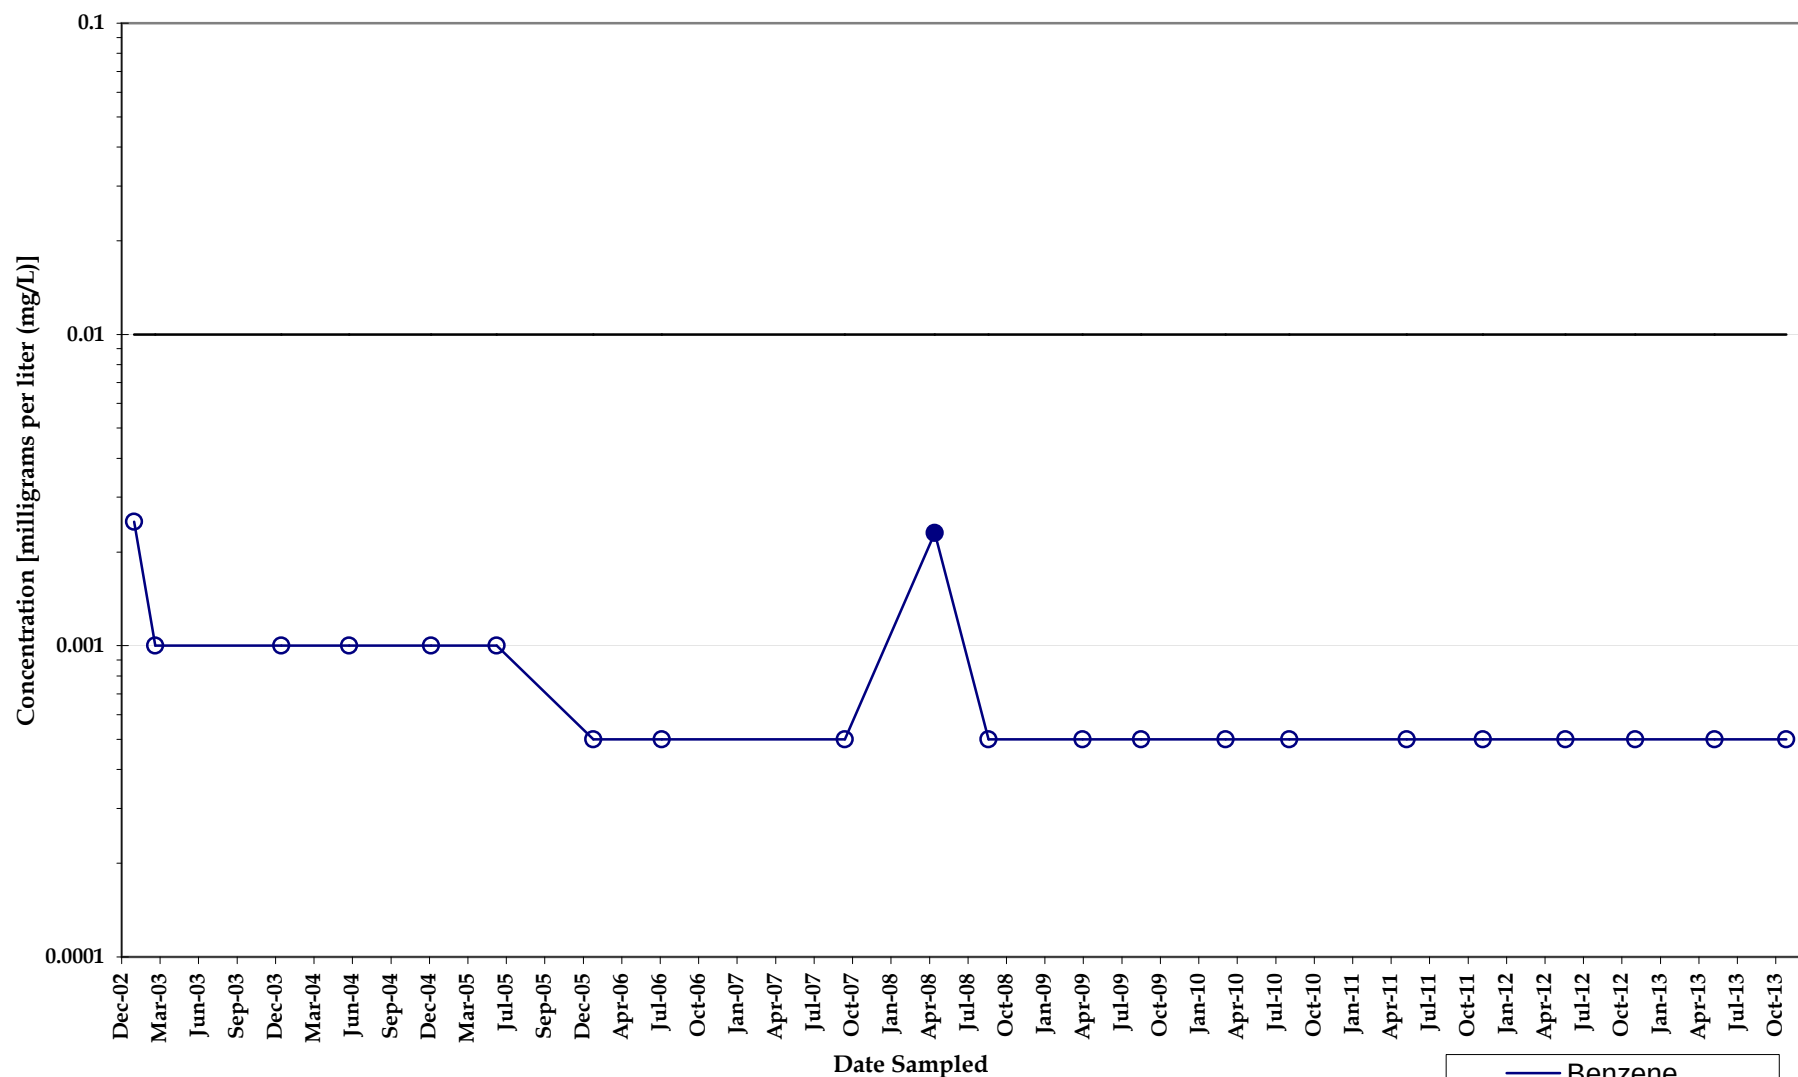
## Benzene Concentrations Monitoring Well MW058

Note: Non-detect analyses plotted at the method detection limit or half the reporting limit (RL). Detections denoted by symbol and detection values greater than the RL denoted by shaded symbol.

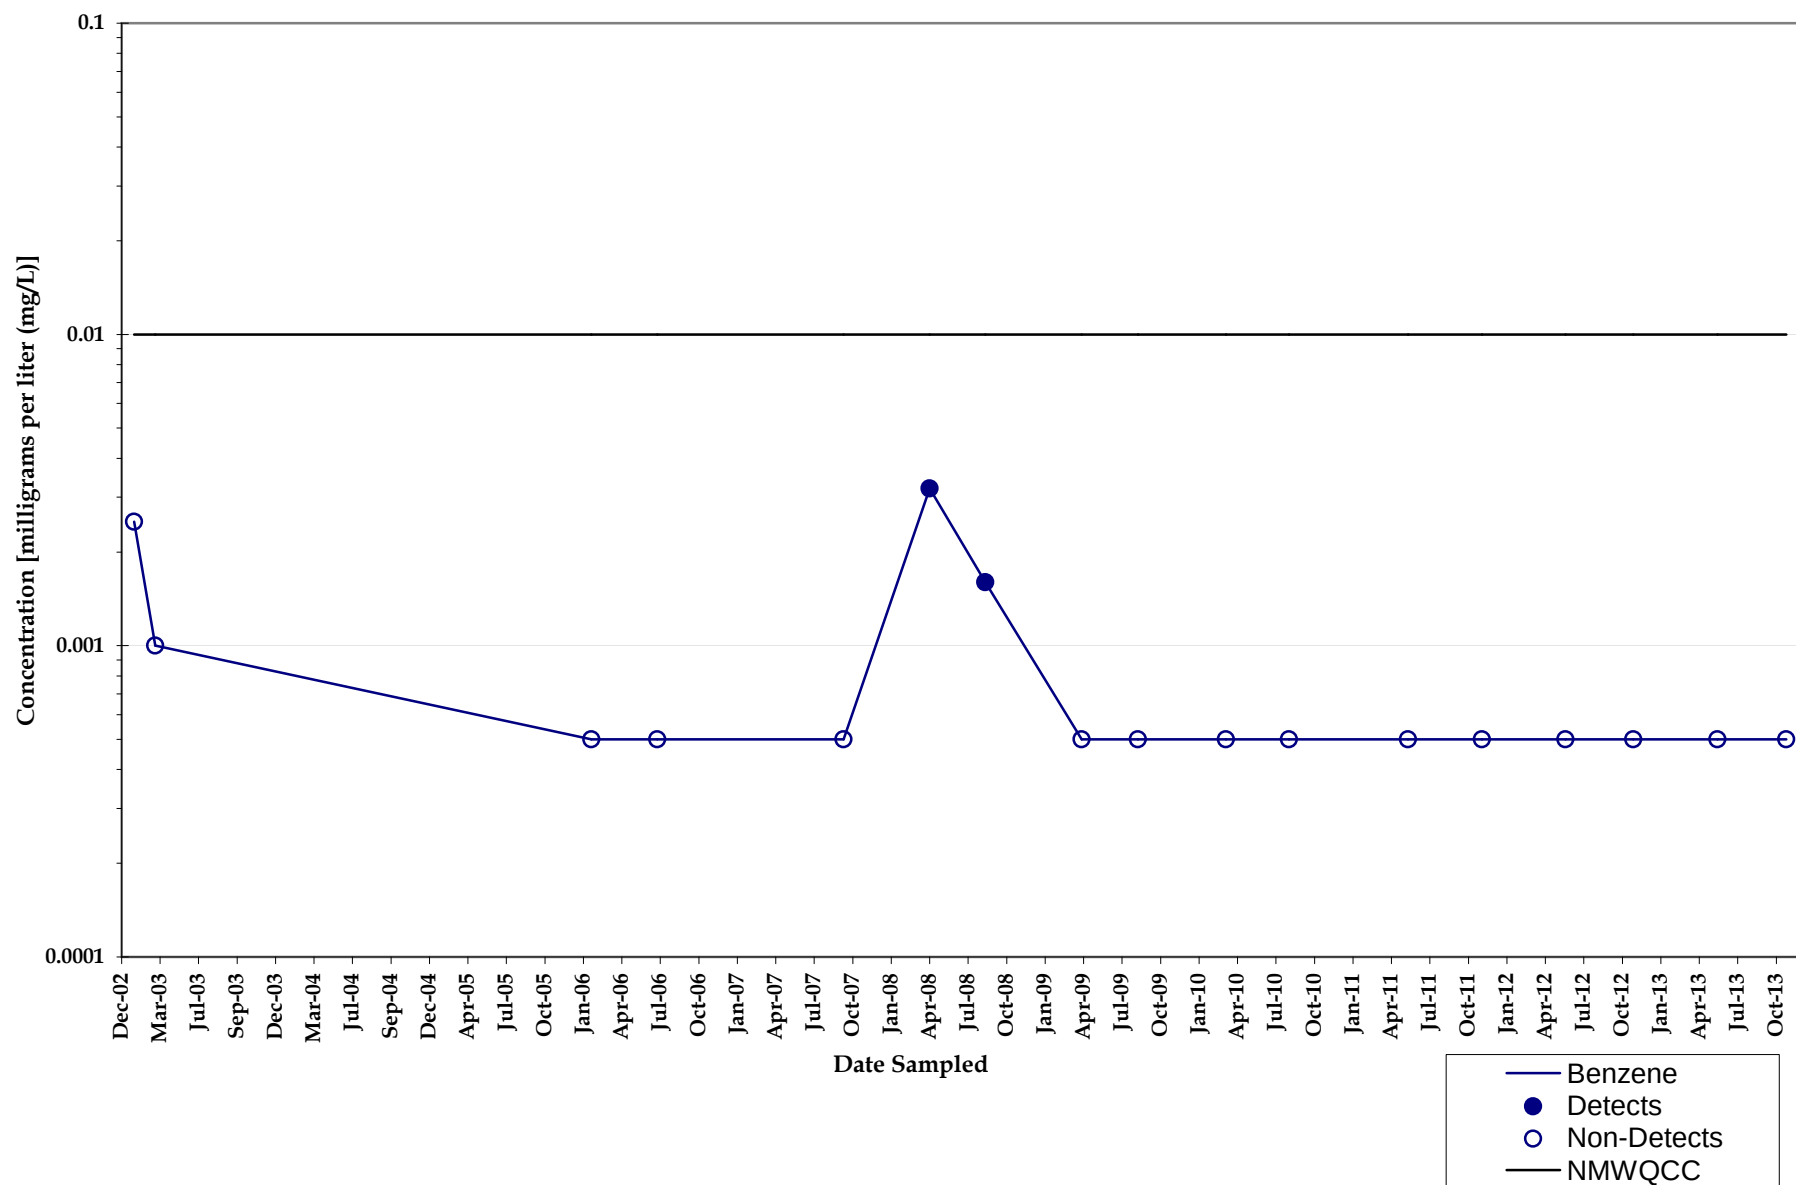
## Benzene Concentrations Monitoring Well MW059

Note: Non-detect analyses plotted at the method detection limit or half the reporting limit (RL). Detections denoted by symbol and detection values greater than the RL denoted by shaded symbol.

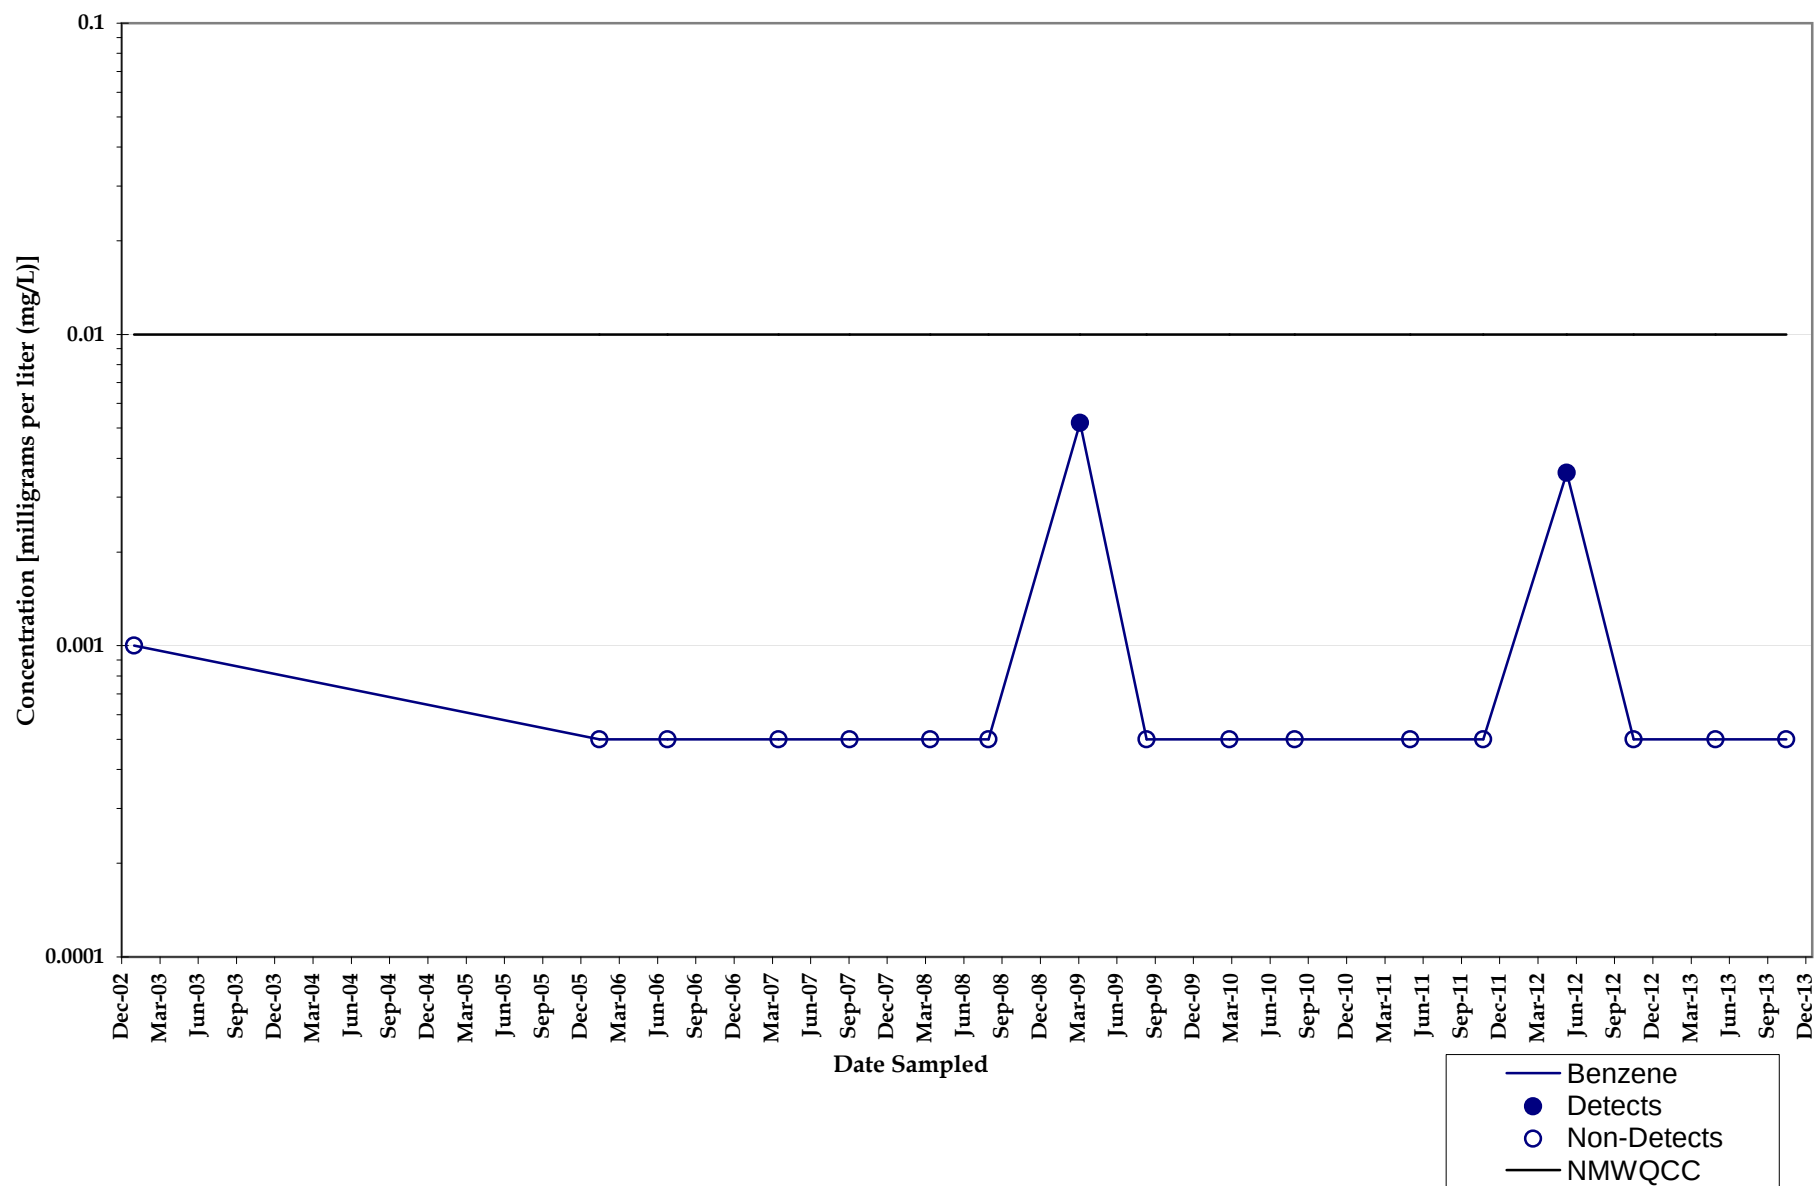
## Benzene Concentrations Monitoring Well MW060

Note: Non-detect analyses plotted at the method detection limit or half the reporting limit (RL). Detections denoted by symbol and detection values greater than the RL denoted by shaded symbol.

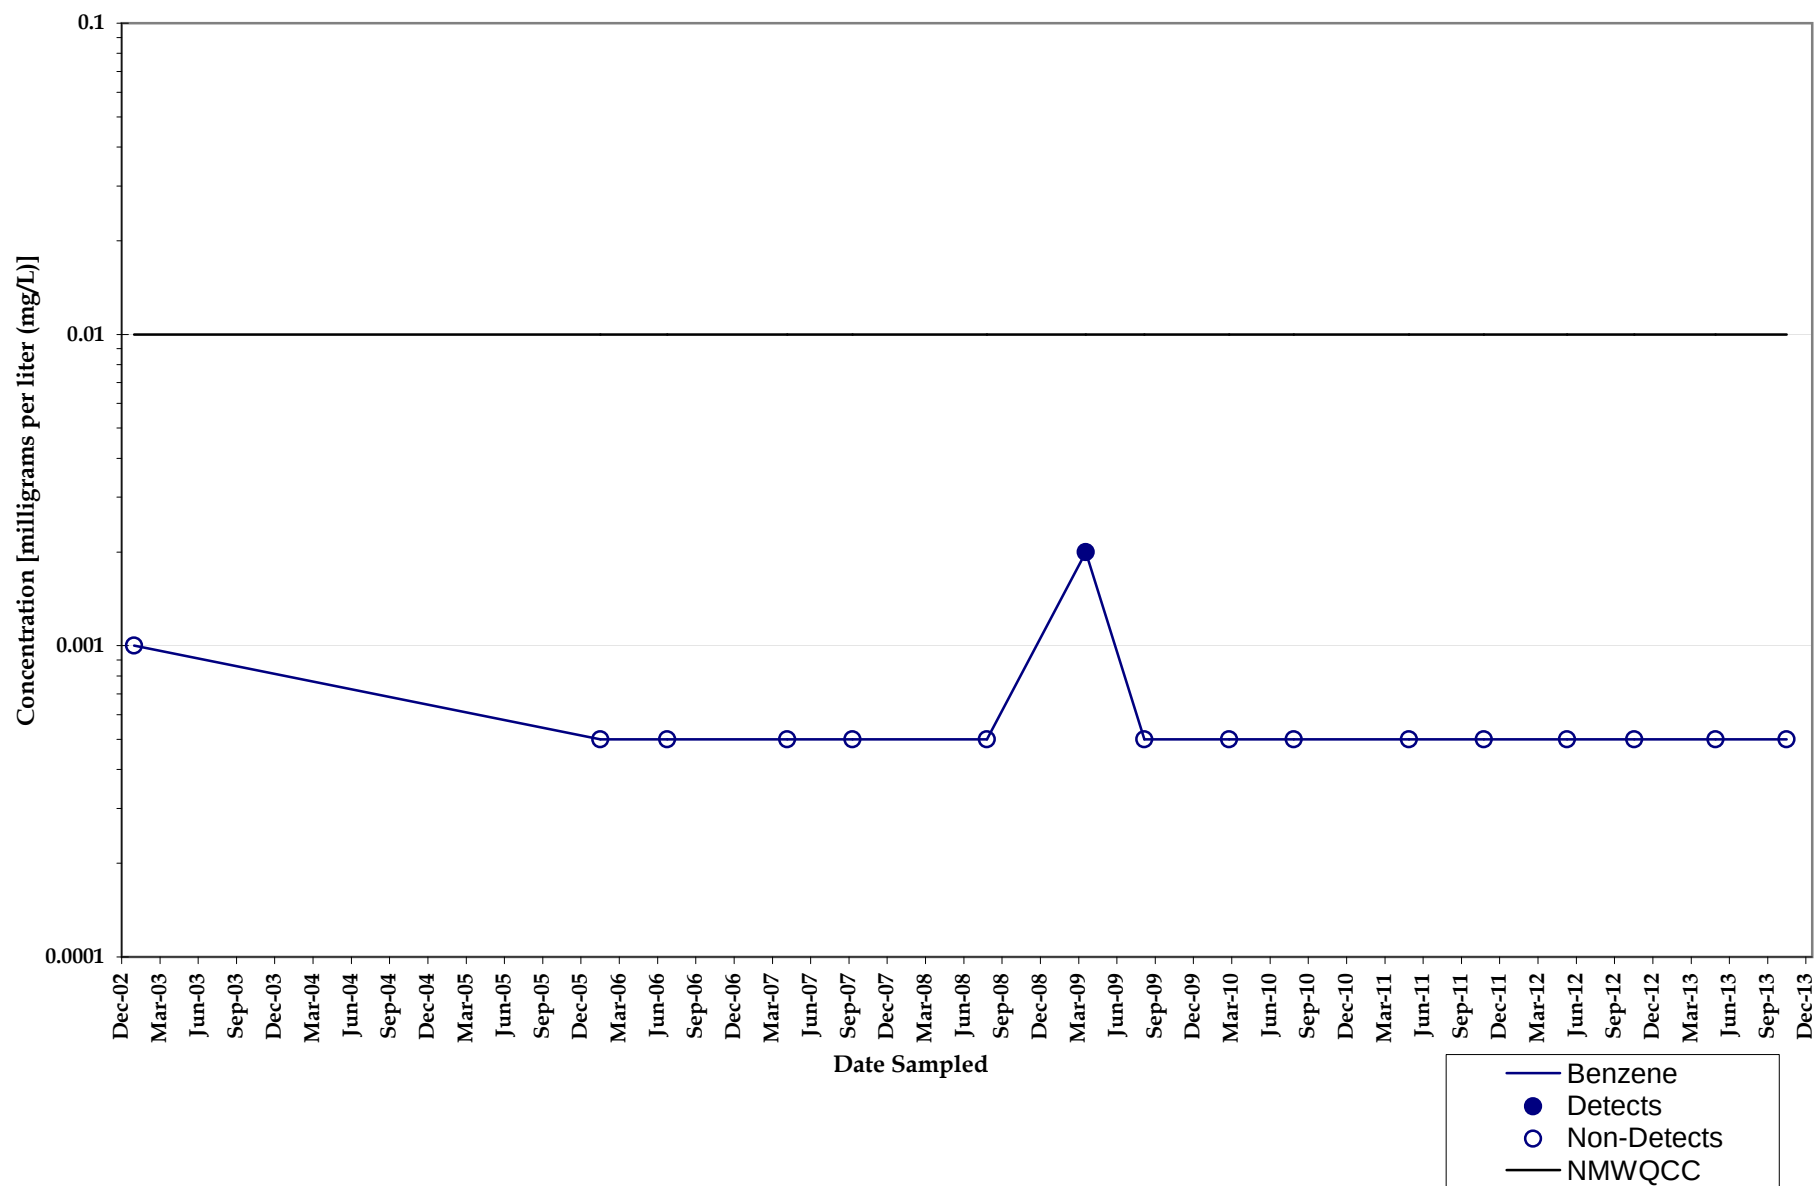
## Benzene Concentrations Monitoring Well MW061

Note: Non-detect analyses plotted at the method detection limit or half the reporting limit (RL). Detections denoted by symbol and detection values greater than the RL denoted by shaded symbol.

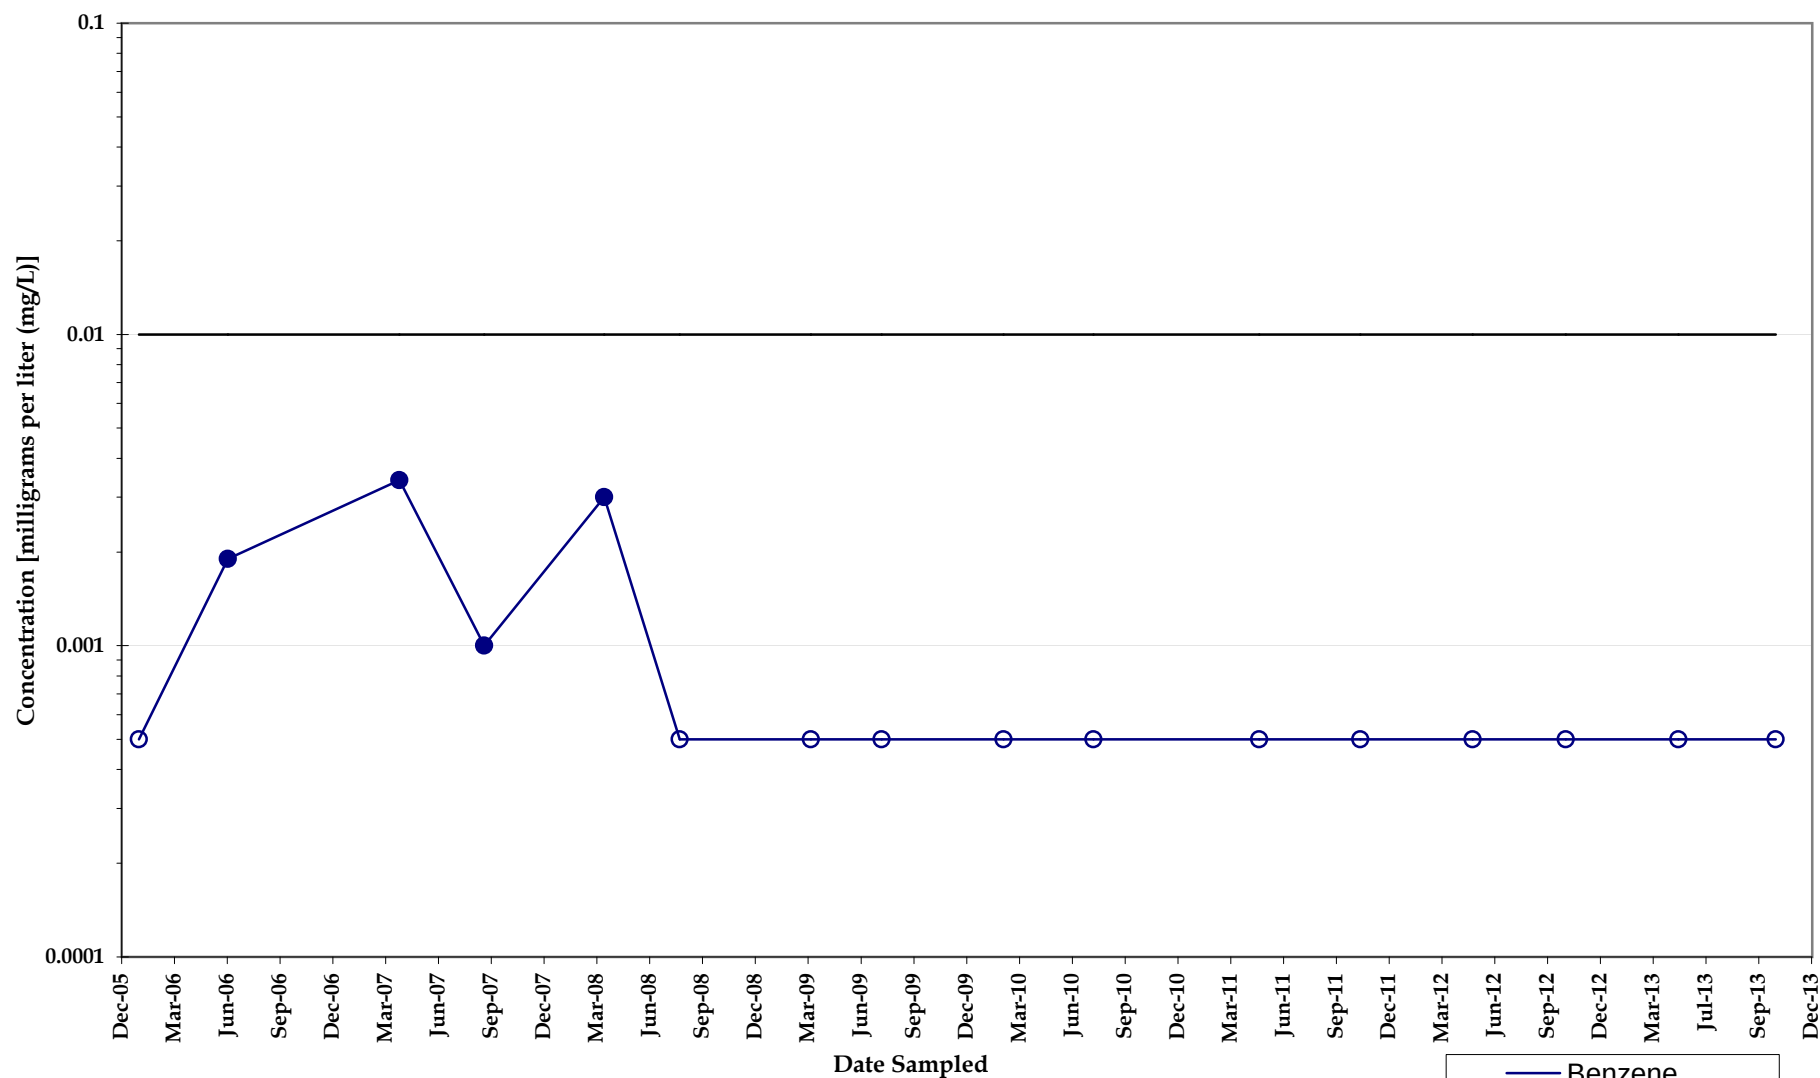
## Benzene Concentrations Monitoring Well MW062A

Note: Non-detect analyses plotted at the method detection limit or half the reporting limit (RL). Detections denoted by symbol and detection values greater than the RL denoted by shaded symbol.

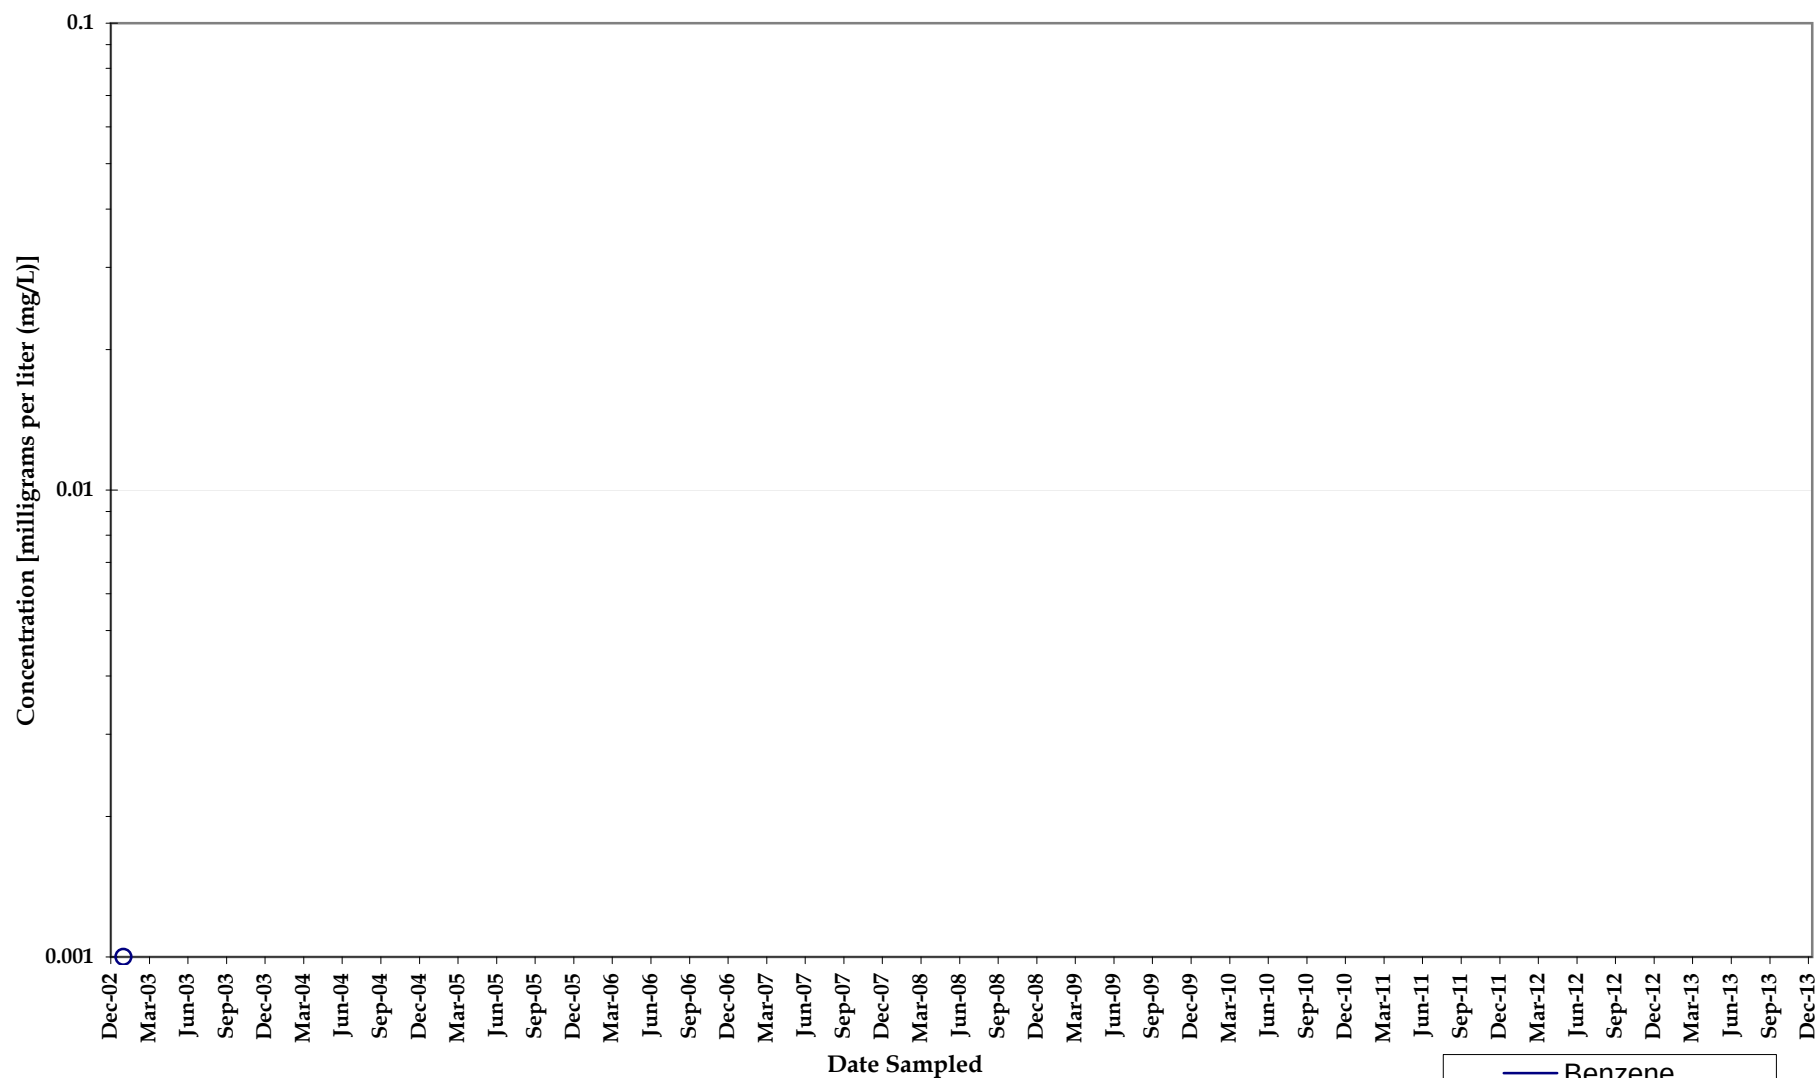
## Benzene Concentrations Monitoring Well MW062SA

Note: Non-detect analyses plotted at the method detection limit or half the reporting limit (RL). Detections denoted by symbol and detection values greater than the RL denoted by shaded symbol.

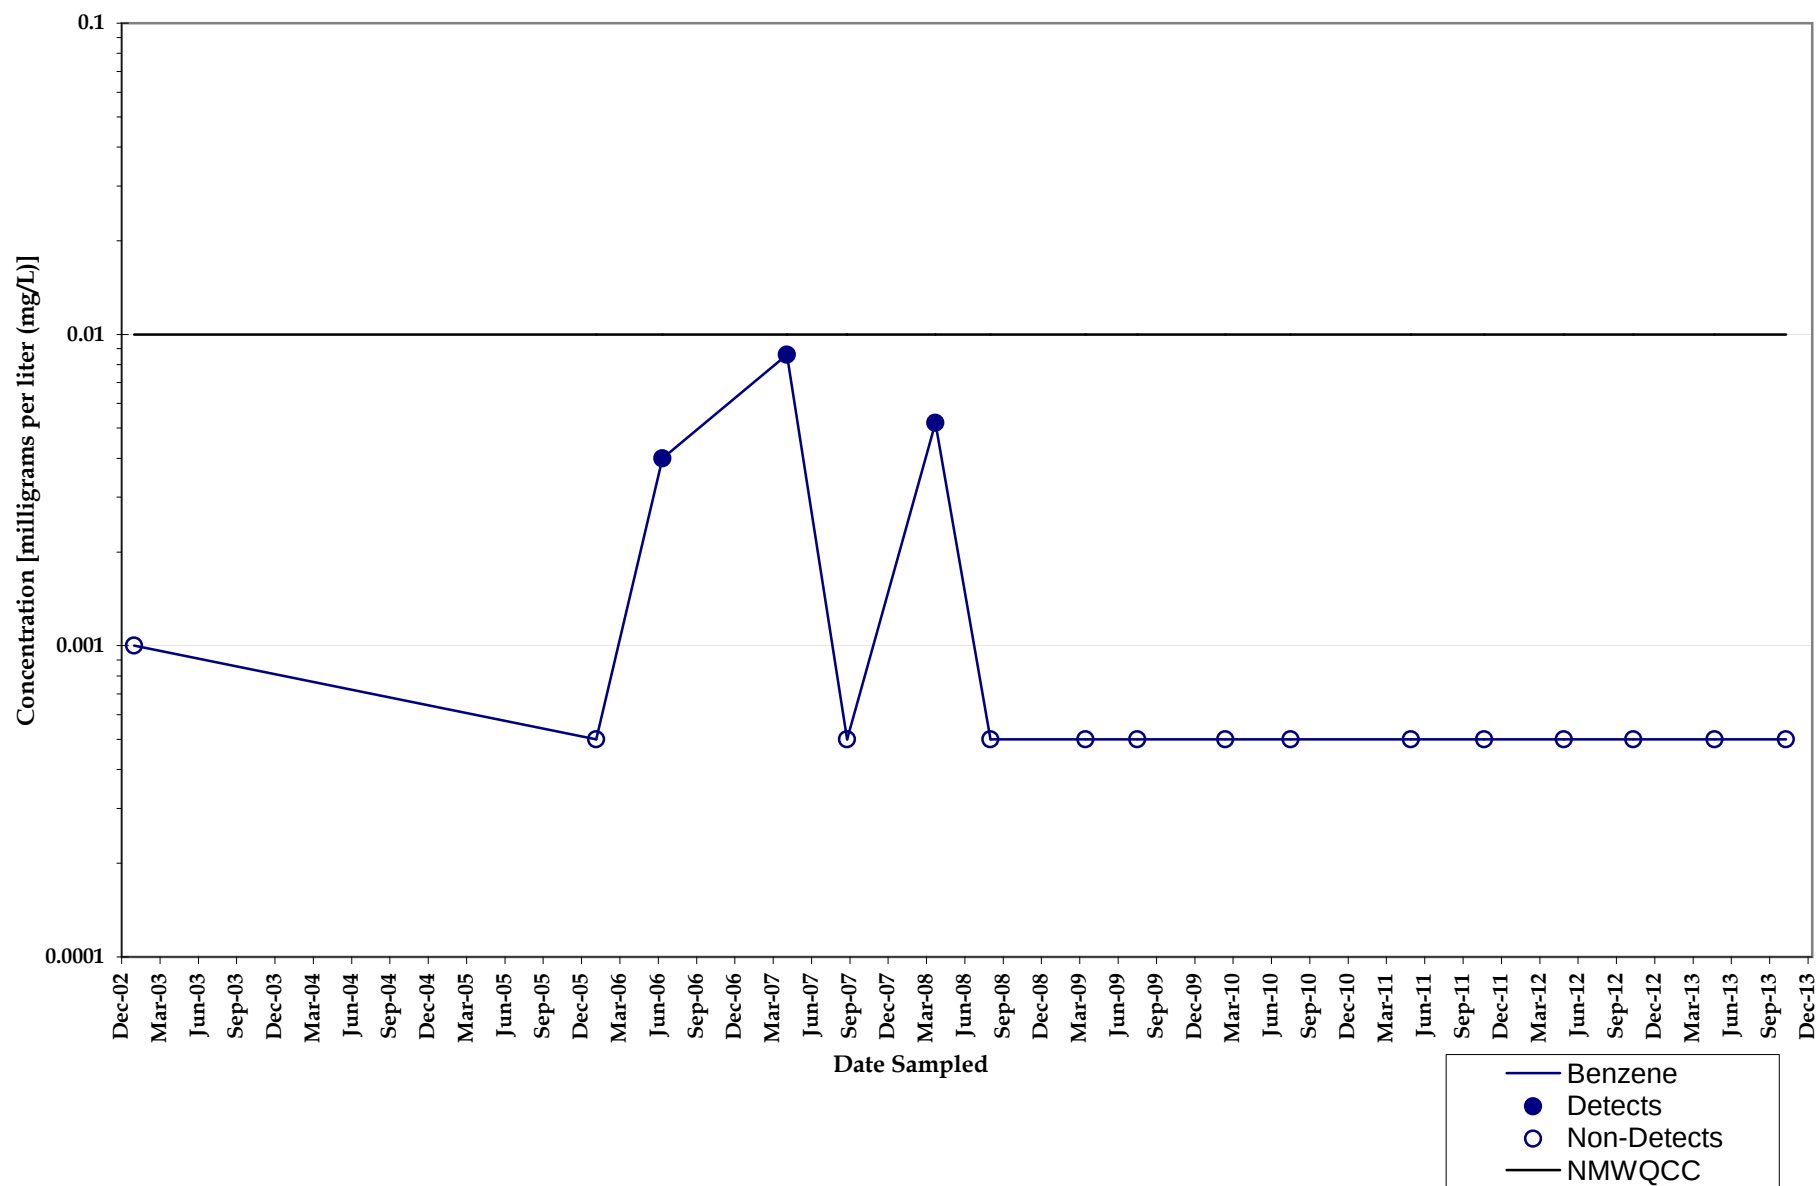
## Benzene Concentrations Monitoring Well MW063A

Note: Non-detect analyses plotted at the method detection limit or half the reporting limit (RL). Detections denoted by symbol and detection values greater than the RL denoted by shaded symbol.

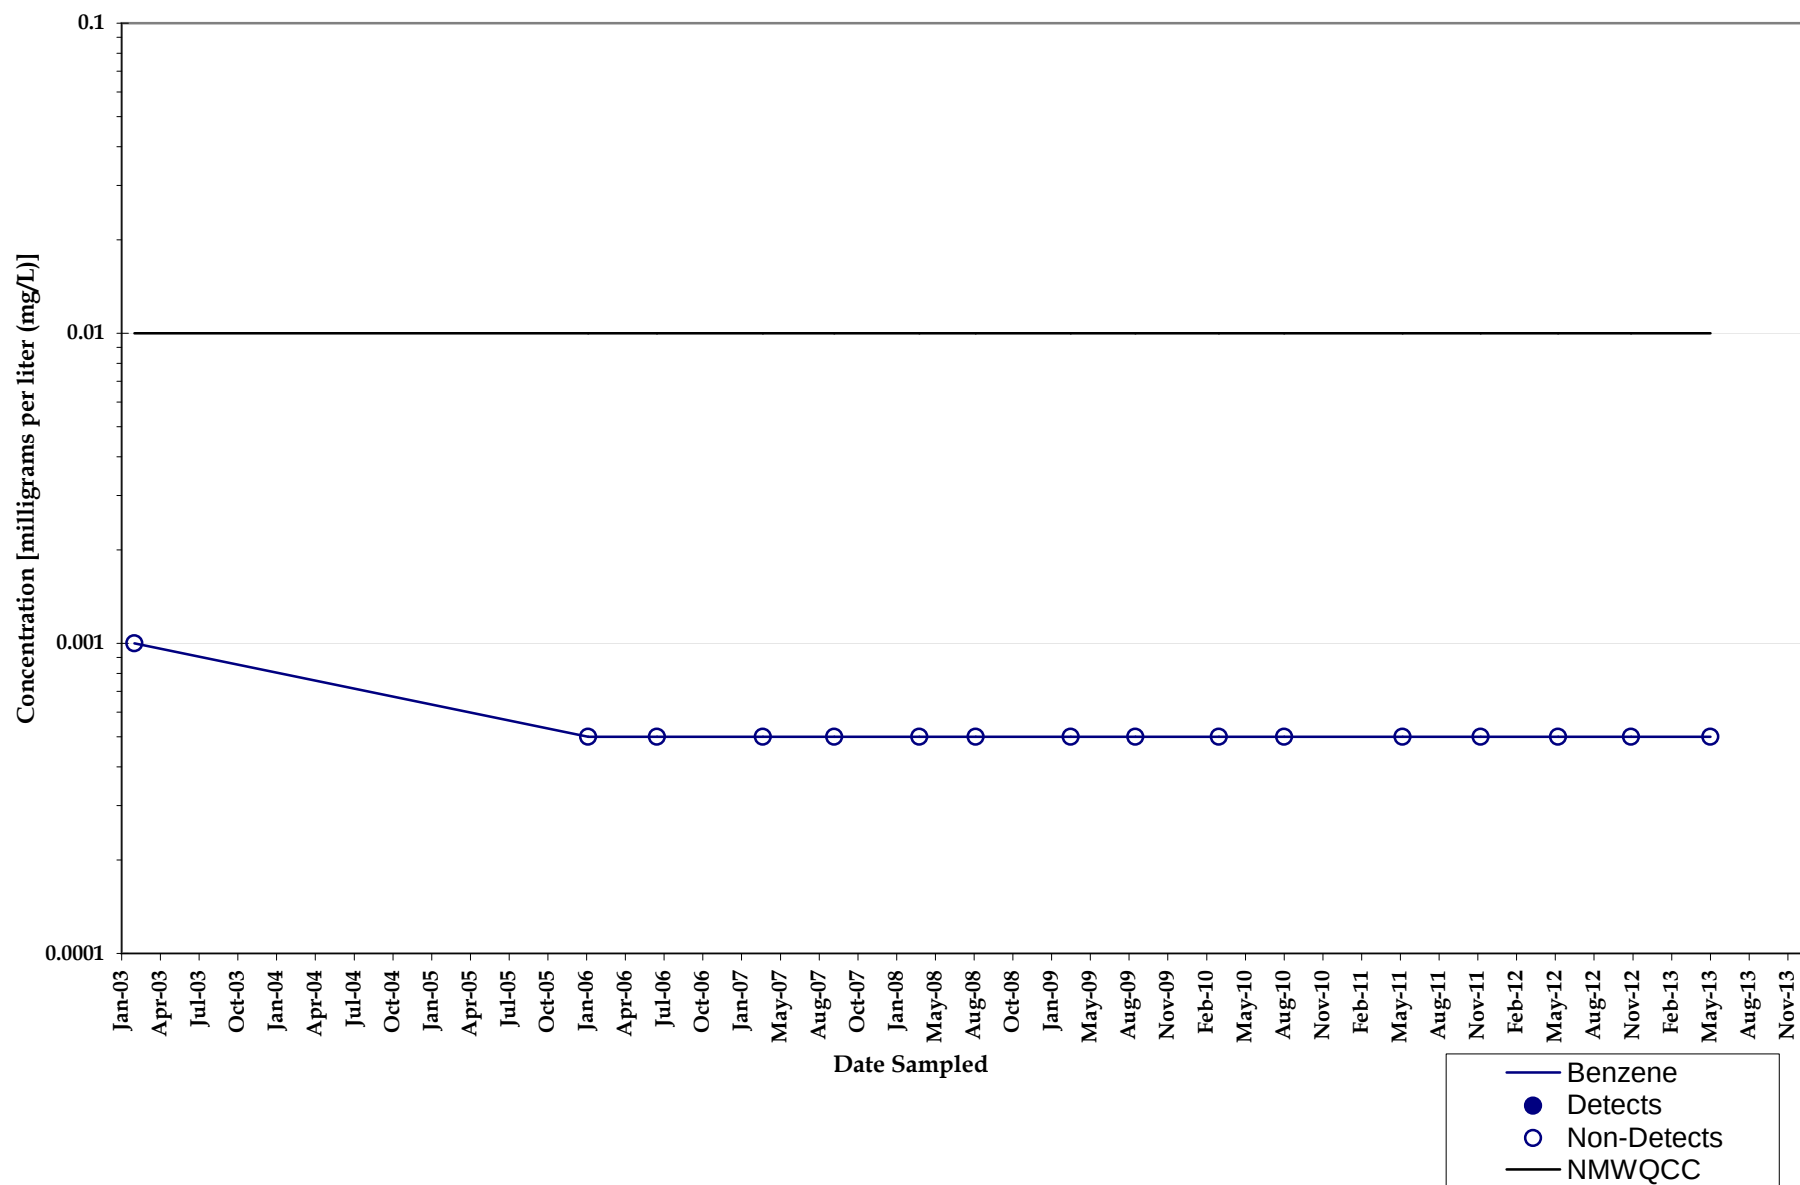
## Benzene Concentrations Monitoring Well MW064SA

Note: Non-detect analyses plotted at the method detection limit or half the reporting limit (RL). Detections denoted by symbol and detection values greater than the RL denoted by shaded symbol.

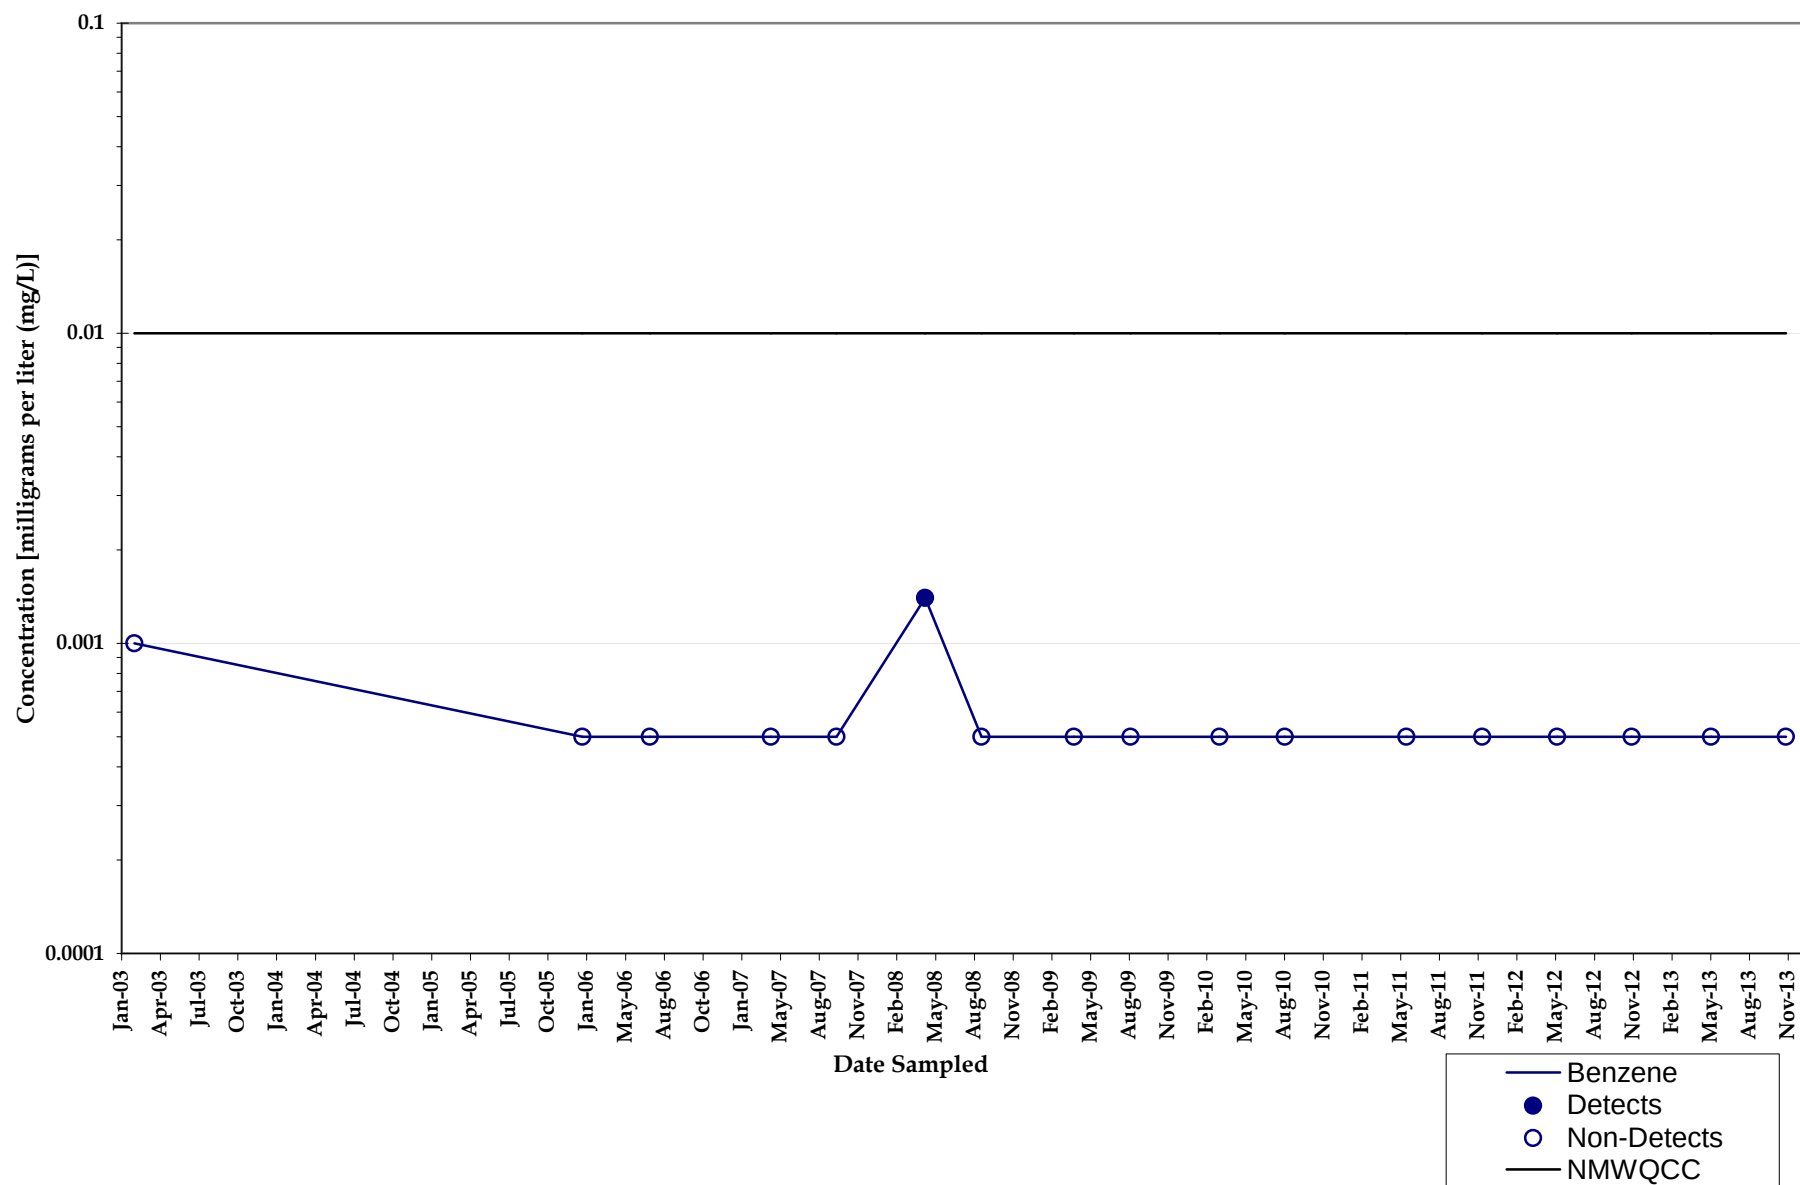
## Benzene Concentrations Monitoring Well MW065SA

Note: Non-detect analyses plotted at the method detection limit or half the reporting limit (RL). Detections denoted by symbol and detection values greater than the RL denoted by shaded symbol.
