**GW - 004**

**2013 AGWMR**

**VOL 5 OF 5**

*North Eunice Gas Plant  
Lea County, New Mexico*

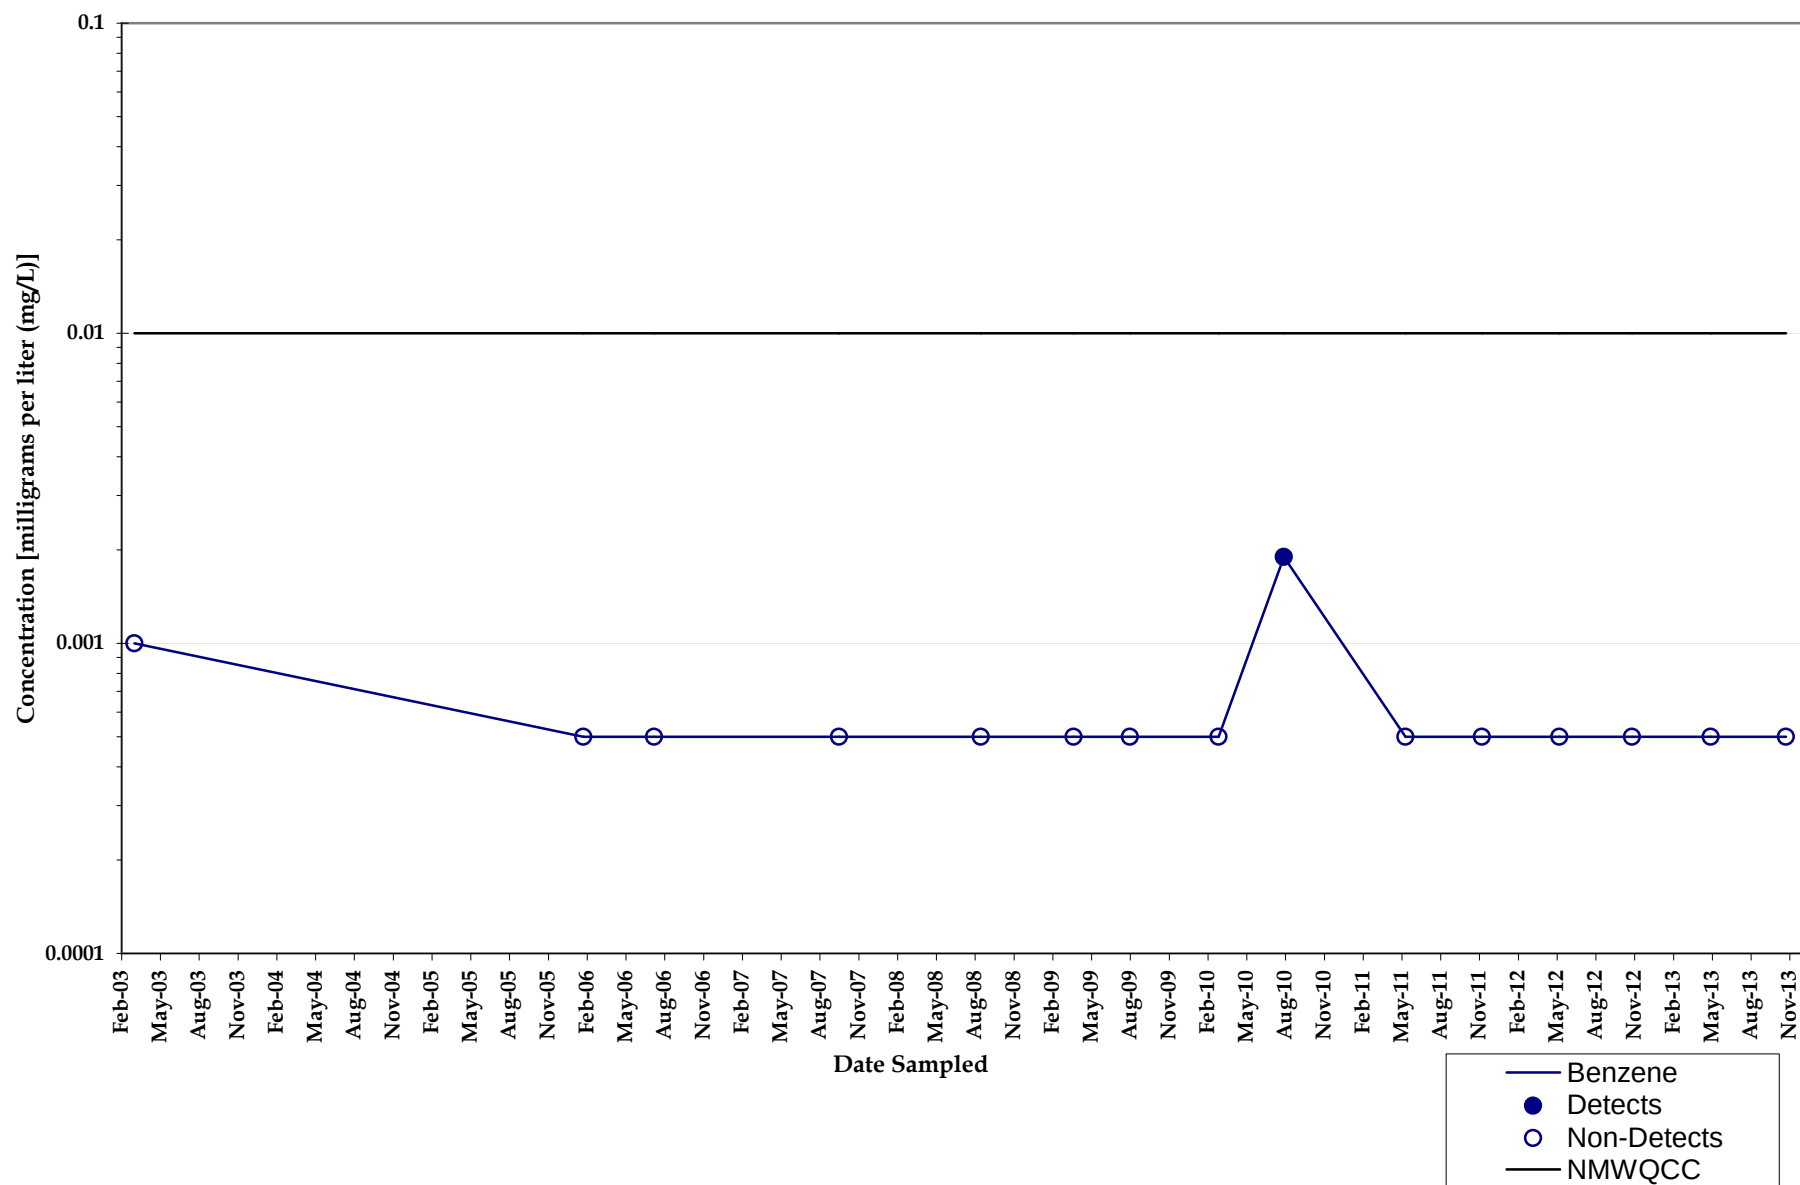
## Benzene Concentrations Monitoring Well MW066SA

Note: Non-detect analyses plotted at the method detection limit or half the reporting limit (RL). Detections denoted by symbol and detection values greater than the RL denoted by shaded symbol.

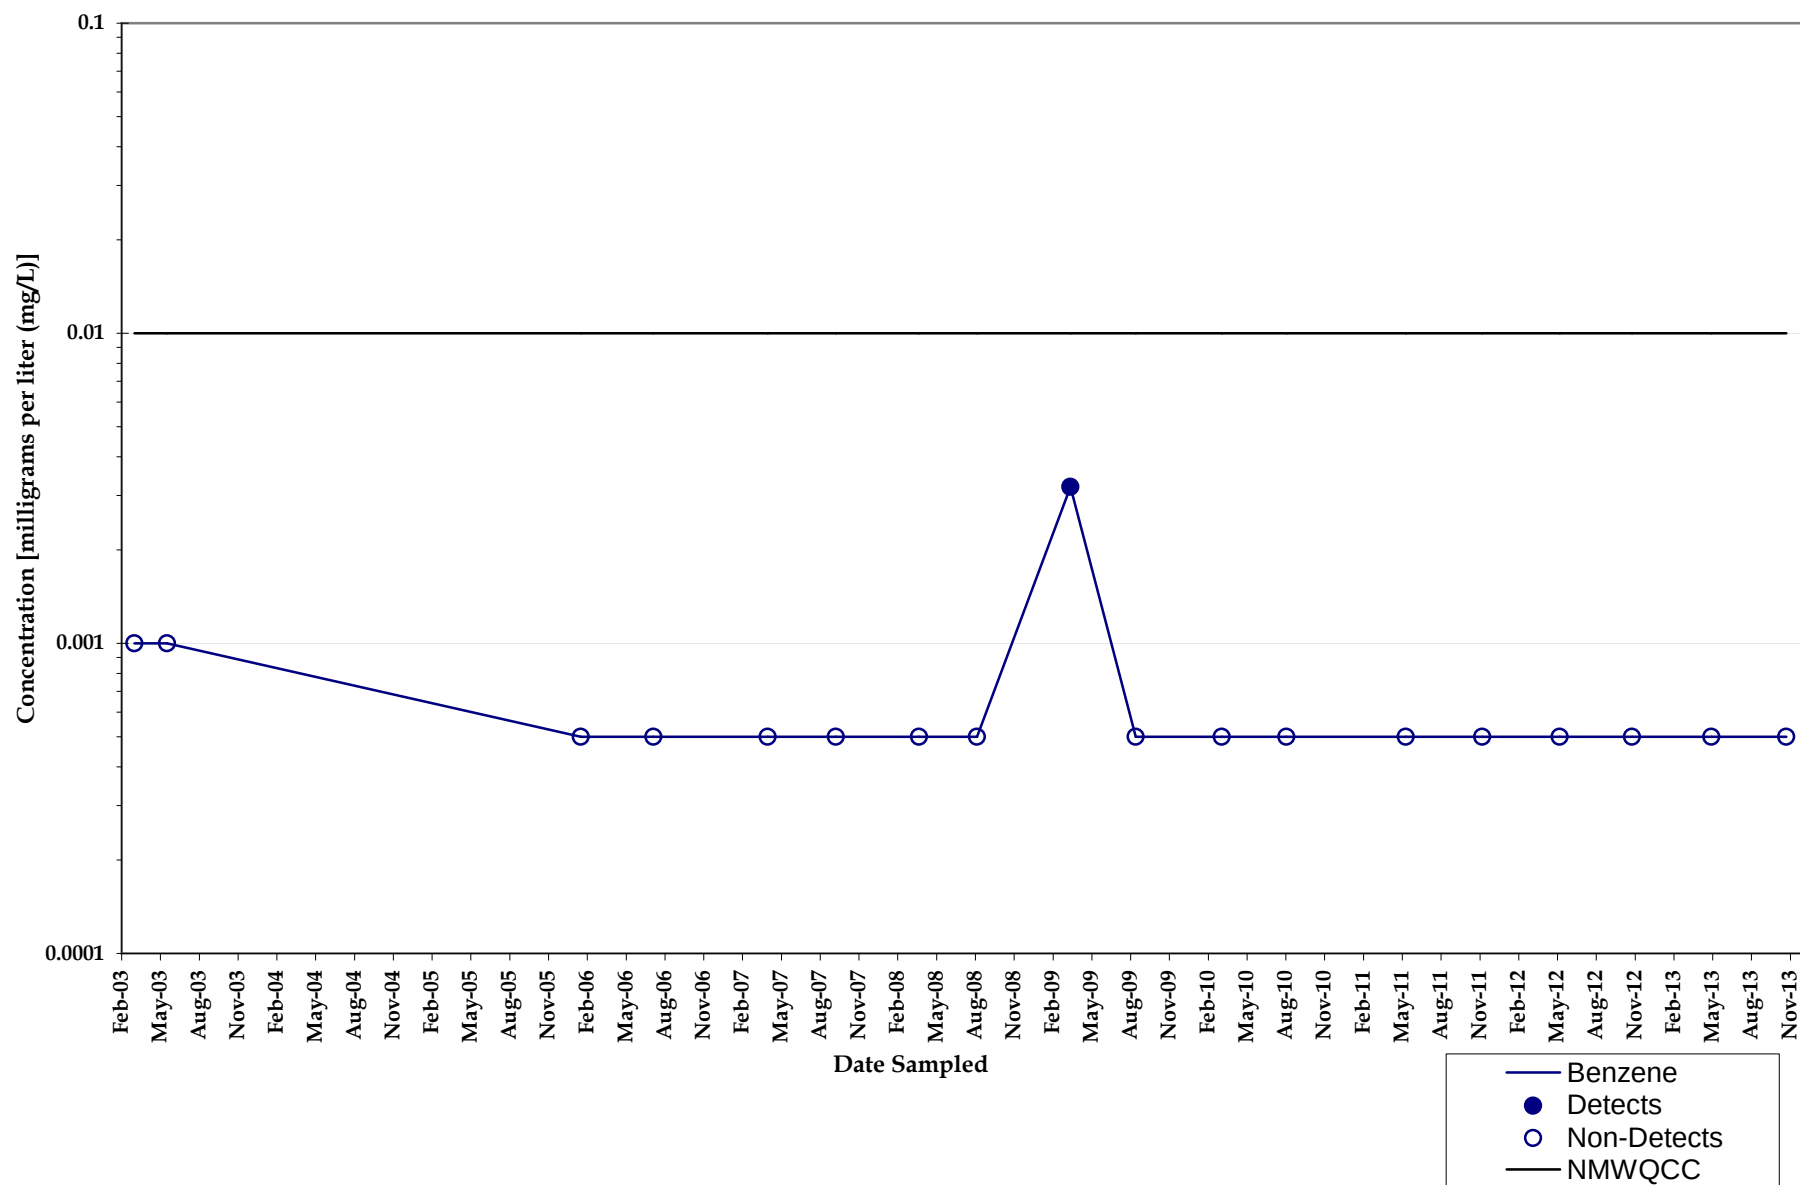
## Benzene Concentrations Monitoring Well MW067SA

Note: Non-detect analyses plotted at the method detection limit or half the reporting limit (RL). Detections denoted by symbol and detection values greater than the RL denoted by shaded symbol.

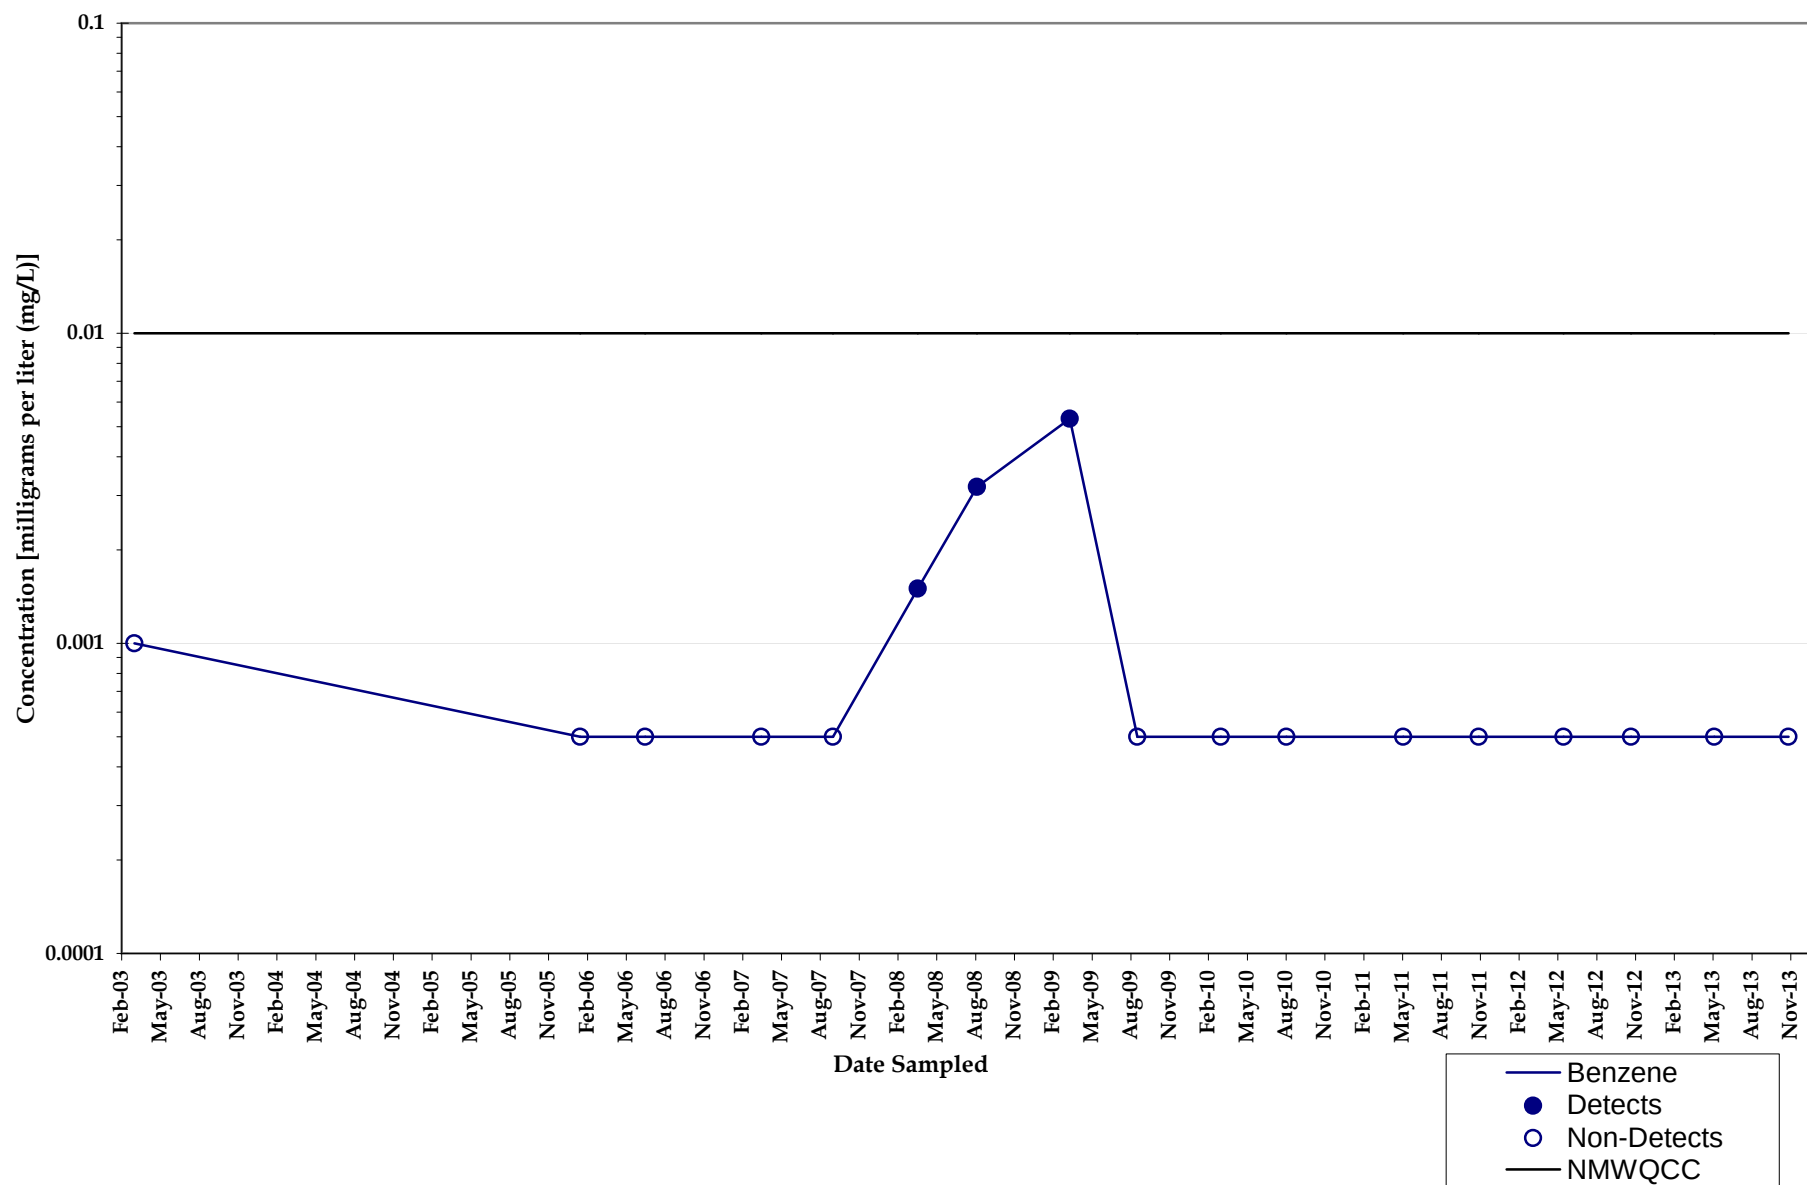
## Benzene Concentrations Monitoring Well MW068

Note: Non-detect analyses plotted at the method detection limit or half the reporting limit (RL). Detections denoted by symbol and detection values greater than the RL denoted by shaded symbol.

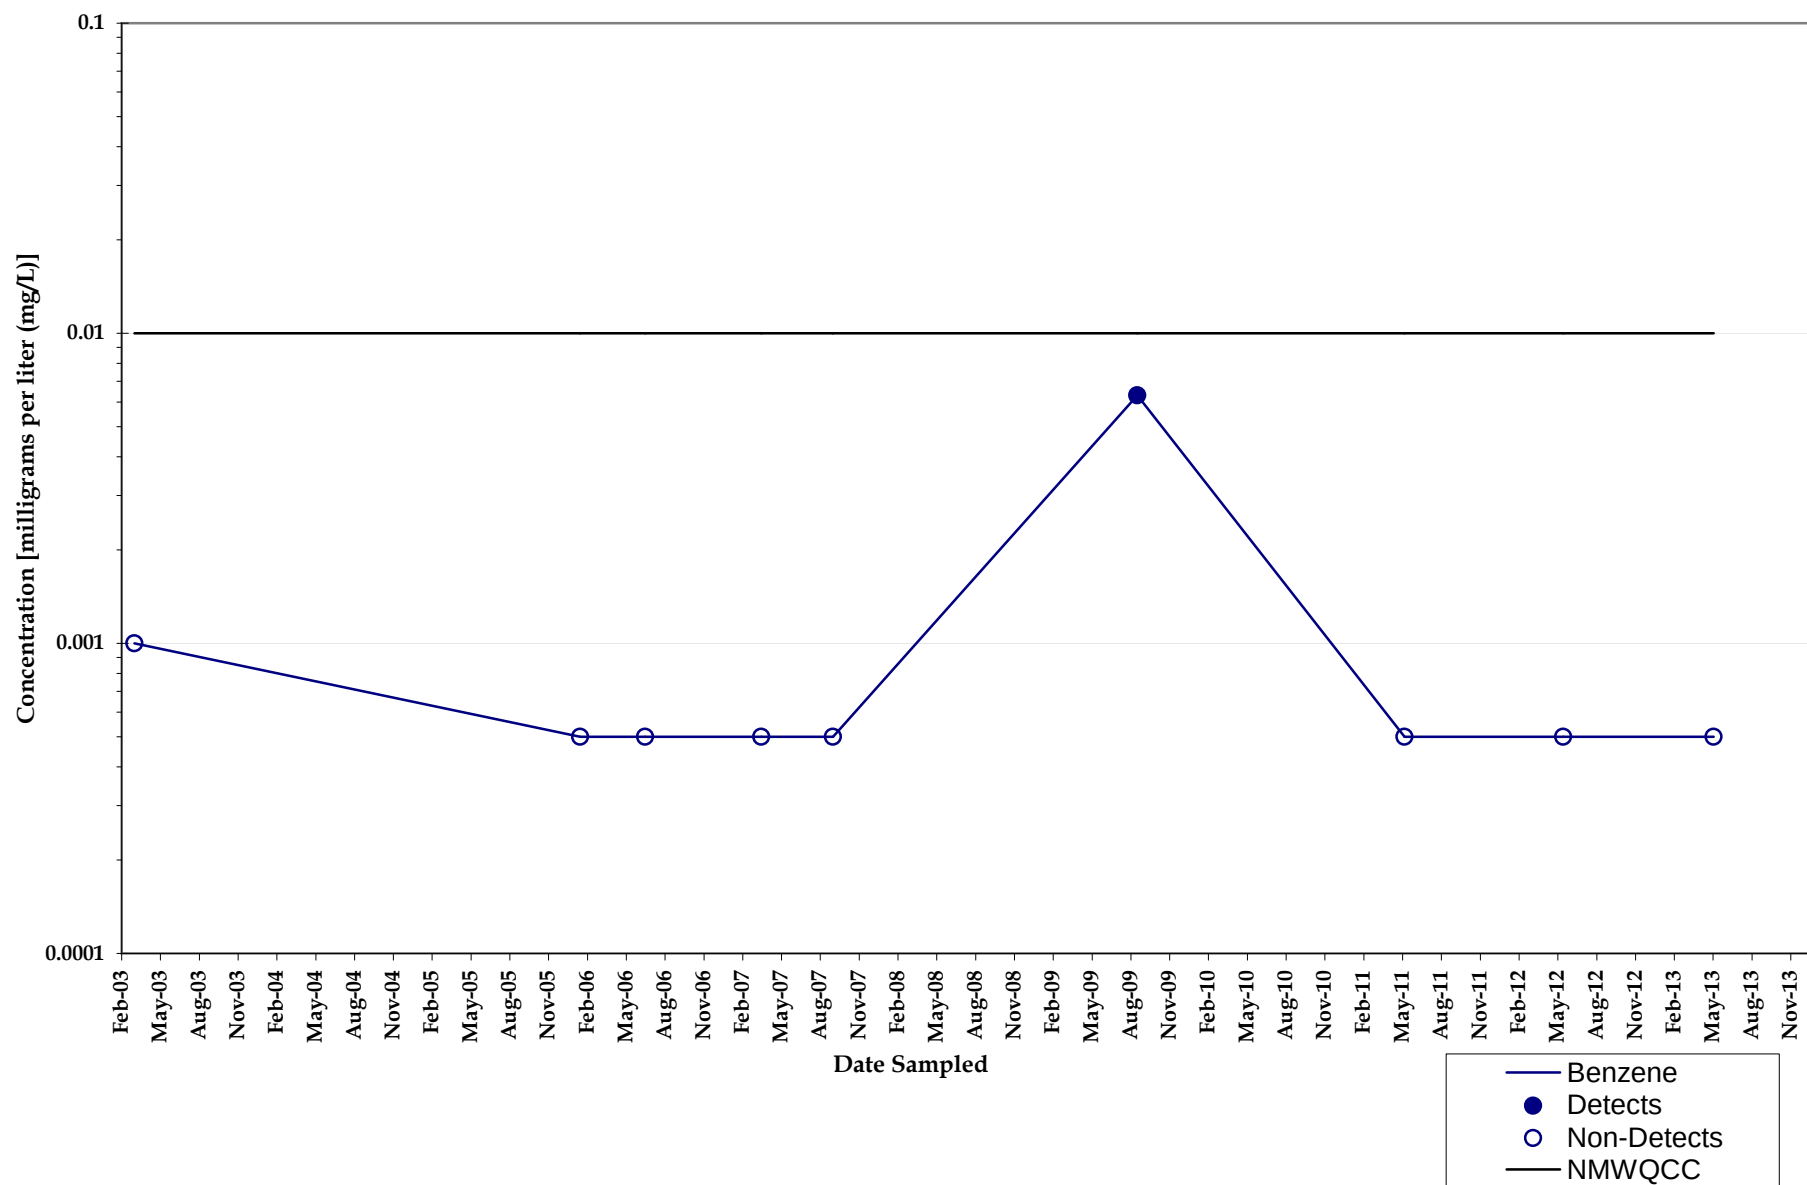
## Benzene Concentrations Monitoring Well MW069

Note: Non-detect analyses plotted at the method detection limit or half the reporting limit (RL). Detections denoted by symbol and detection values greater than the RL denoted by shaded symbol.

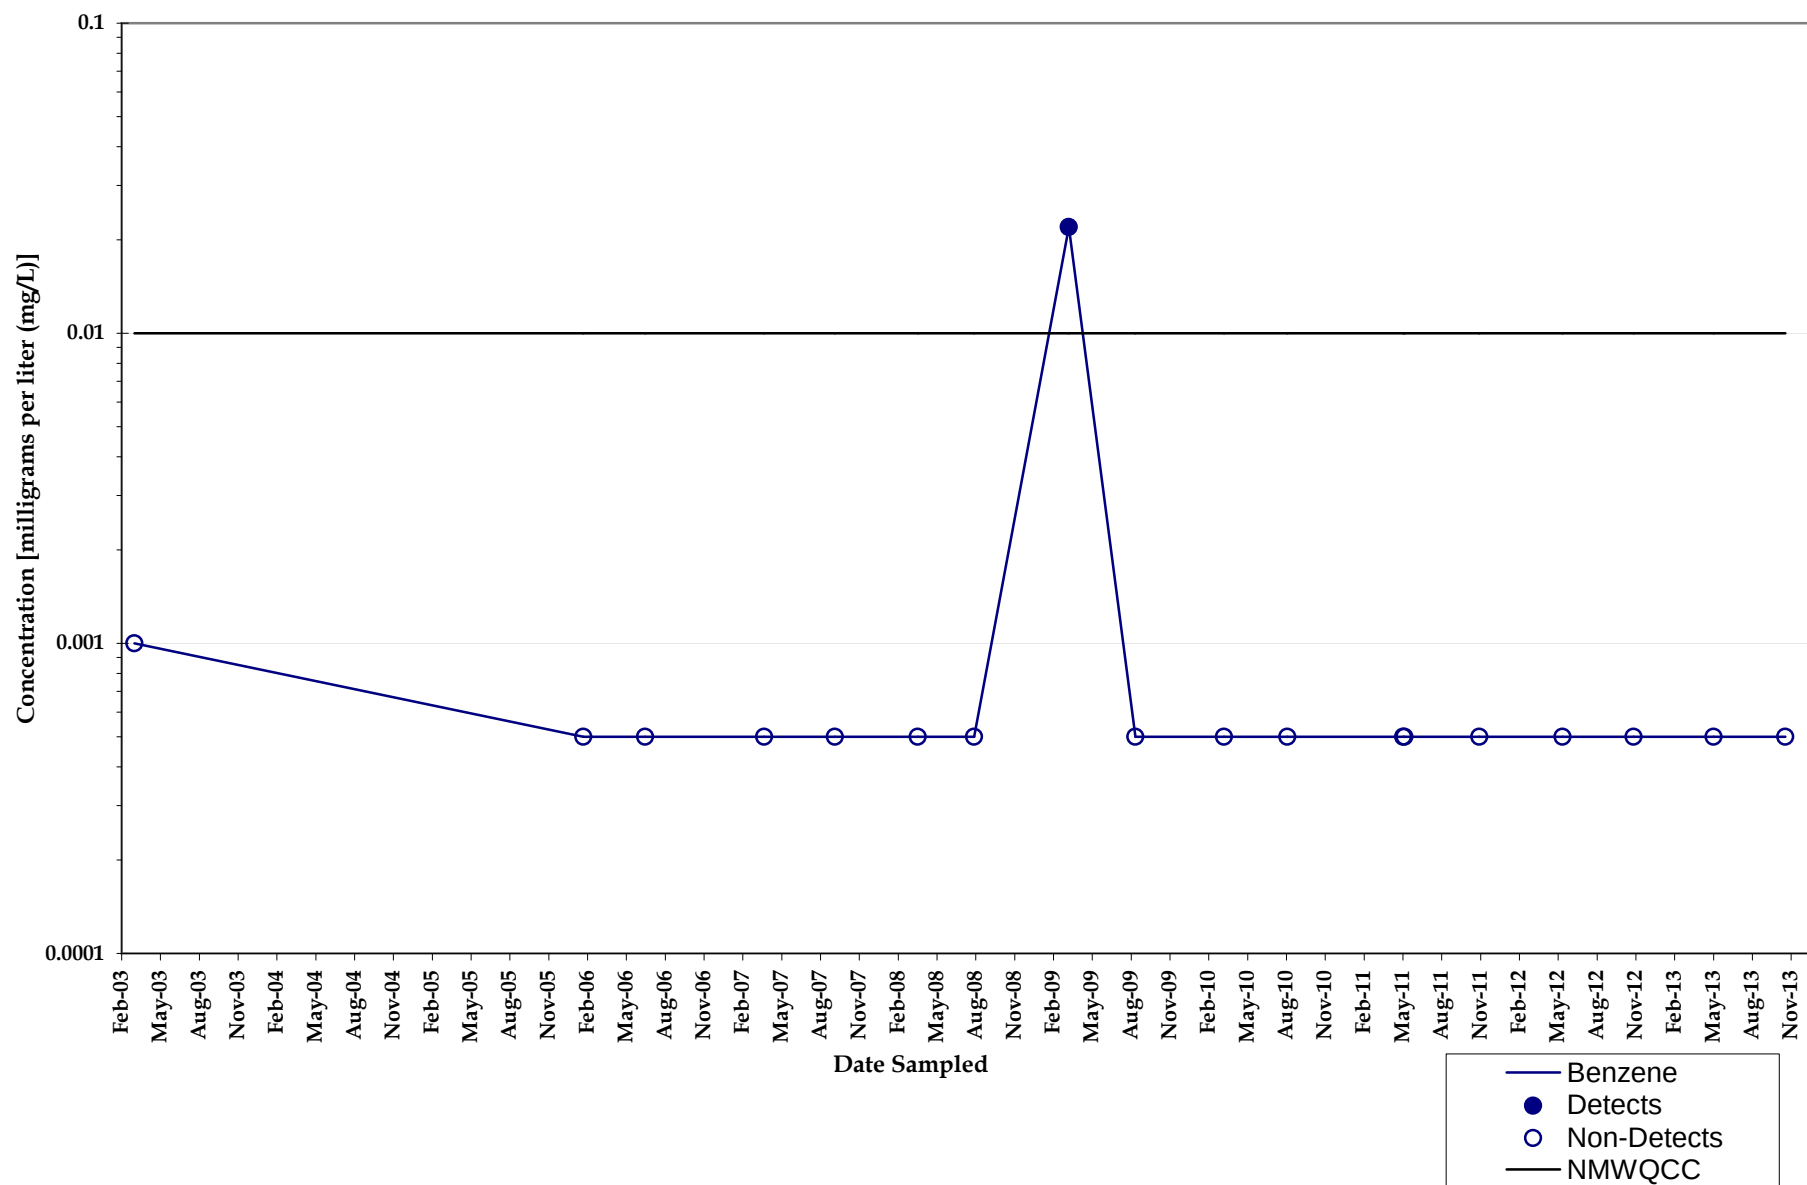
## Benzene Concentrations Monitoring Well MW070

Note: Non-detect analyses plotted at the method detection limit or half the reporting limit (RL). Detections denoted by symbol and detection values greater than the RL denoted by shaded symbol.

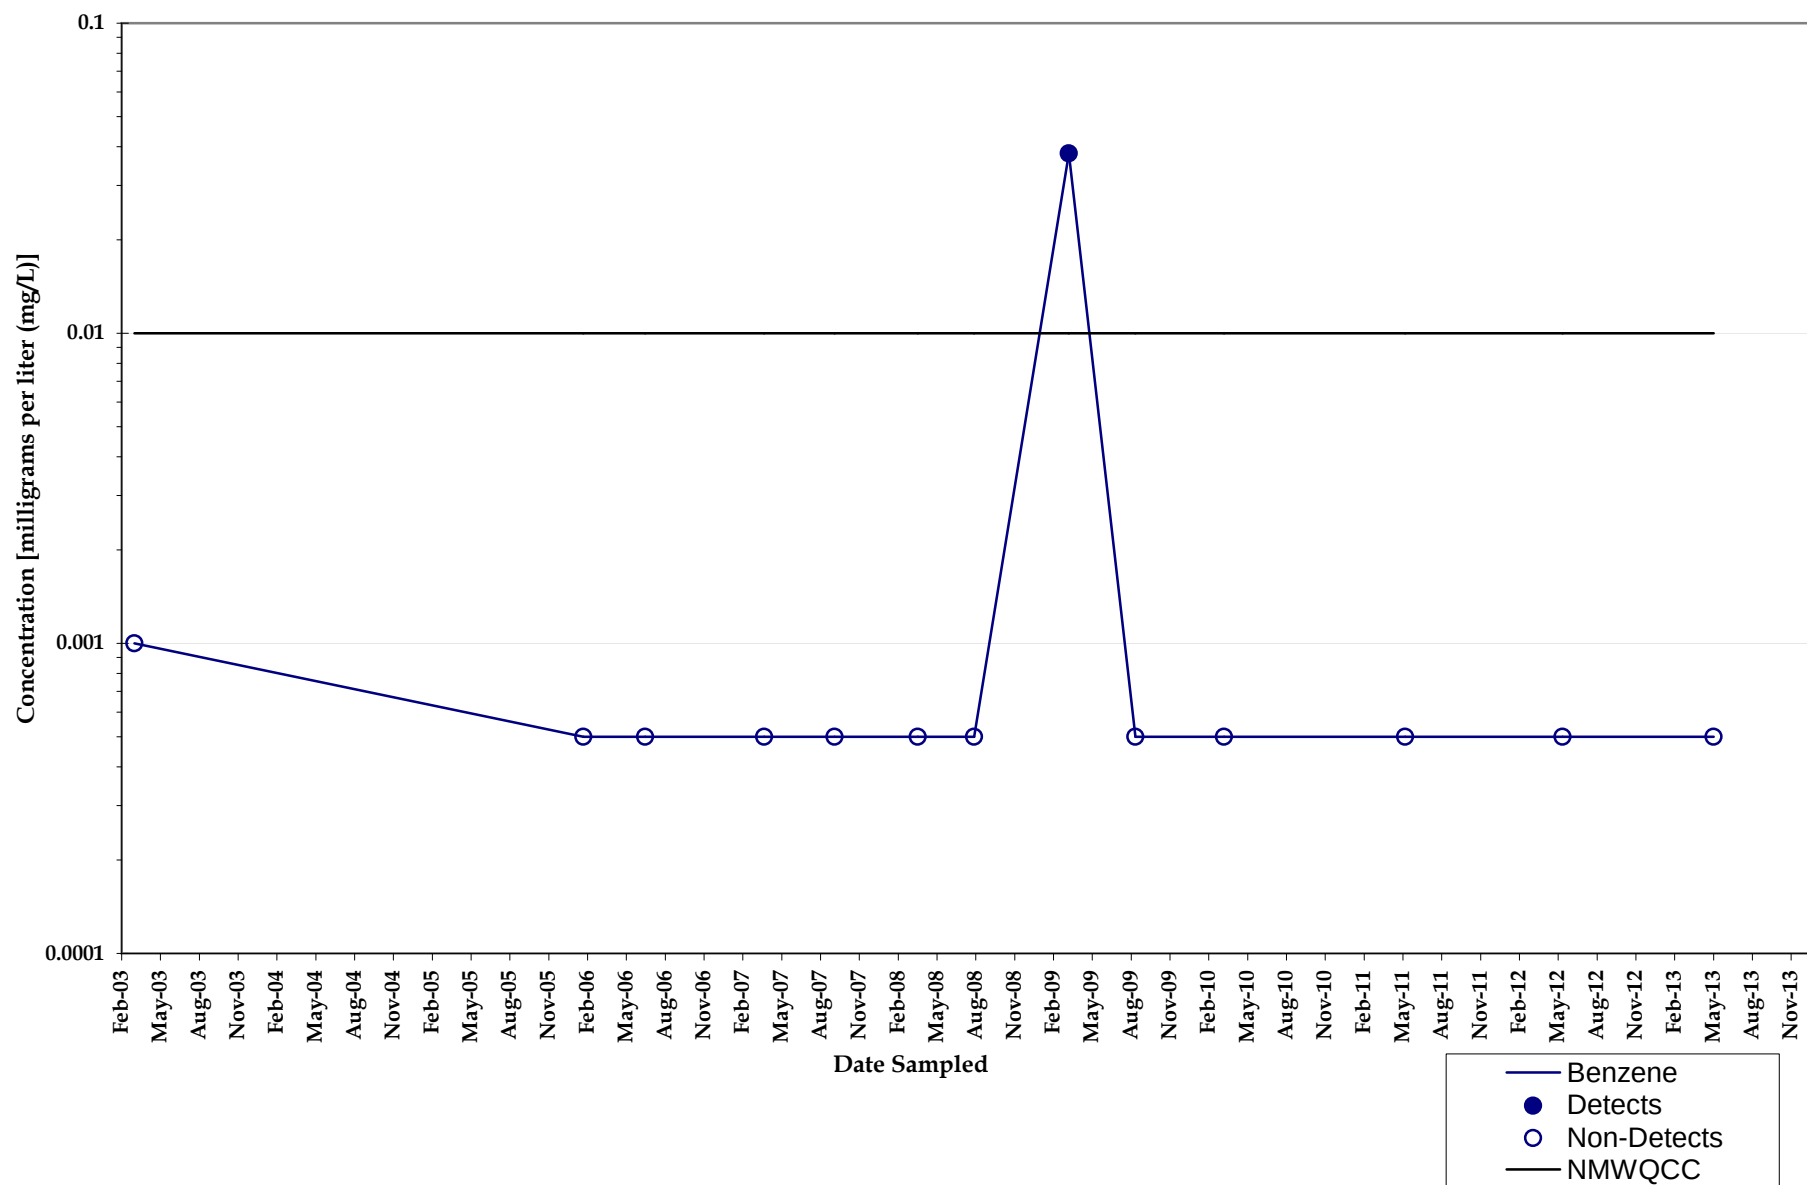
## Benzene Concentrations Monitoring Well MW070A

Note: Non-detect analyses plotted at the method detection limit or half the reporting limit (RL). Detections denoted by symbol and detection values greater than the RL denoted by shaded symbol.

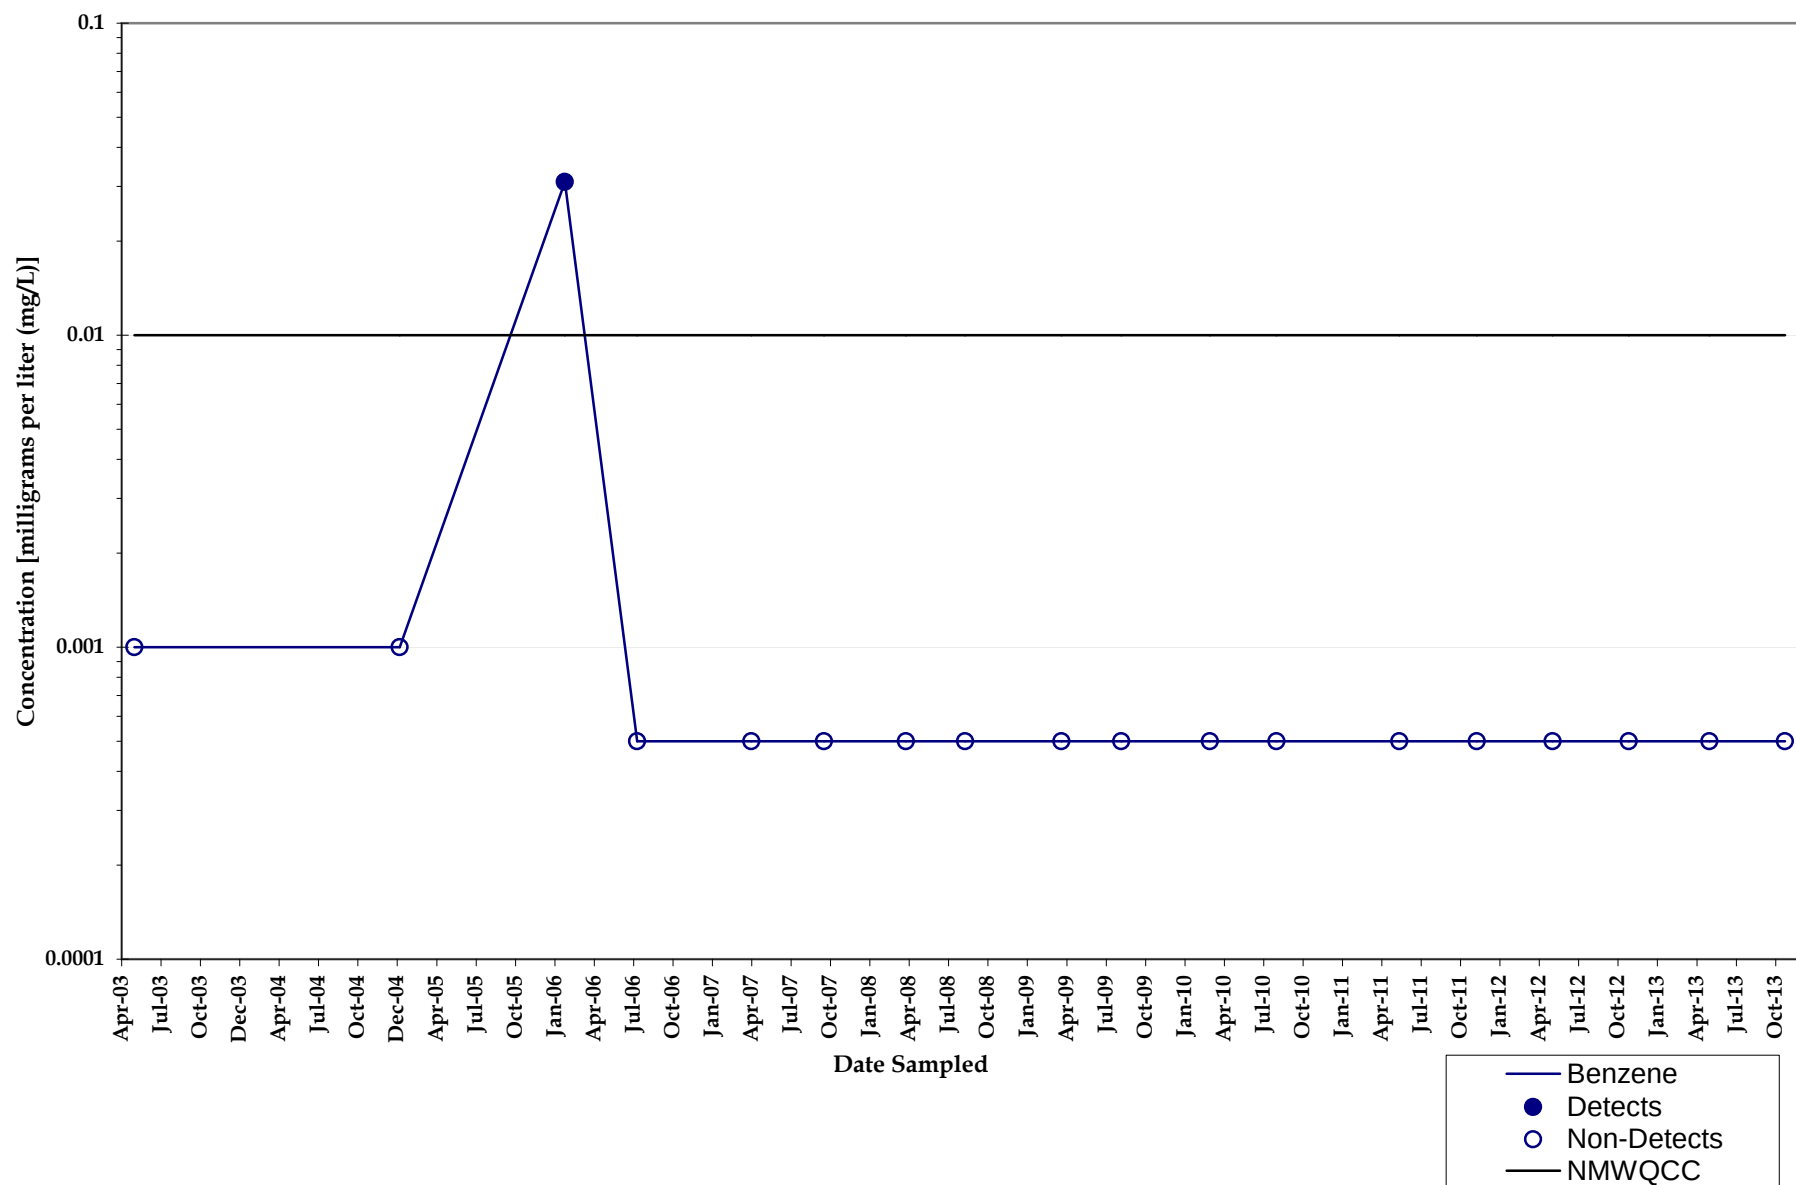
## Benzene Concentrations Monitoring Well MW071SA

Note: Non-detect analyses plotted at the method detection limit or half the reporting limit (RL). Detections denoted by symbol and detection values greater than the RL denoted by shaded symbol.

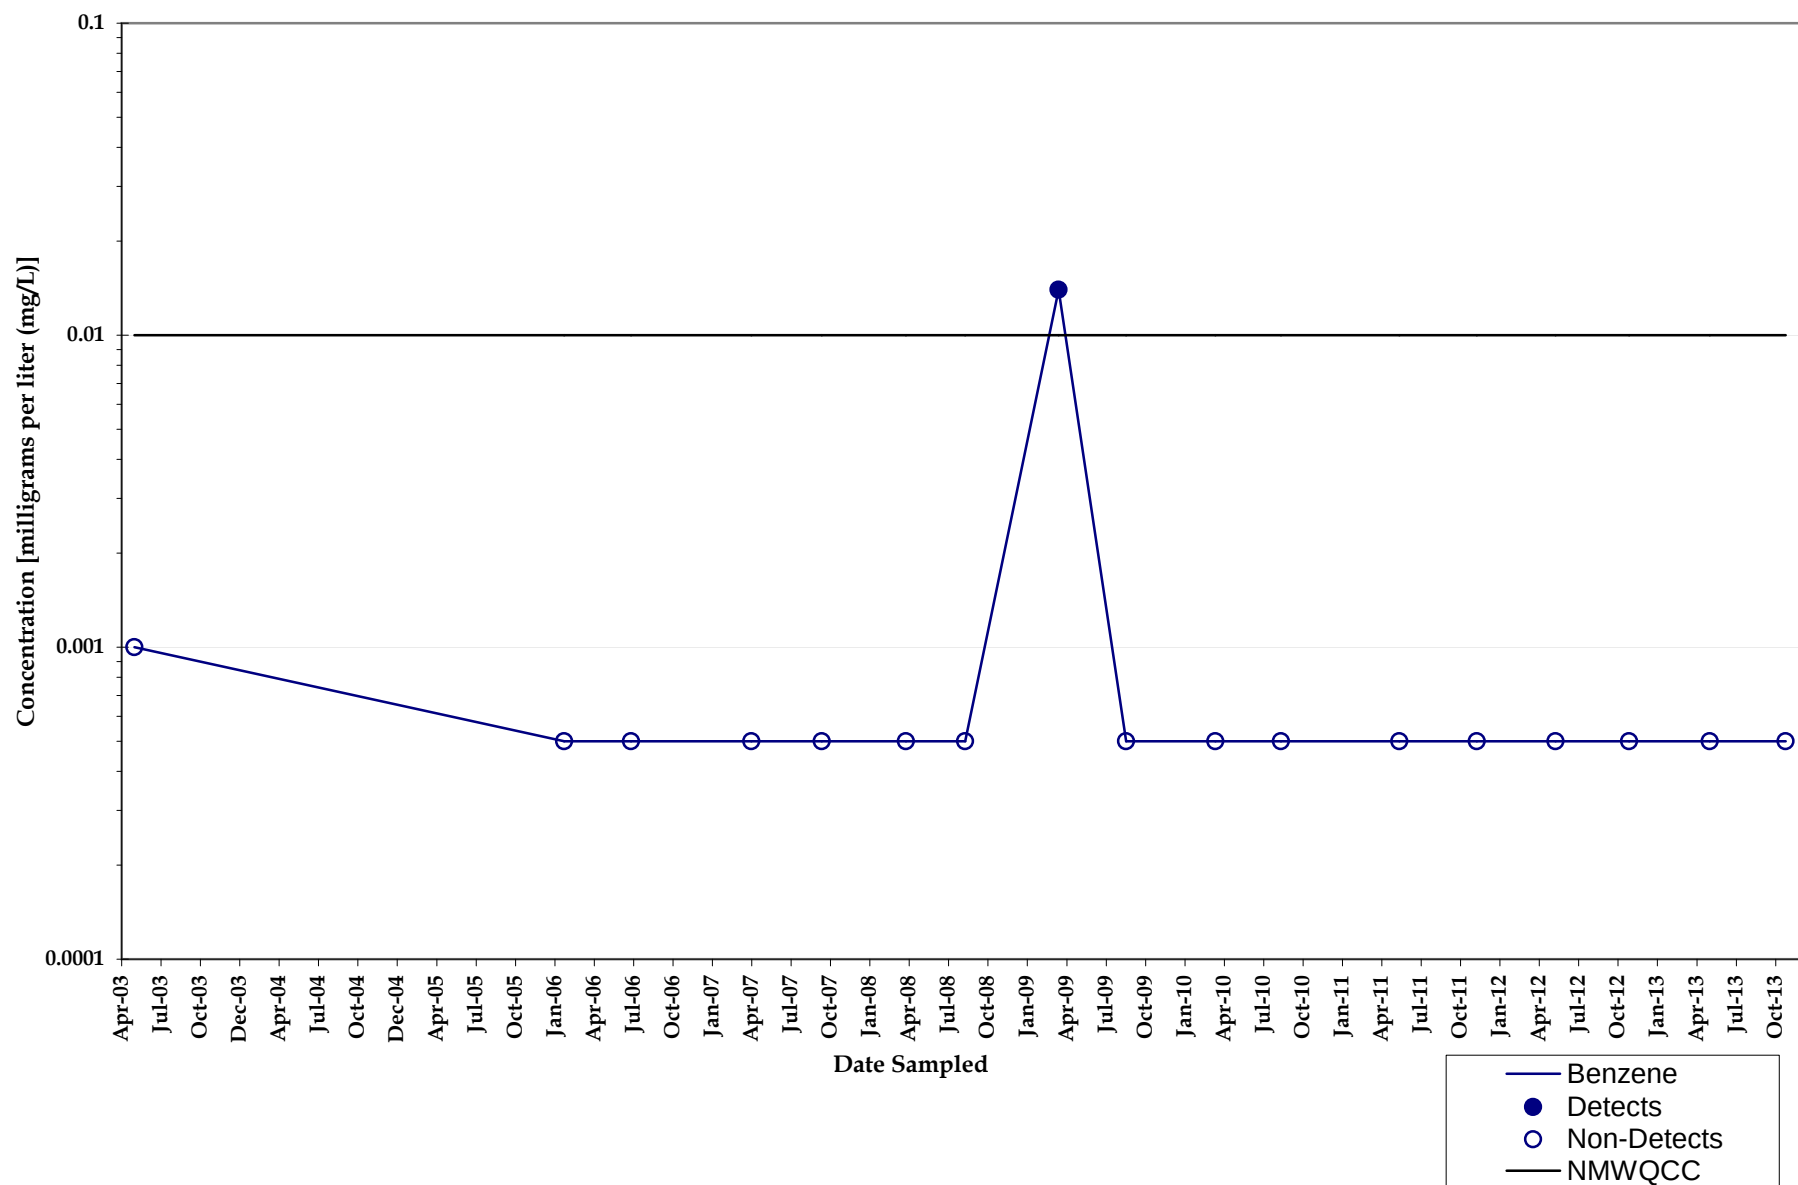
## Benzene Concentrations Monitoring Well MW072SA

Note: Non-detect analyses plotted at the method detection limit or half the reporting limit (RL). Detections denoted by symbol and detection values greater than the RL denoted by shaded symbol.

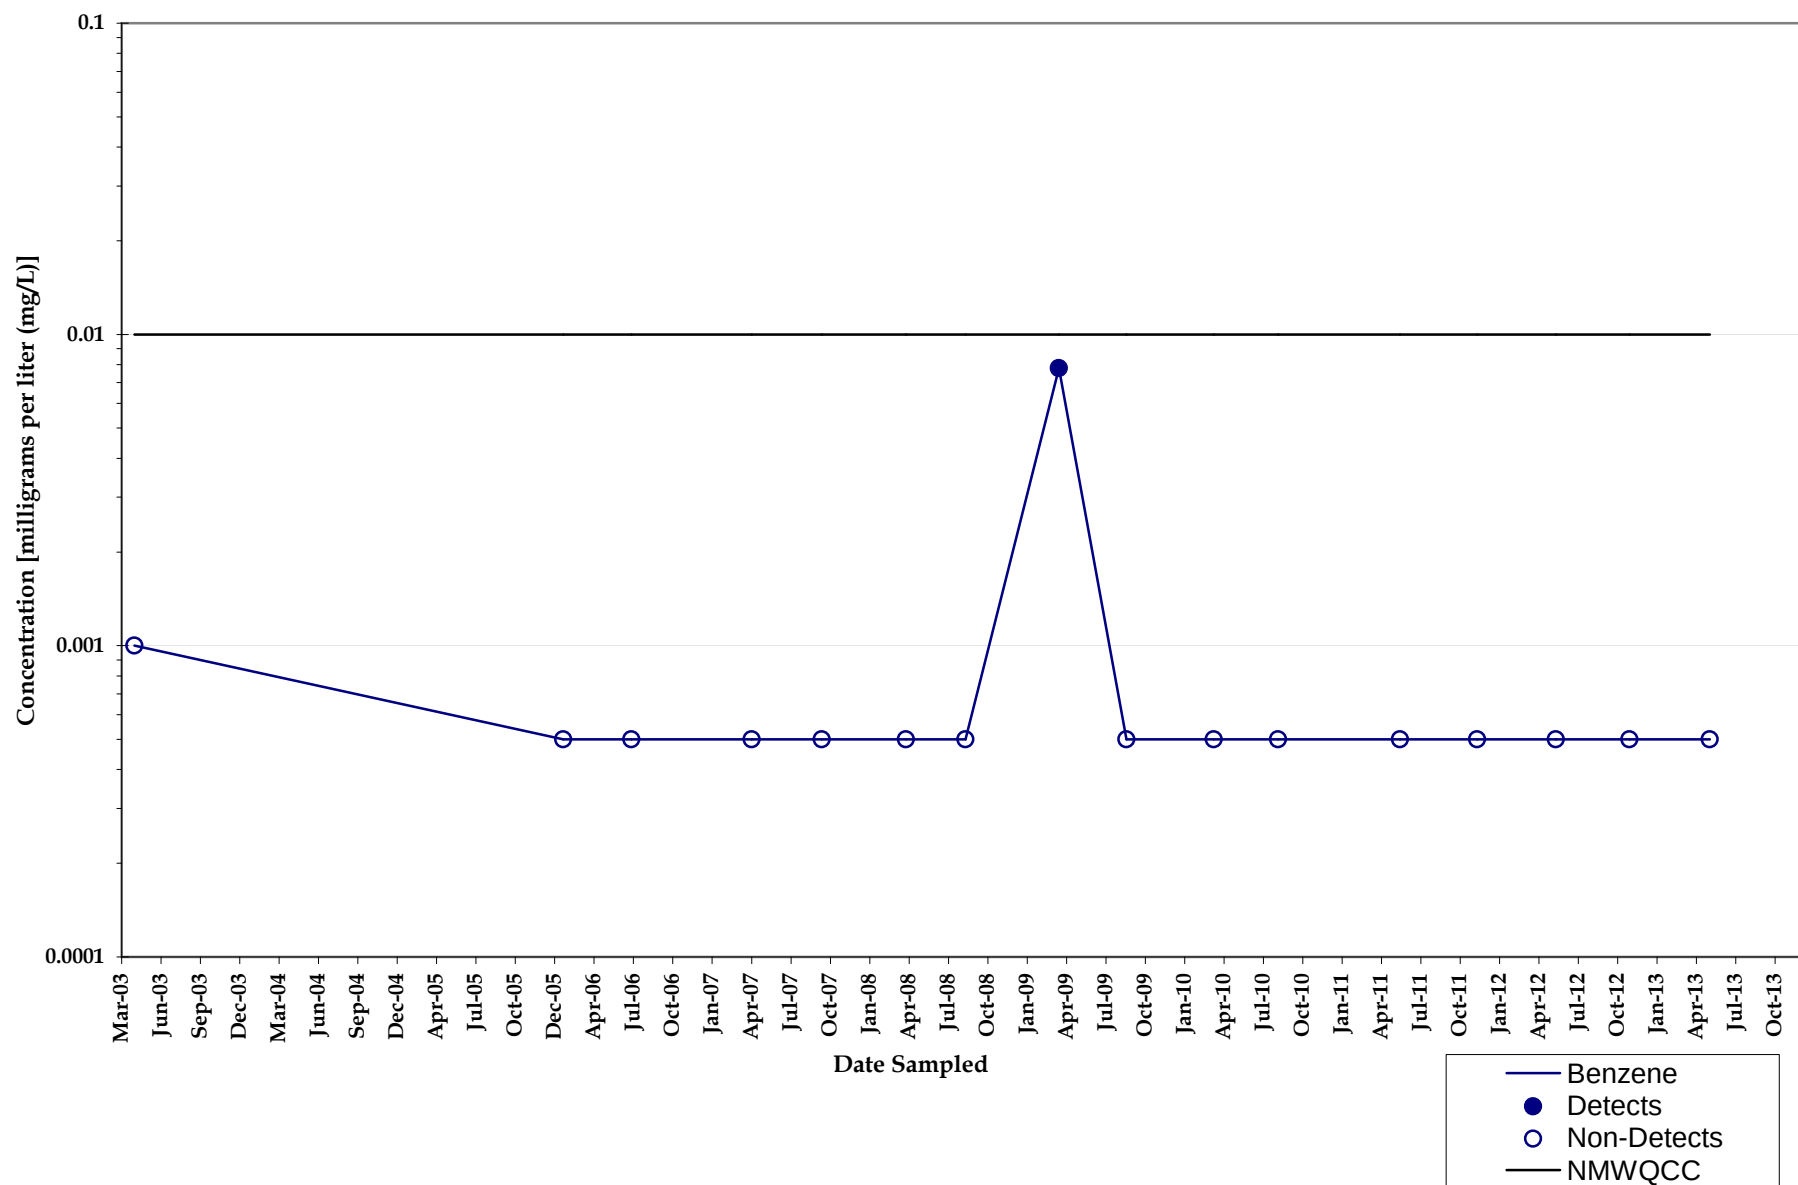
## Benzene Concentrations Monitoring Well MW073SA

Note: Non-detect analyses plotted at the method detection limit or half the reporting limit (RL). Detections denoted by symbol and detection values greater than the RL denoted by shaded symbol.

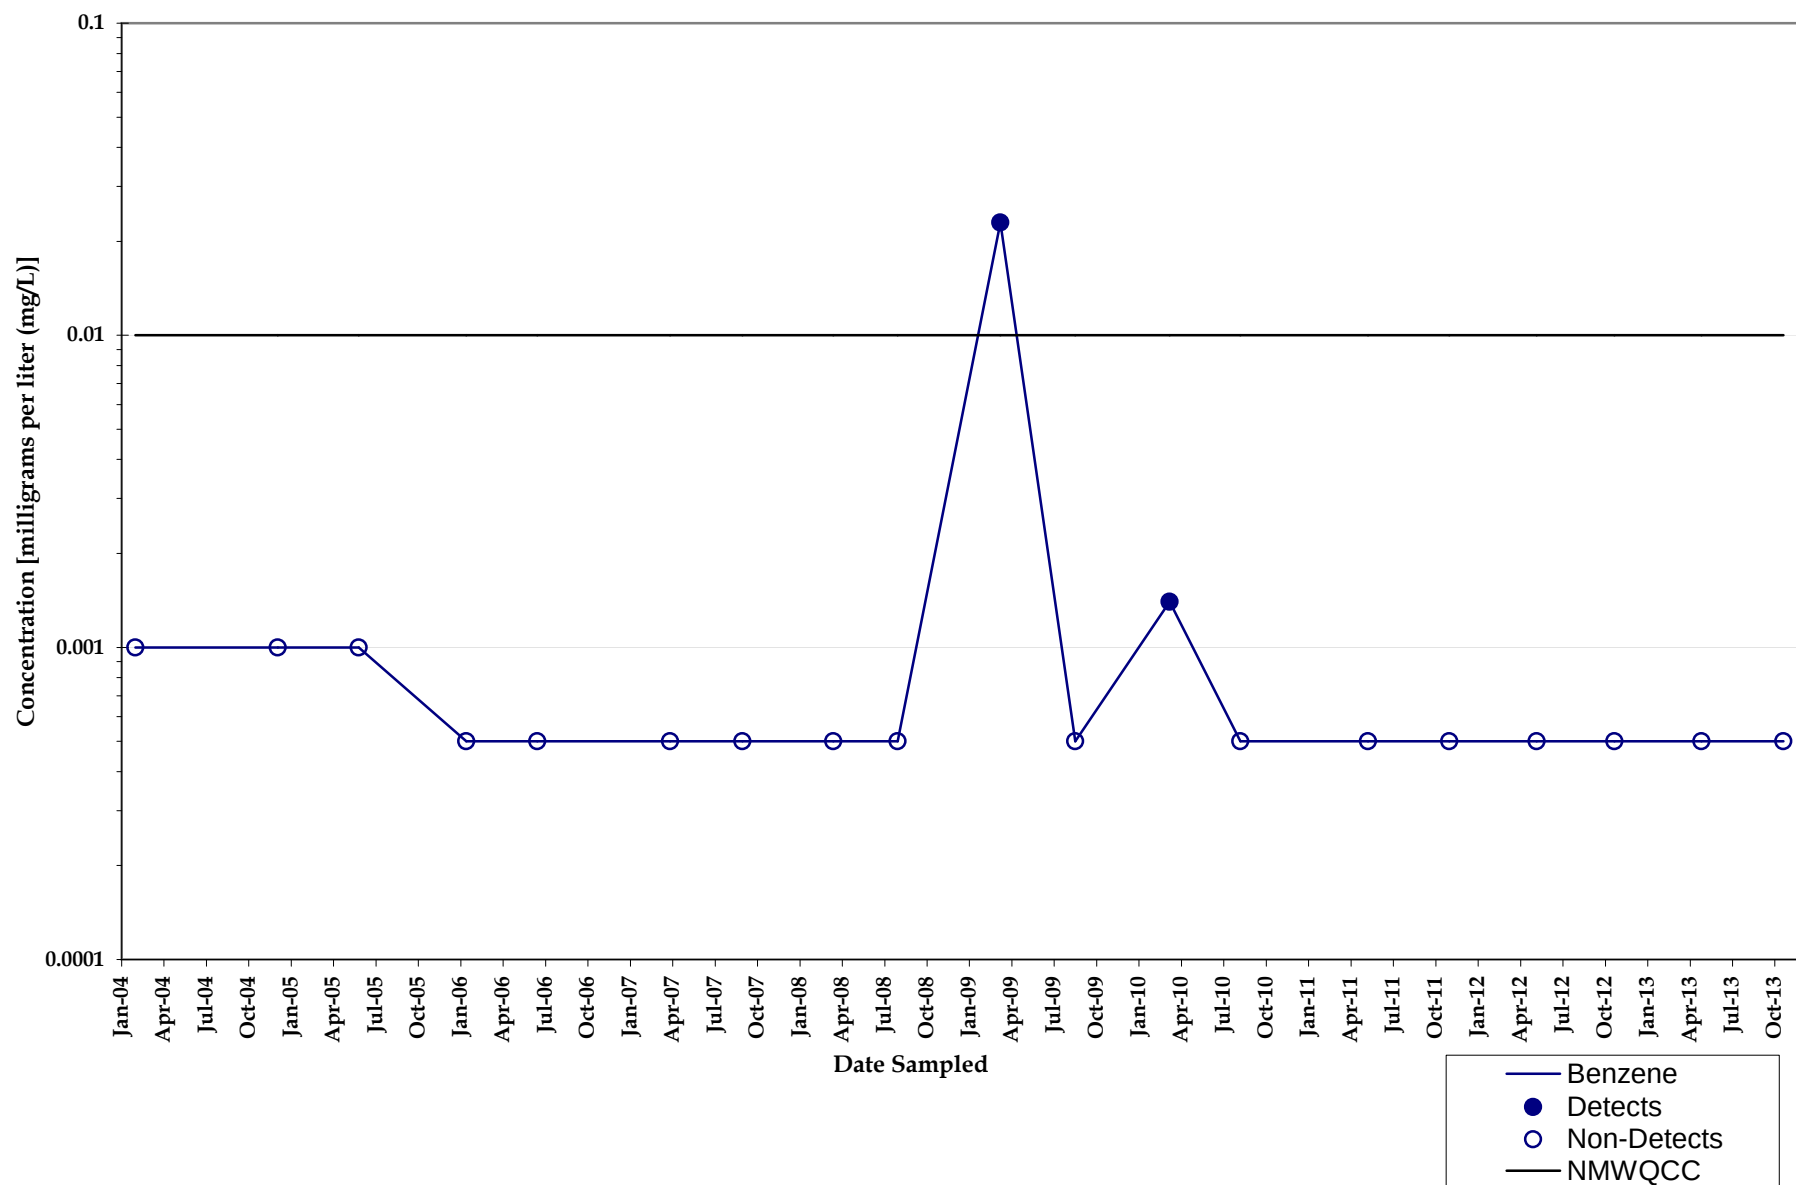
## Benzene Concentrations Monitoring Well MW074SA

Note: Non-detect analyses plotted at the method detection limit or half the reporting limit (RL). Detections denoted by symbol and detection values greater than the RL denoted by shaded symbol.
