**GW - 004**

**2013 AGWMR**

**VOL 5 OF 5**

*North Eunice Gas Plant  
Lea County, New Mexico*

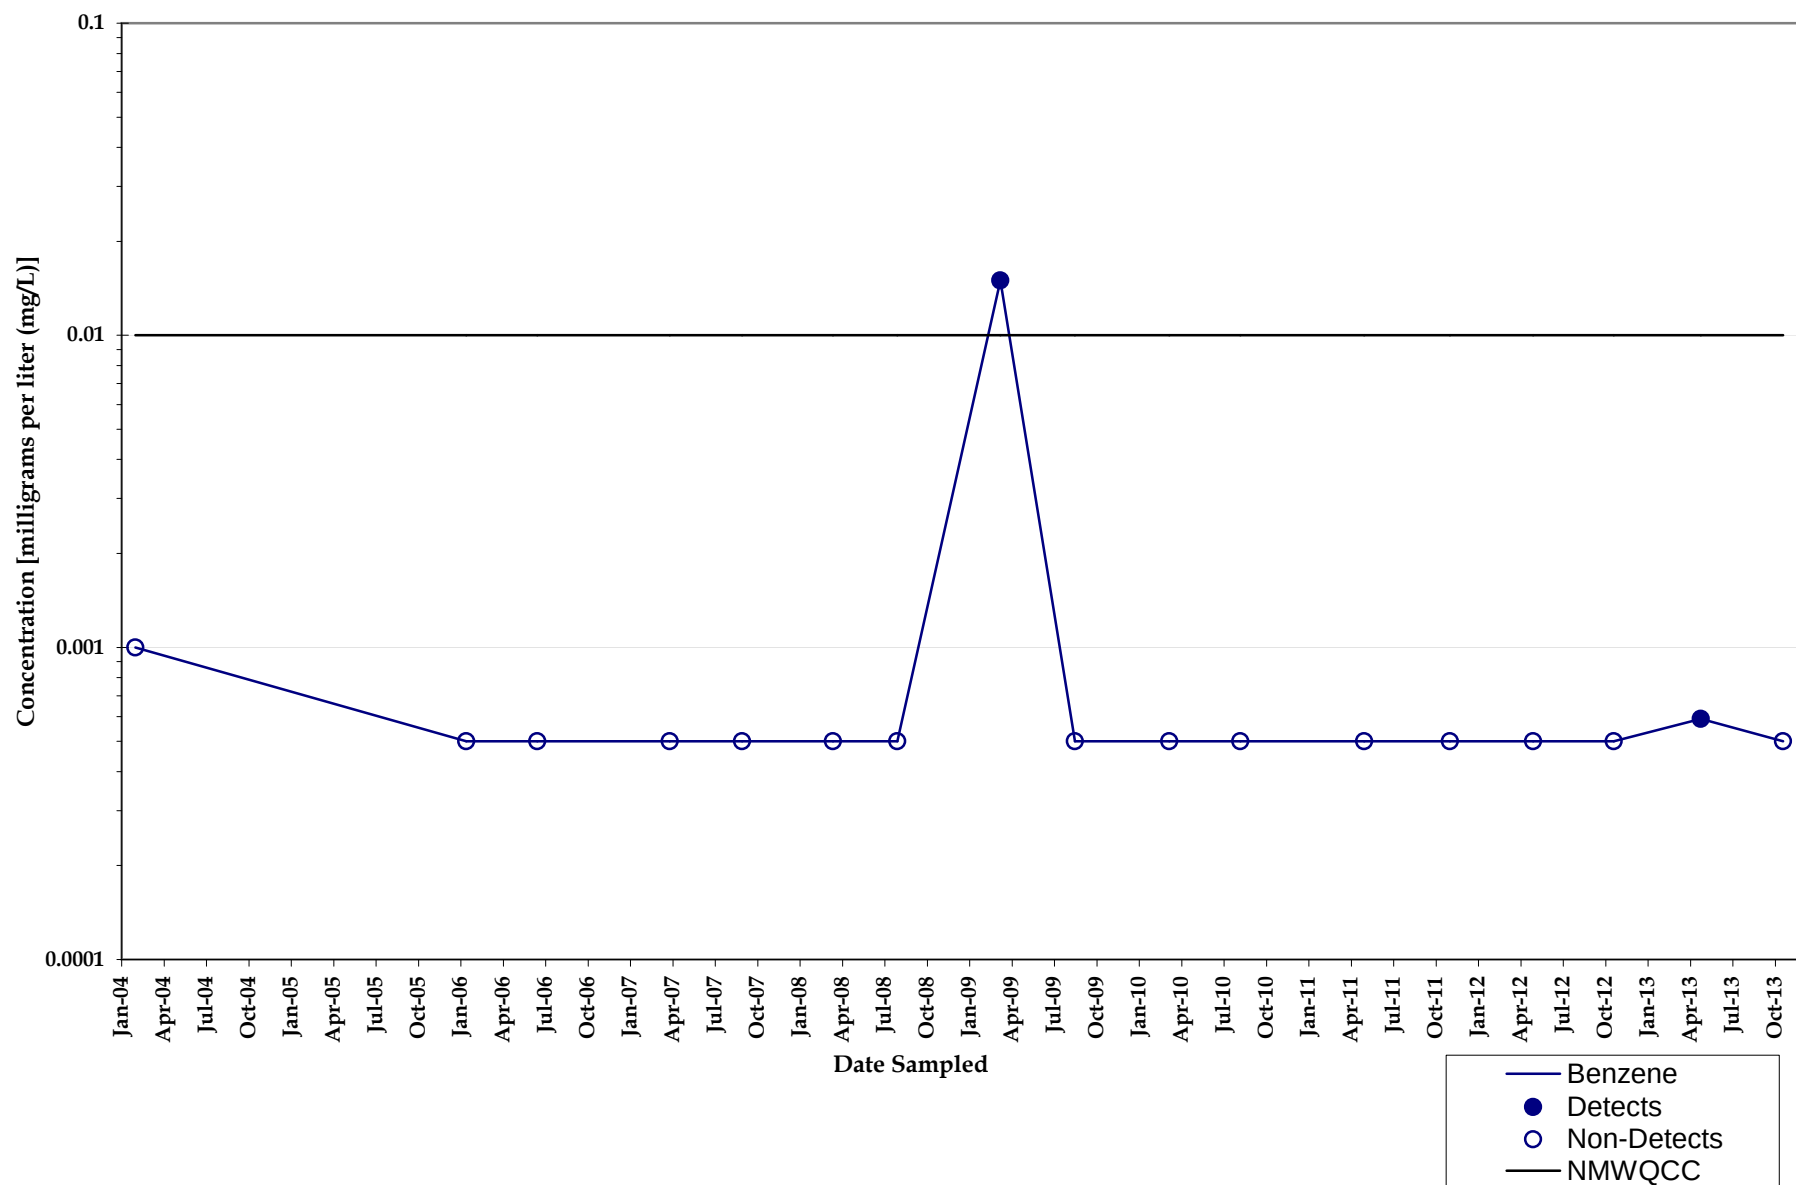
## Benzene Concentrations Monitoring Well MW075SA

Note: Non-detect analyses plotted at the method detection limit or half the reporting limit (RL). Detections denoted by symbol and detection values greater than the RL denoted by shaded symbol.

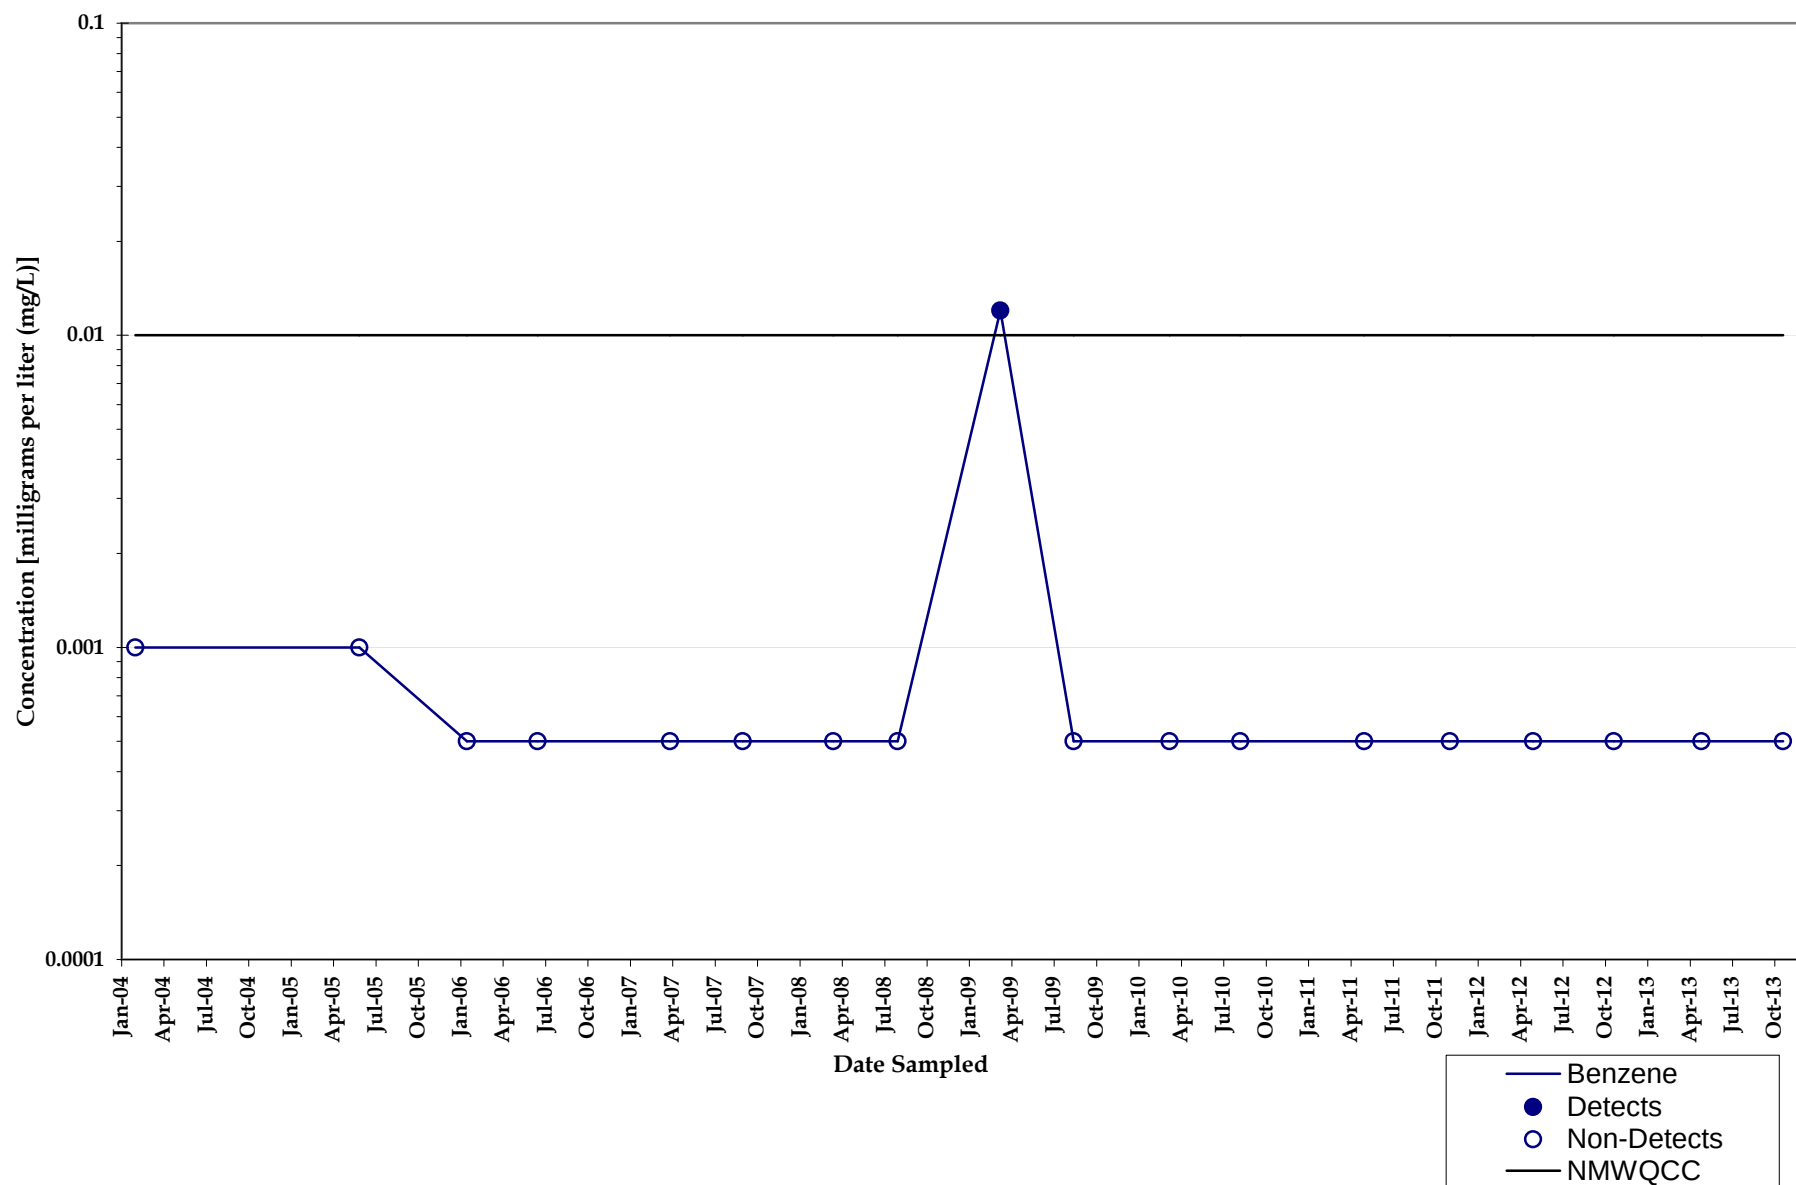
## Benzene Concentrations Monitoring Well MW076SA

Note: Non-detect analyses plotted at the method detection limit or half the reporting limit (RL). Detections denoted by symbol and detection values greater than the RL denoted by shaded symbol.

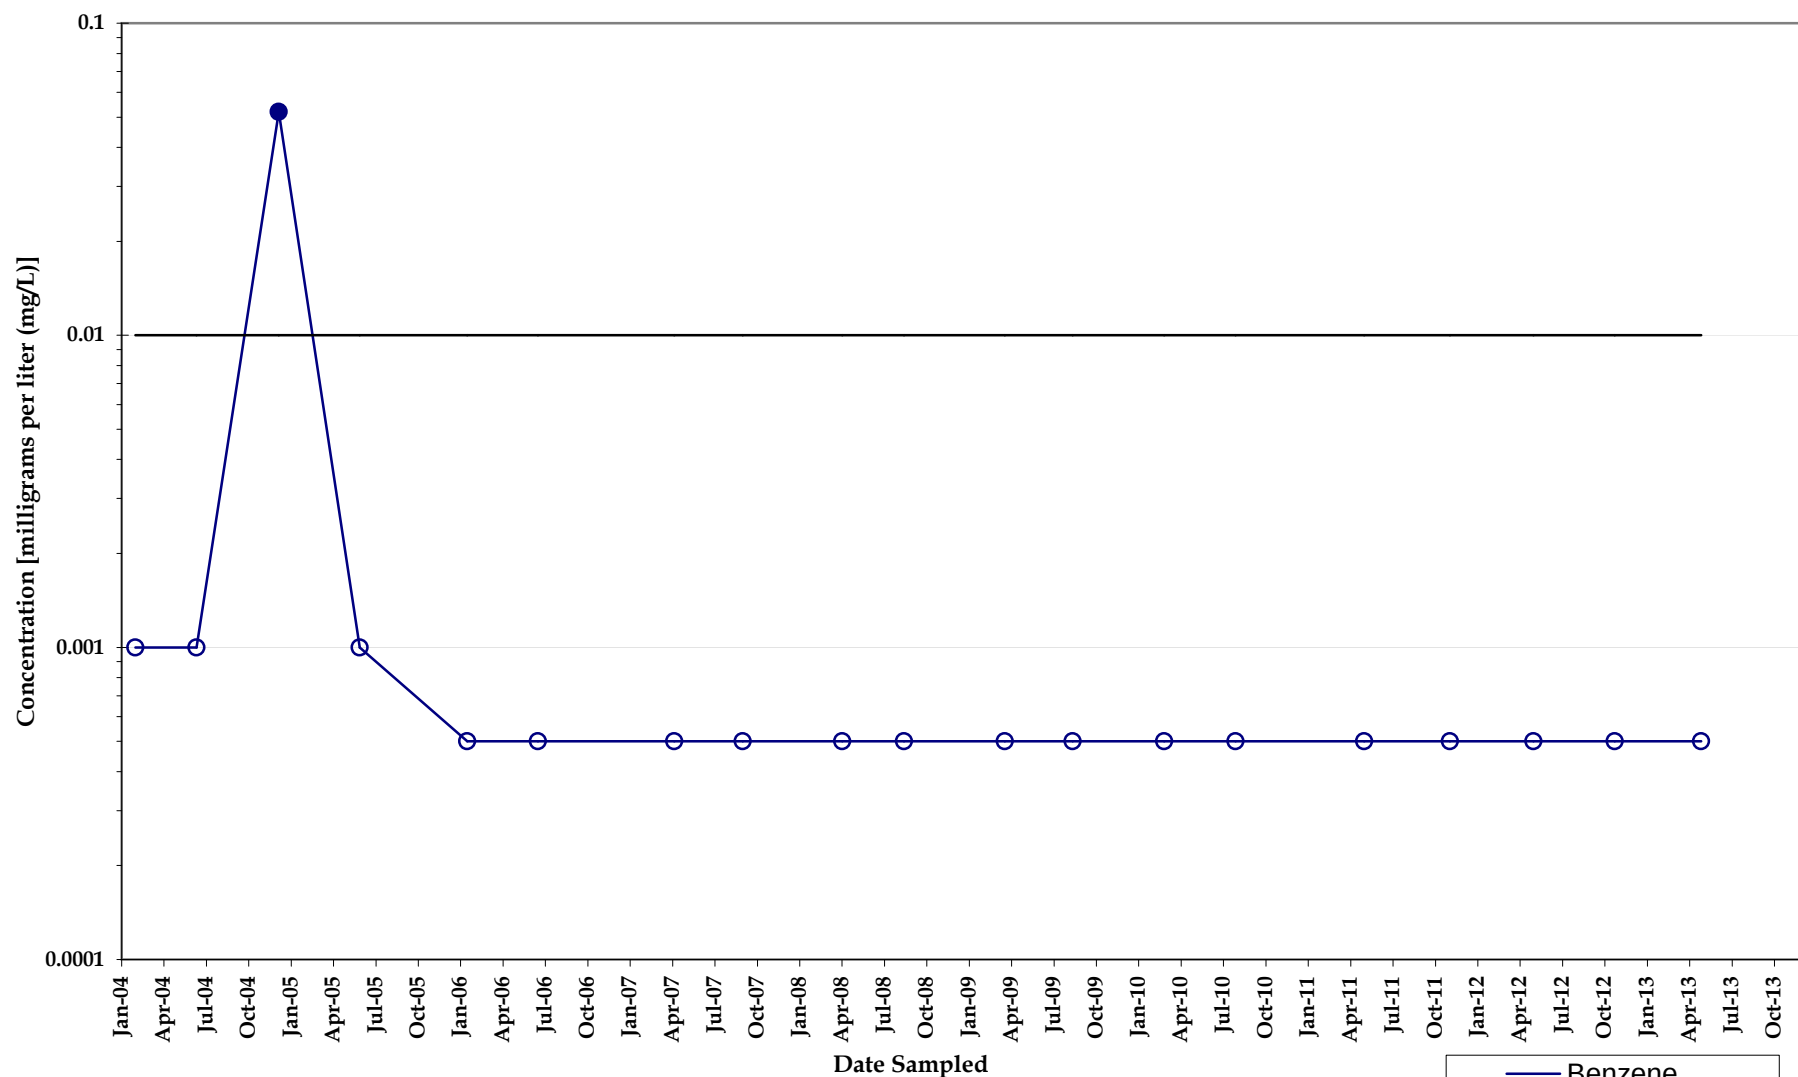
## Benzene Concentrations Monitoring Well MW077SA

Note: Non-detect analyses plotted at the method detection limit or half the reporting limit (RL). Detections denoted by symbol and detection values greater than the RL denoted by shaded symbol.

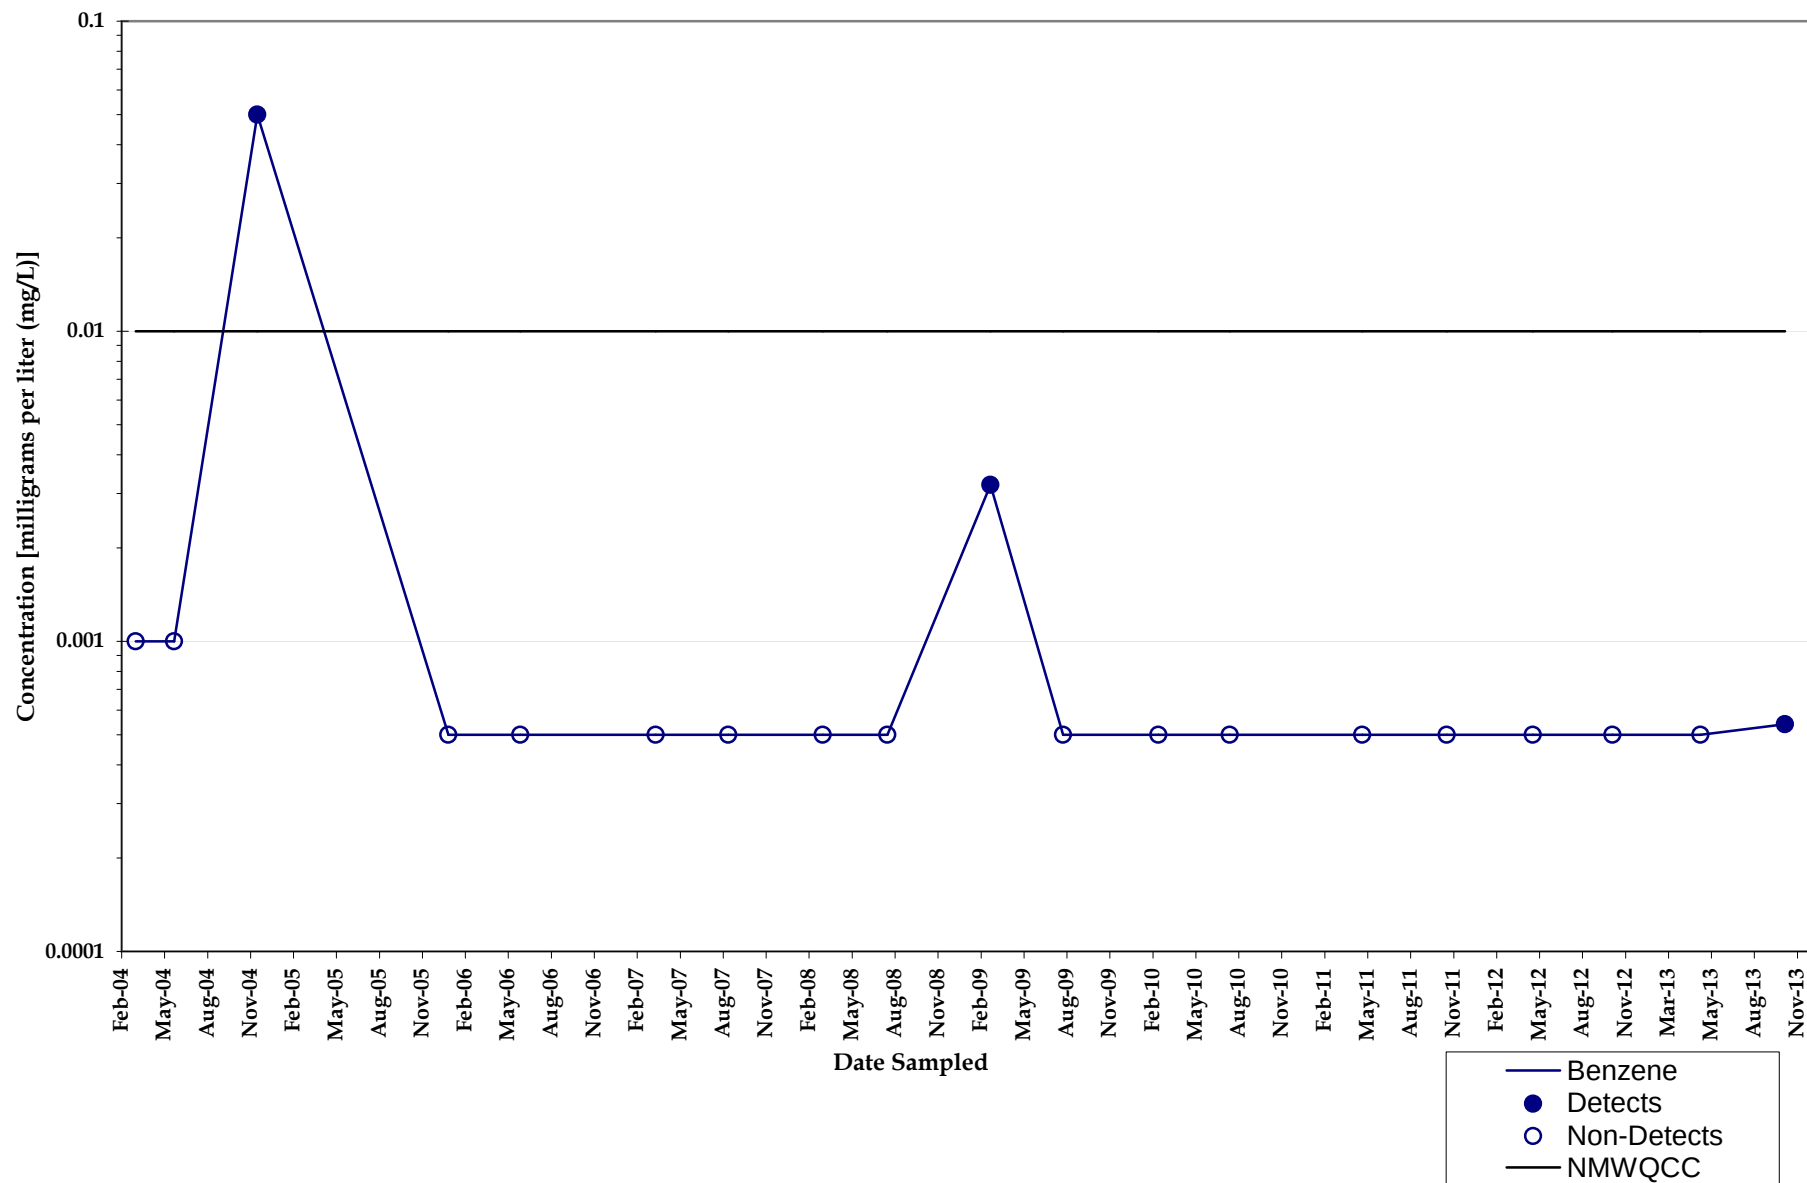
## Benzene Concentrations Monitoring Well MW078SA

Note: Non-detect analyses plotted at the method detection limit or half the reporting limit (RL). Detections denoted by symbol and detection values greater than the RL denoted by shaded symbol.

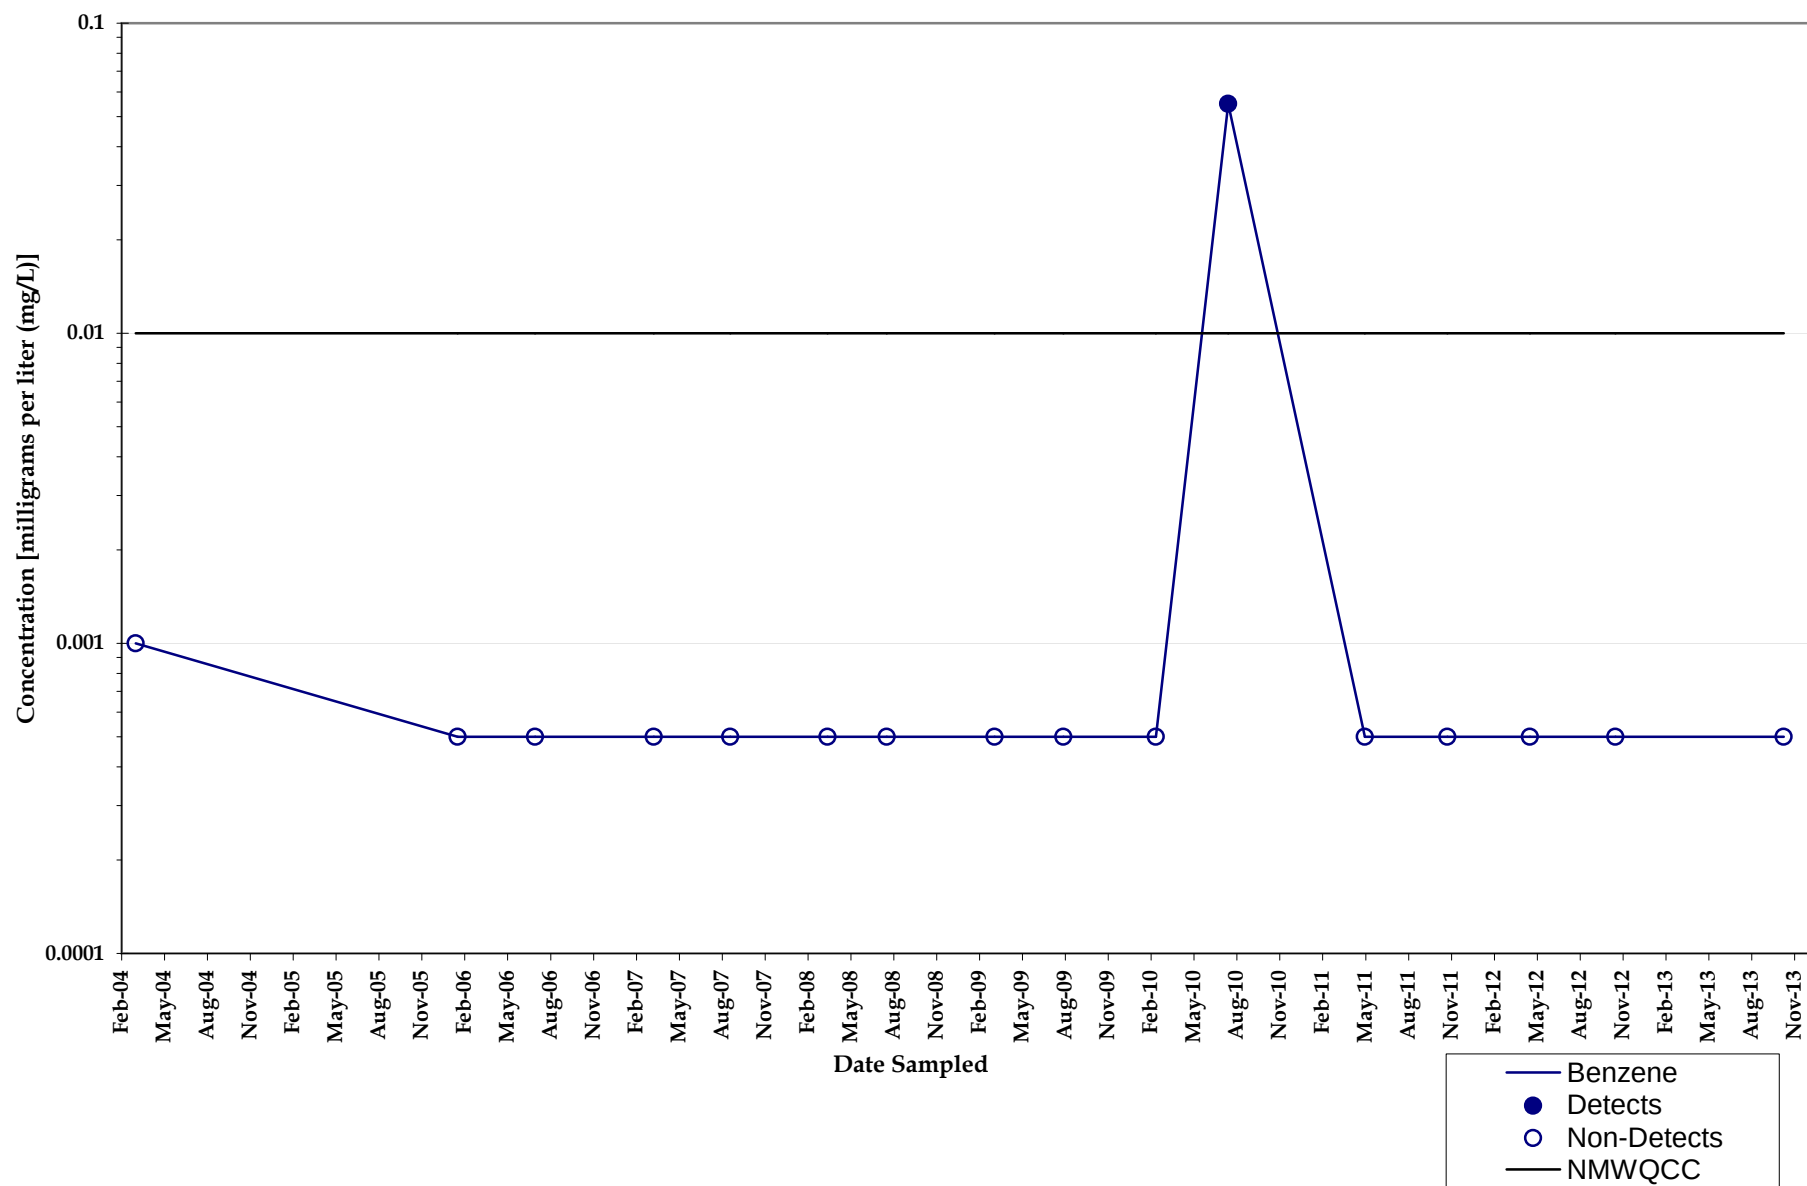
## Benzene Concentrations Monitoring Well MW079SA

Note: Non-detect analyses plotted at the method detection limit or half the reporting limit (RL). Detections denoted by symbol and detection values greater than the RL denoted by shaded symbol.

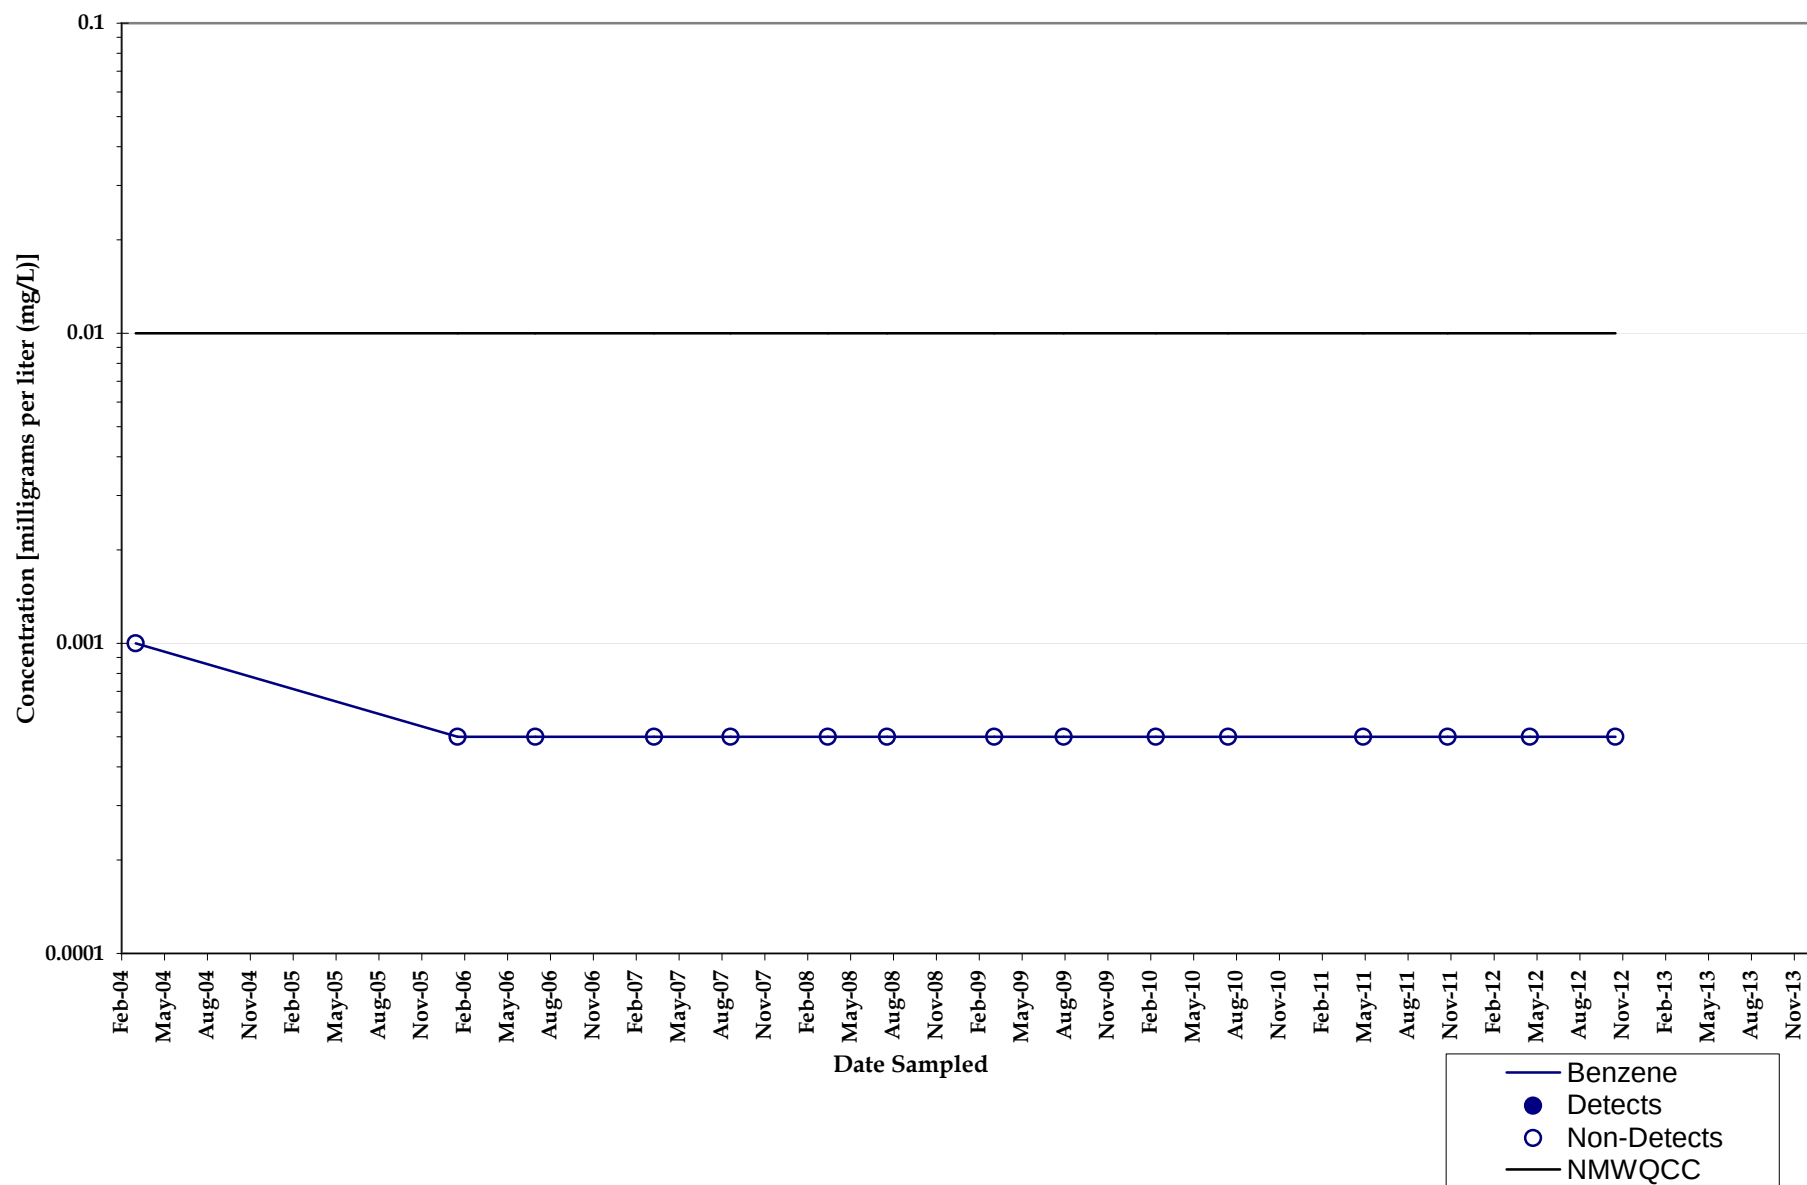
## Benzene Concentrations Monitoring Well MW080SA

Note: Non-detect analyses plotted at the method detection limit or half the reporting limit (RL). Detections denoted by symbol and detection values greater than the RL denoted by shaded symbol.

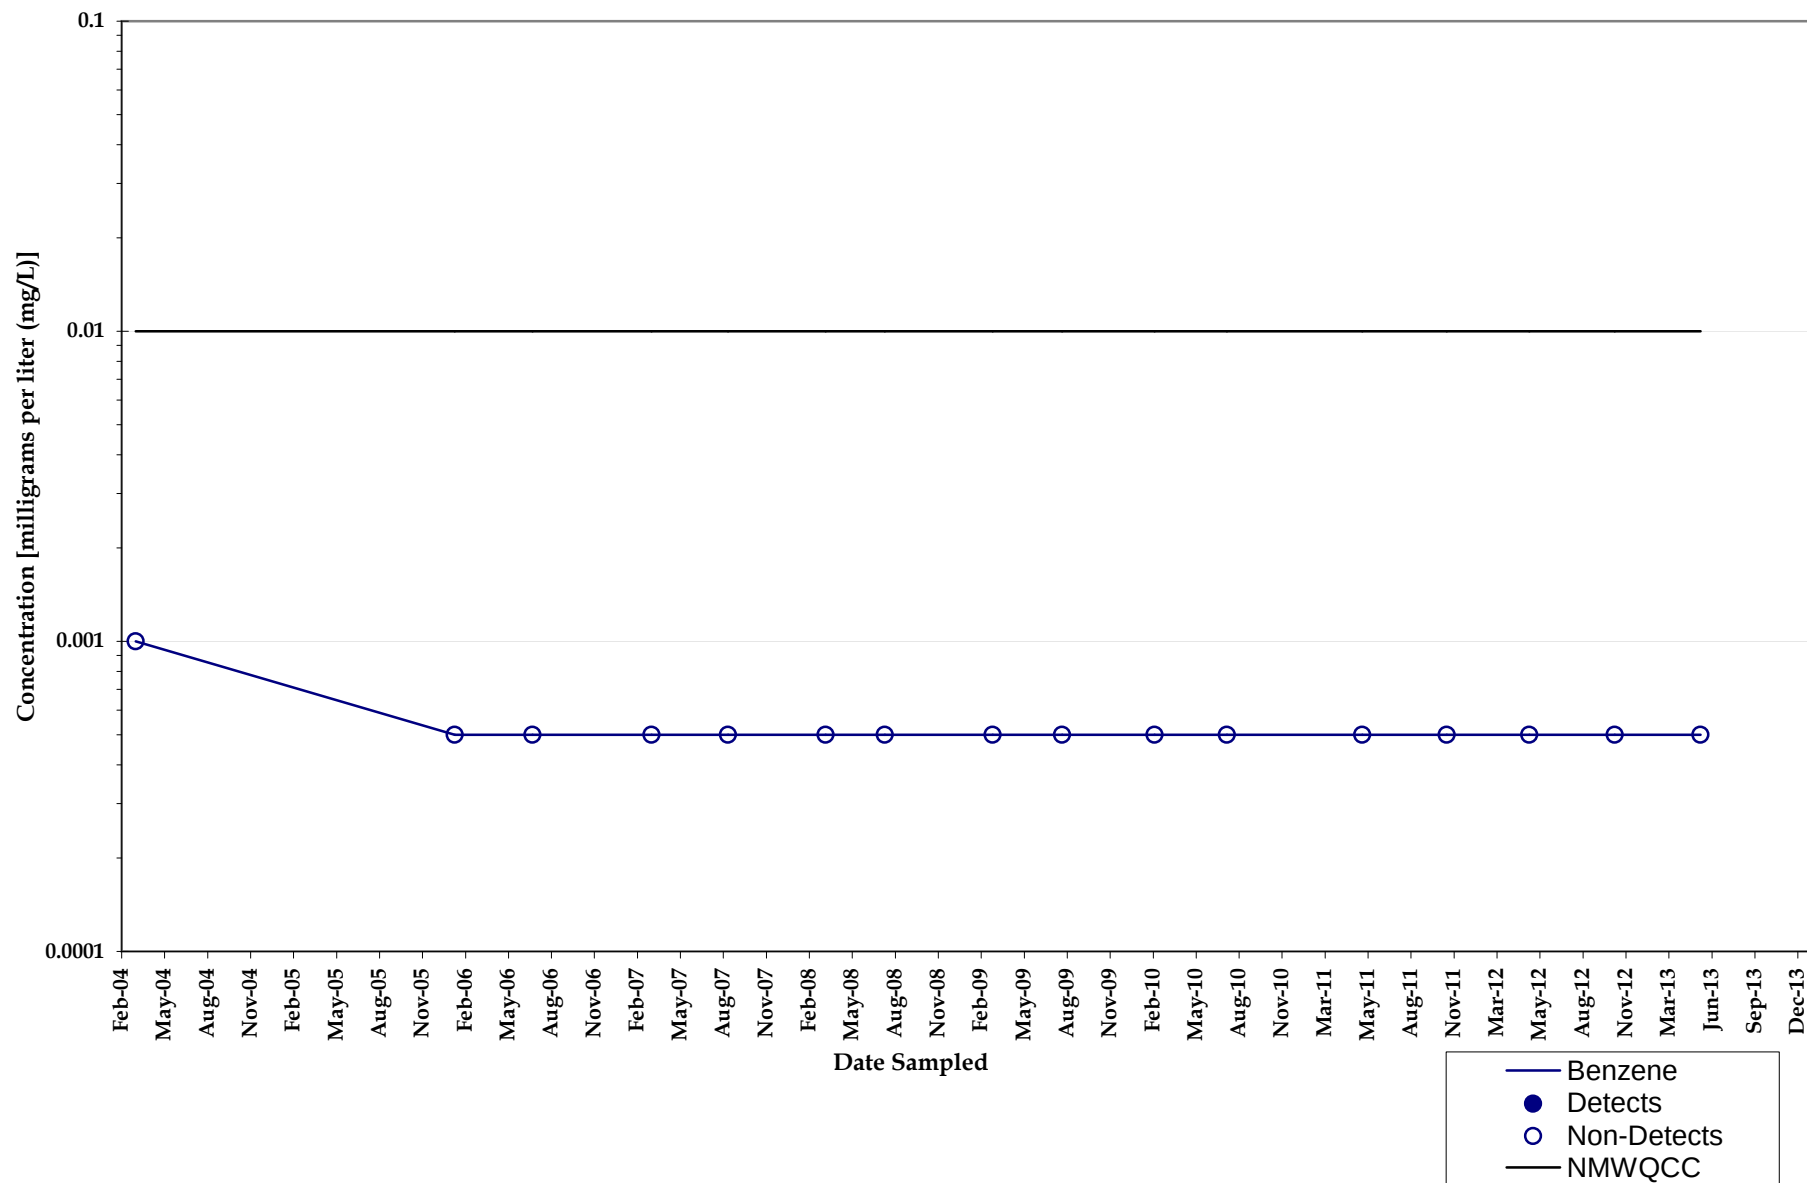
## Benzene Concentrations Monitoring Well MW081SA

Note: Non-detect analyses plotted at the method detection limit or half the reporting limit (RL). Detections denoted by symbol and detection values greater than the RL denoted by shaded symbol.

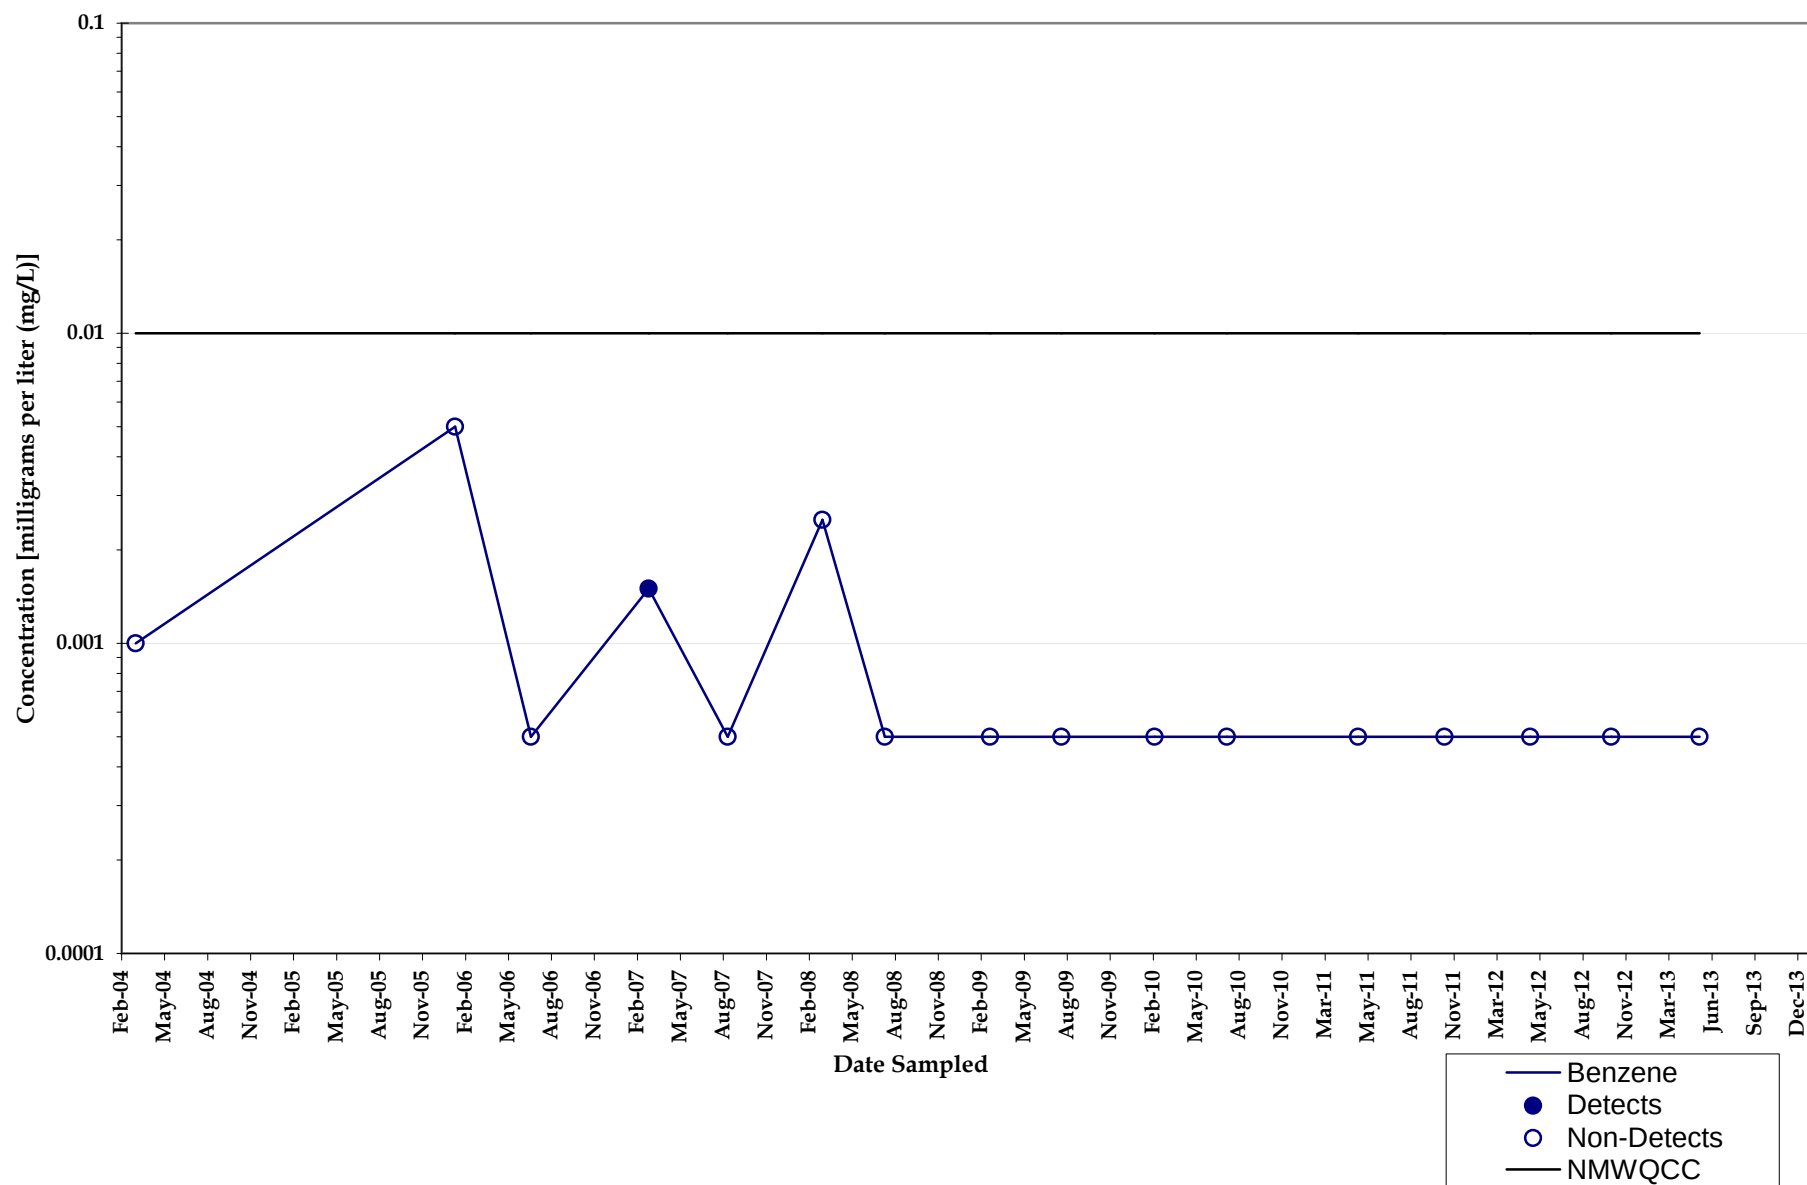
## Benzene Concentrations Monitoring Well MW082SA

Note: Non-detect analyses plotted at the method detection limit or half the reporting limit (RL). Detections denoted by symbol and detection values greater than the RL denoted by shaded symbol.

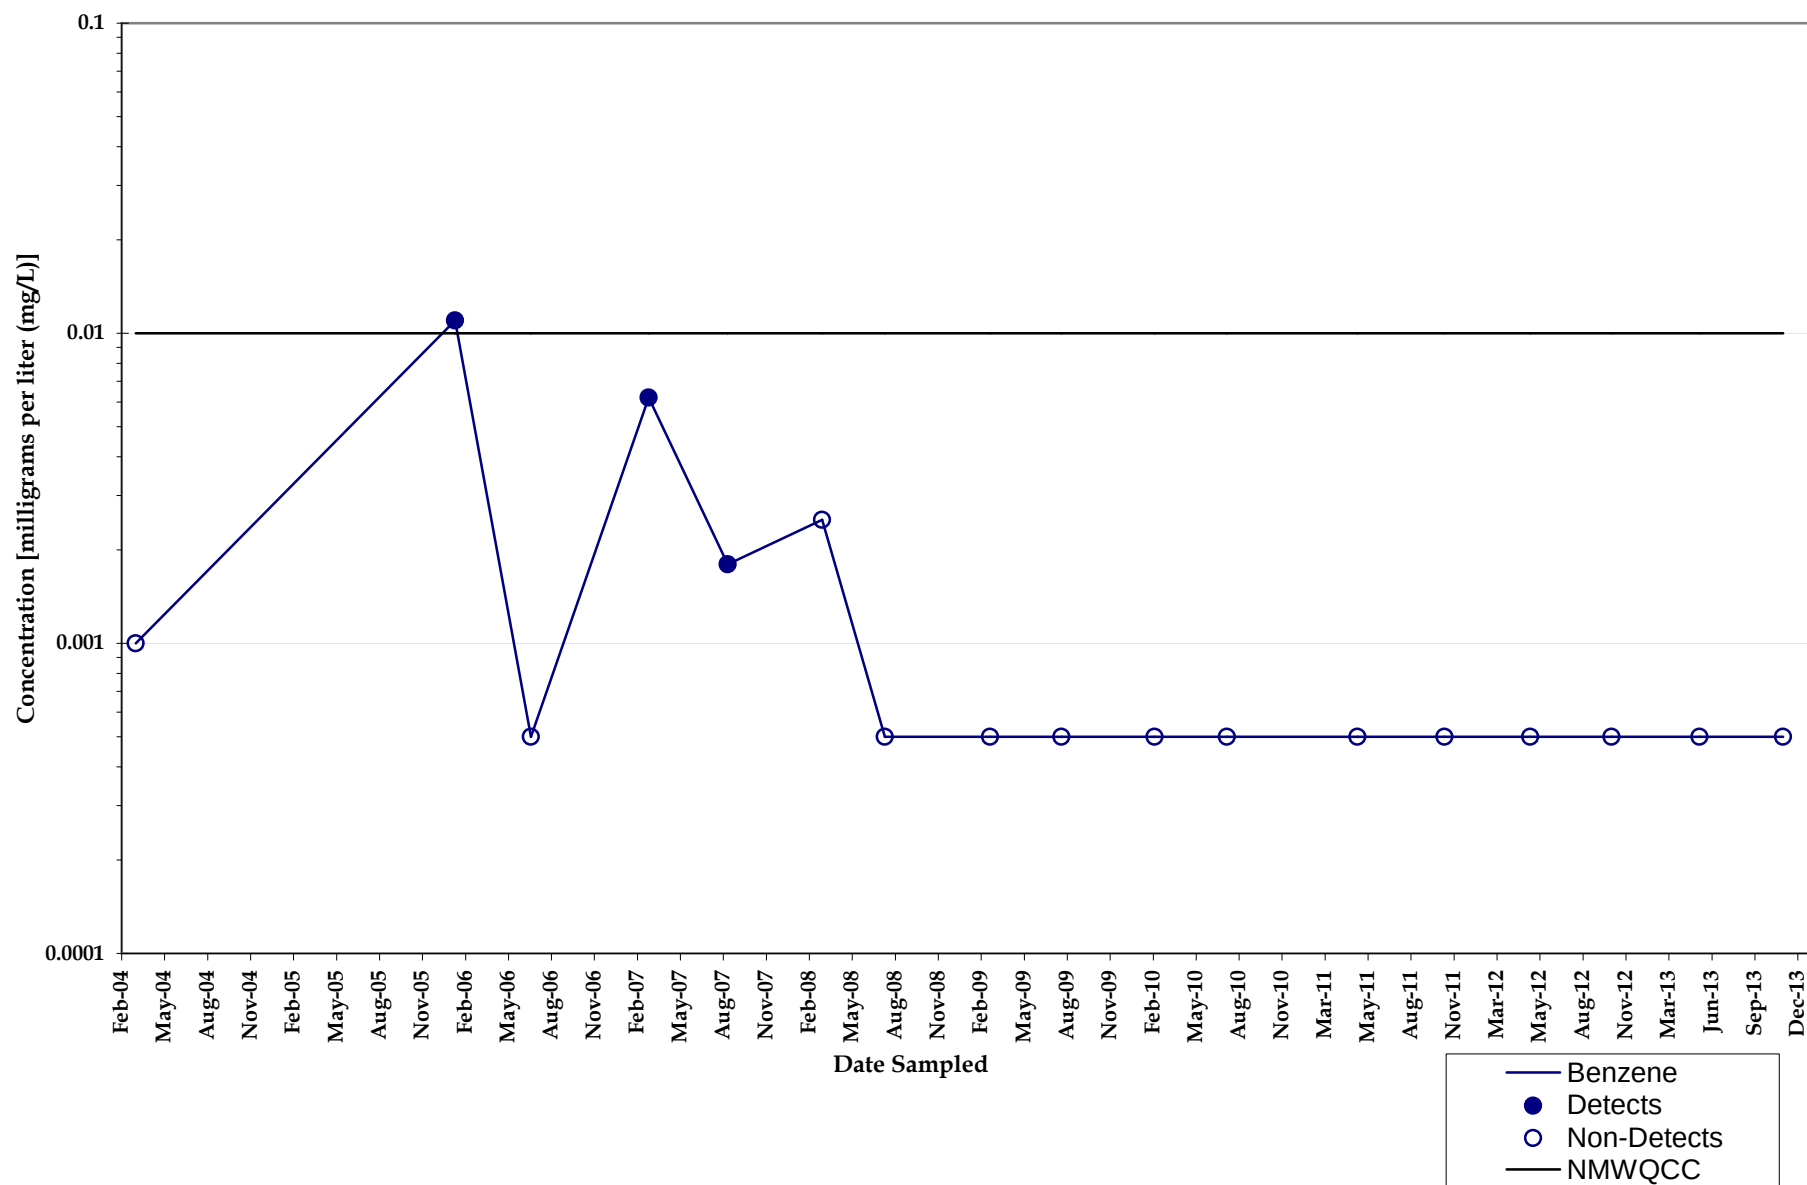
## Benzene Concentrations Monitoring Well MW083SA

Note: Non-detect analyses plotted at the method detection limit or half the reporting limit (RL). Detections denoted by symbol and detection values greater than the RL denoted by shaded symbol.

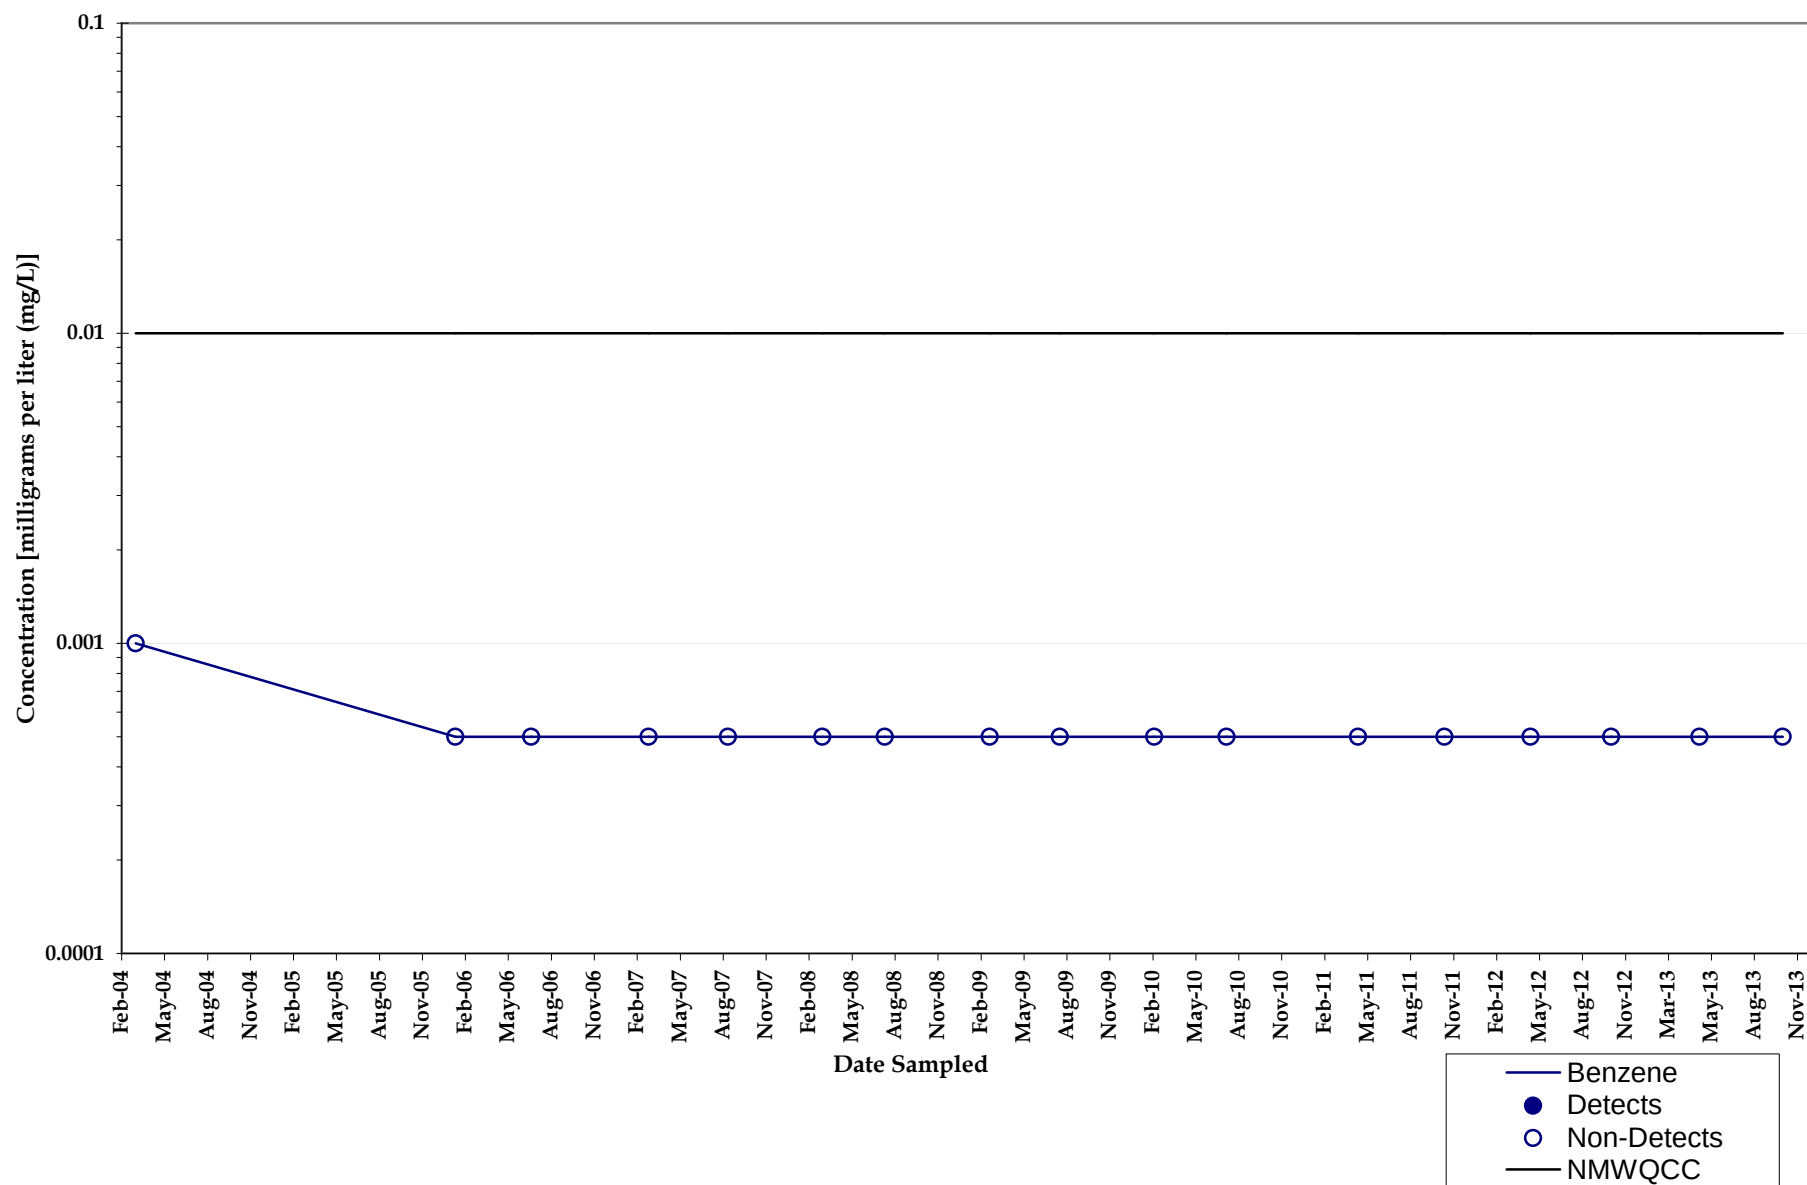
## Benzene Concentrations Monitoring Well MW084SA

Note: Non-detect analyses plotted at the method detection limit or half the reporting limit (RL). Detections denoted by symbol and detection values greater than the RL denoted by shaded symbol.
