**GW - 004**

**2013 AGWMR**

**VOL 5 OF 5**

*North Eunice Gas Plant  
Lea County, New Mexico*

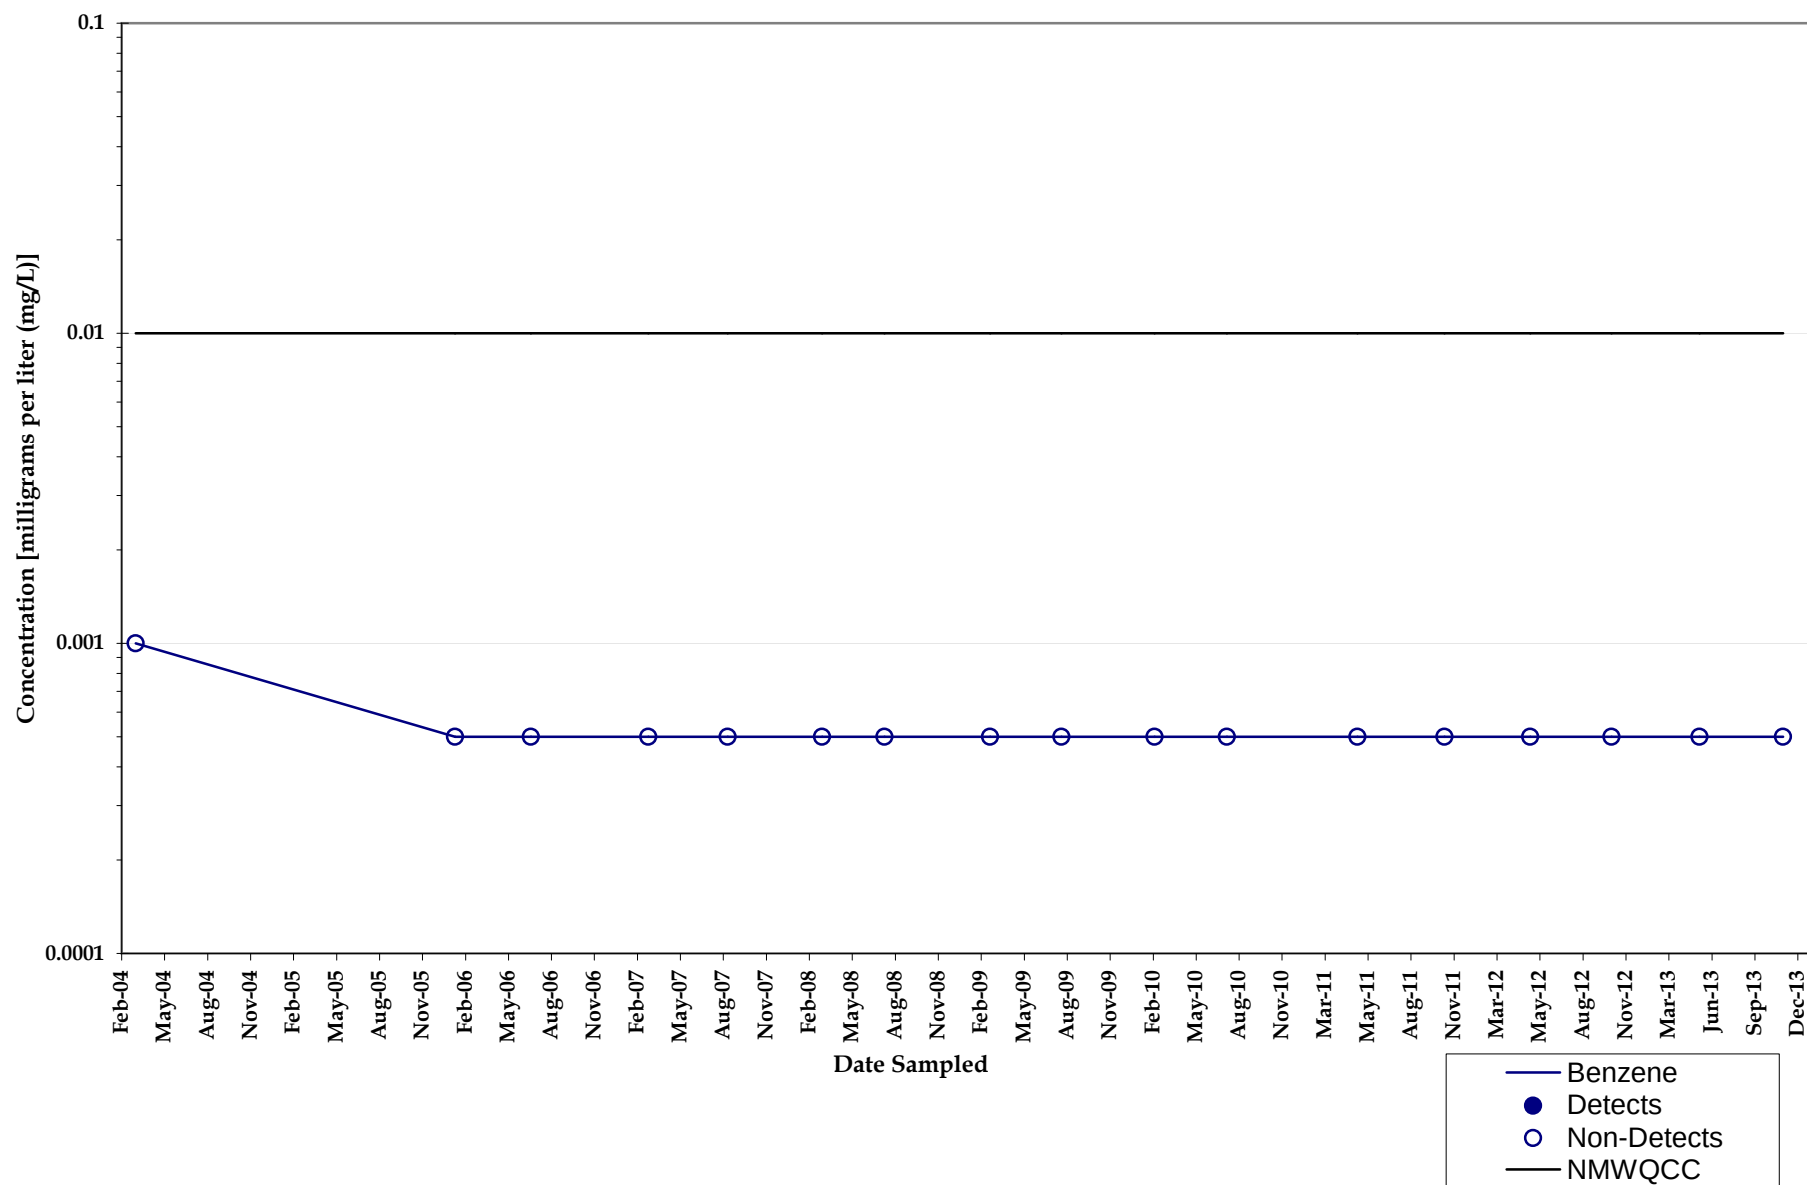
## Benzene Concentrations Monitoring Well MW085SA

Note: Non-detect analyses plotted at the method detection limit or half the reporting limit (RL). Detections denoted by symbol and detection values greater than the RL denoted by shaded symbol.

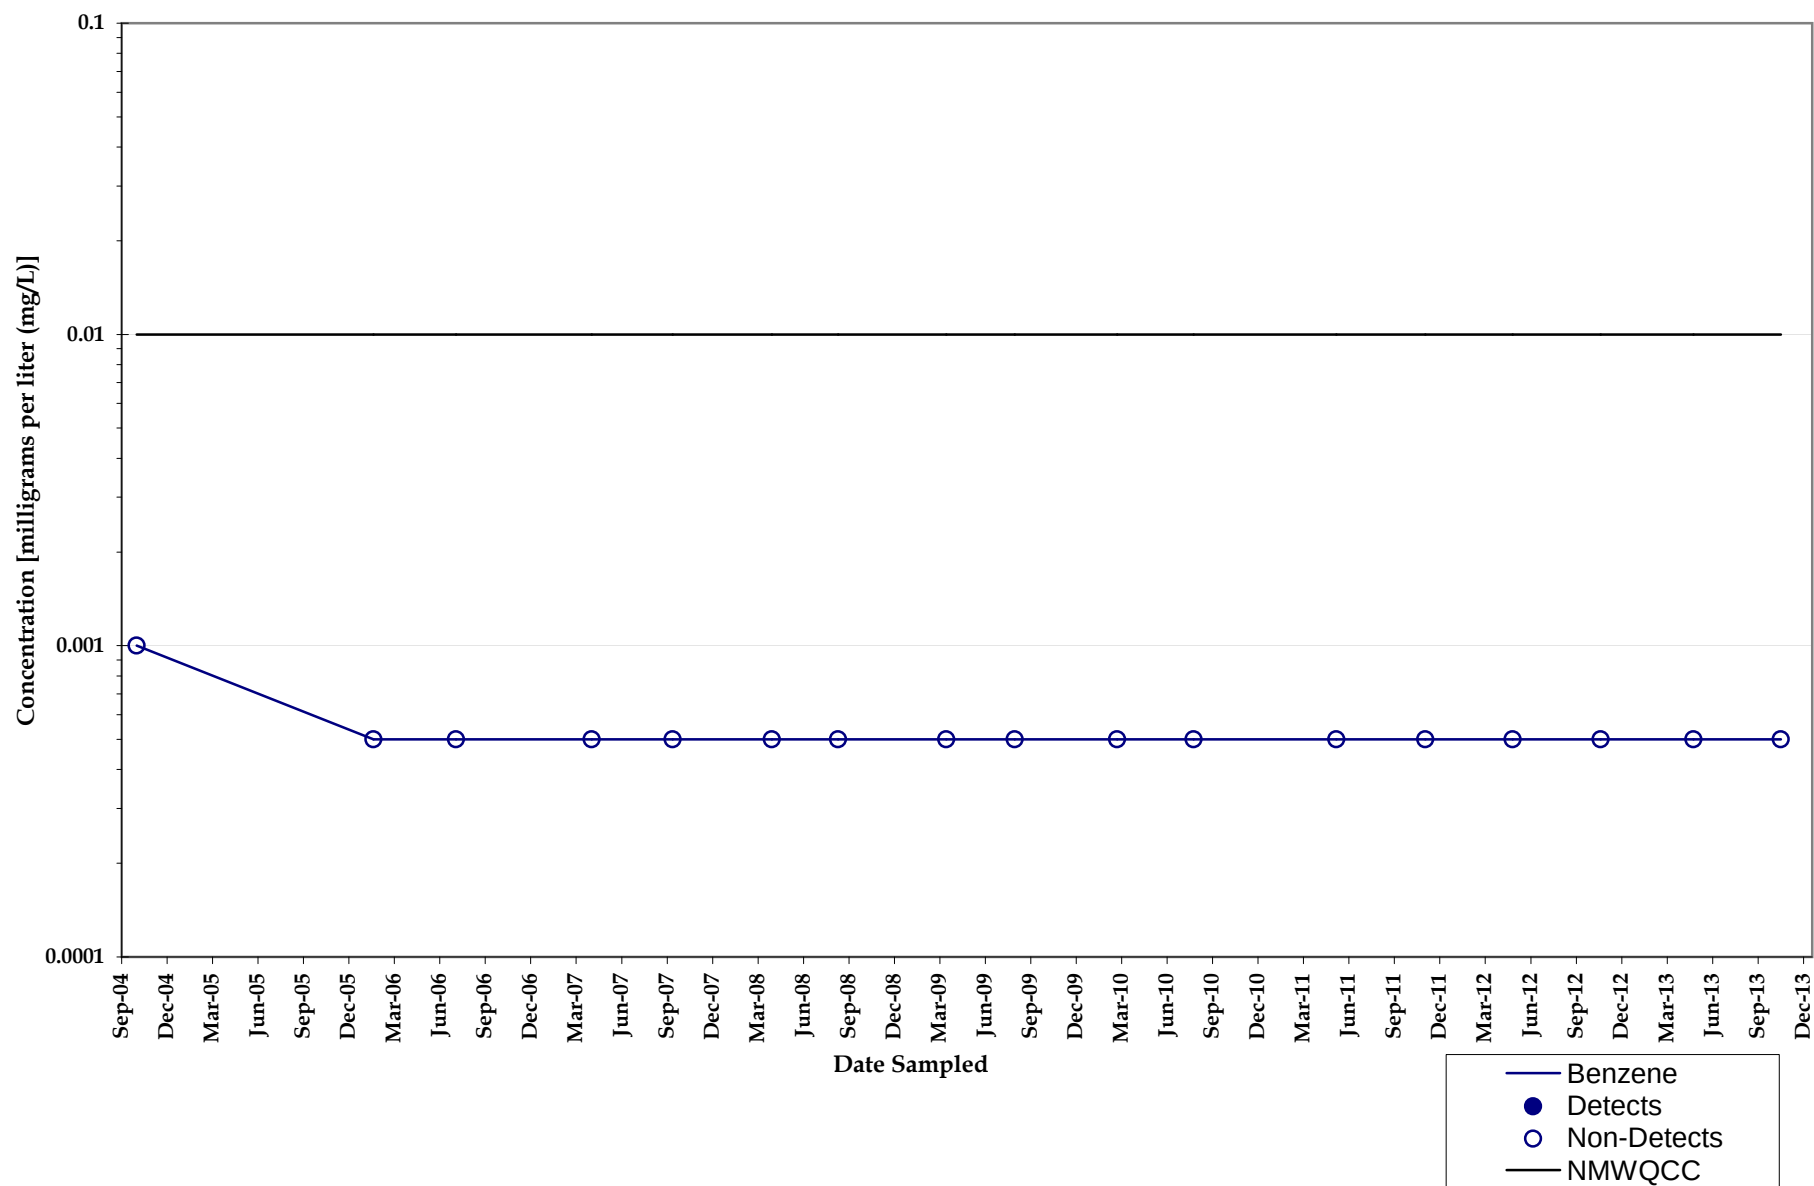
## Benzene Concentrations Monitoring Well MW086SA

Note: Non-detect analyses plotted at the method detection limit or half the reporting limit (RL). Detections denoted by symbol and detection values greater than the RL denoted by shaded symbol.

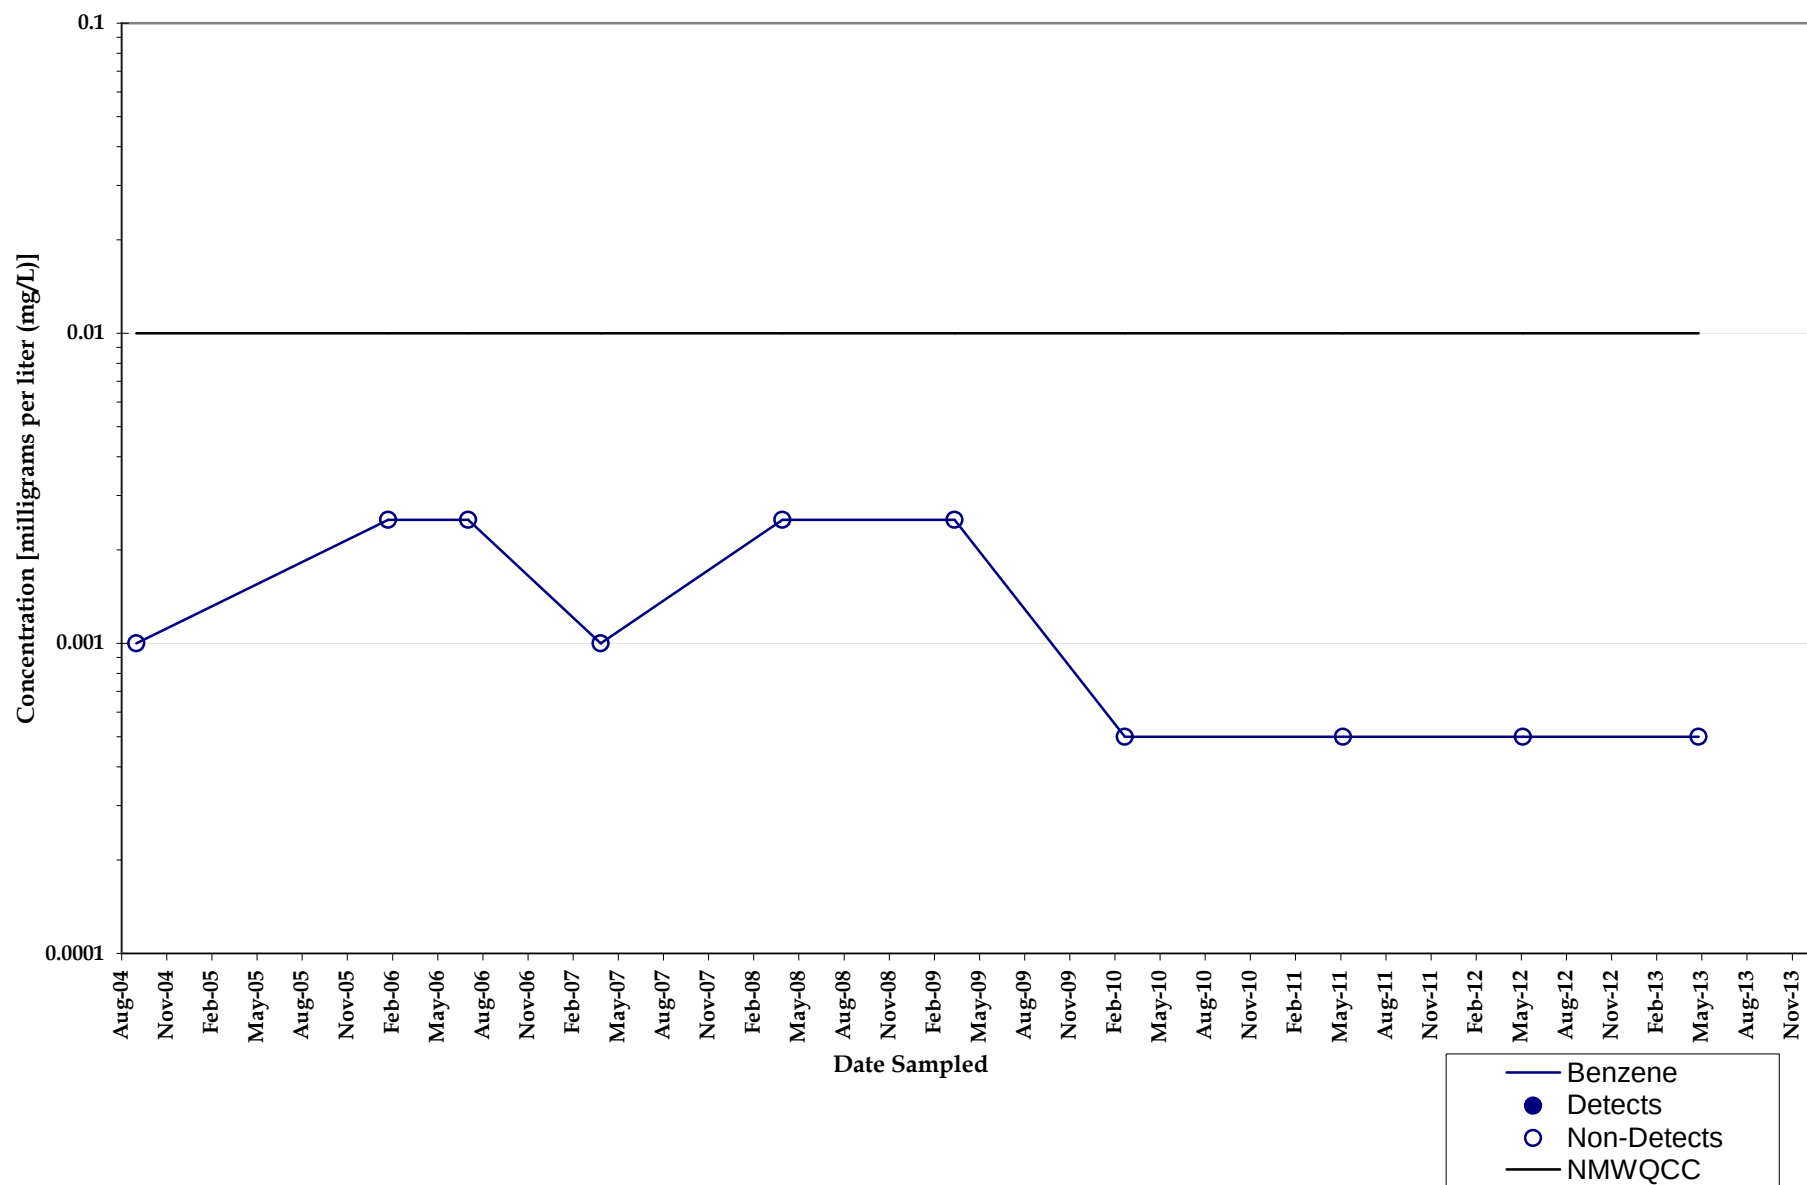
## Benzene Concentrations Monitoring Well MW087A

Note: Non-detect analyses plotted at the method detection limit or half the reporting limit (RL). Detections denoted by symbol and detection values greater than the RL denoted by shaded symbol.

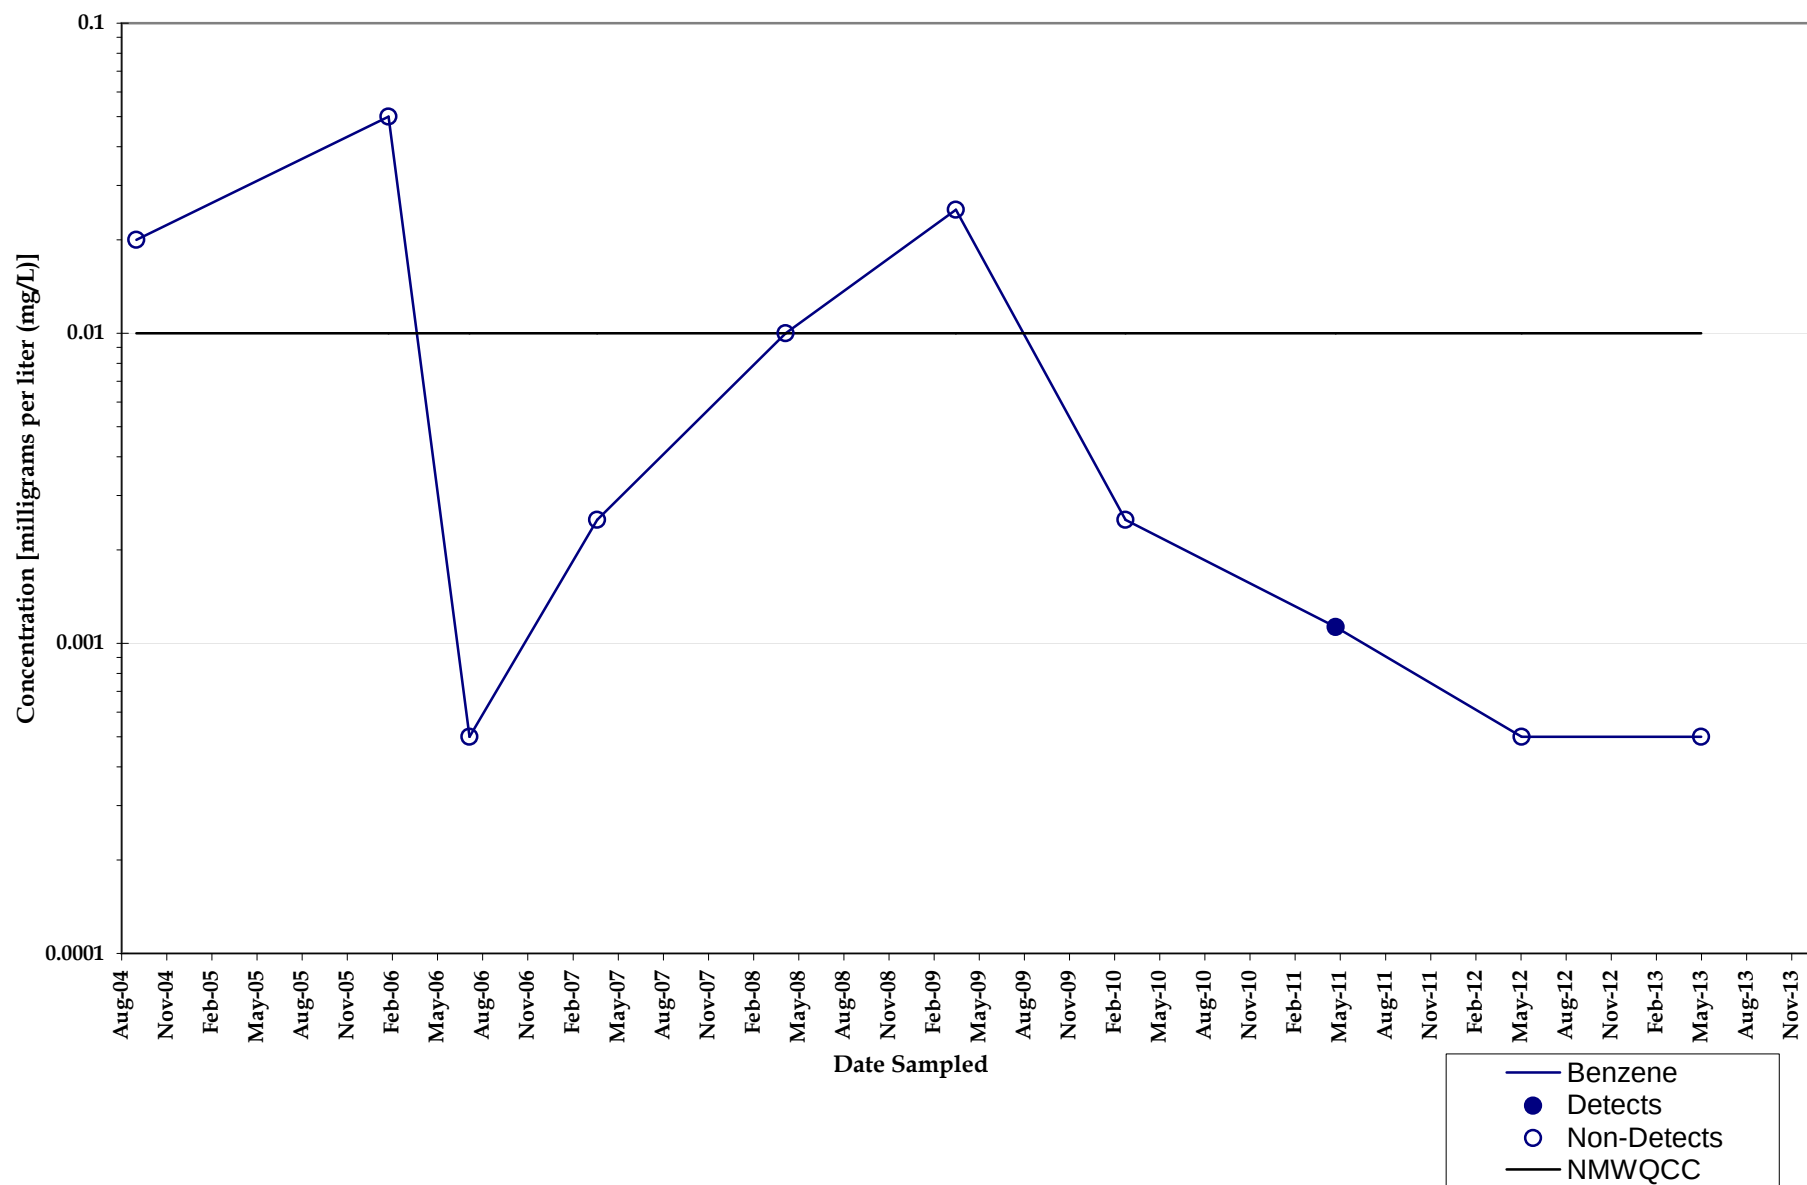
## Benzene Concentrations Monitoring Well MW088M

Note: Non-detect analyses plotted at the method detection limit or half the reporting limit (RL). Detections denoted by symbol and detection values greater than the RL denoted by shaded symbol.

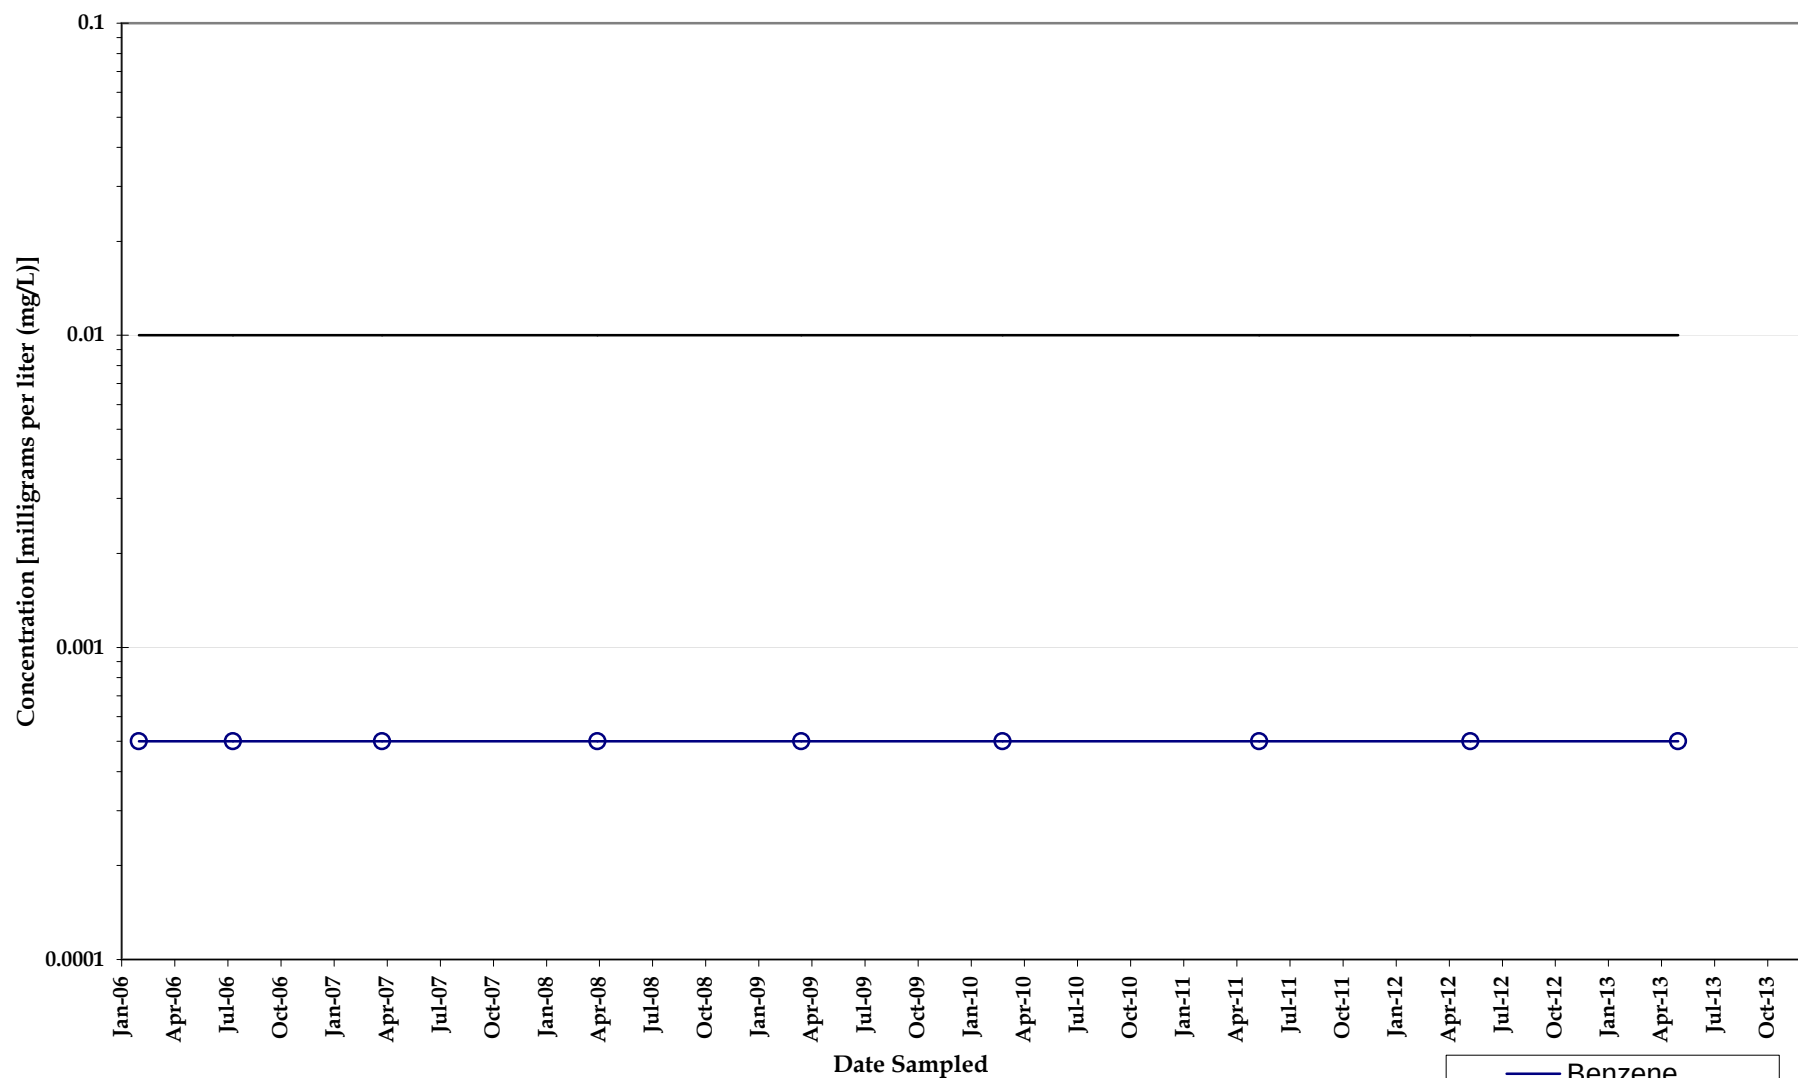
## Benzene Concentrations Monitoring Well MW089SA

Note: Non-detect analyses plotted at the method detection limit or half the reporting limit (RL). Detections denoted by symbol and detection values greater than the RL denoted by shaded symbol.

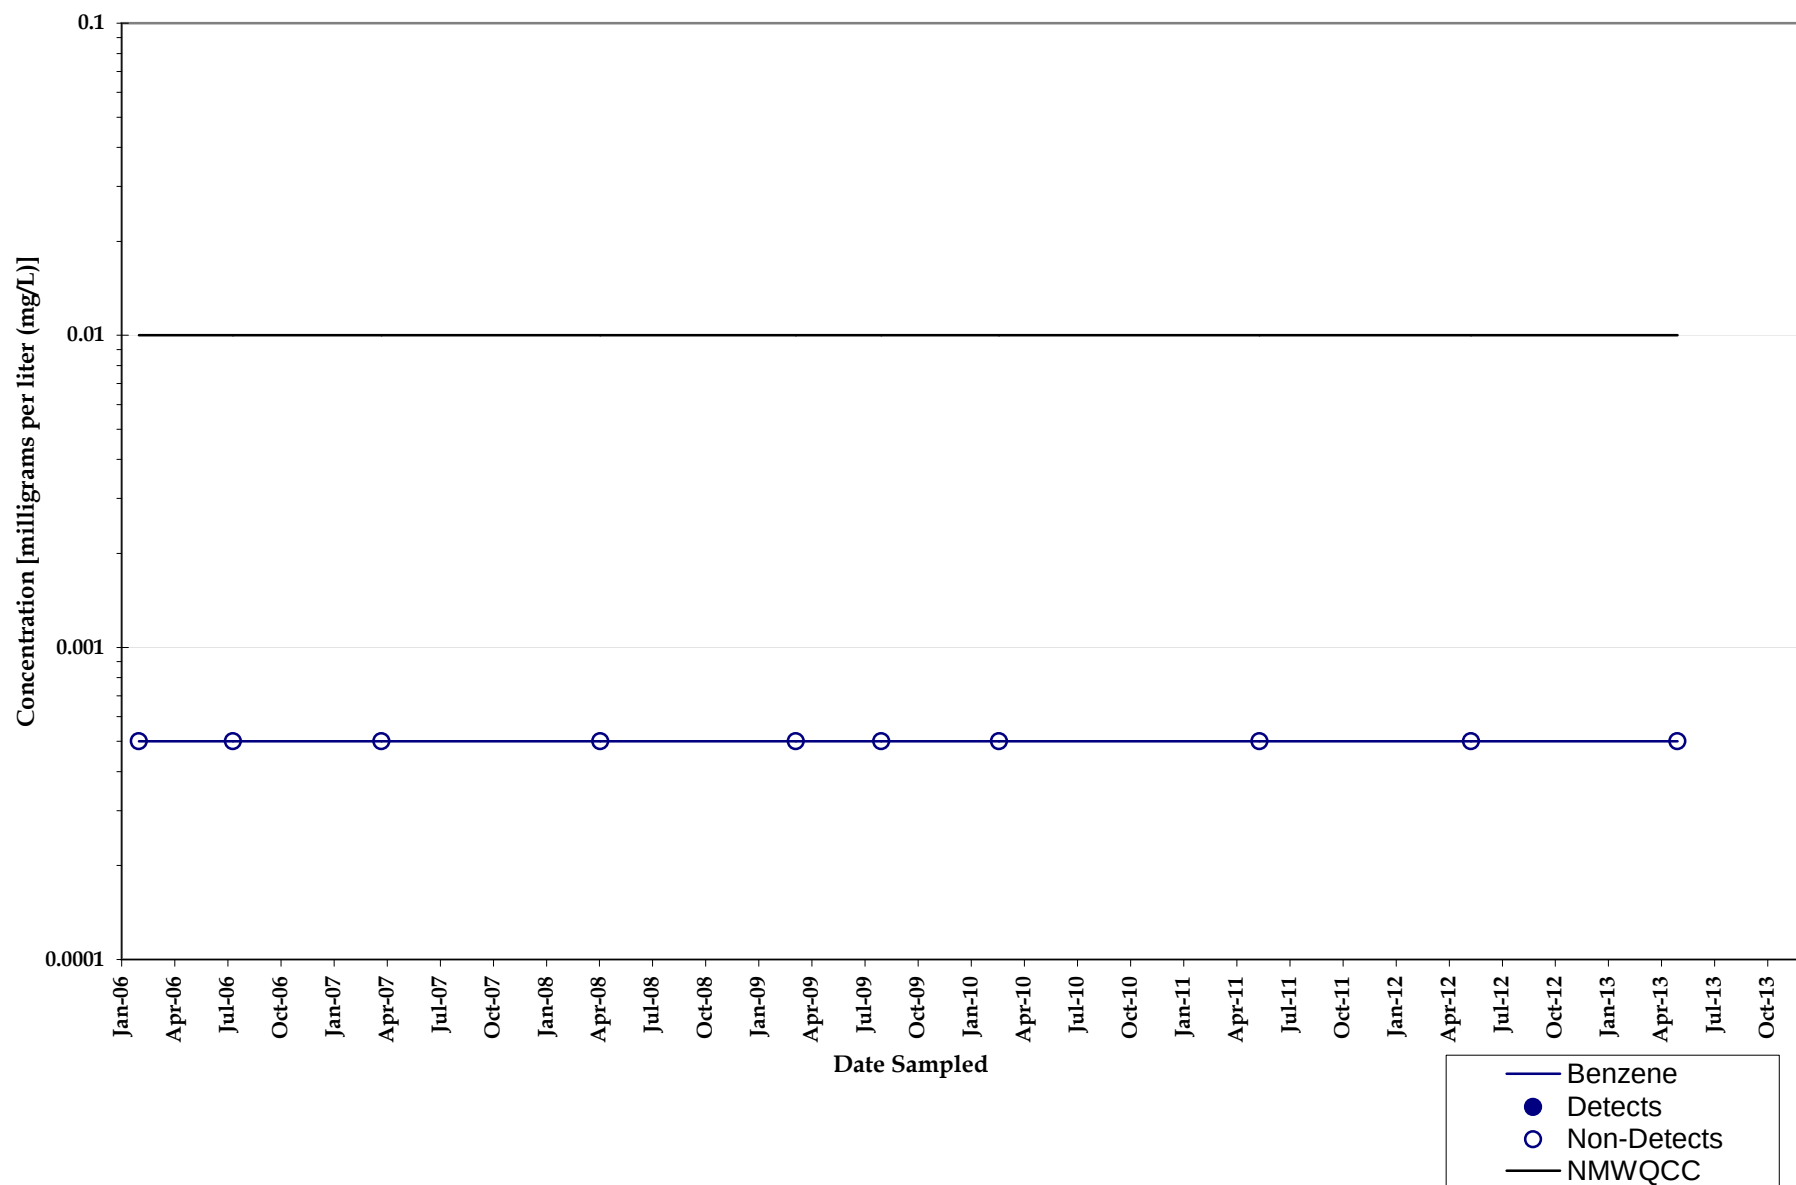
## Benzene Concentrations Monitoring Well MW090SA

Note: Non-detect analyses plotted at the method detection limit or half the reporting limit (RL). Detections denoted by symbol and detection values greater than the RL denoted by shaded symbol.

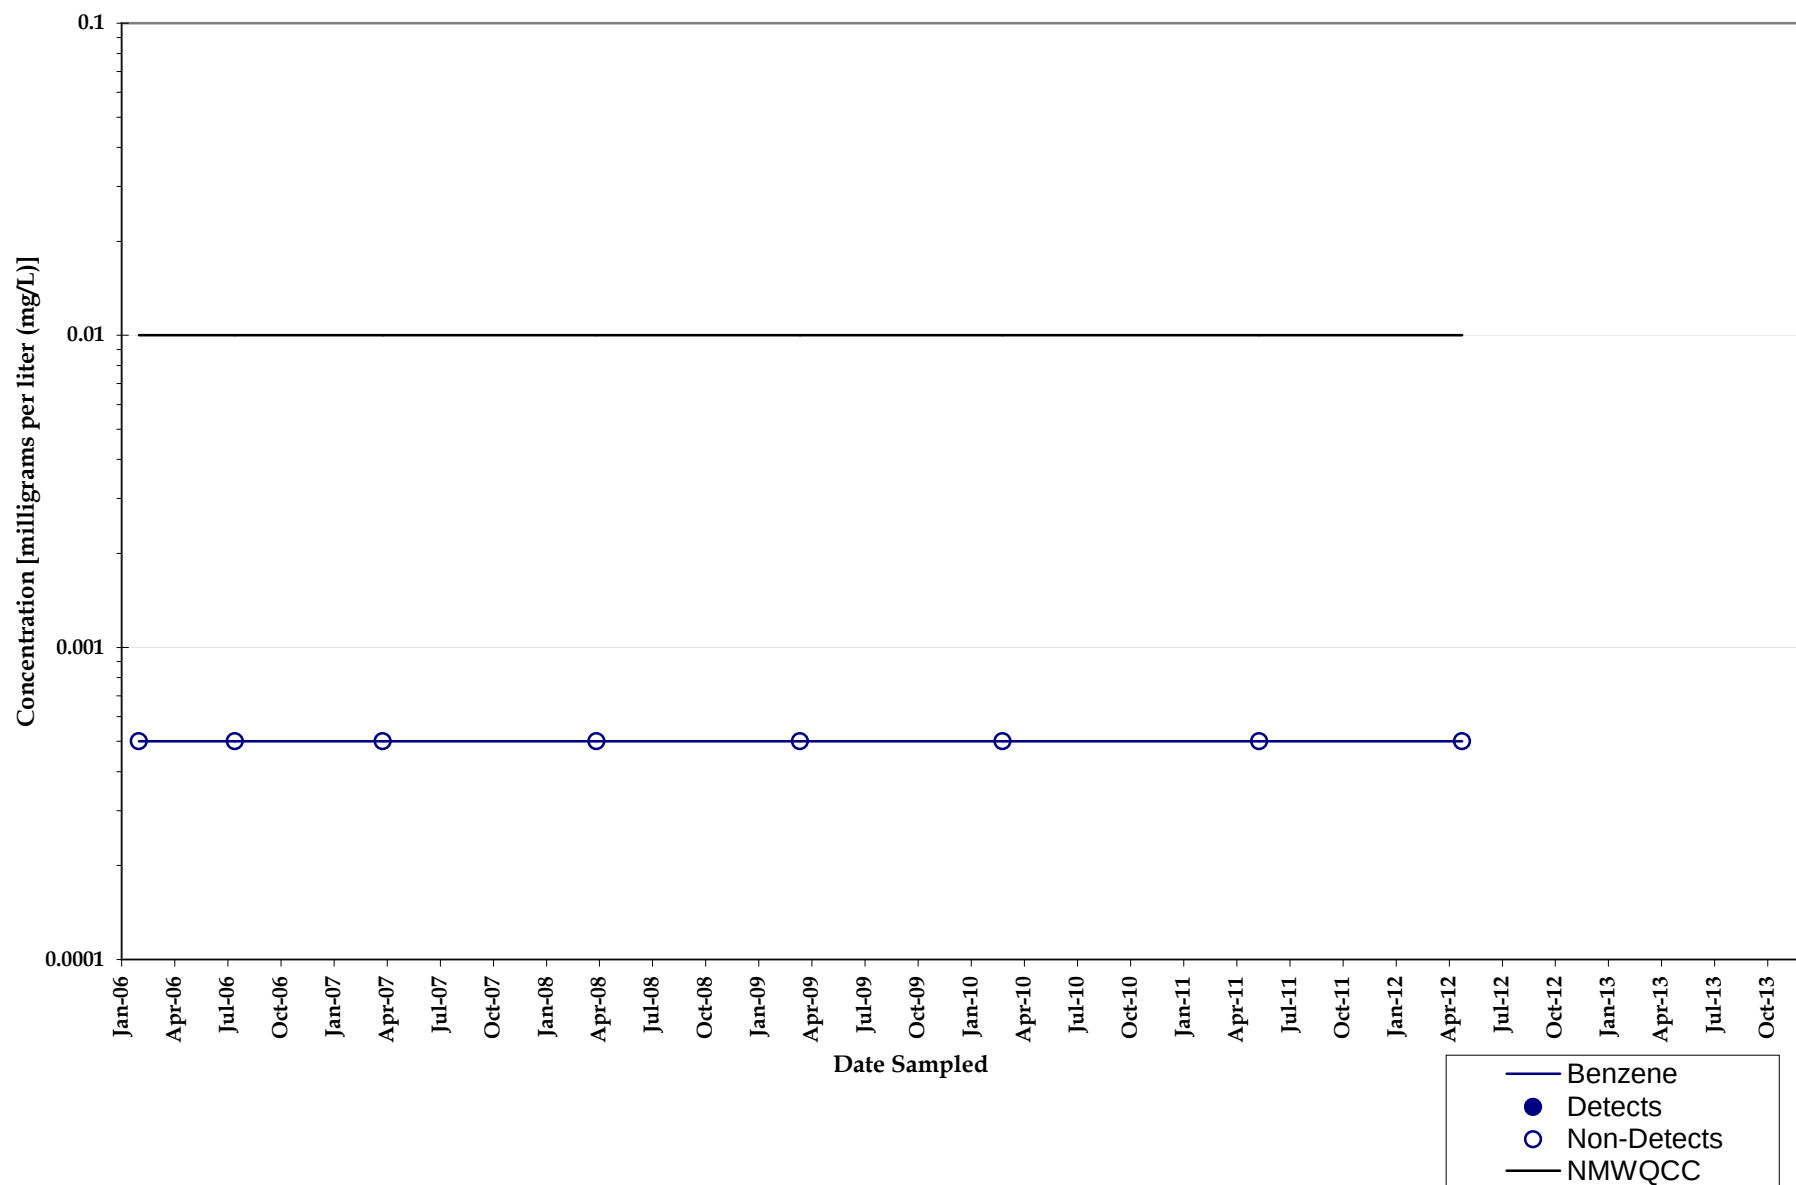
## Benzene Concentrations Monitoring Well MW091SA

Note: Non-detect analyses plotted at the method detection limit or half the reporting limit (RL). Detections denoted by symbol and detection values greater than the RL denoted by shaded symbol.

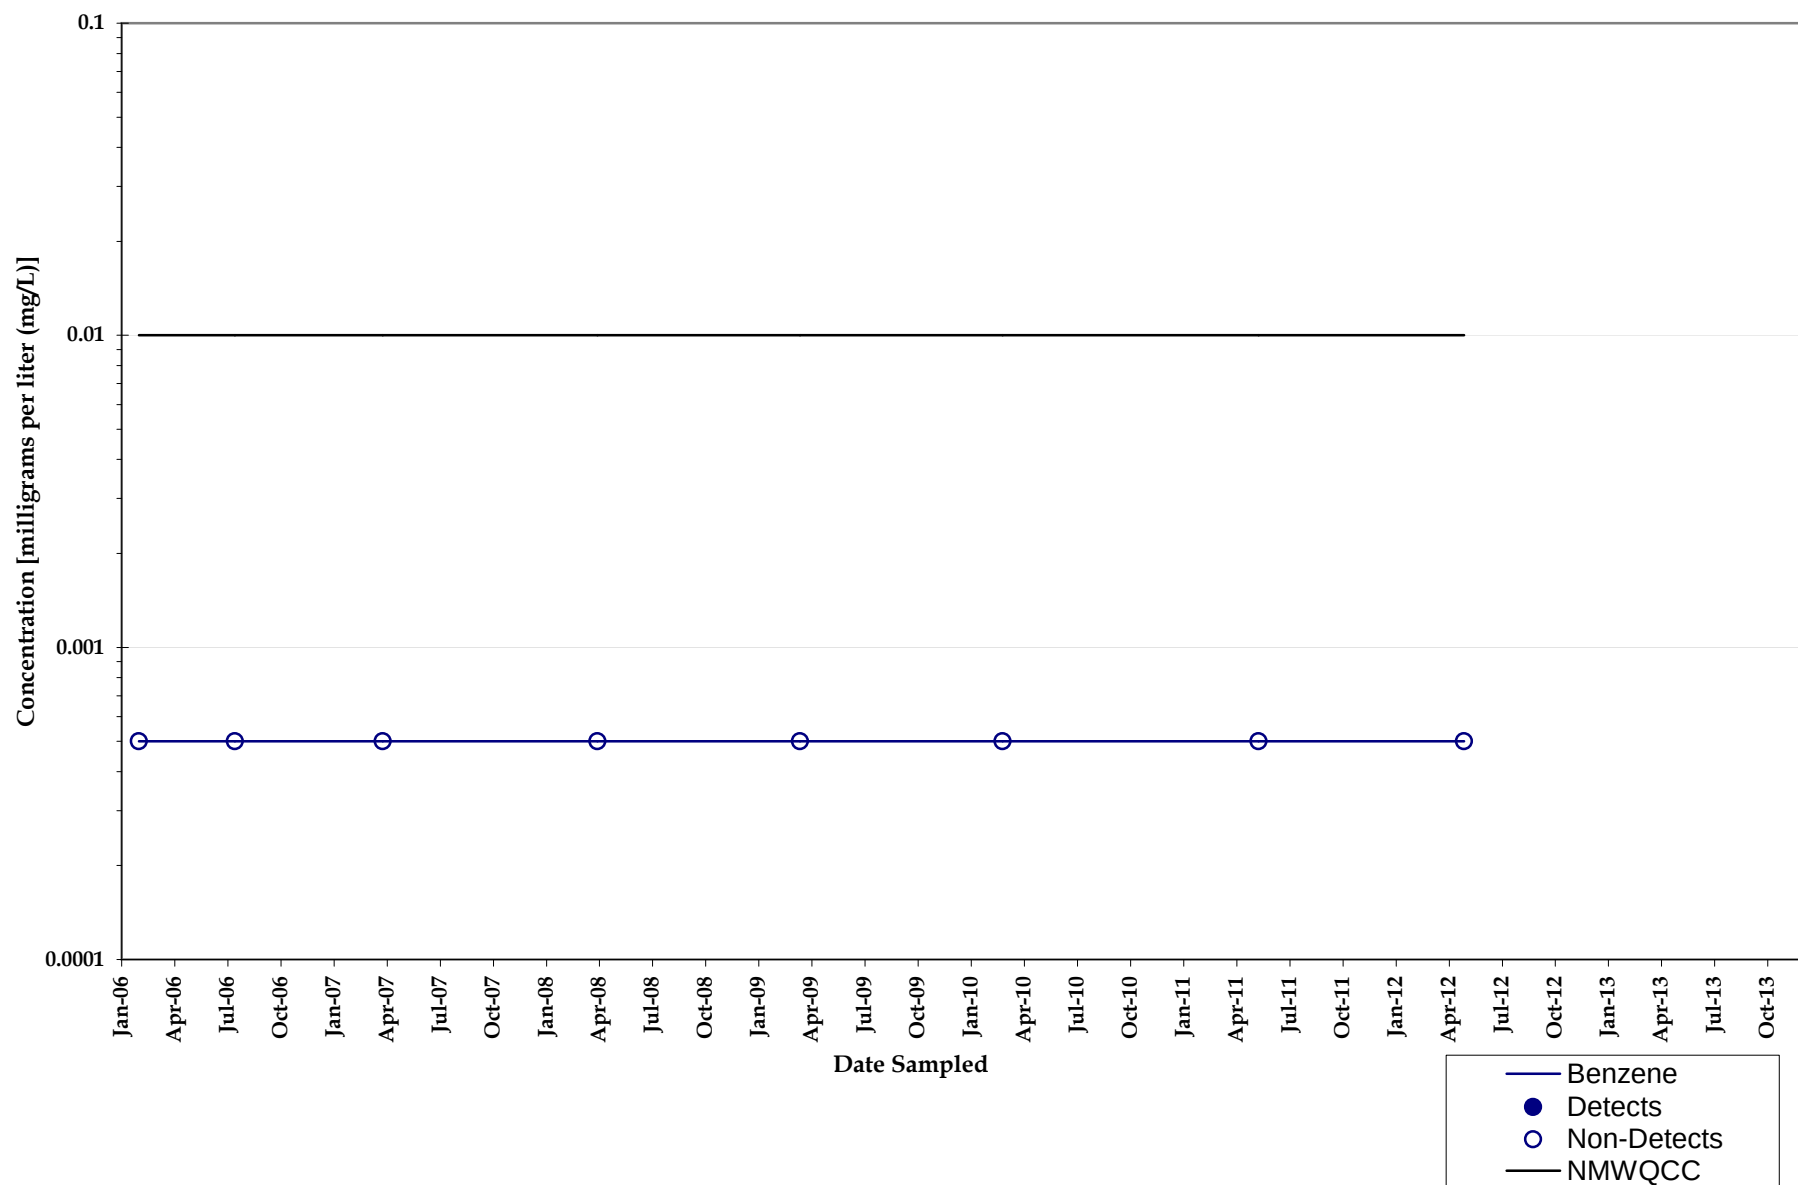
## Benzene Concentrations Monitoring Well MW092SA

Note: Non-detect analyses plotted at the method detection limit or half the reporting limit (RL). Detections denoted by symbol and detection values greater than the RL denoted by shaded symbol.

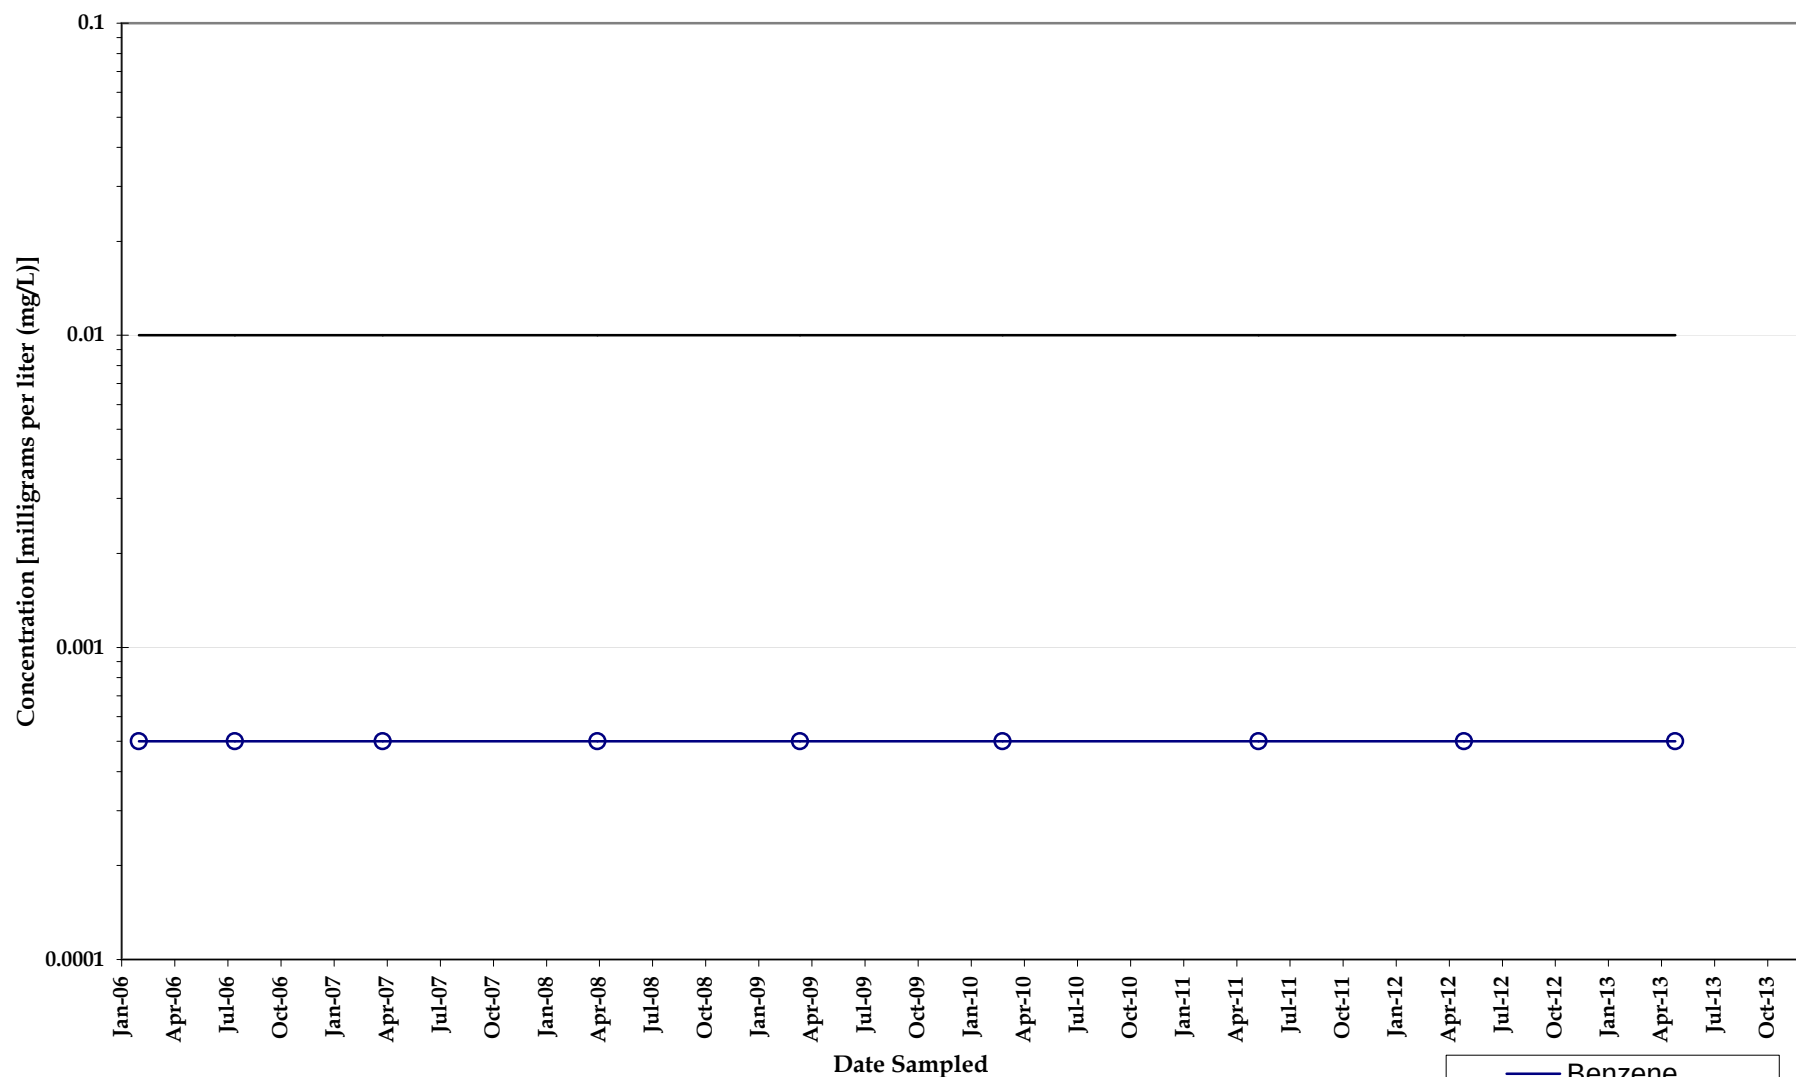
## Benzene Concentrations Monitoring Well MW093SA

Note: Non-detect analyses plotted at the method detection limit or half the reporting limit (RL). Detections denoted by symbol and detection values greater than the RL denoted by shaded symbol.

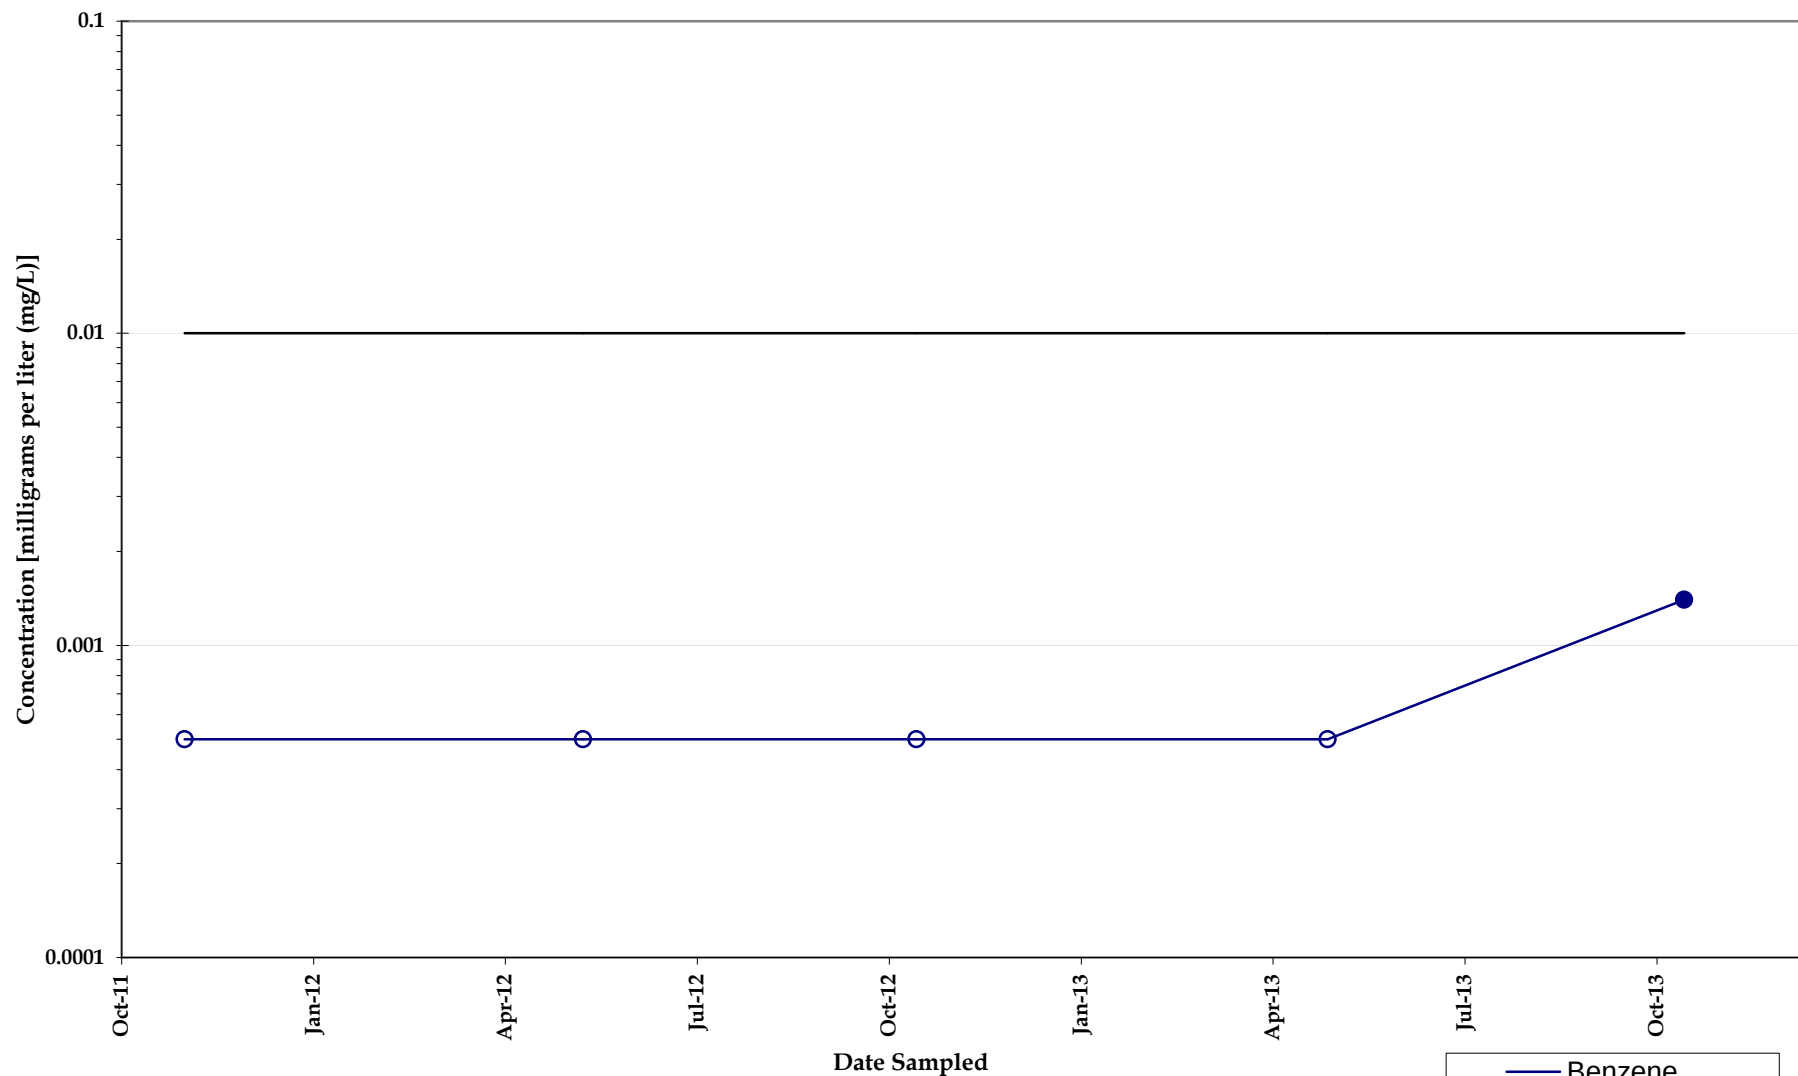
## Benzene Concentrations Monitoring Well MW094

Note: Non-detect analyses plotted at the method detection limit or half the reporting limit (RL). Detections denoted by symbol and detection values greater than the RL denoted by shaded symbol.
