**GW - 004**

**2013 AGWMR**

**VOL 5 OF 5**

*North Eunice Gas Plant  
Lea County, New Mexico*

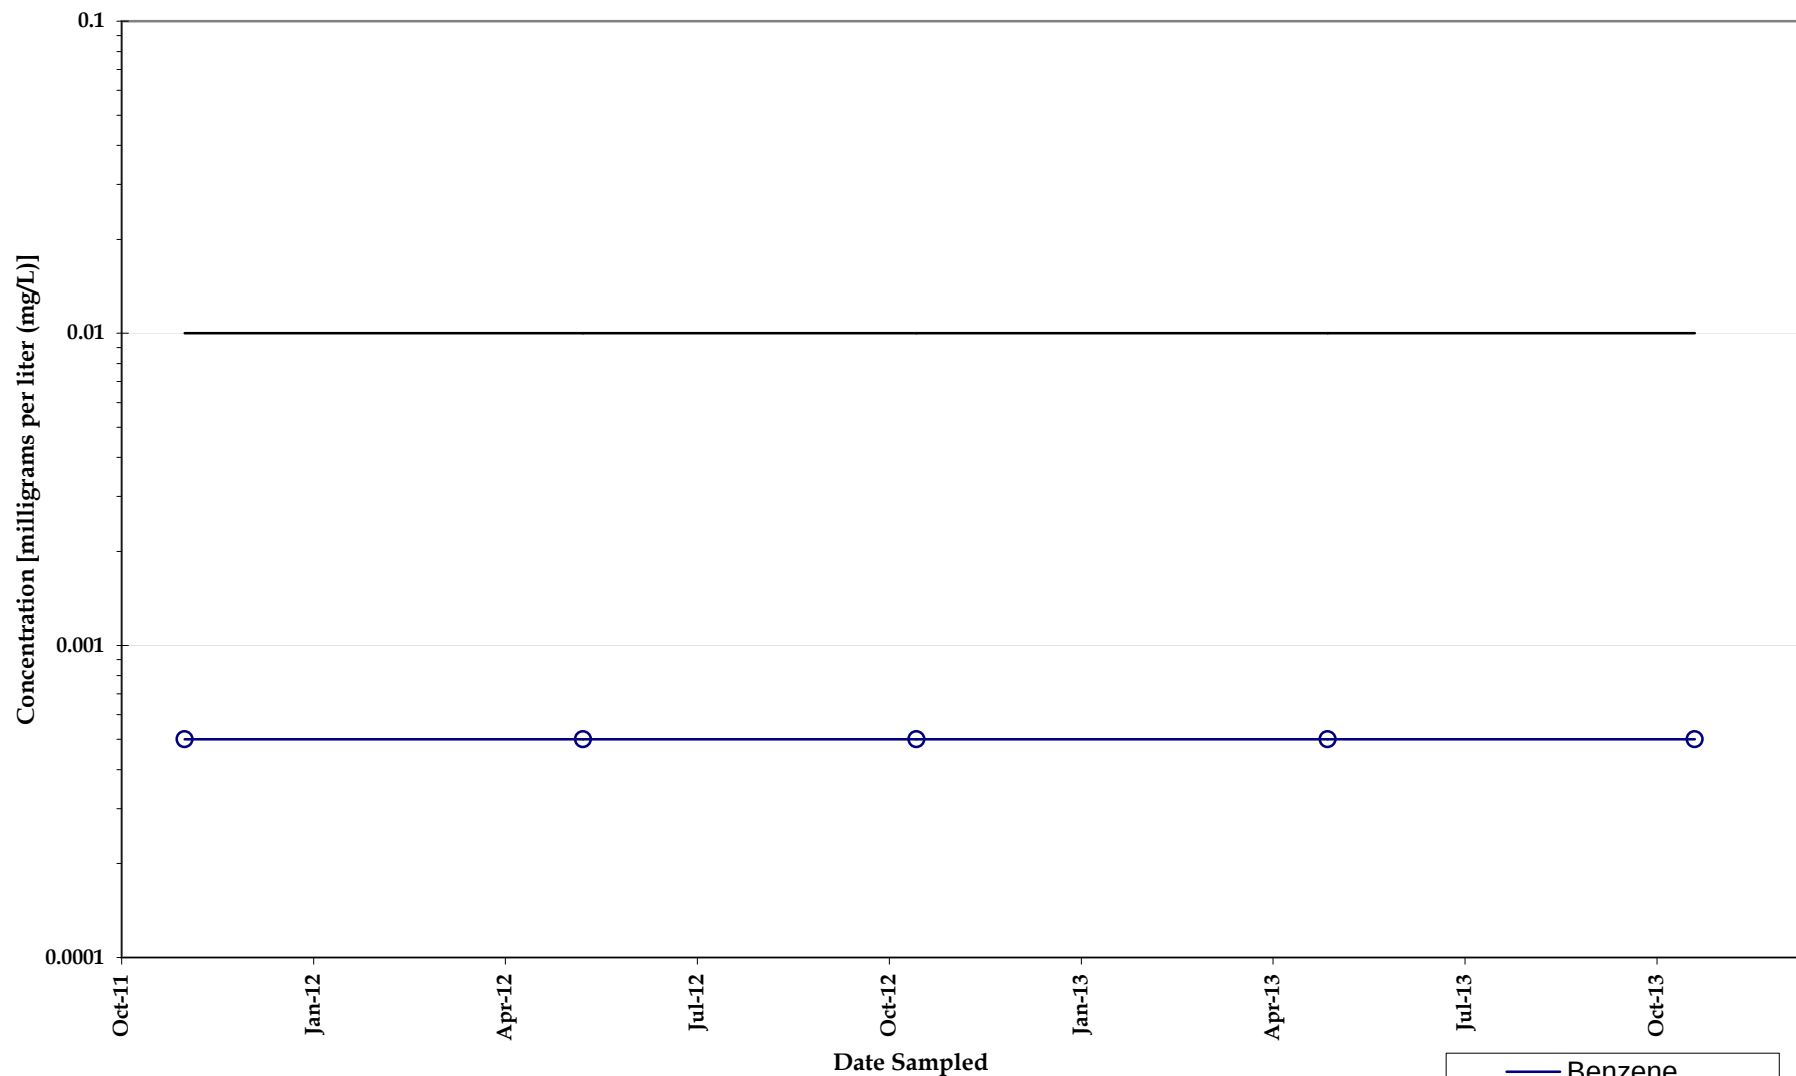
## Benzene Concentrations Monitoring Well MW095

Note: Non-detect analyses plotted at the method detection limit or half the reporting limit (RL). Detections denoted by symbol and detection values greater than the RL denoted by shaded symbol.

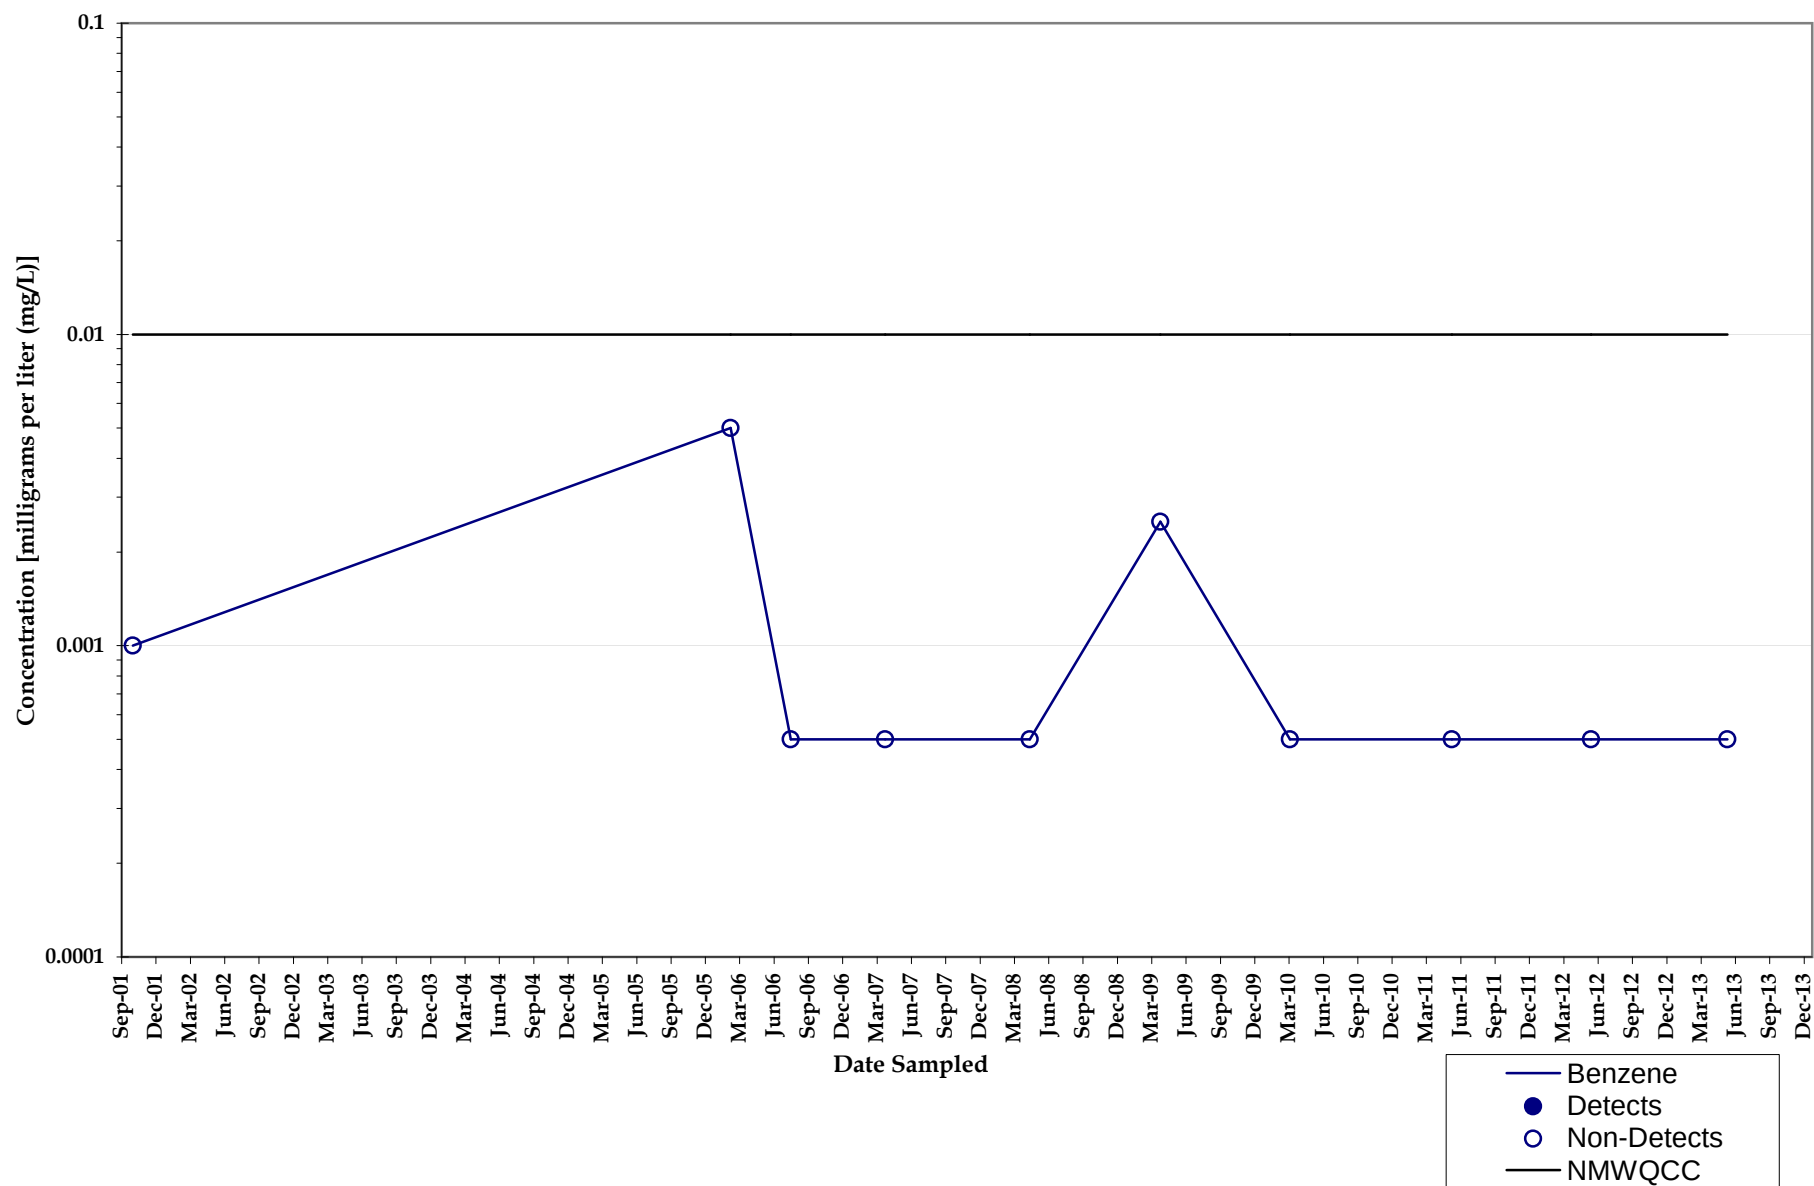
## Benzene Concentrations Monitoring Well RW002

Note: Non-detect analyses plotted at the method detection limit or half the reporting limit (RL). Detections denoted by symbol and detection values greater than the RL denoted by shaded symbol.

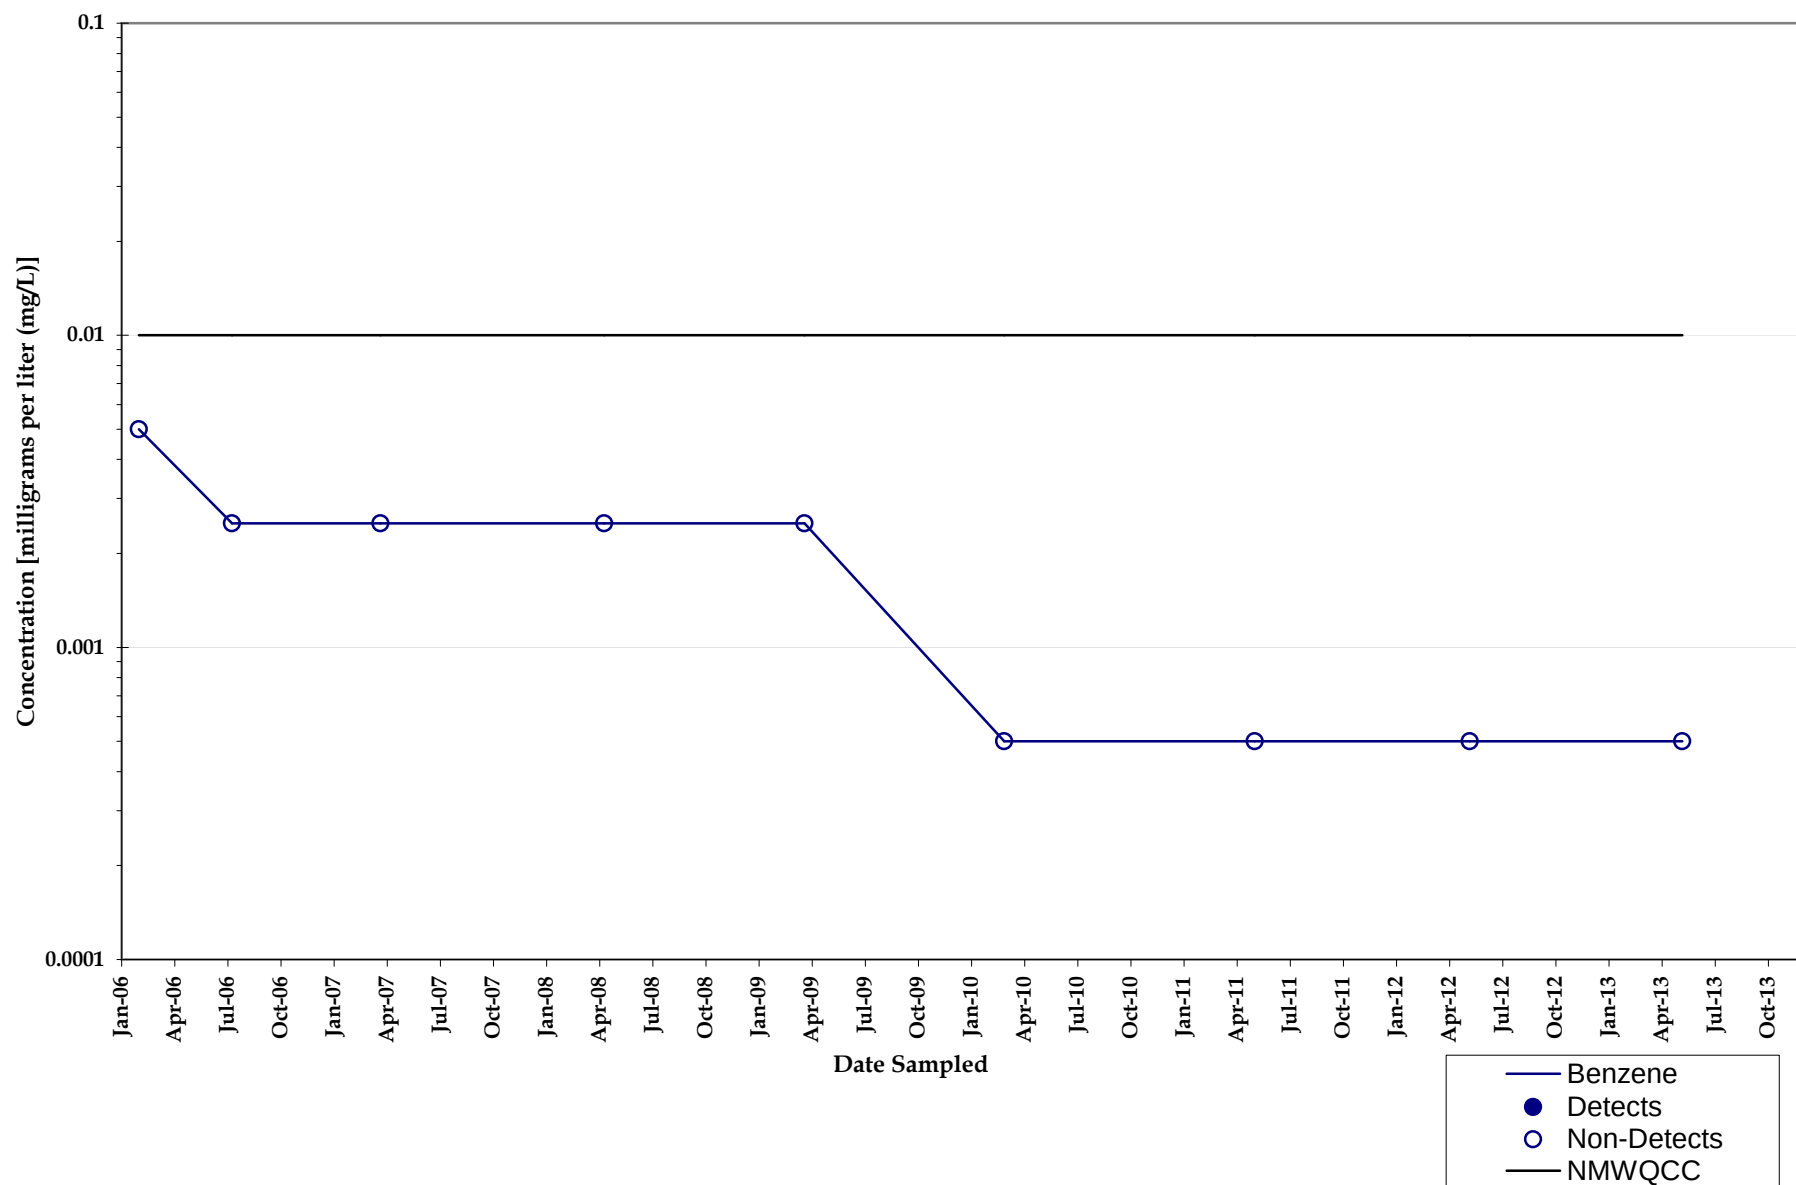
## Benzene Concentrations Monitoring Well RW003

Note: Non-detect analyses plotted at the method detection limit or half the reporting limit (RL). Detections denoted by symbol and detection values greater than the RL denoted by shaded symbol.

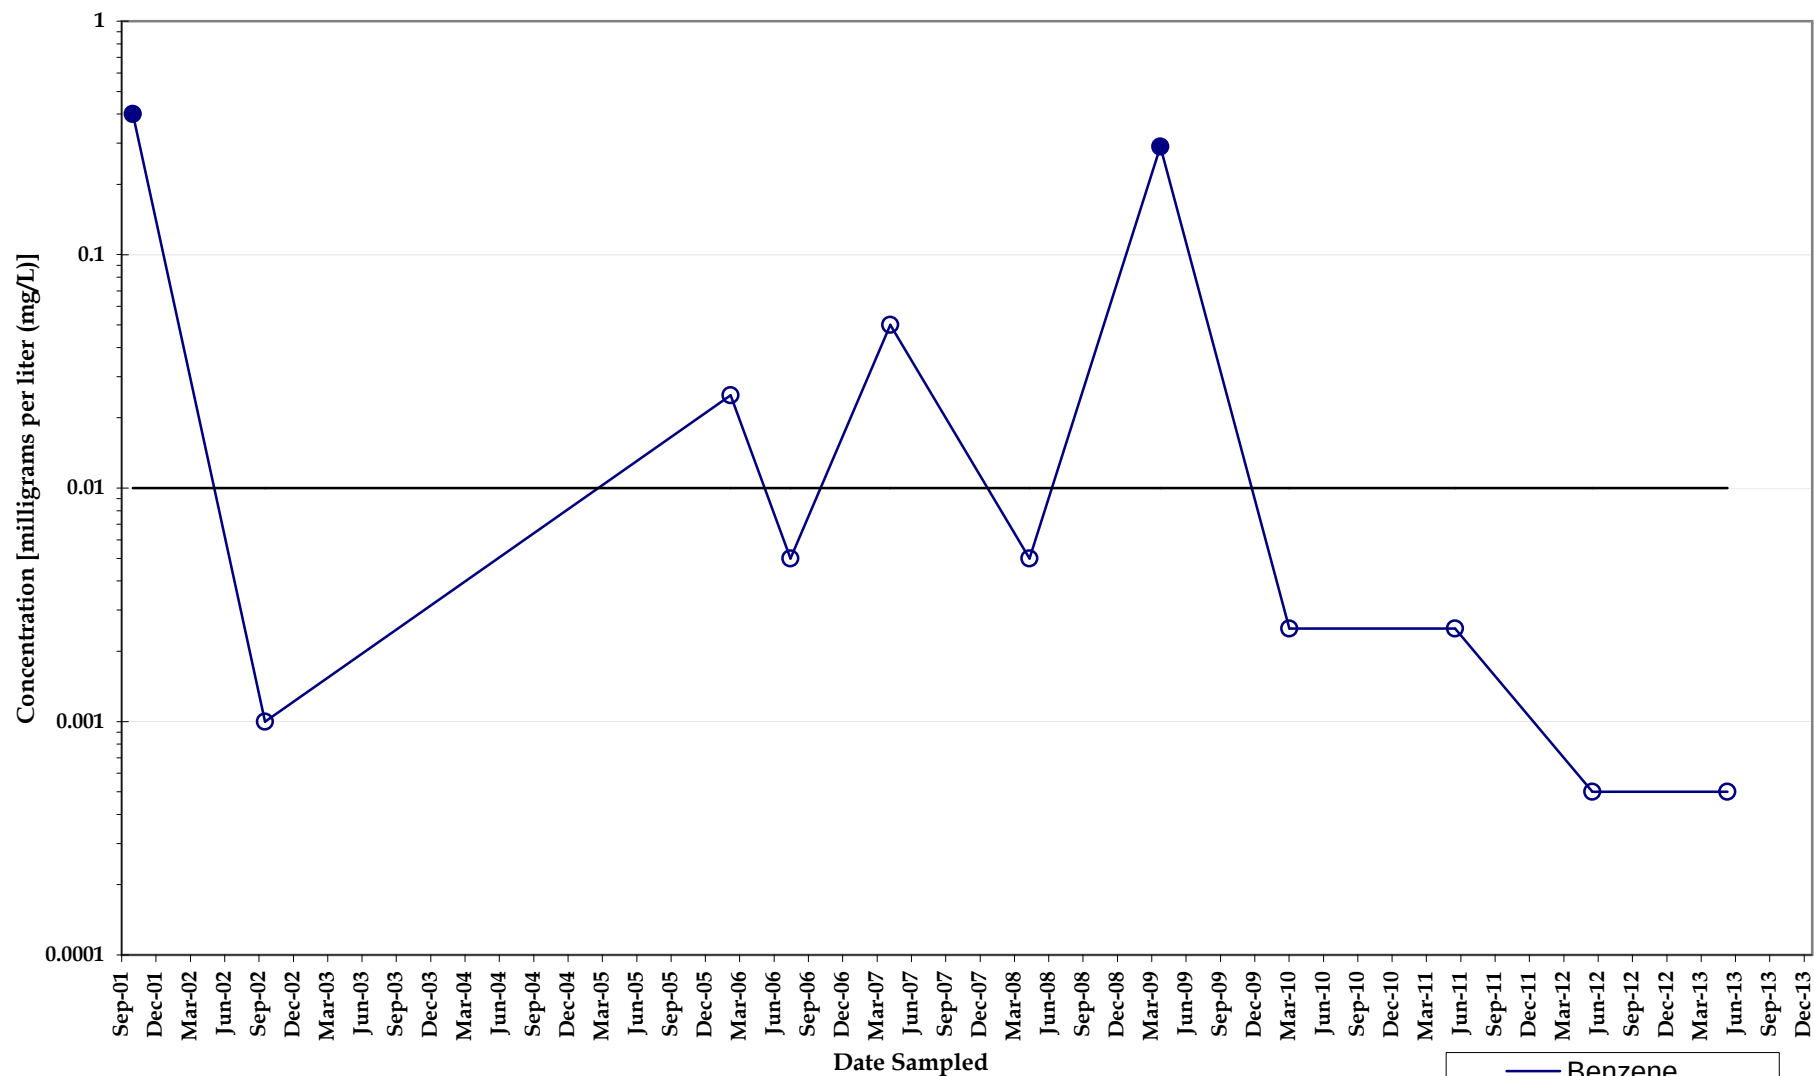
## Benzene Concentrations Monitoring Well RW004A

Note: Non-detect analyses plotted at the method detection limit or half the reporting limit (RL). Detections denoted by symbol and detection values greater than the RL denoted by shaded symbol.

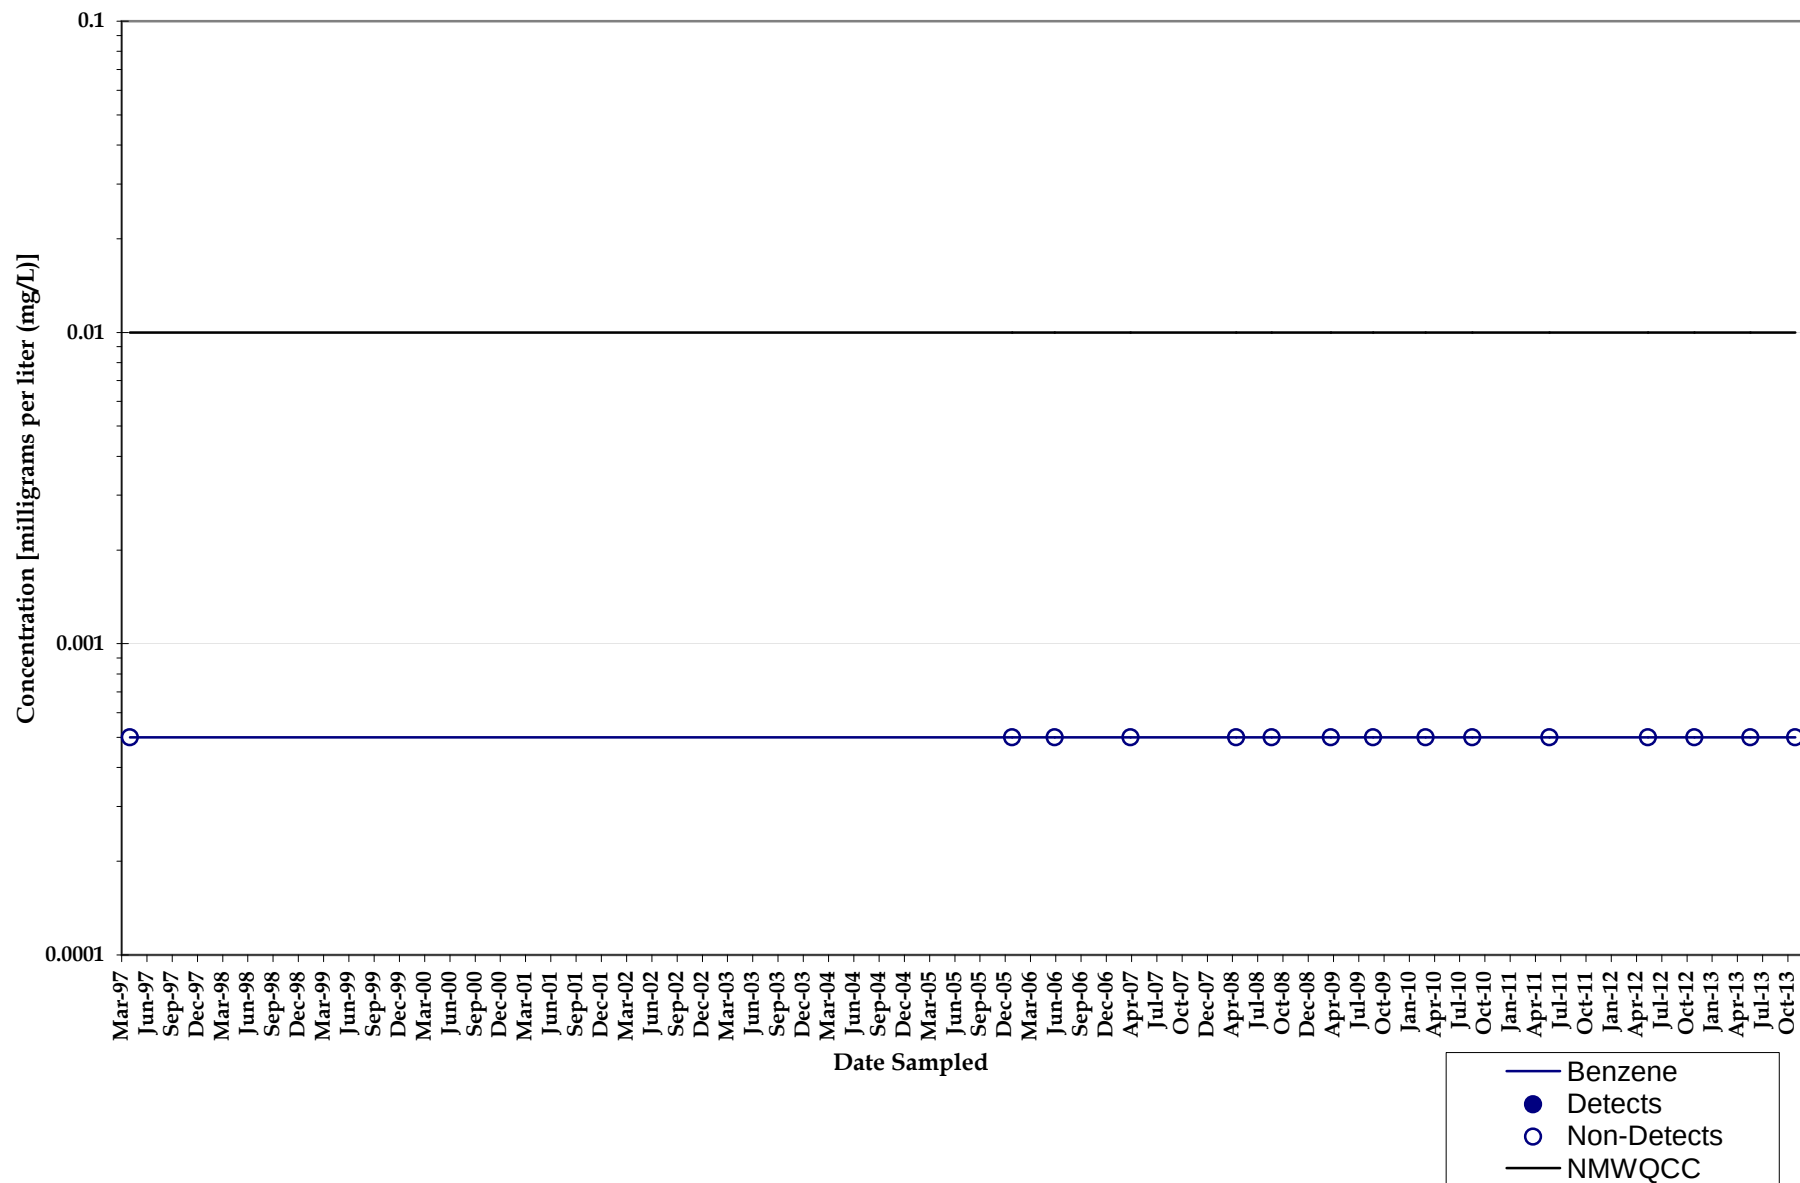
## Benzene Concentrations Monitoring Well WOODELLWW

Note: Non-detect analyses plotted at the method detection limit or half the reporting limit (RL). Detections denoted by symbol and detection values greater than the RL denoted by shaded symbol.

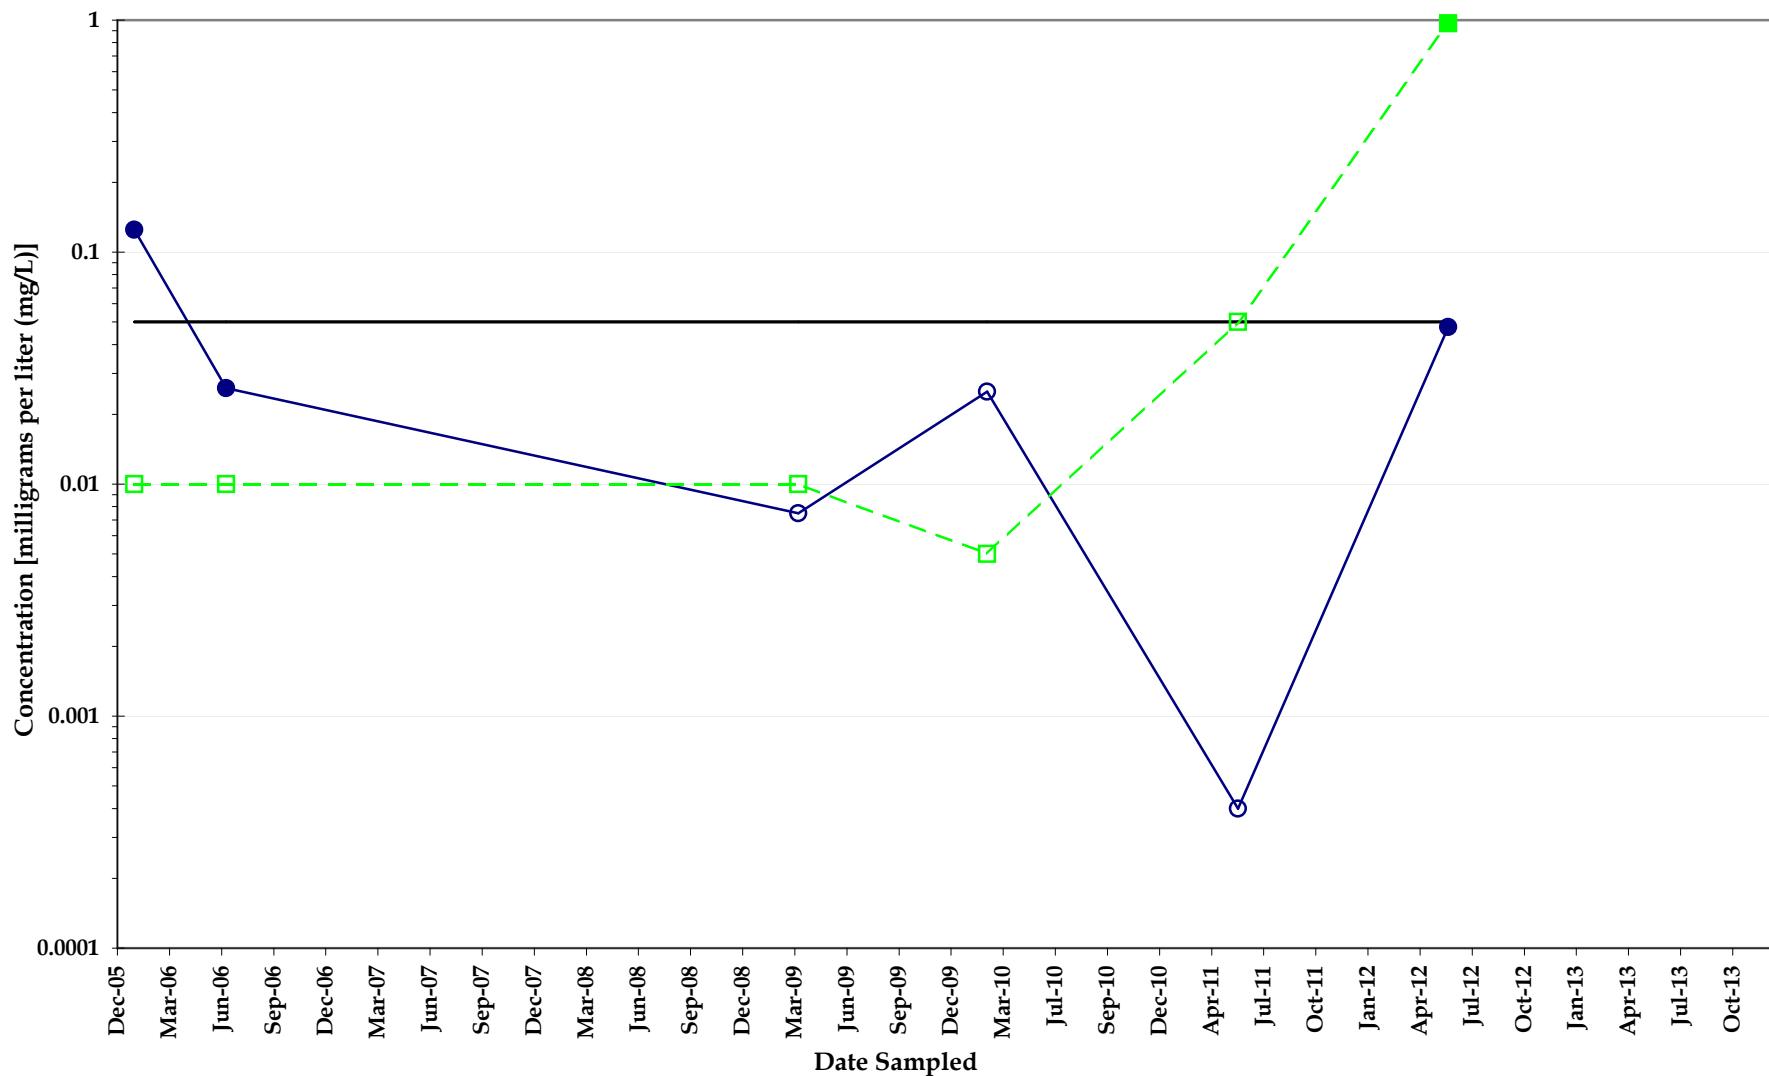
## Chromium Concentrations Monitoring Well EPWW1

Note: Non-detect analyses plotted at the method detection limit or half the reporting limit (RL). Detections denoted by symbol and detection values greater than the RL denoted by shaded symbol.

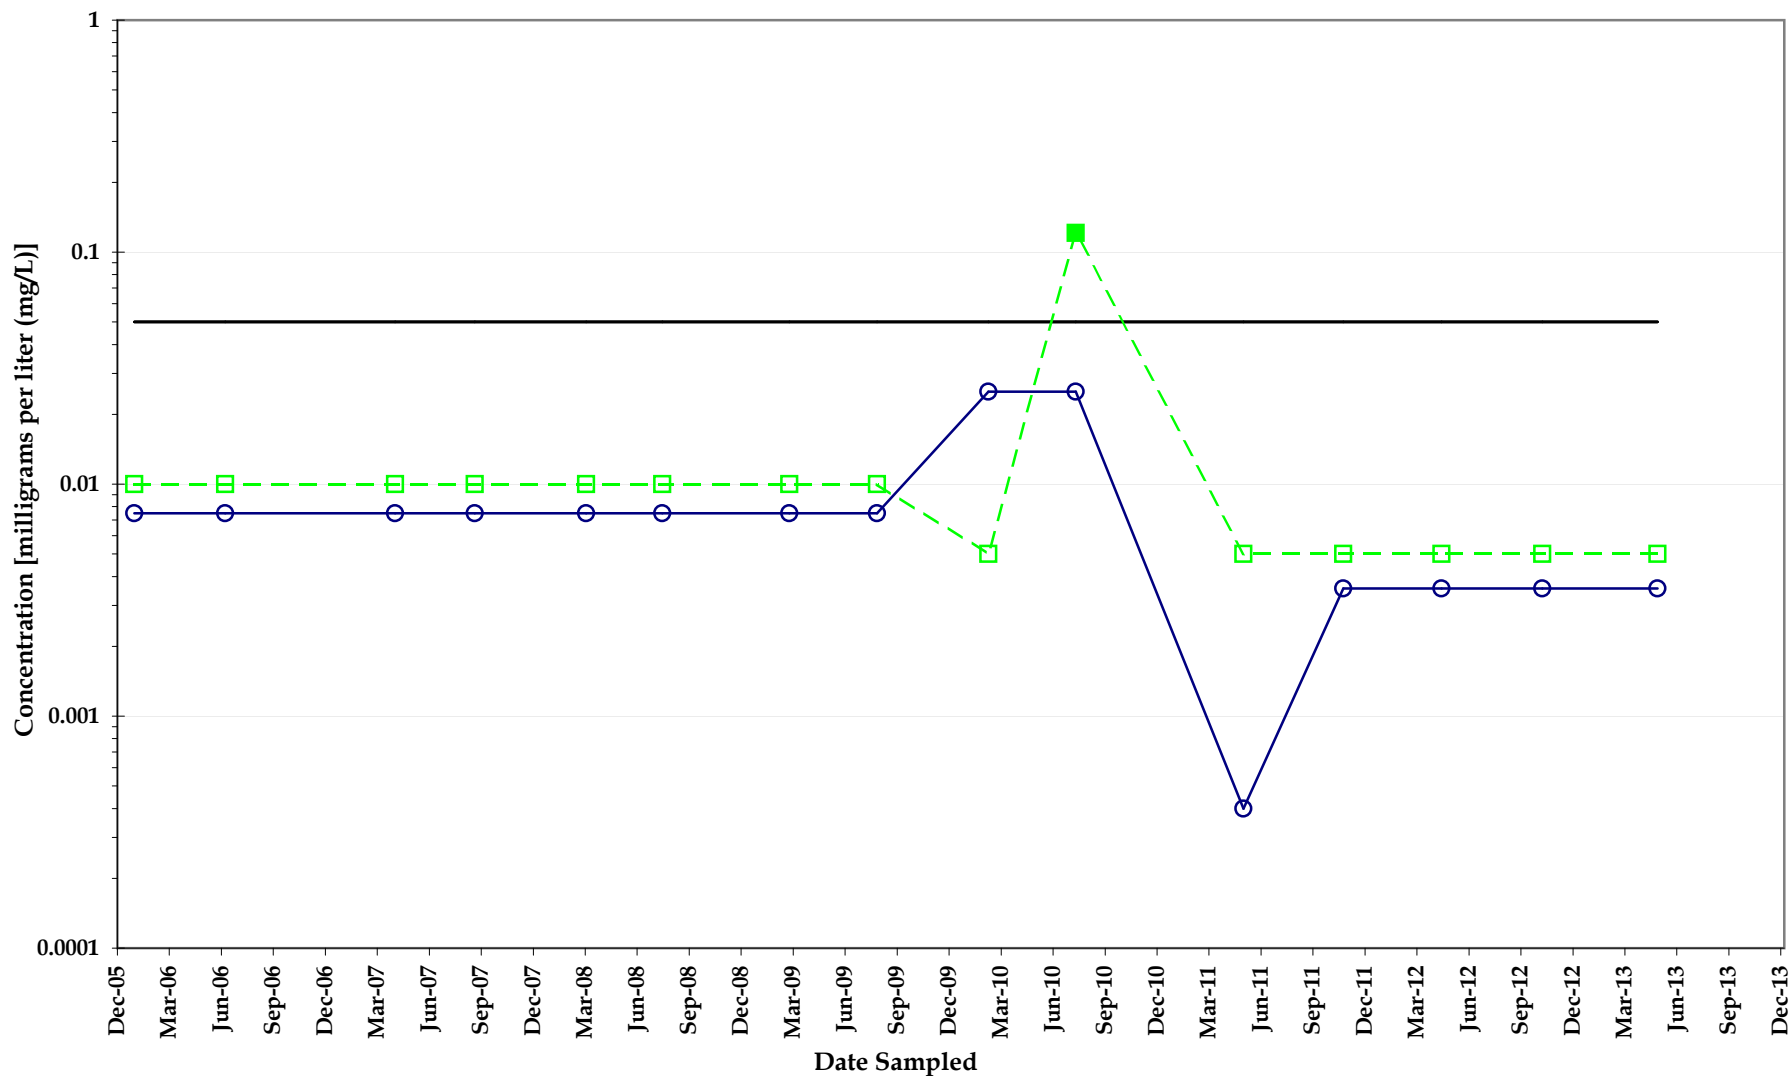
## Chromium Concentrations Monitoring Well GOPWW2

Note: Non-detect analyses plotted at the method detection limit or half the reporting limit (RL). Detections denoted by symbol and detection values greater than the RL denoted by shaded symbol.

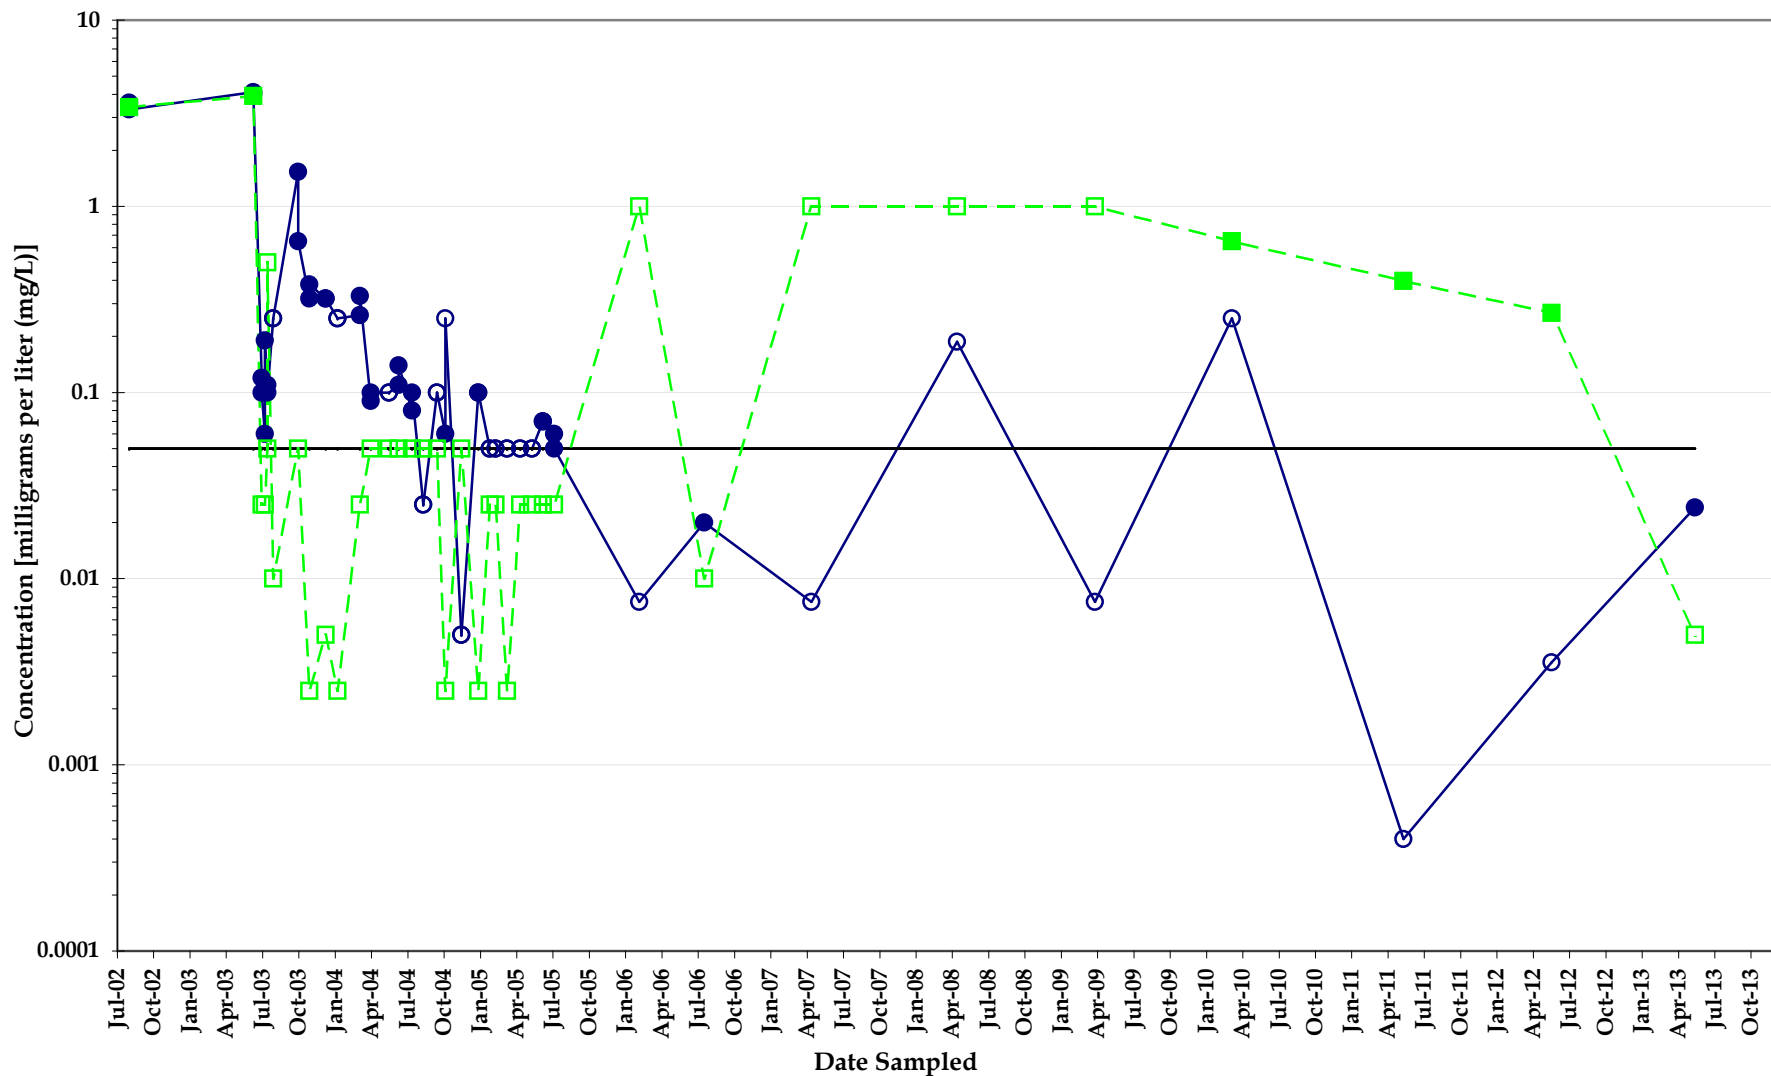
## Chromium Concentrations Monitoring Well IW001

Note: Non-detect analyses plotted at the method detection limit or half the reporting limit (RL). Detections denoted by symbol and detection values greater than the RL denoted by shaded symbol.

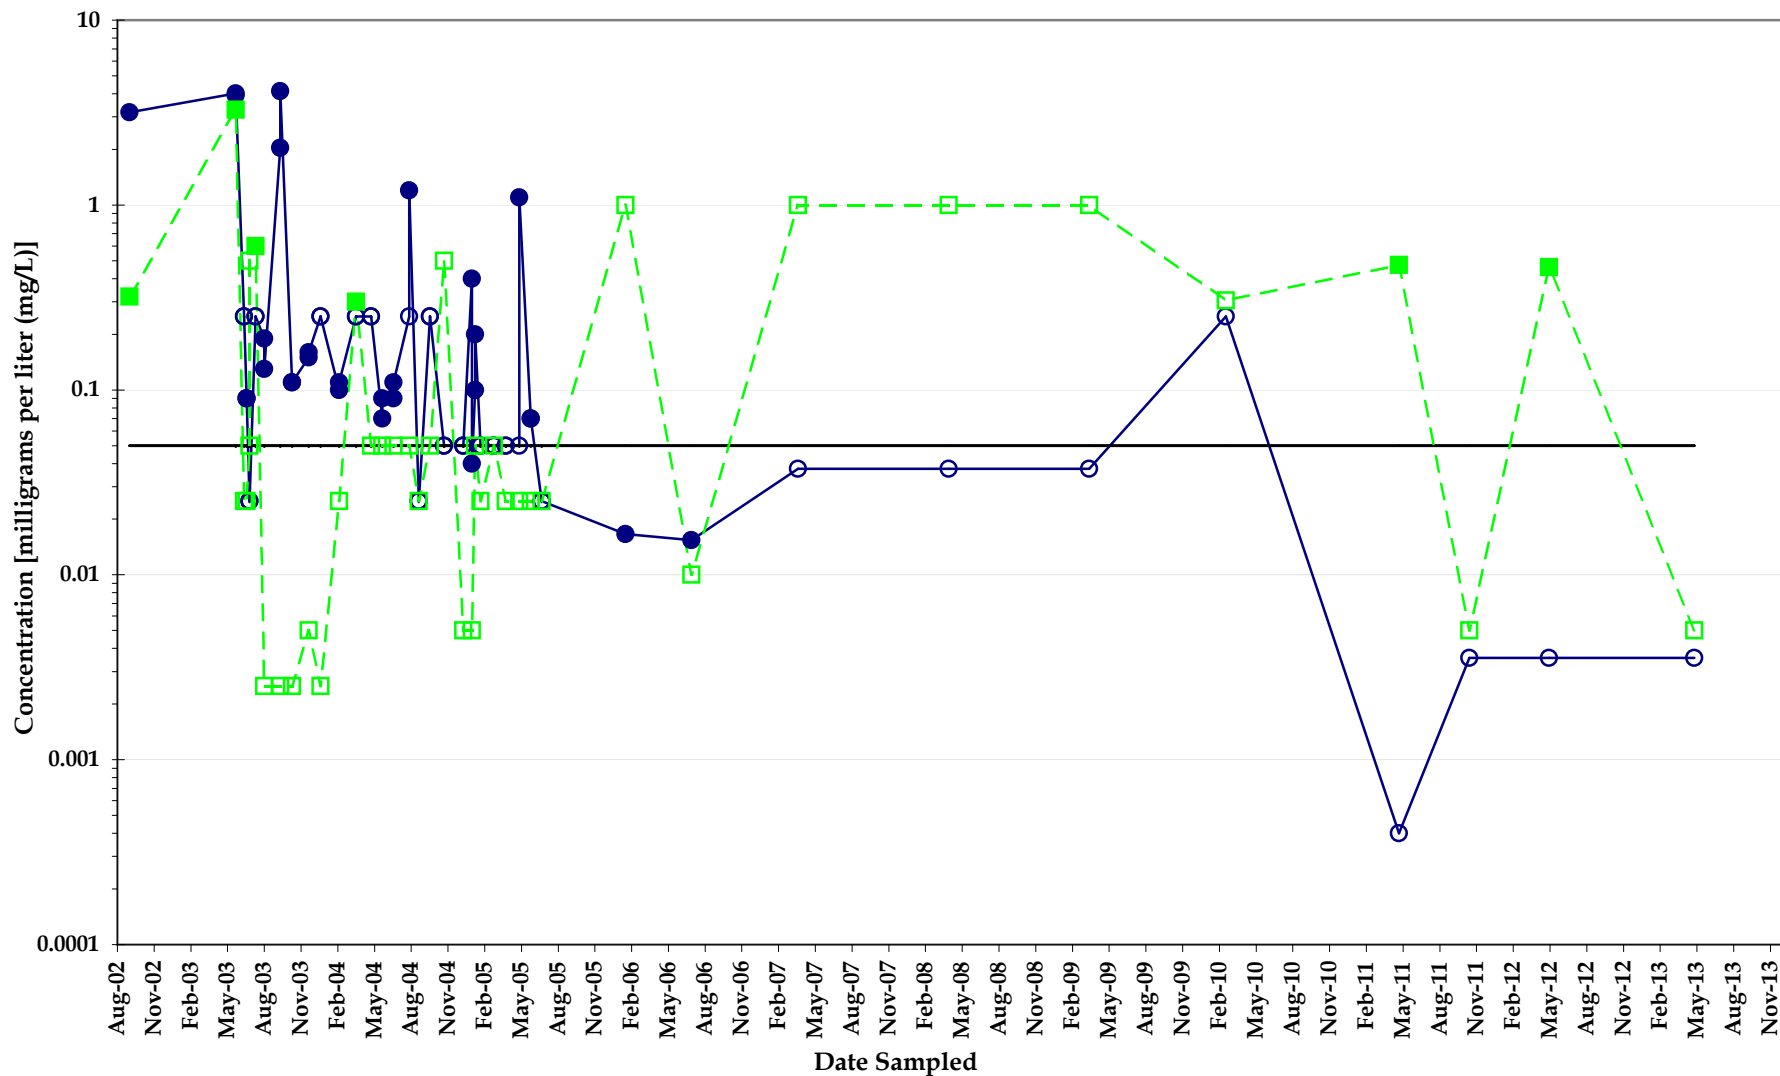
## Chromium Concentrations Monitoring Well IW002

Note: Non-detect analyses plotted at the method detection limit or half the reporting limit (RL). Detections denoted by symbol and detection values greater than the RL denoted by shaded symbol.

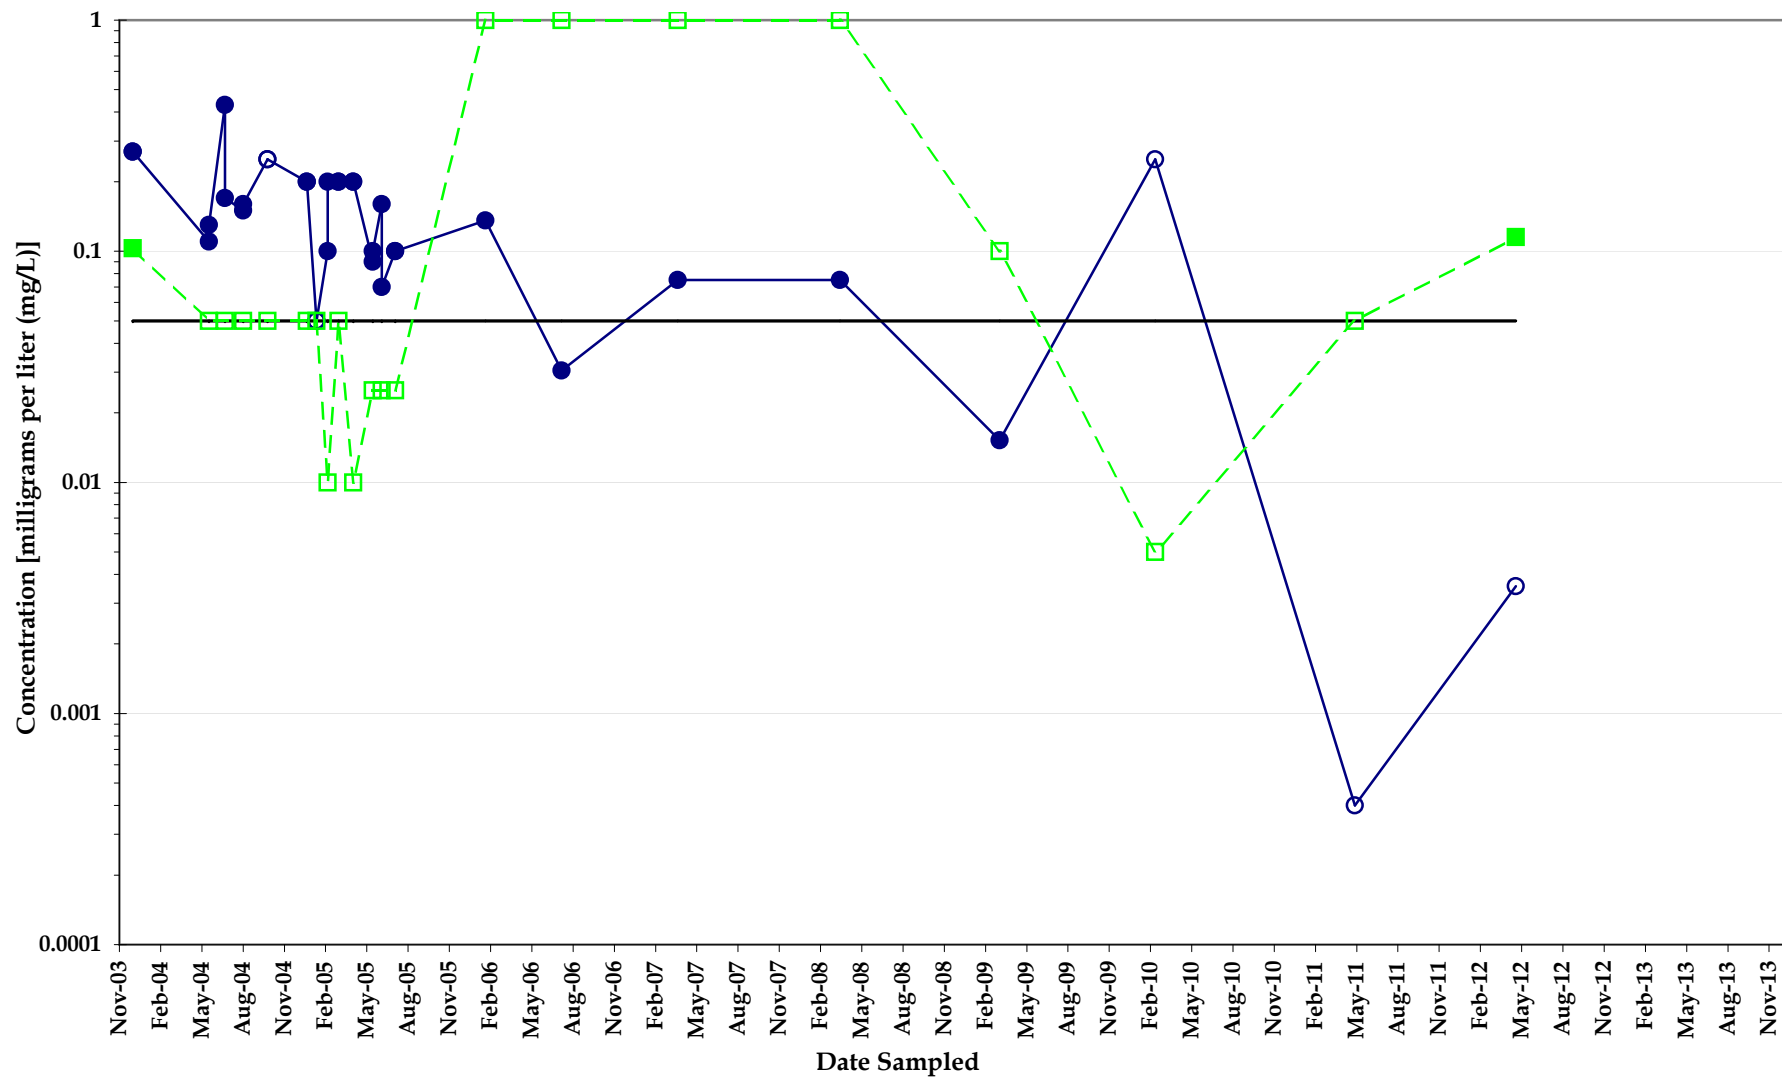
## Chromium Concentrations Monitoring Well IW003

Note: Non-detect analyses plotted at the method detection limit or half the reporting limit (RL). Detections denoted by symbol and detection values greater than the RL denoted by shaded symbol.

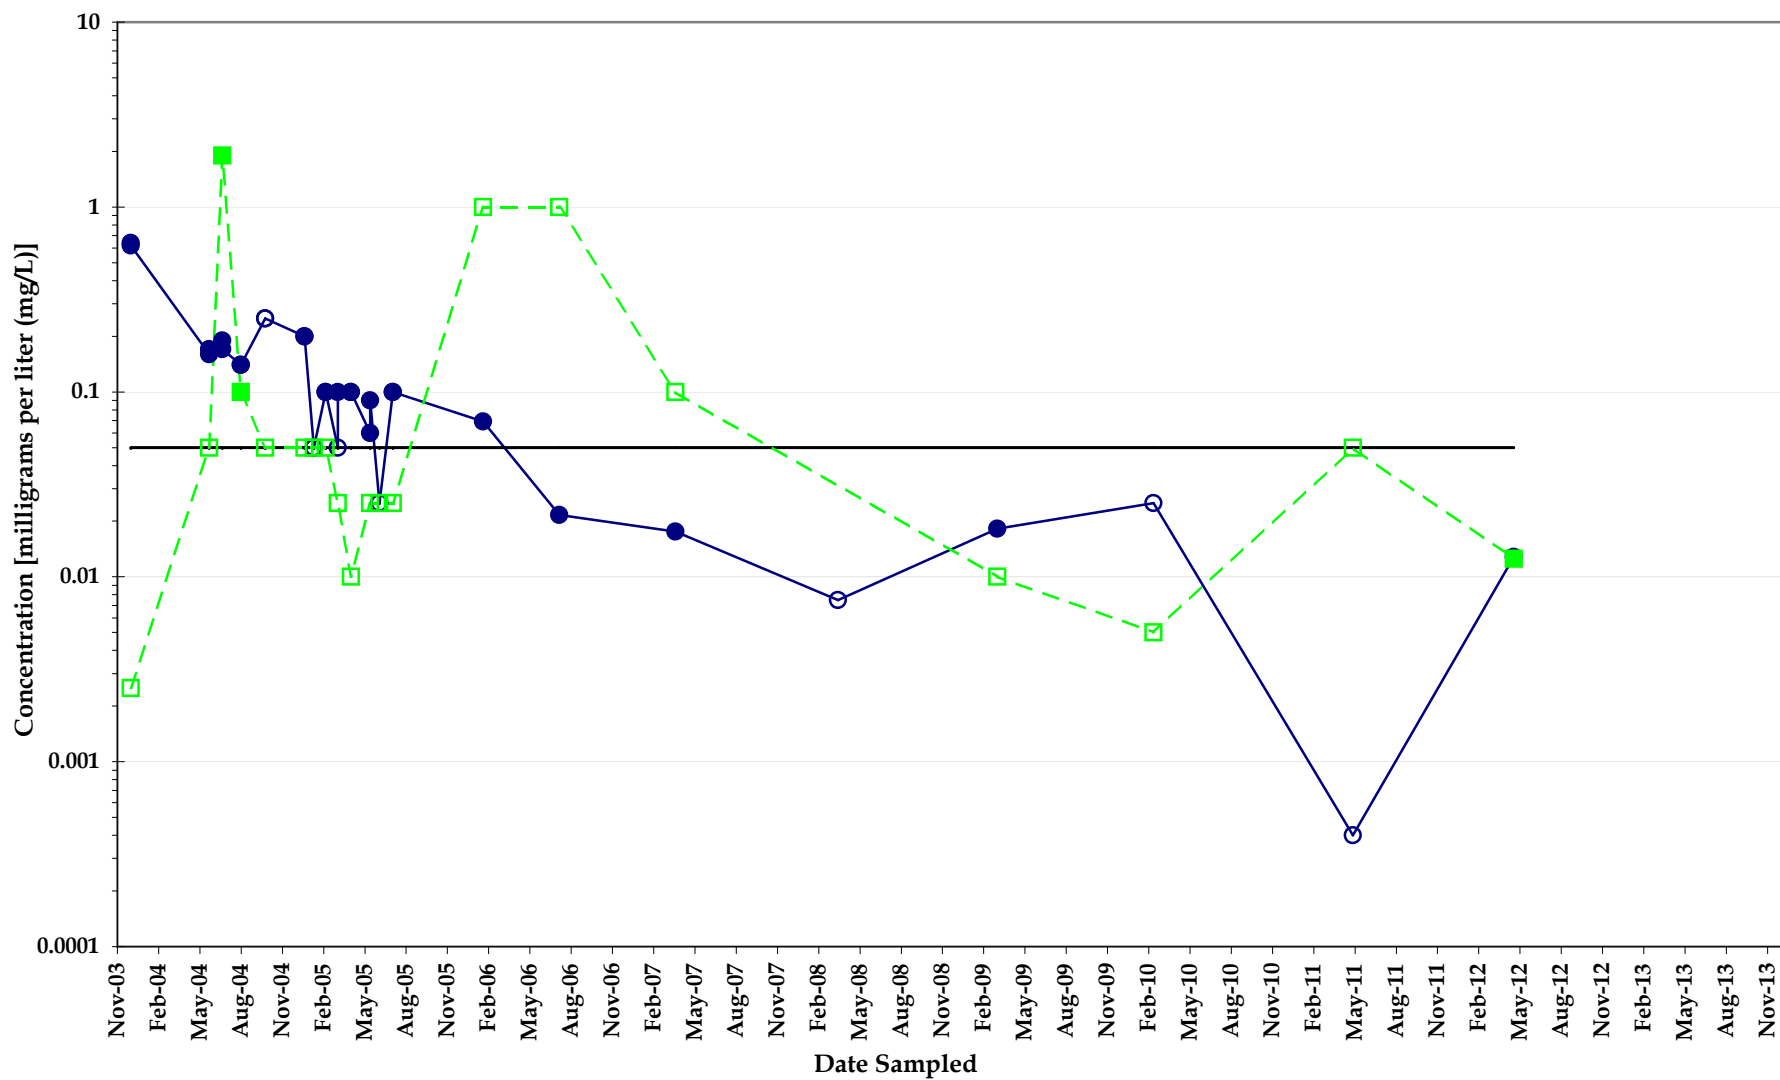
## Chromium Concentrations Monitoring Well IW004

Note: Non-detect analyses plotted at the method detection limit or half the reporting limit (RL). Detections denoted by symbol and detection values greater than the RL denoted by shaded symbol.
