**GW - 004**

**2013 AGWMR**

**VOL 5 OF 5**

*North Eunice Gas Plant  
Lea County, New Mexico*

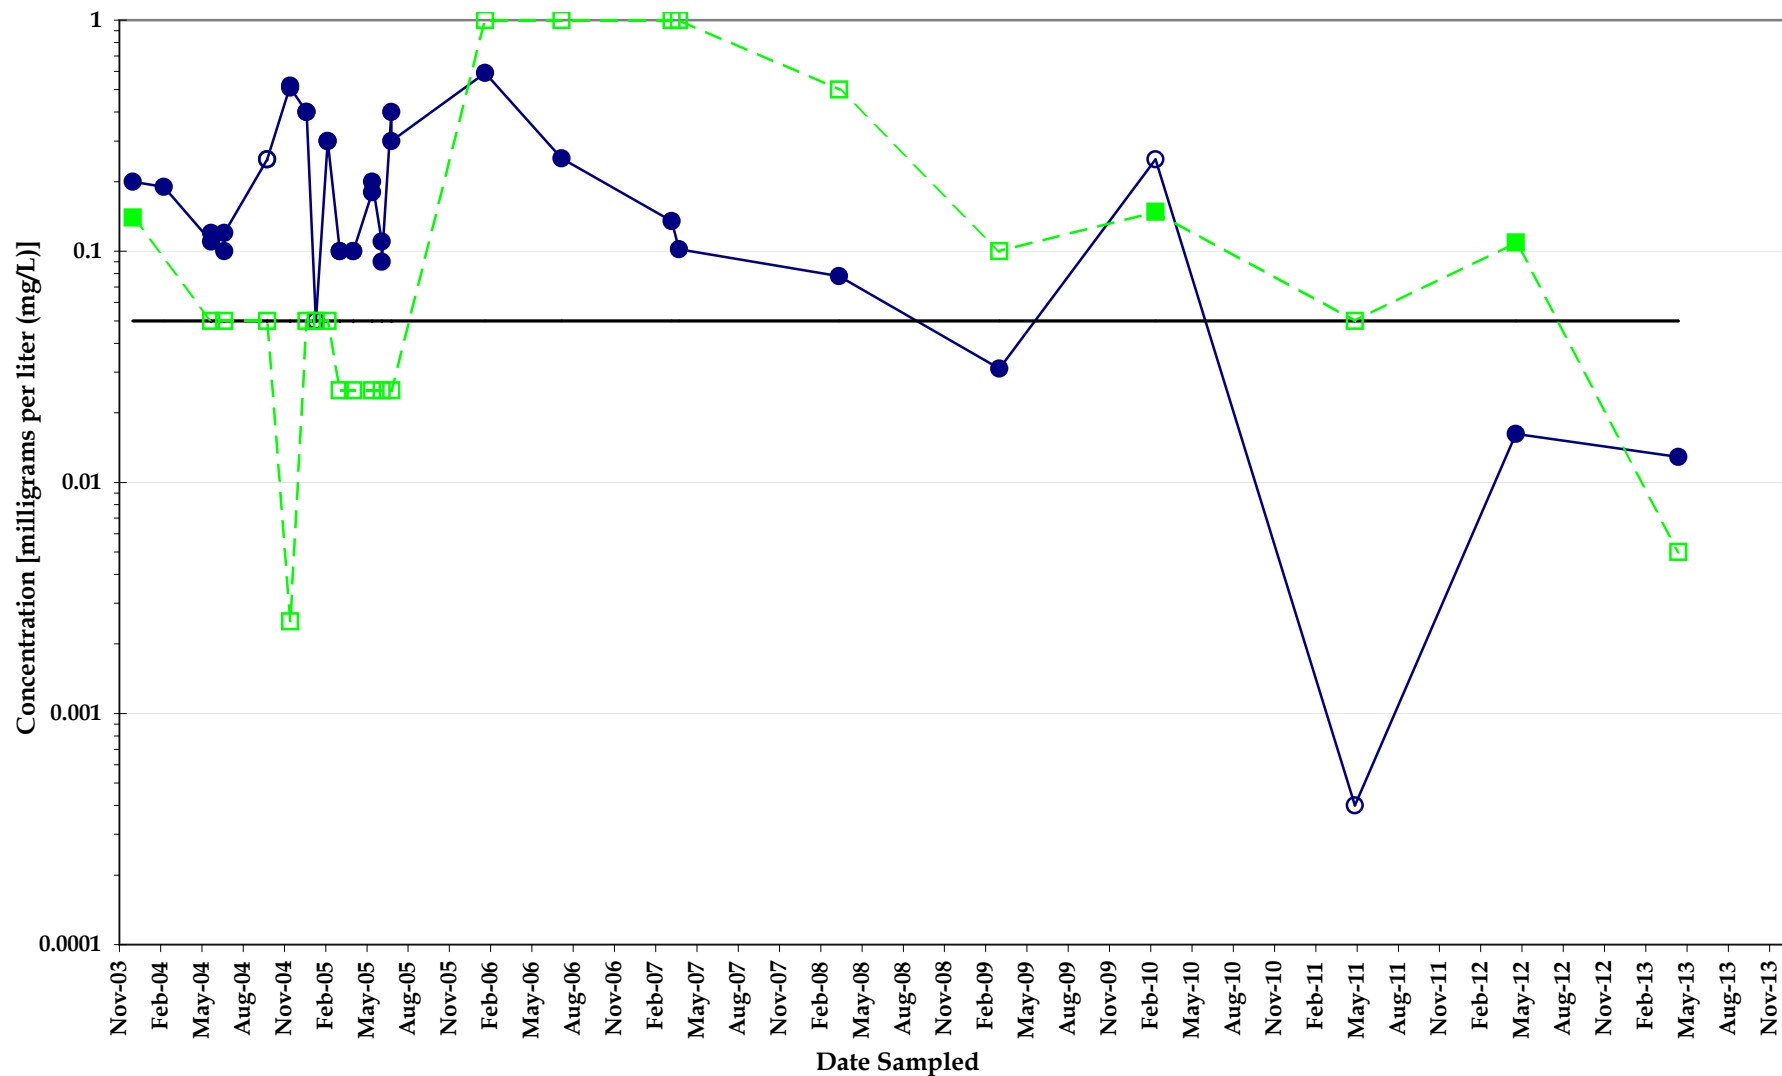
## Chromium Concentrations Monitoring Well IW005

Note: Non-detect analyses plotted at the method detection limit or half the reporting limit (RL). Detections denoted by symbol and detection values greater than the RL denoted by shaded symbol.

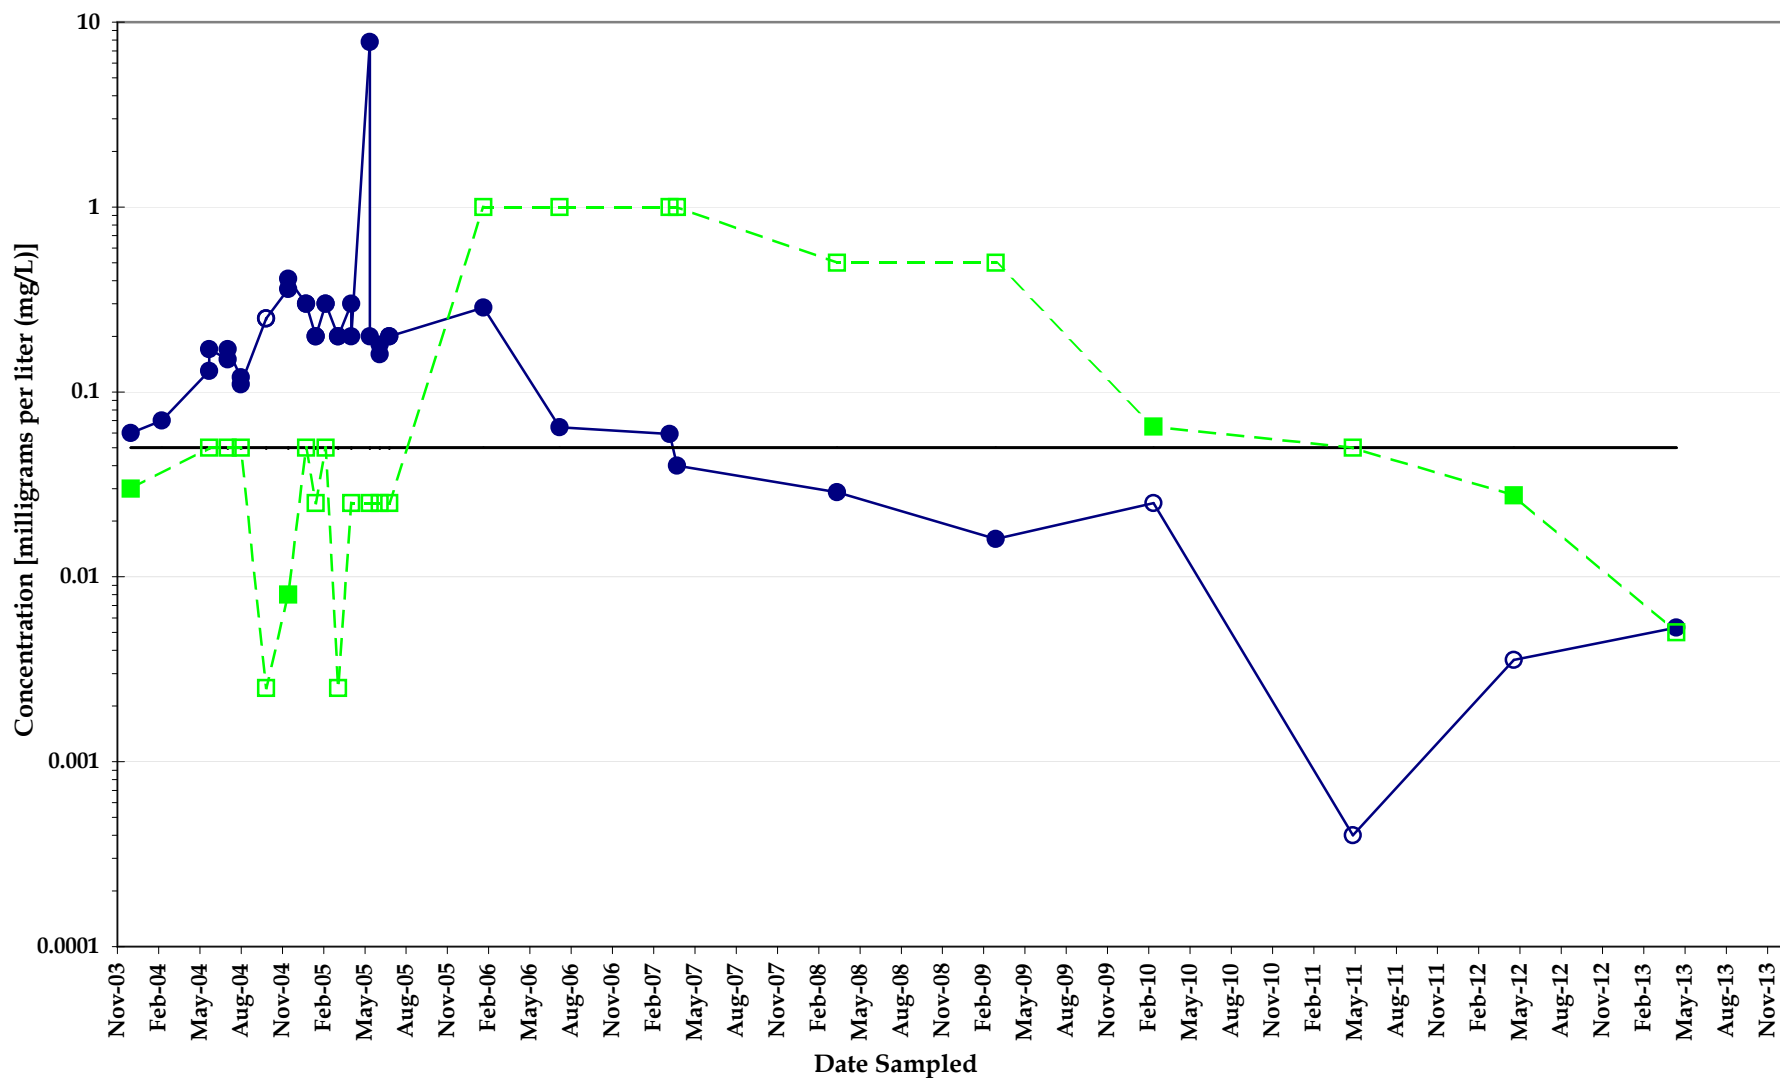
## Chromium Concentrations Monitoring Well IW006

Note: Non-detect analyses plotted at the method detection limit or half the reporting limit (RL). Detections denoted by symbol and detection values greater than the RL denoted by shaded symbol.

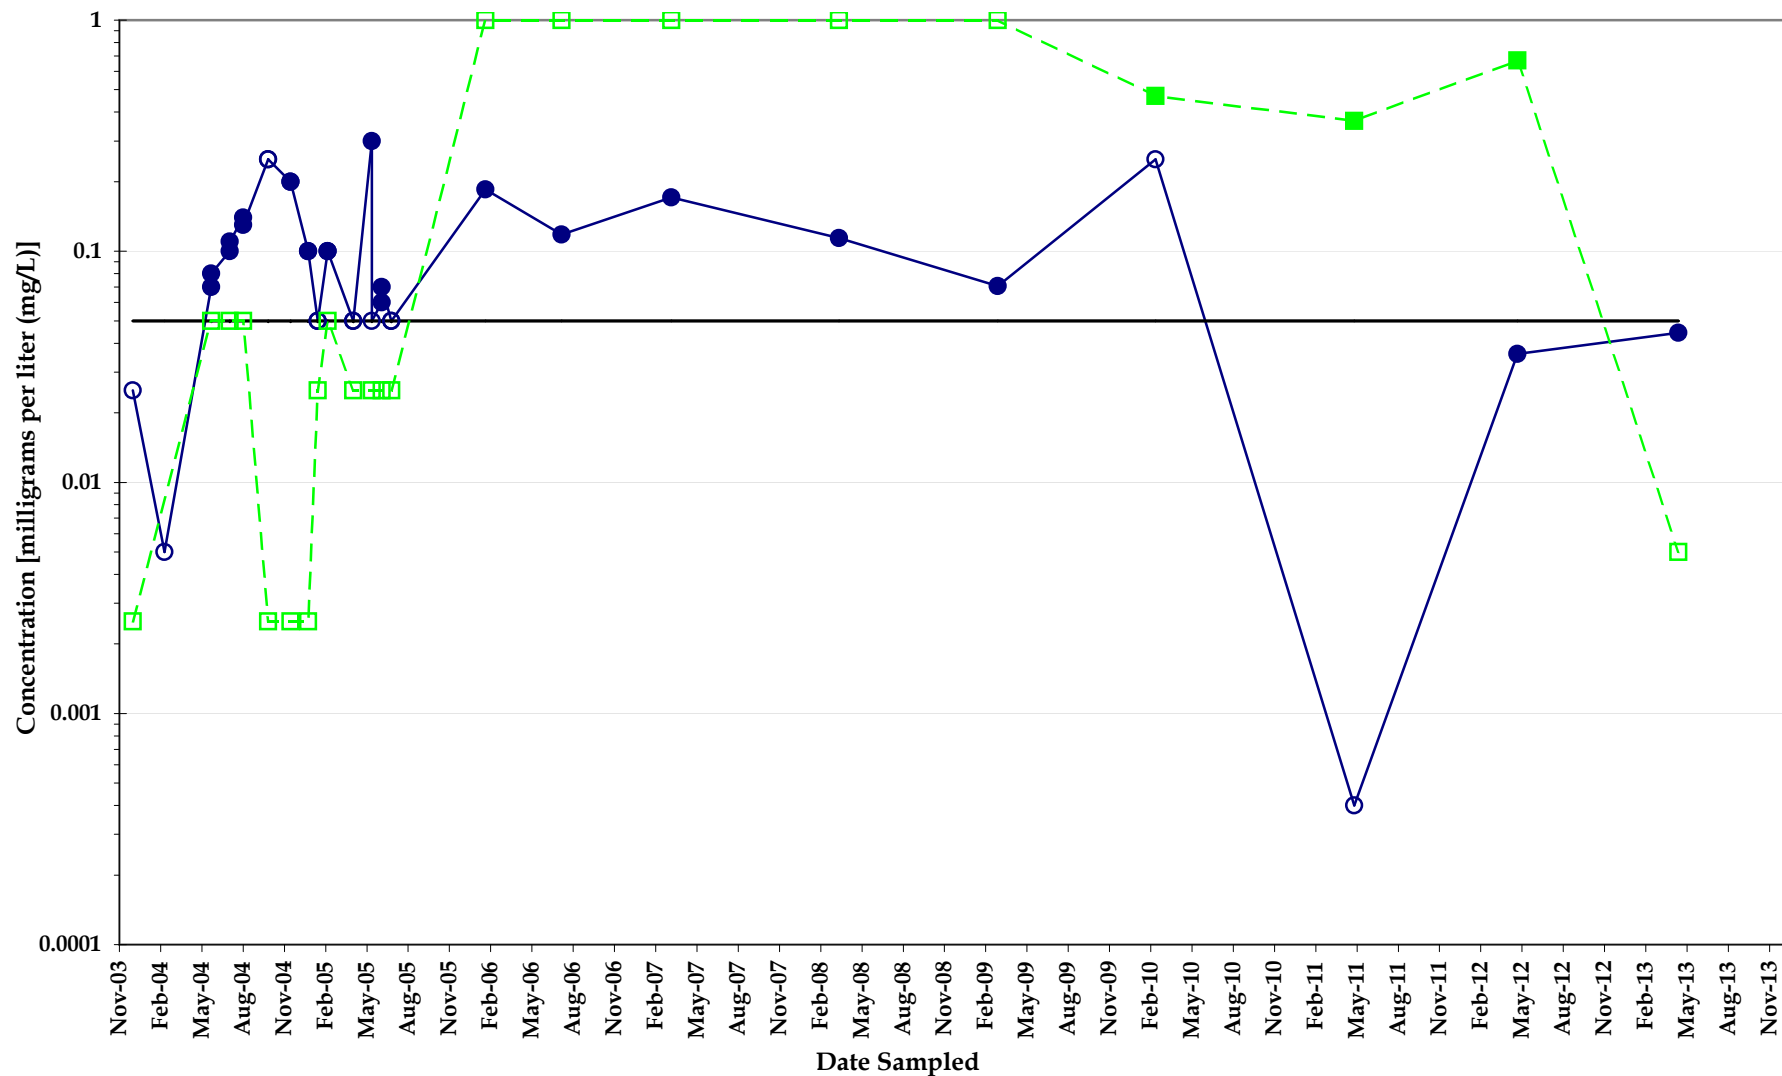
## Chromium Concentrations Monitoring Well IW007

Note: Non-detect analyses plotted at the method detection limit or half the reporting limit (RL). Detections denoted by symbol and detection values greater than the RL denoted by shaded symbol.

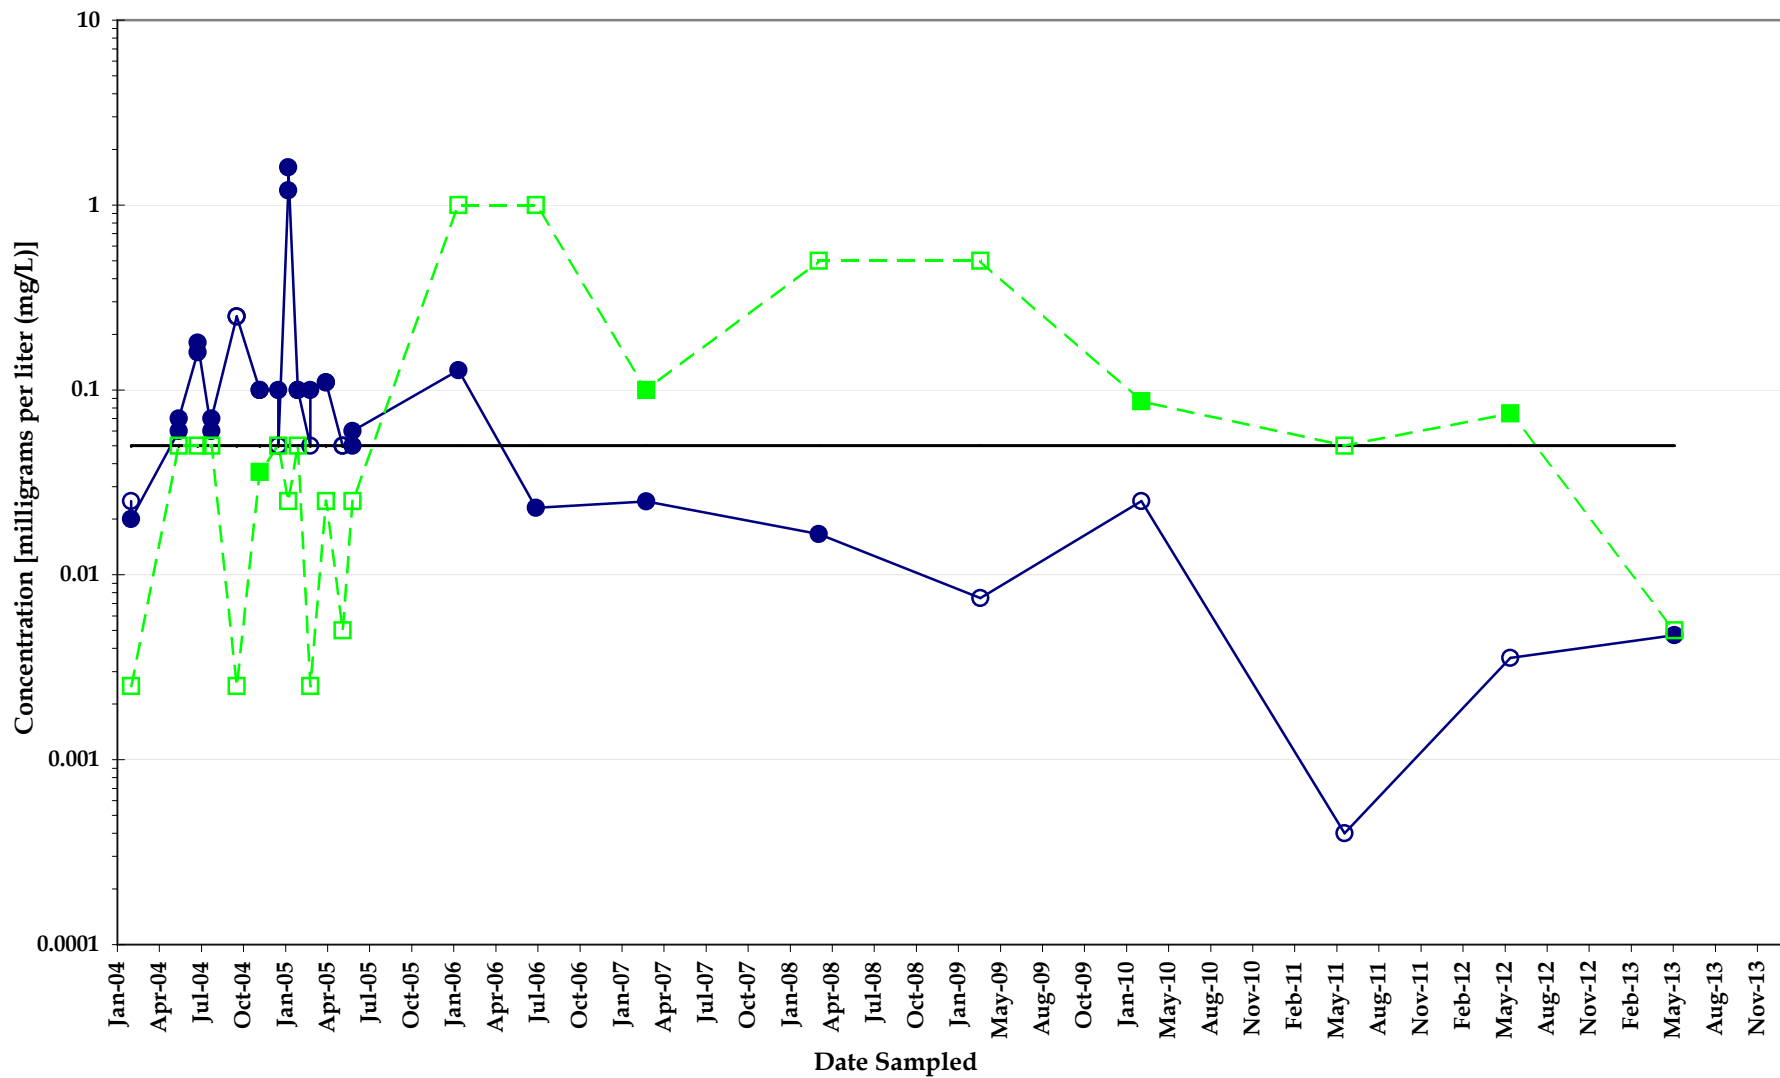
## Chromium Concentrations Monitoring Well IW008

Note: Non-detect analyses plotted at the method detection limit or half the reporting limit (RL). Detections denoted by symbol and detection values greater than the RL denoted by shaded symbol.

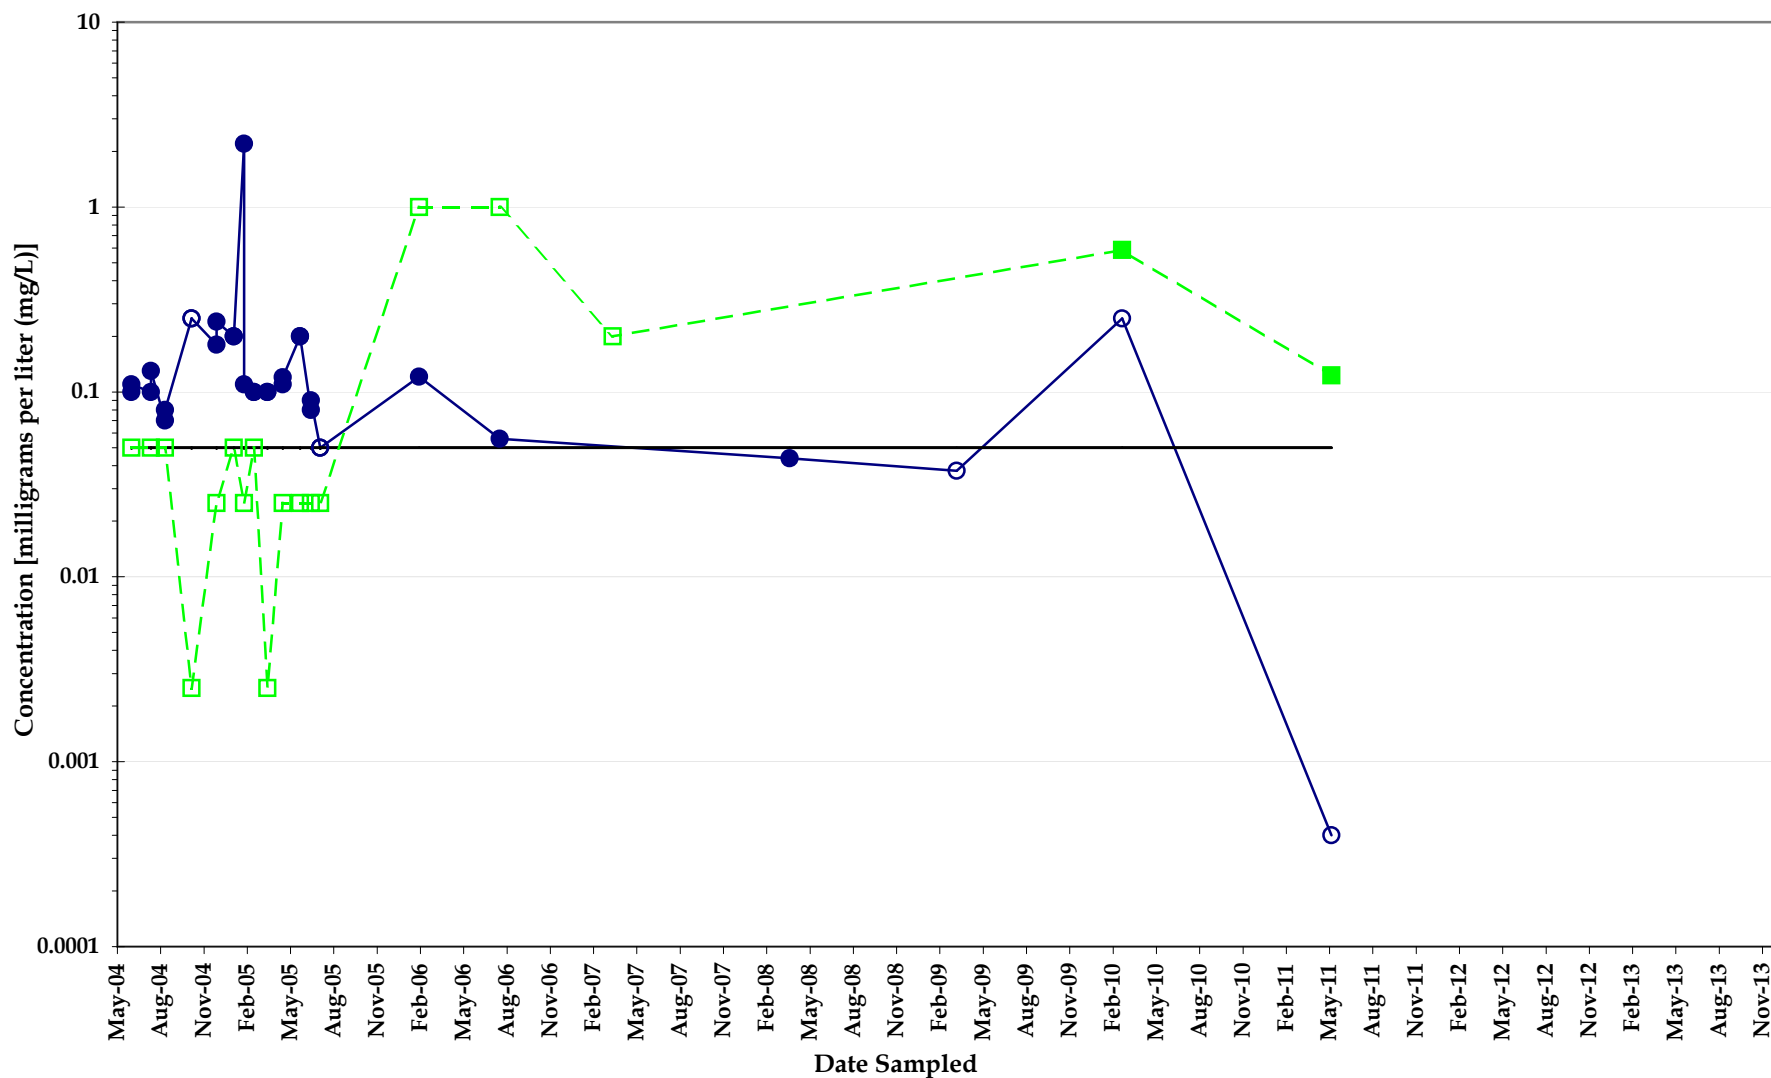
## Chromium Concentrations Monitoring Well IW009

Note: Non-detect analyses plotted at the method detection limit or half the reporting limit (RL). Detections denoted by symbol and detection values greater than the RL denoted by shaded symbol.

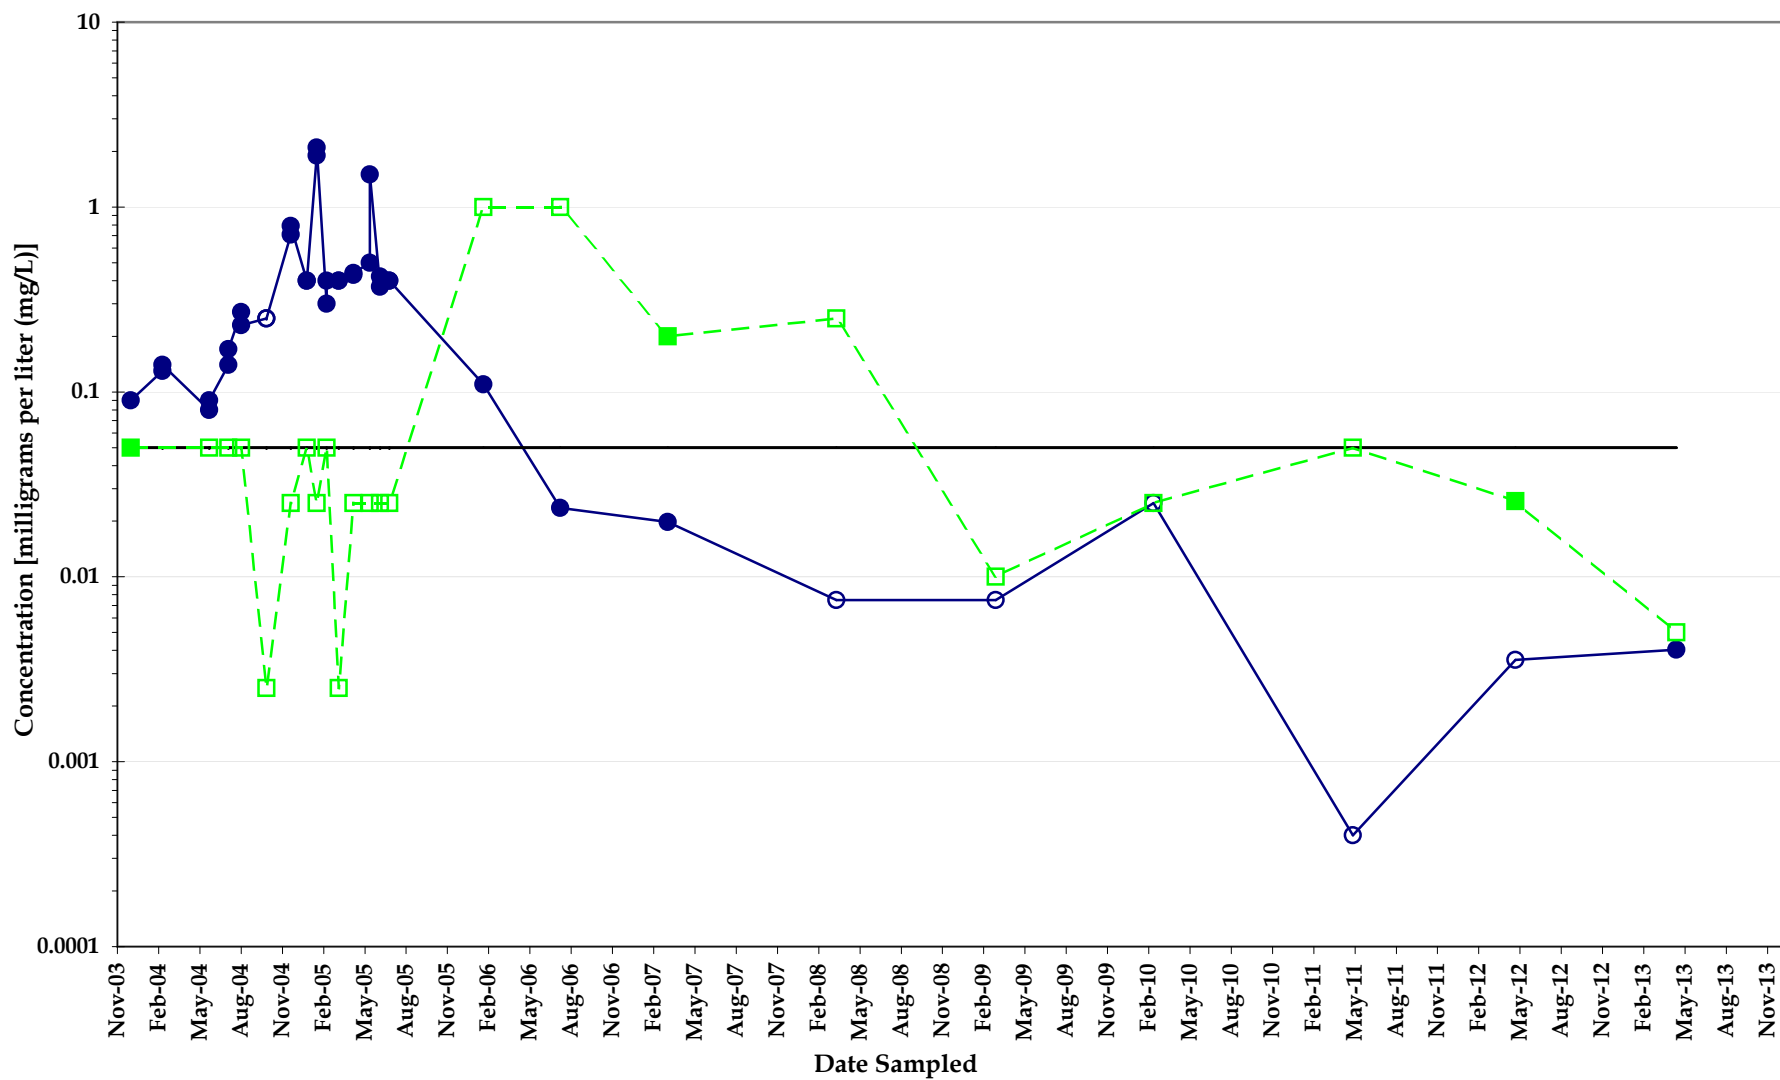
## Chromium Concentrations Monitoring Well IW010

Note: Non-detect analyses plotted at the method detection limit or half the reporting limit (RL). Detections denoted by symbol and detection values greater than the RL denoted by shaded symbol.

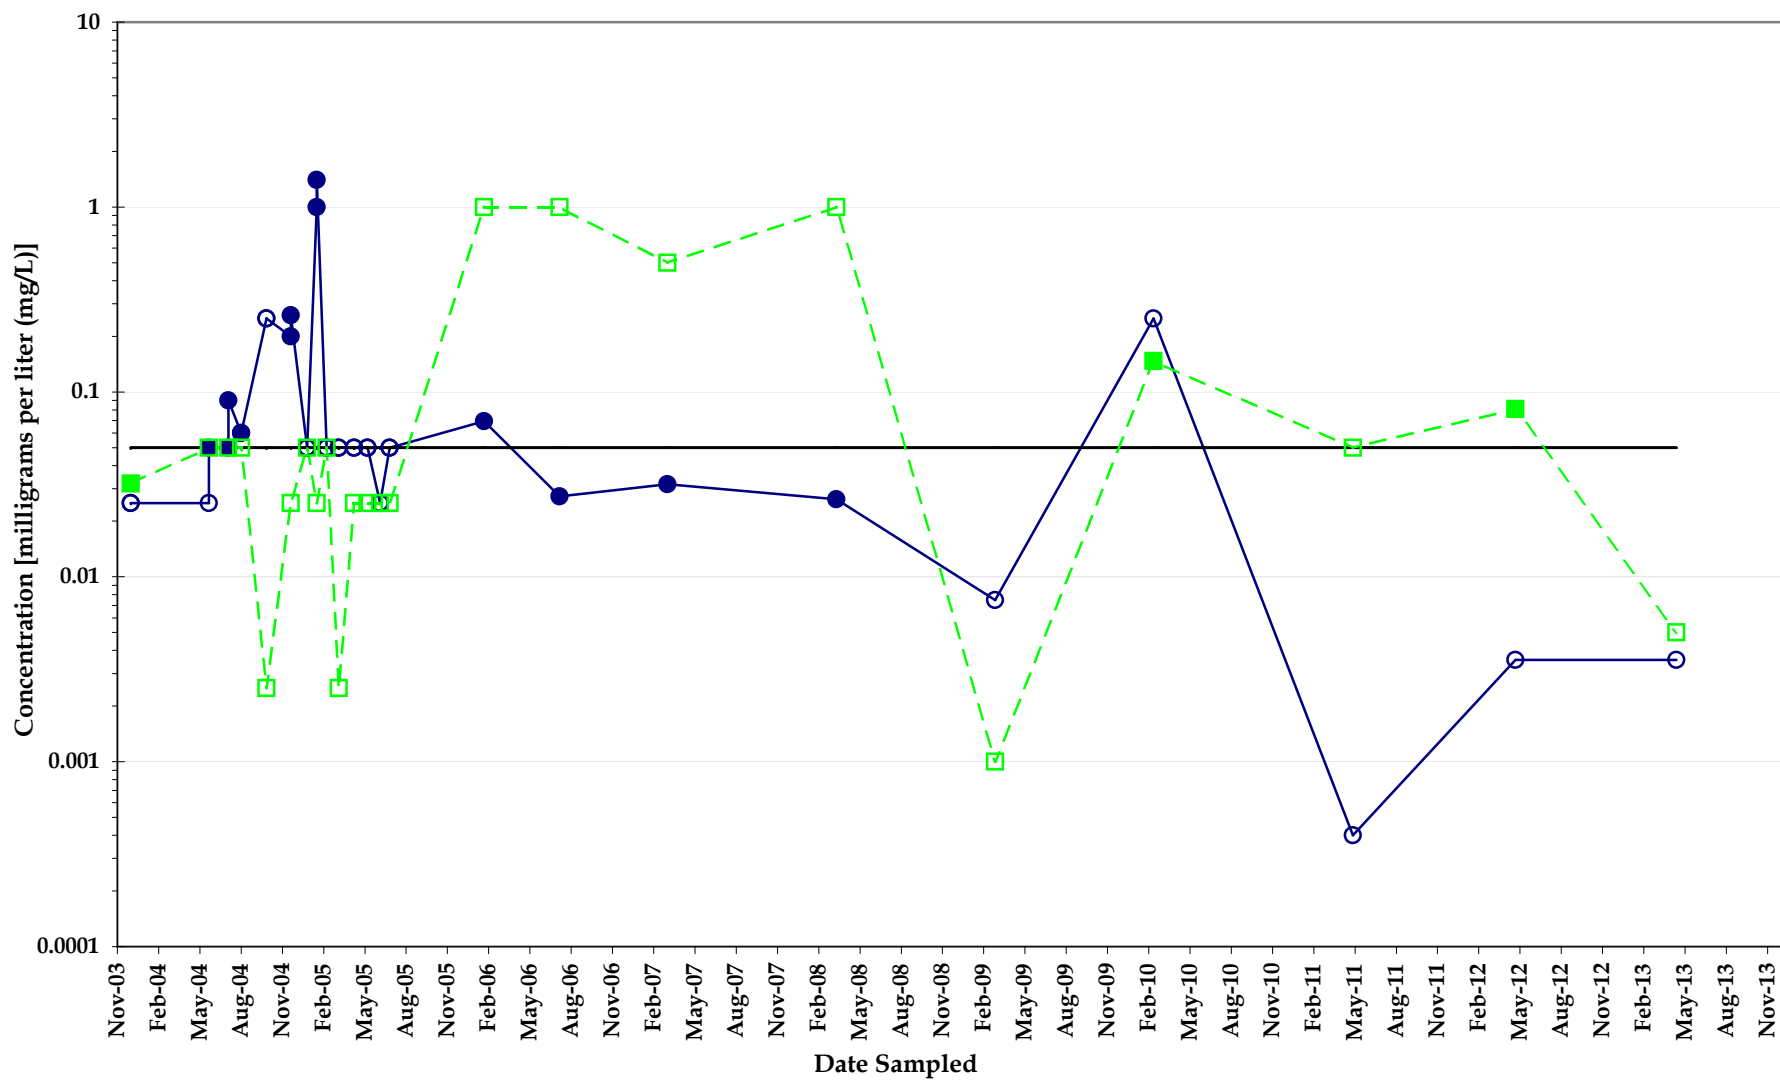
## Chromium Concentrations Monitoring Well IW011

Note: Non-detect analyses plotted at the method detection limit or half the reporting limit (RL). Detections denoted by symbol and detection values greater than the RL denoted by shaded symbol.

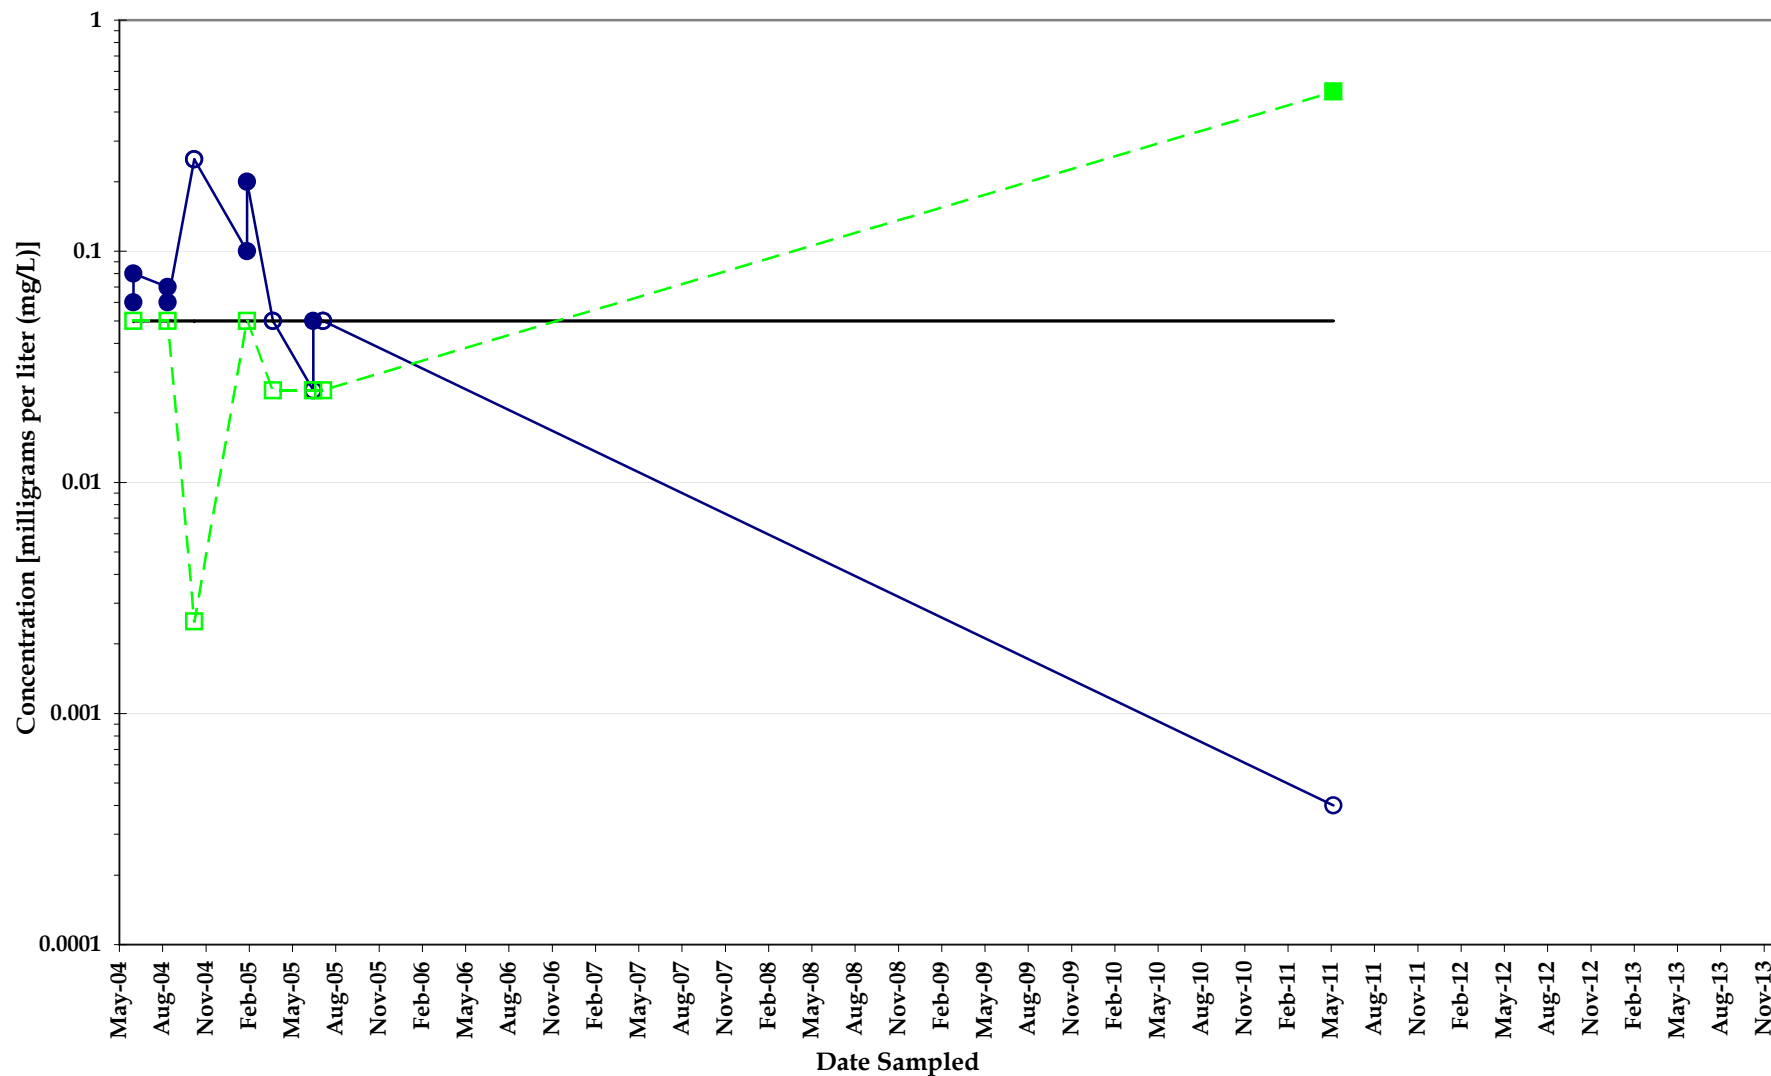
## Chromium Concentrations Monitoring Well IW012

Note: Non-detect analyses plotted at the method detection limit or half the reporting limit (RL). Detections denoted by symbol and detection values greater than the RL denoted by shaded symbol.

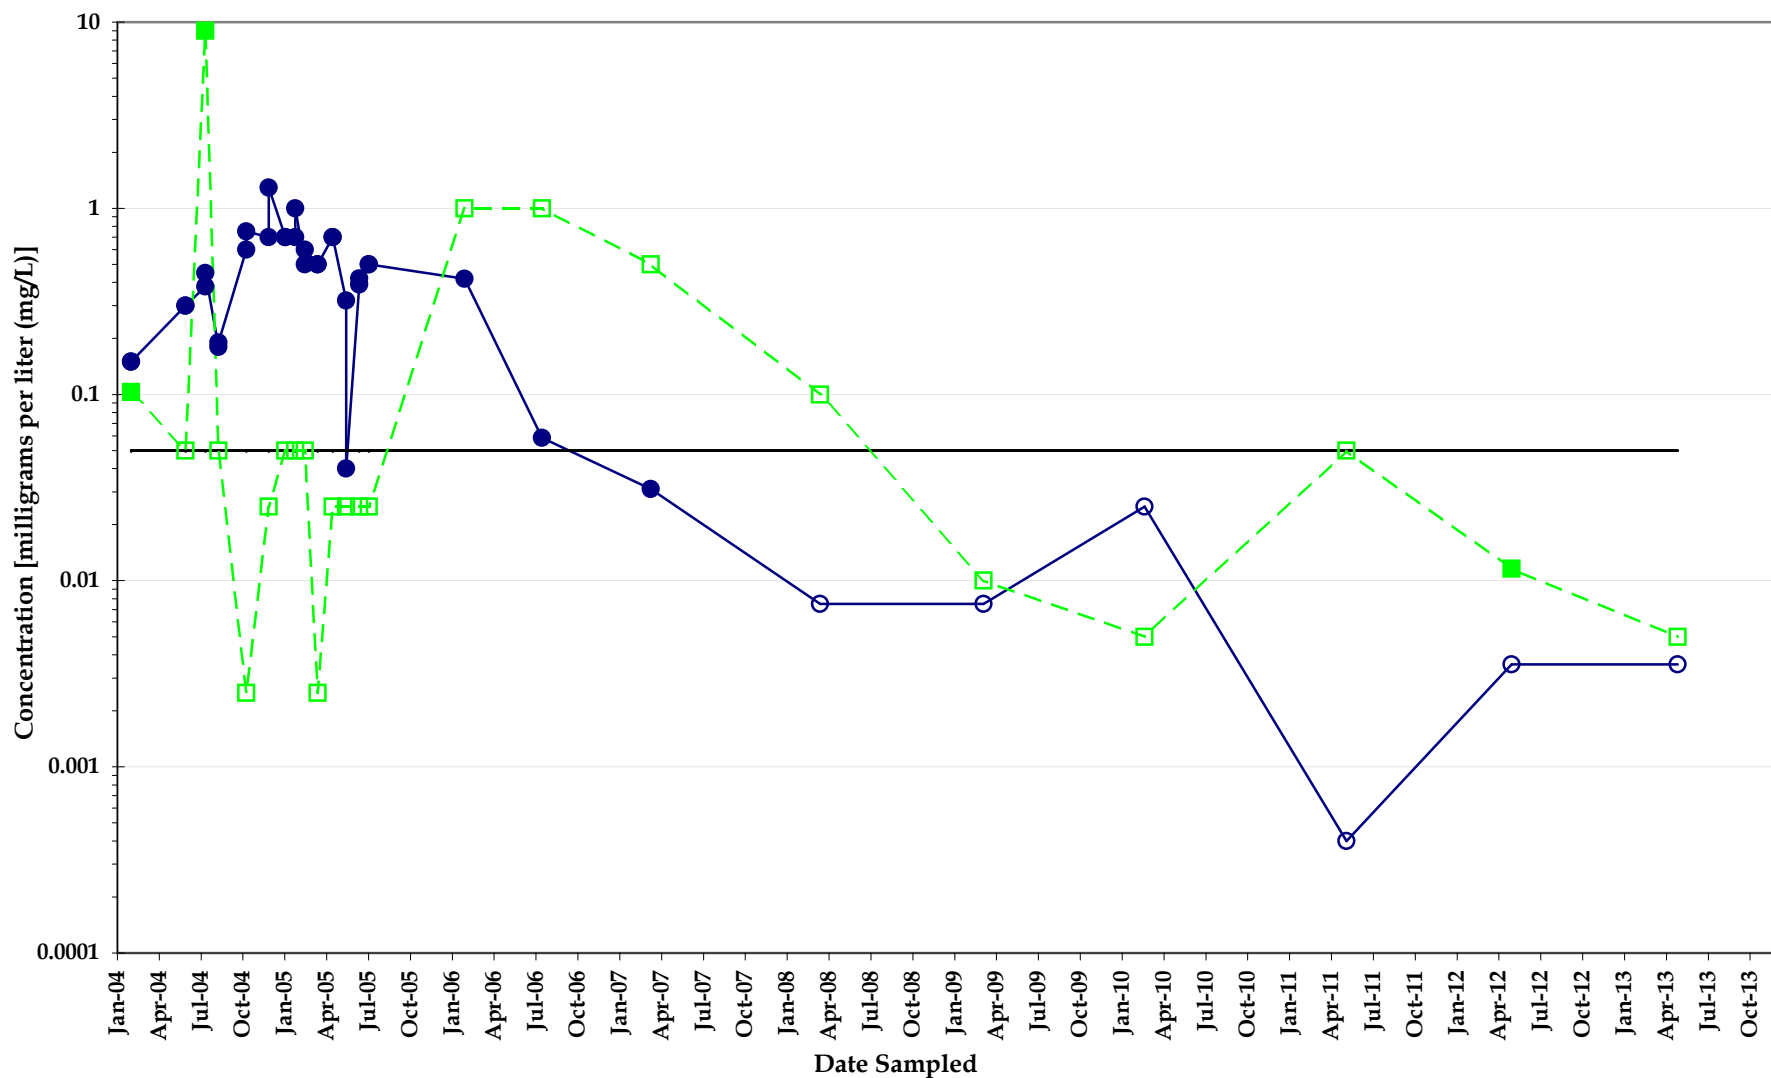
## Chromium Concentrations Monitoring Well IW013

Note: Non-detect analyses plotted at the method detection limit or half the reporting limit (RL). Detections denoted by symbol and detection values greater than the RL denoted by shaded symbol.

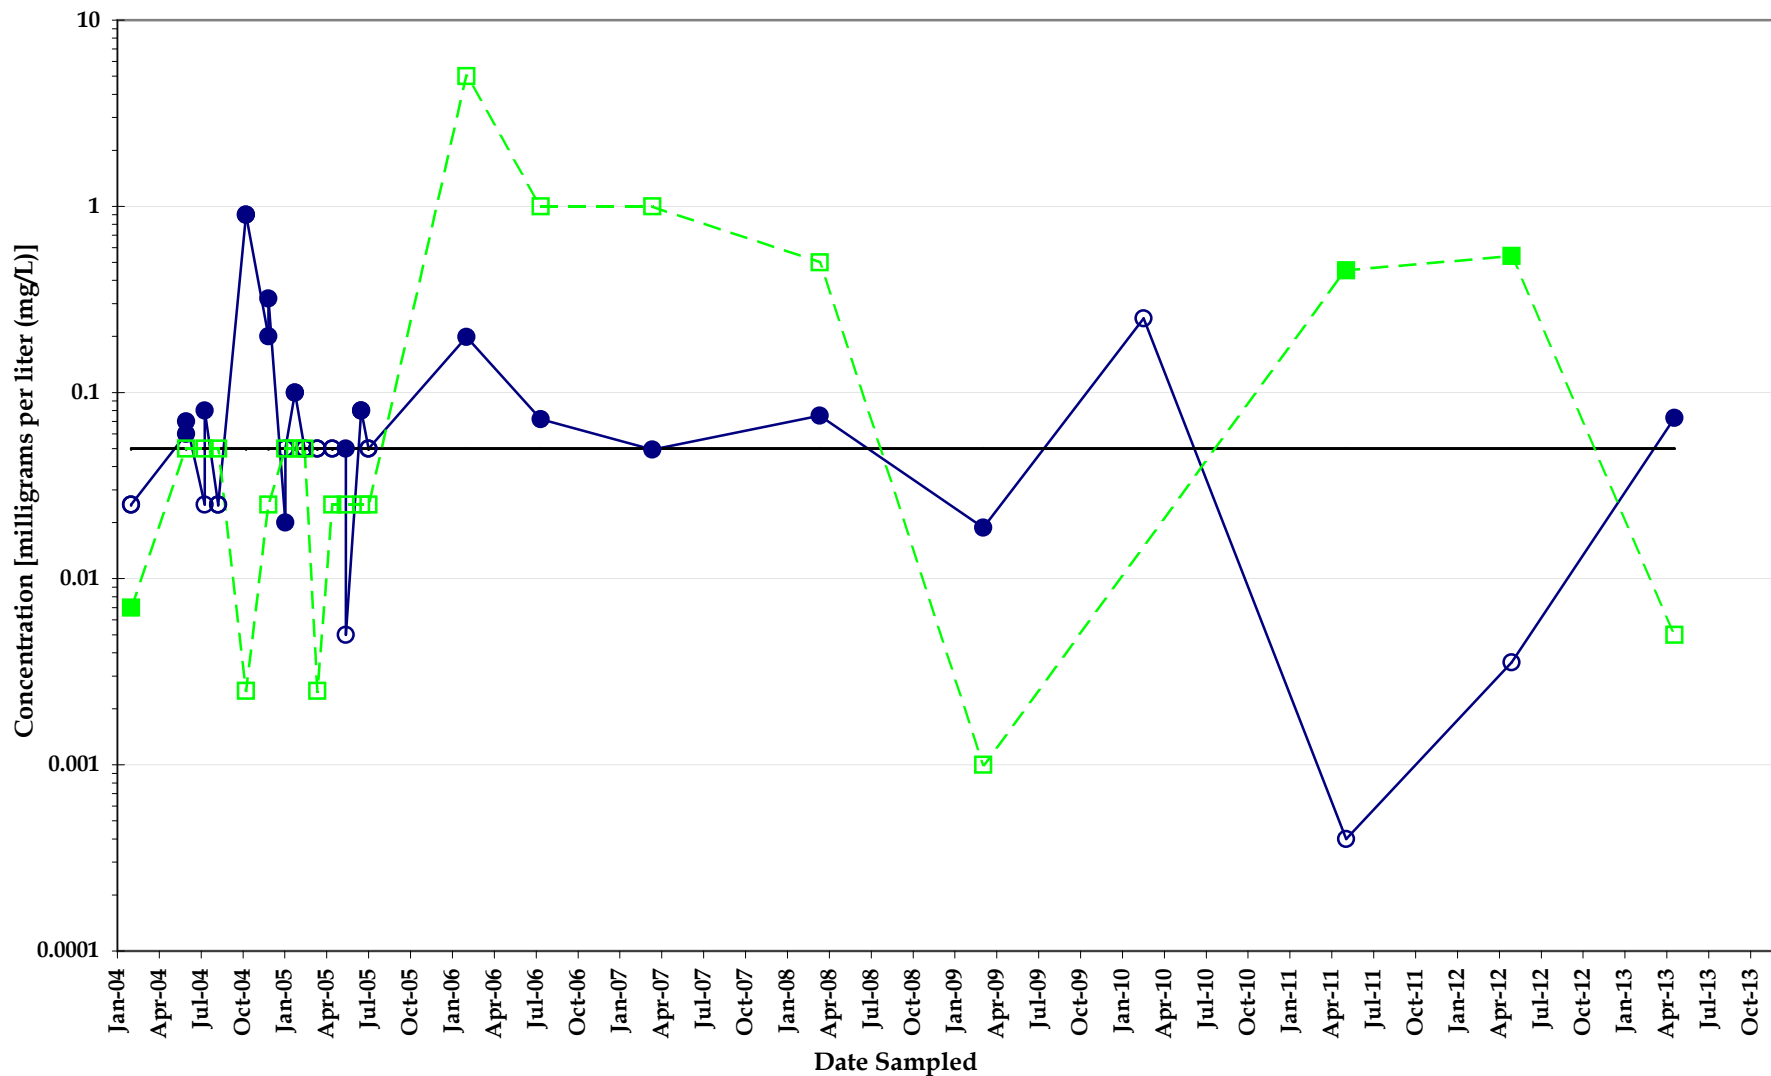
## Chromium Concentrations Monitoring Well IW014

Note: Non-detect analyses plotted at the method detection limit or half the reporting limit (RL). Detections denoted by symbol and detection values greater than the RL denoted by shaded symbol.

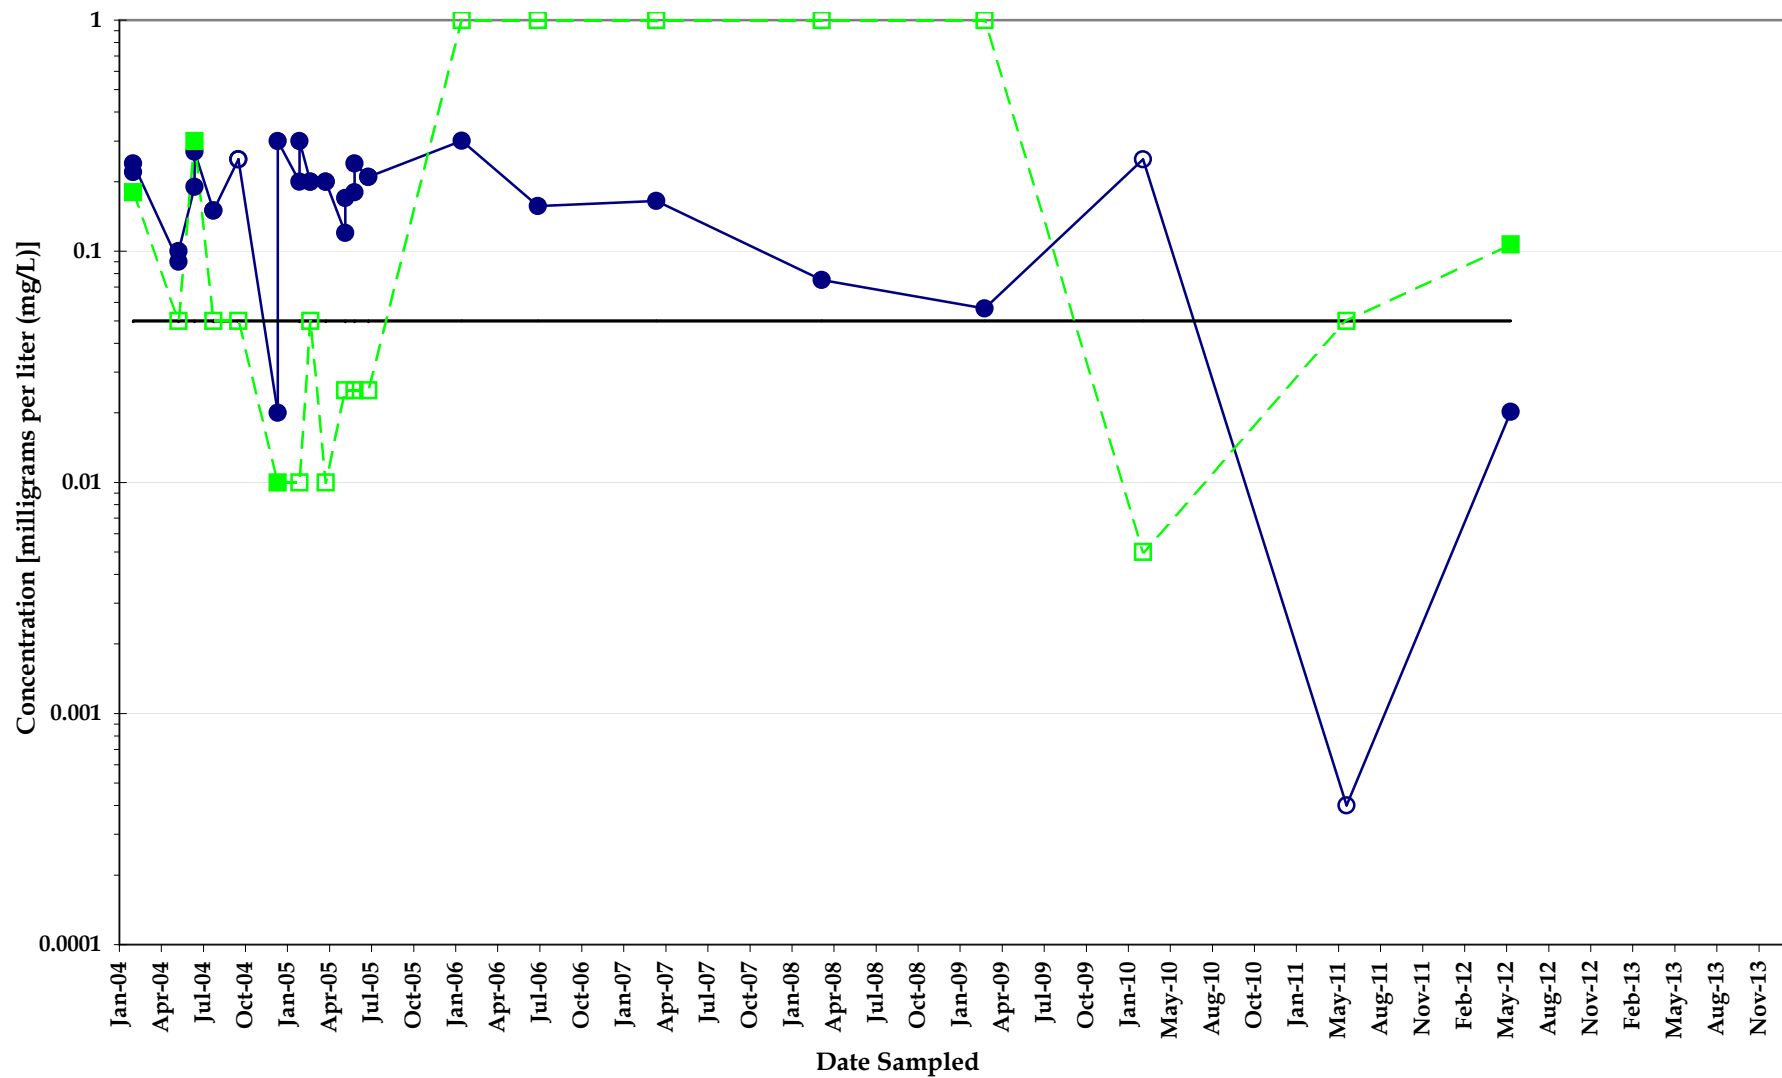
## Chromium Concentrations Monitoring Well IW015

Note: Non-detect analyses plotted at the method detection limit or half the reporting limit (RL). Detections denoted by symbol and detection values greater than the RL denoted by shaded symbol.
