**GW - 004**

**2013 AGWMR**

**VOL 5 OF 5**

*North Eunice Gas Plant  
Lea County, New Mexico*

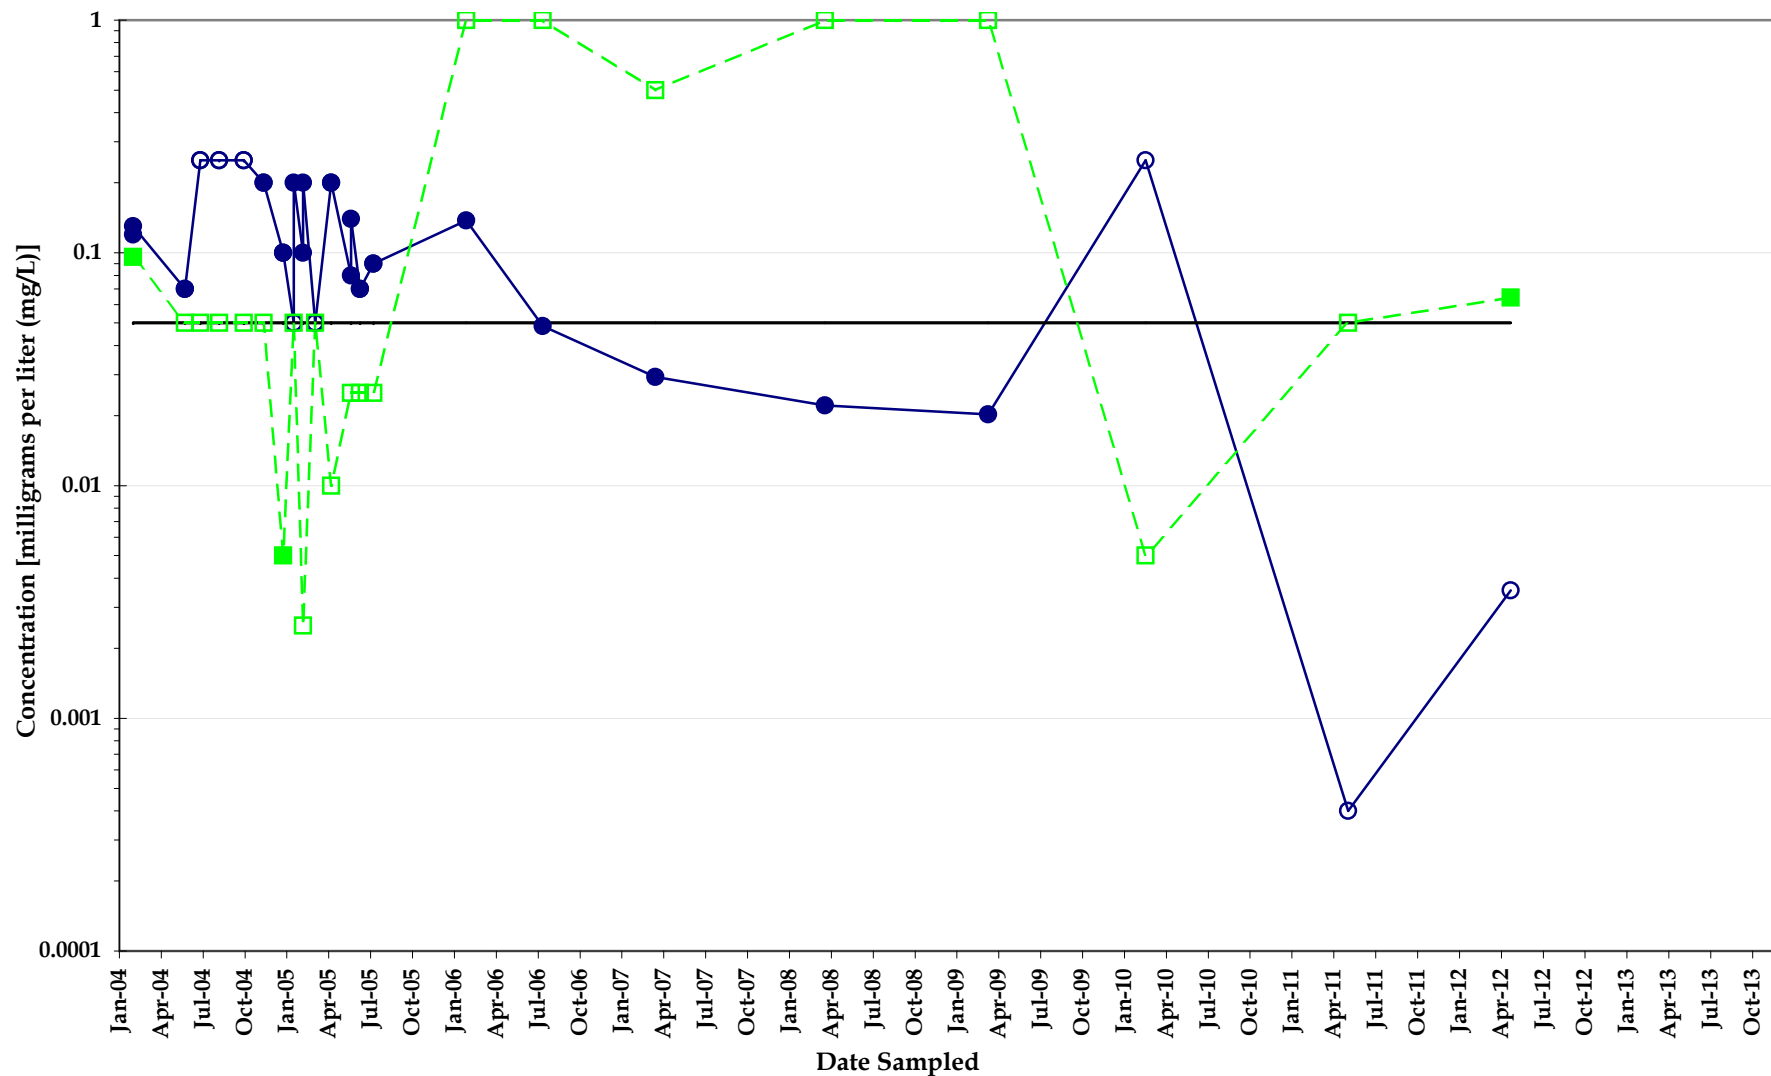
## Chromium Concentrations Monitoring Well IW016

Note: Non-detect analyses plotted at the method detection limit or half the reporting limit (RL). Detections denoted by symbol and detection values greater than the RL denoted by shaded symbol.

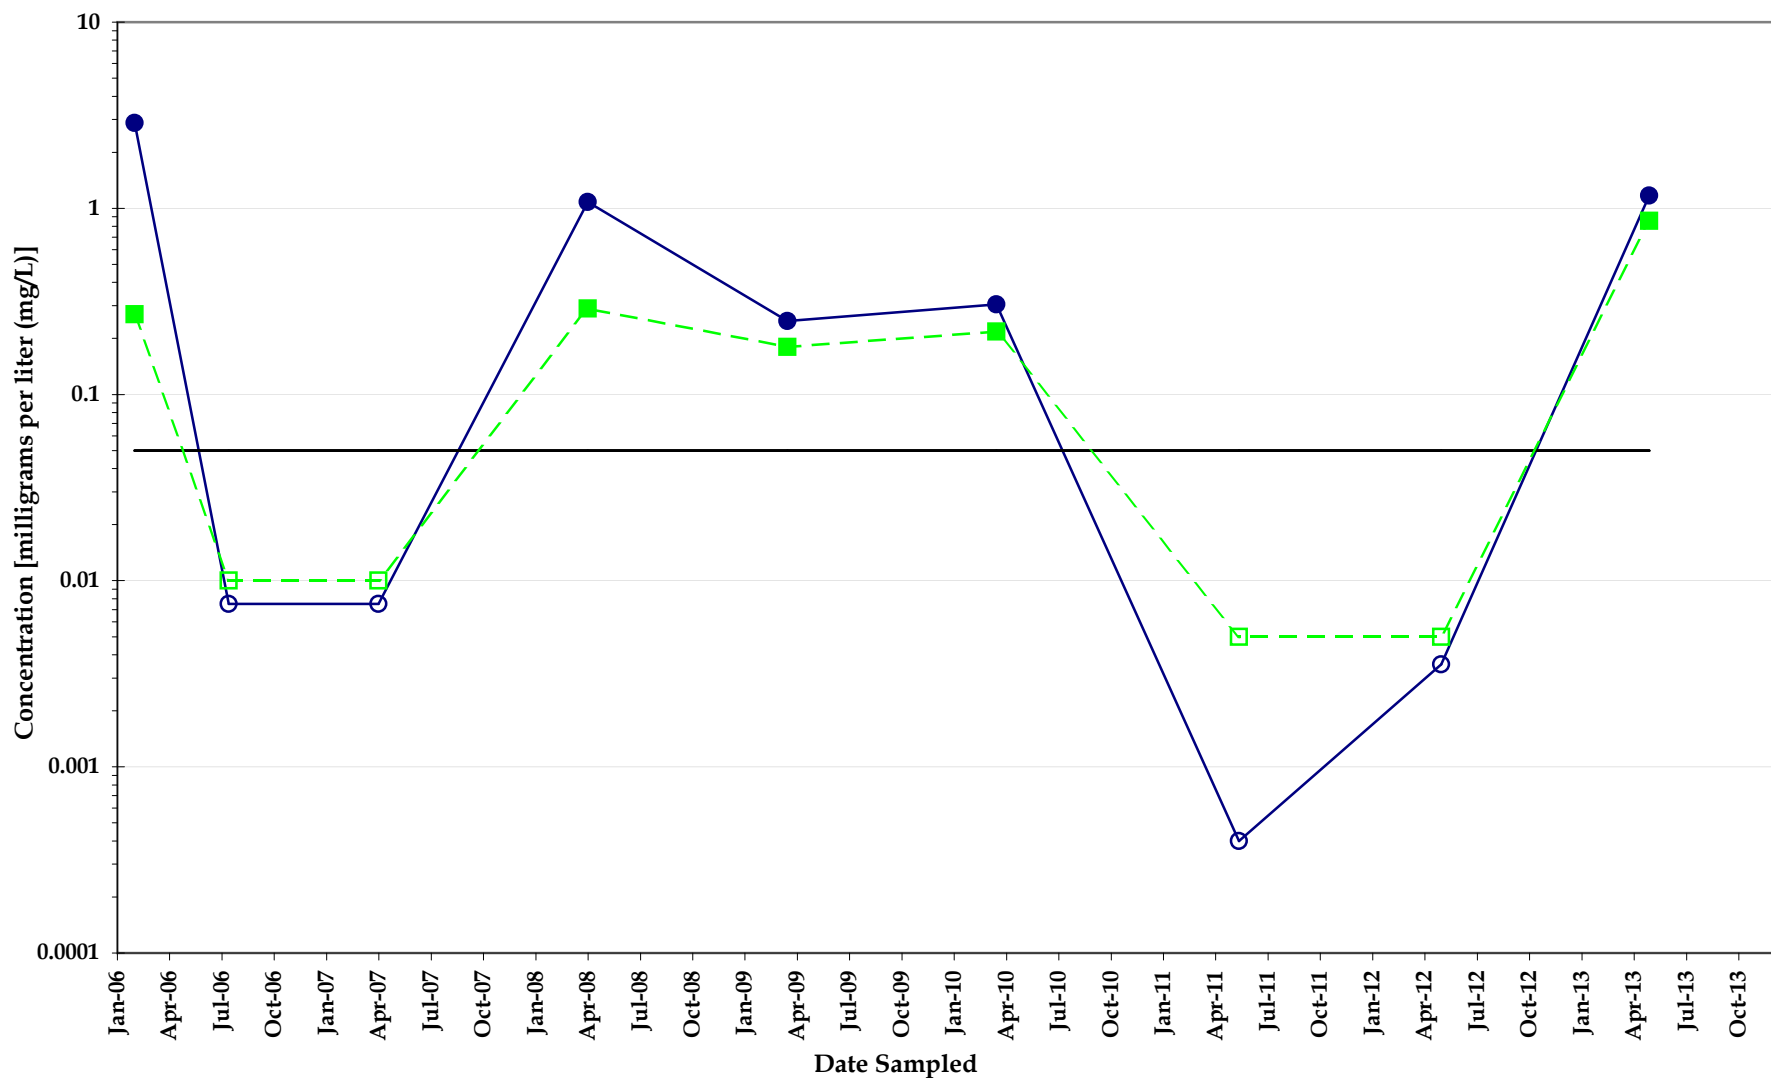
## Chromium Concentrations Monitoring Well IW018

Note: Non-detect analyses plotted at the method detection limit or half the reporting limit (RL). Detections denoted by symbol and detection values greater than the RL denoted by shaded symbol.

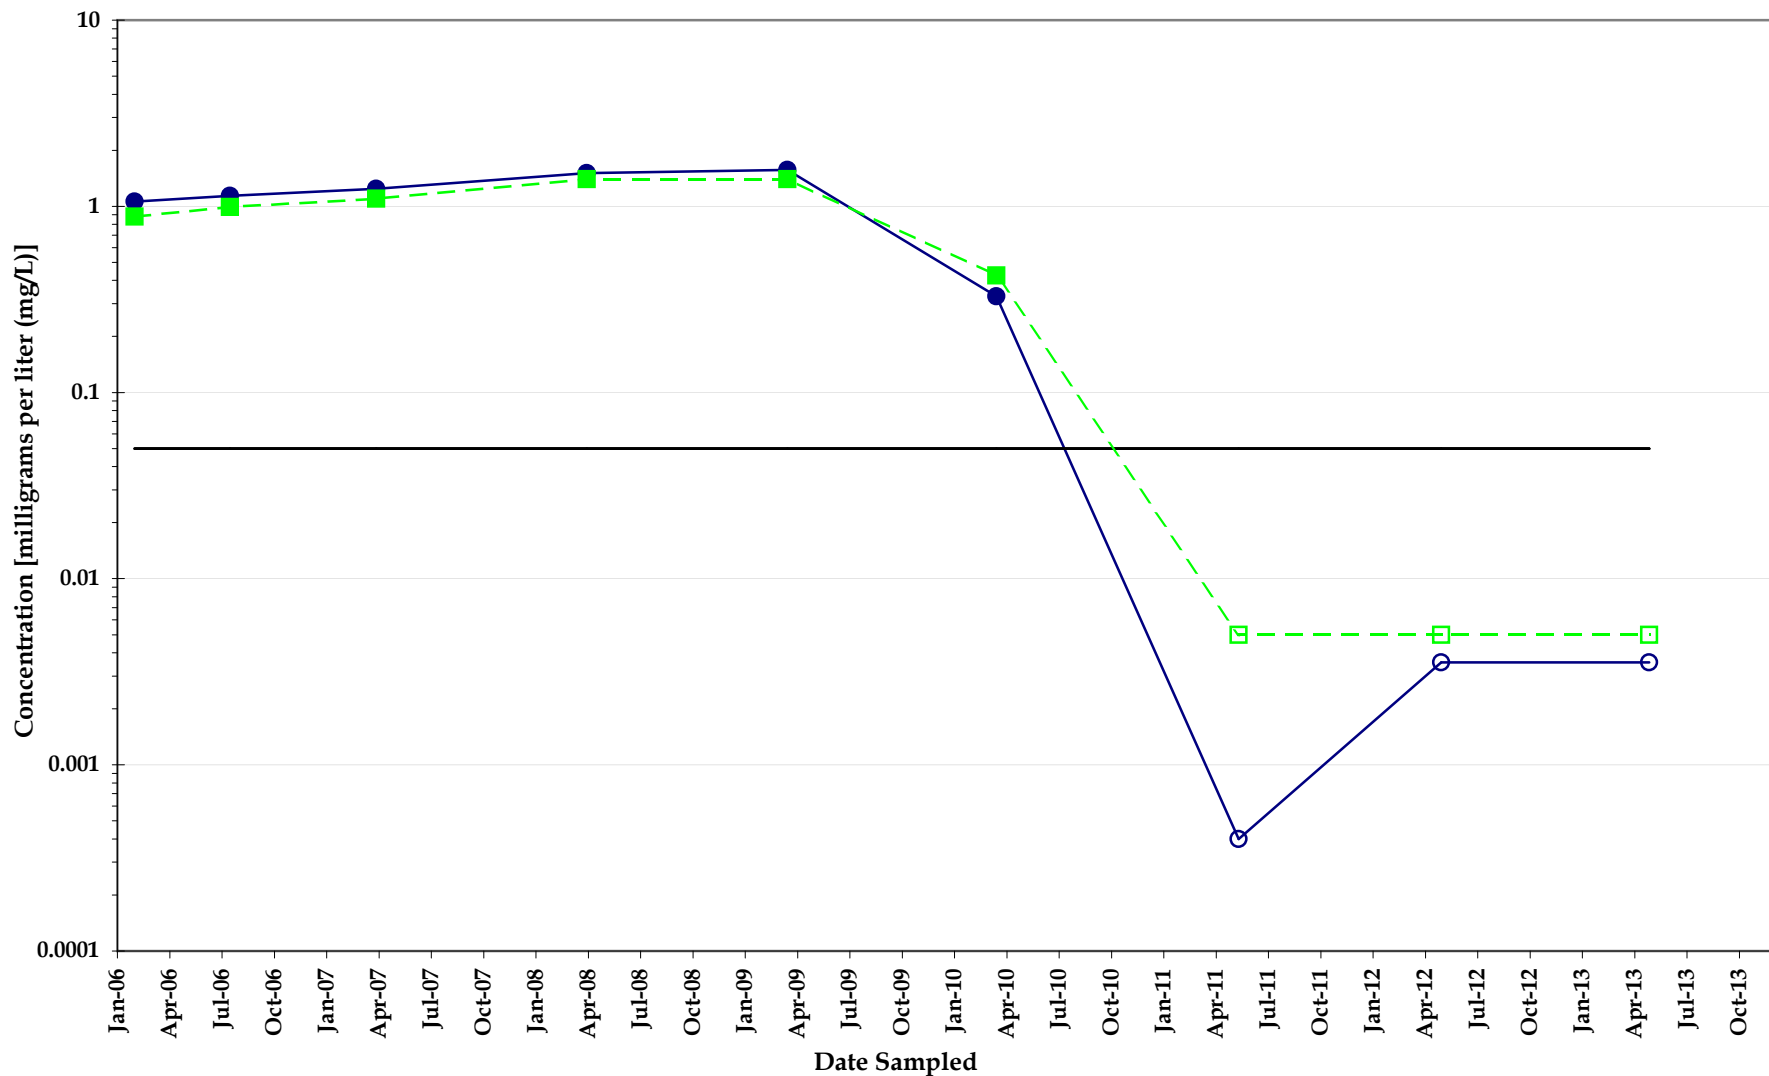
## Chromium Concentrations Monitoring Well IW019

Note: Non-detect analyses plotted at the method detection limit or half the reporting limit (RL). Detections denoted by symbol and detection values greater than the RL denoted by shaded symbol.

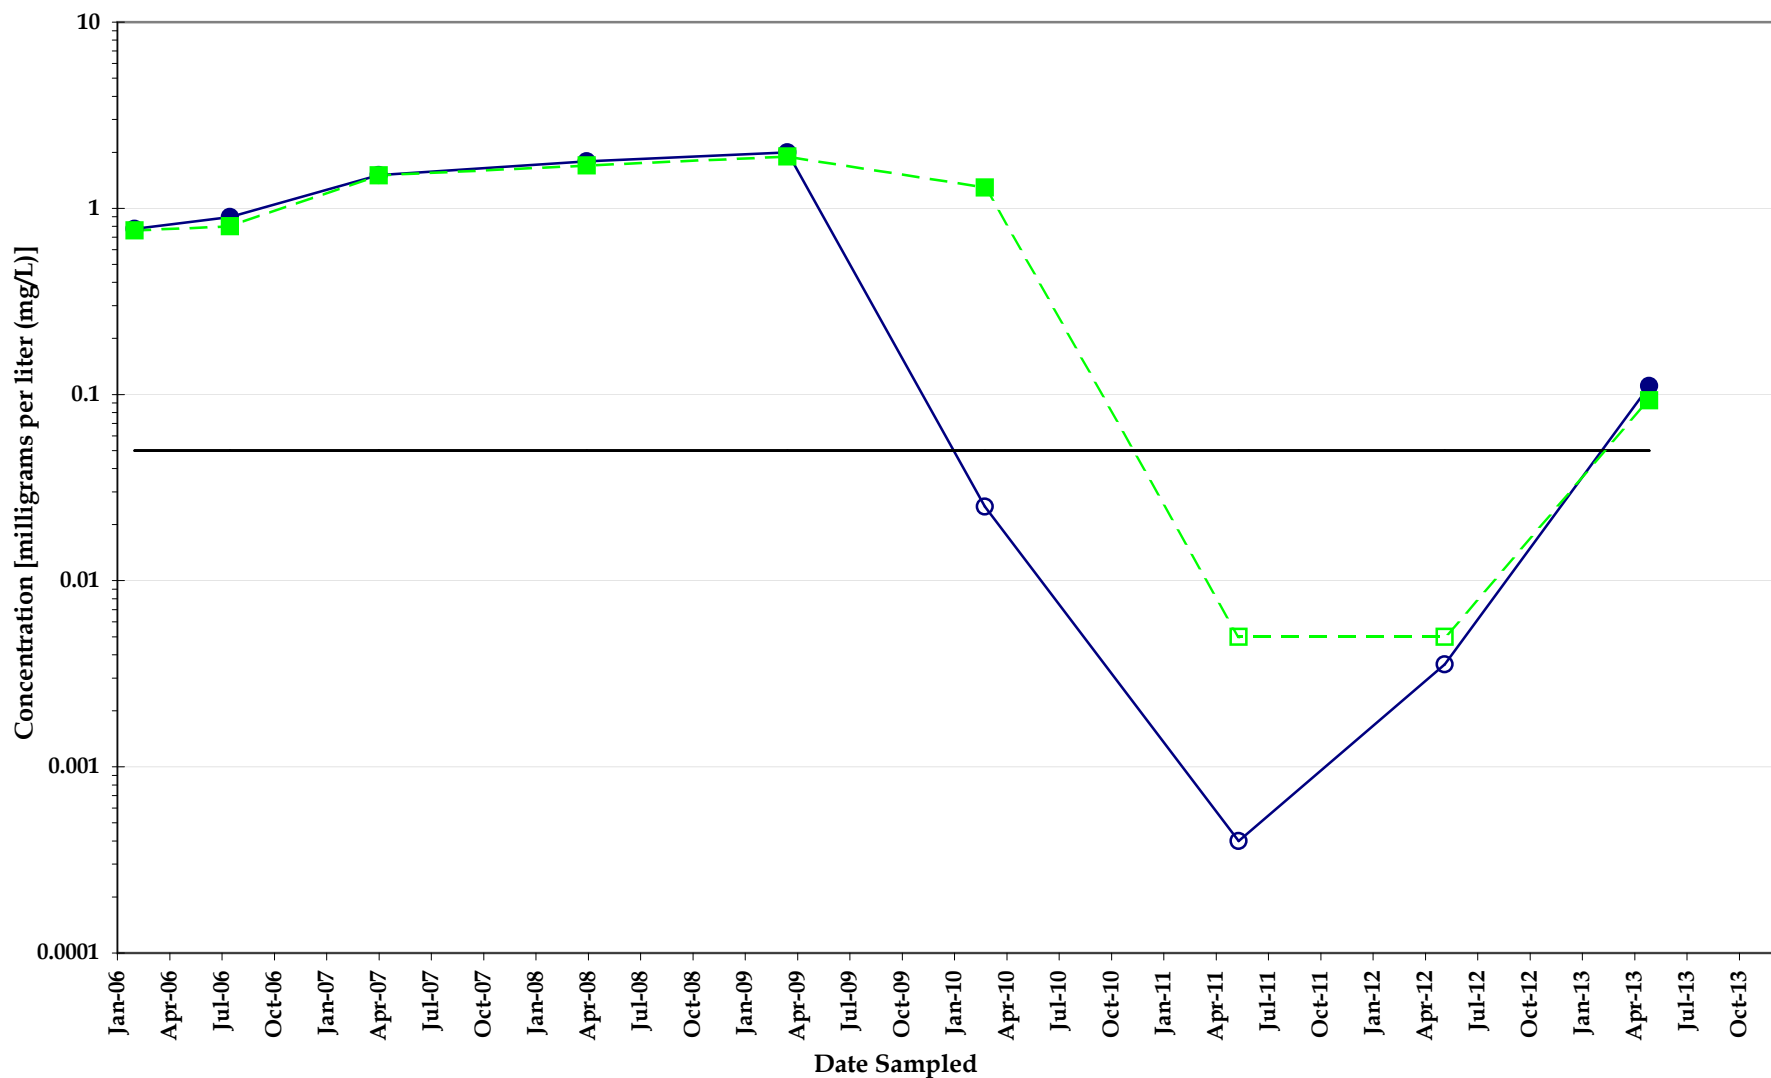
## Chromium Concentrations Monitoring Well IW020

Note: Non-detect analyses plotted at the method detection limit or half the reporting limit (RL). Detections denoted by symbol and detection values greater than the RL denoted by shaded symbol.

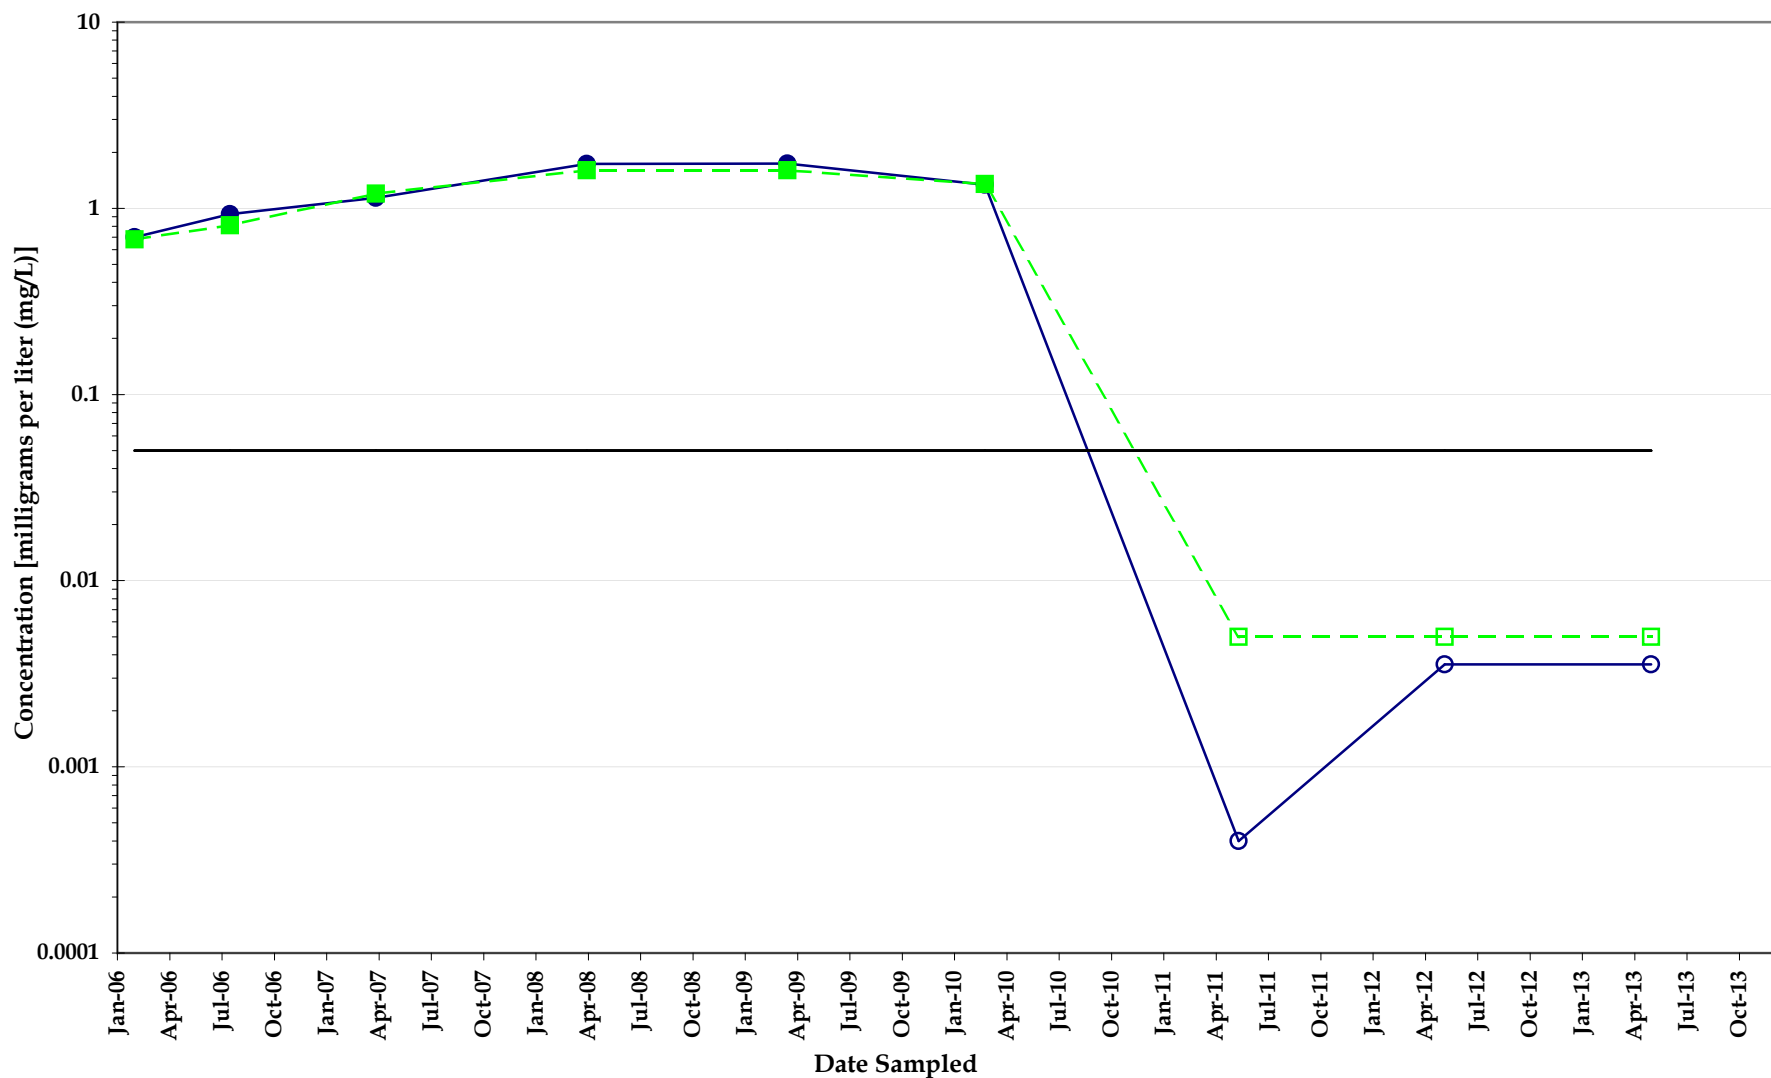
## Chromium Concentrations Monitoring Well IW021

Note: Non-detect analyses plotted at the method detection limit or half the reporting limit (RL). Detections denoted by symbol and detection values greater than the RL denoted by shaded symbol.

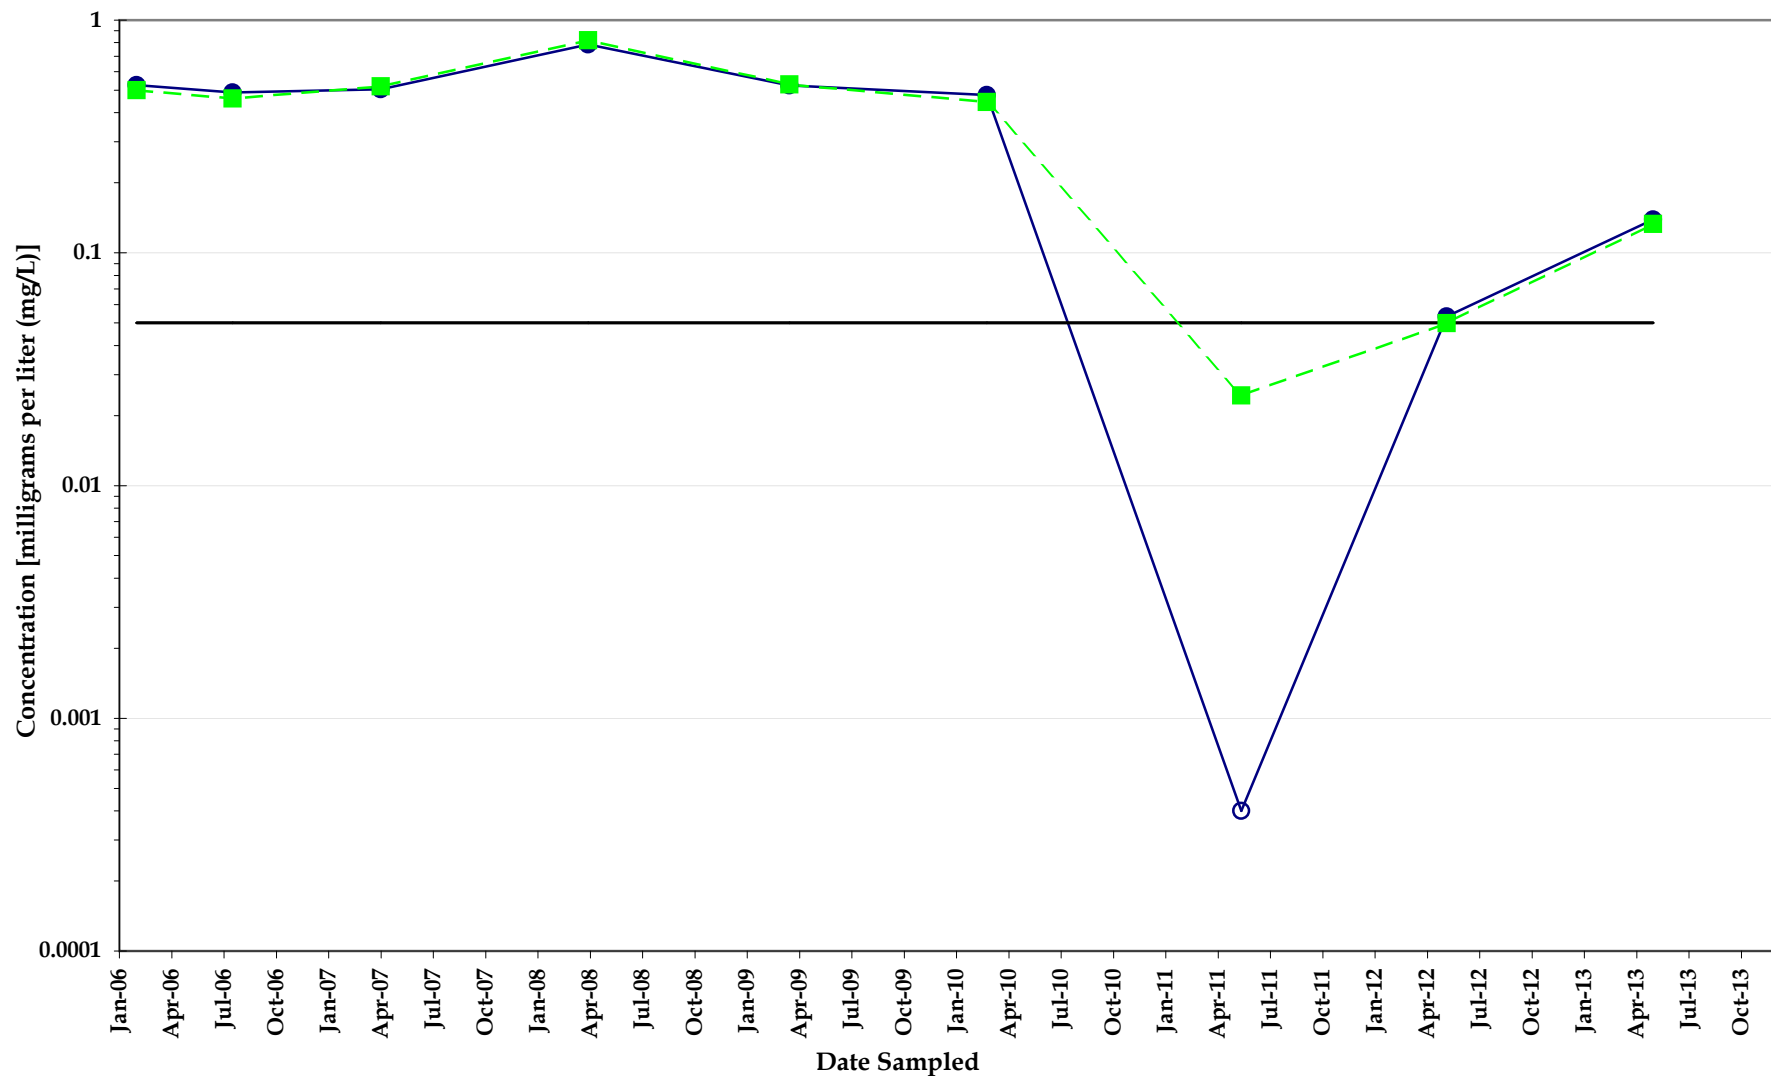
## Chromium Concentrations Monitoring Well IW022

Note: Non-detect analyses plotted at the method detection limit or half the reporting limit (RL). Detections denoted by symbol and detection values greater than the RL denoted by shaded symbol.

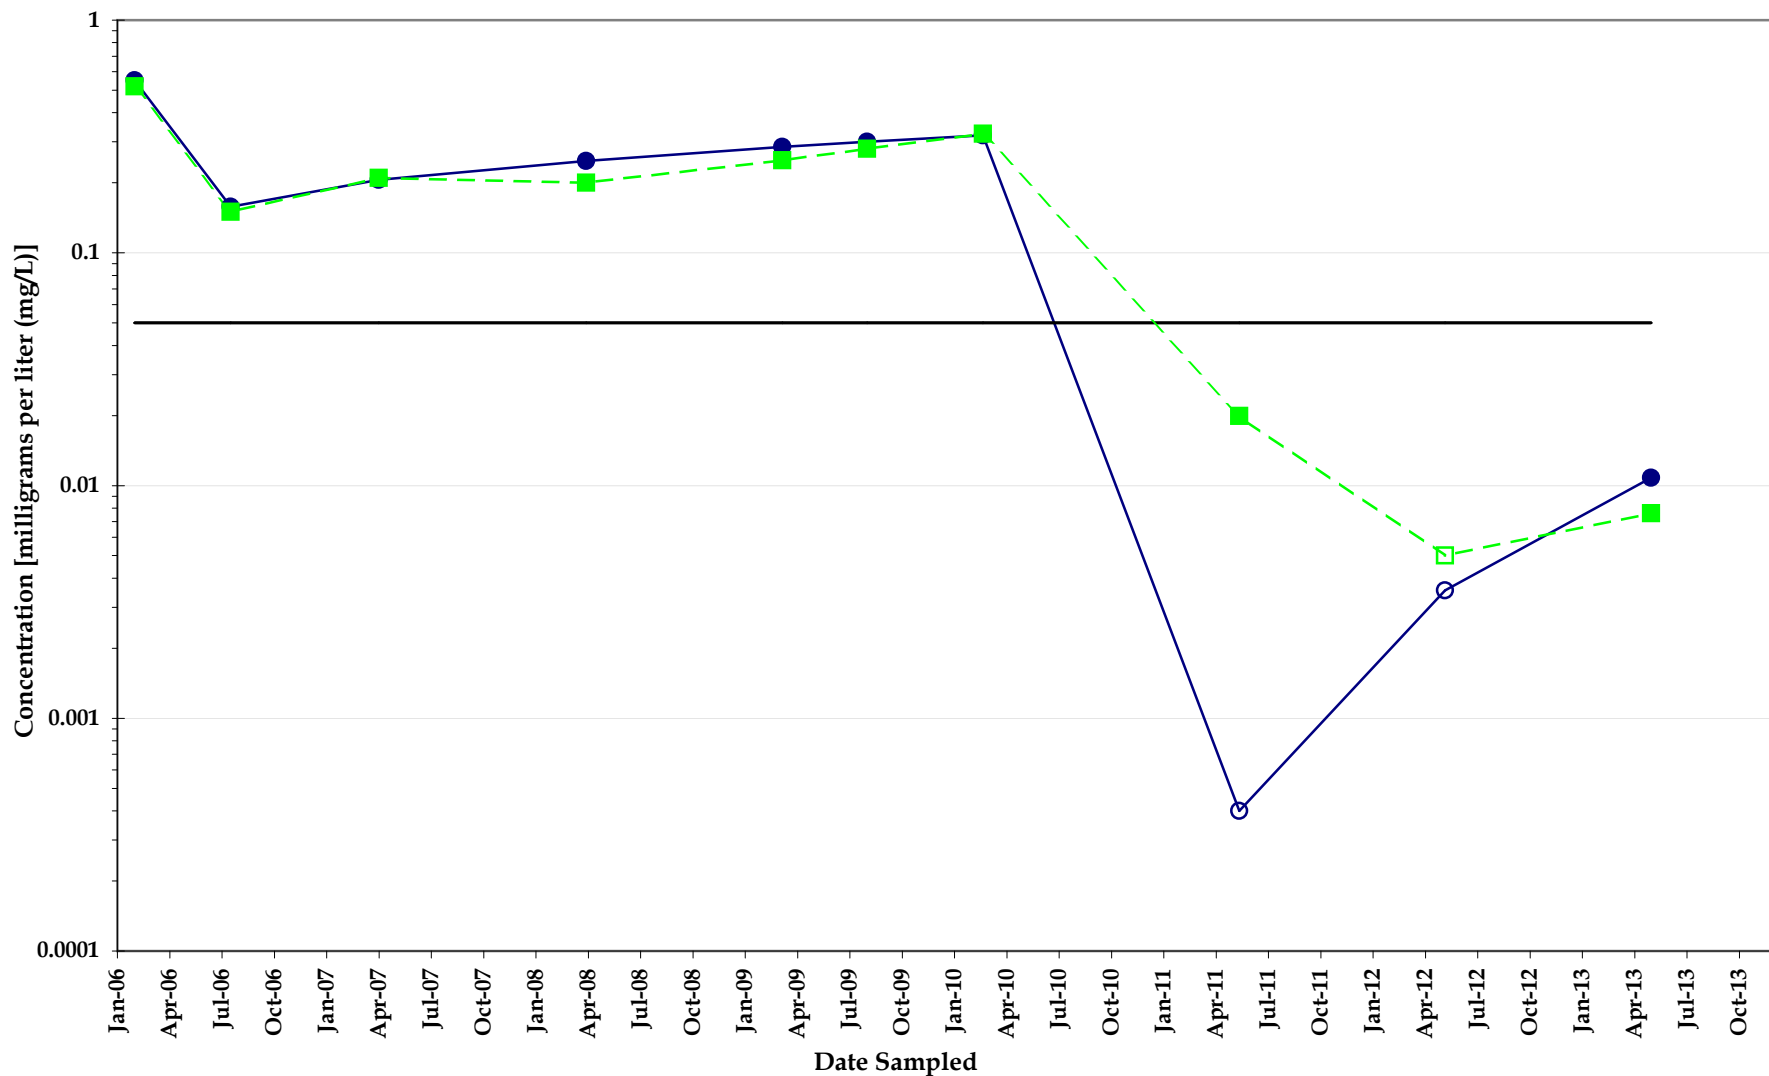
## Chromium Concentrations Monitoring Well IW023

Note: Non-detect analyses plotted at the method detection limit or half the reporting limit (RL). Detections denoted by symbol and detection values greater than the RL denoted by shaded symbol.

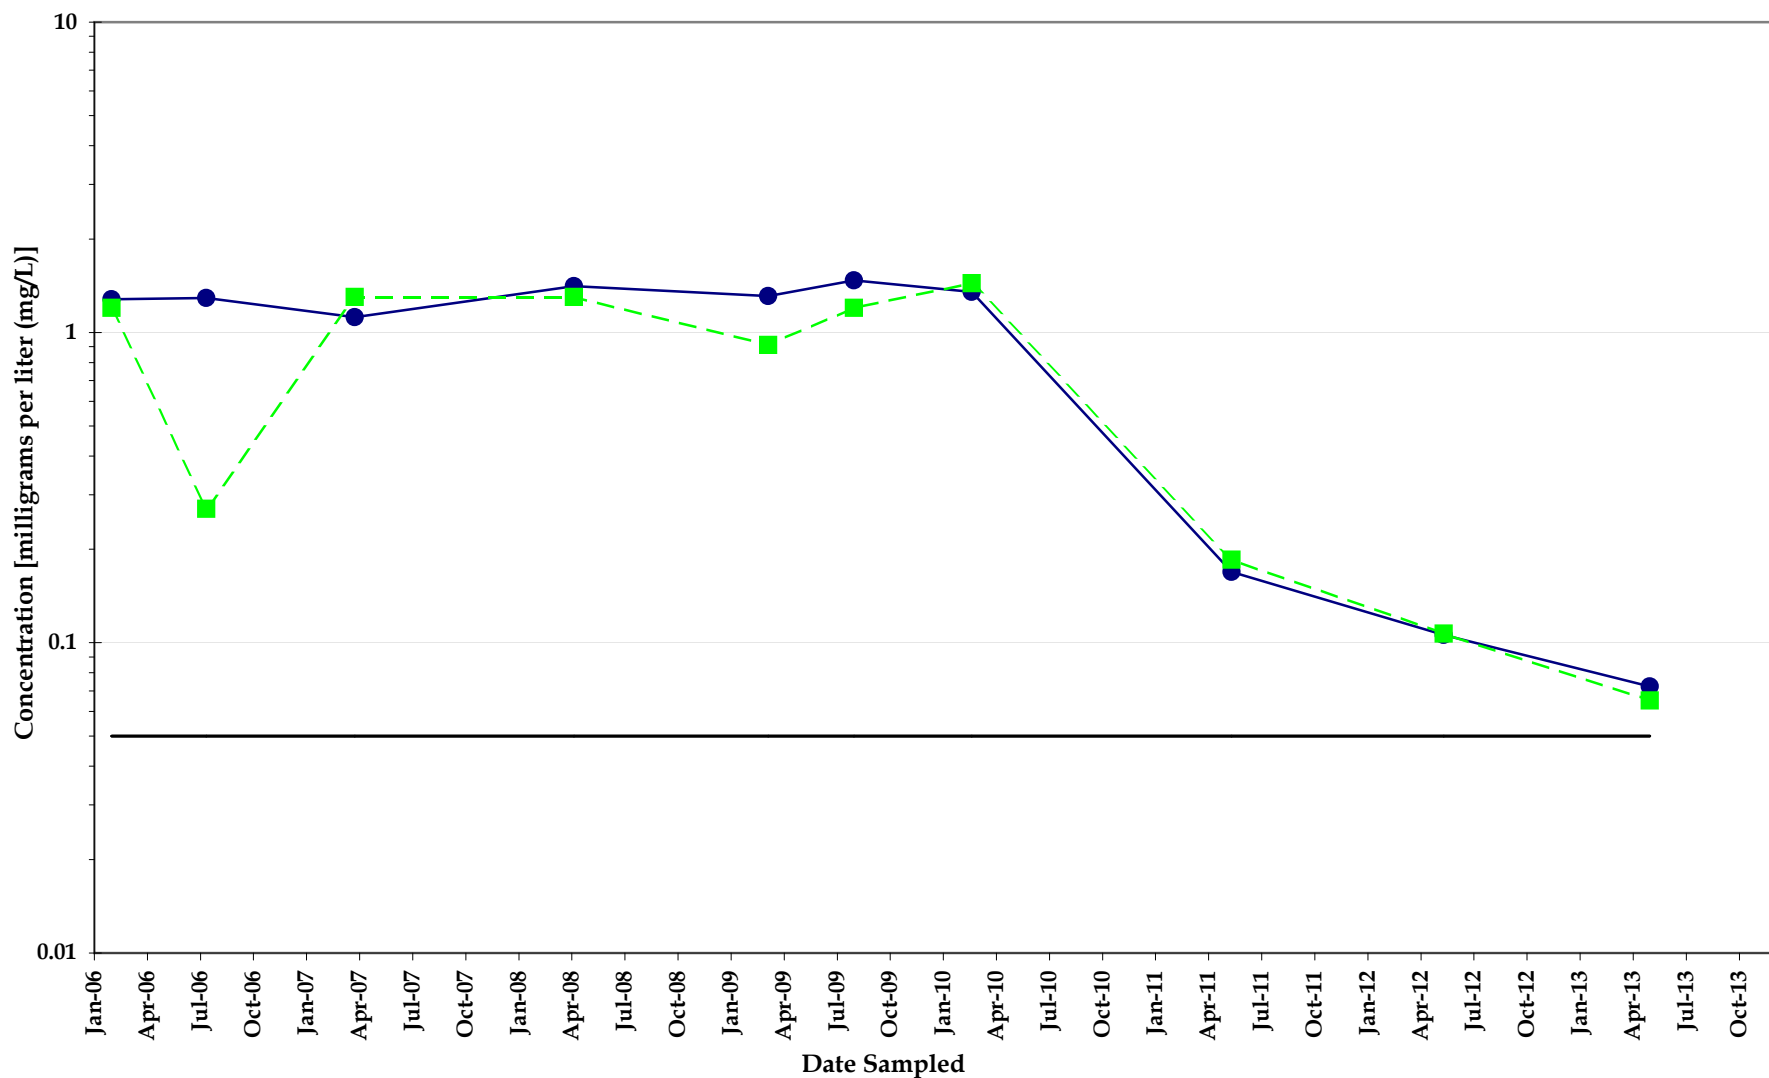
## Chromium Concentrations Monitoring Well IW024

Note: Non-detect analyses plotted at the method detection limit or half the reporting limit (RL). Detections denoted by symbol and detection values greater than the RL denoted by shaded symbol.

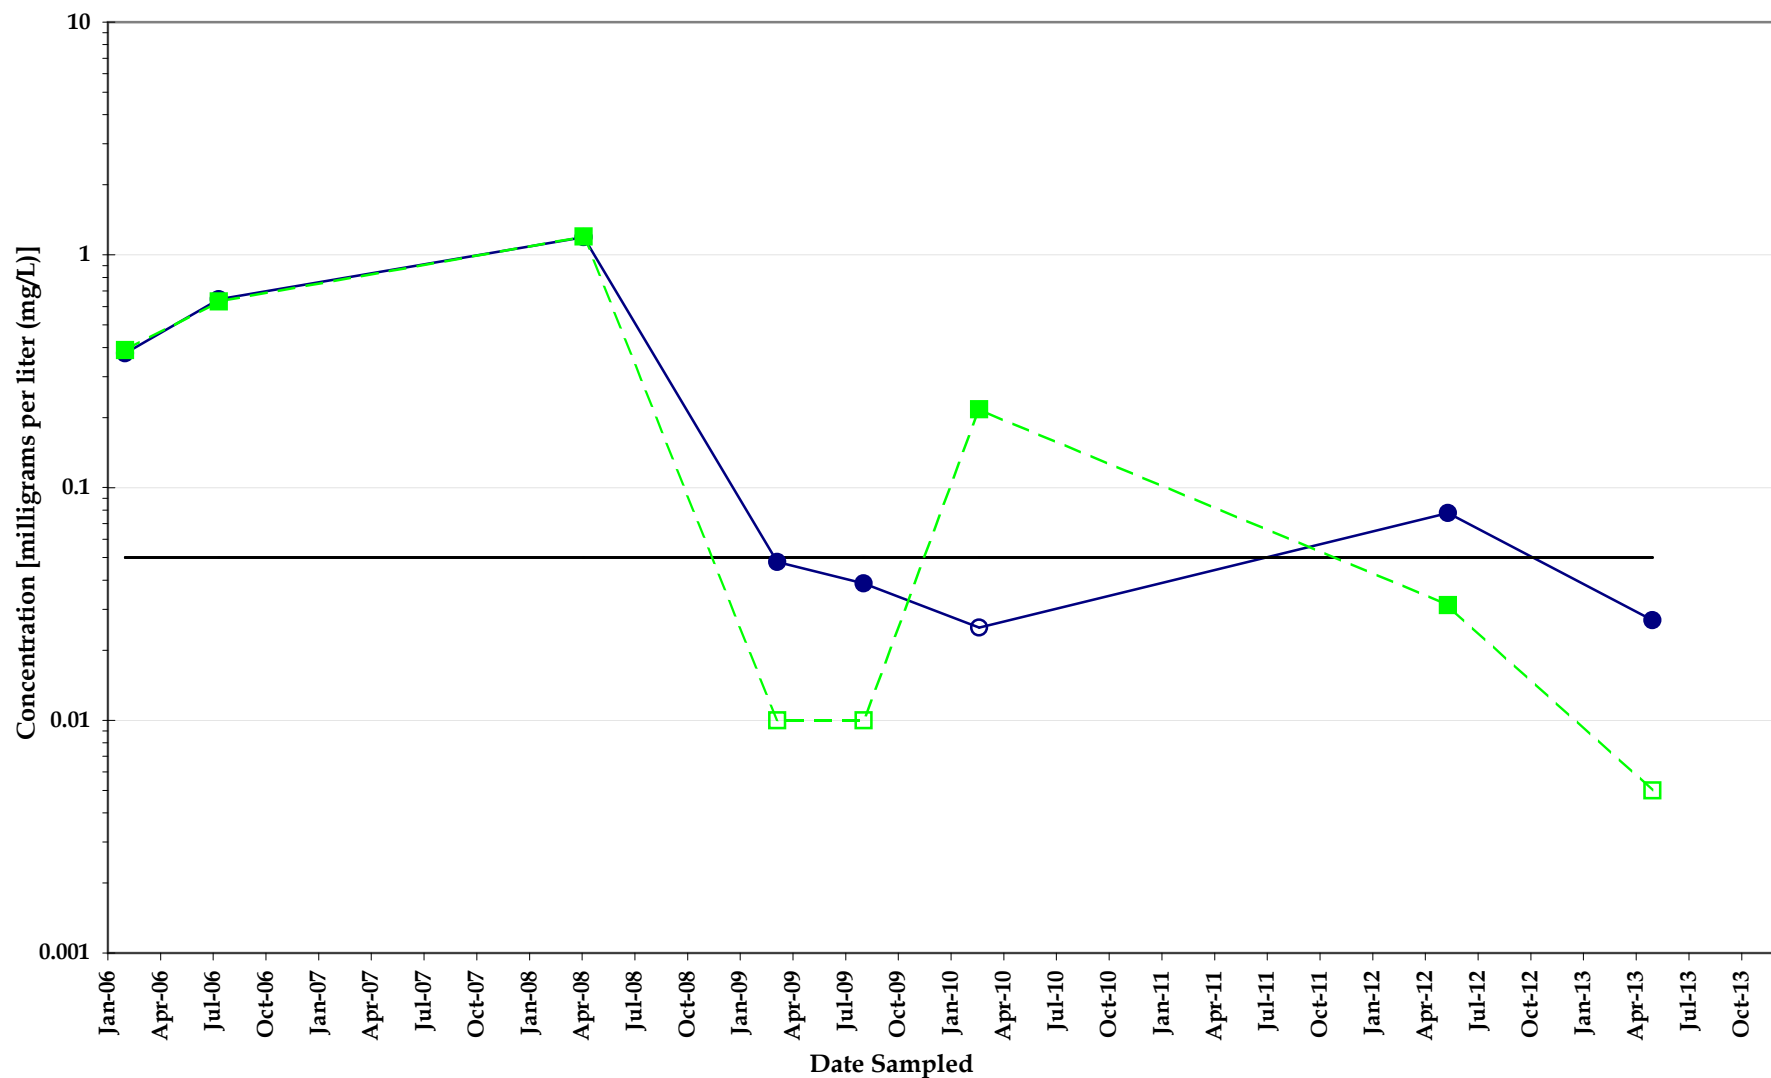
## Chromium Concentrations Monitoring Well IW025

Note: Non-detect analyses plotted at the method detection limit or half the reporting limit (RL). Detections denoted by symbol and detection values greater than the RL denoted by shaded symbol.

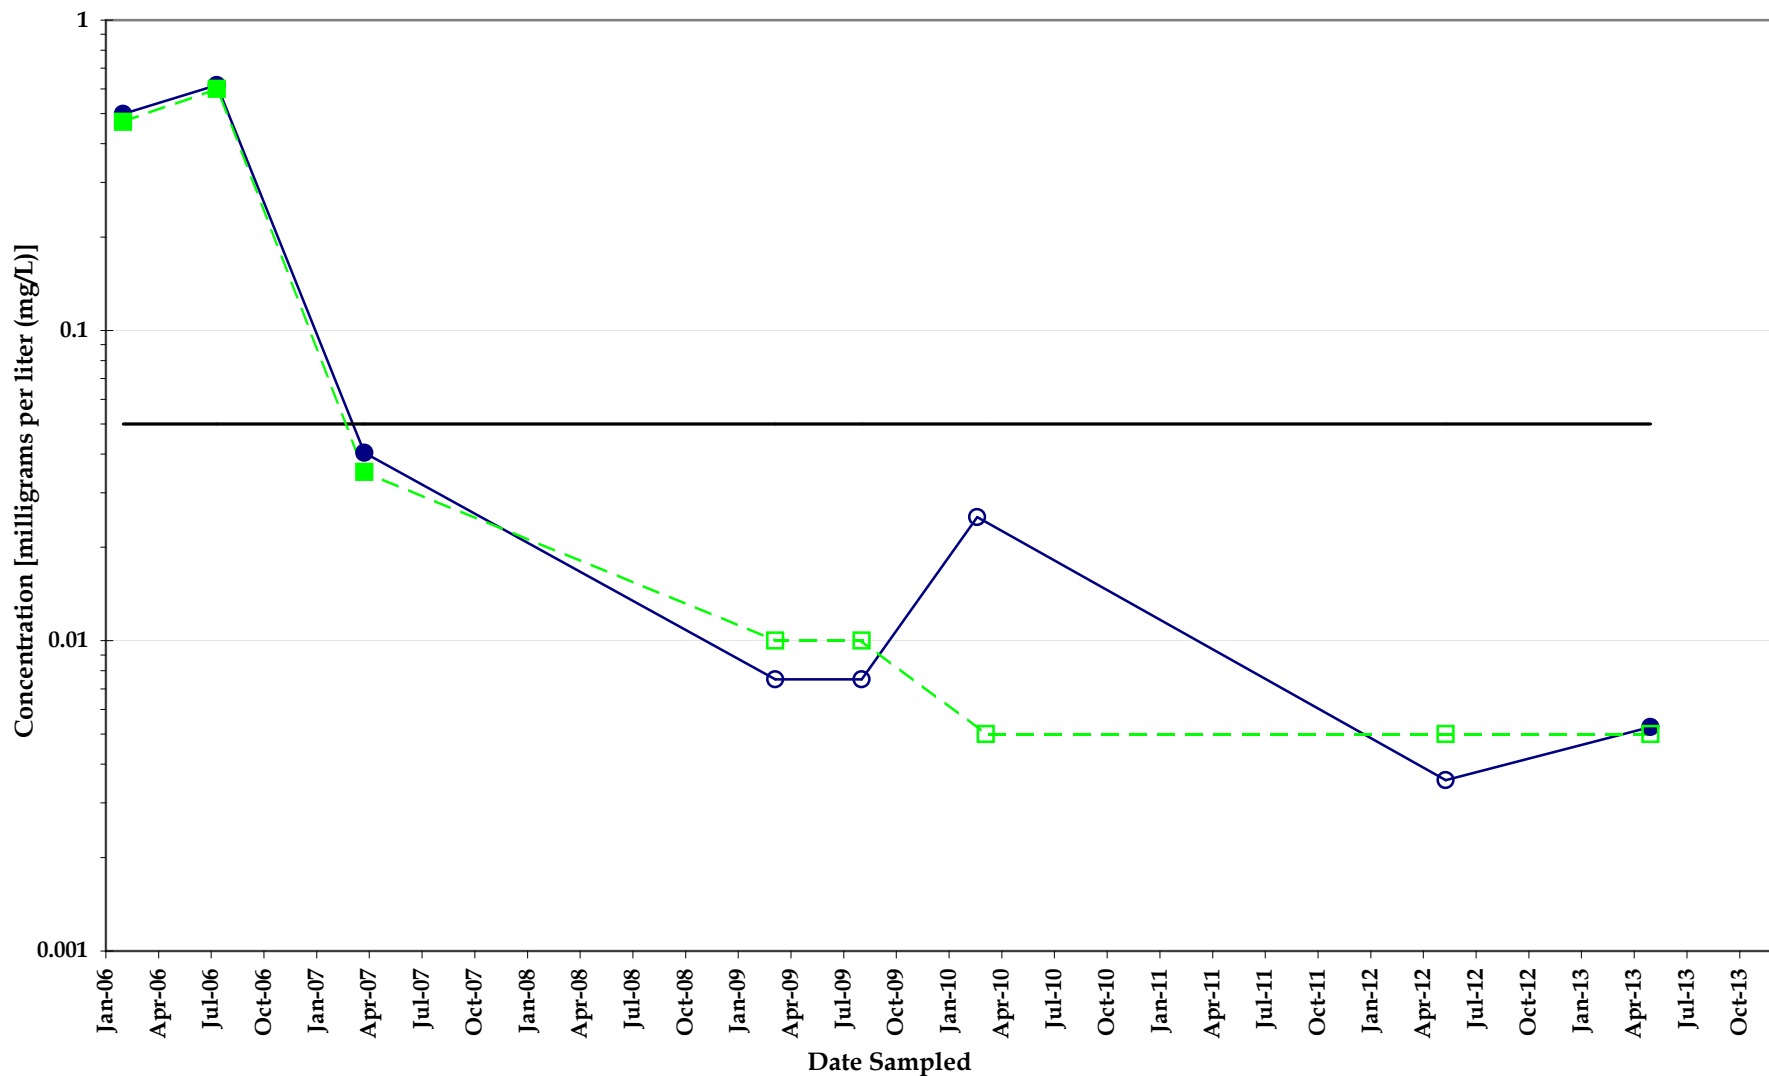
## Chromium Concentrations Monitoring Well IW026

Note: Non-detect analyses plotted at the method detection limit or half the reporting limit (RL). Detections denoted by symbol and detection values greater than the RL denoted by shaded symbol.

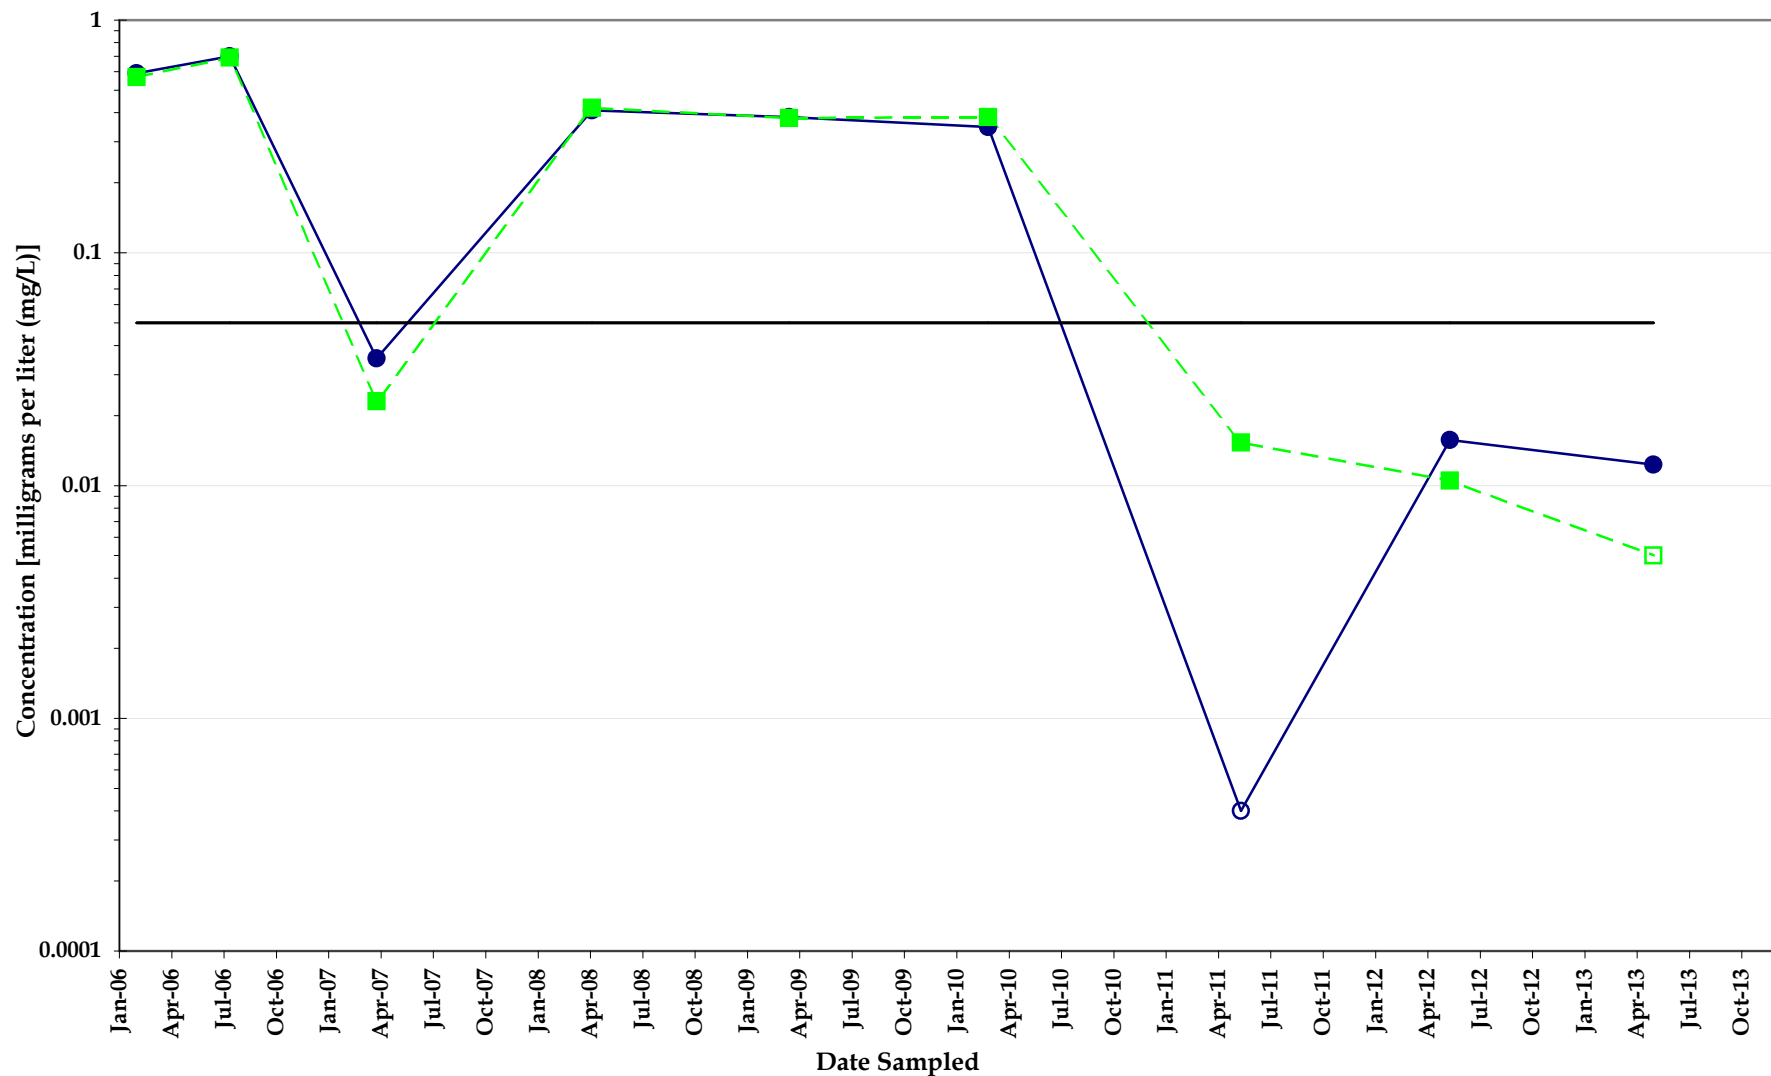
## Chromium Concentrations Monitoring Well IW027

Note: Non-detect analyses plotted at the method detection limit or half the reporting limit (RL). Detections denoted by symbol and detection values greater than the RL denoted by shaded symbol.
