**GW - 004**

**2013 AGWMR**

**VOL 5 OF 5**

*North Eunice Gas Plant  
Lea County, New Mexico*

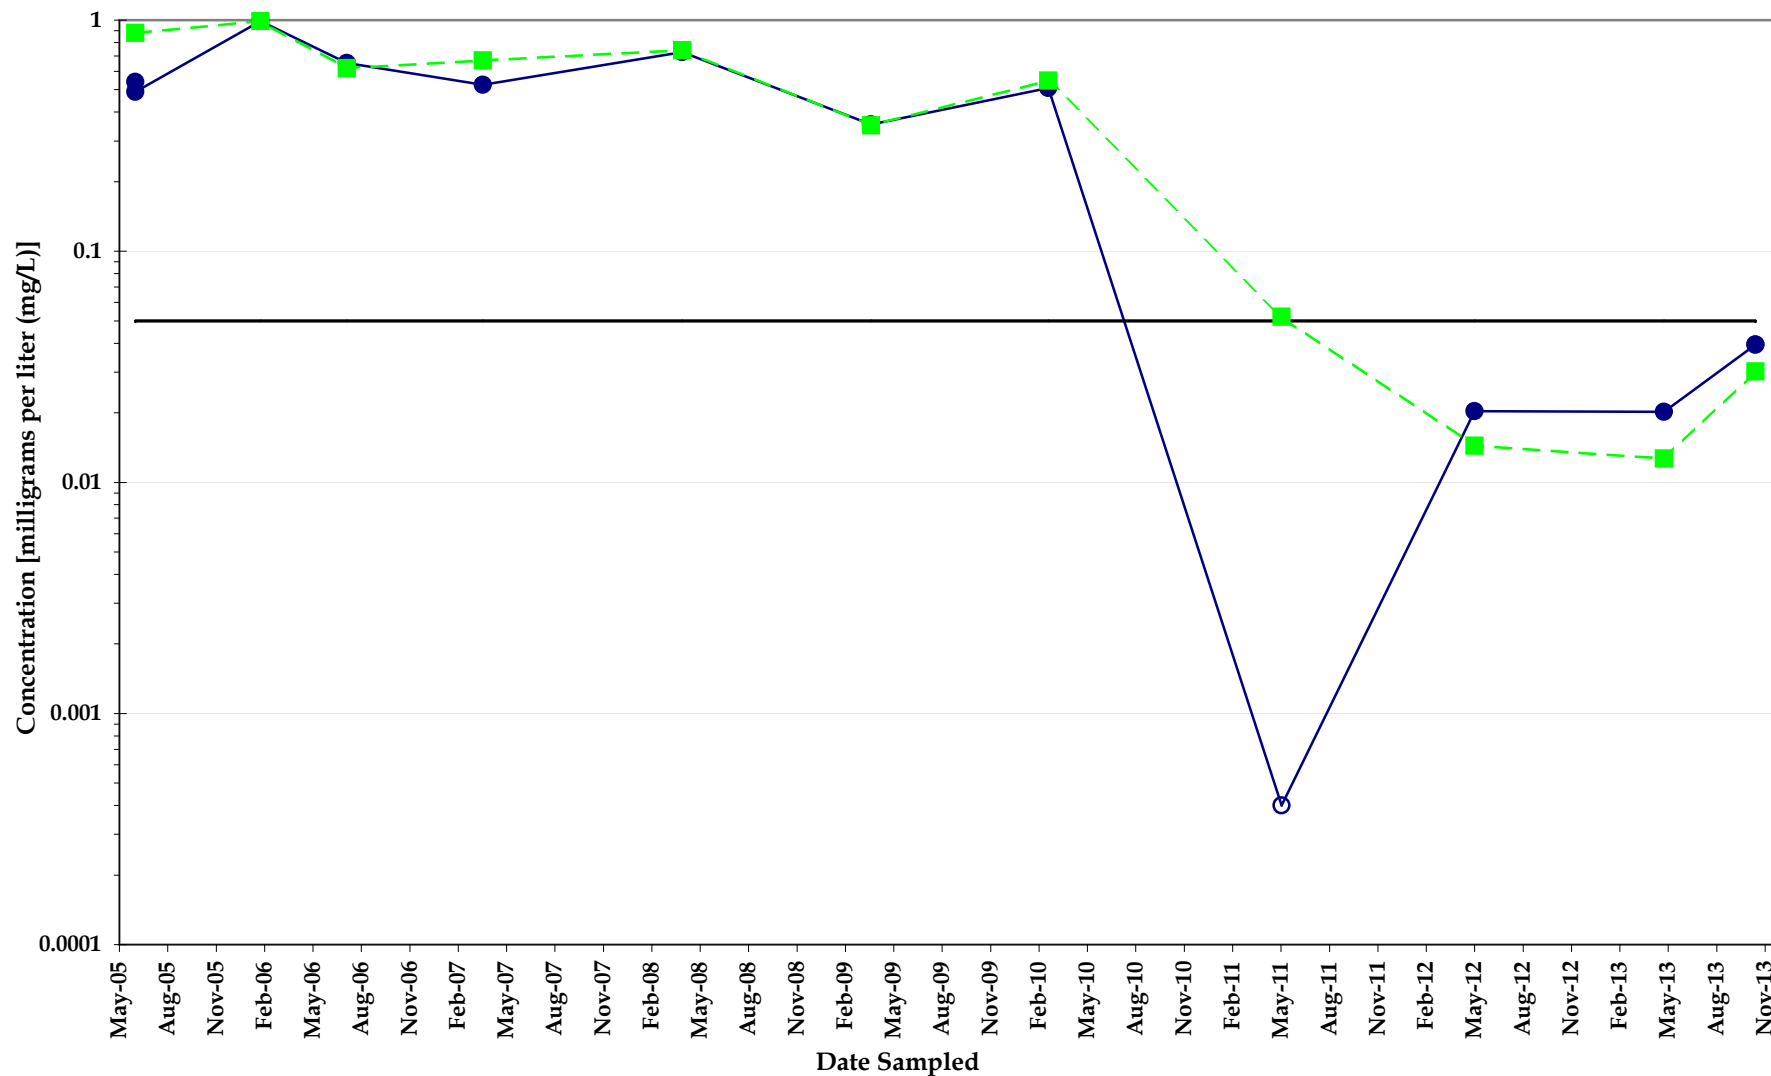
## Chromium Concentrations Monitoring Well IW028

Note: Non-detect analyses plotted at the method detection limit or half the reporting limit (RL). Detections denoted by symbol and detection values greater than the RL denoted by shaded symbol.

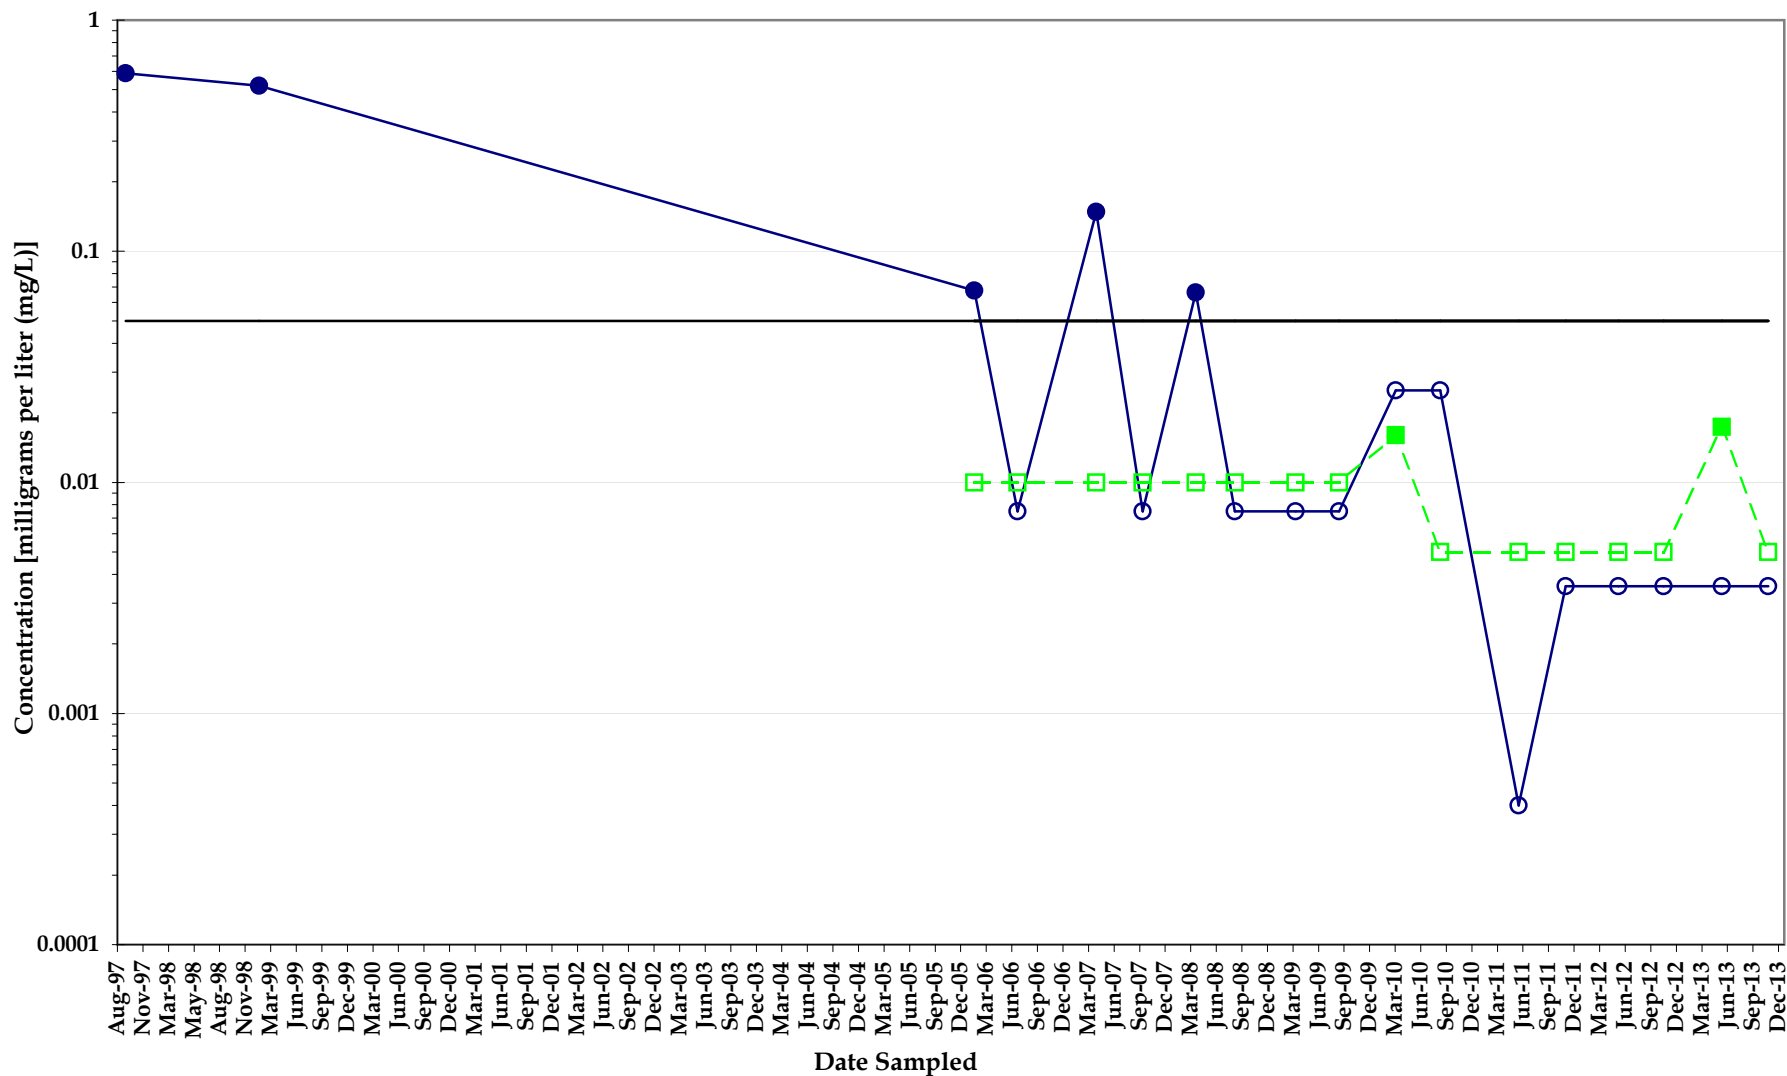
## Chromium Concentrations Monitoring Well LORDWW

Note: Non-detect analyses plotted at the method detection limit or half the reporting limit (RL). Detections denoted by symbol and detection values greater than the RL denoted by shaded symbol.

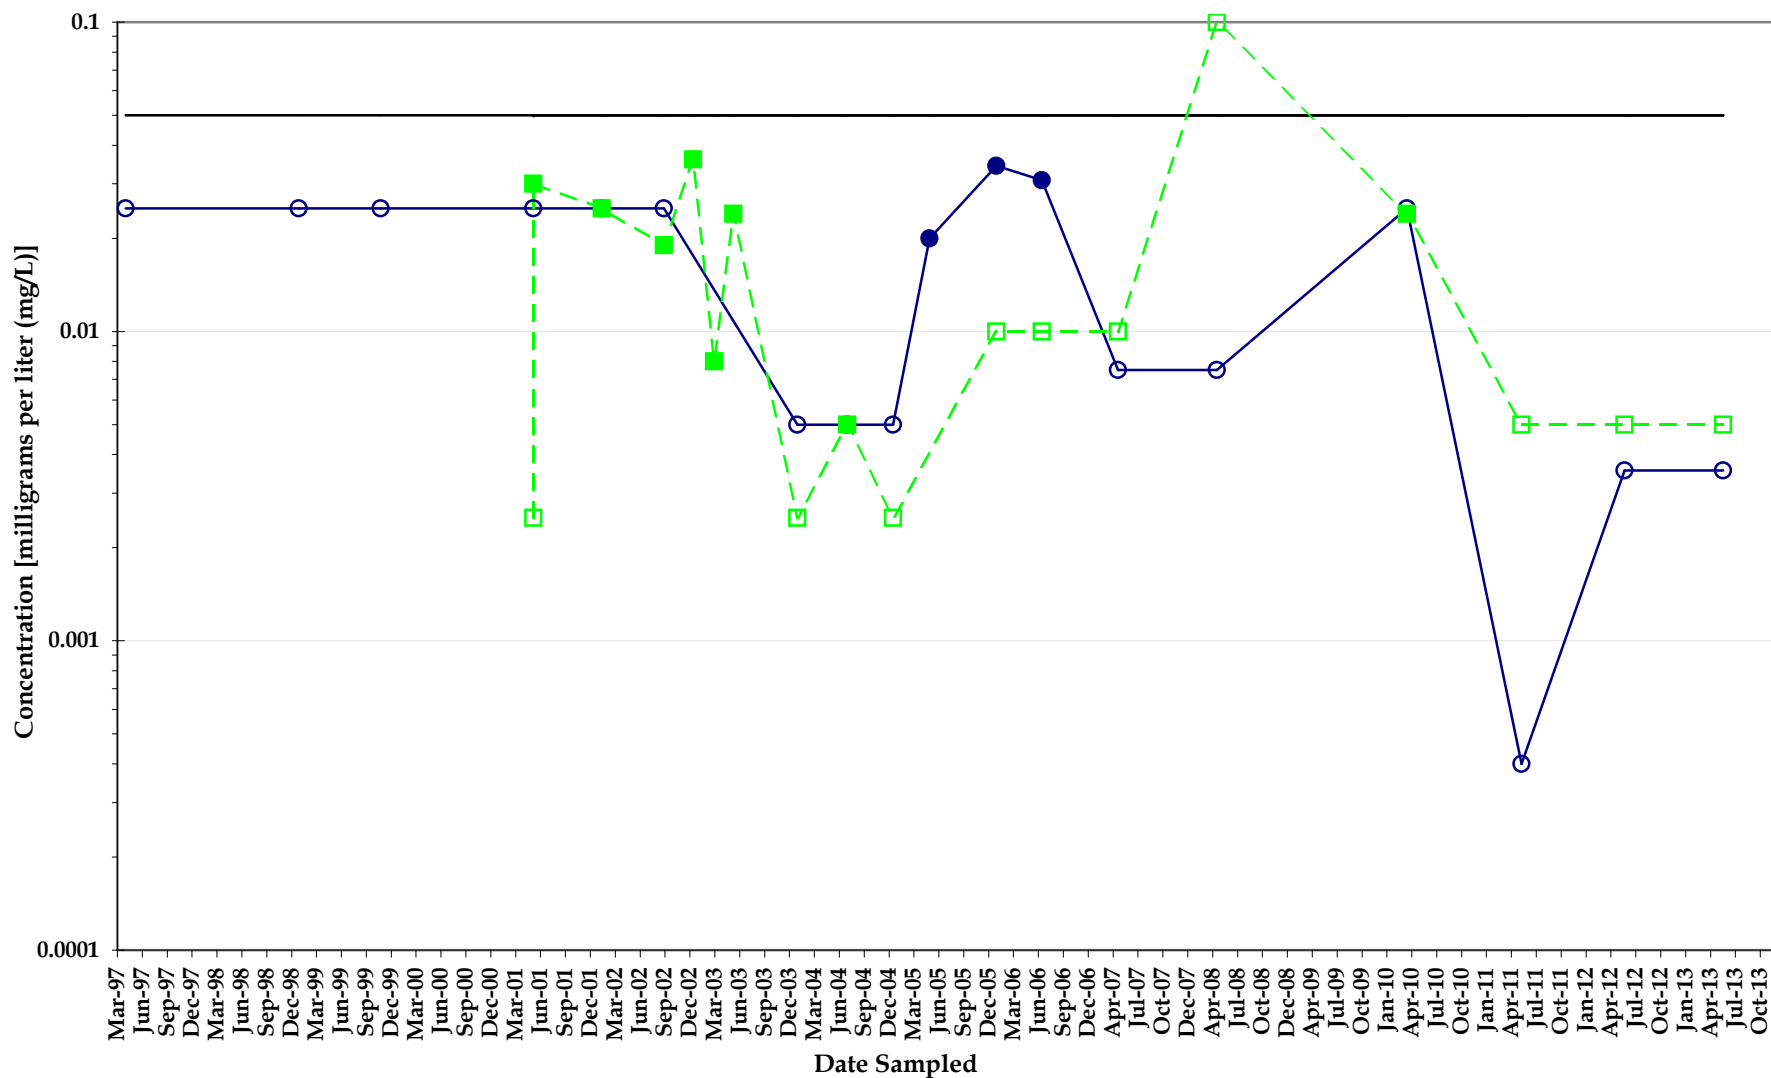
## Chromium Concentrations Monitoring Well MW001

Note: Non-detect analyses plotted at the method detection limit or half the reporting limit (RL). Detections denoted by symbol and detection values greater than the RL denoted by shaded symbol.

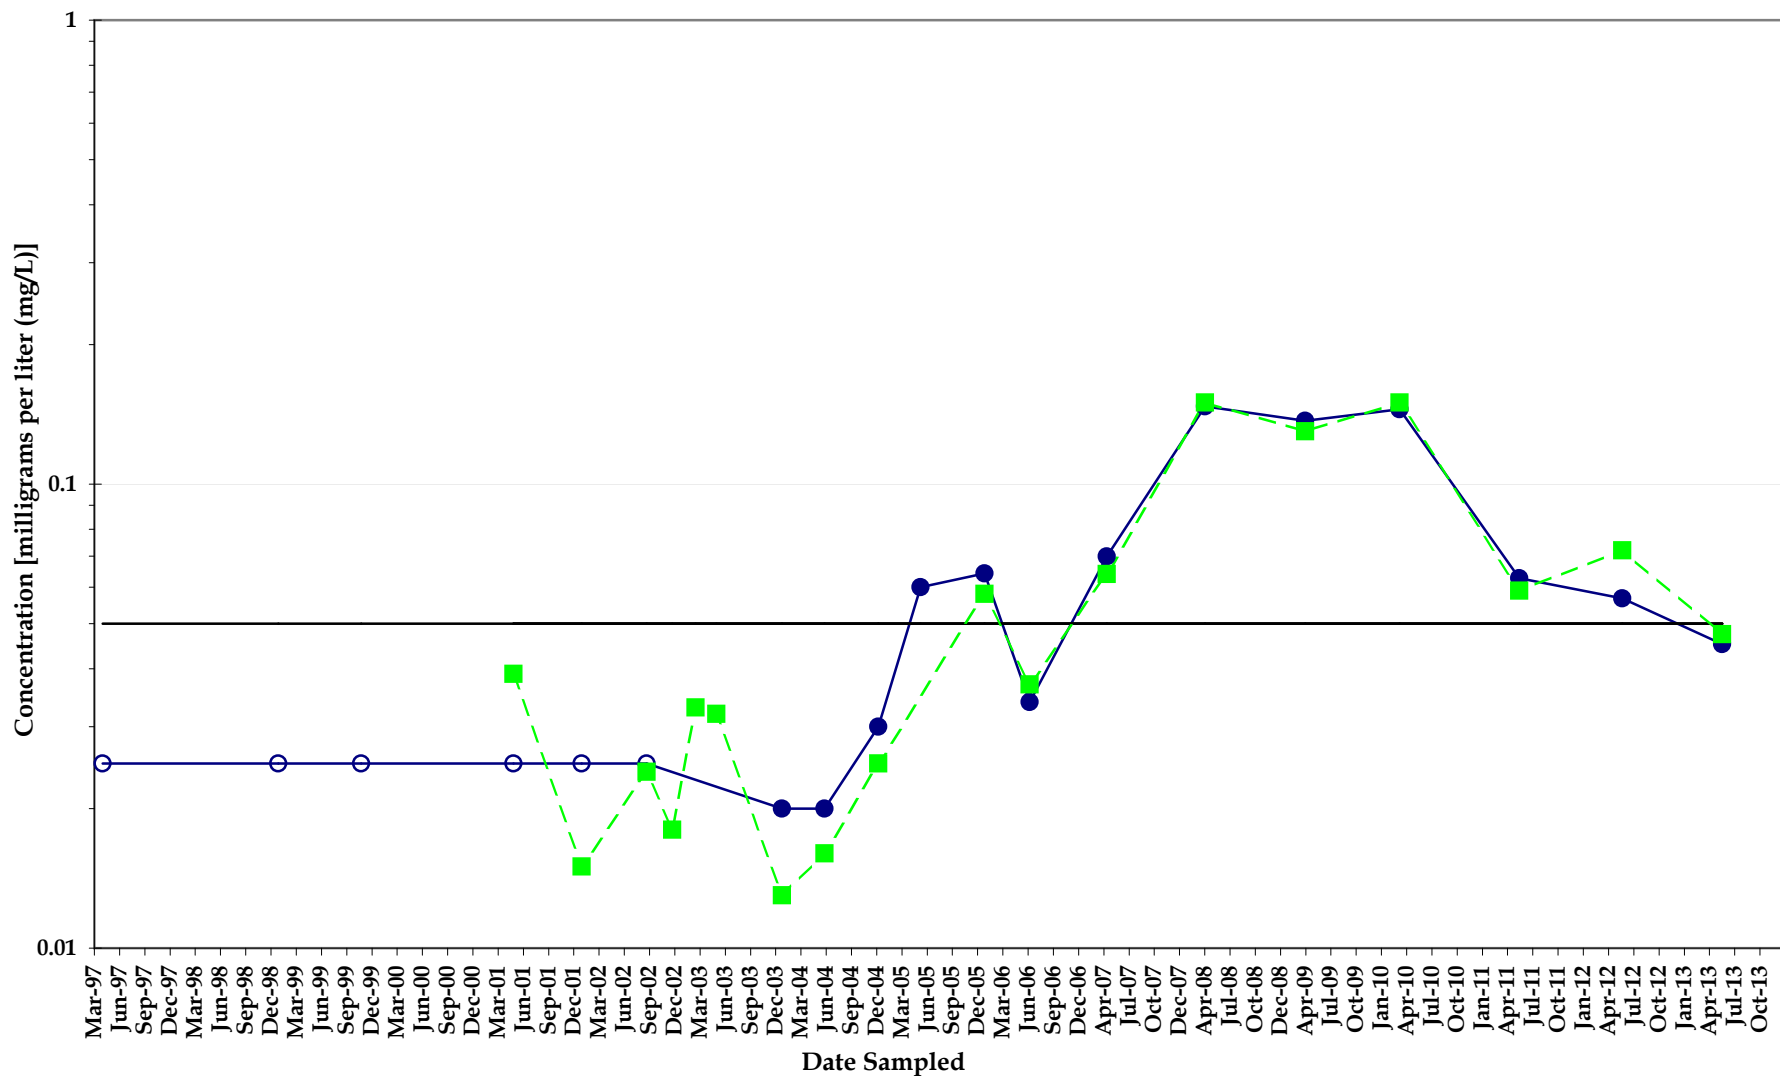
## Chromium Concentrations Monitoring Well MW002

Note: Non-detect analyses plotted at the method detection limit or half the reporting limit (RL). Detections denoted by symbol and detection values greater than the RL denoted by shaded symbol.

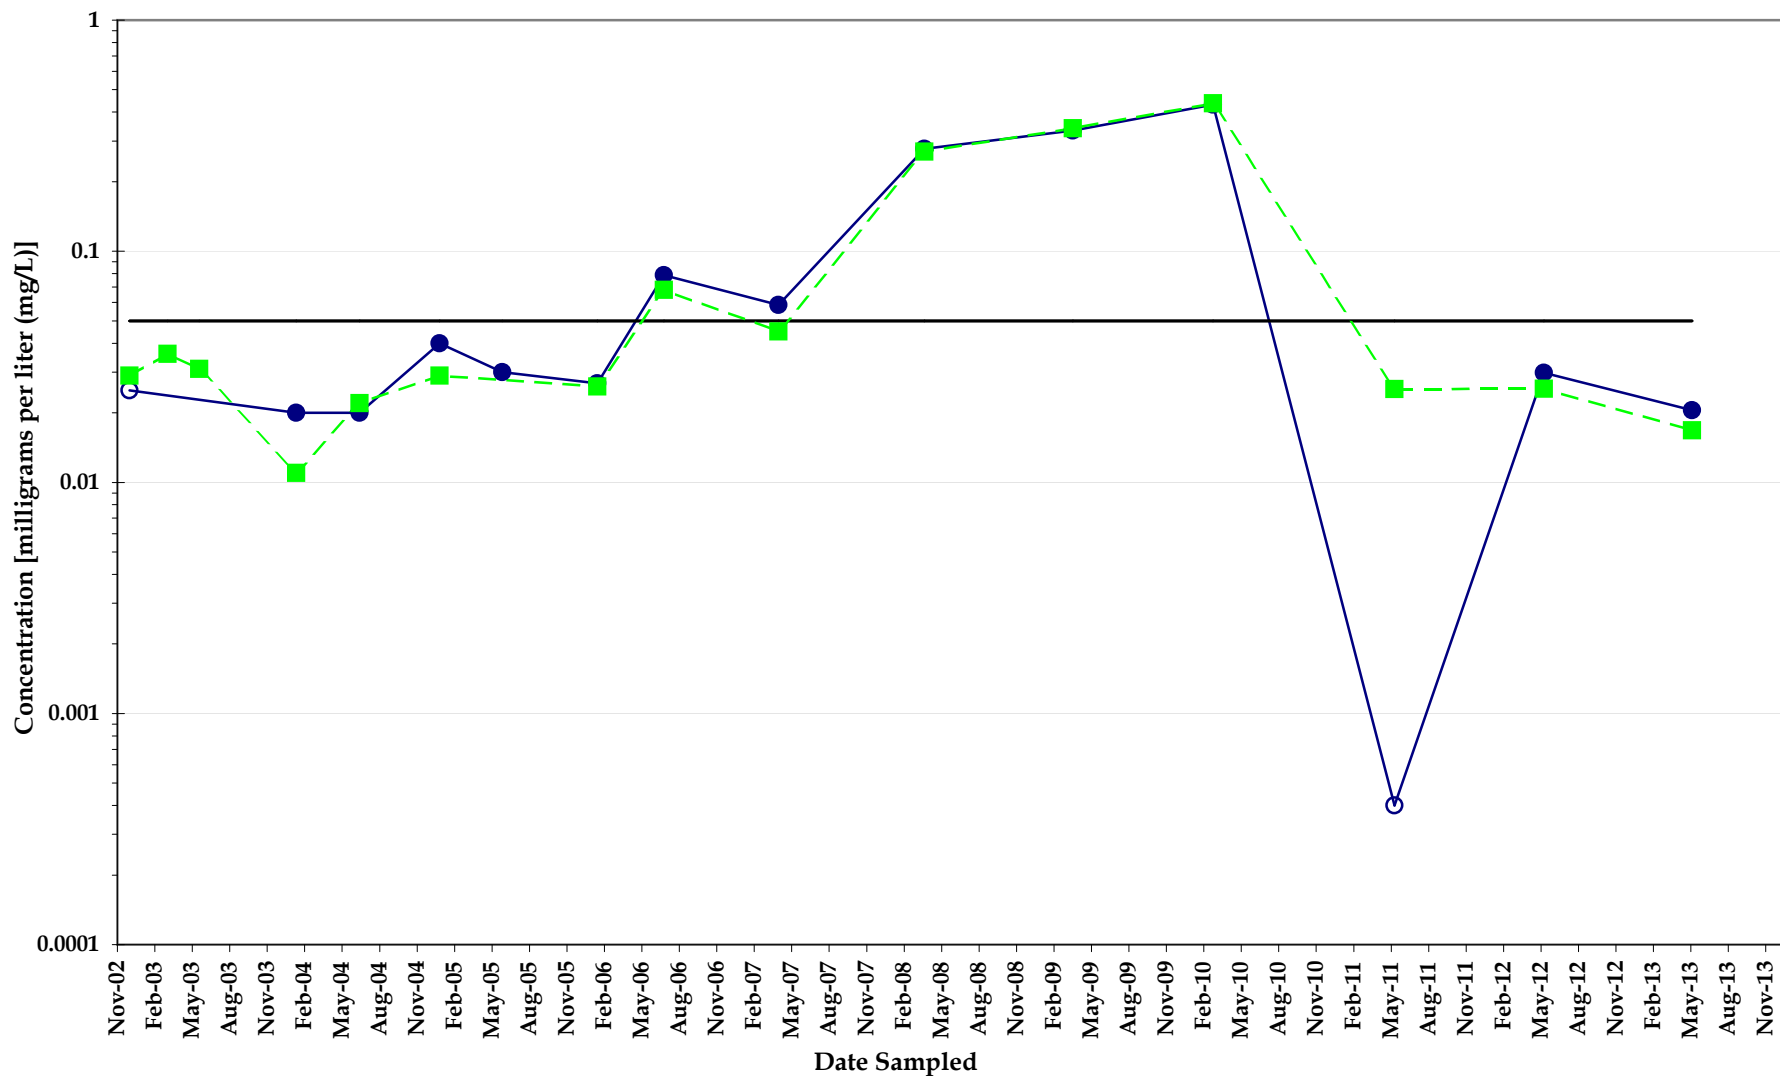
## Chromium Concentrations Monitoring Well MW002A

Note: Non-detect analyses plotted at the method detection limit or half the reporting limit (RL). Detections denoted by symbol and detection values greater than the RL denoted by shaded symbol.

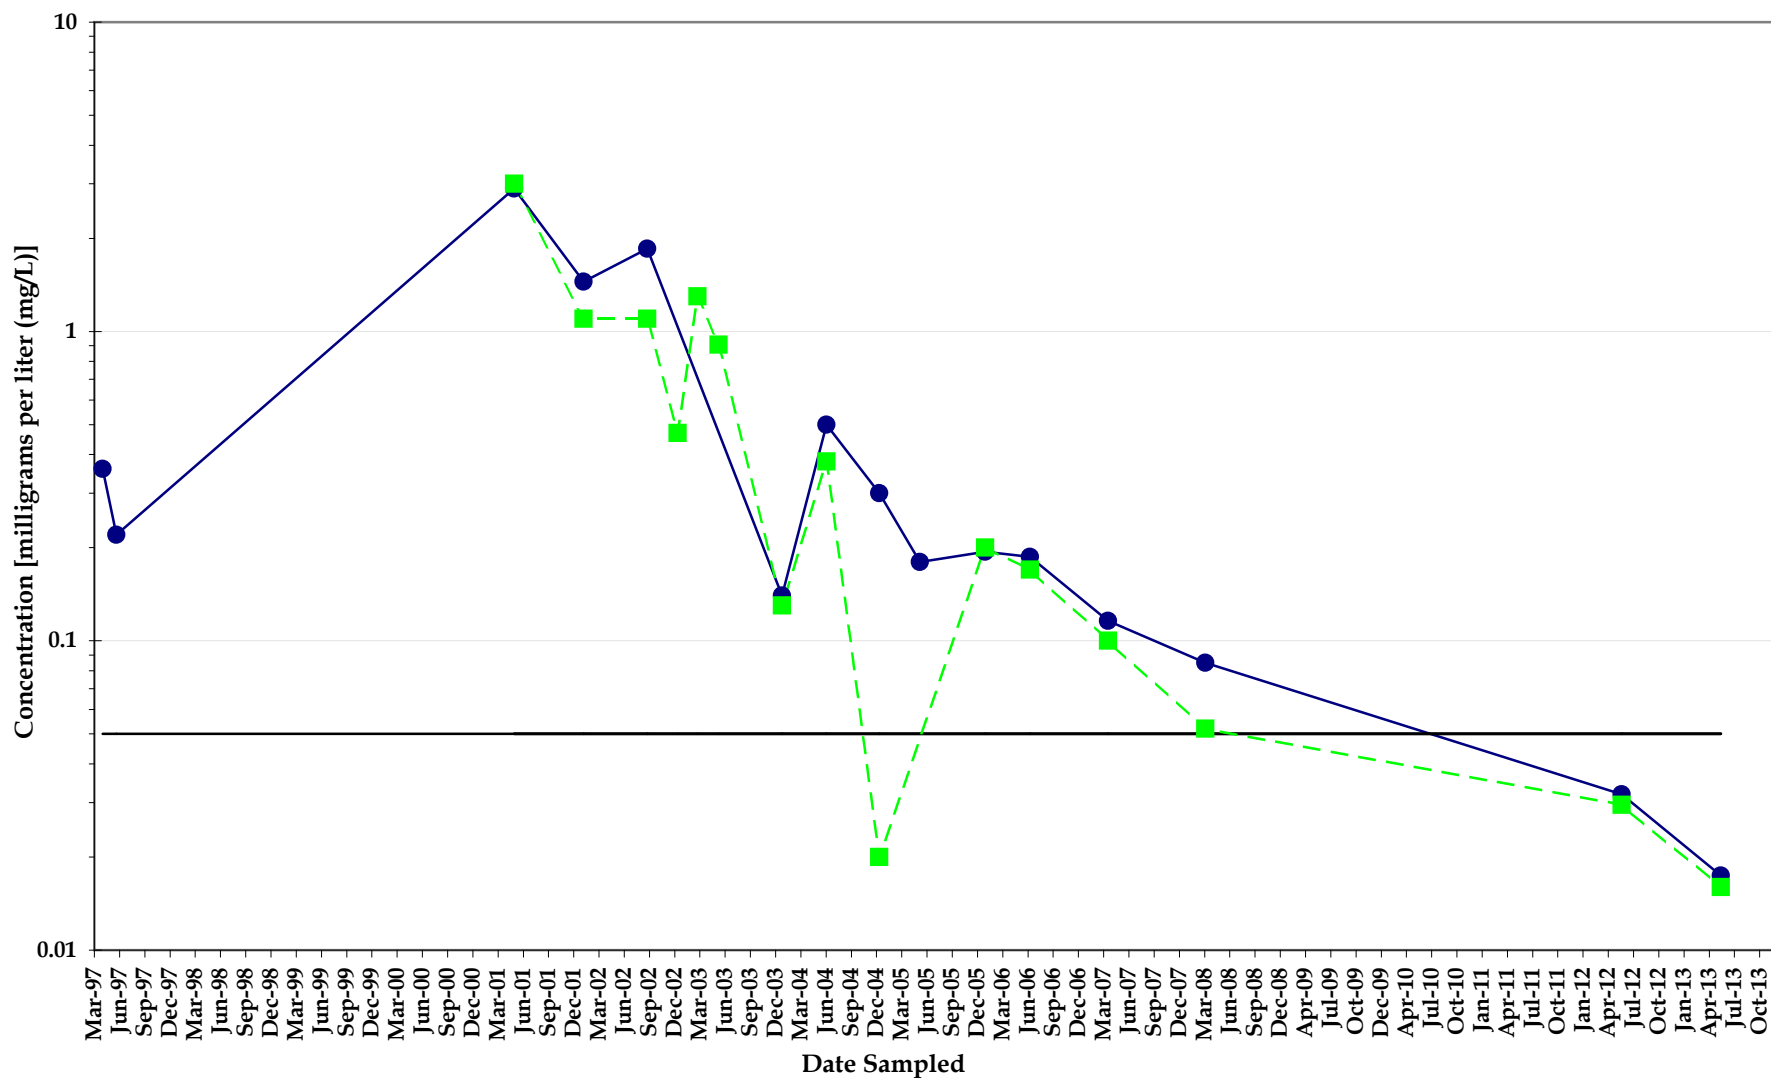
## Chromium Concentrations Monitoring Well MW003

Note: Non-detect analyses plotted at the method detection limit or half the reporting limit (RL). Detections denoted by symbol and detection values greater than the RL denoted by shaded symbol.

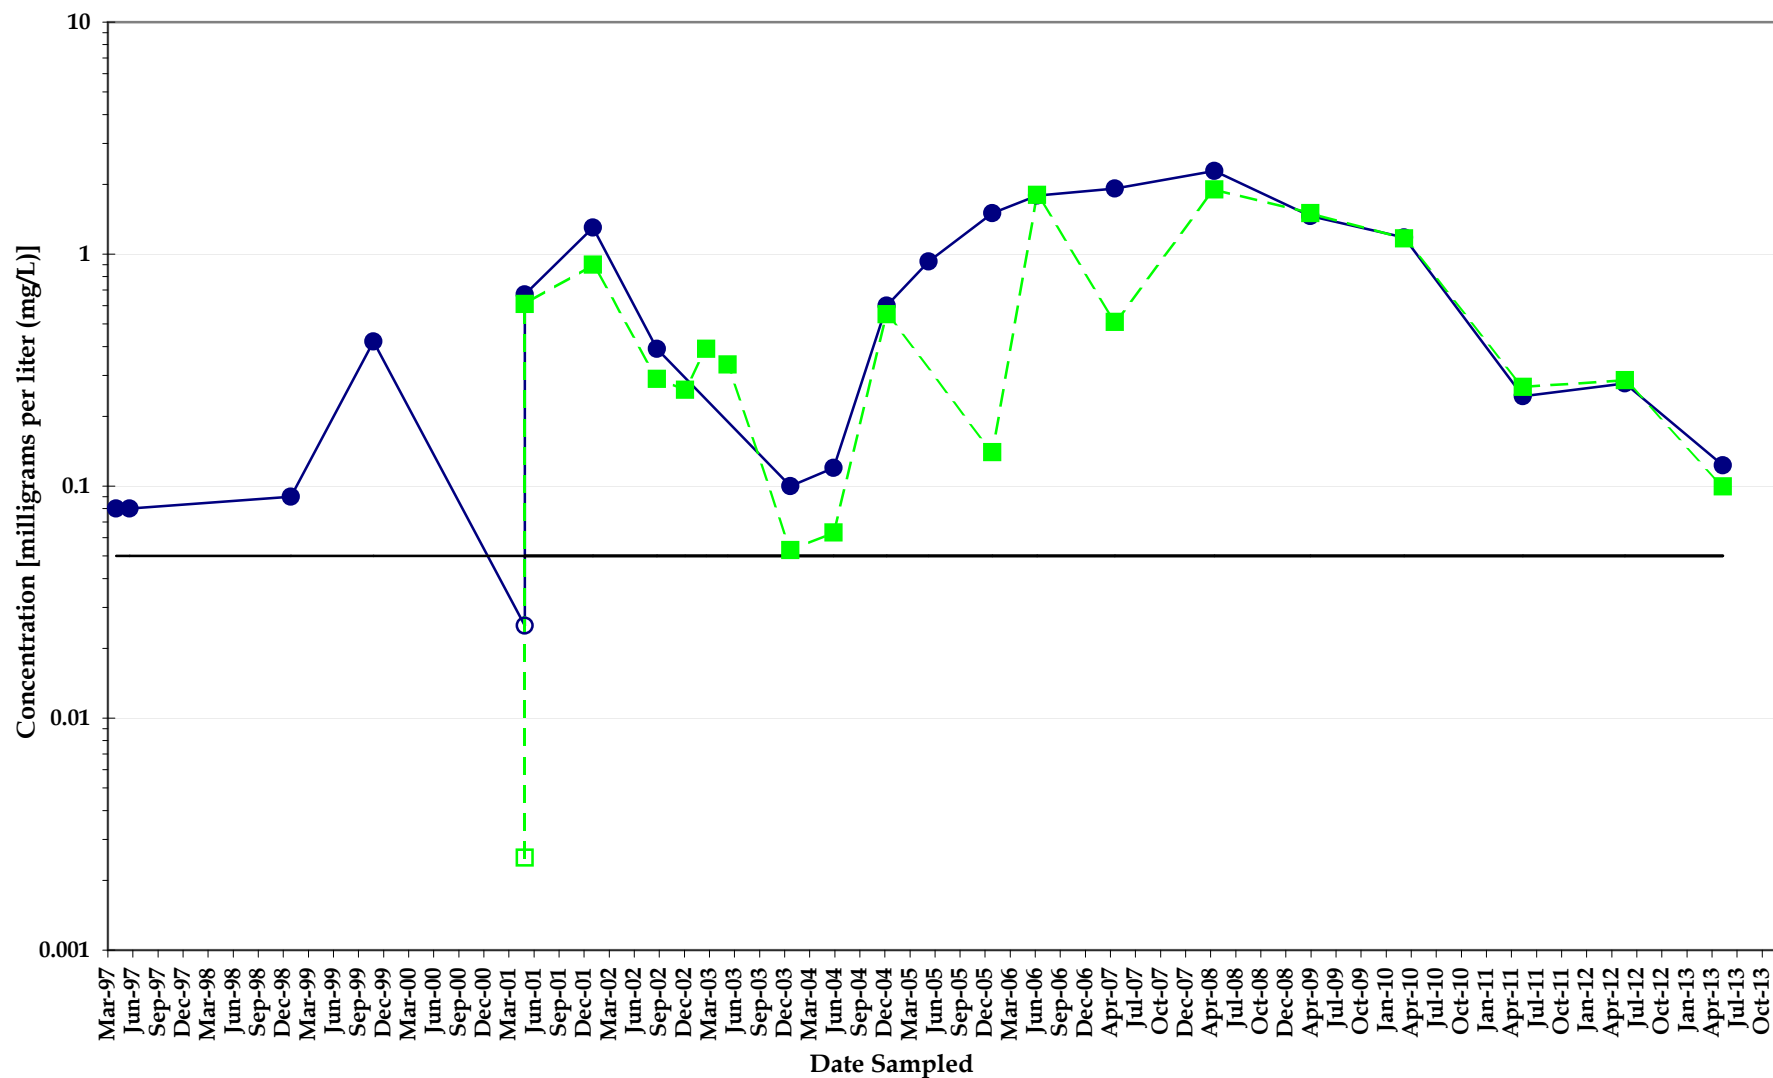
## Chromium Concentrations Monitoring Well MW004

Note: Non-detect analyses plotted at the method detection limit or half the reporting limit (RL). Detections denoted by symbol and detection values greater than the RL denoted by shaded symbol.

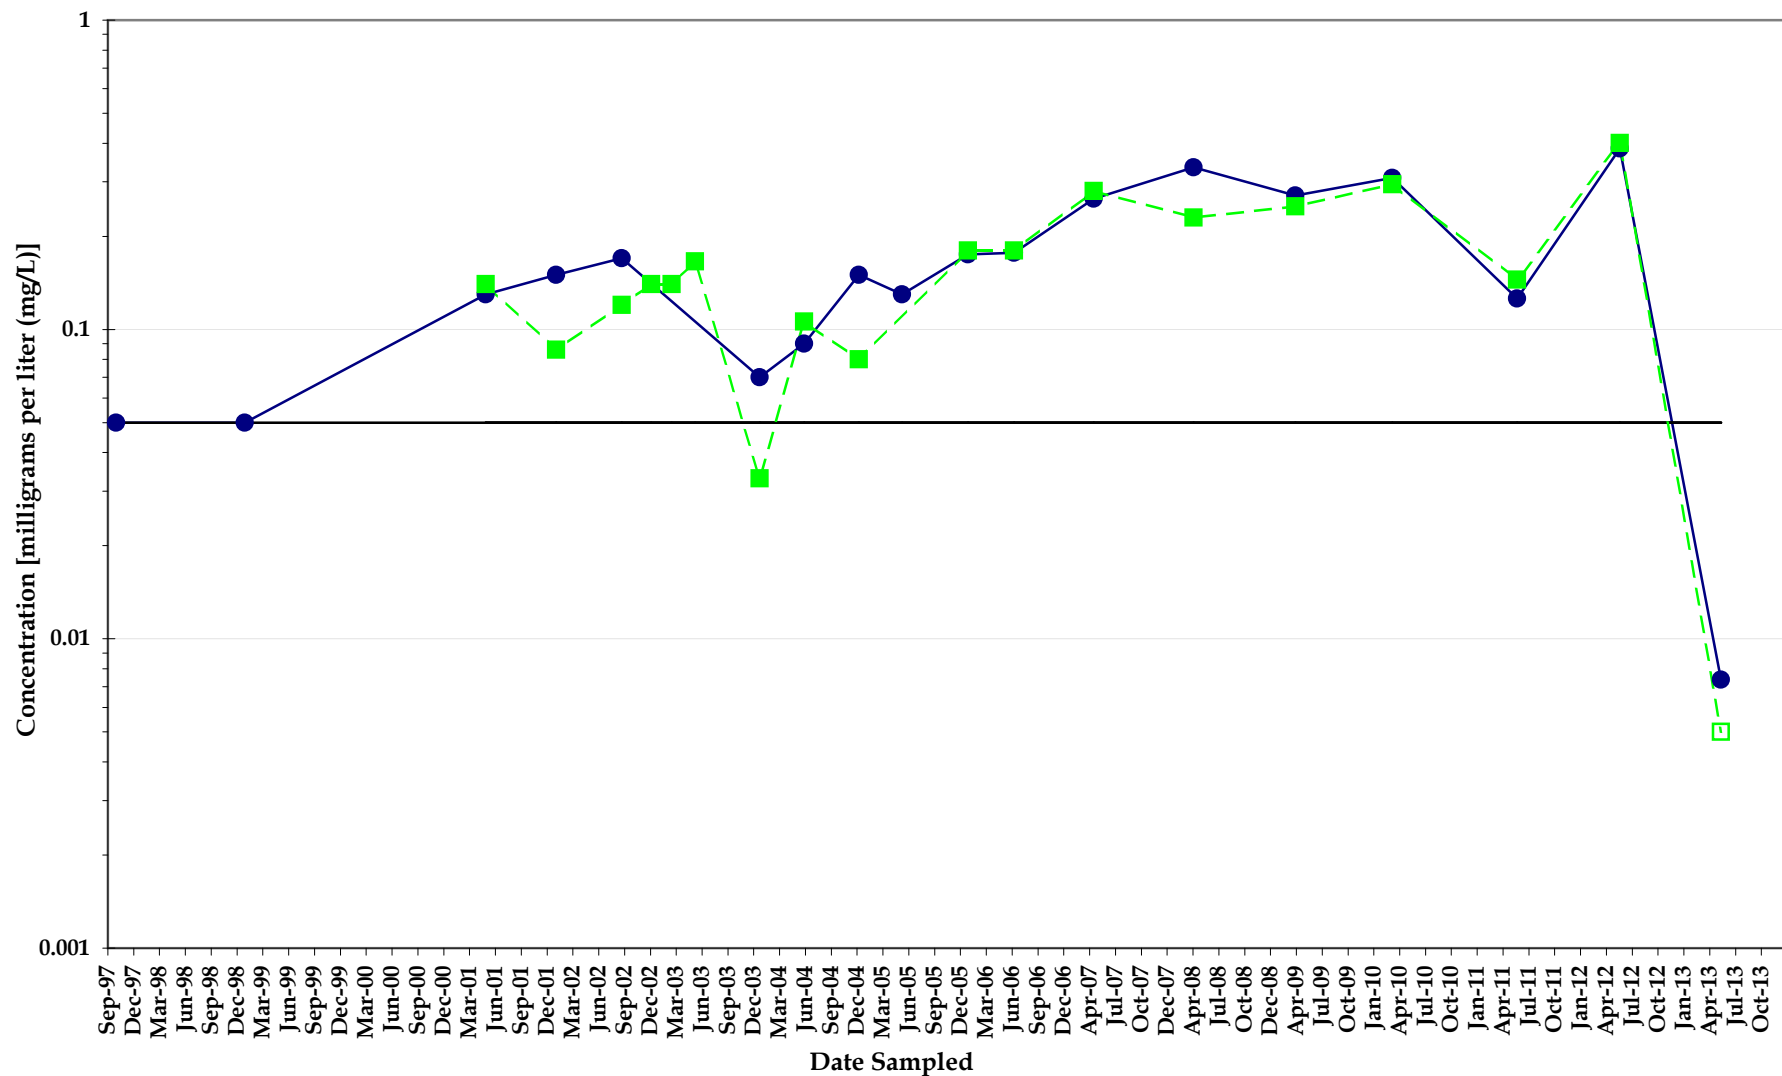
## Chromium Concentrations Monitoring Well MW004A

Note: Non-detect analyses plotted at the method detection limit or half the reporting limit (RL). Detections denoted by symbol and detection values greater than the RL denoted by shaded symbol.

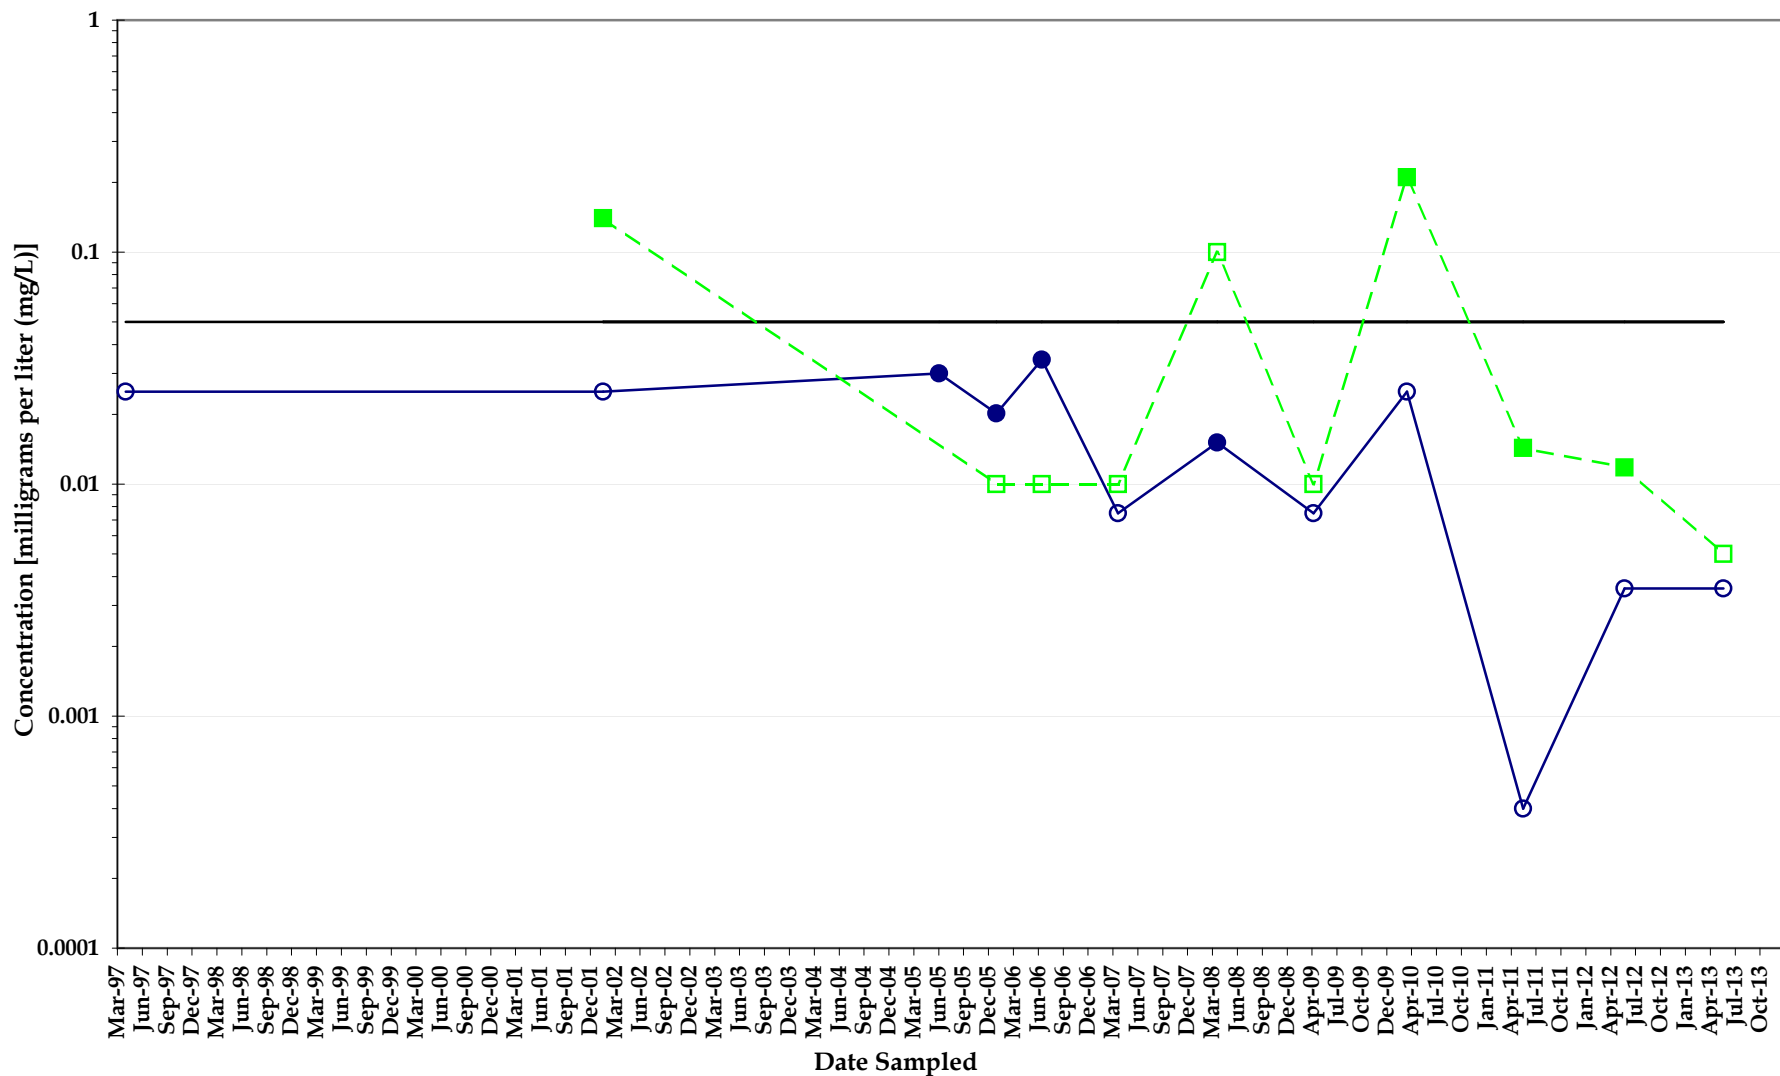
## Chromium Concentrations Monitoring Well MW005

Note: Non-detect analyses plotted at the method detection limit or half the reporting limit (RL). Detections denoted by symbol and detection values greater than the RL denoted by shaded symbol.

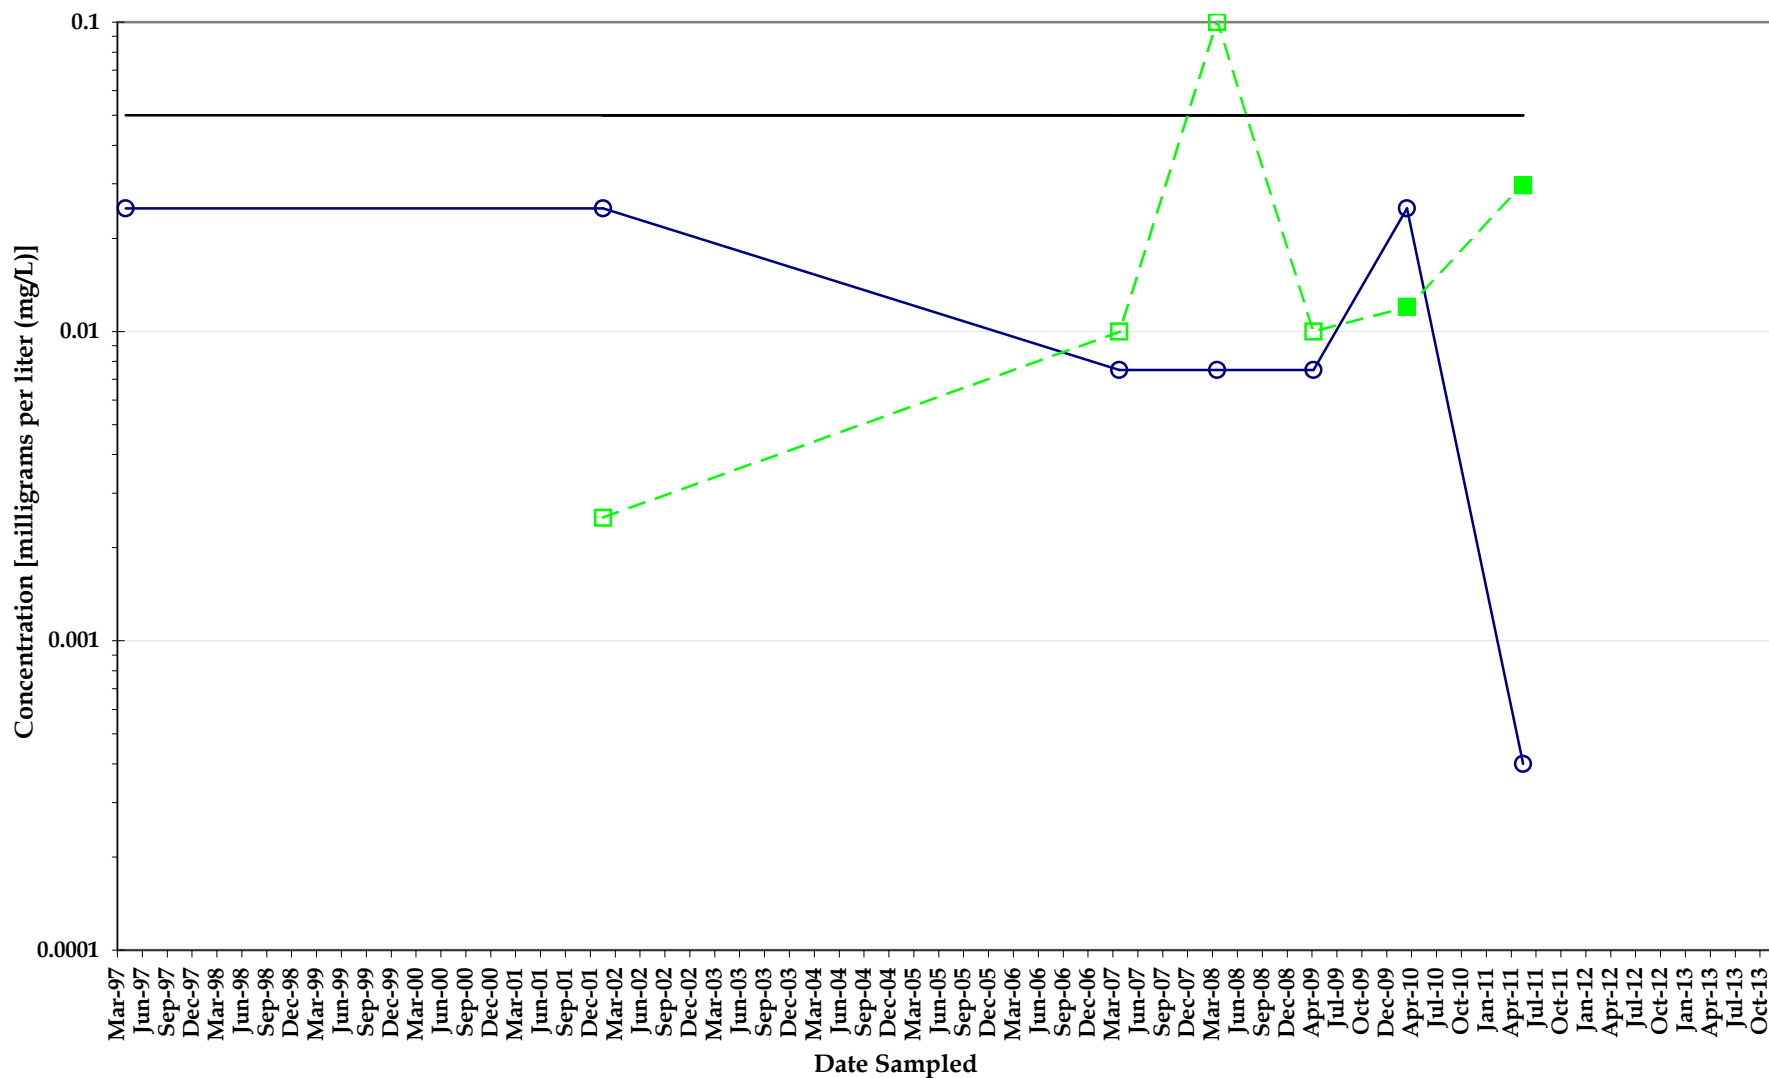
## Chromium Concentrations Monitoring Well MW006

Note: Non-detect analyses plotted at the method detection limit or half the reporting limit (RL). Detections denoted by symbol and detection values greater than the RL denoted by shaded symbol.

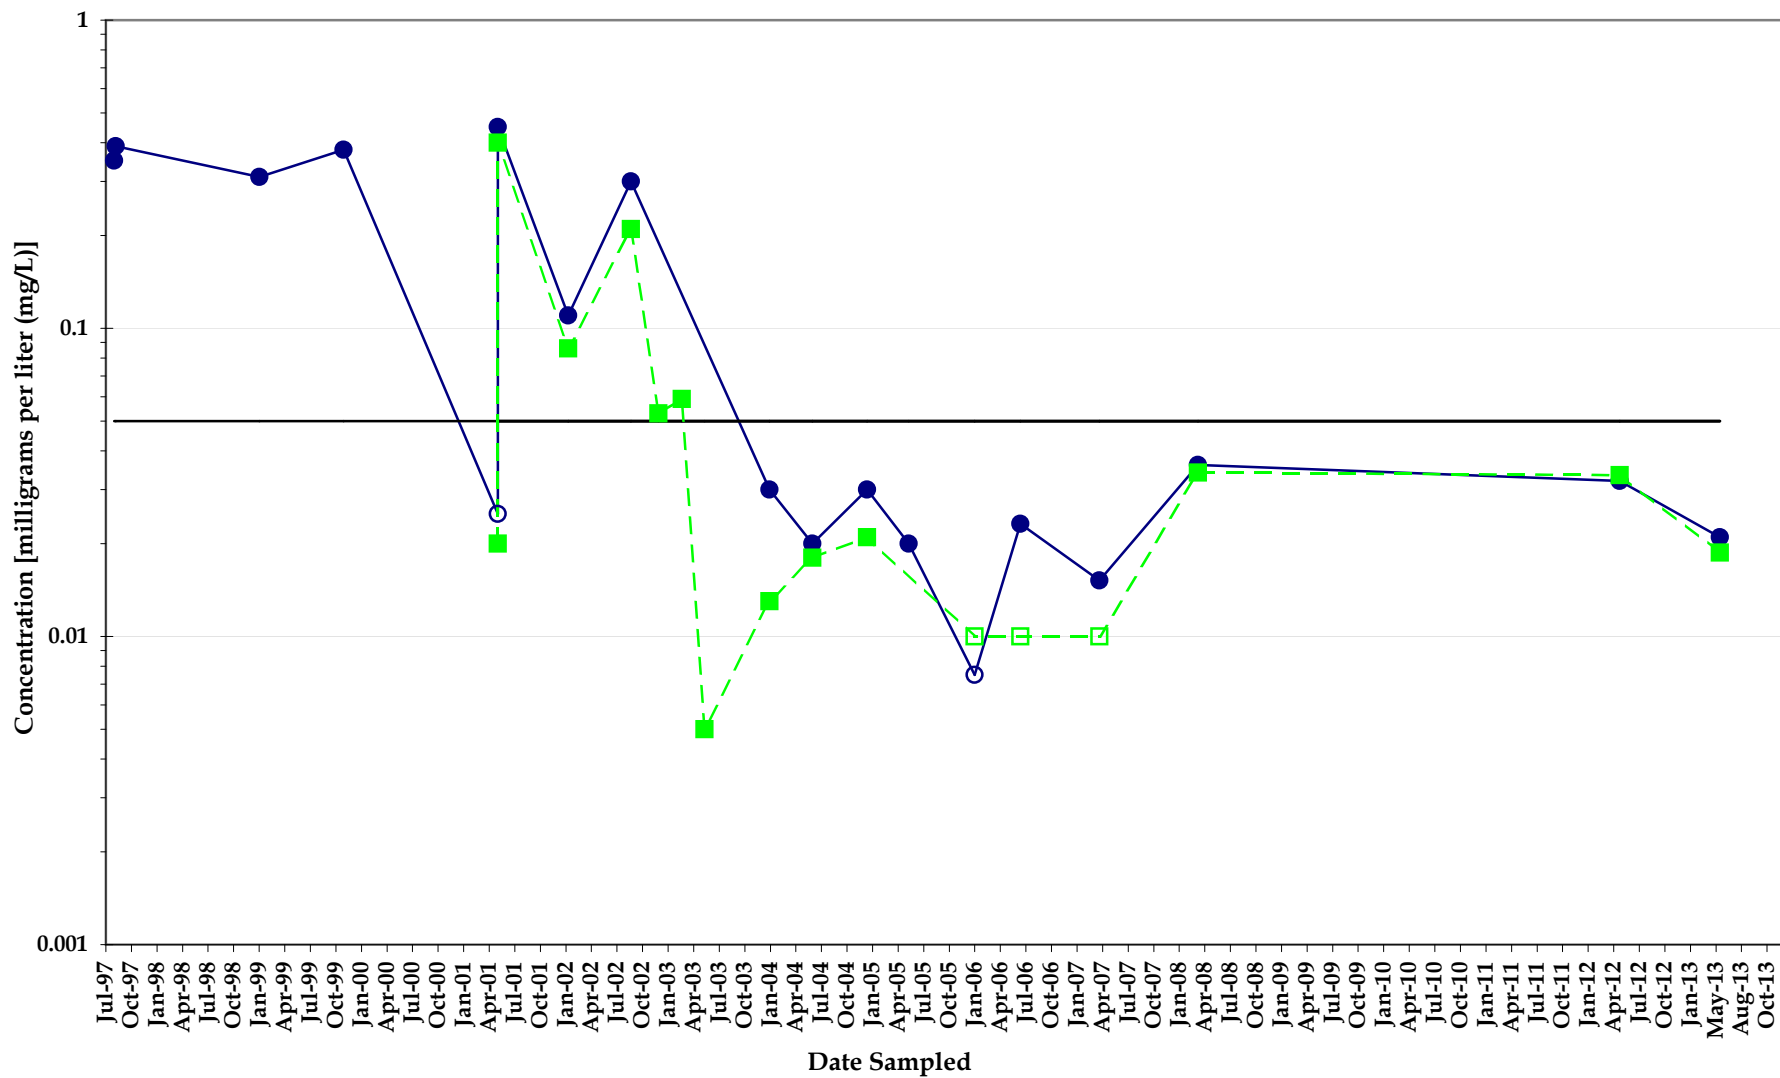
## Chromium Concentrations Monitoring Well MW007

Note: Non-detect analyses plotted at the method detection limit or half the reporting limit (RL). Detections denoted by symbol and detection values greater than the RL denoted by shaded symbol.
