**GW - 004**

**2013 AGWMR**

**VOL 5 OF 5**

*North Eunice Gas Plant  
Lea County, New Mexico*

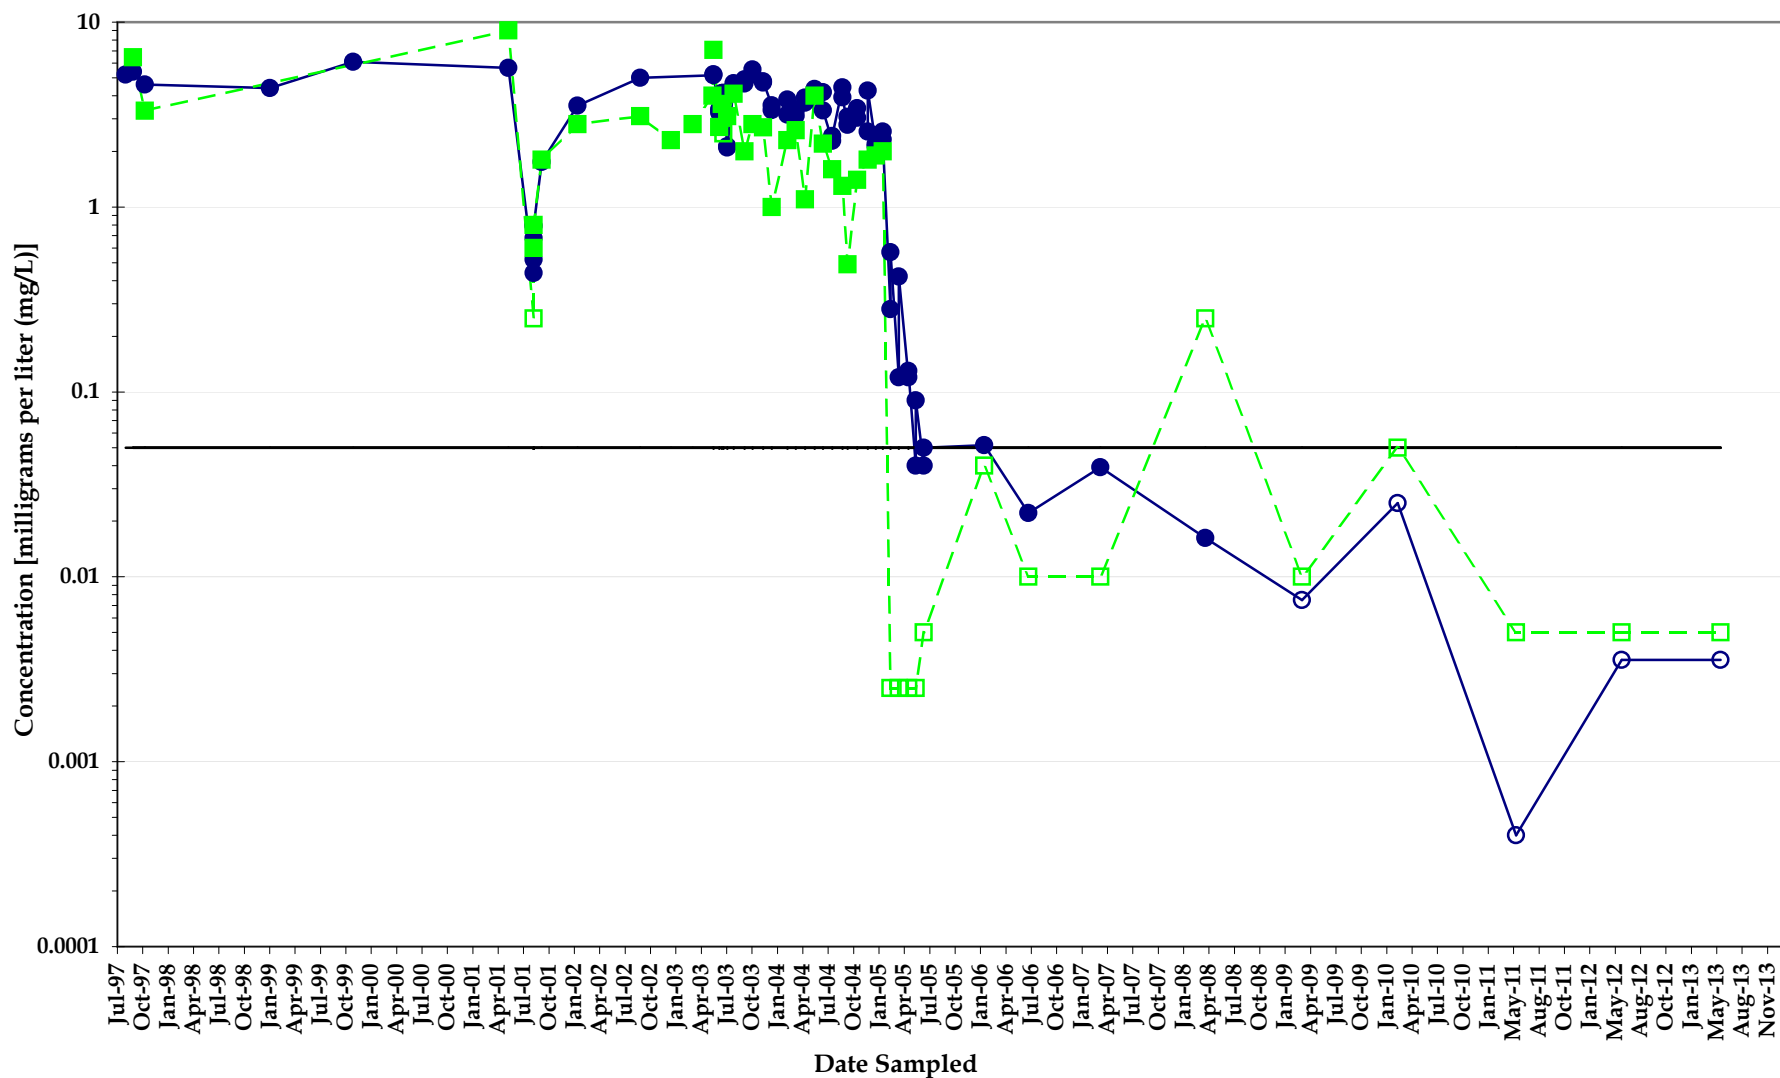
## Chromium Concentrations Monitoring Well MW008

Note: Non-detect analyses plotted at the method detection limit or half the reporting limit (RL). Detections denoted by symbol and detection values greater than the RL denoted by shaded symbol.

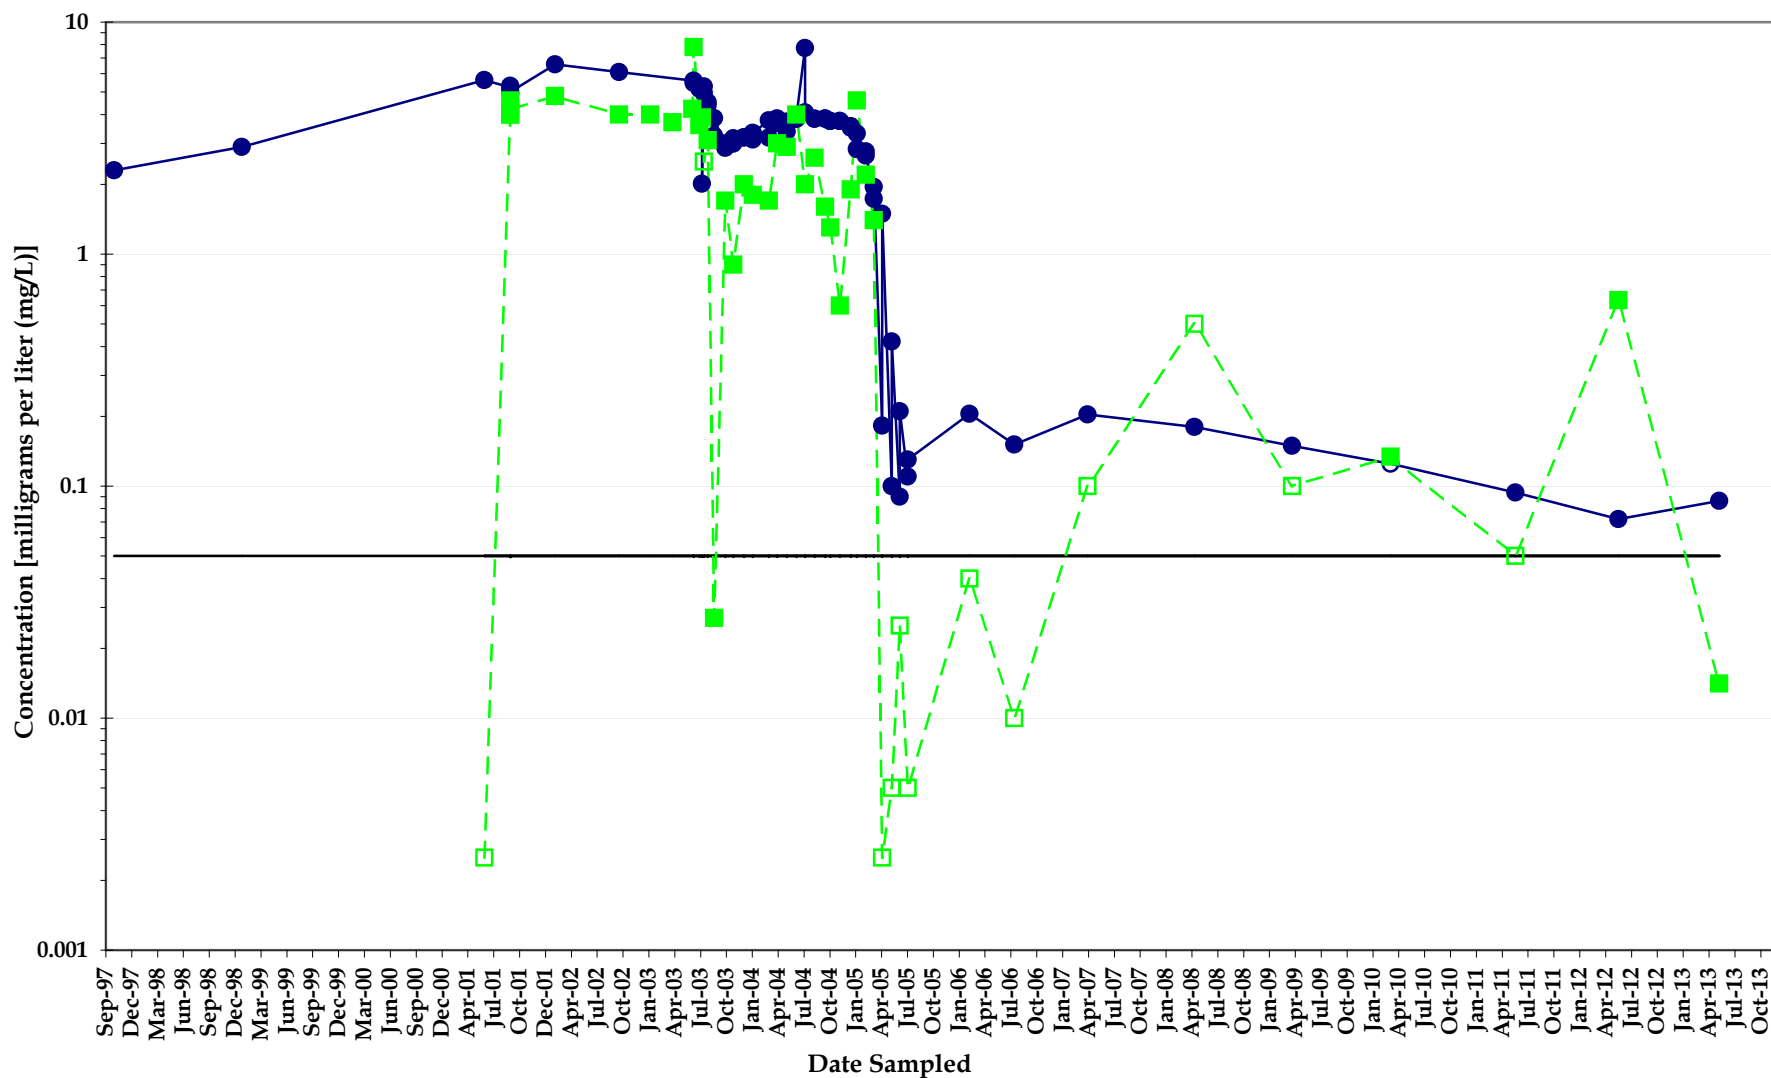
## Chromium Concentrations Monitoring Well MW008A

Note: Non-detect analyses plotted at the method detection limit or half the reporting limit (RL). Detections denoted by symbol and detection values greater than the RL denoted by shaded symbol.

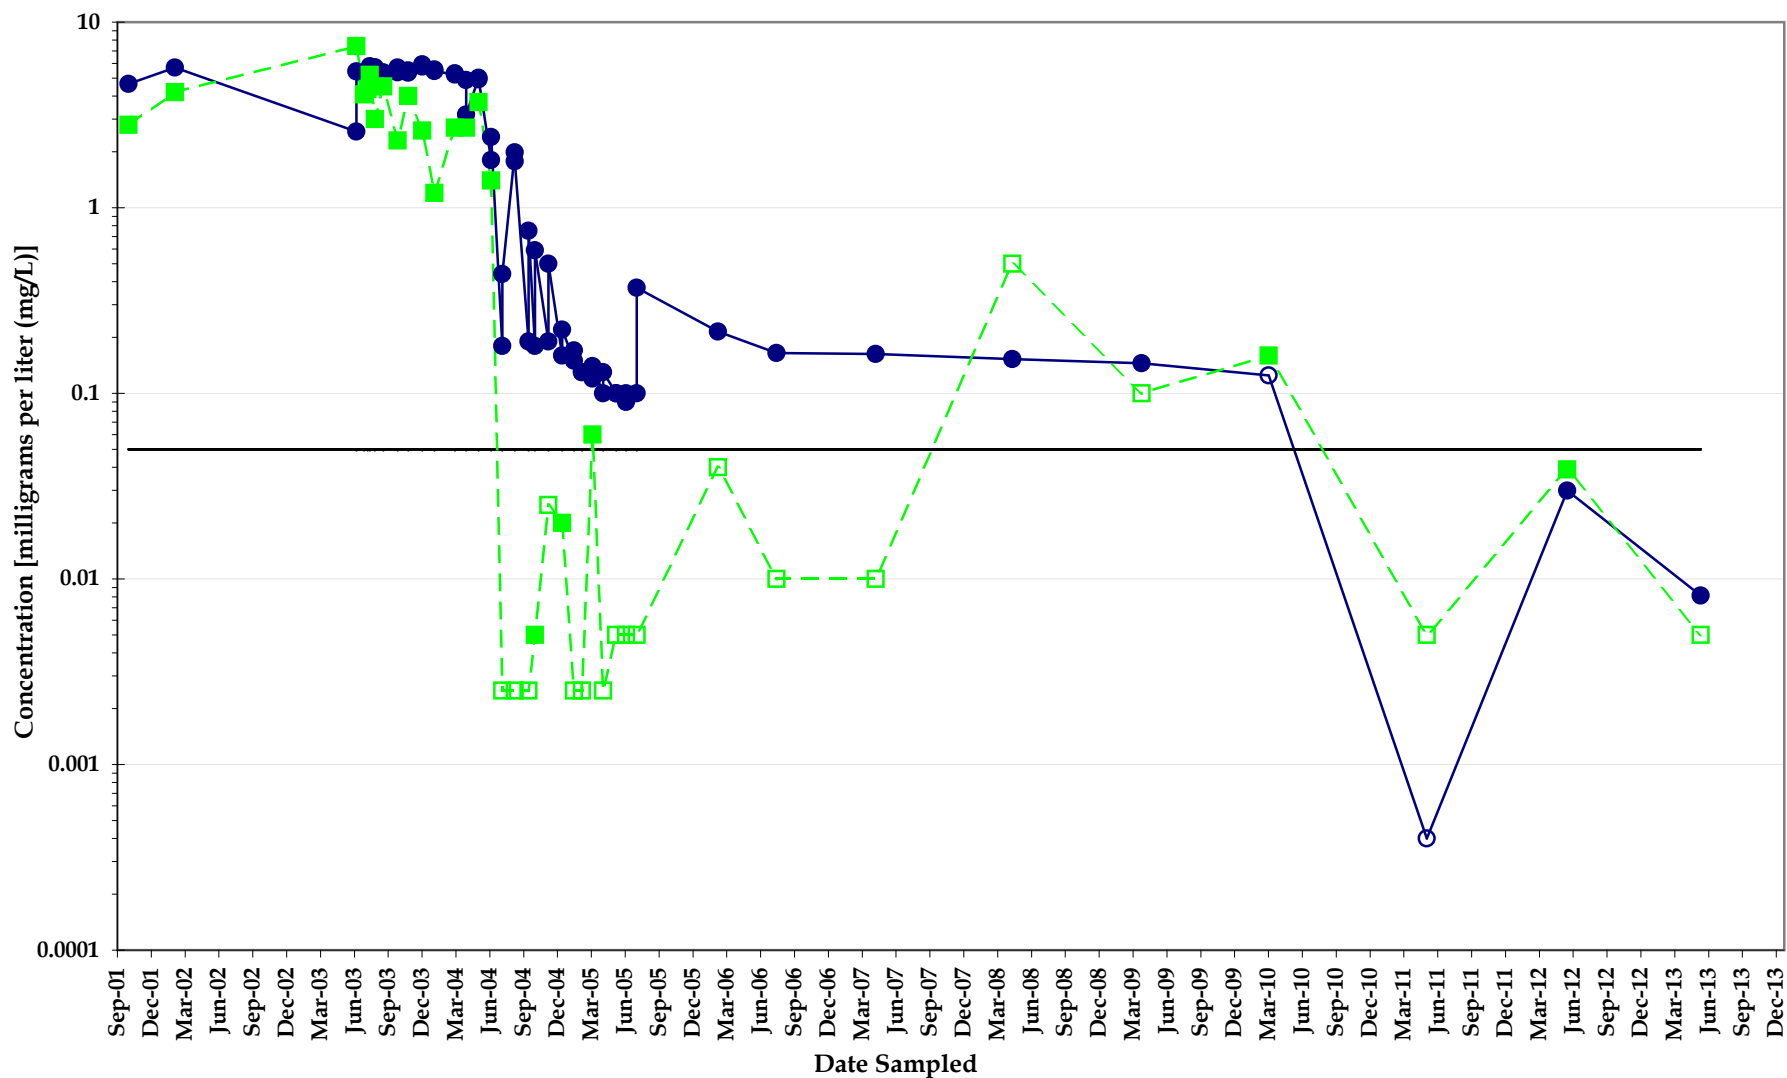
## Chromium Concentrations Monitoring Well MW008M

Note: Non-detect analyses plotted at the method detection limit or half the reporting limit (RL). Detections denoted by symbol and detection values greater than the RL denoted by shaded symbol.

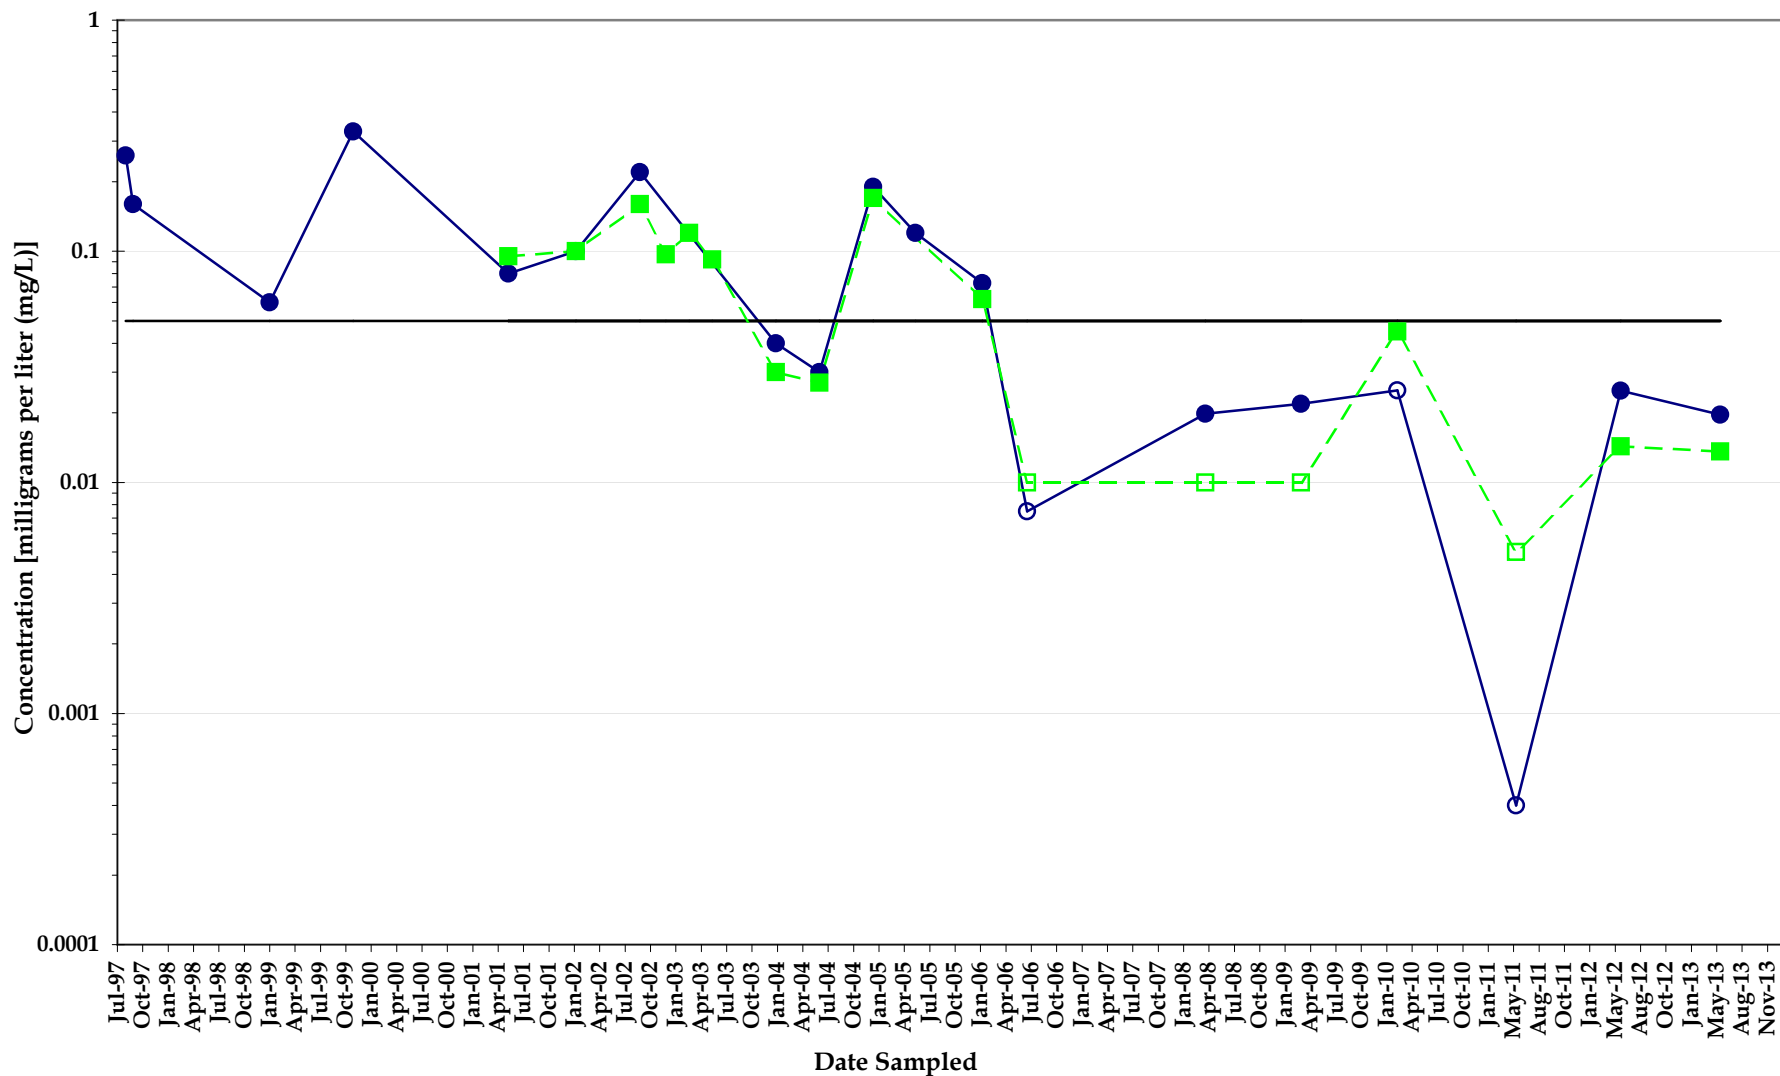
## Chromium Concentrations Monitoring Well MW009

Note: Non-detect analyses plotted at the method detection limit or half the reporting limit (RL). Detections denoted by symbol and detection values greater than the RL denoted by shaded symbol.

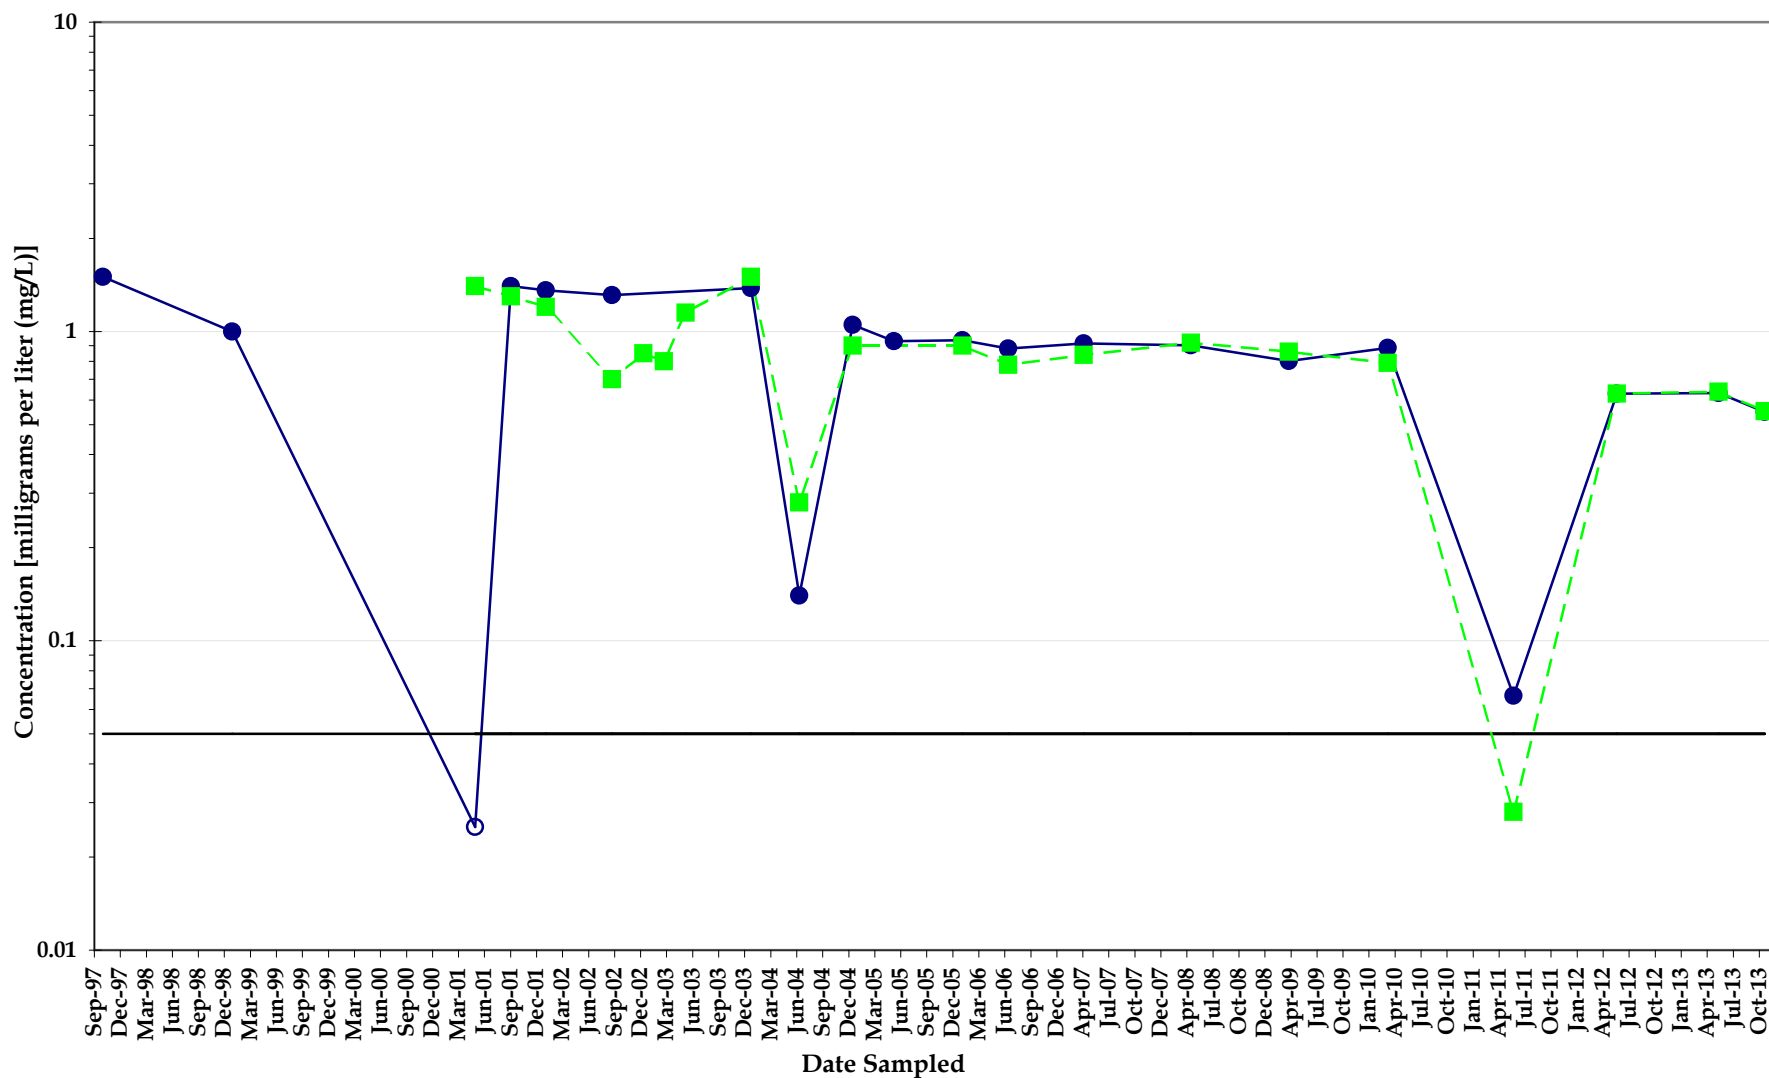
## Chromium Concentrations Monitoring Well MW009A

Note: Non-detect analyses plotted at the method detection limit or half the reporting limit (RL). Detections denoted by symbol and detection values greater than the RL denoted by shaded symbol.

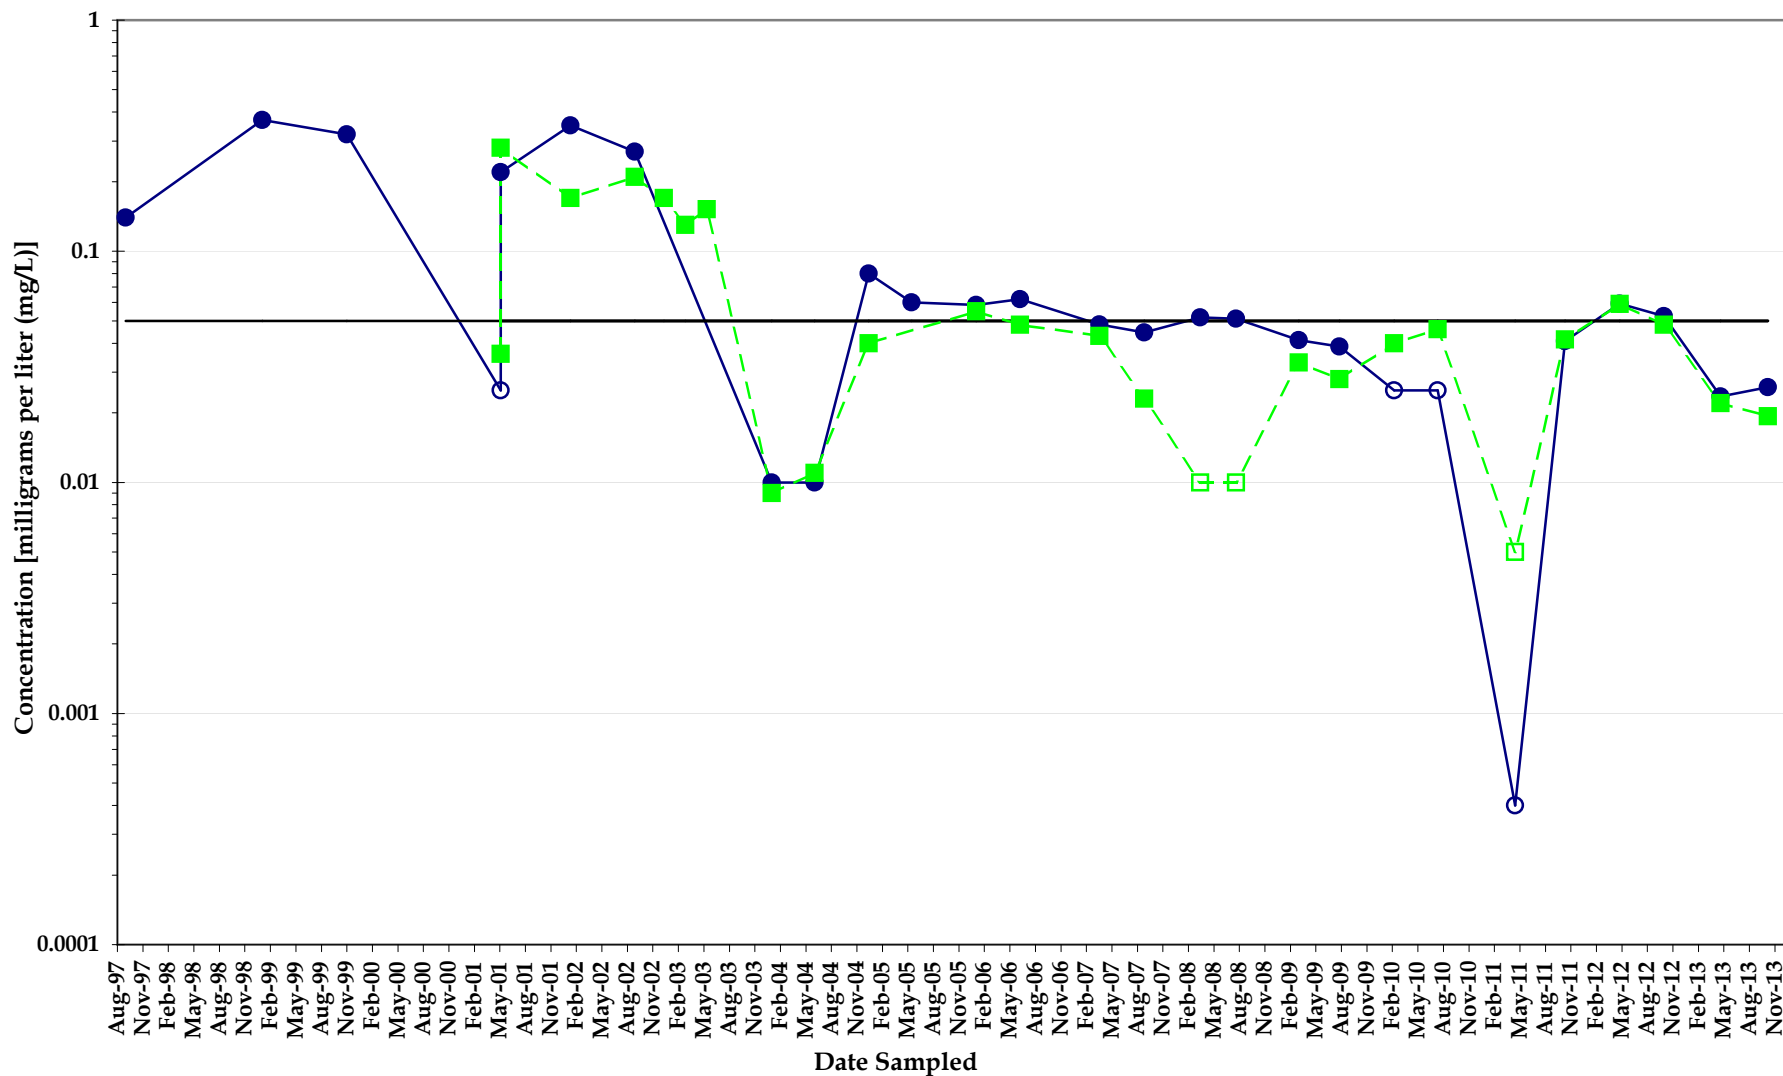
## Chromium Concentrations Monitoring Well MW010

Note: Non-detect analyses plotted at the method detection limit or half the reporting limit (RL). Detections denoted by symbol and detection values greater than the RL denoted by shaded symbol.

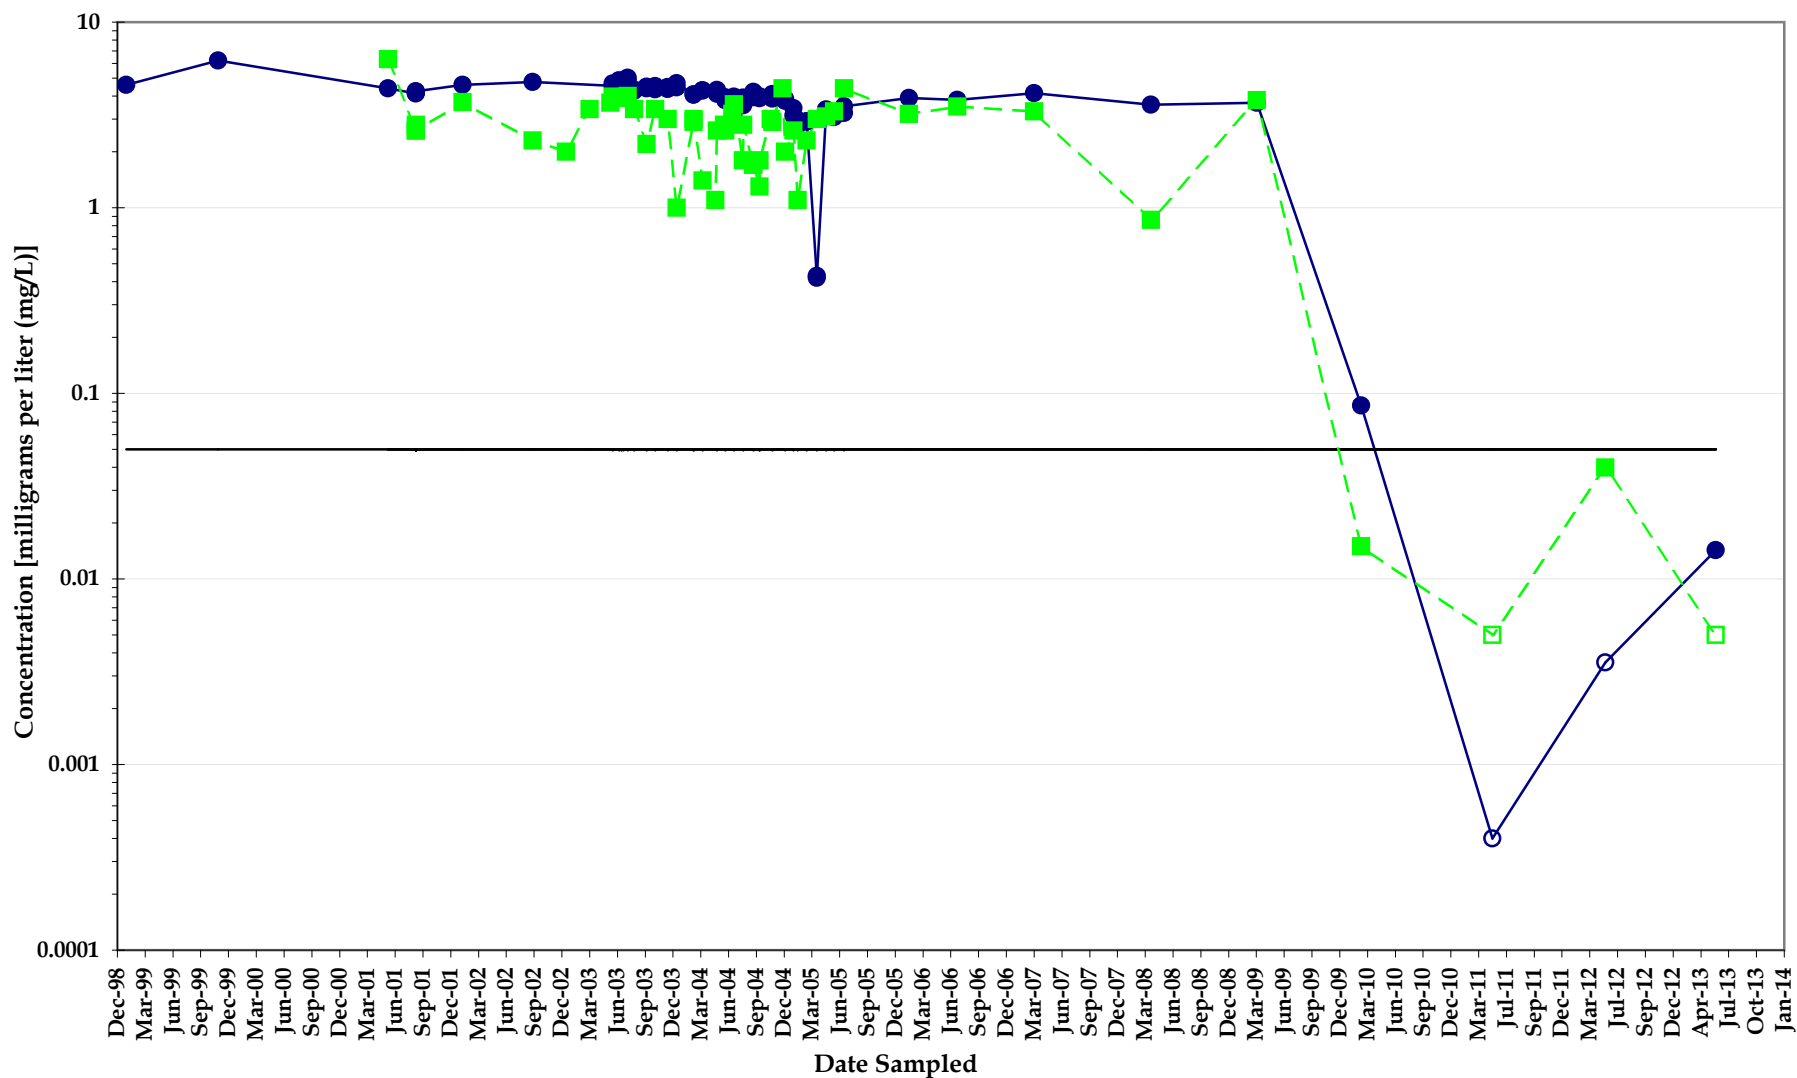
## Chromium Concentrations Monitoring Well MW011

Note: Non-detect analyses plotted at the method detection limit or half the reporting limit (RL). Detections denoted by symbol and detection values greater than the RL denoted by shaded symbol.

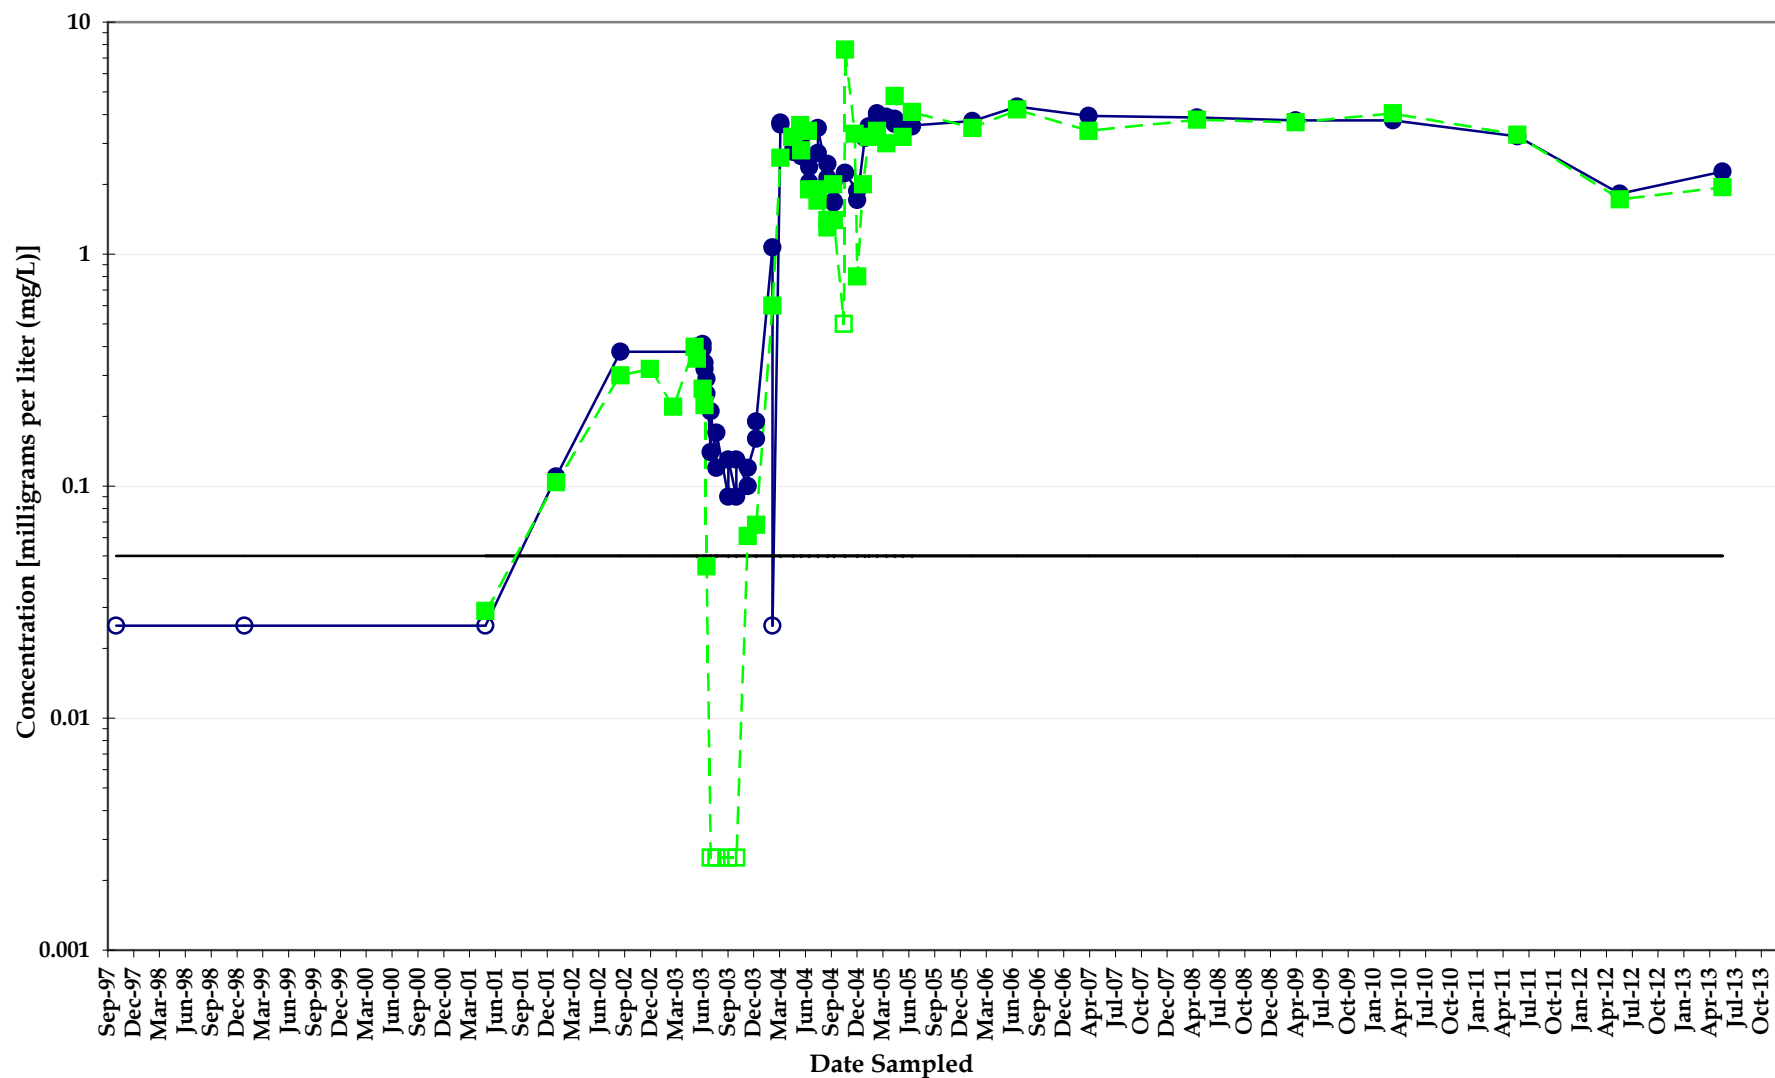
## Chromium Concentrations Monitoring Well MW011A

Note: Non-detect analyses plotted at the method detection limit or half the reporting limit (RL). Detections denoted by symbol and detection values greater than the RL denoted by shaded symbol.

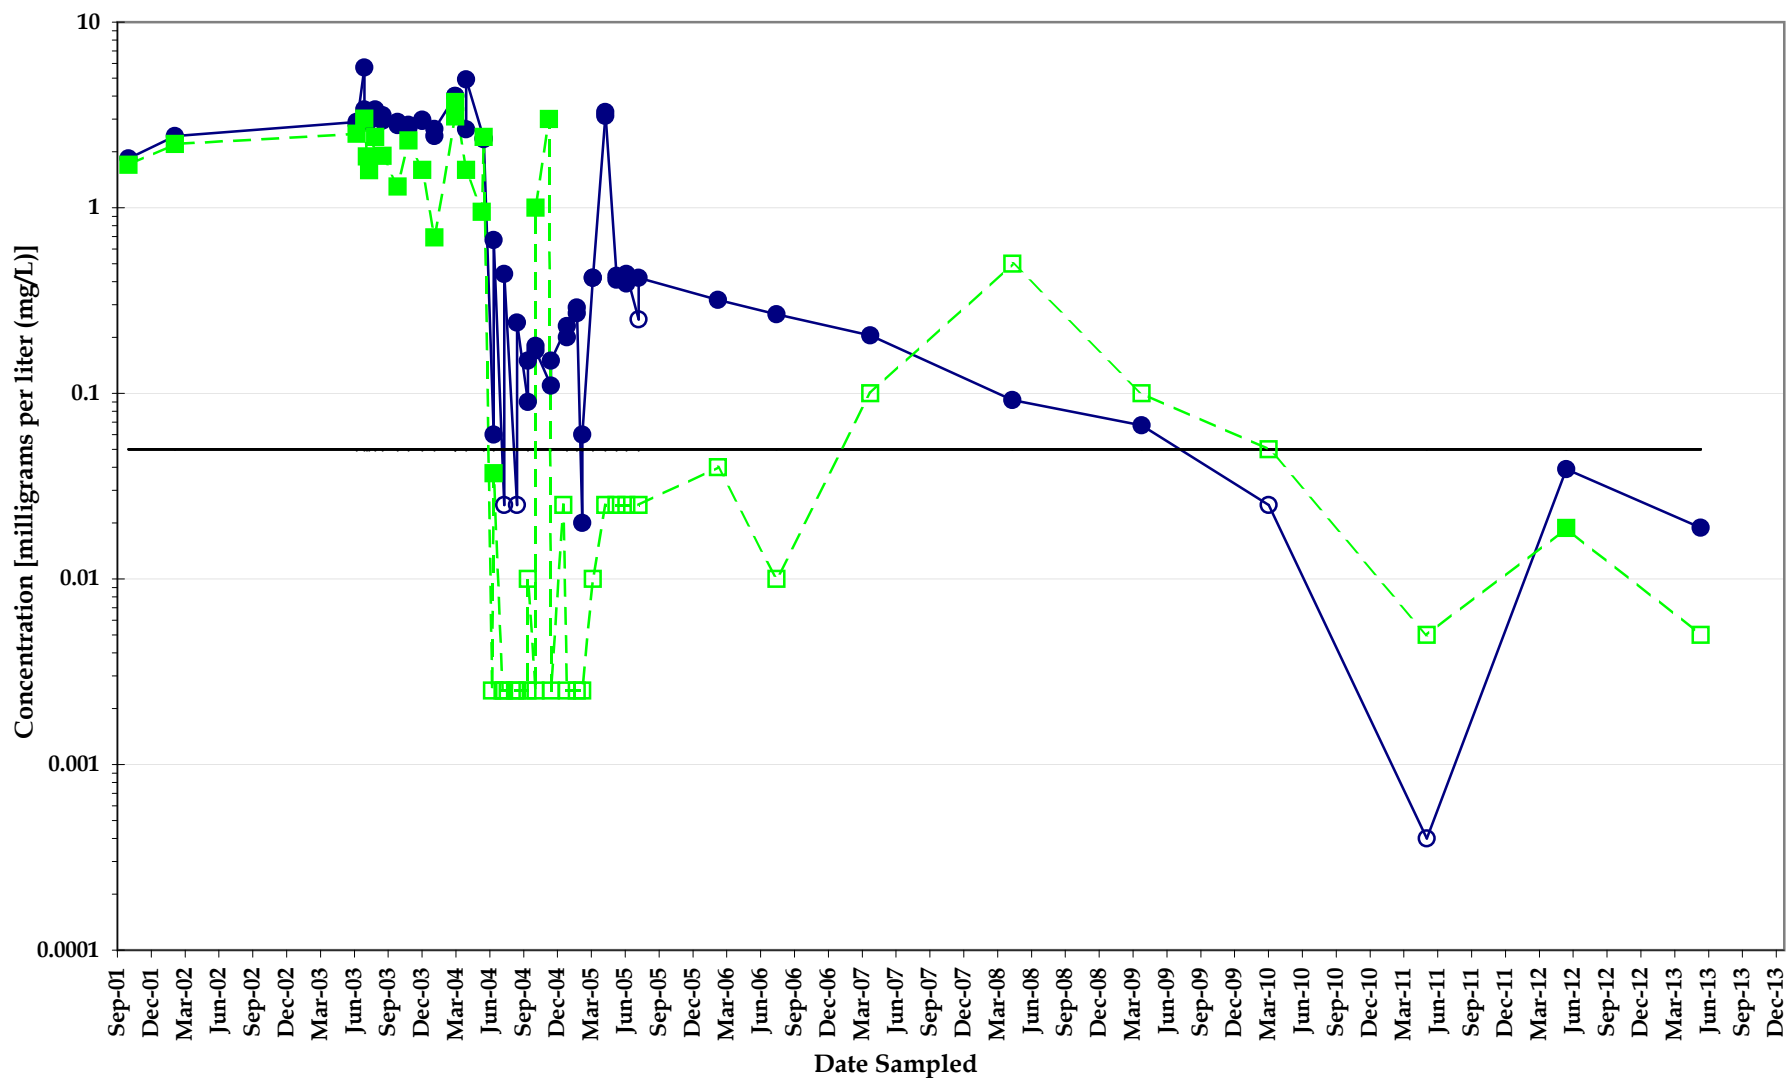
## Chromium Concentrations Monitoring Well MW011M

Note: Non-detect analyses plotted at the method detection limit or half the reporting limit (RL). Detections denoted by symbol and detection values greater than the RL denoted by shaded symbol.

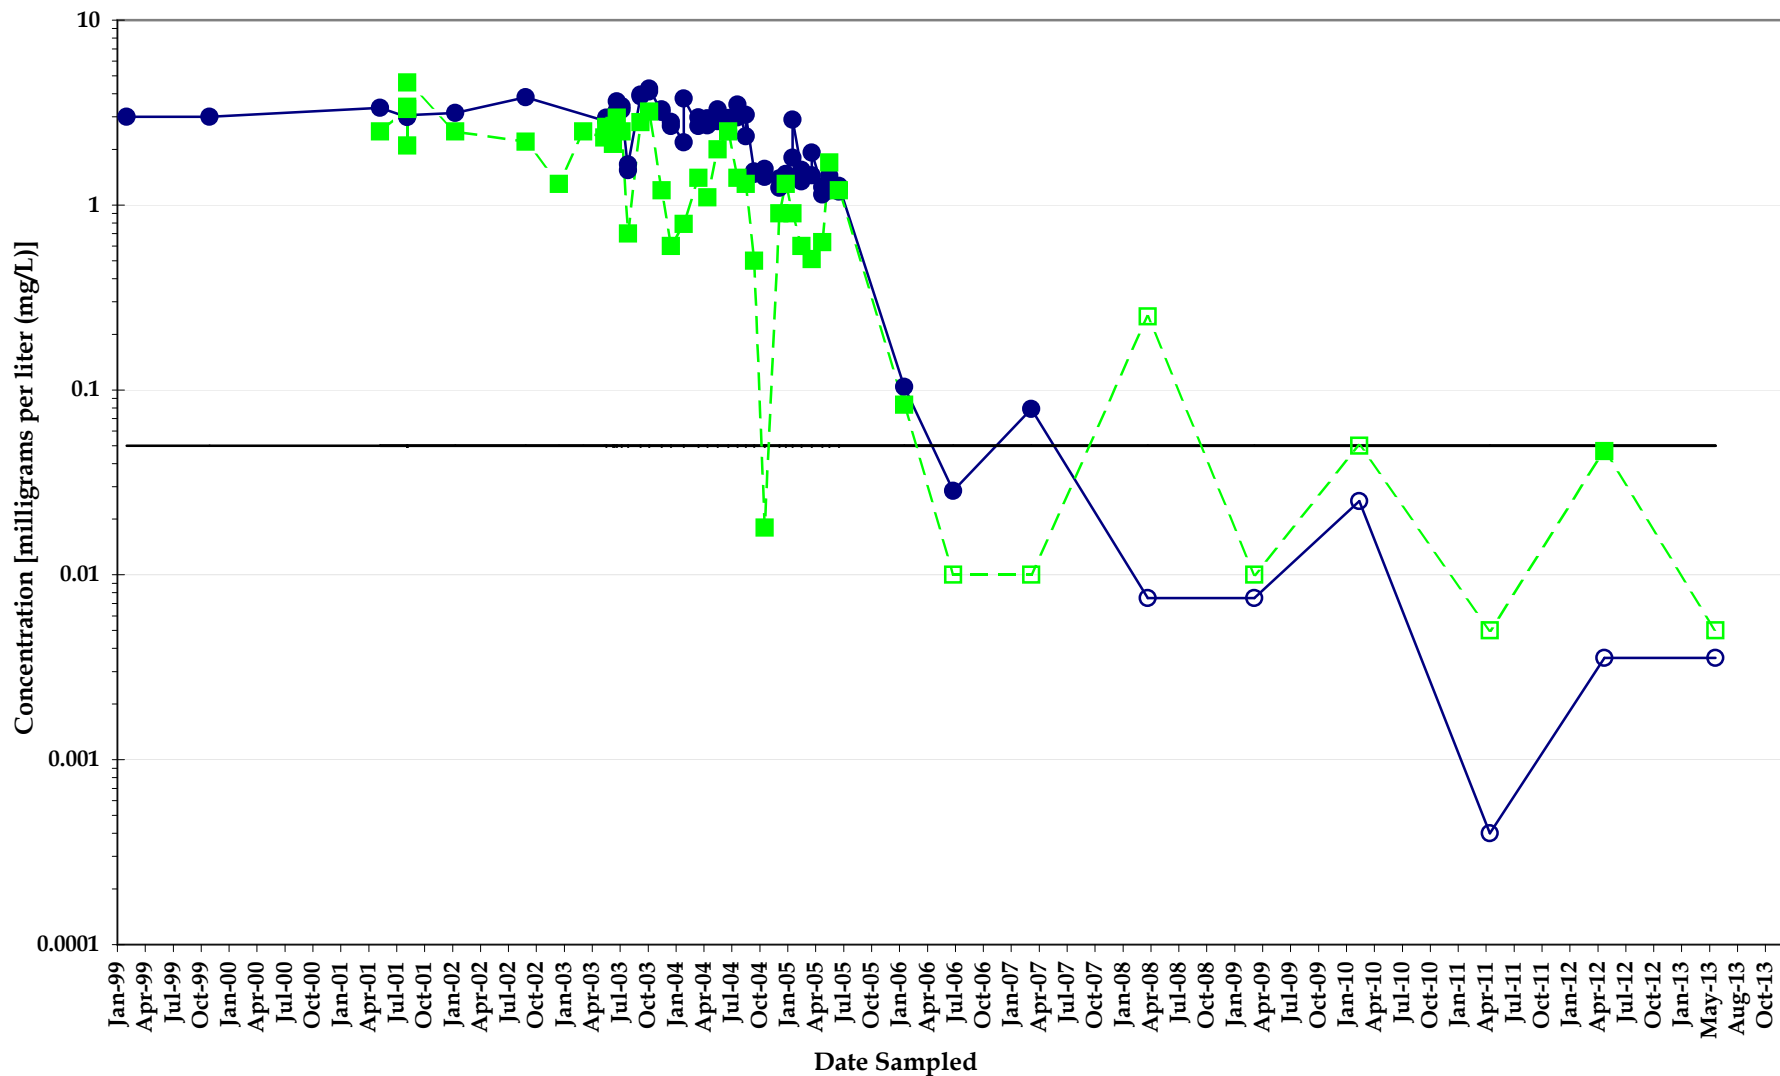
## Chromium Concentrations Monitoring Well MW012

Note: Non-detect analyses plotted at the method detection limit or half the reporting limit (RL). Detections denoted by symbol and detection values greater than the RL denoted by shaded symbol.

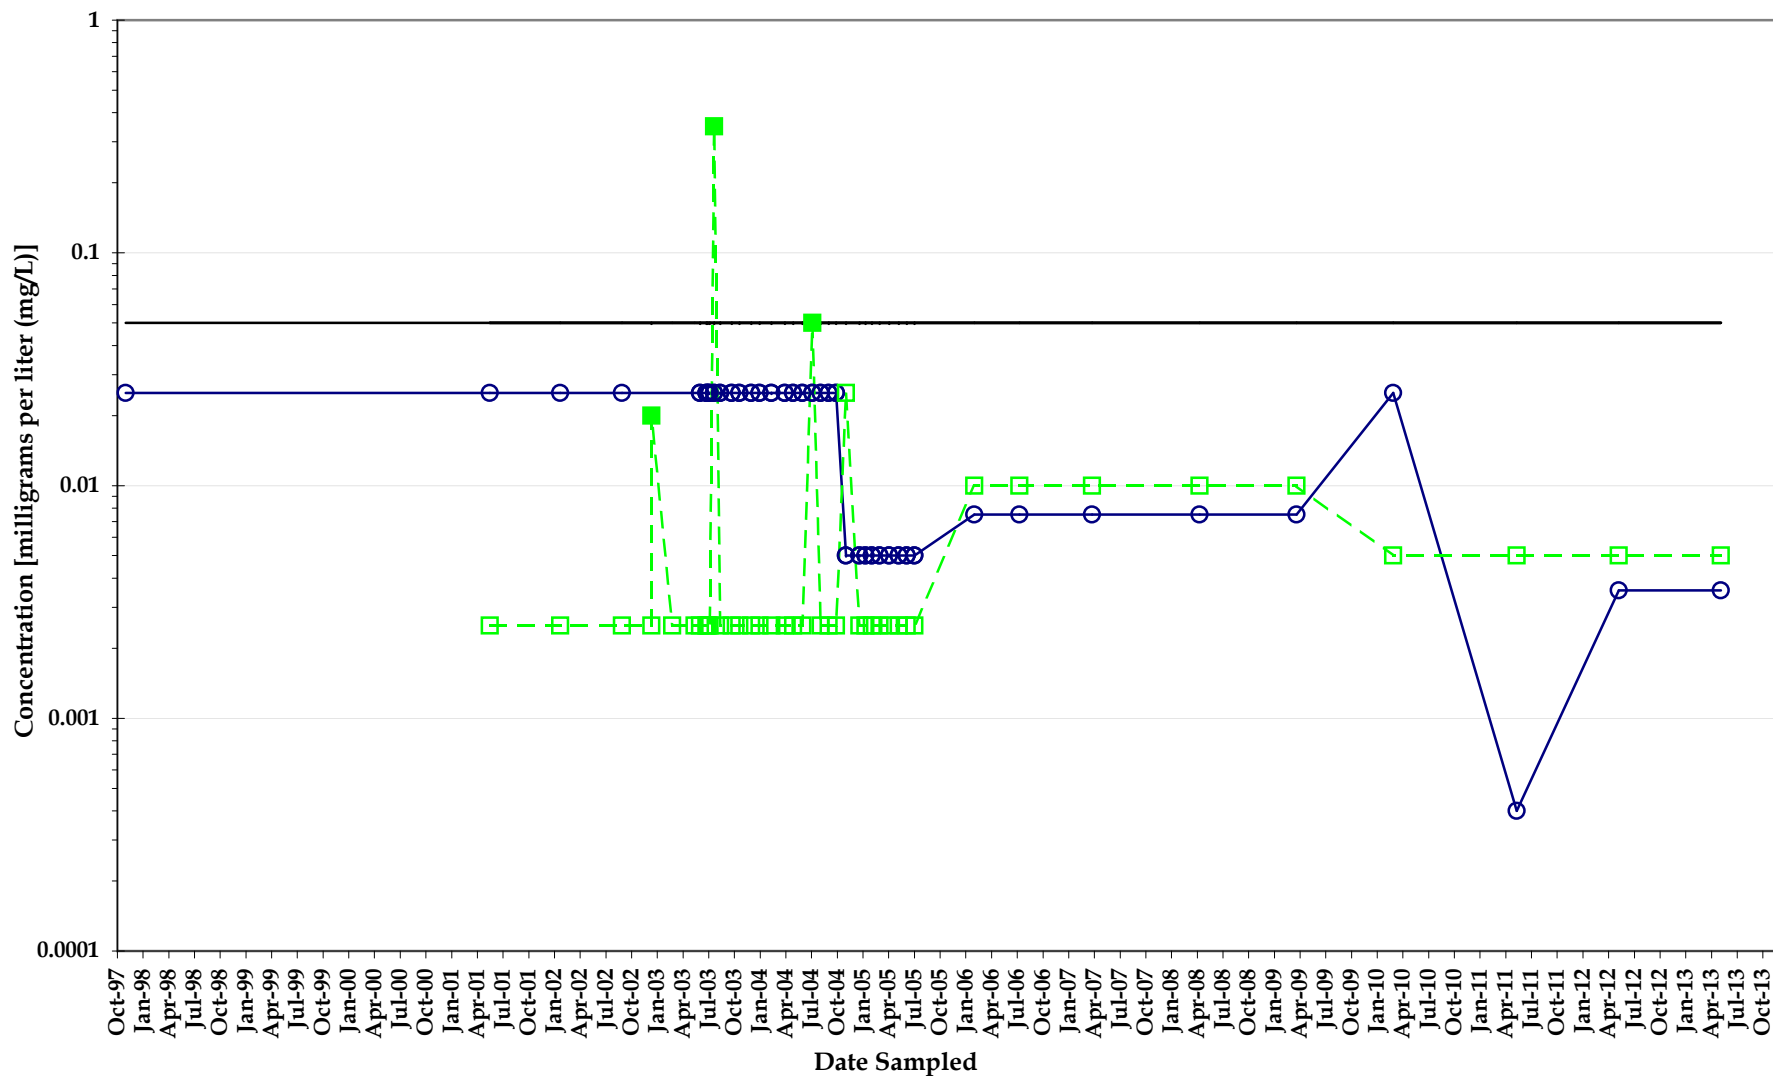
## Chromium Concentrations Monitoring Well MW012A

Note: Non-detect analyses plotted at the method detection limit or half the reporting limit (RL). Detections denoted by symbol and detection values greater than the RL denoted by shaded symbol.
