**GW - 004**

**2013 AGWMR**

**VOL 5 OF 5**

*North Eunice Gas Plant  
Lea County, New Mexico*

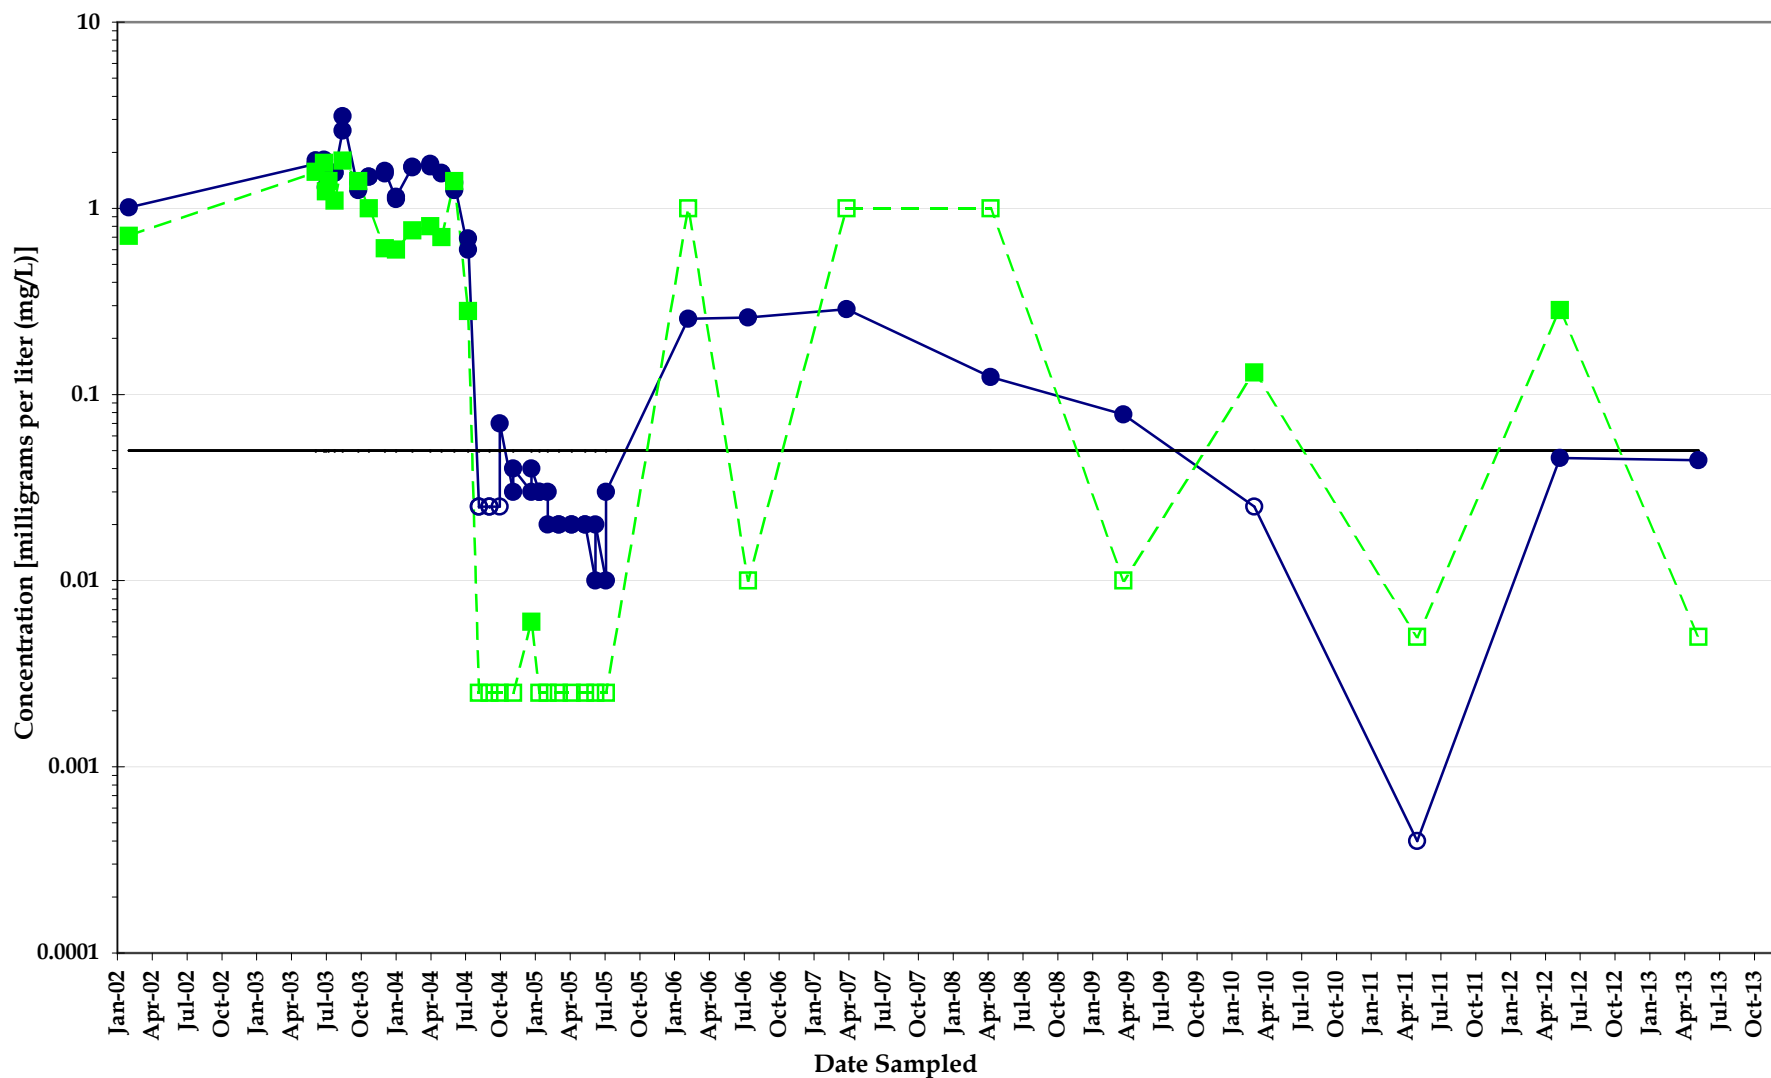
## Chromium Concentrations Monitoring Well MW012M

Note: Non-detect analyses plotted at the method detection limit or half the reporting limit (RL). Detections denoted by symbol and detection values greater than the RL denoted by shaded symbol.

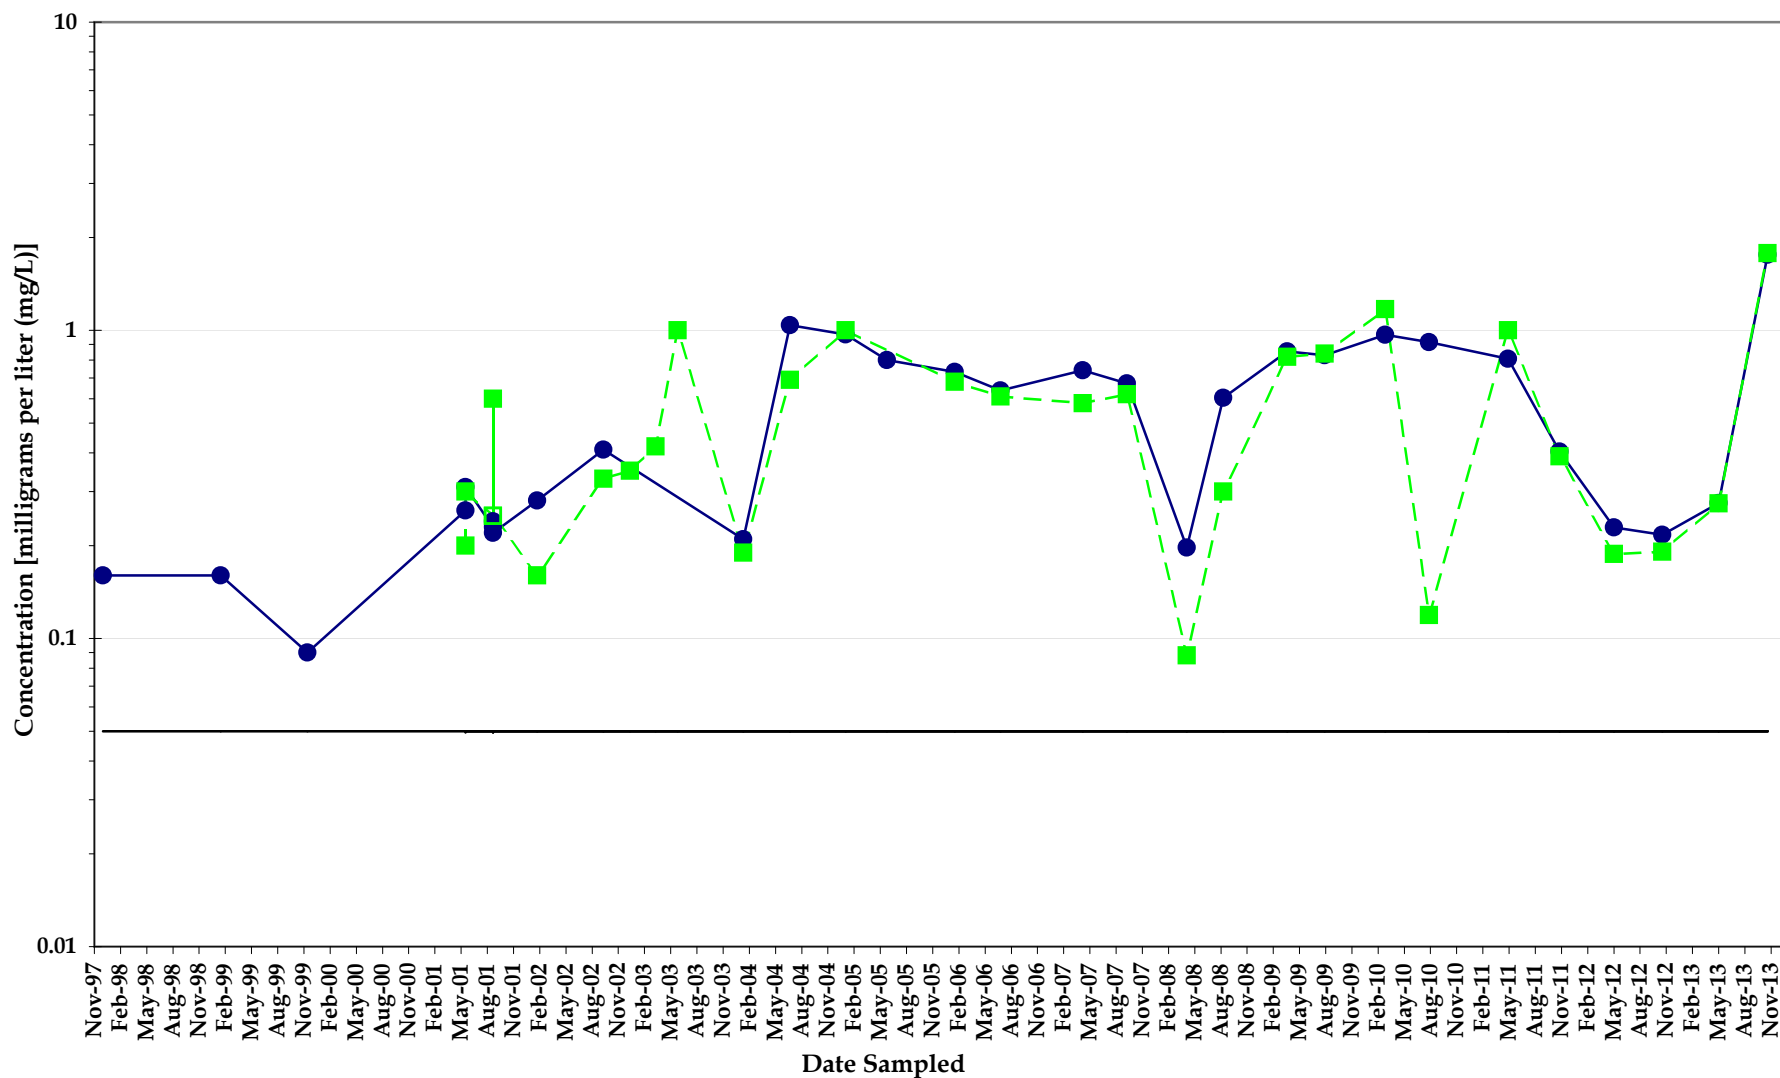
## Chromium Concentrations Monitoring Well MW013

Note: Non-detect analyses plotted at the method detection limit or half the reporting limit (RL). Detections denoted by symbol and detection values greater than the RL denoted by shaded symbol.

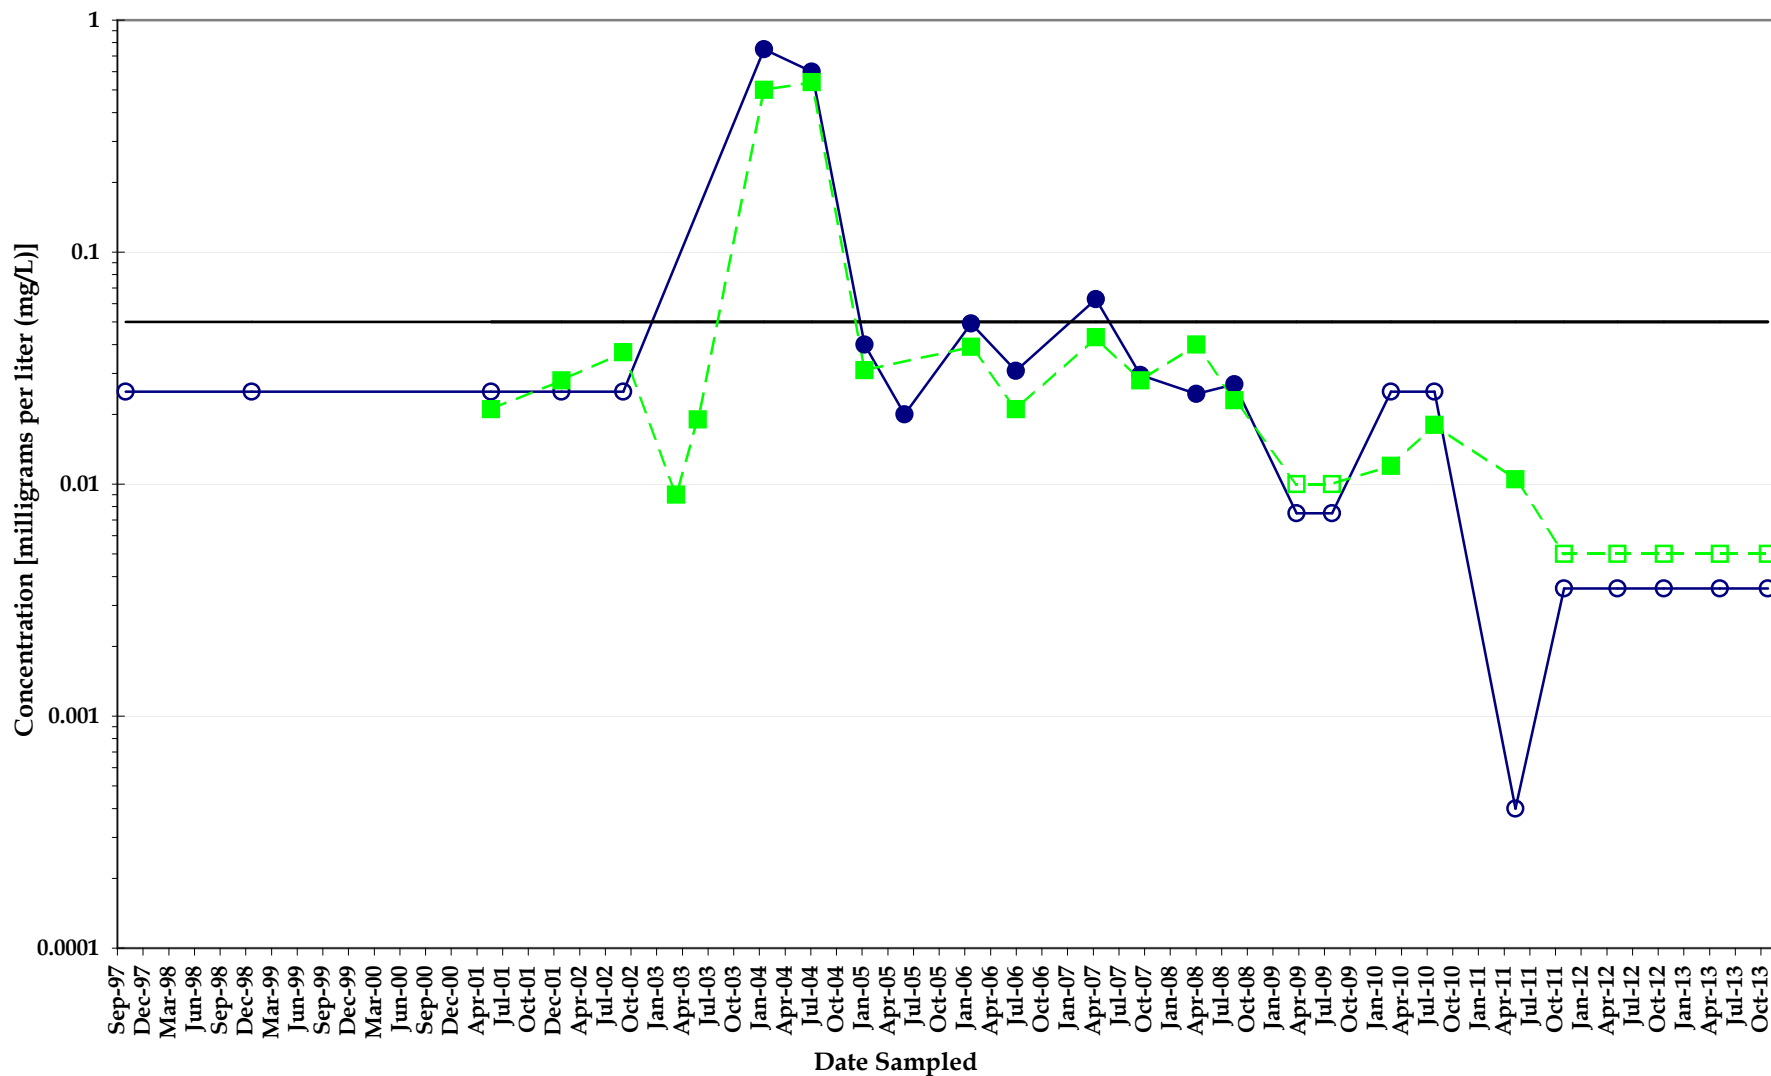
## Chromium Concentrations Monitoring Well MW013A

Note: Non-detect analyses plotted at the method detection limit or half the reporting limit (RL). Detections denoted by symbol and detection values greater than the RL denoted by shaded symbol.

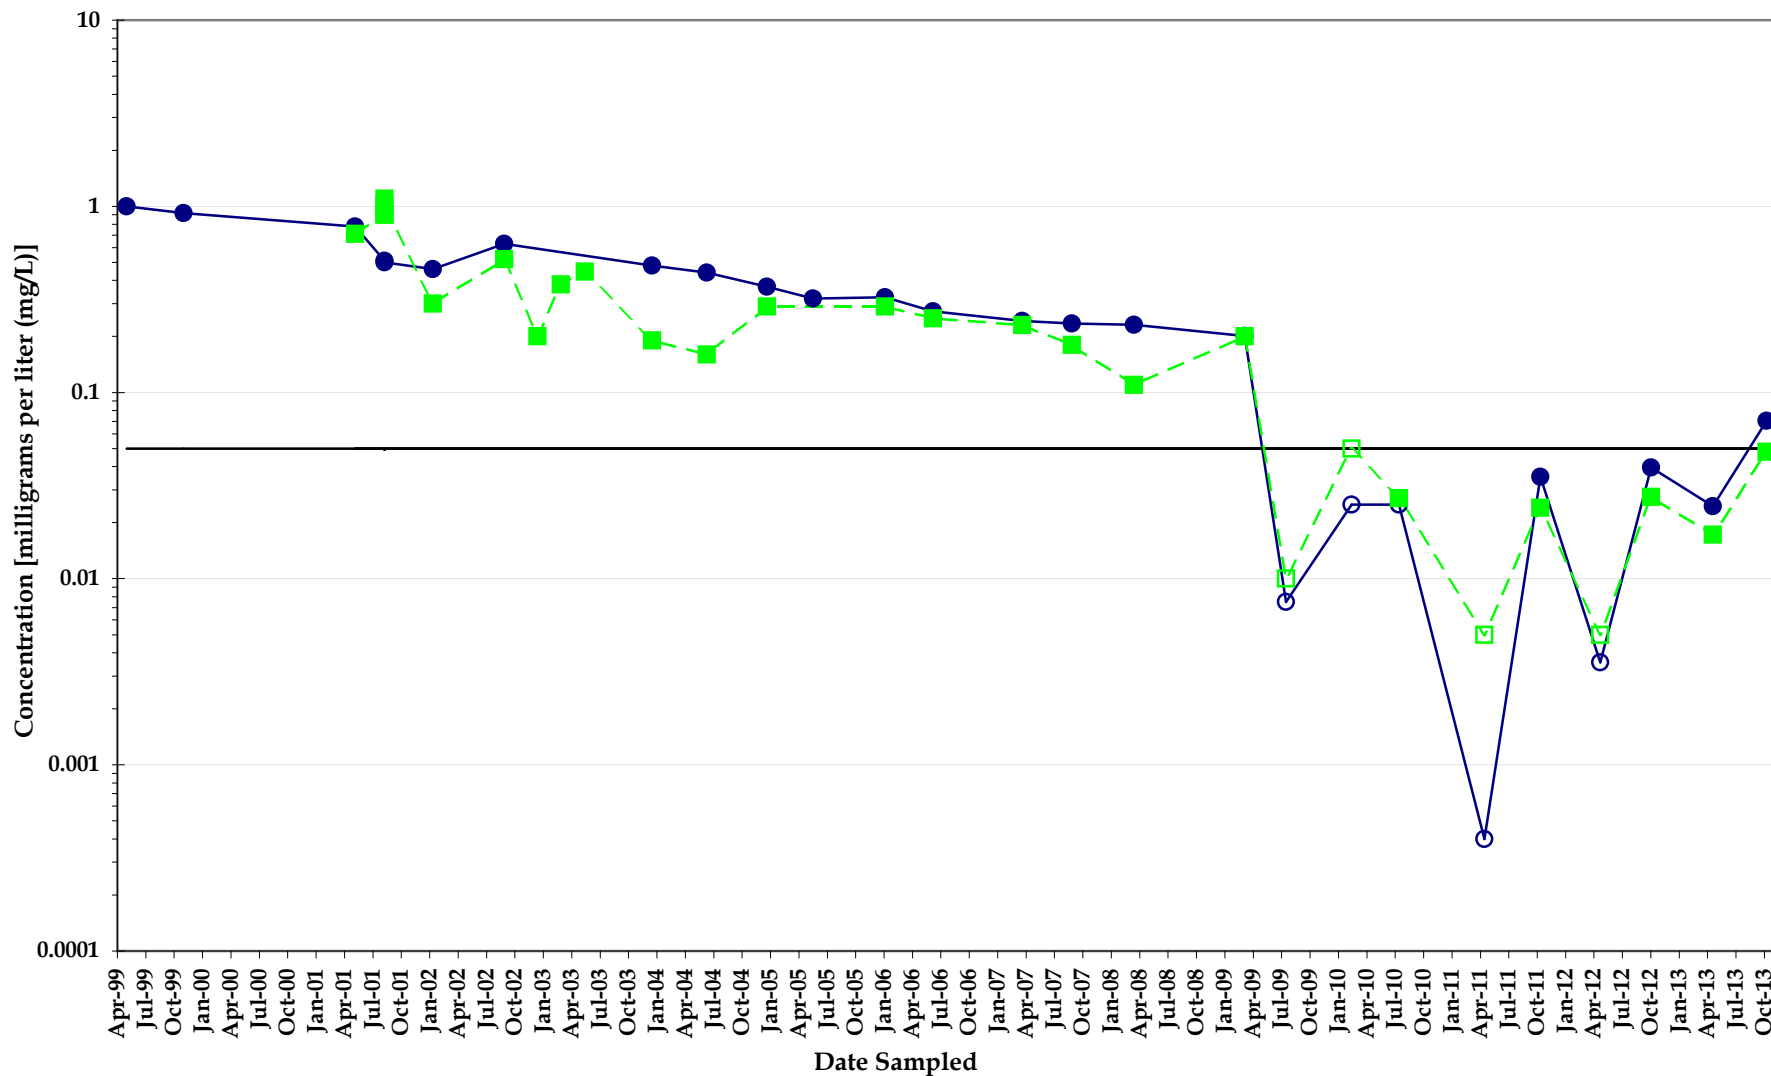
## Chromium Concentrations Monitoring Well MW014

Note: Non-detect analyses plotted at the method detection limit or half the reporting limit (RL). Detections denoted by symbol and detection values greater than the RL denoted by shaded symbol.

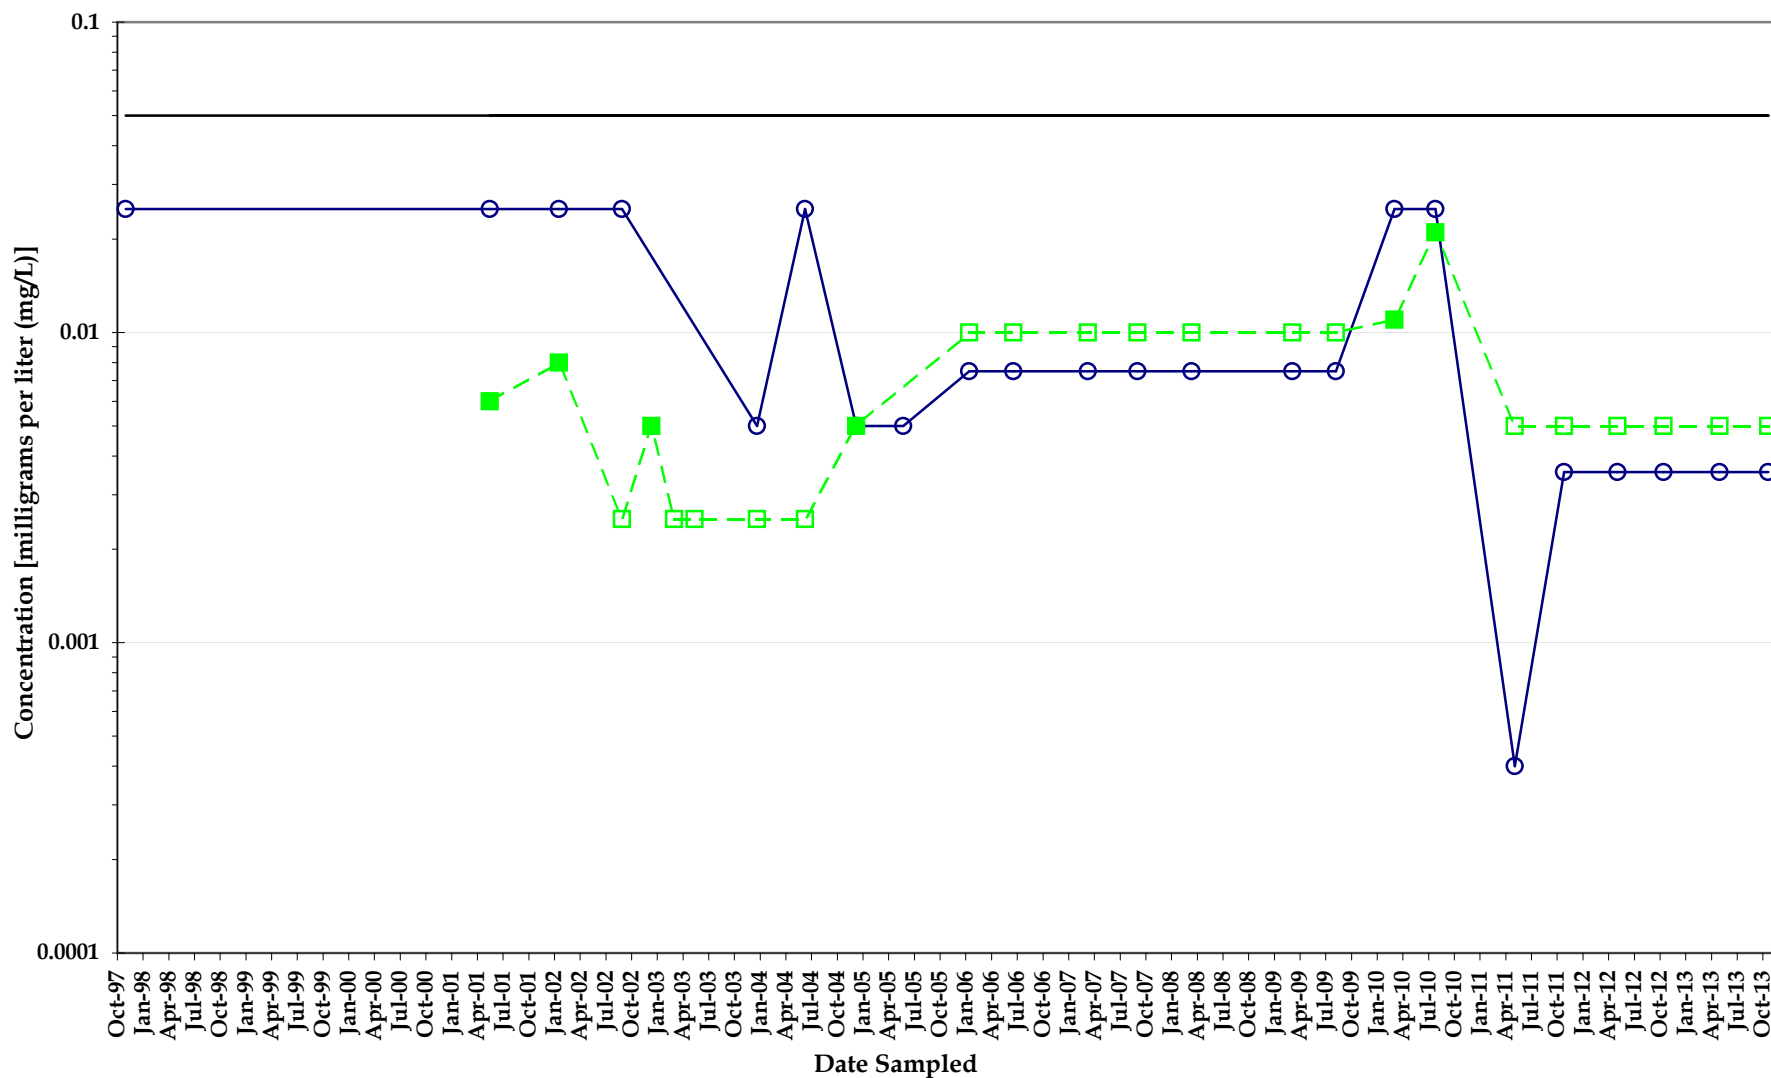
## Chromium Concentrations Monitoring Well MW014A

Note: Non-detect analyses plotted at the method detection limit or half the reporting limit (RL). Detections denoted by symbol and detection values greater than the RL denoted by shaded symbol.

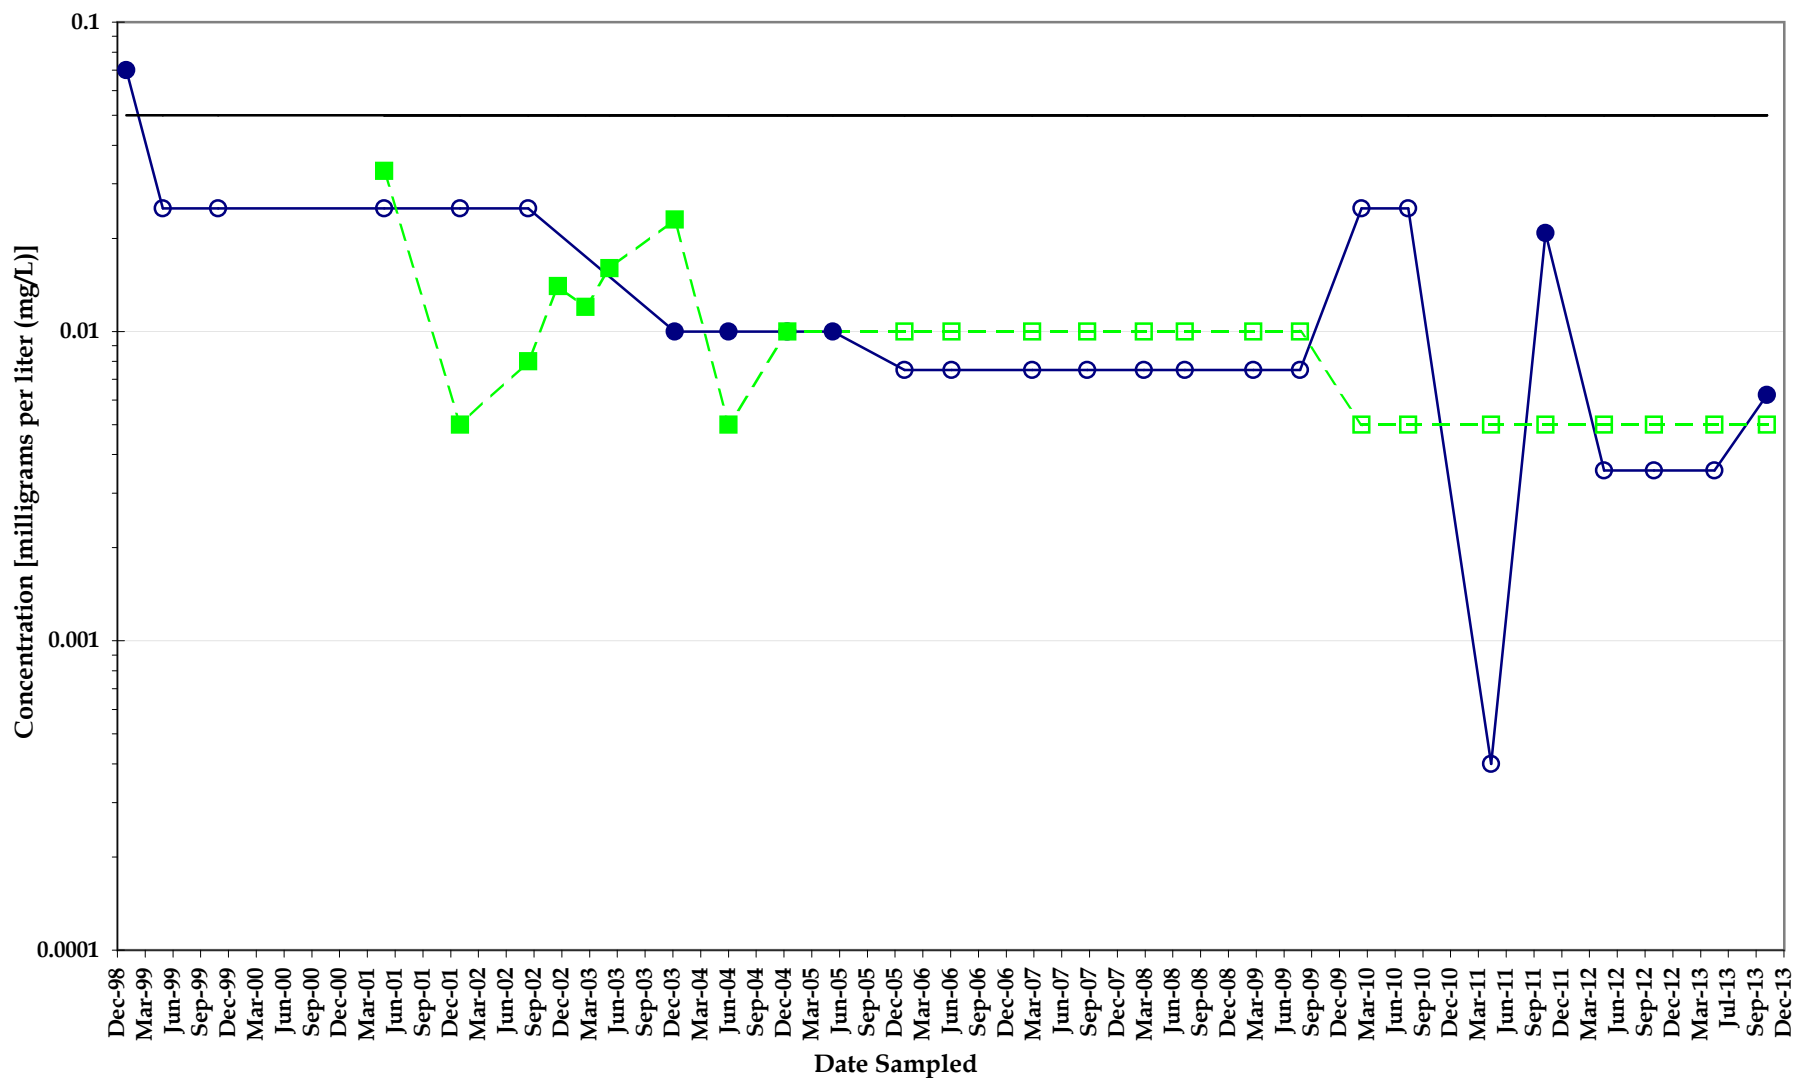
## Chromium Concentrations Monitoring Well MW015

Note: Non-detect analyses plotted at the method detection limit or half the reporting limit (RL). Detections denoted by symbol and detection values greater than the RL denoted by shaded symbol.

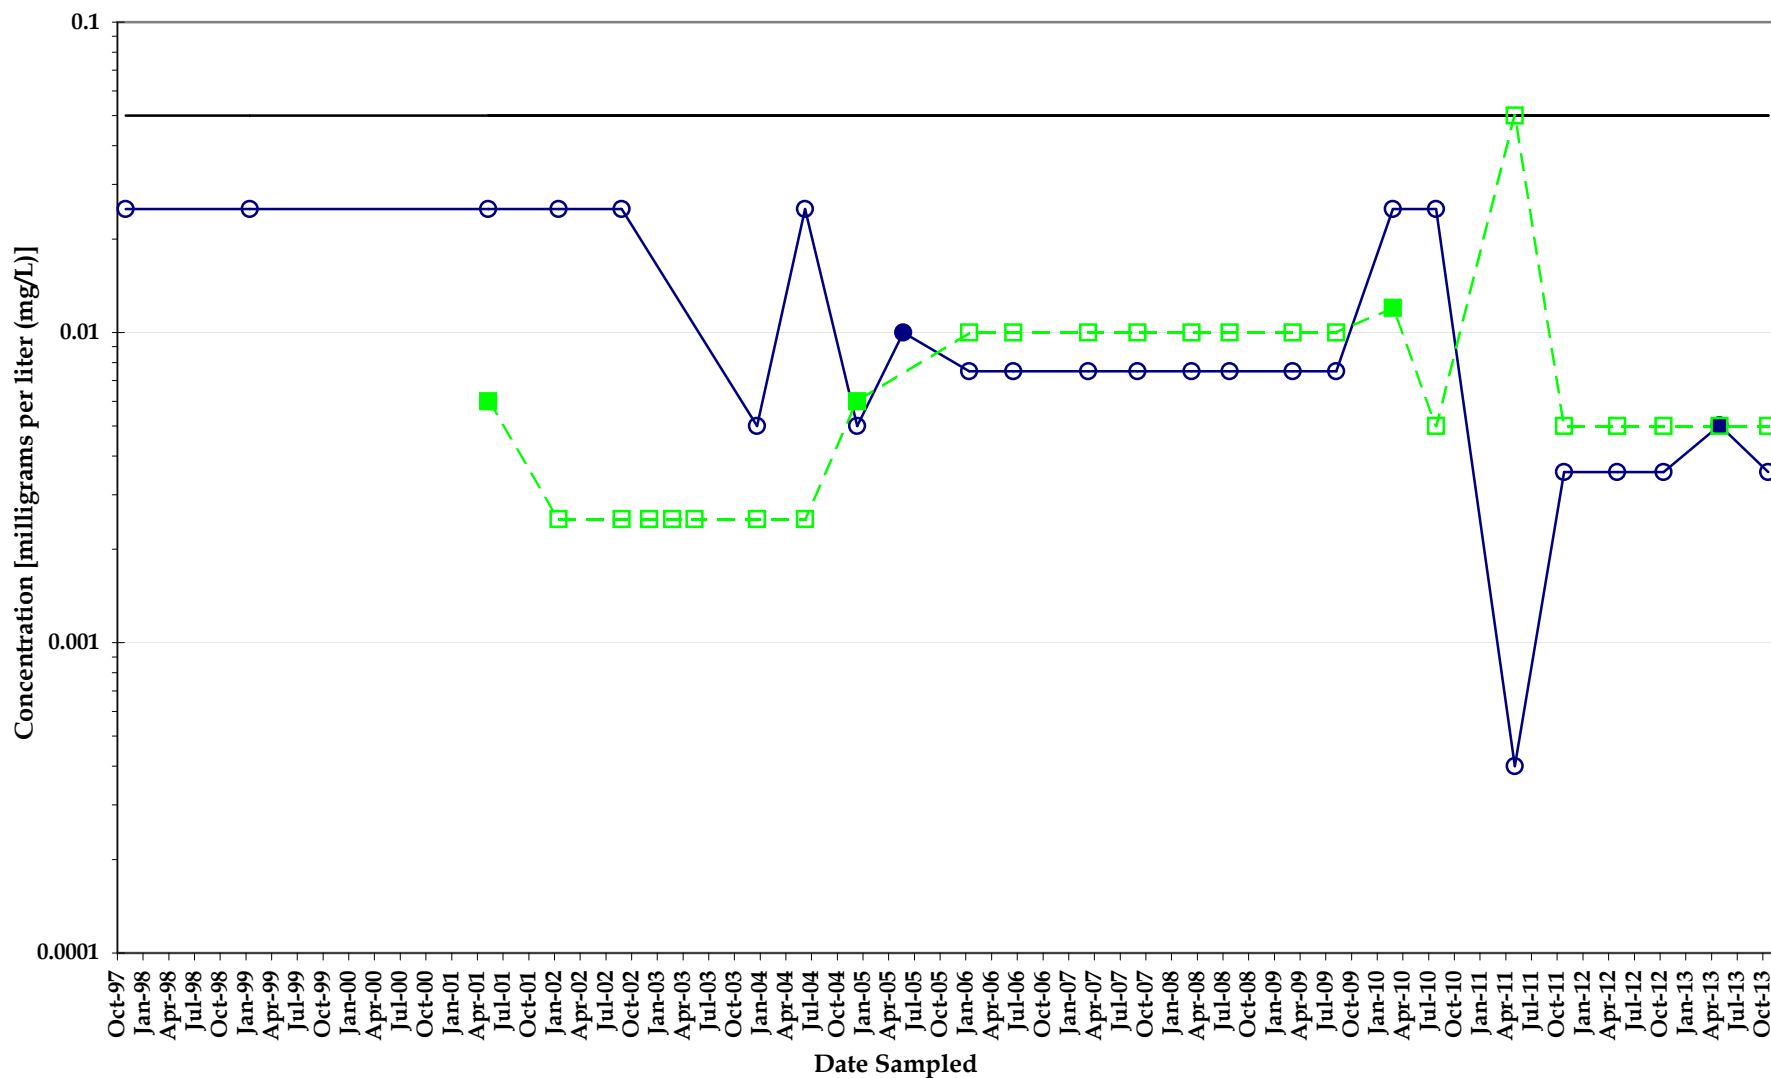
## Chromium Concentrations Monitoring Well MW015A

Note: Non-detect analyses plotted at the method detection limit or half the reporting limit (RL). Detections denoted by symbol and detection values greater than the RL denoted by shaded symbol.

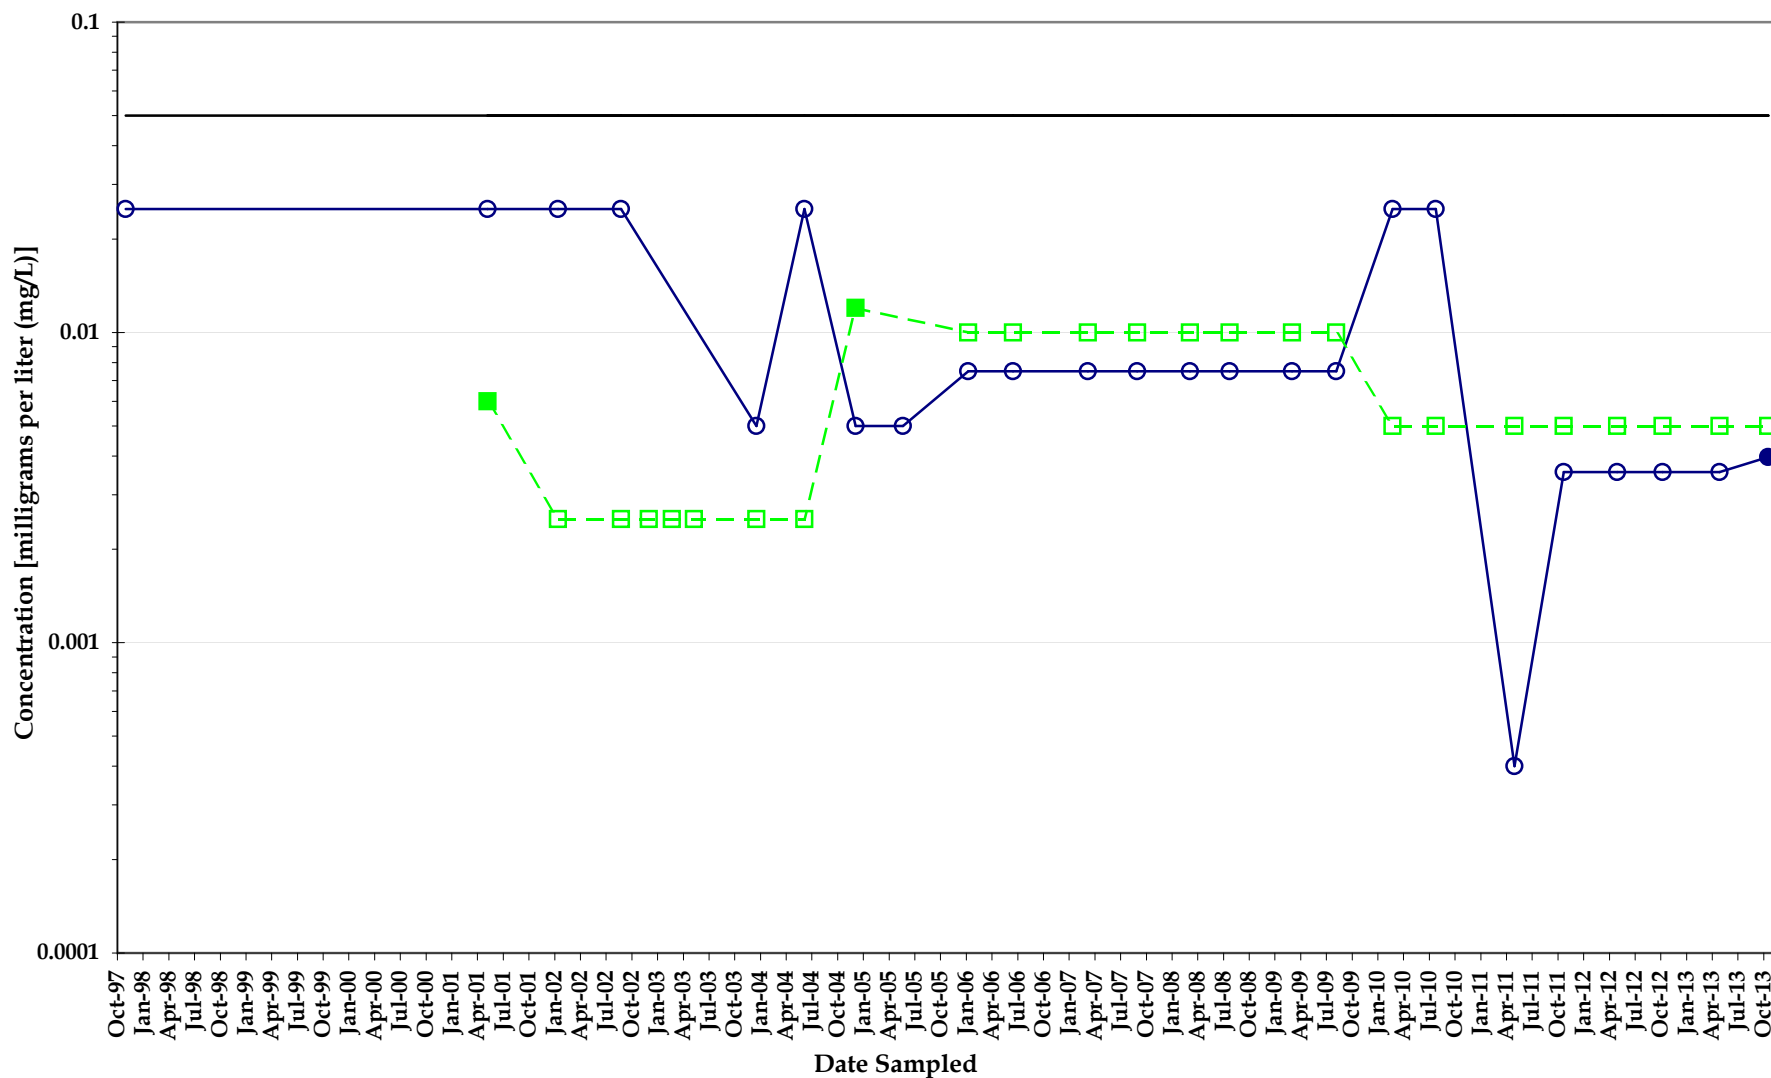
## Chromium Concentrations Monitoring Well MW016A

Note: Non-detect analyses plotted at the method detection limit or half the reporting limit (RL). Detections denoted by symbol and detection values greater than the RL denoted by shaded symbol.

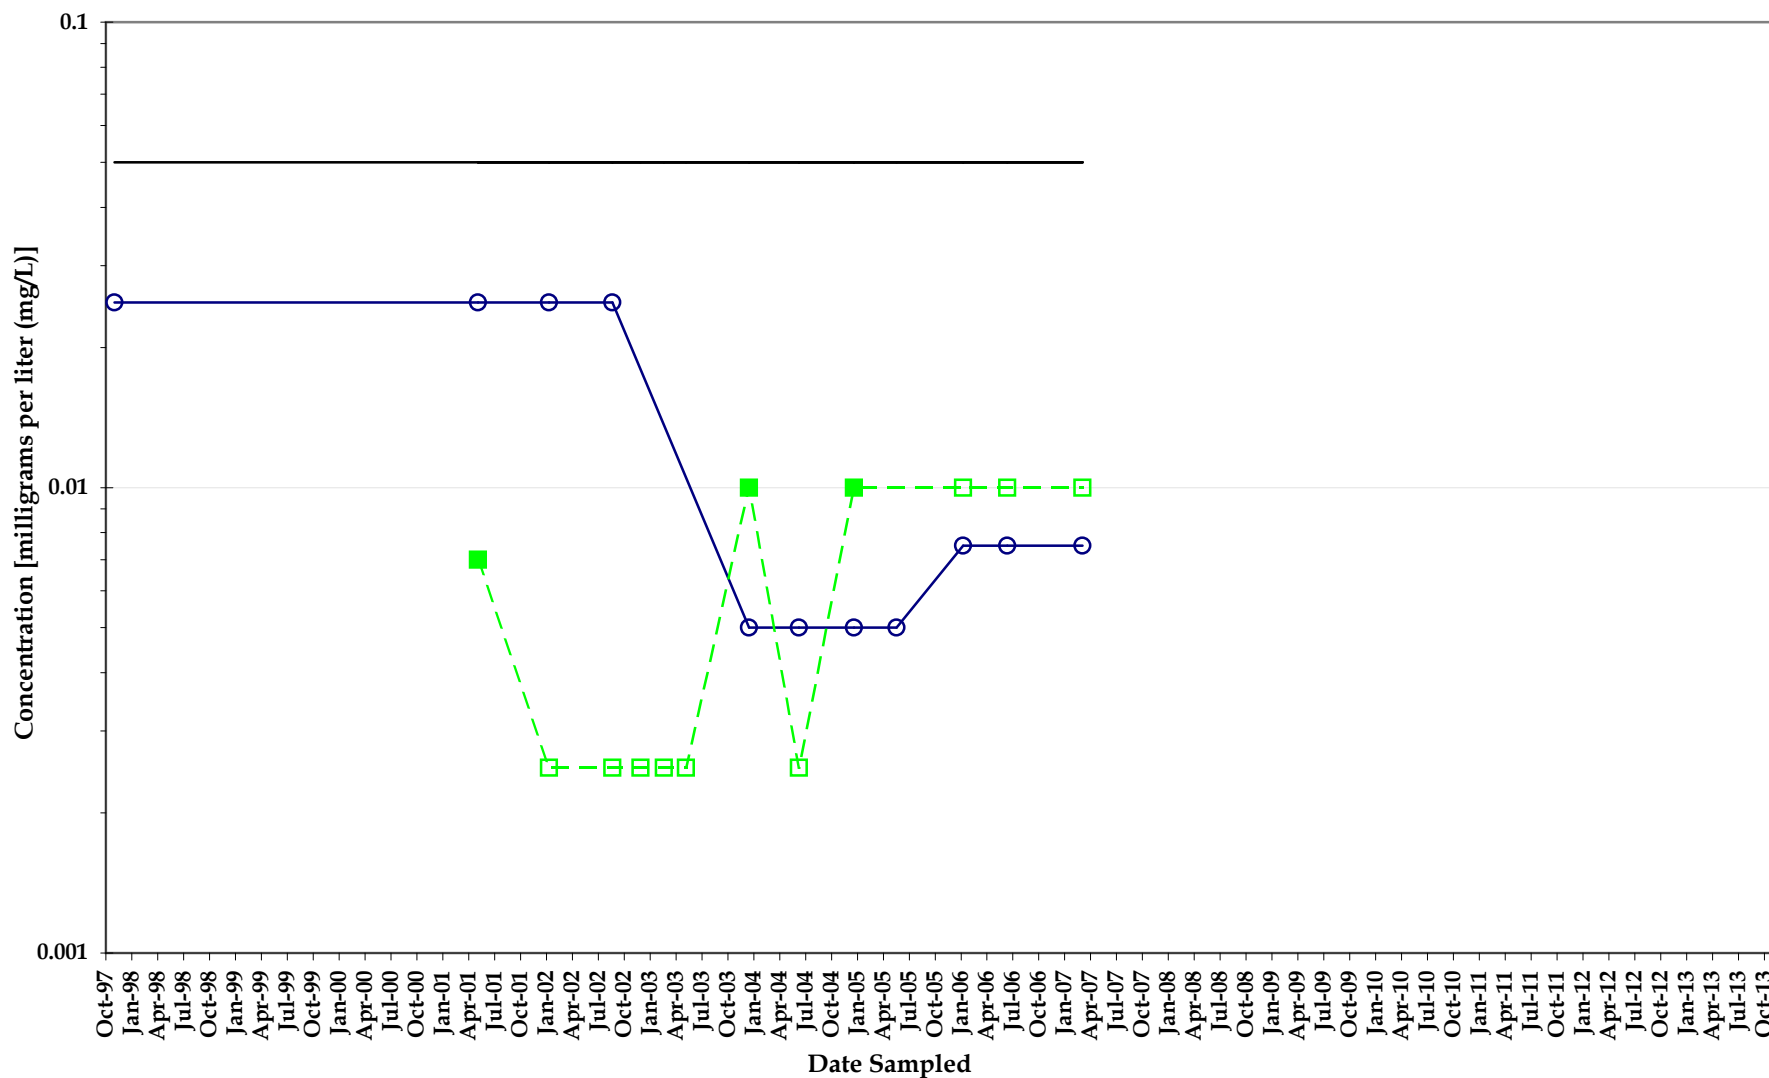
## Chromium Concentrations Monitoring Well MW017A

Note: Non-detect analyses plotted at the method detection limit or half the reporting limit (RL). Detections denoted by symbol and detection values greater than the RL denoted by shaded symbol.

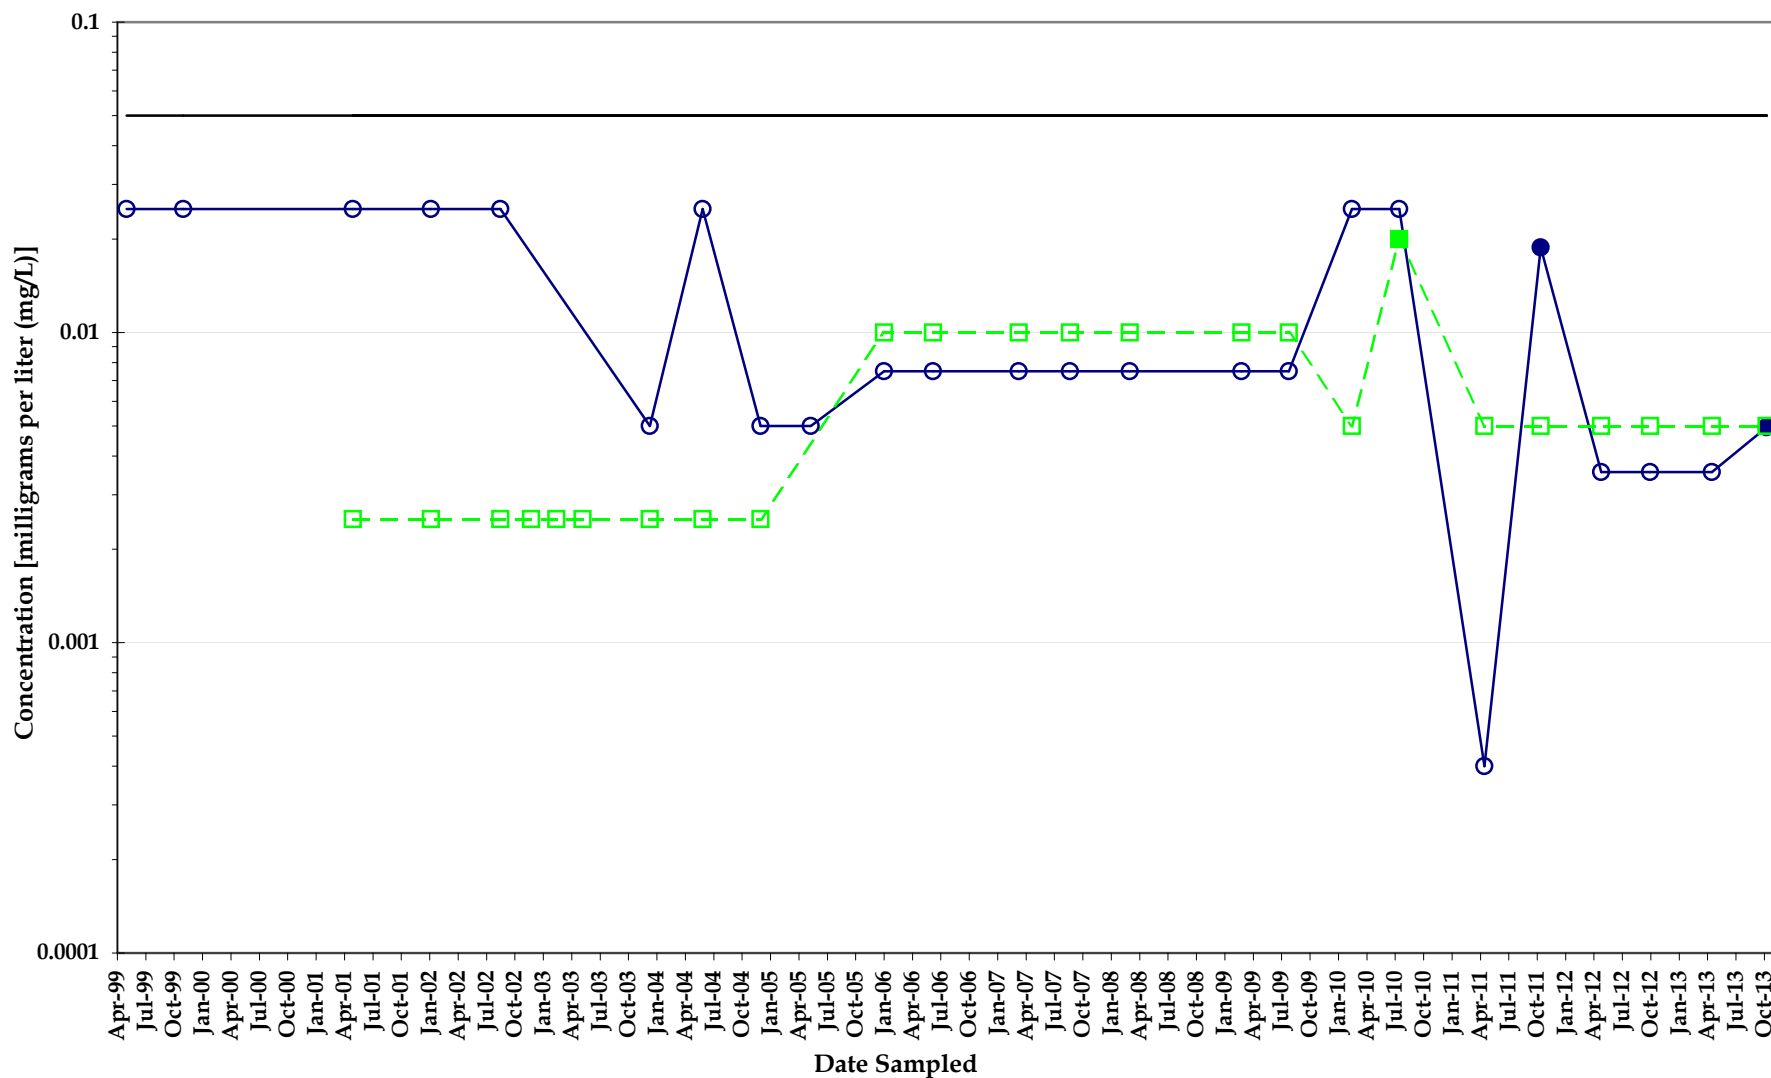
## Chromium Concentrations Monitoring Well MW018

Note: Non-detect analyses plotted at the method detection limit or half the reporting limit (RL). Detections denoted by symbol and detection values greater than the RL denoted by shaded symbol.

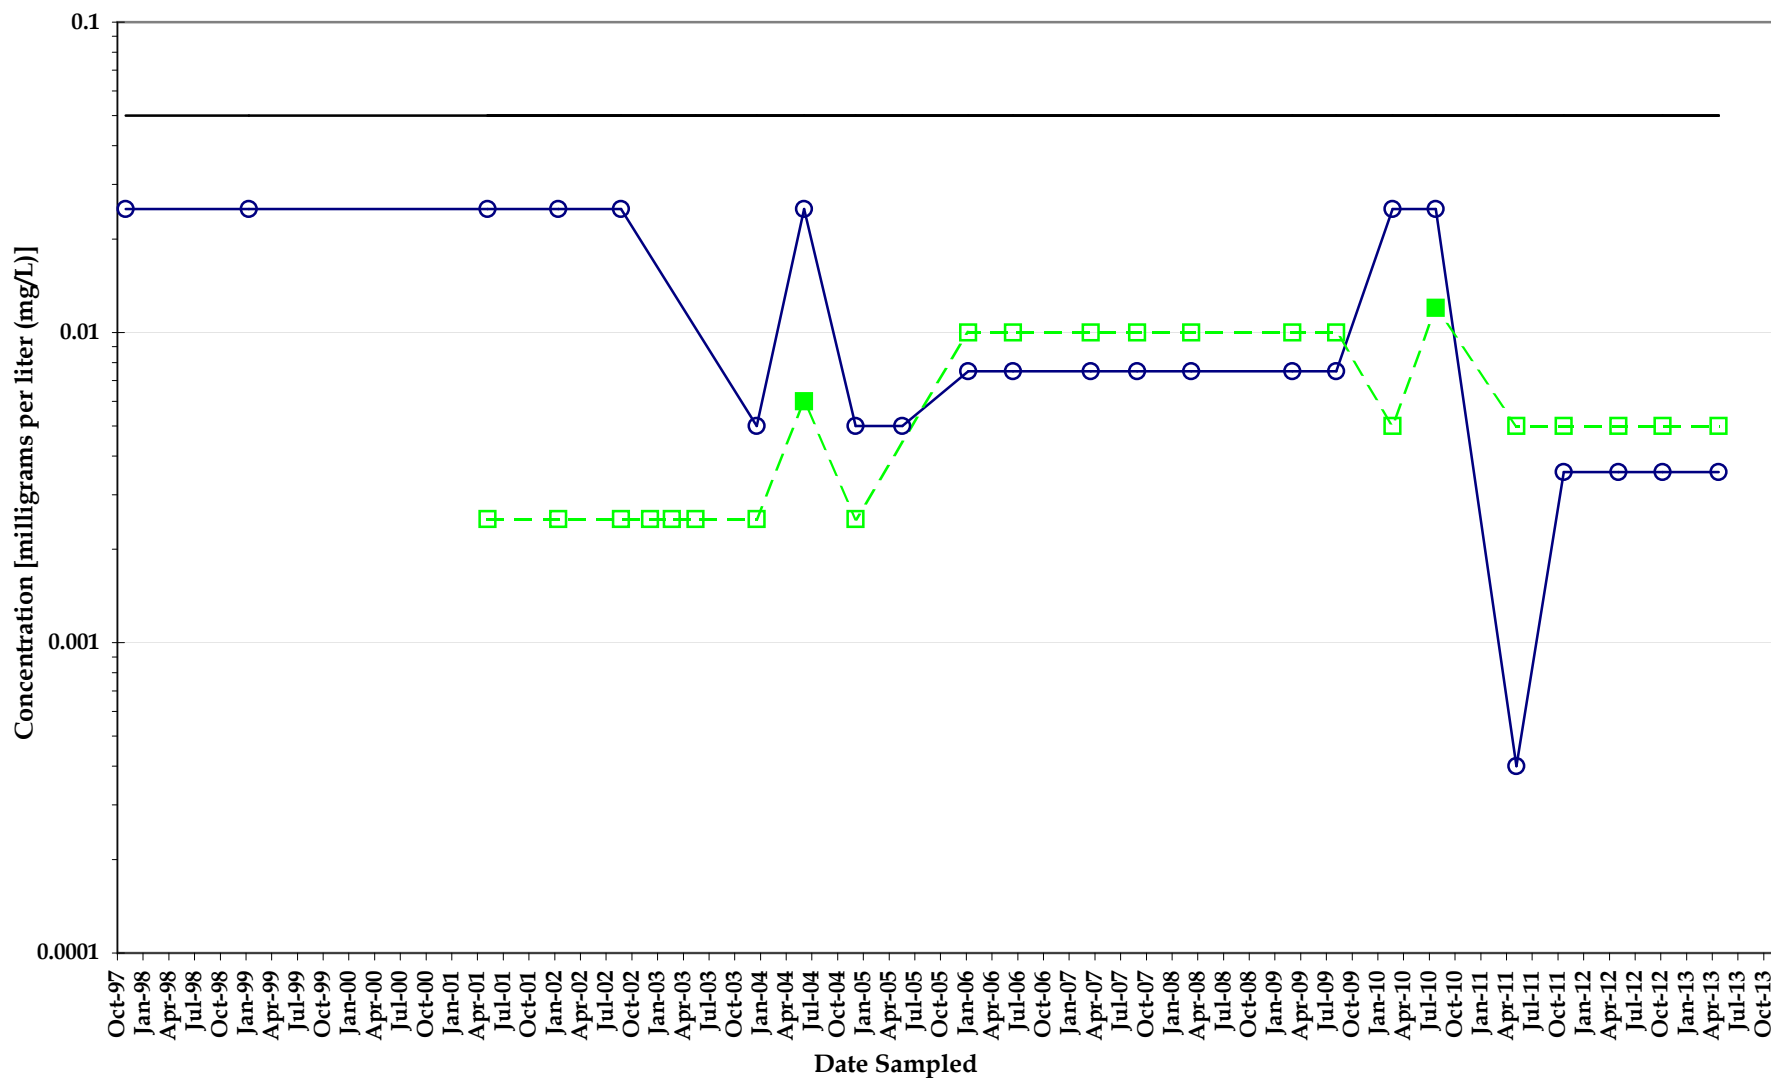
## Chromium Concentrations Monitoring Well MW018A

Note: Non-detect analyses plotted at the method detection limit or half the reporting limit (RL). Detections denoted by symbol and detection values greater than the RL denoted by shaded symbol.
