**GW - 004**

**2013 AGWMR**

**VOL 5 OF 5**

*North Eunice Gas Plant  
Lea County, New Mexico*

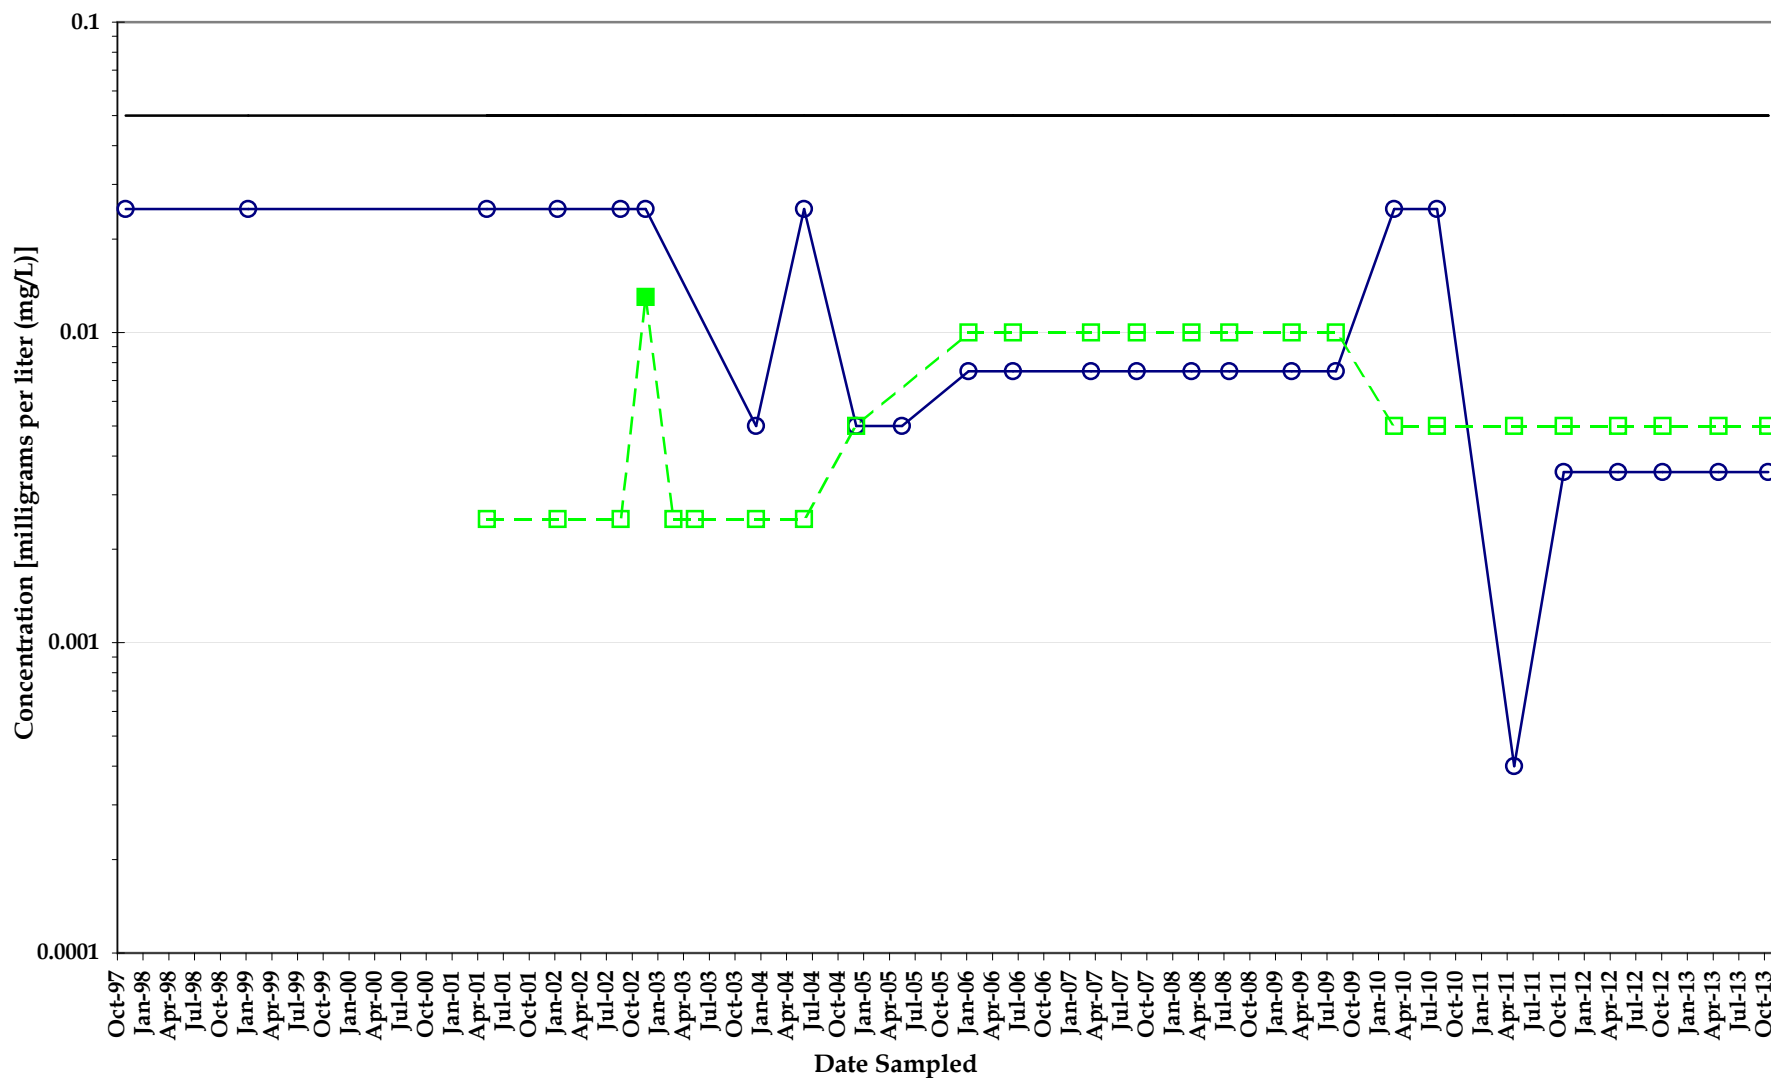
## Chromium Concentrations Monitoring Well MW019A

Note: Non-detect analyses plotted at the method detection limit or half the reporting limit (RL). Detections denoted by symbol and detection values greater than the RL denoted by shaded symbol.

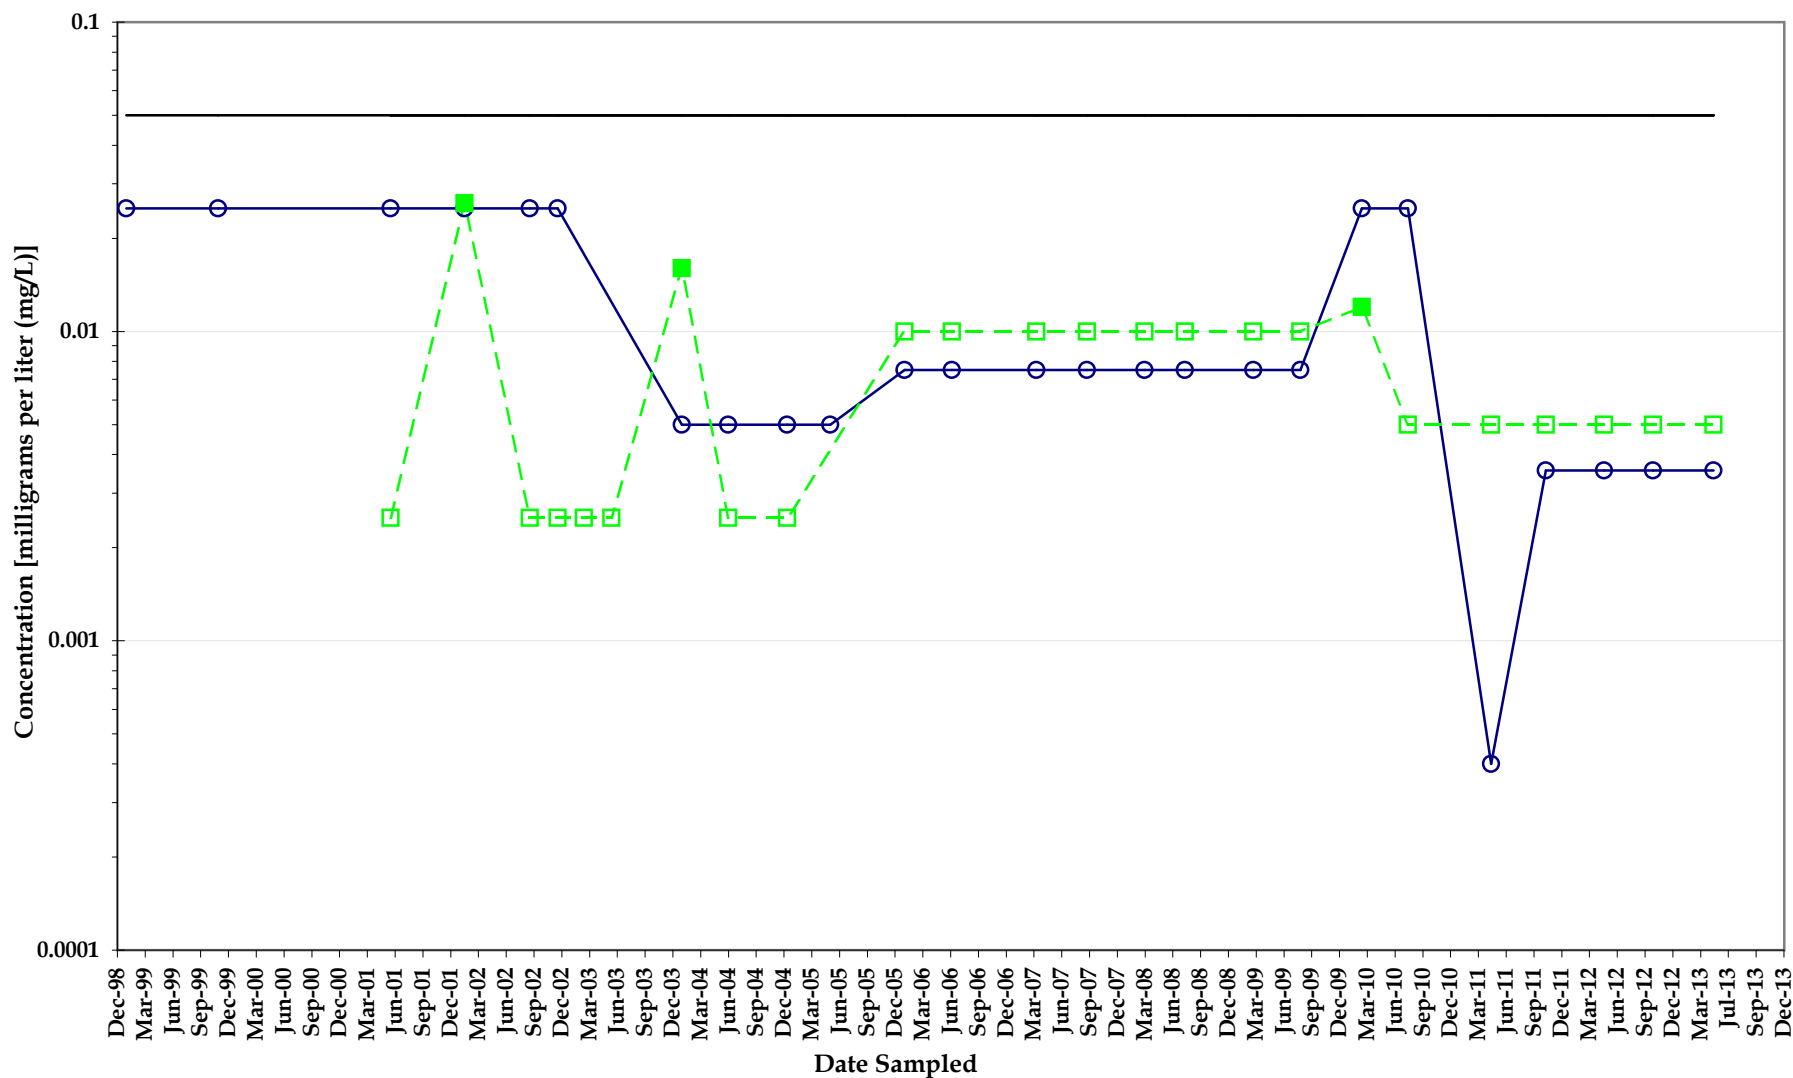
## Chromium Concentrations Monitoring Well MW020

Note: Non-detect analyses plotted at the method detection limit or half the reporting limit (RL). Detections denoted by symbol and detection values greater than the RL denoted by shaded symbol.

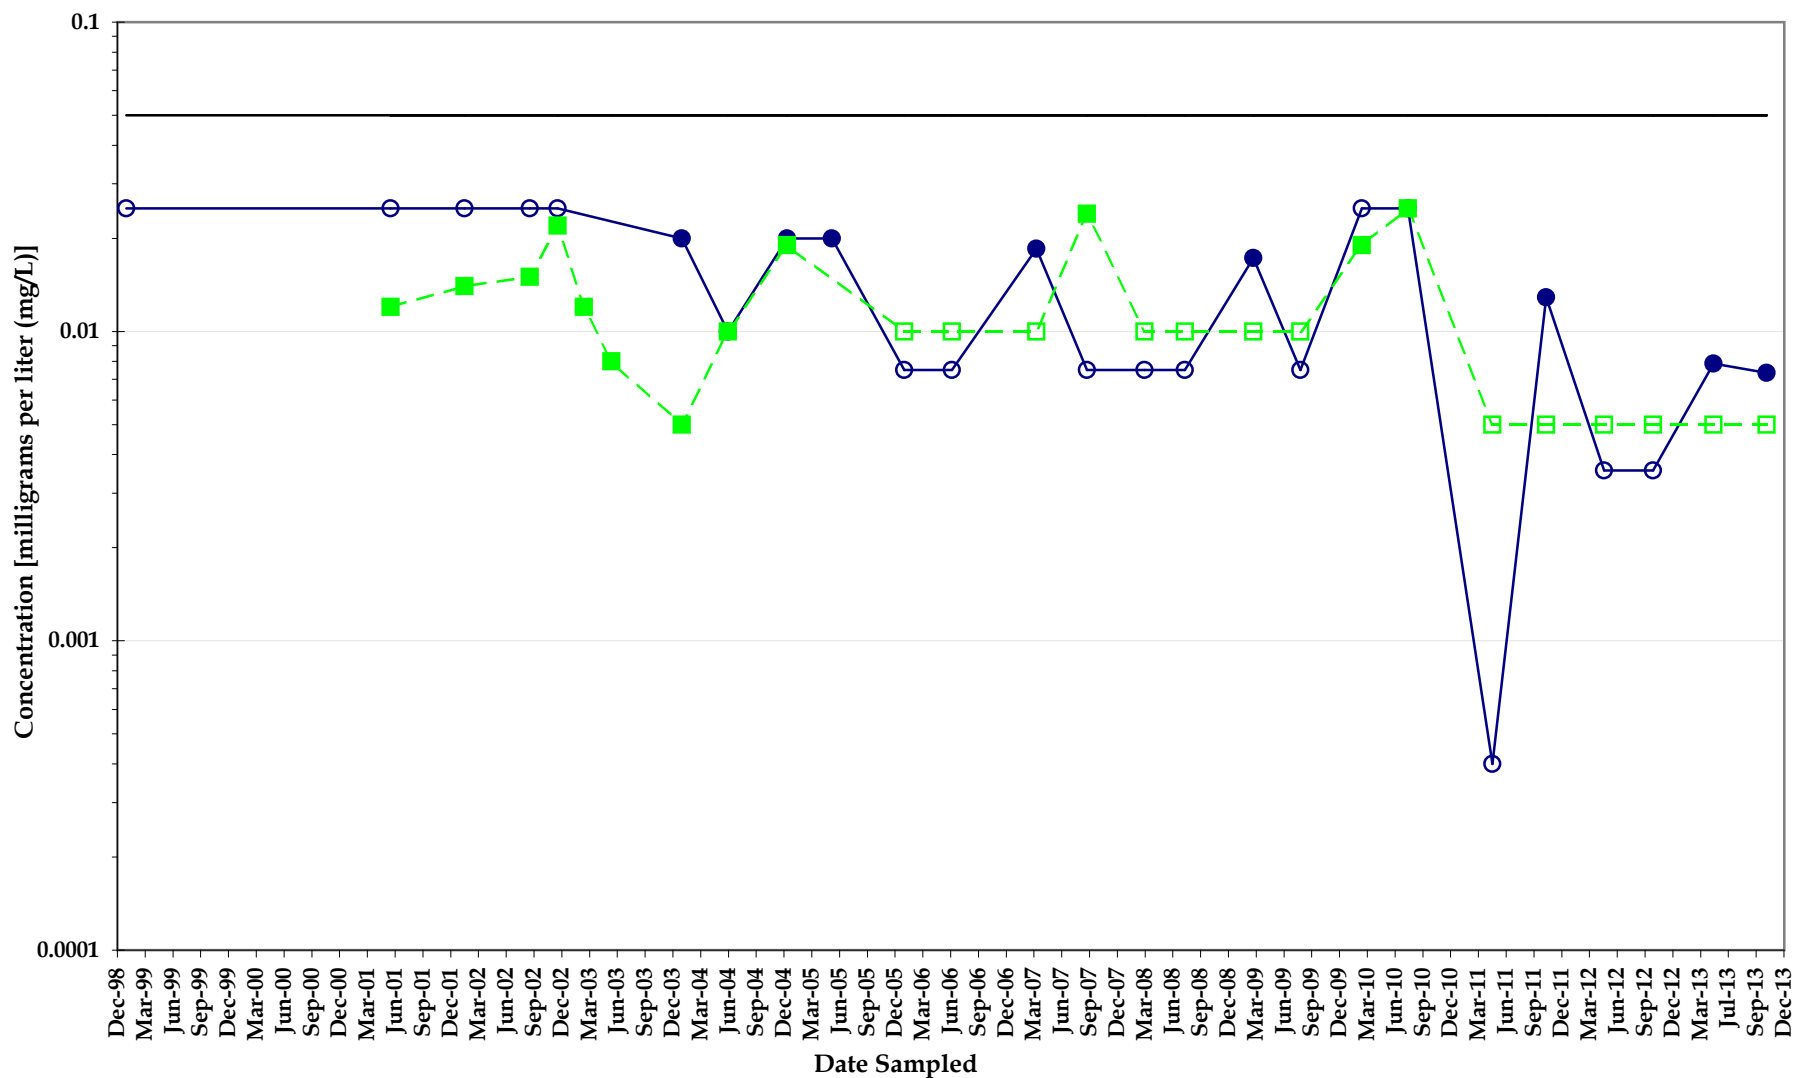
# Chromium Concentrations Monitoring Well MW020A

Note: Non-detect analyses plotted at the method detection limit or half the reporting limit (RL). Detections denoted by symbol and detection values greater than the RL denoted by shaded symbol.

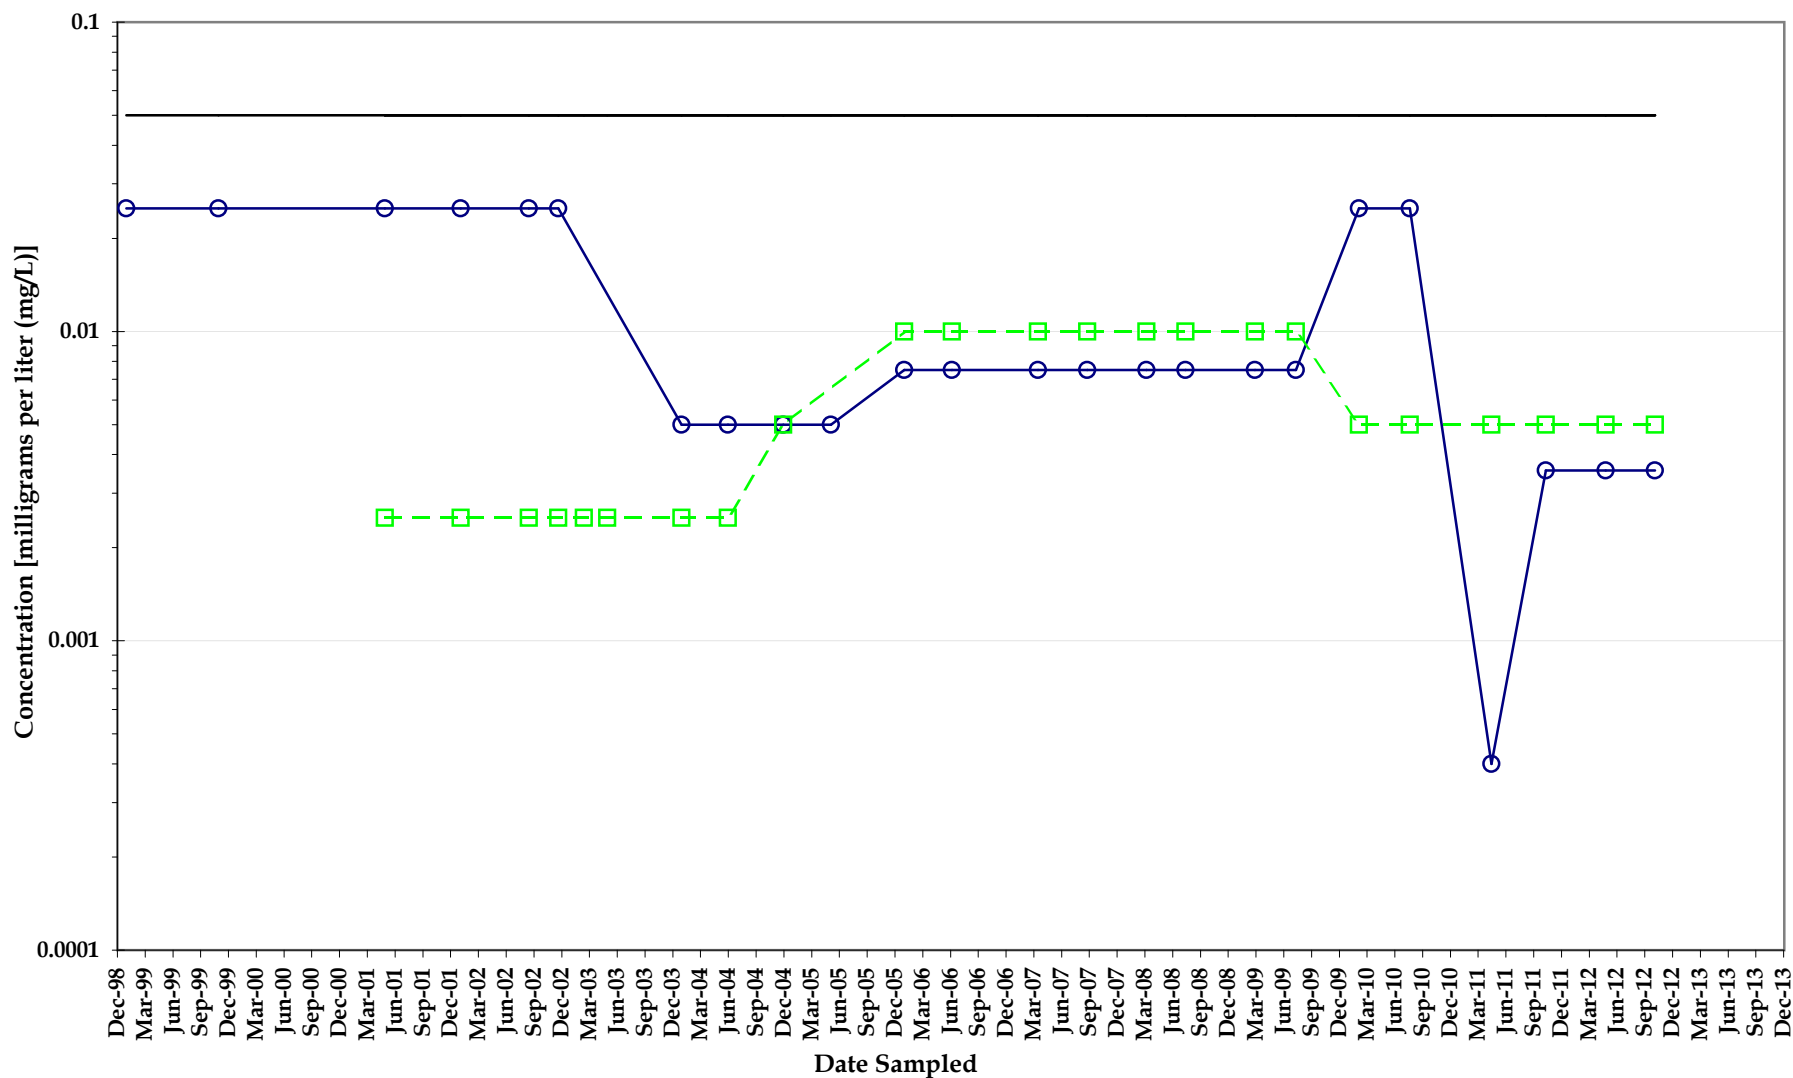
## Chromium Concentrations Monitoring Well MW021

Note: Non-detect analyses plotted at the method detection limit or half the reporting limit (RL). Detections denoted by symbol and detection values greater than the RL denoted by shaded symbol.

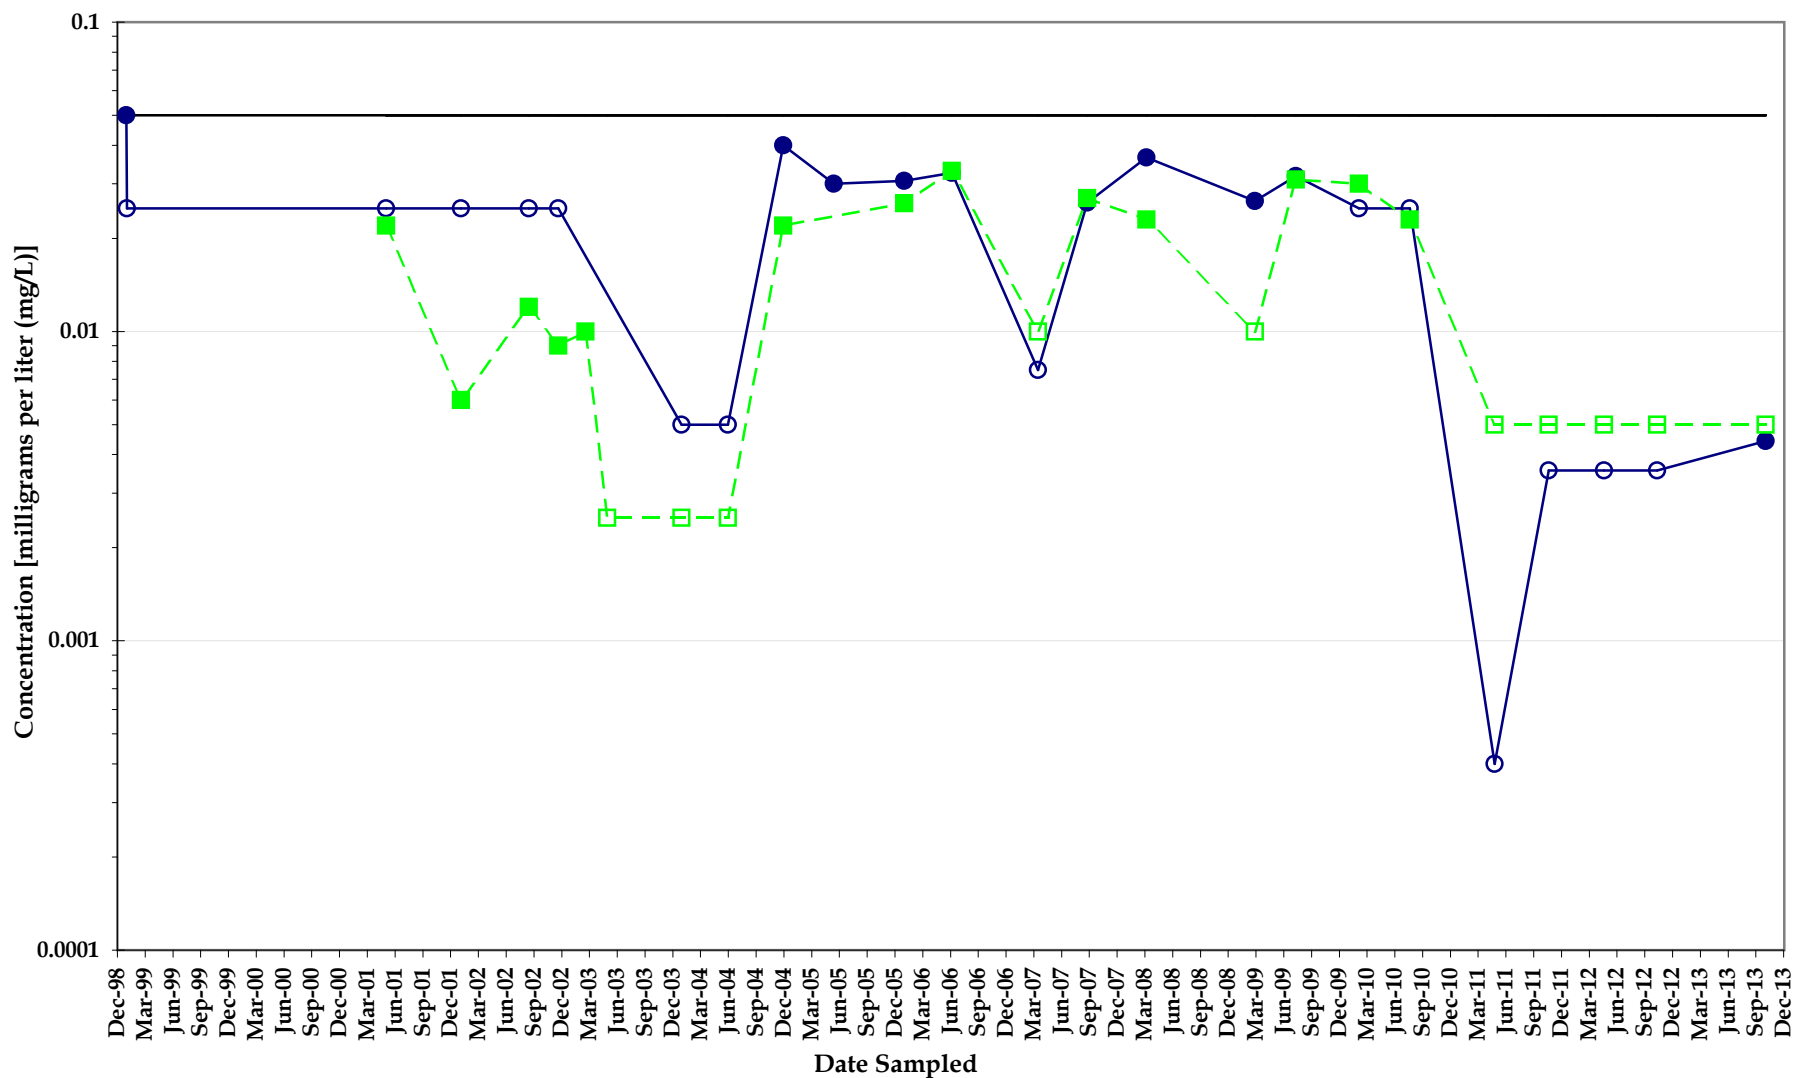
## Chromium Concentrations Monitoring Well MW021A

Note: Non-detect analyses plotted at the method detection limit or half the reporting limit (RL). Detections denoted by symbol and detection values greater than the RL denoted by shaded symbol.

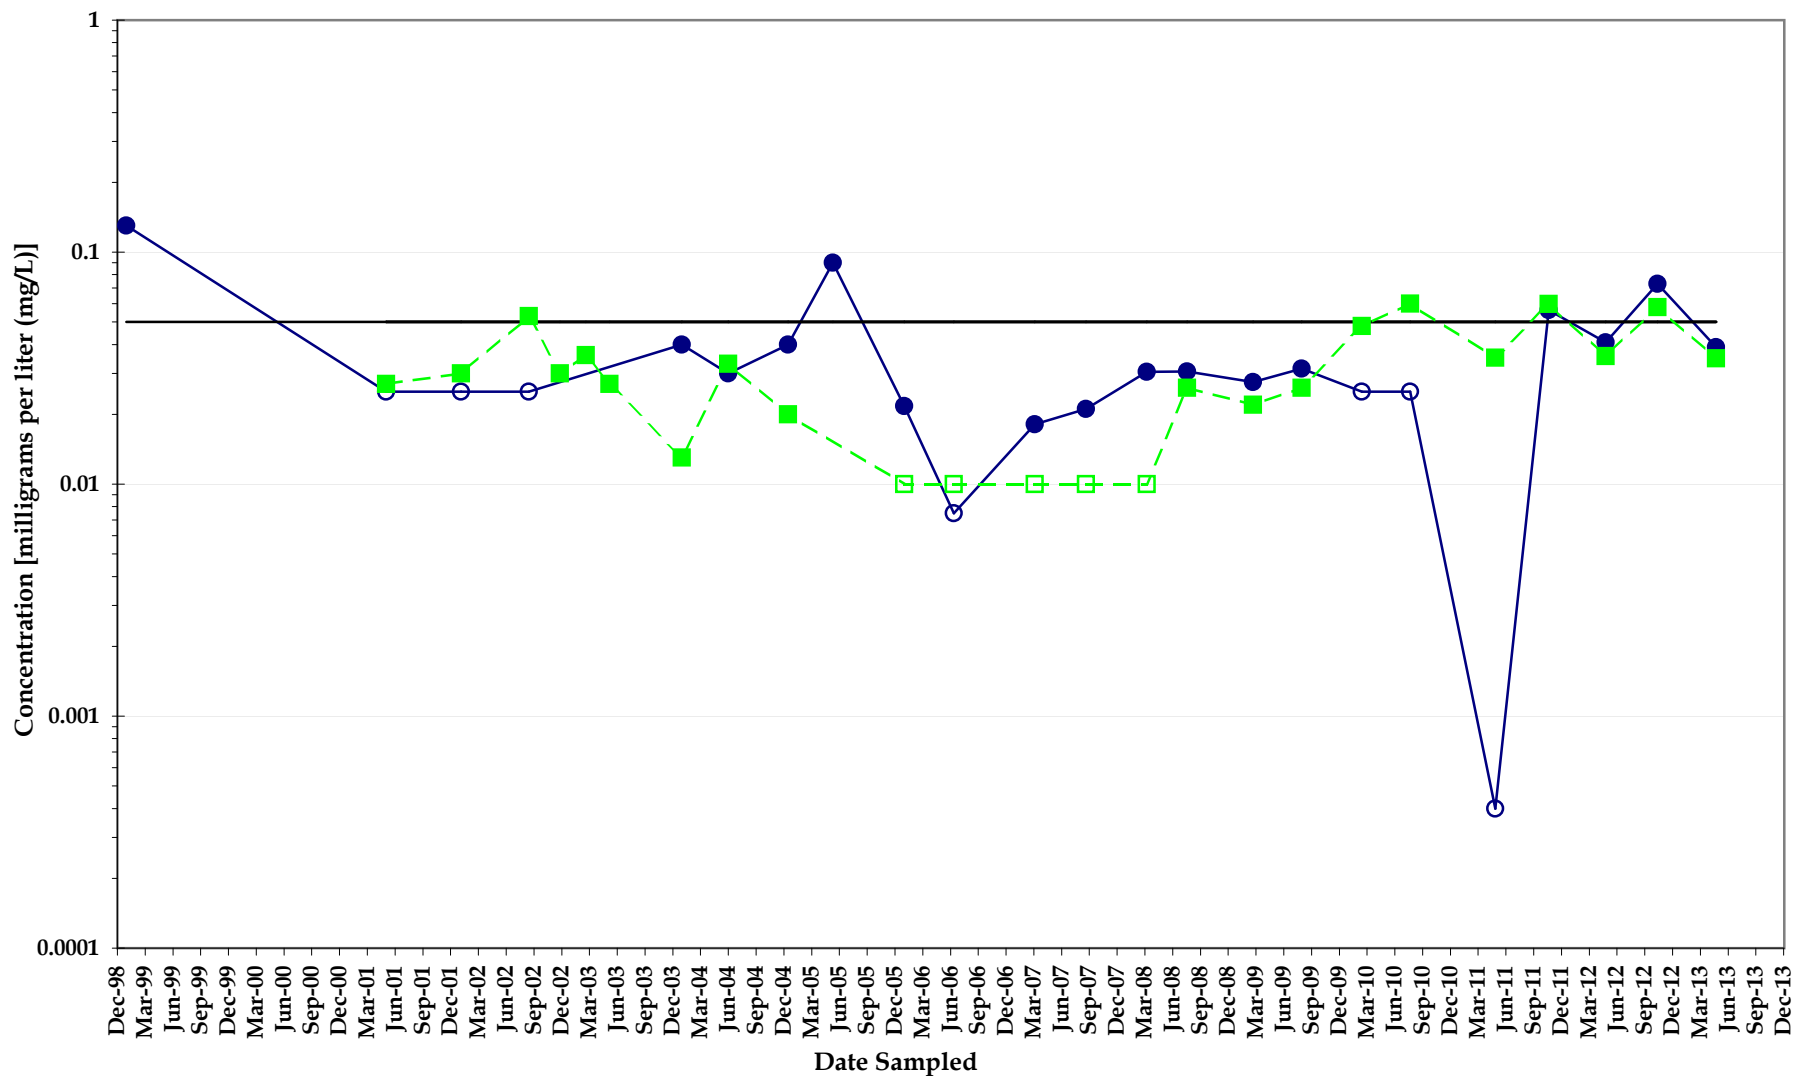
## Chromium Concentrations Monitoring Well MW022A

Note: Non-detect analyses plotted at the method detection limit or half the reporting limit (RL). Detections denoted by symbol and detection values greater than the RL denoted by shaded symbol.

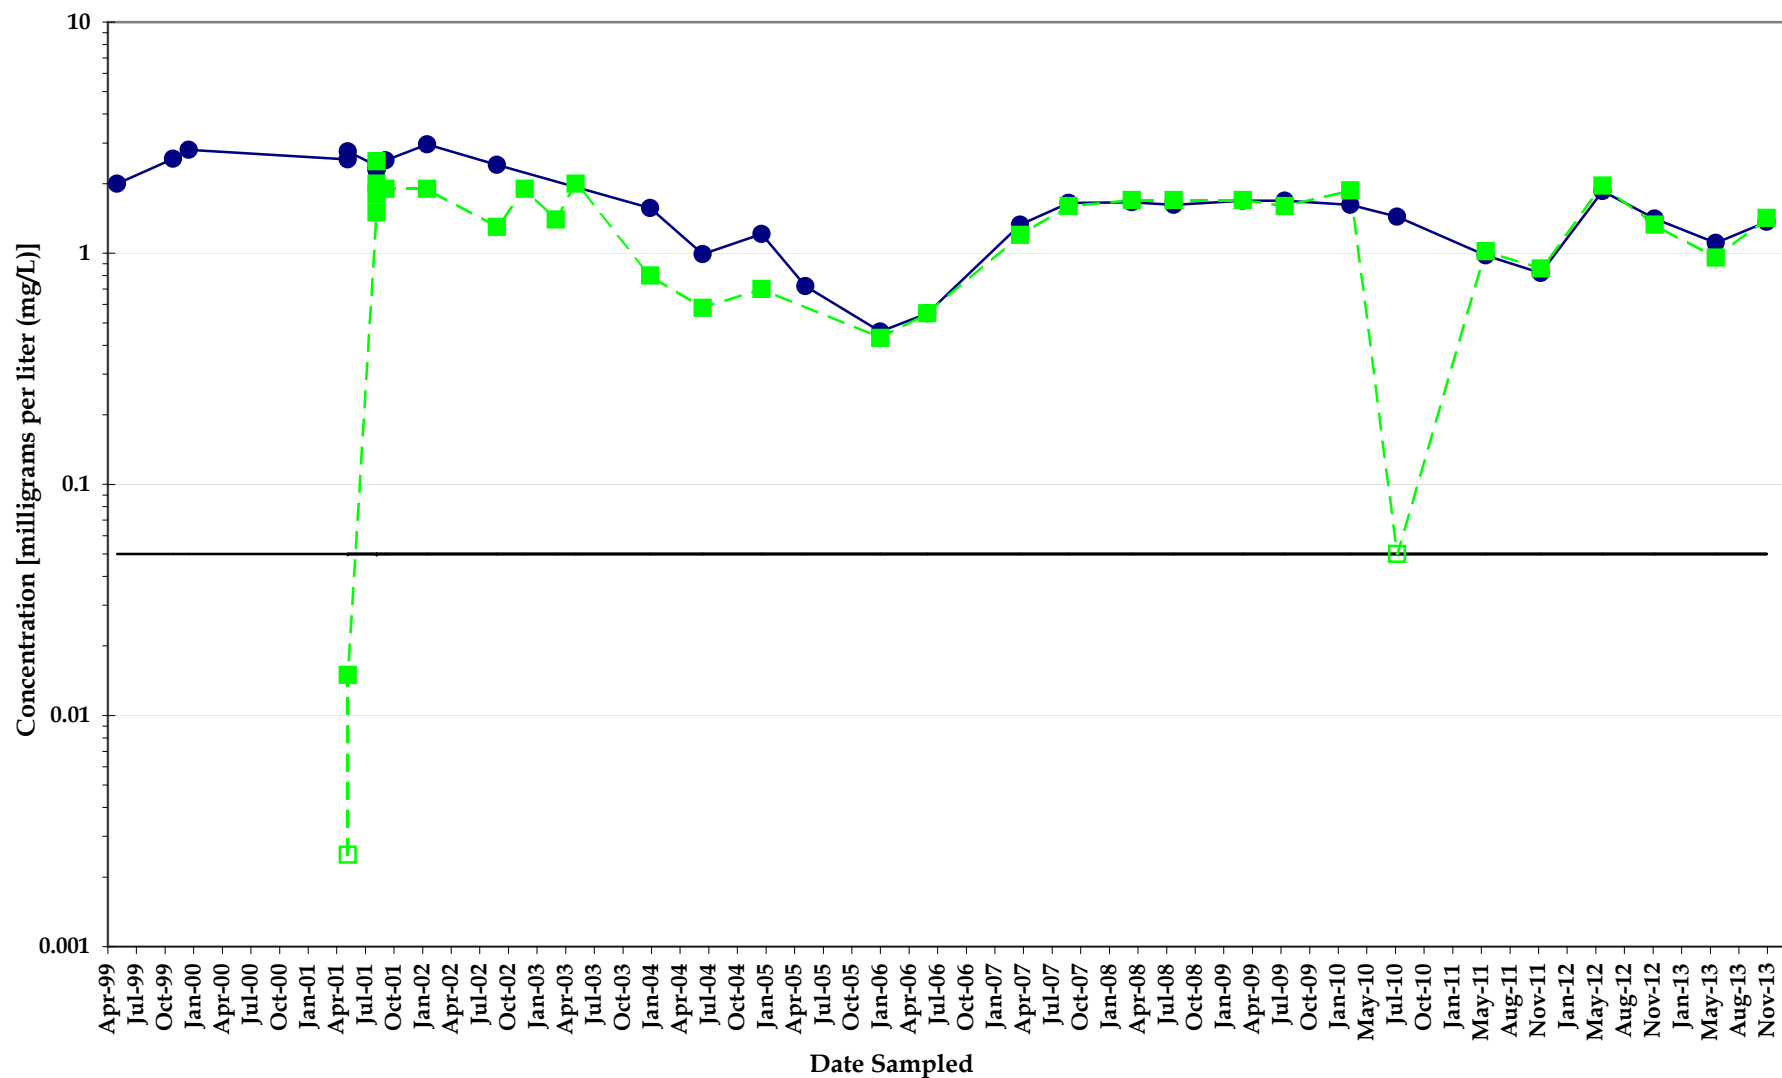
## Chromium Concentrations Monitoring Well MW023

Note: Non-detect analyses plotted at the method detection limit or half the reporting limit (RL). Detections denoted by symbol and detection values greater than the RL denoted by shaded symbol.

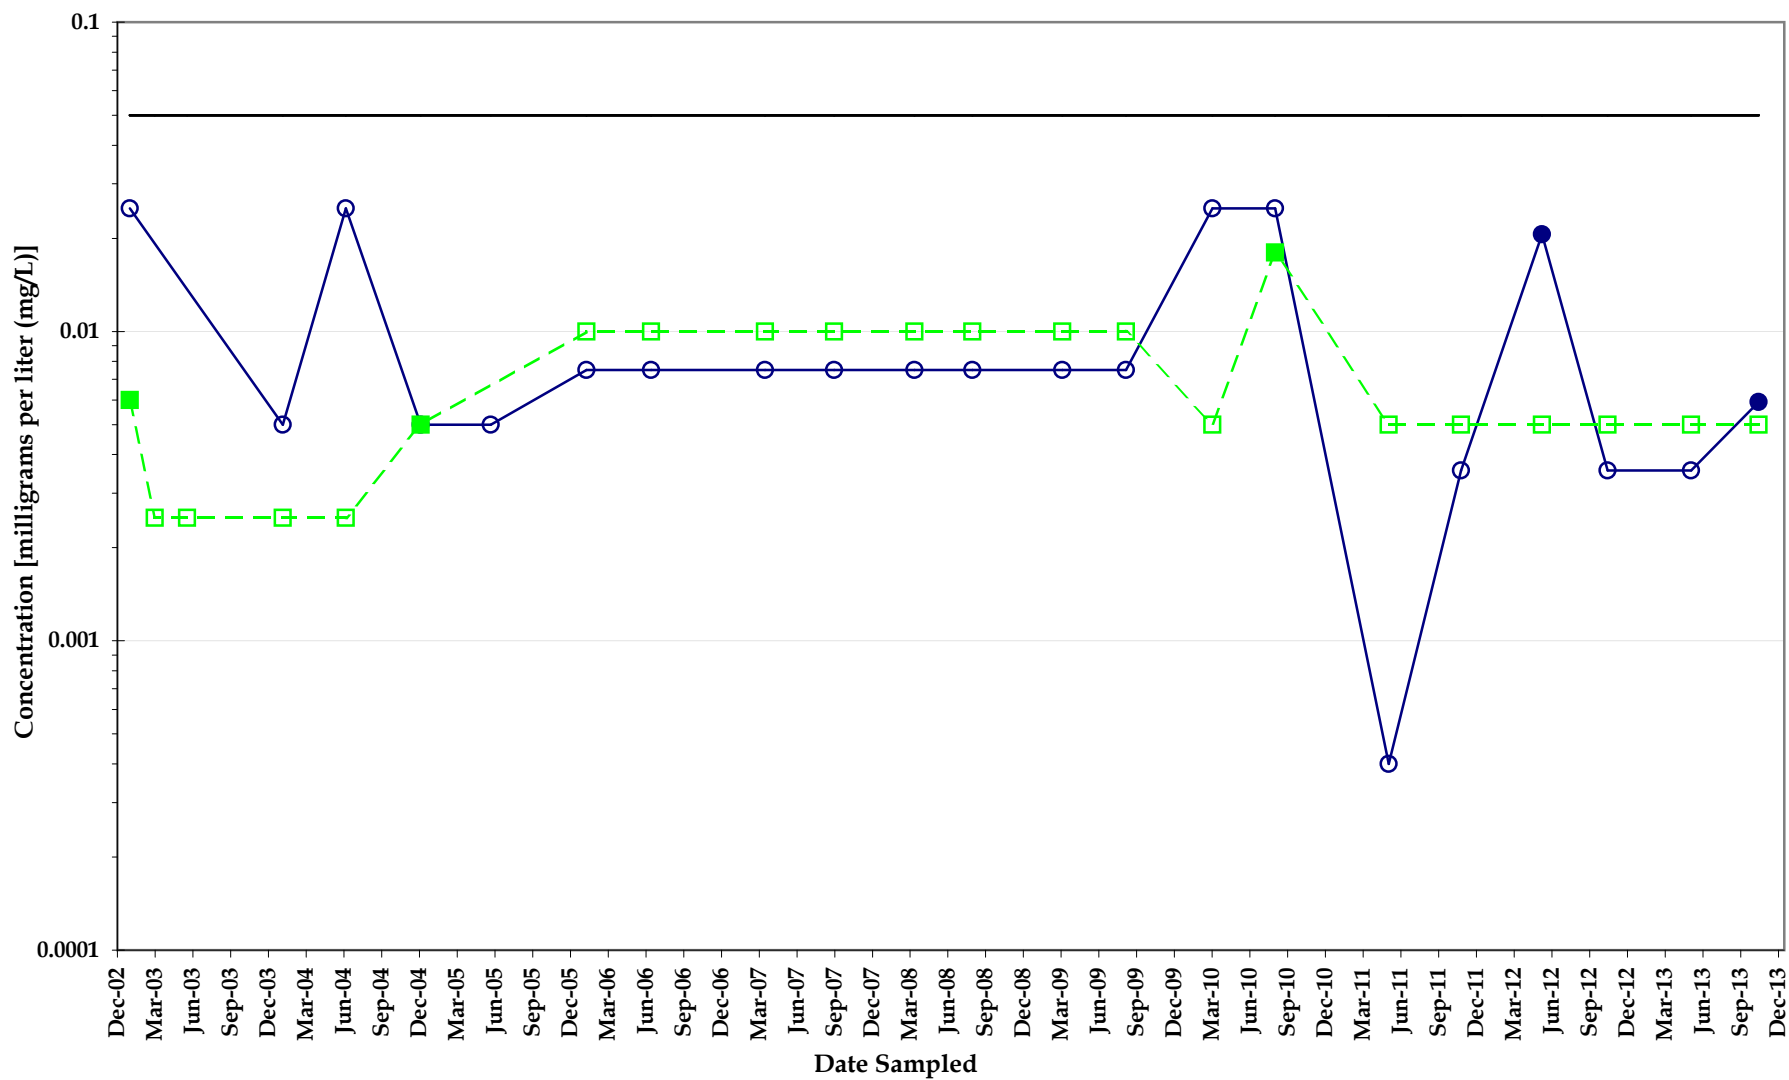
# Chromium Concentrations Monitoring Well MW023A

Note: Non-detect analyses plotted at the method detection limit or half the reporting limit (RL). Detections denoted by symbol and detection values greater than the RL denoted by shaded symbol.

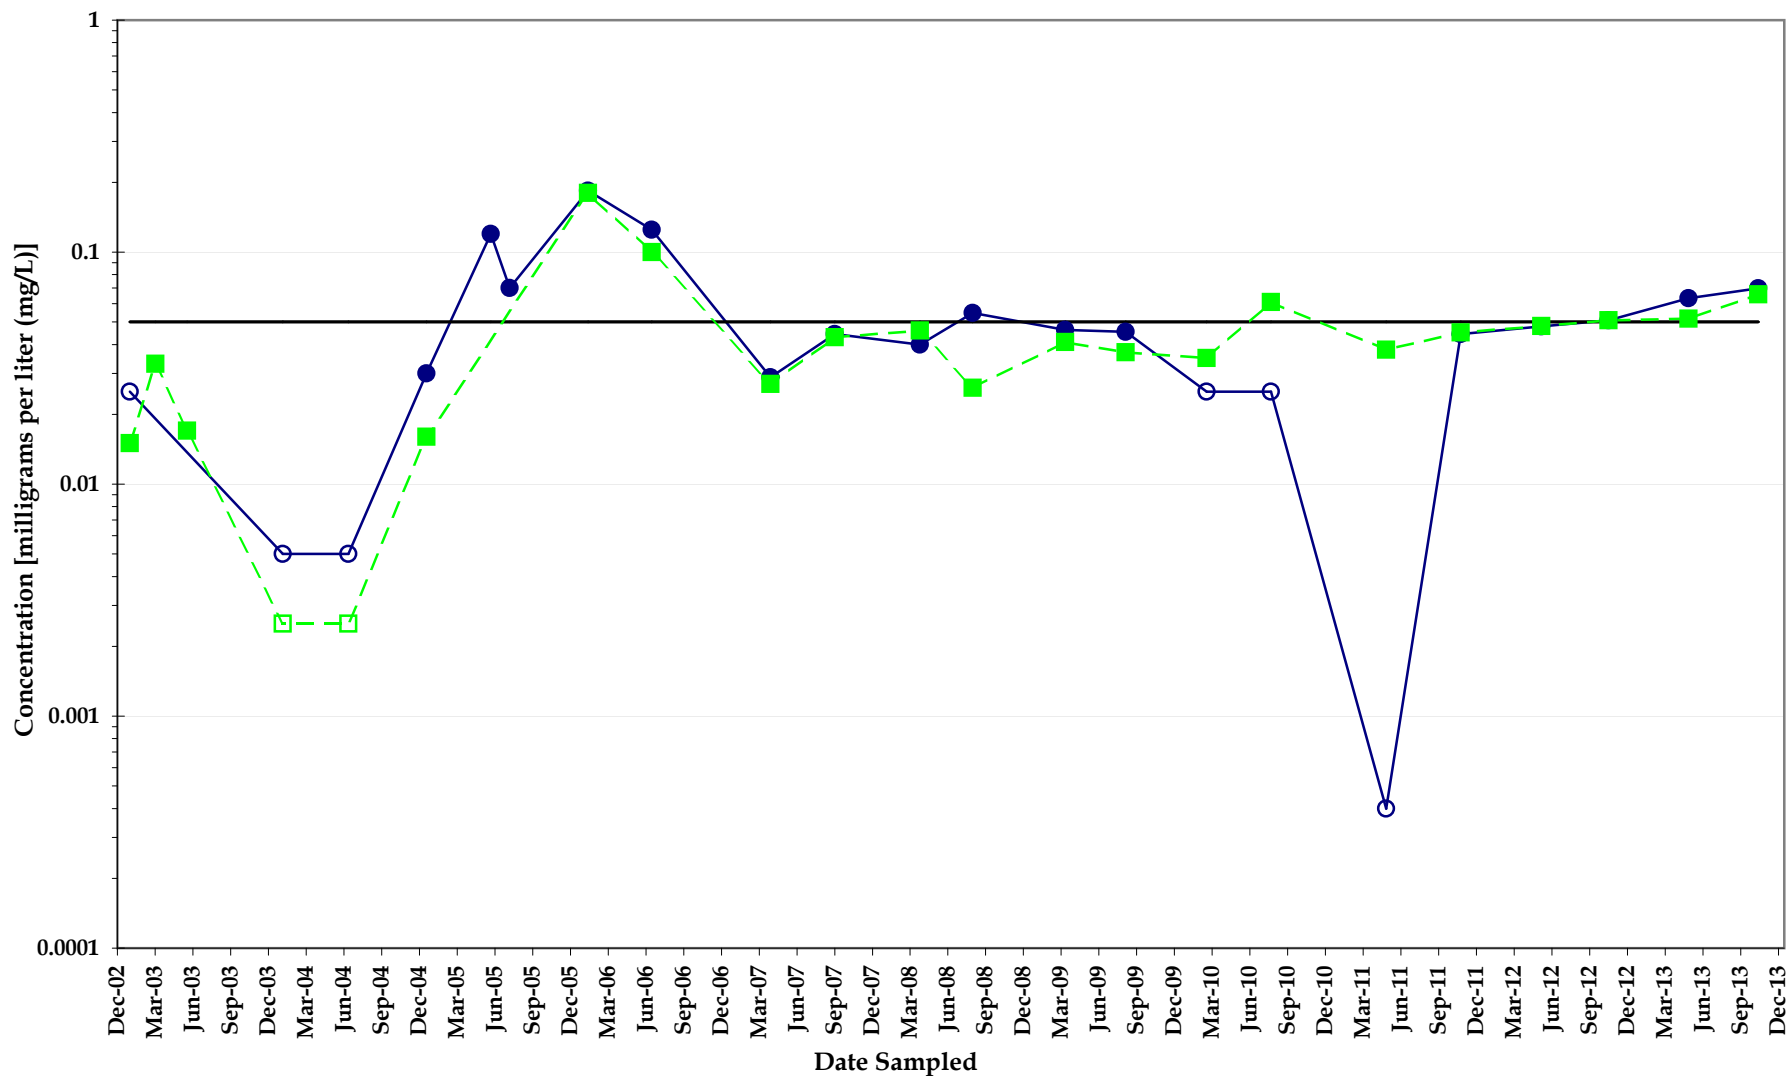
## Chromium Concentrations Monitoring Well MW024

Note: Non-detect analyses plotted at the method detection limit or half the reporting limit (RL). Detections denoted by symbol and detection values greater than the RL denoted by shaded symbol.

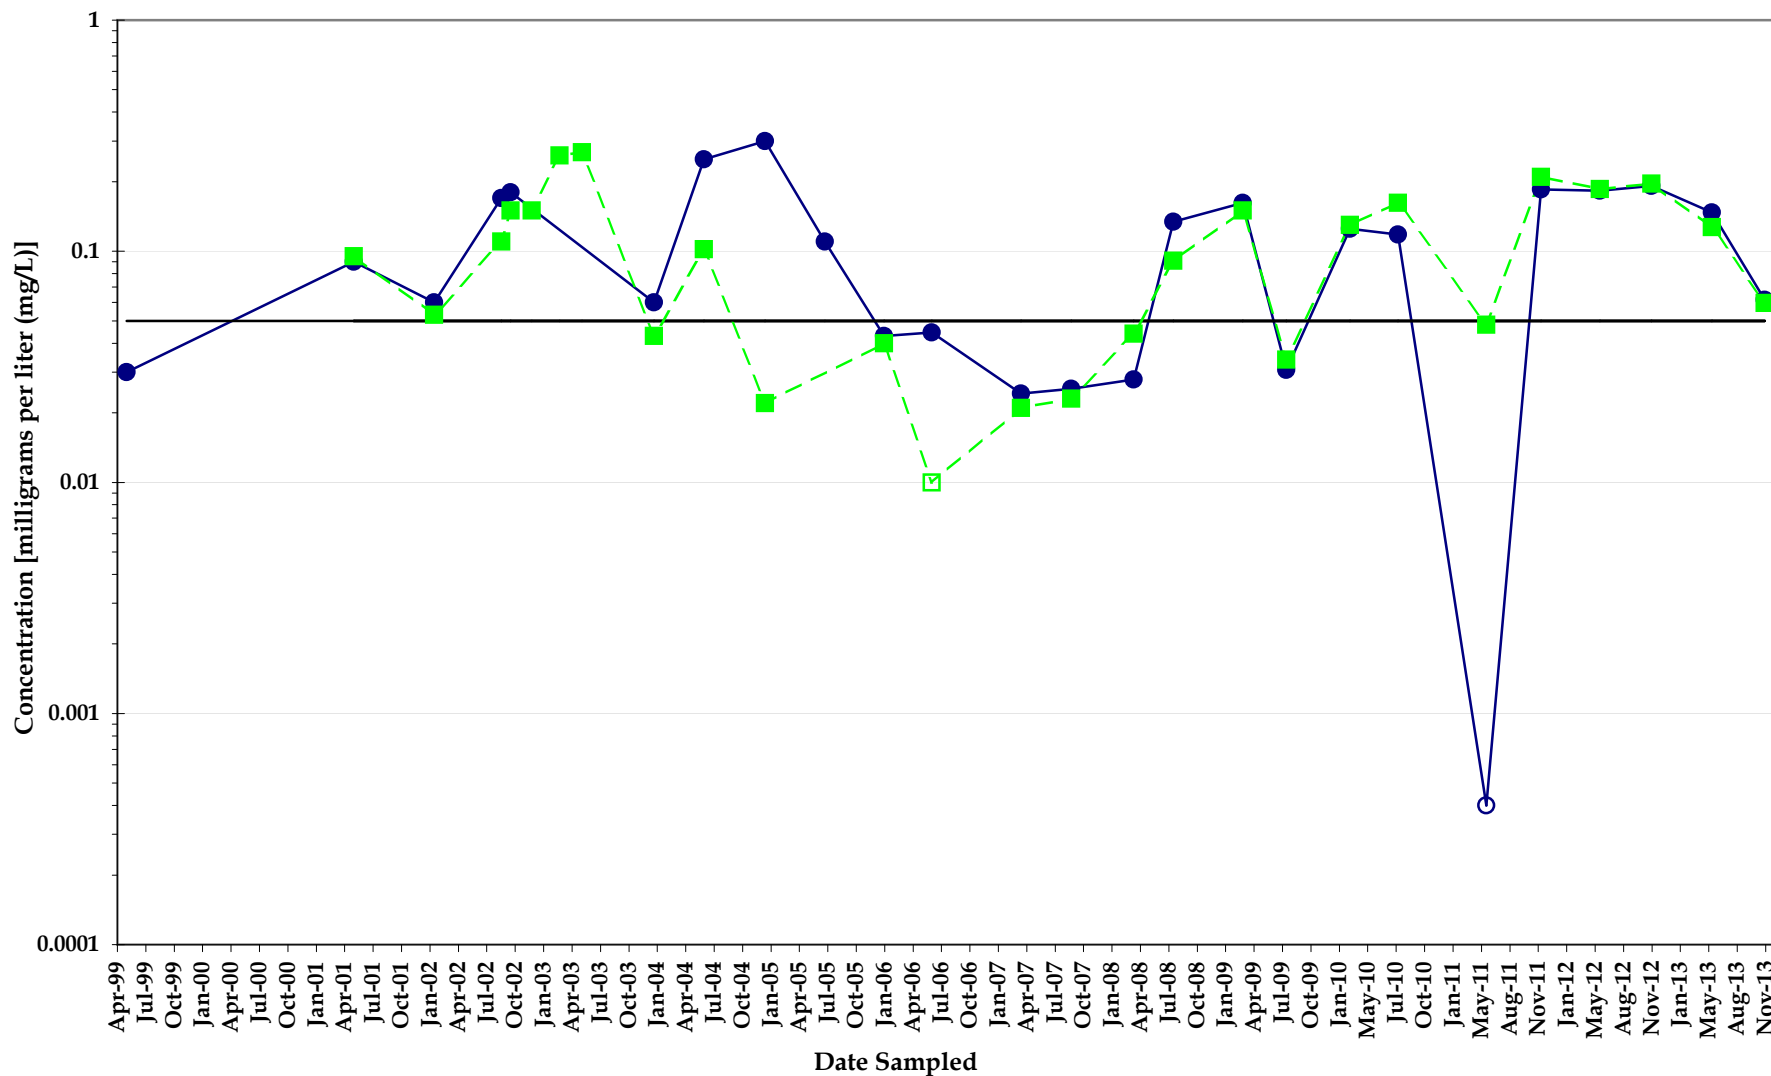
## Chromium Concentrations Monitoring Well MW024A

Note: Non-detect analyses plotted at the method detection limit or half the reporting limit (RL). Detections denoted by symbol and detection values greater than the RL denoted by shaded symbol.

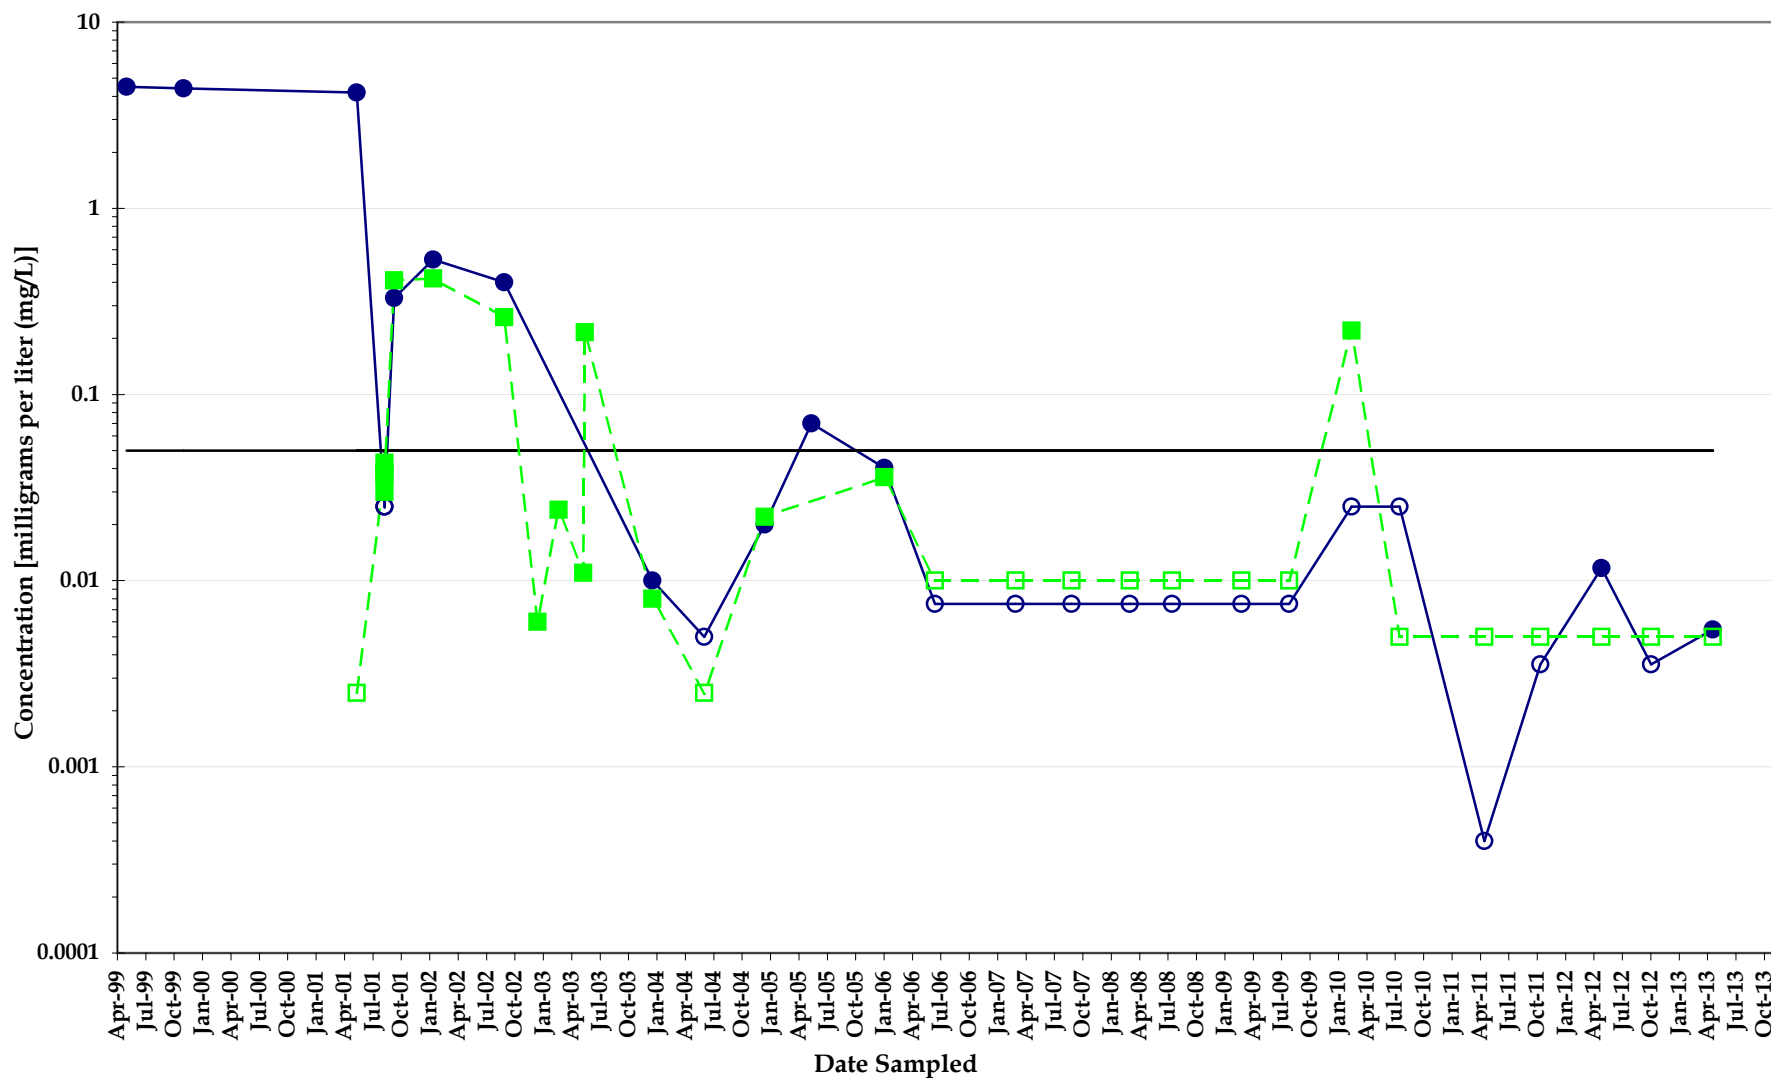
## Chromium Concentrations Monitoring Well MW025

Note: Non-detect analyses plotted at the method detection limit or half the reporting limit (RL). Detections denoted by symbol and detection values greater than the RL denoted by shaded symbol.
