**GW - 004**

**2013 AGWMR**

**VOL 5 OF 5**

*North Eunice Gas Plant  
Lea County, New Mexico*

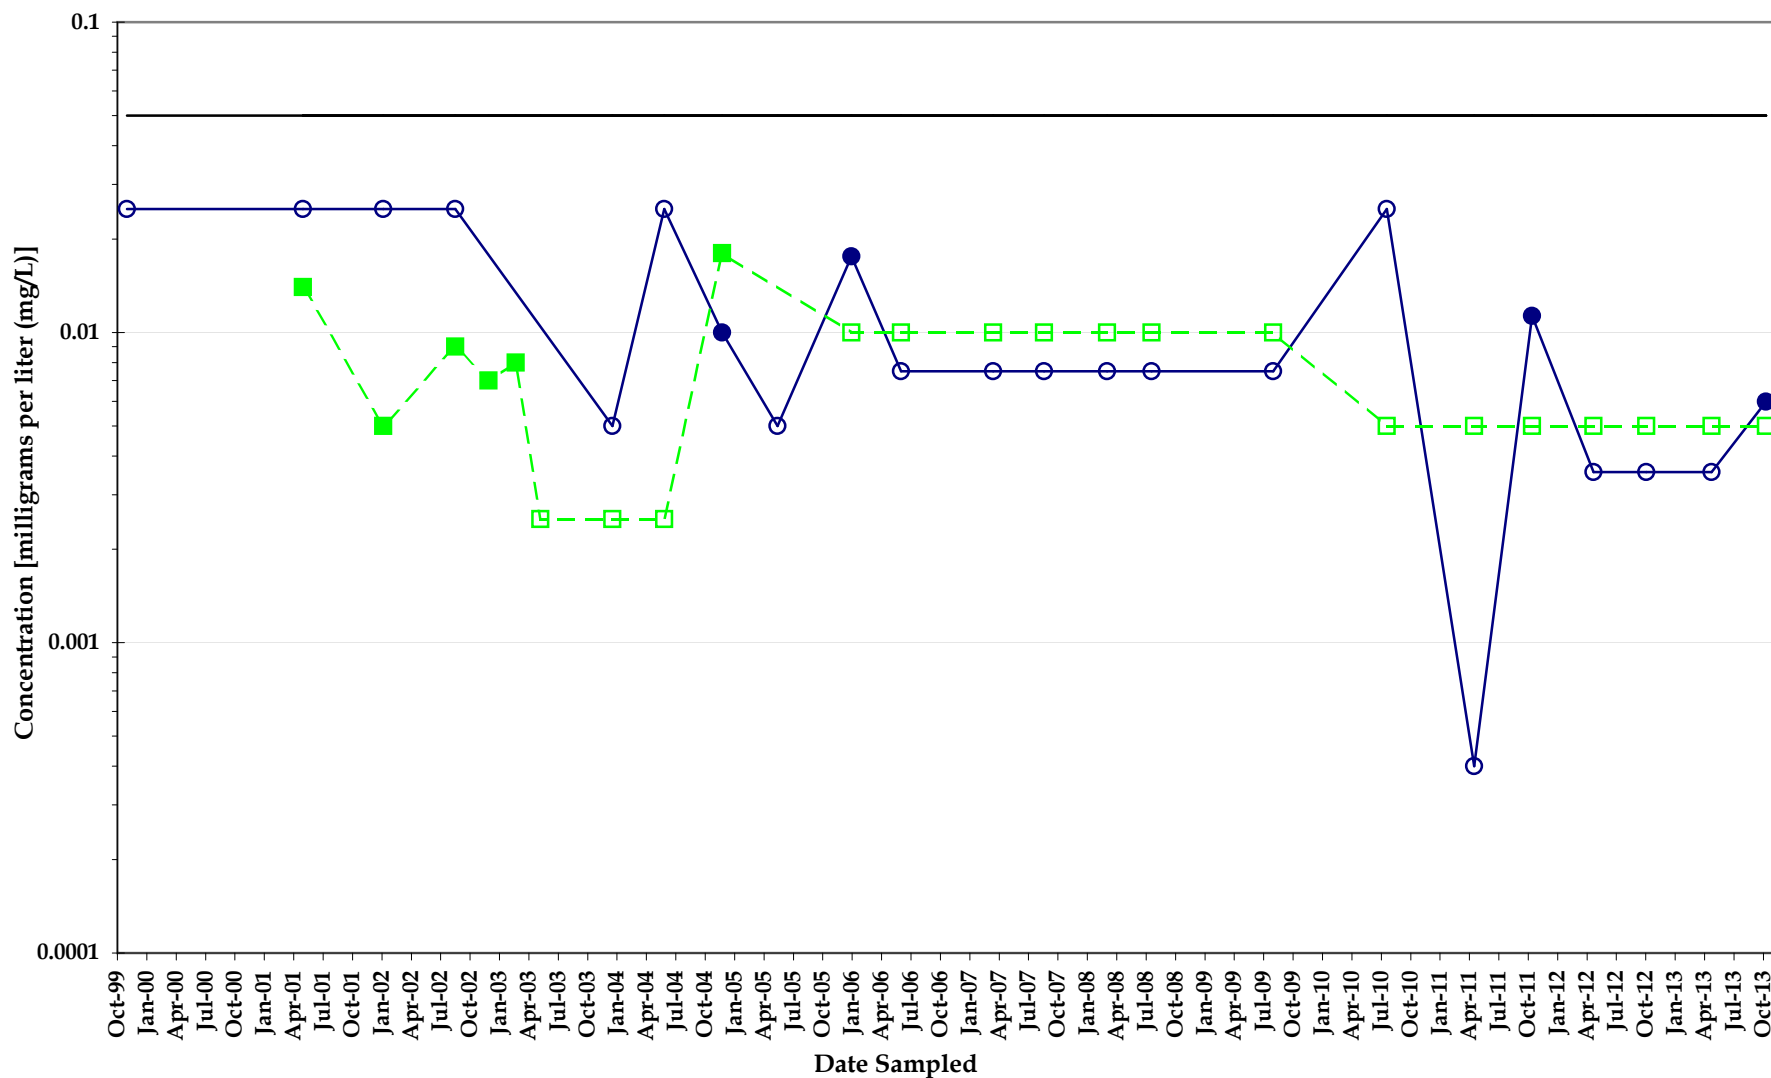
## Chromium Concentrations Monitoring Well MW026

Note: Non-detect analyses plotted at the method detection limit or half the reporting limit (RL). Detections denoted by symbol and detection values greater than the RL denoted by shaded symbol.

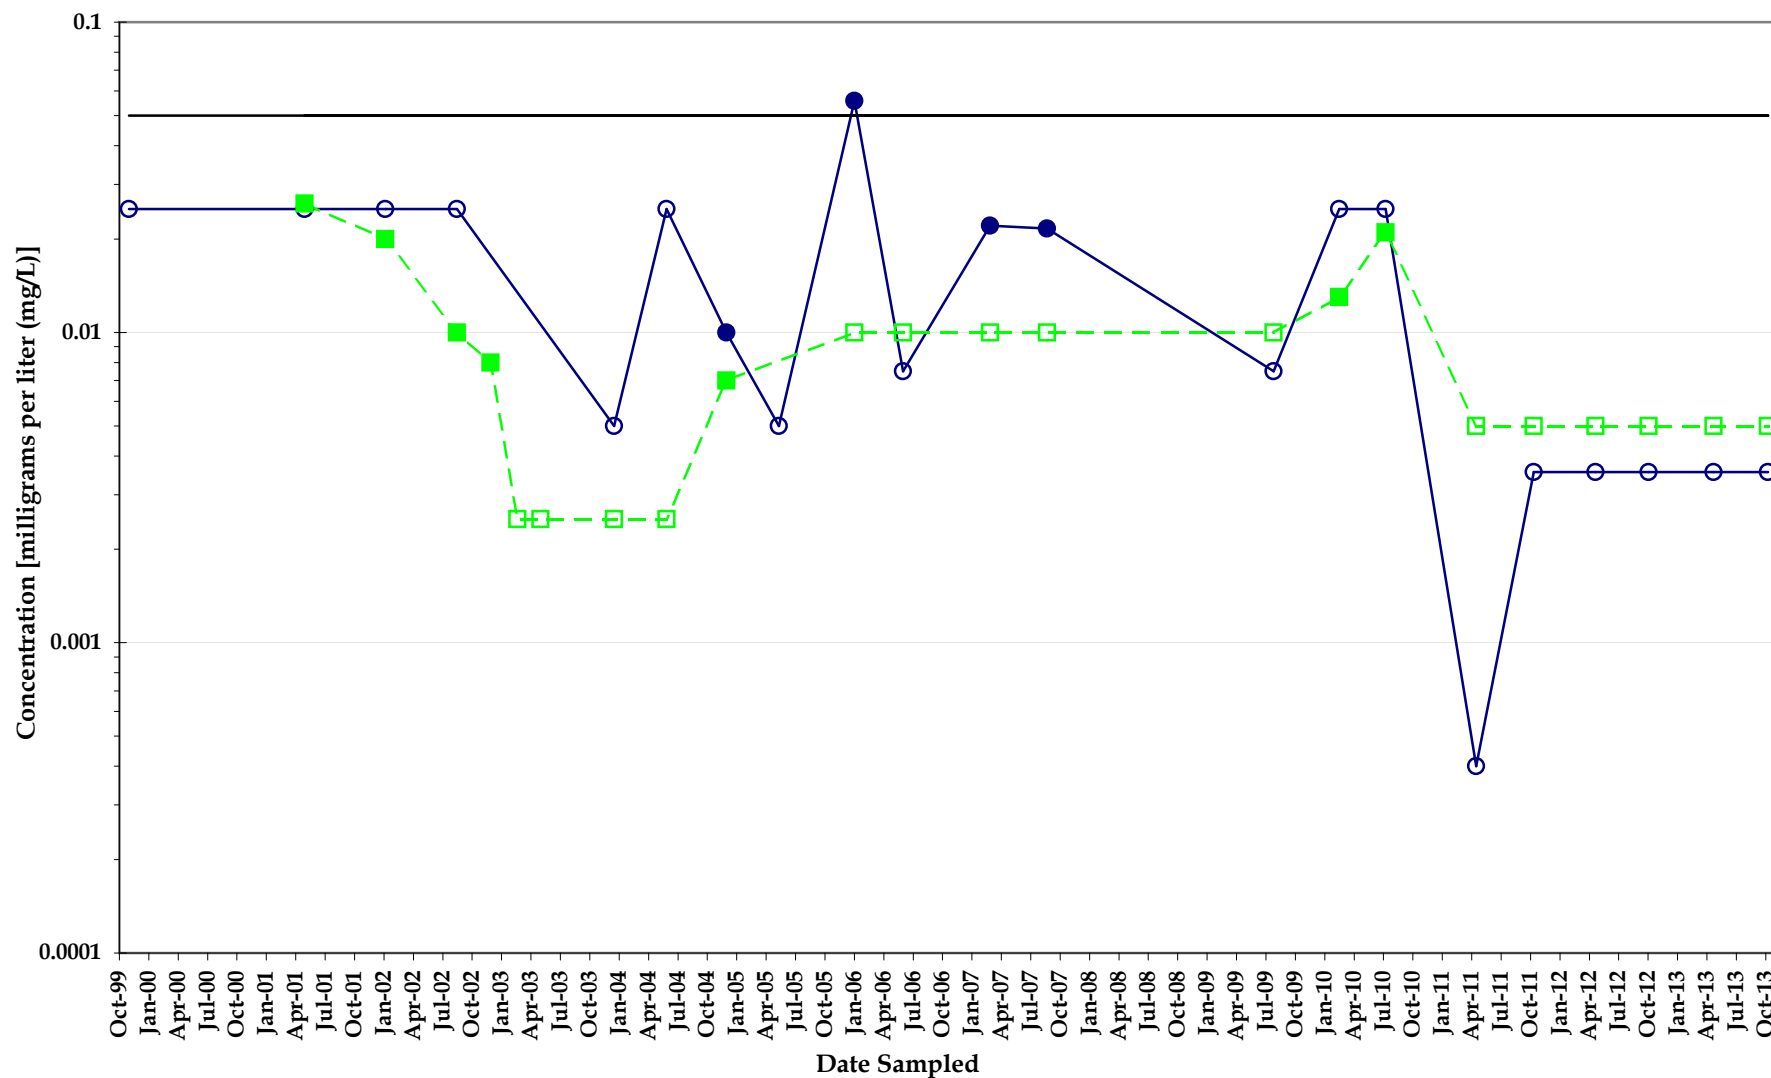
## Chromium Concentrations Monitoring Well MW027

Note: Non-detect analyses plotted at the method detection limit or half the reporting limit (RL). Detections denoted by symbol and detection values greater than the RL denoted by shaded symbol.

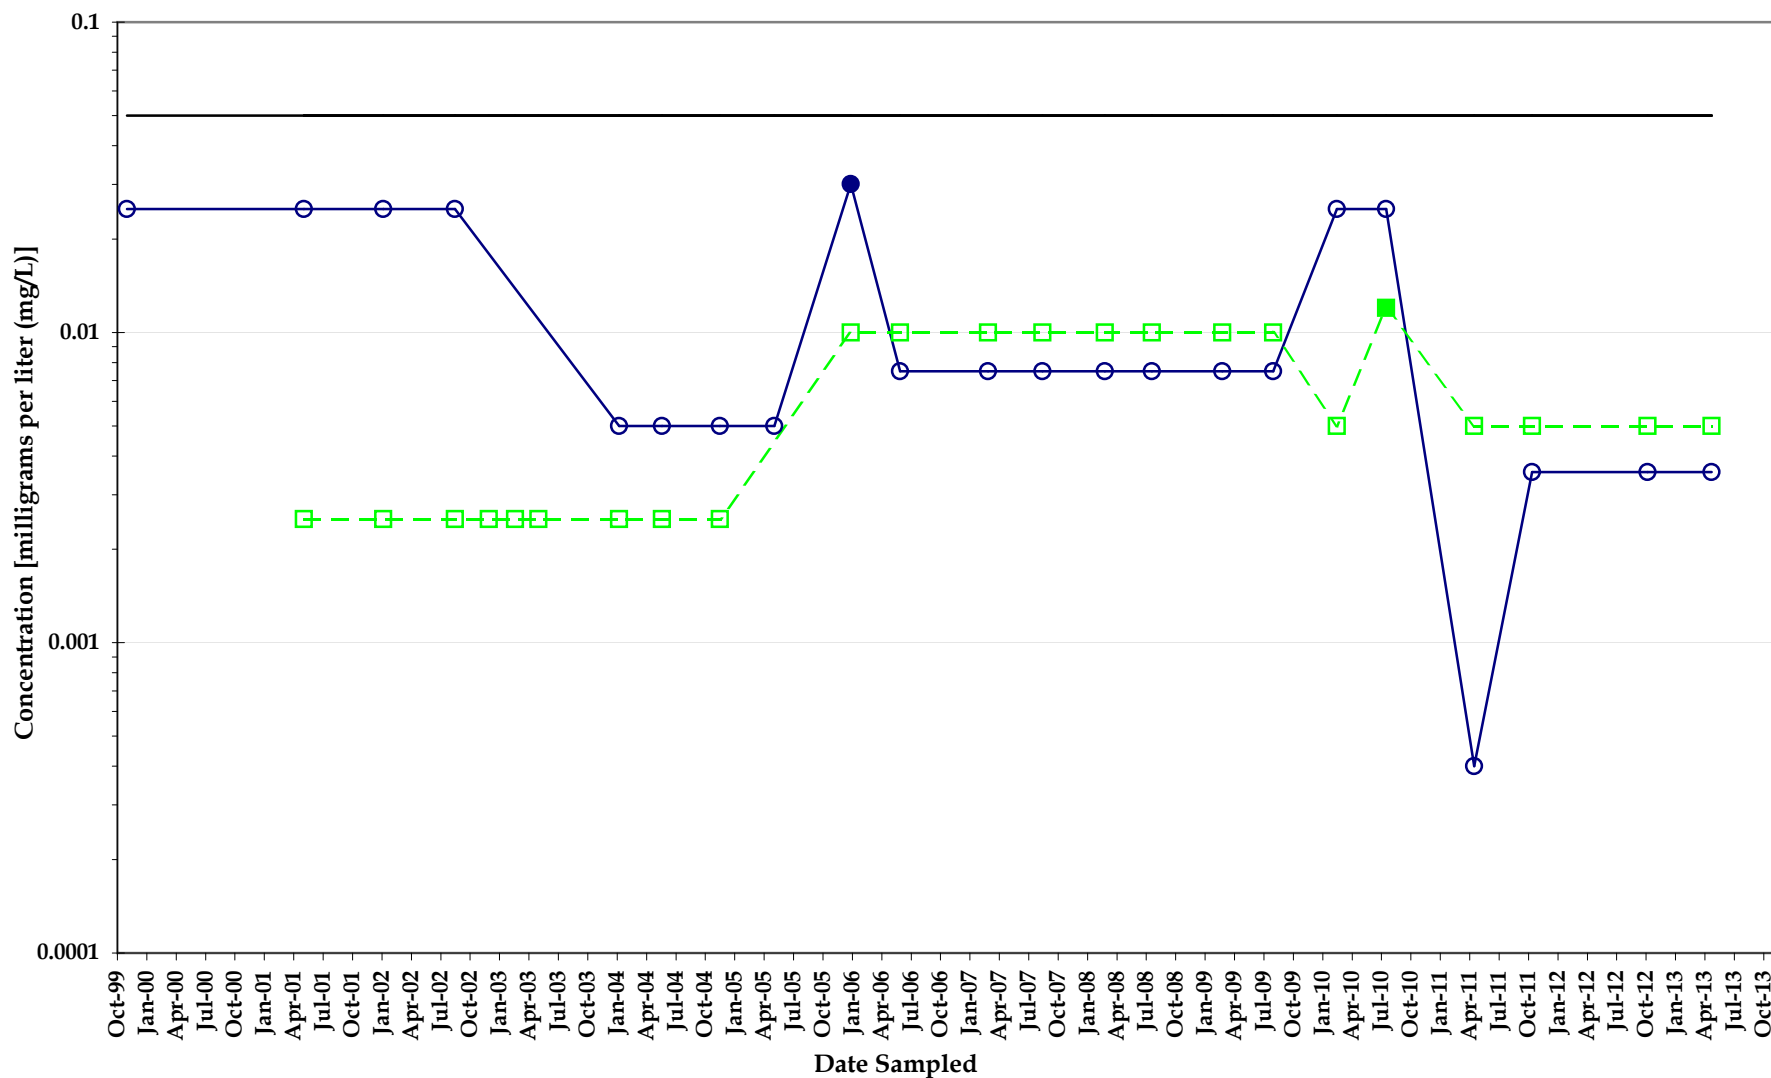
## Chromium Concentrations Monitoring Well MW028

— Chromium      ● Detects      ○ Non-Detects      — NMWQCC  
 - - - Hexavalent Chromium      ■ Detects      □ Non-Detects

Note: Non-detect analyses plotted at the method detection limit or half the reporting limit (RL). Detections denoted by symbol and detection values greater than the RL denoted by shaded symbol.

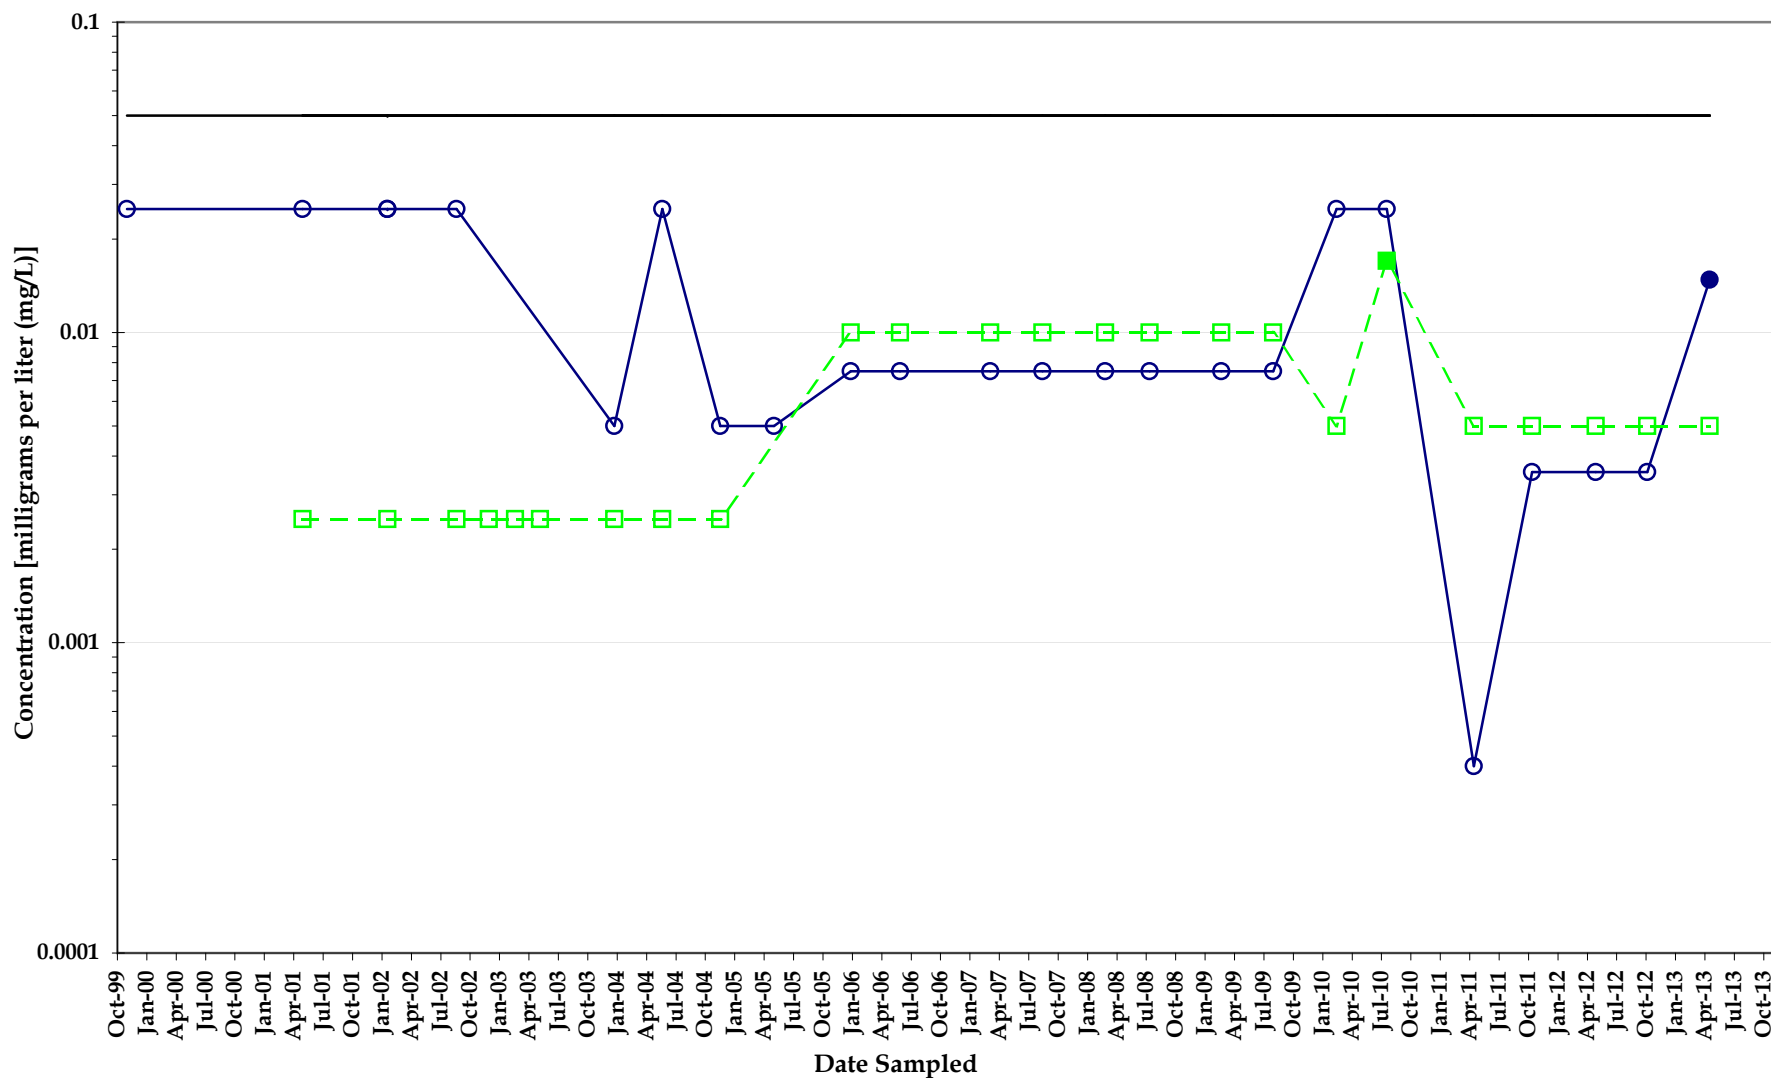
## Chromium Concentrations Monitoring Well MW029

Note: Non-detect analyses plotted at the method detection limit or half the reporting limit (RL). Detections denoted by symbol and detection values greater than the RL denoted by shaded symbol.

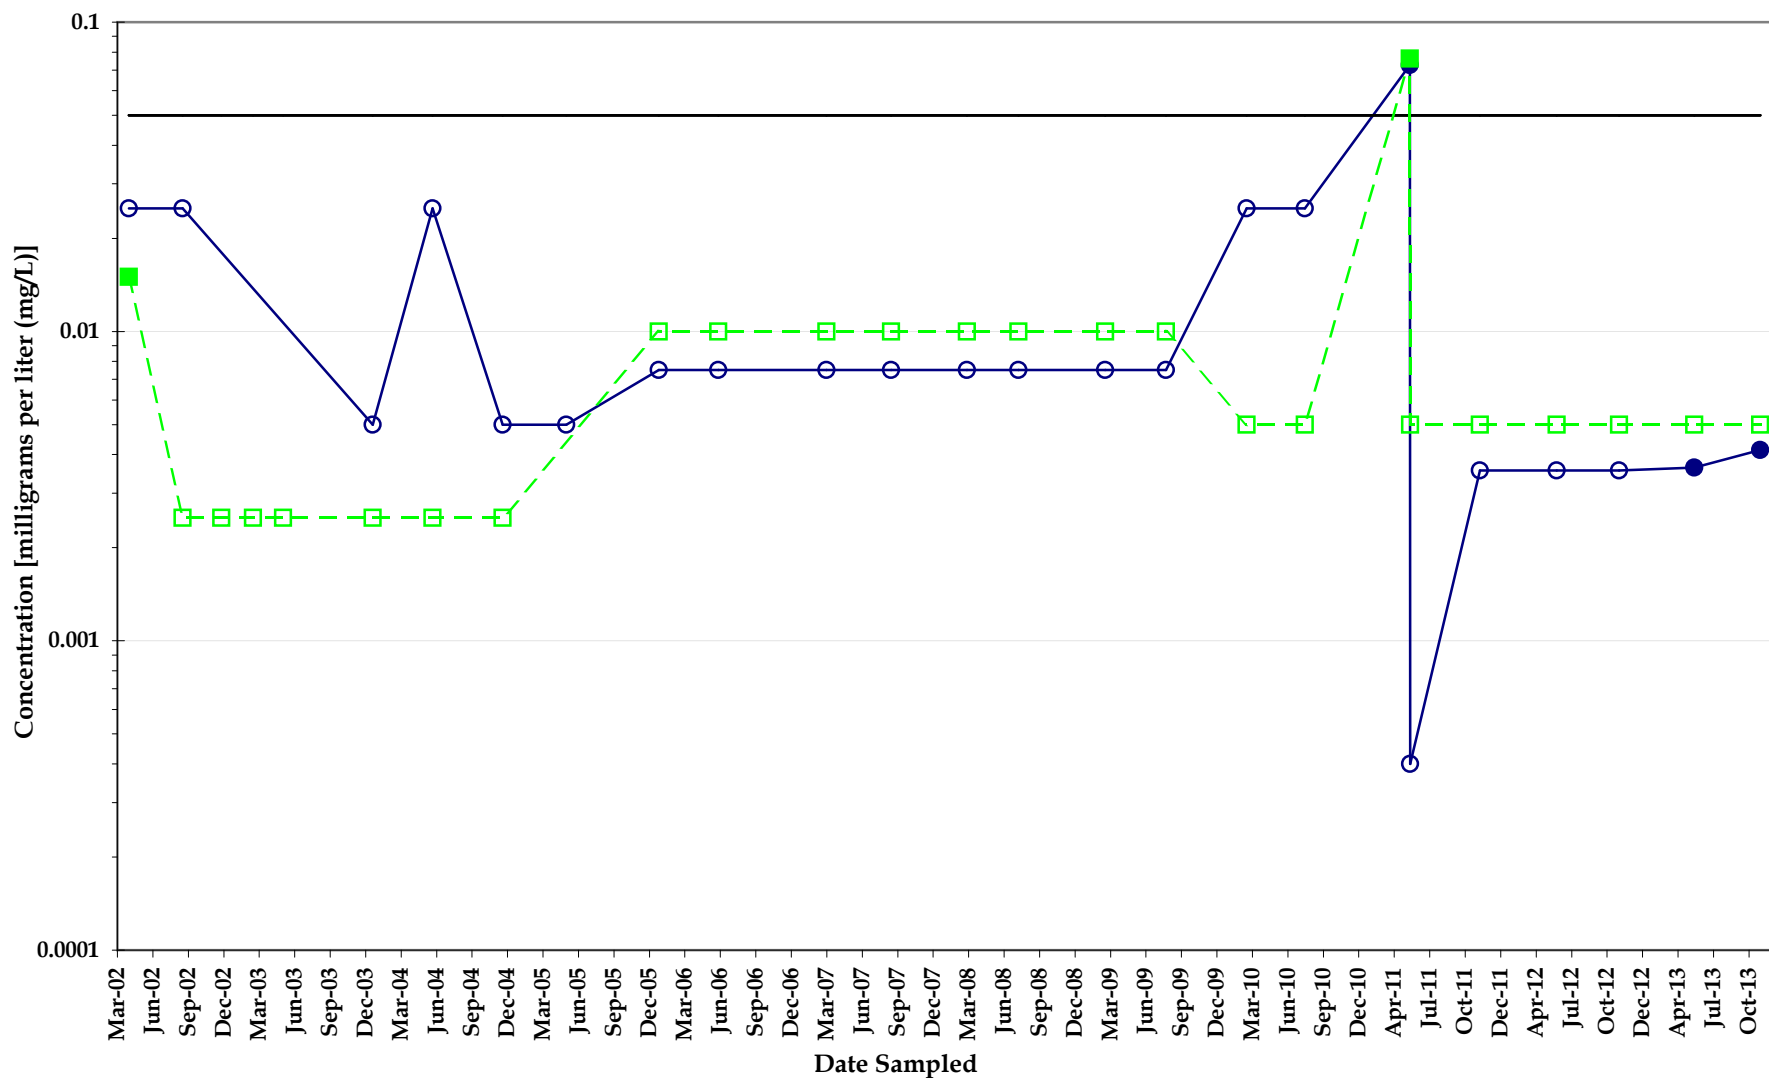
## Chromium Concentrations Monitoring Well MW030

Note: Non-detect analyses plotted at the method detection limit or half the reporting limit (RL). Detections denoted by symbol and detection values greater than the RL denoted by shaded symbol.

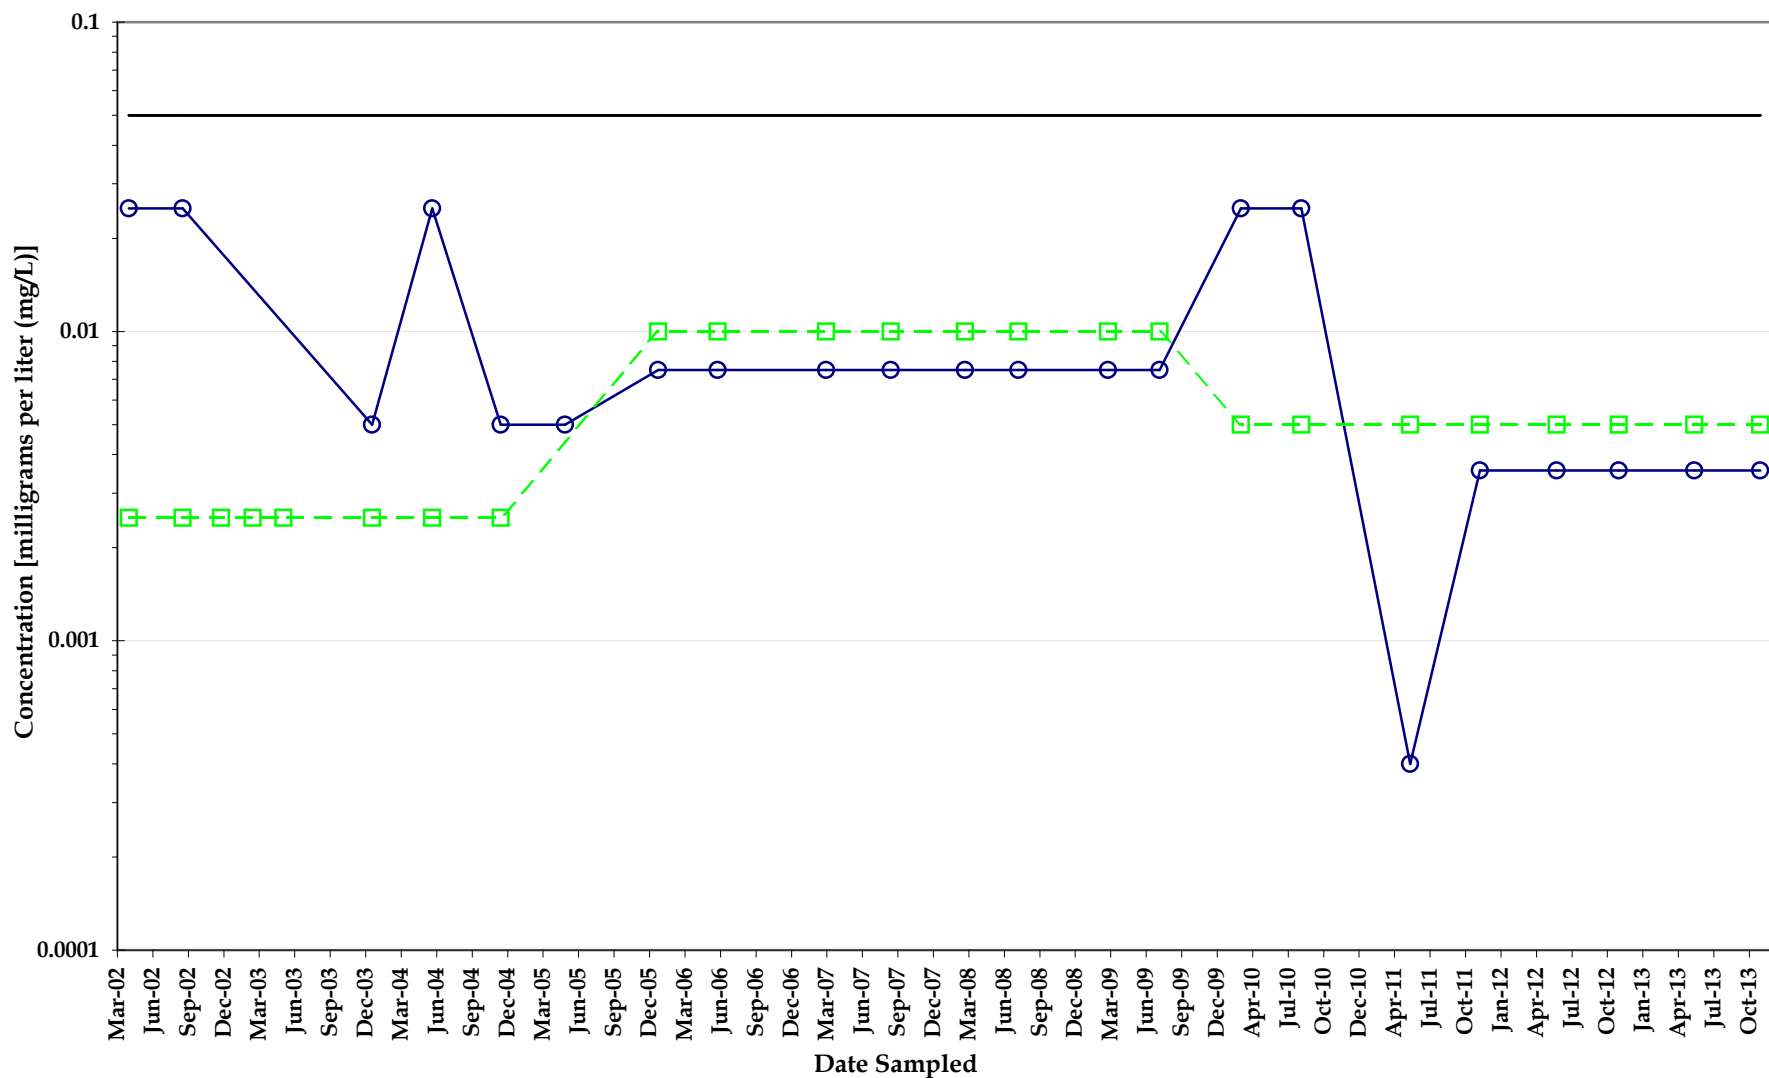
## Chromium Concentrations Monitoring Well MW031

Note: Non-detect analyses plotted at the method detection limit or half the reporting limit (RL). Detections denoted by symbol and detection values greater than the RL denoted by shaded symbol.

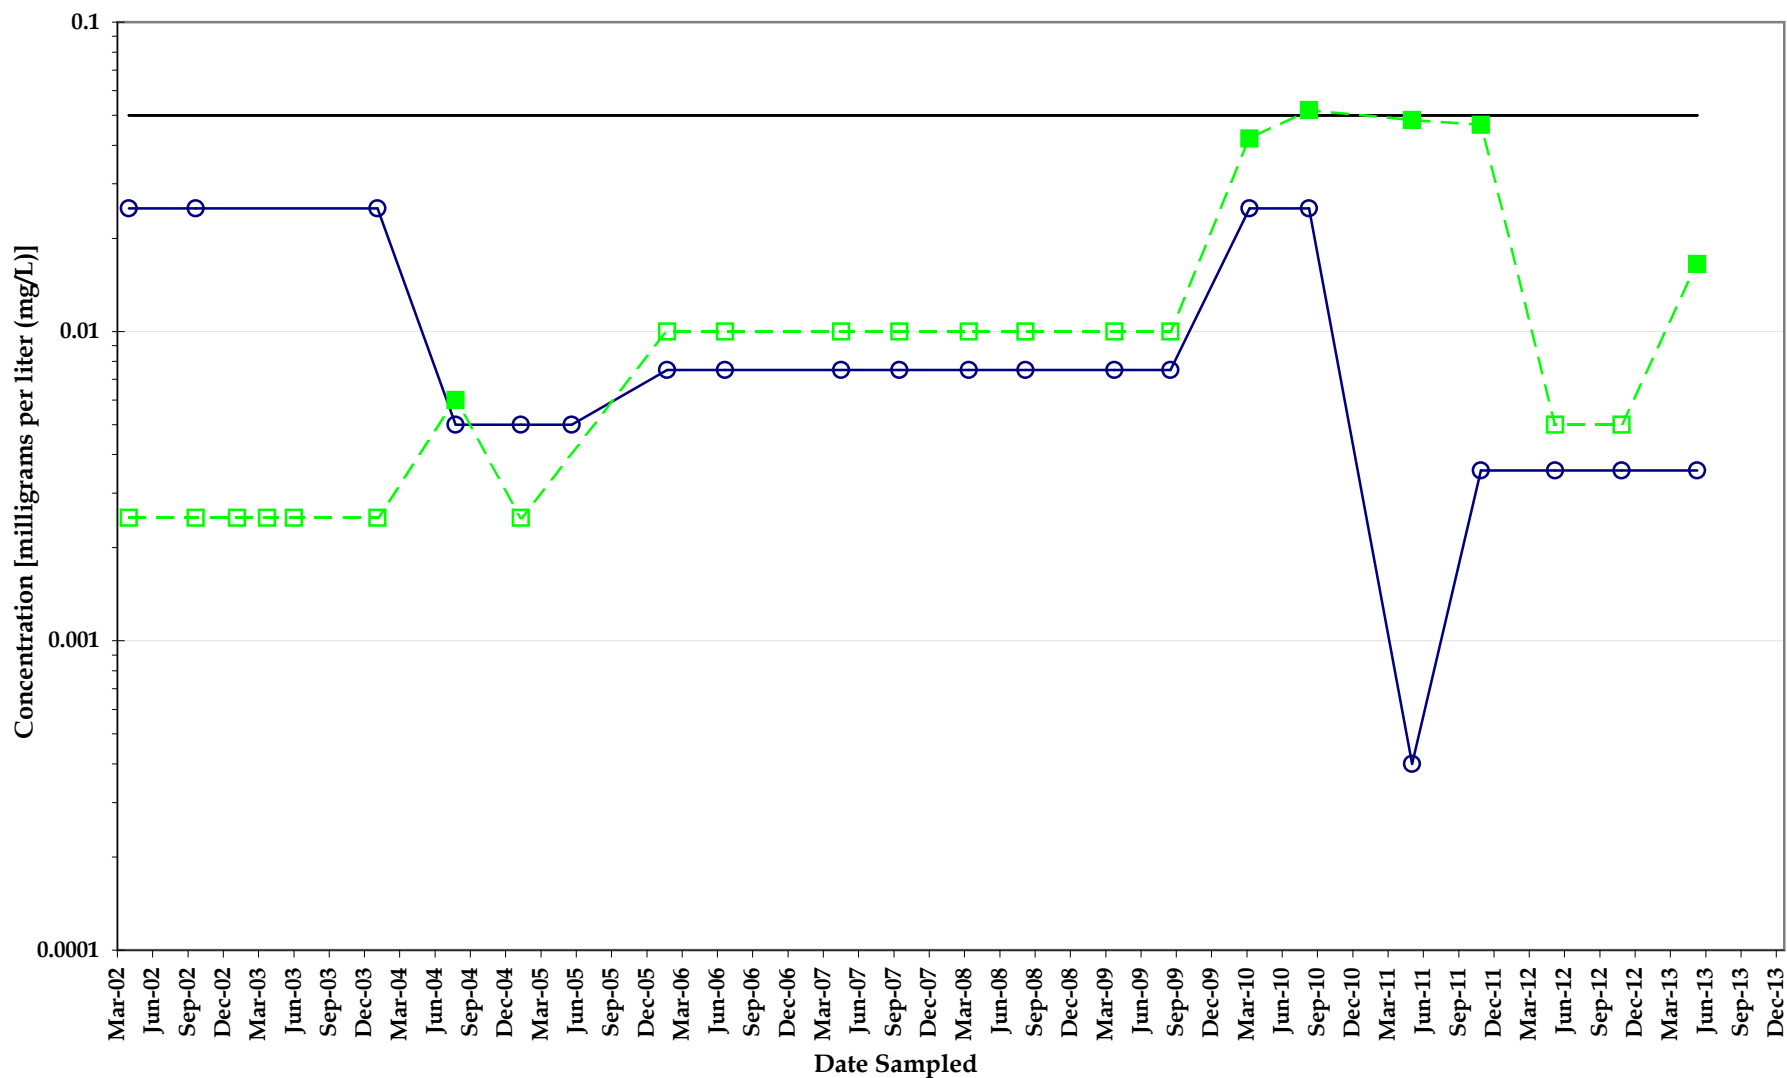
## Chromium Concentrations Monitoring Well MW033

Note: Non-detect analyses plotted at the method detection limit or half the reporting limit (RL). Detections denoted by symbol and detection values greater than the RL denoted by shaded symbol.

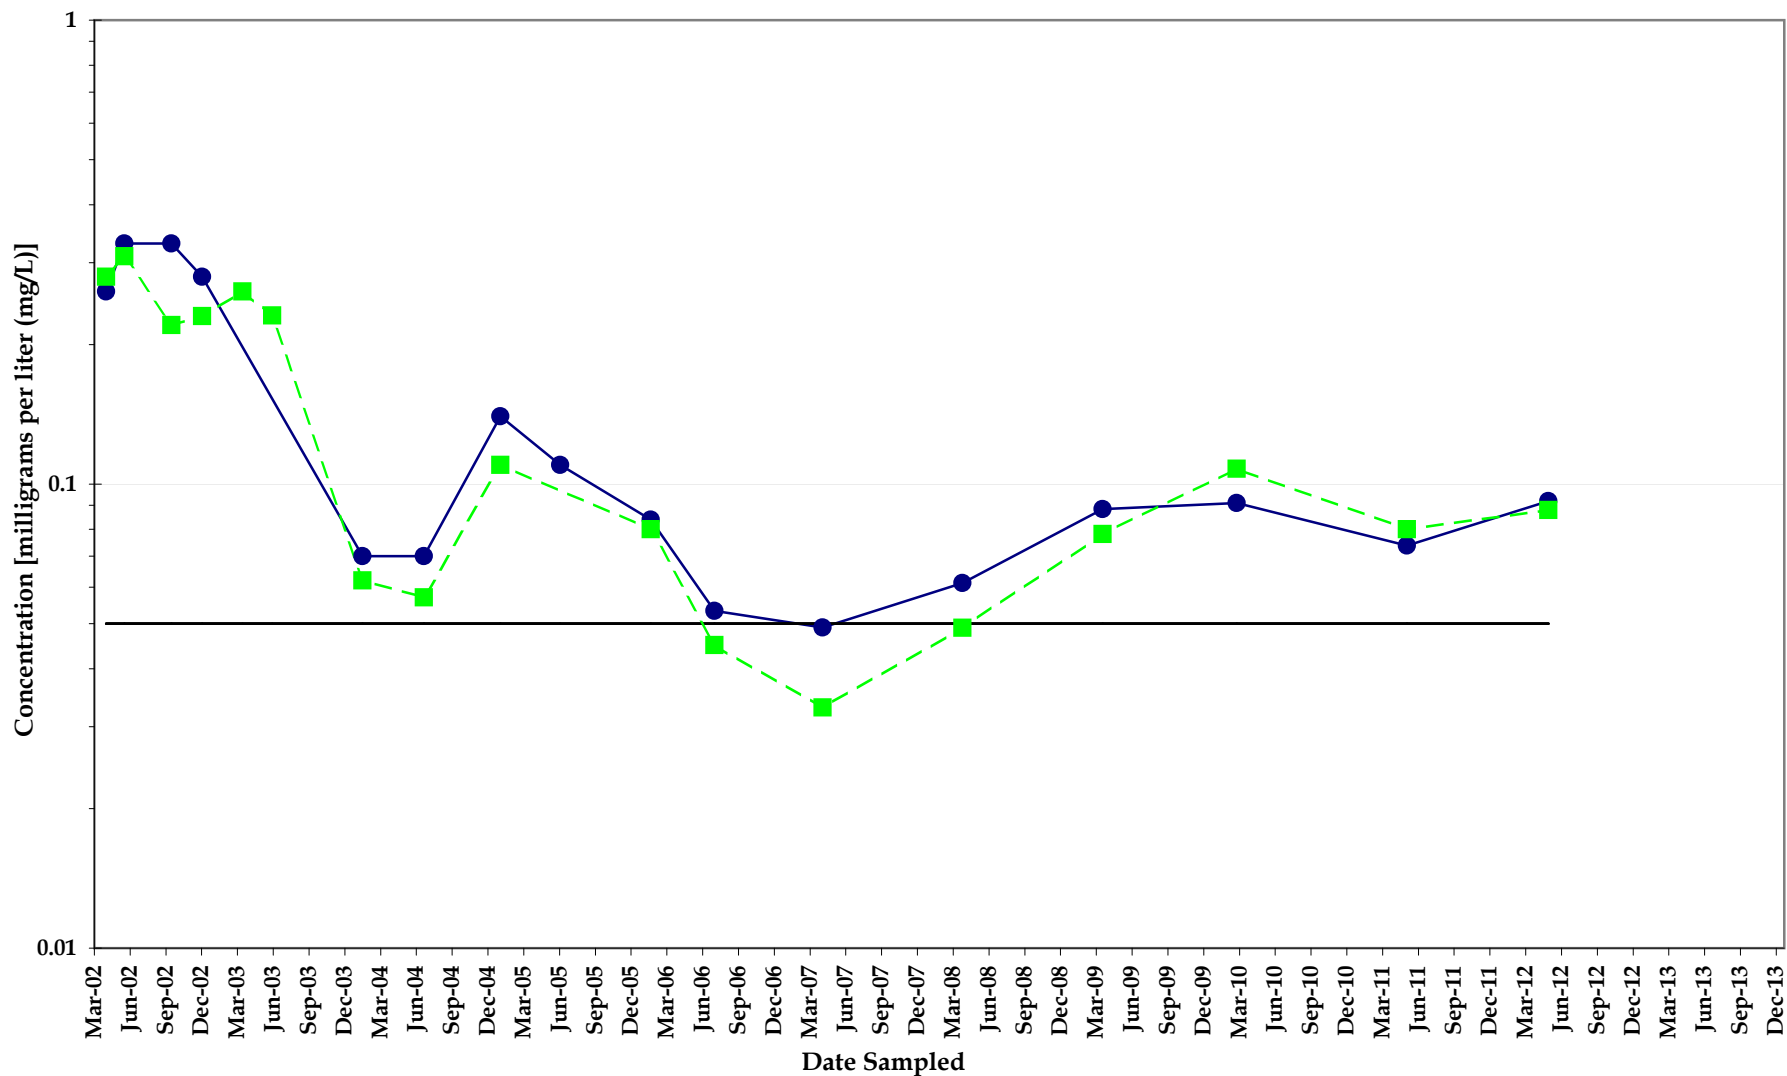
## Chromium Concentrations Monitoring Well MW034

Note: Non-detect analyses plotted at the method detection limit or half the reporting limit (RL). Detections denoted by symbol and detection values greater than the RL denoted by shaded symbol.

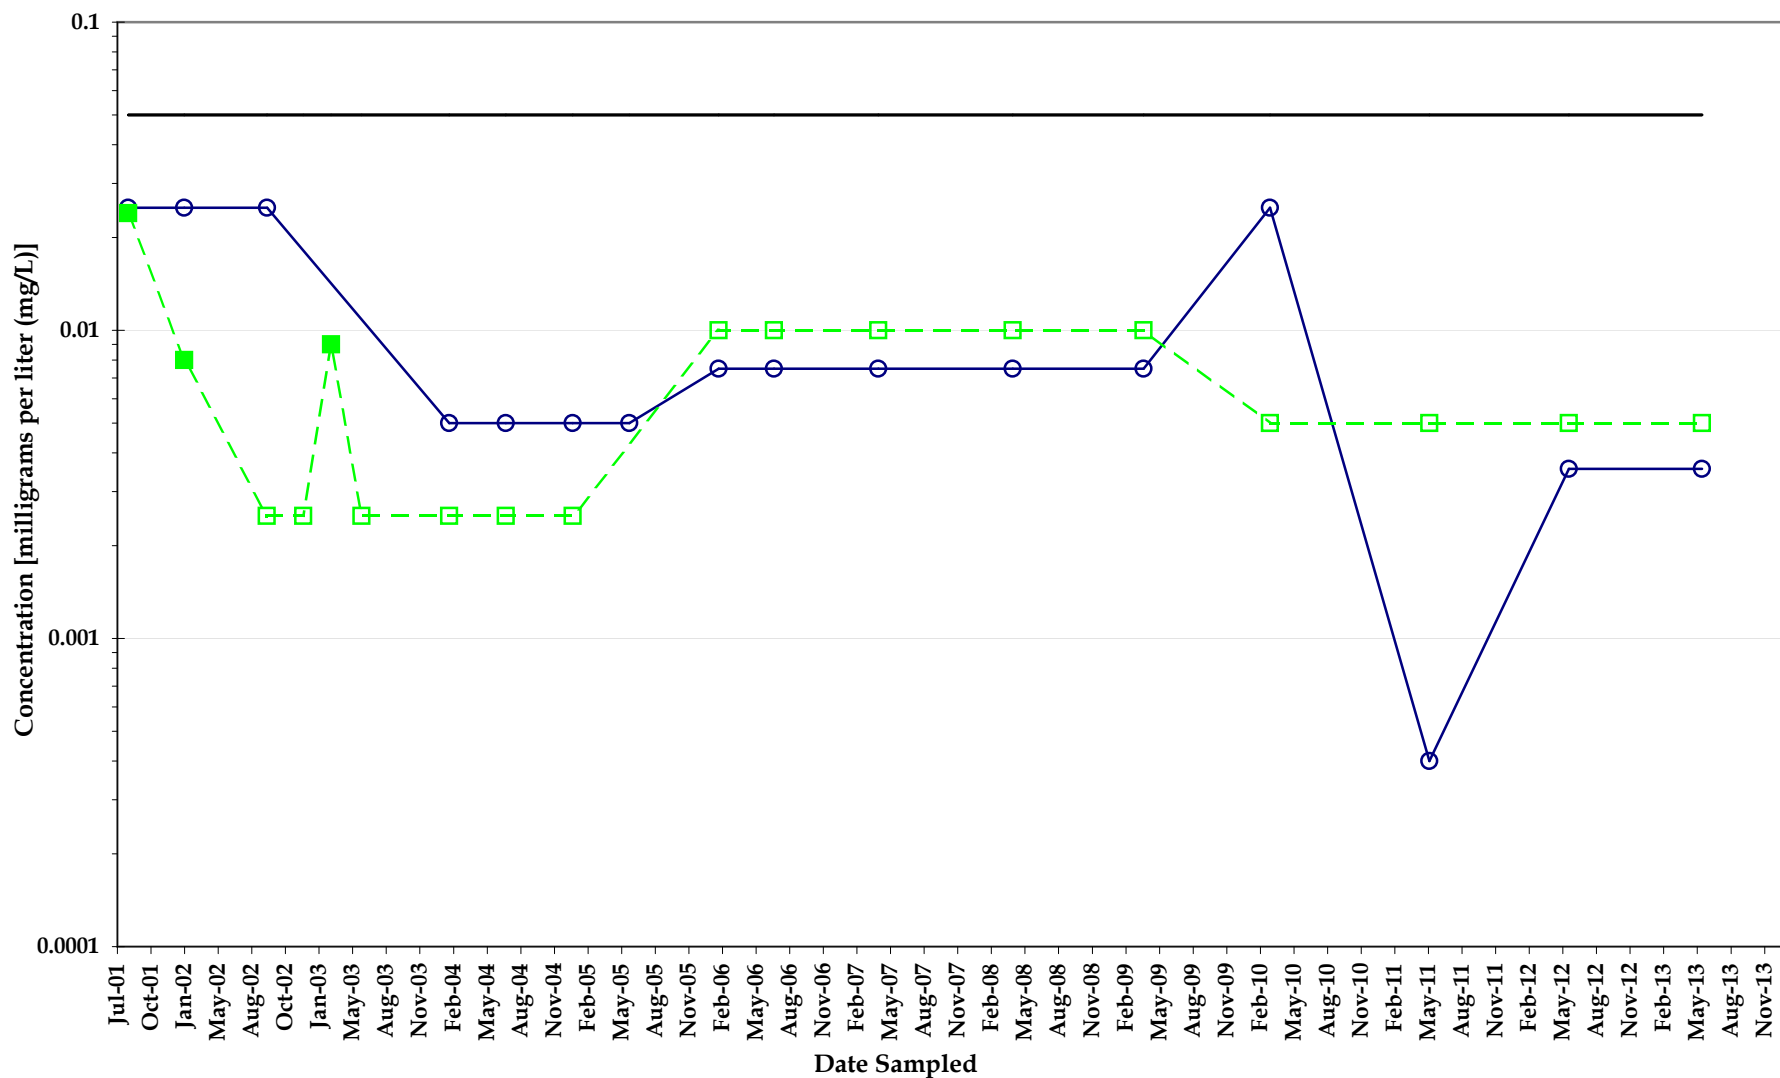
## Chromium Concentrations Monitoring Well MW035

Note: Non-detect analyses plotted at the method detection limit or half the reporting limit (RL). Detections denoted by symbol and detection values greater than the RL denoted by shaded symbol.

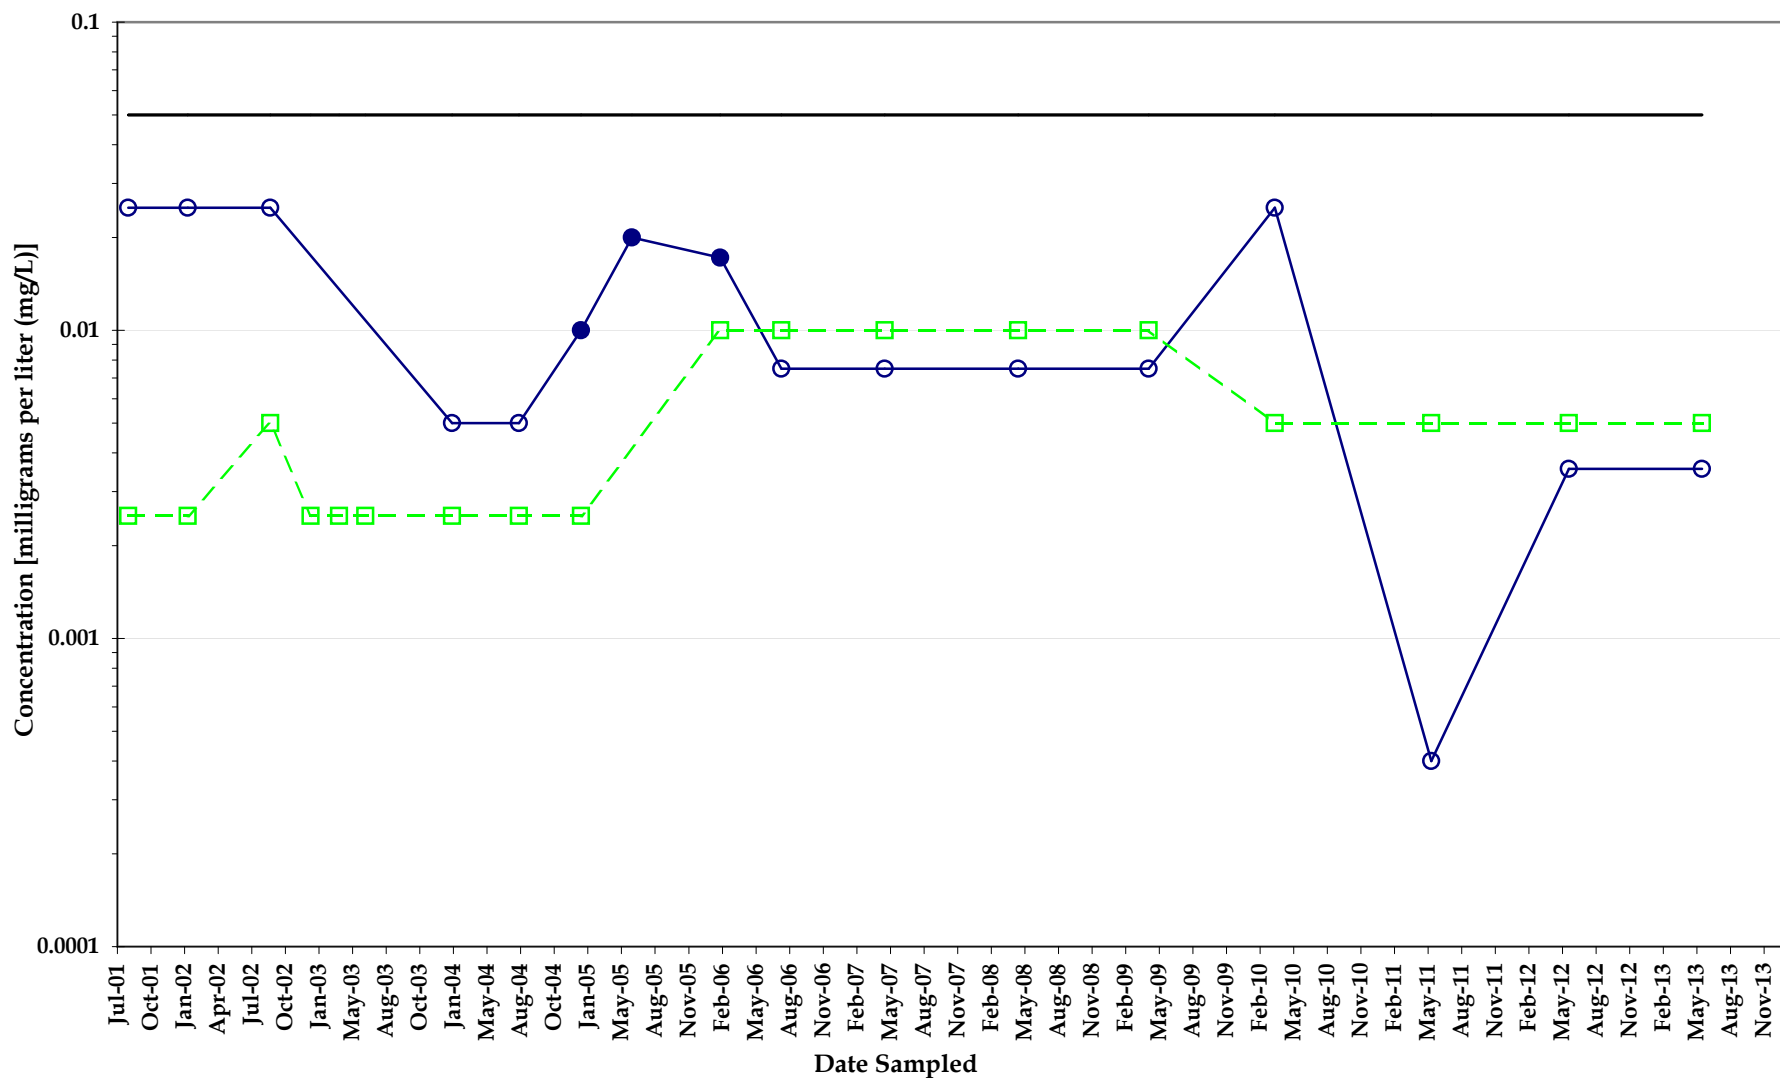
## Chromium Concentrations Monitoring Well MW036

Note: Non-detect analyses plotted at the method detection limit or half the reporting limit (RL). Detections denoted by symbol and detection values greater than the RL denoted by shaded symbol.

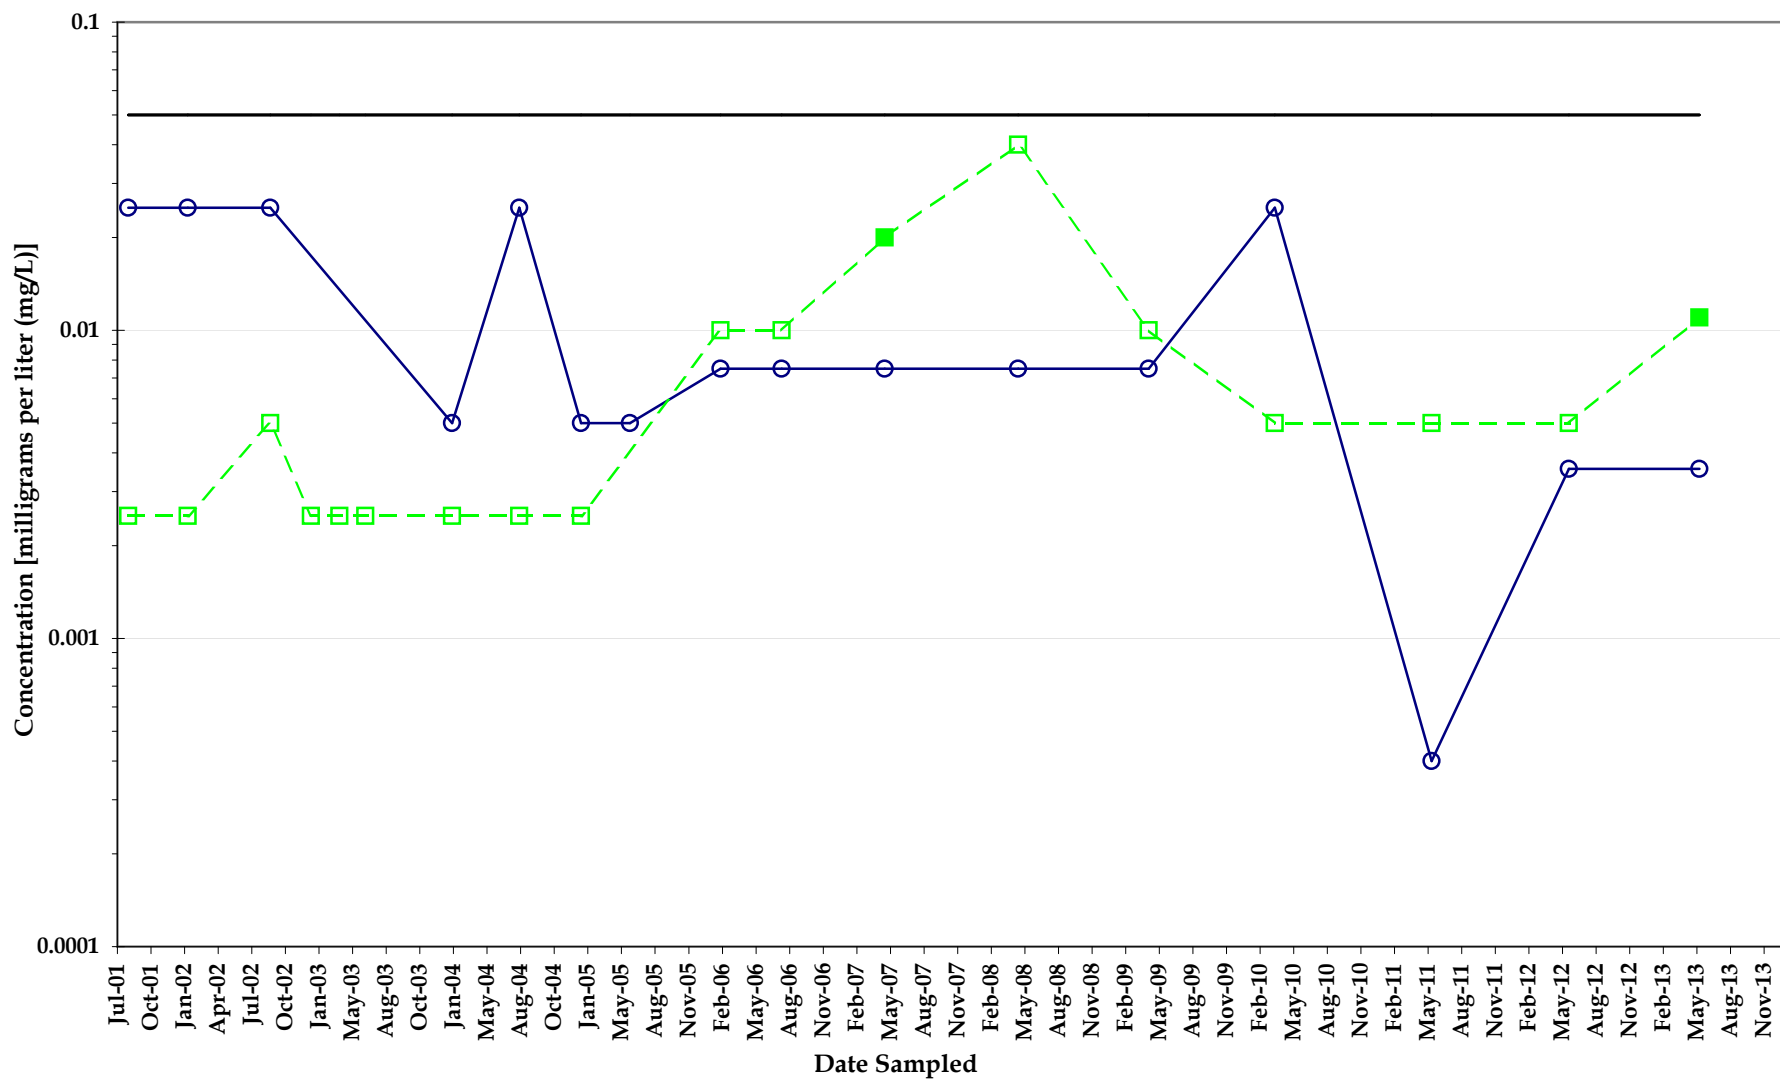
## Chromium Concentrations Monitoring Well MW037

Note: Non-detect analyses plotted at the method detection limit or half the reporting limit (RL). Detections denoted by symbol and detection values greater than the RL denoted by shaded symbol.
