**GW - 004**

**2013 AGWMR**

**VOL 5 OF 5**

*North Eunice Gas Plant  
Lea County, New Mexico*

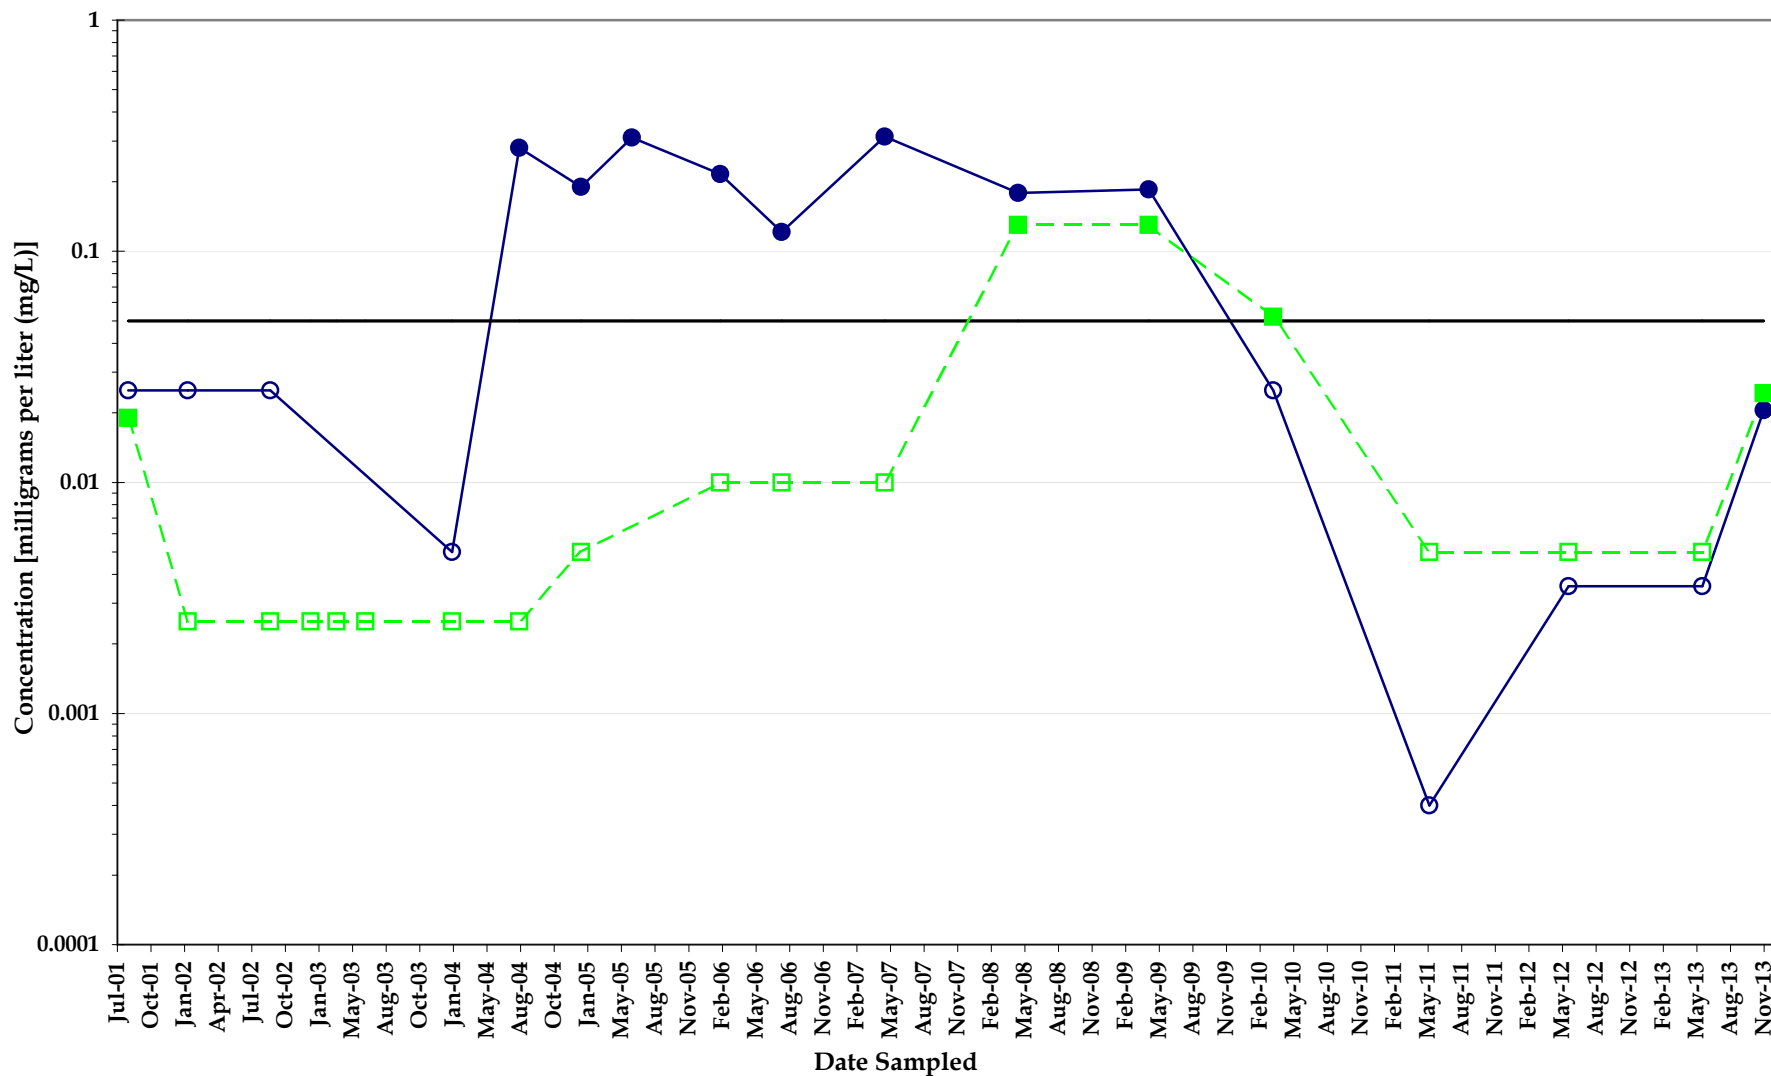
## Chromium Concentrations Monitoring Well MW038

Note: Non-detect analyses plotted at the method detection limit or half the reporting limit (RL). Detections denoted by symbol and detection values greater than the RL denoted by shaded symbol.

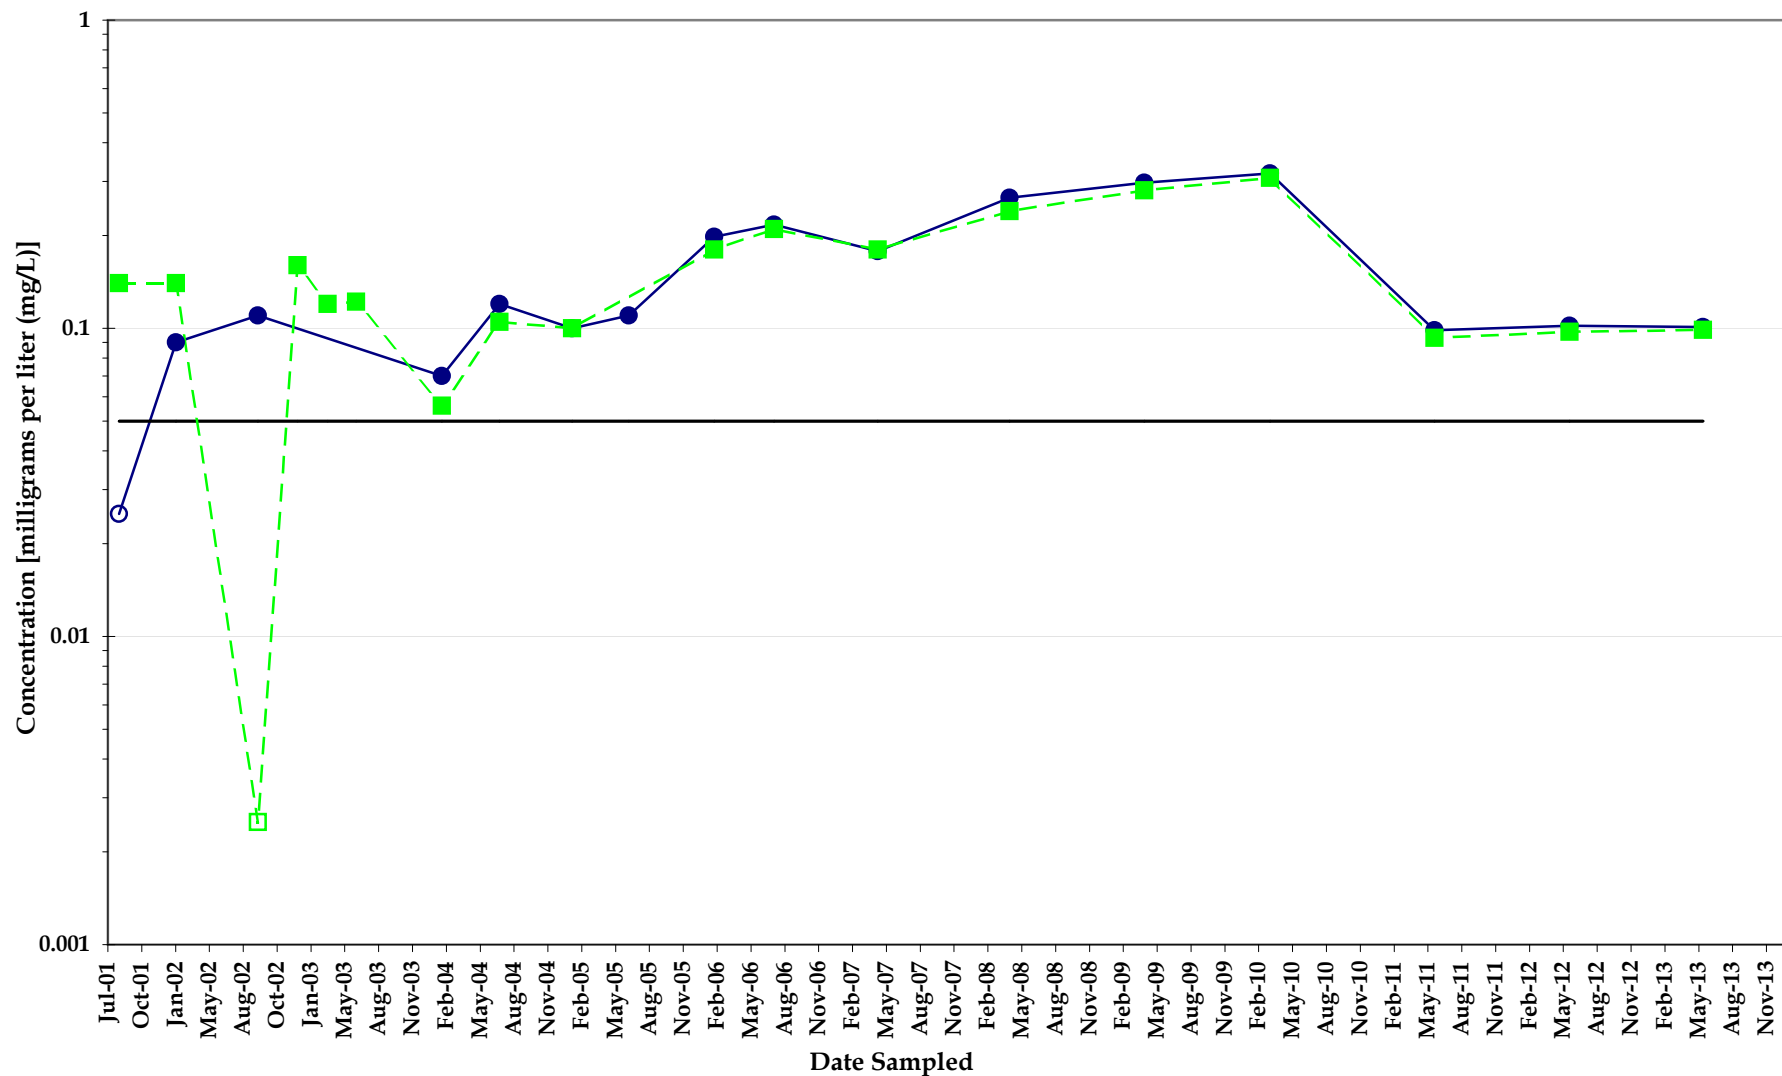
## Chromium Concentrations Monitoring Well MW039A

Note: Non-detect analyses plotted at the method detection limit or half the reporting limit (RL). Detections denoted by symbol and detection values greater than the RL denoted by shaded symbol.

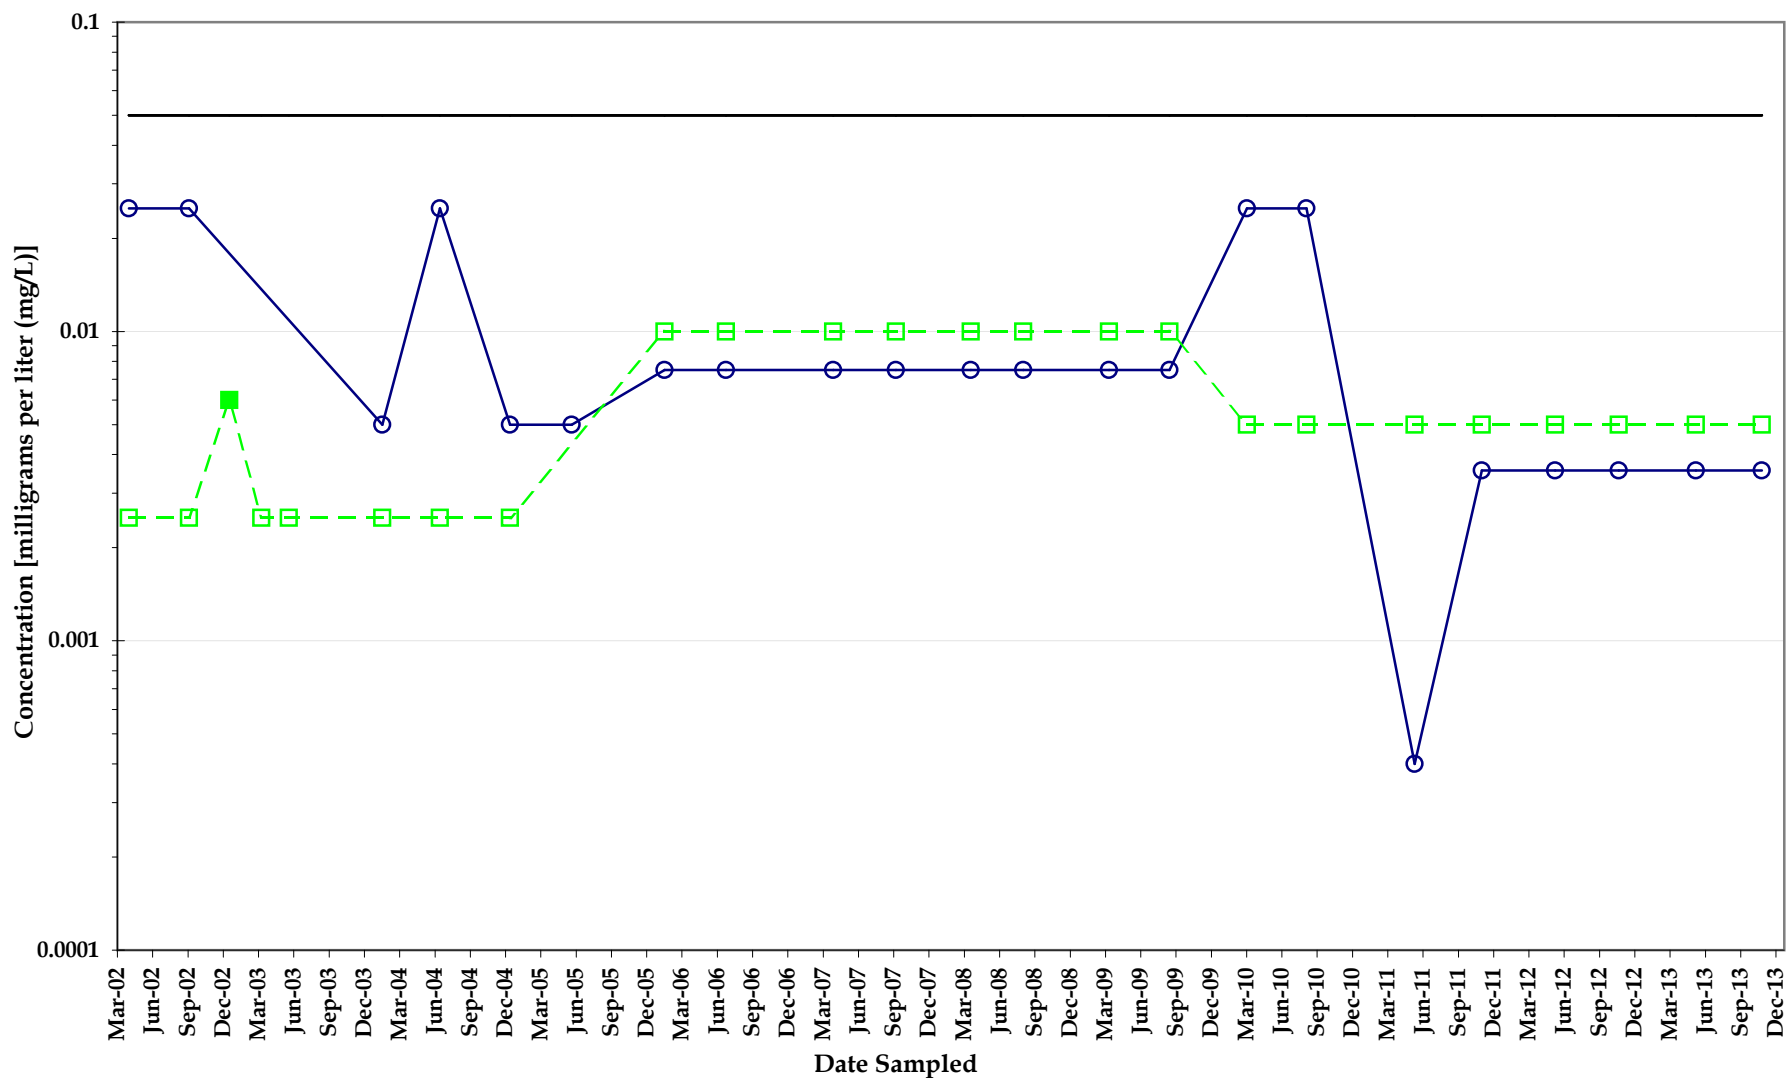
## Chromium Concentrations Monitoring Well MW040A

Note: Non-detect analyses plotted at the method detection limit or half the reporting limit (RL). Detections denoted by symbol and detection values greater than the RL denoted by shaded symbol.

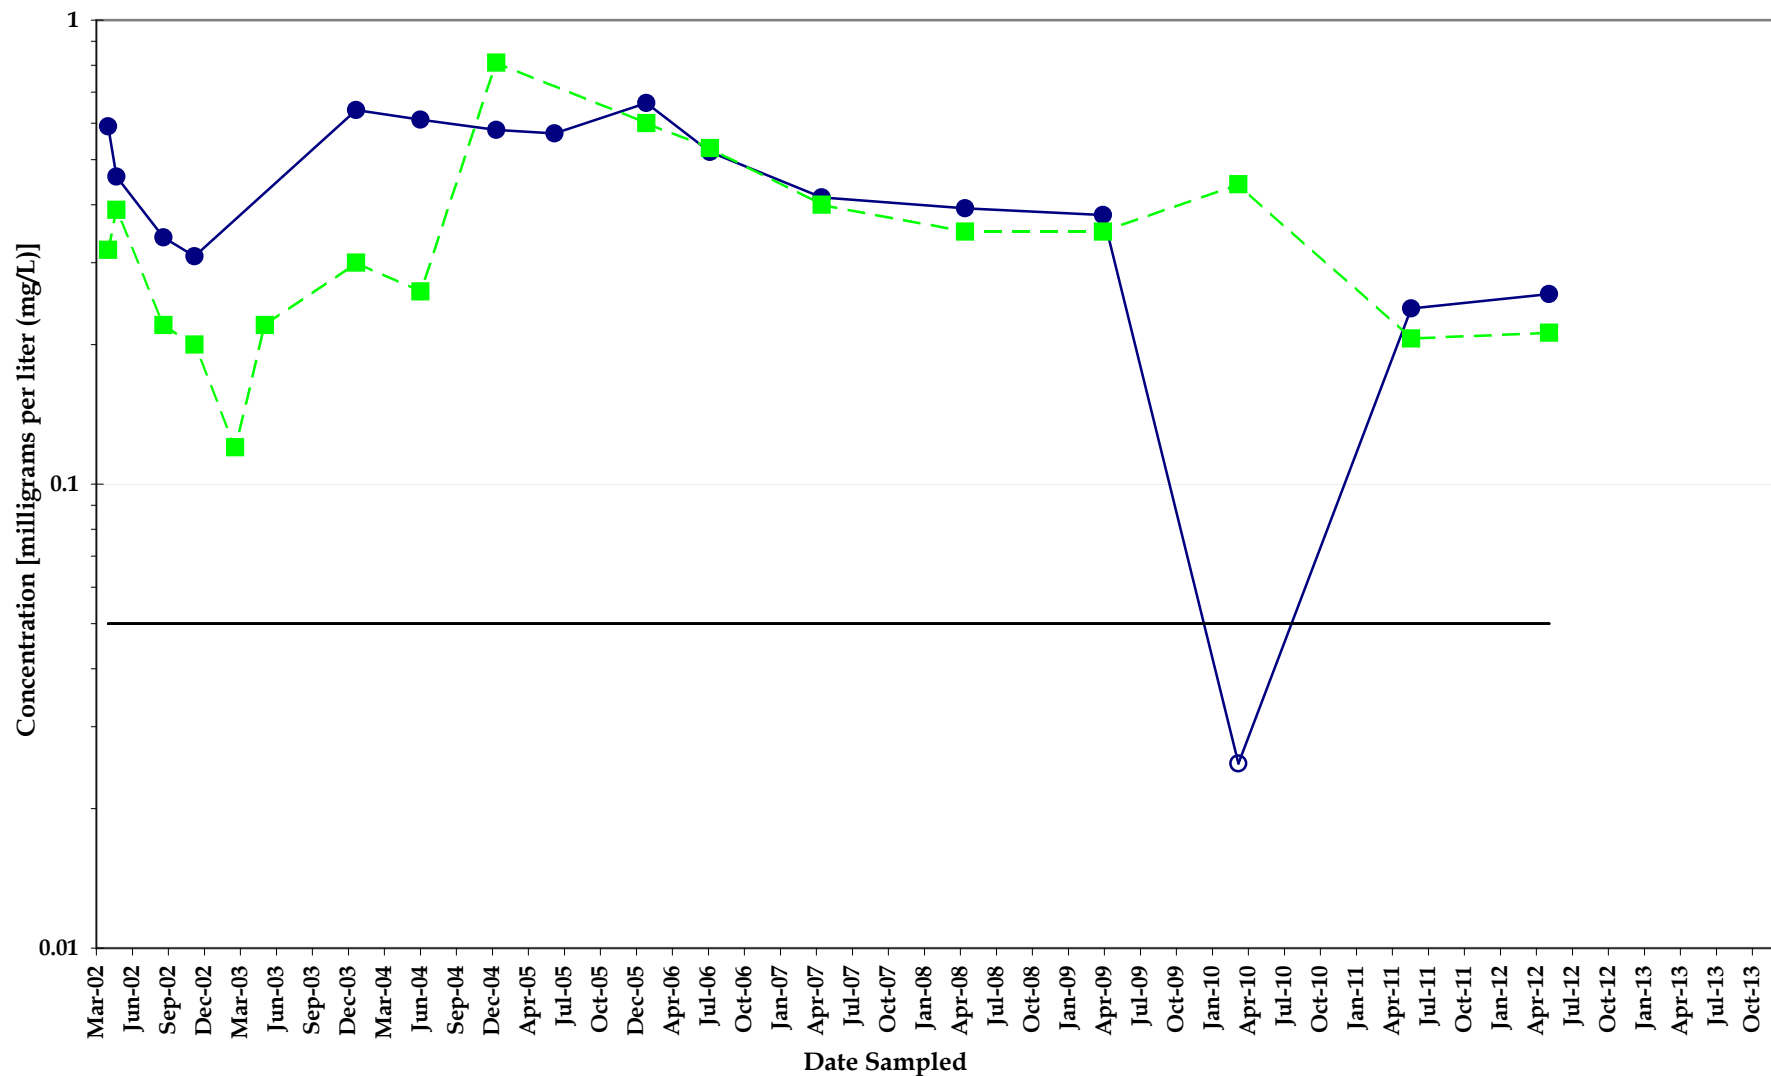
## Chromium Concentrations Monitoring Well MW041A

Note: Non-detect analyses plotted at the method detection limit or half the reporting limit (RL). Detections denoted by symbol and detection values greater than the RL denoted by shaded symbol.

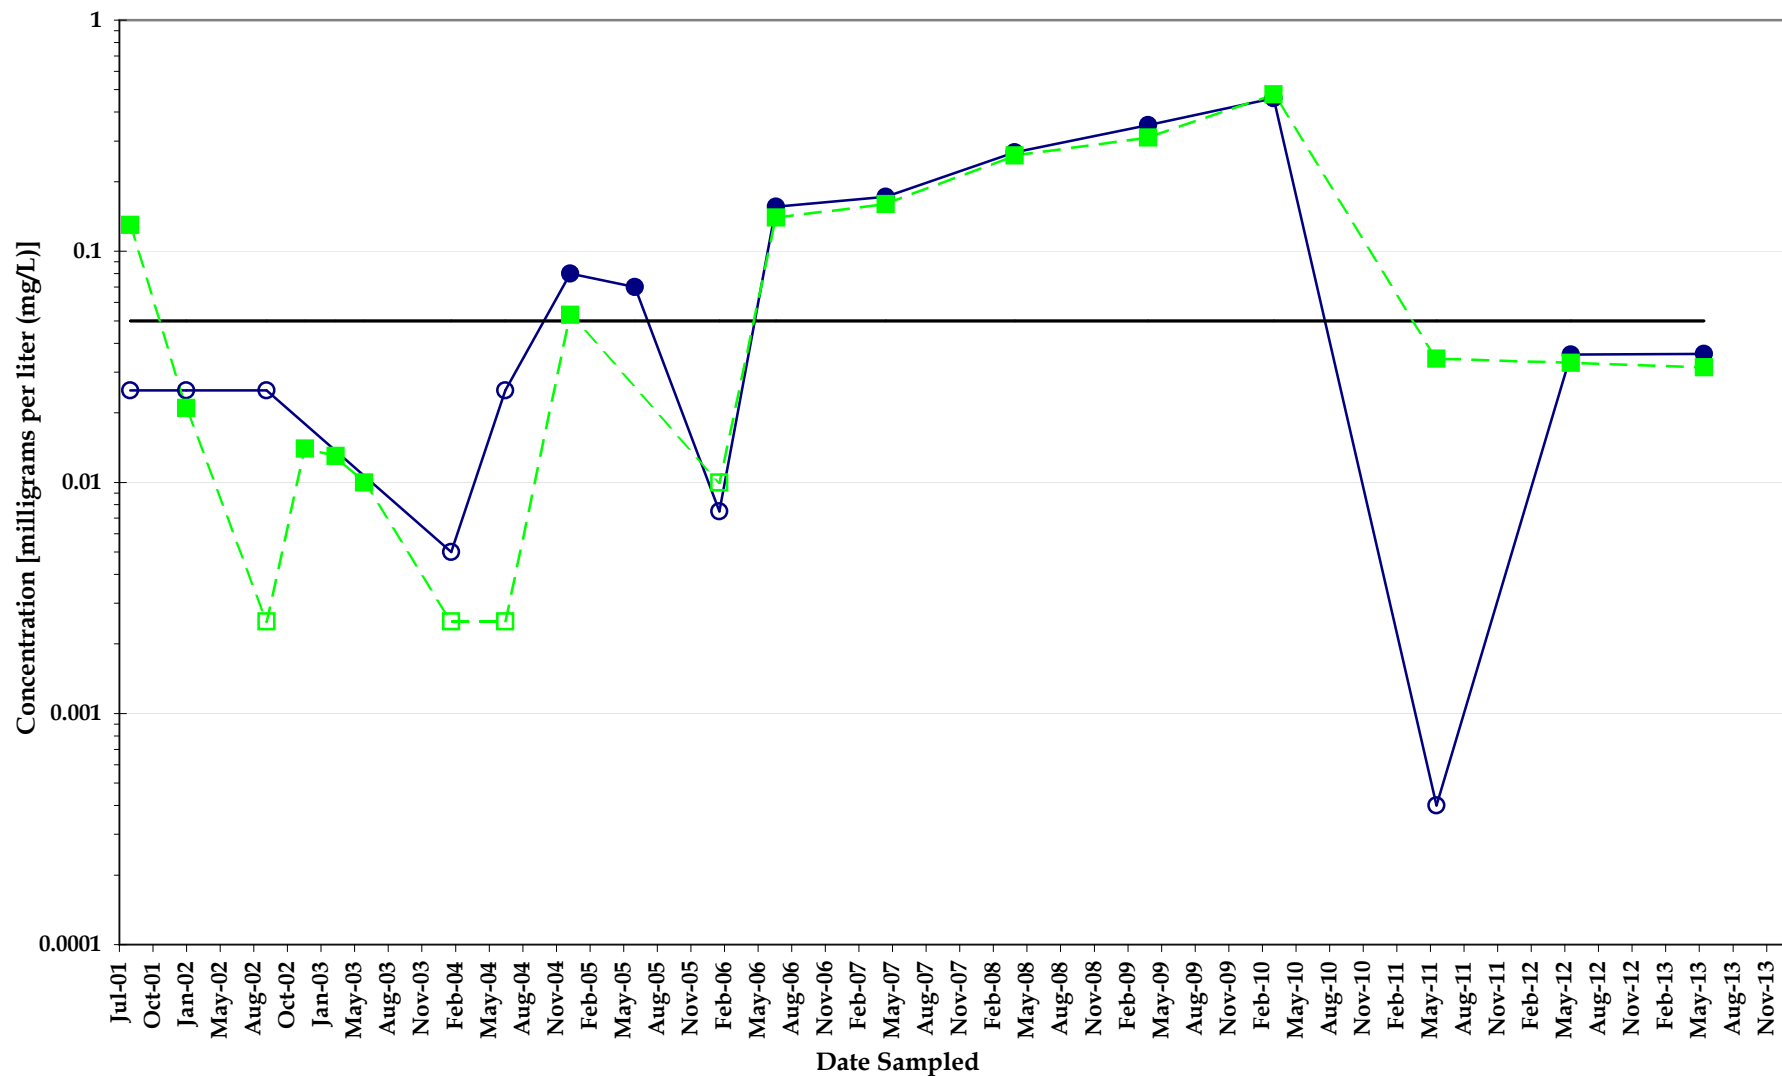
## Chromium Concentrations Monitoring Well MW042A

Note: Non-detect analyses plotted at the method detection limit or half the reporting limit (RL). Detections denoted by symbol and detection values greater than the RL denoted by shaded symbol.

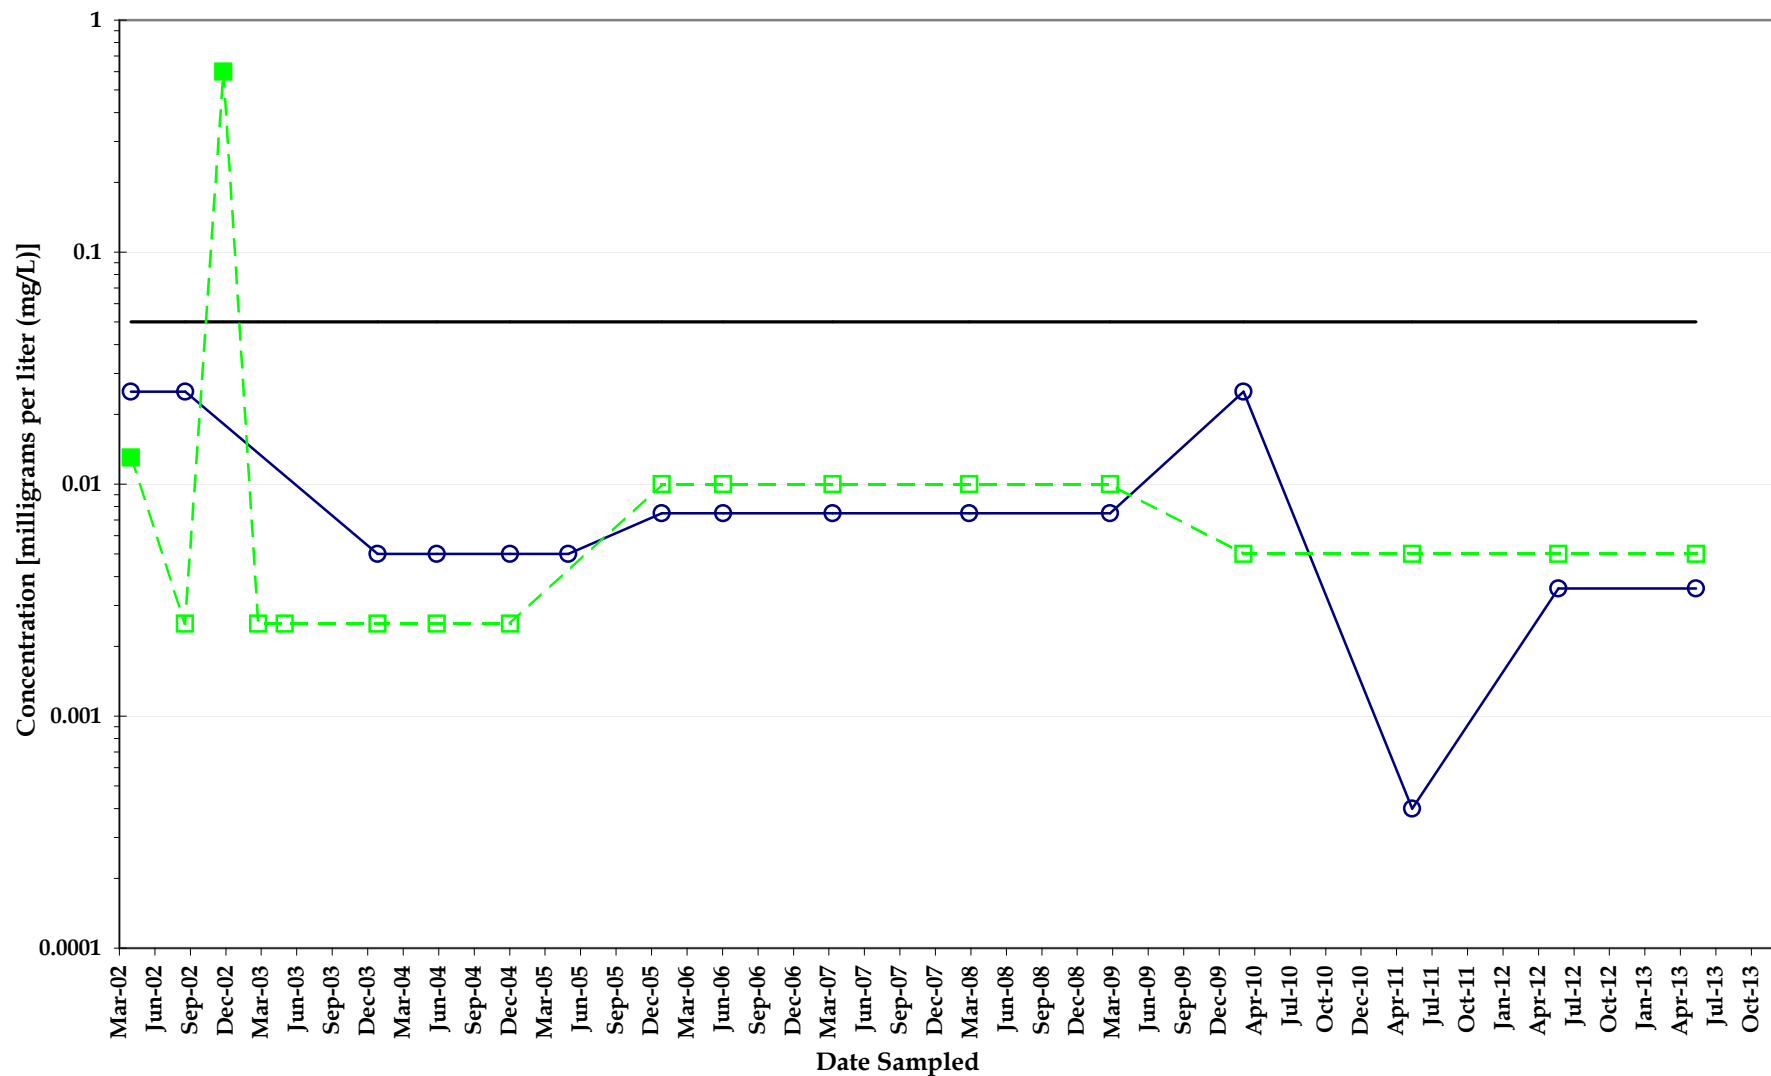
## Chromium Concentrations Monitoring Well MW043

Note: Non-detect analyses plotted at the method detection limit or half the reporting limit (RL). Detections denoted by symbol and detection values greater than the RL denoted by shaded symbol.

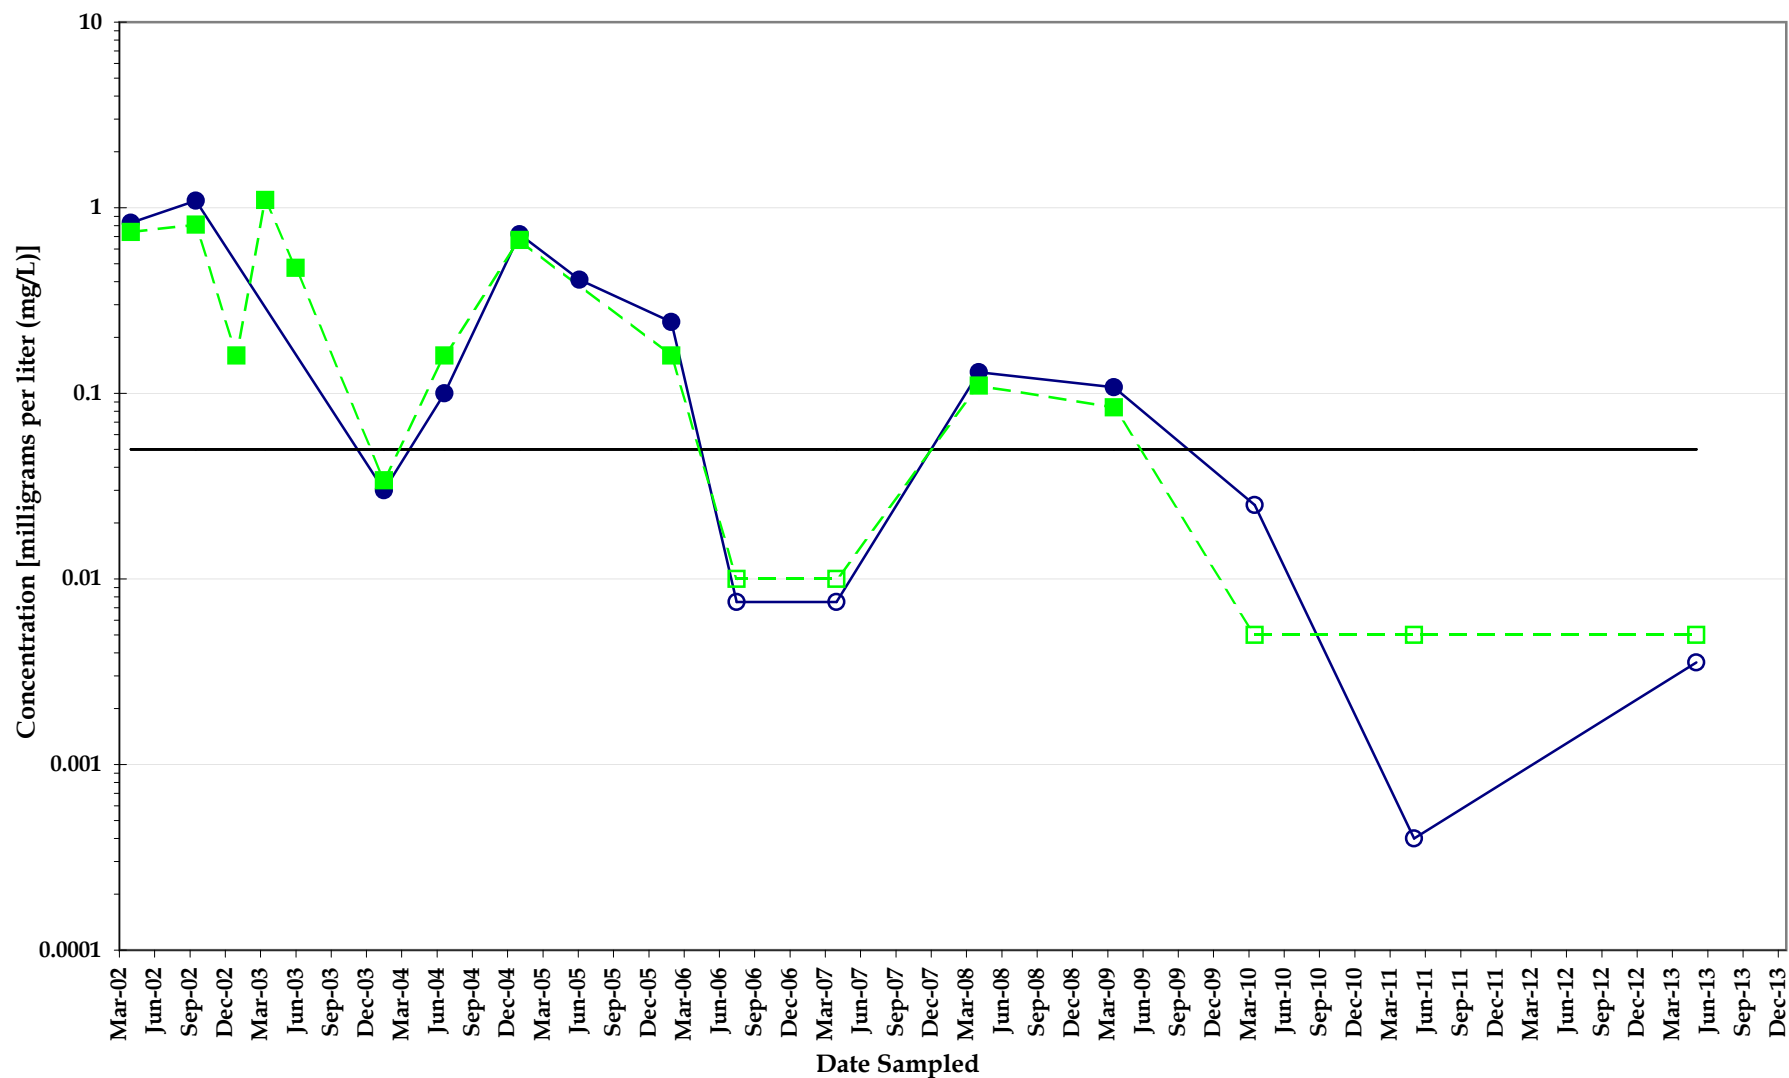
## Chromium Concentrations Monitoring Well MW044

Note: Non-detect analyses plotted at the method detection limit or half the reporting limit (RL). Detections denoted by symbol and detection values greater than the RL denoted by shaded symbol.

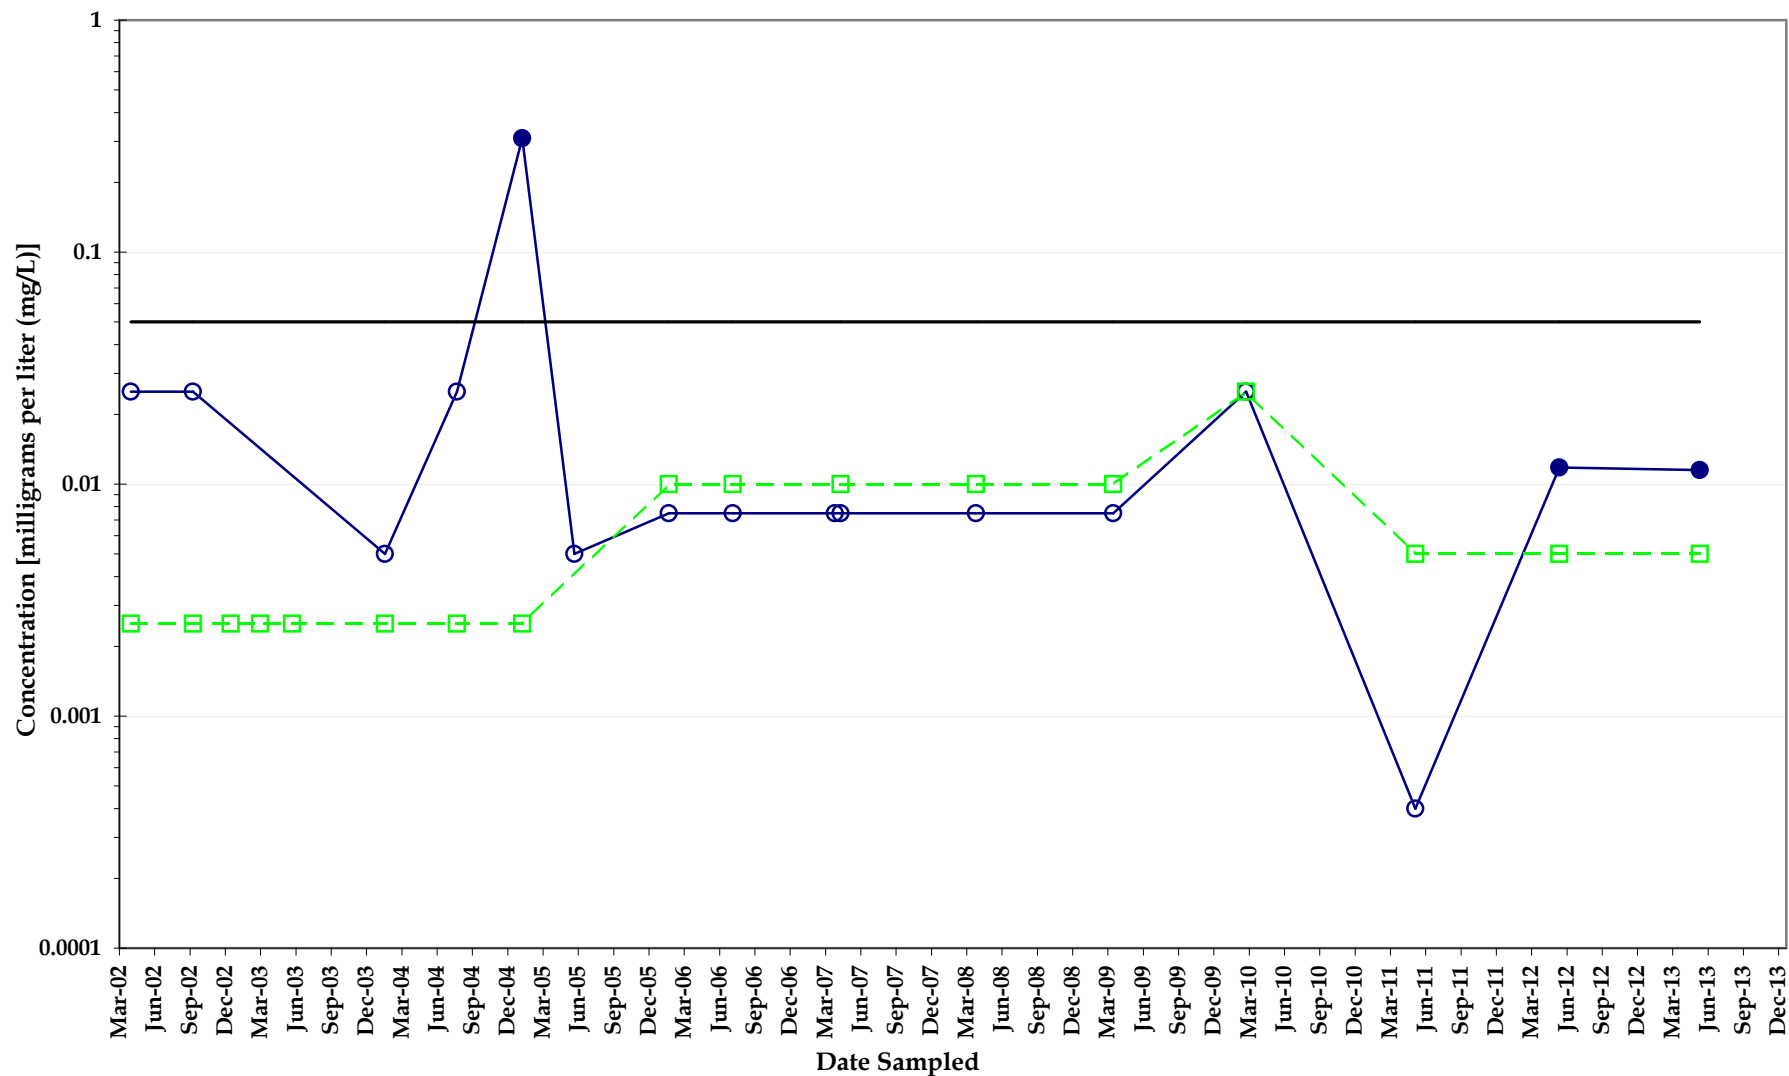
## Chromium Concentrations Monitoring Well MW045

Note: Non-detect analyses plotted at the method detection limit or half the reporting limit (RL). Detections denoted by symbol and detection values greater than the RL denoted by shaded symbol.

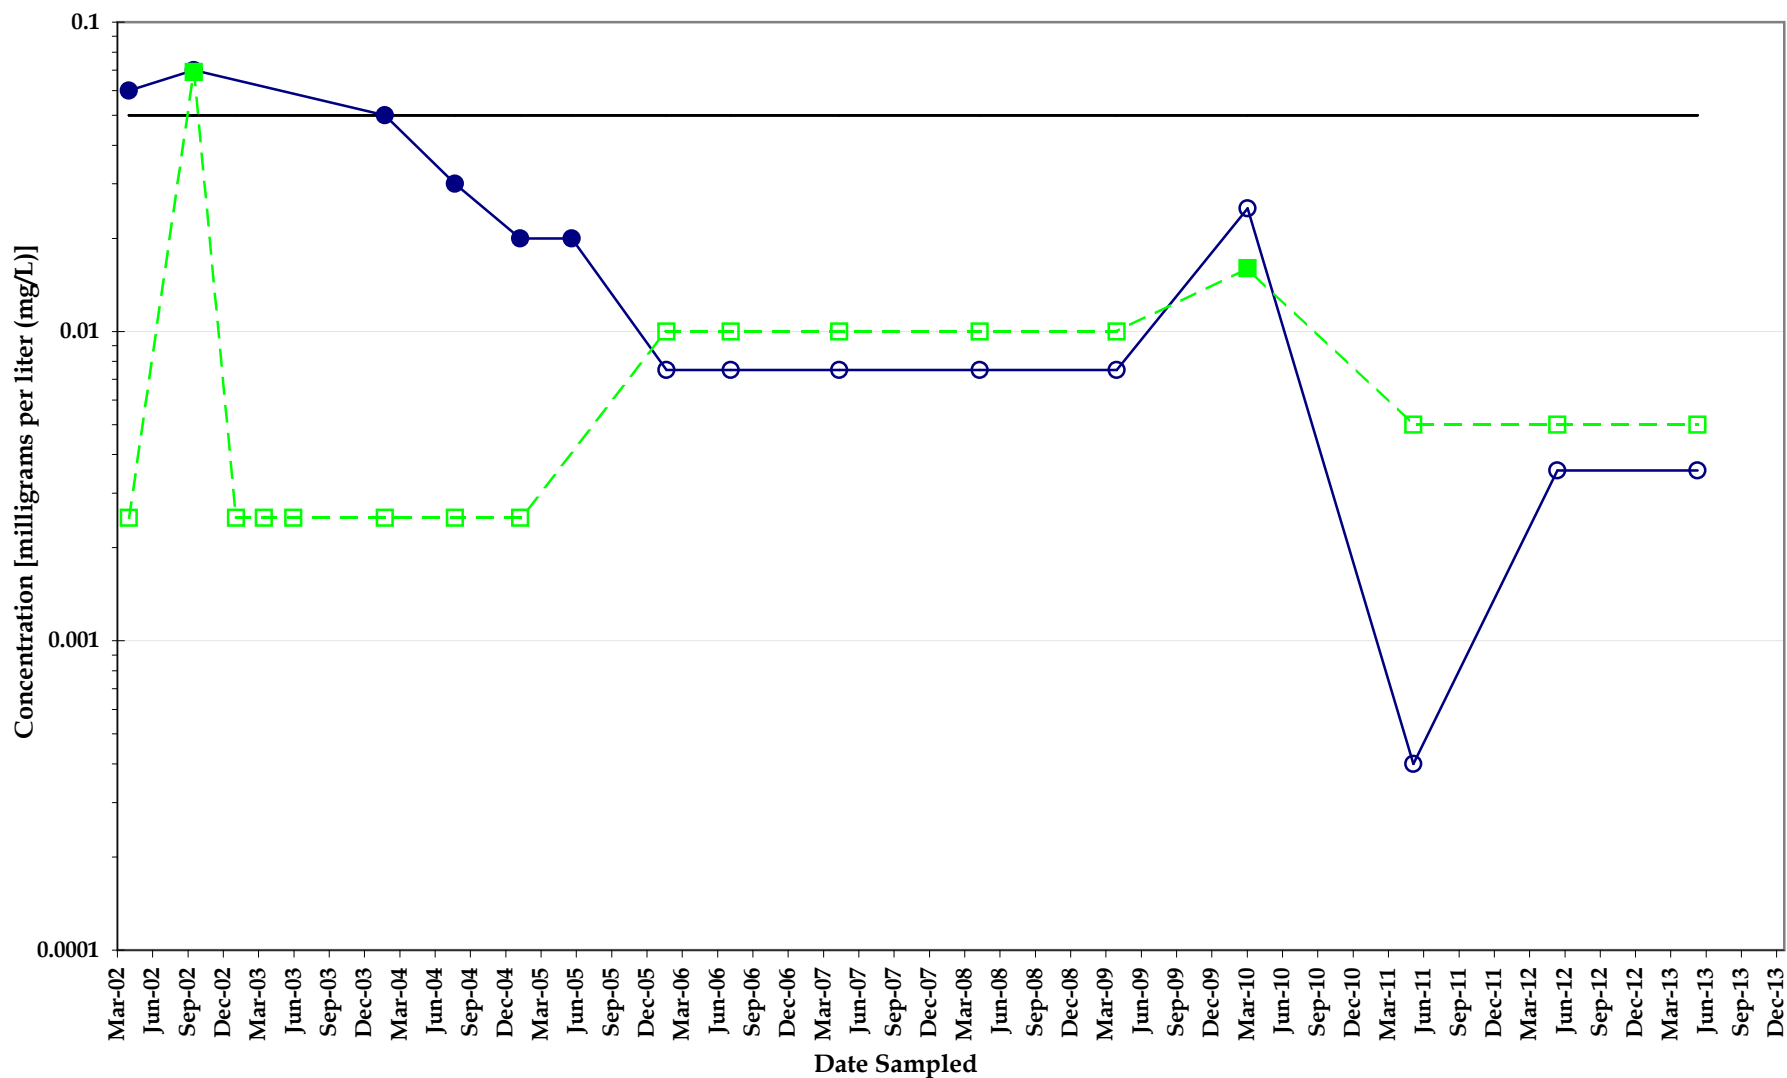
## Chromium Concentrations Monitoring Well MW046

Note: Non-detect analyses plotted at the method detection limit or half the reporting limit (RL). Detections denoted by symbol and detection values greater than the RL denoted by shaded symbol.

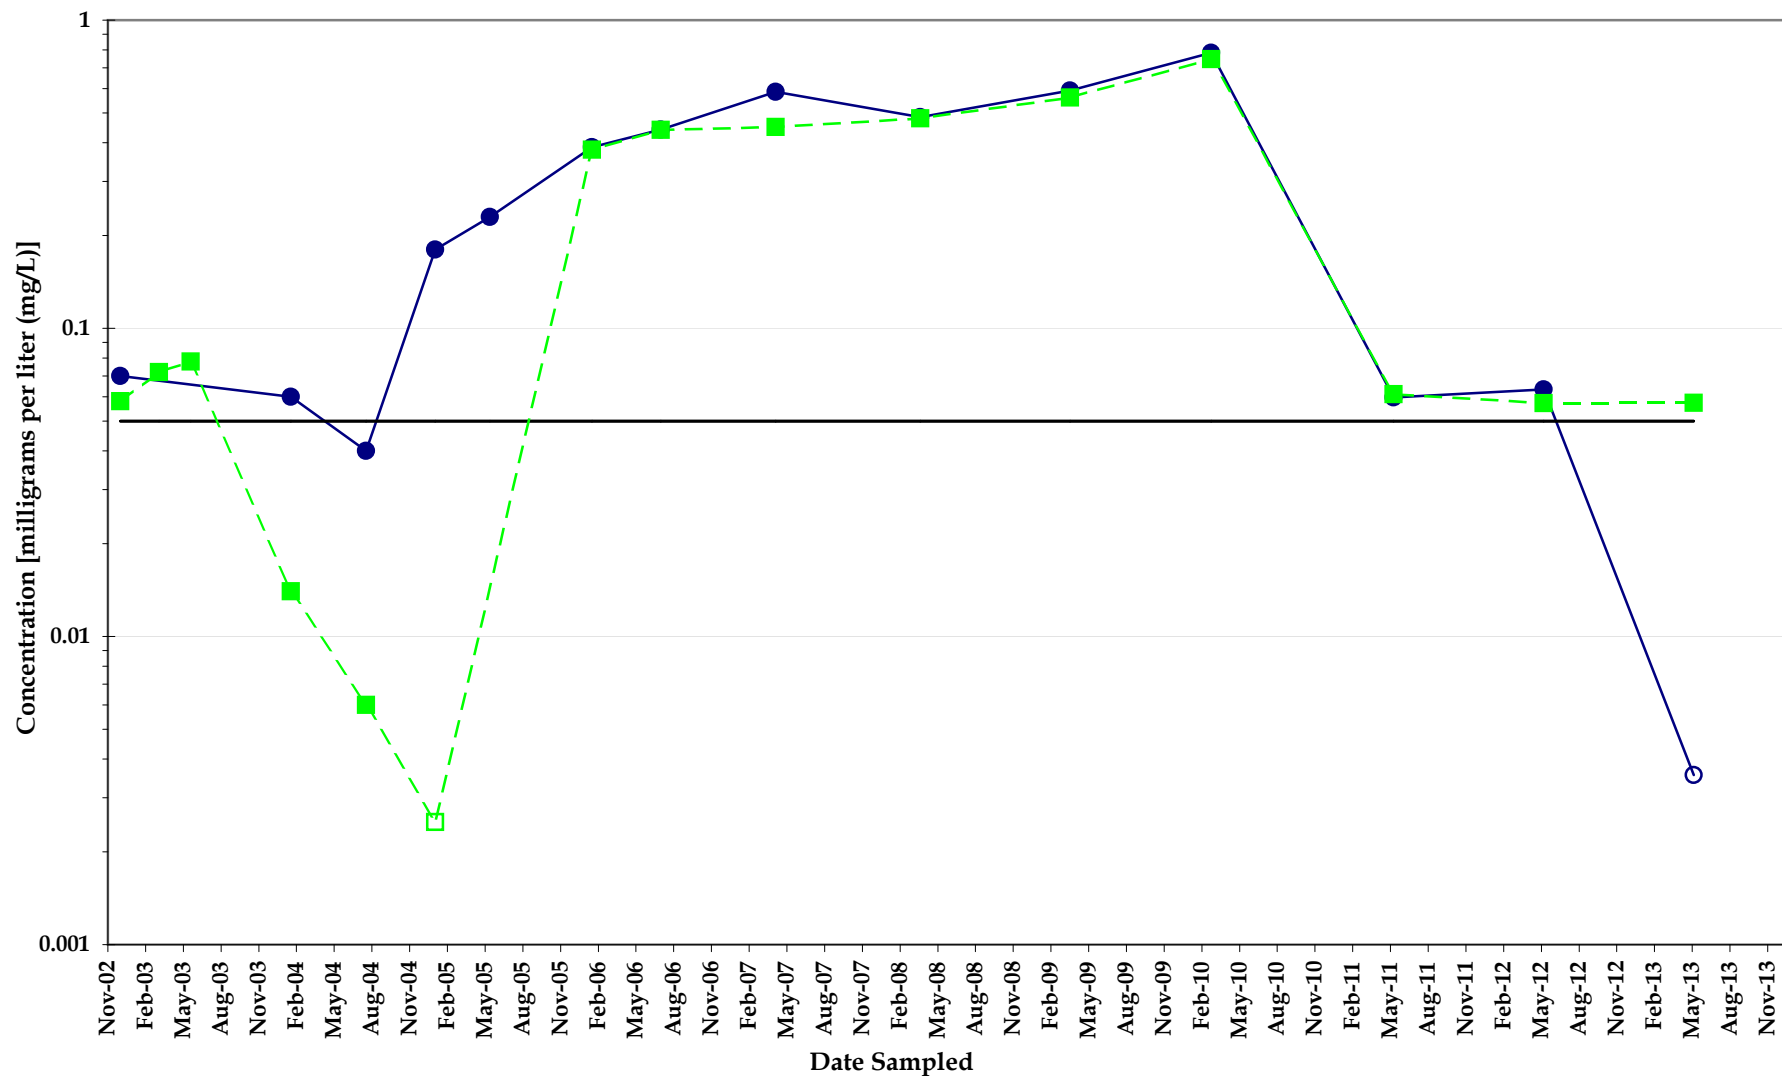
## Chromium Concentrations Monitoring Well MW046A

Note: Non-detect analyses plotted at the method detection limit or half the reporting limit (RL). Detections denoted by symbol and detection values greater than the RL denoted by shaded symbol.

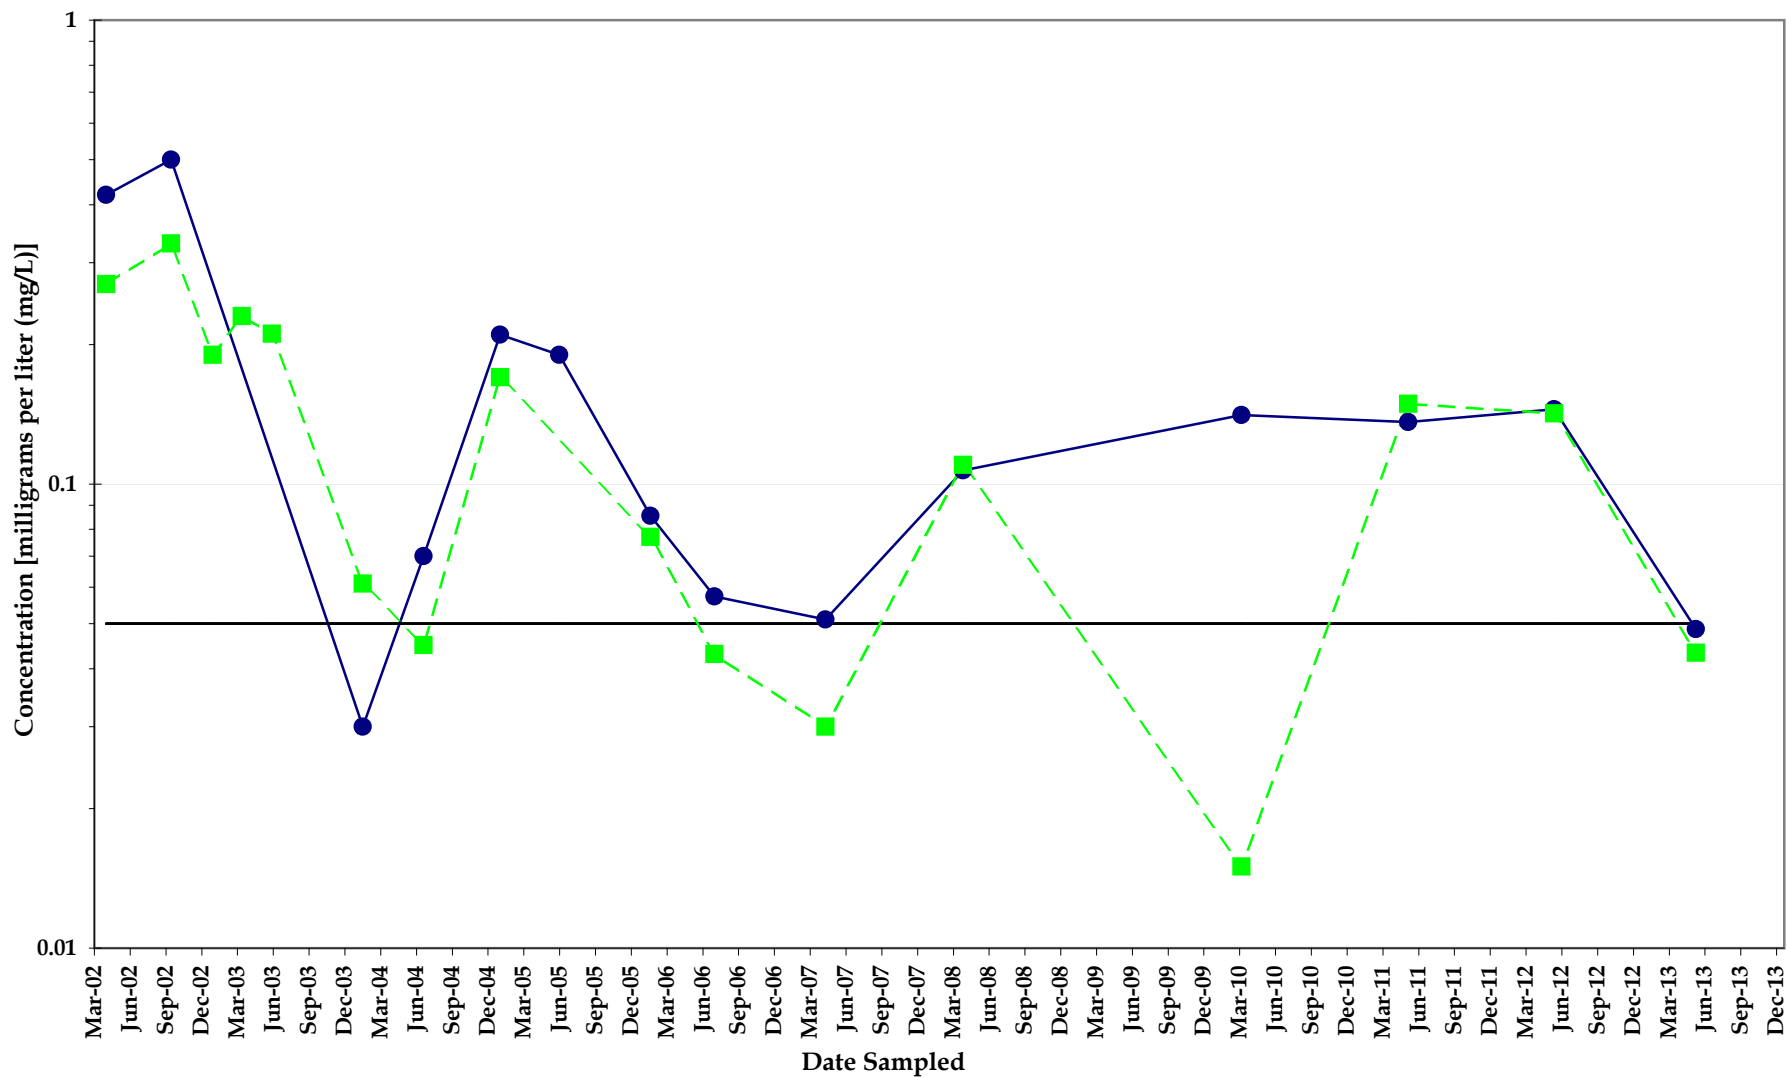
## Chromium Concentrations Monitoring Well MW047

Chromium (solid blue line, circles)      Detects (shaded symbols)      Non-Detects (unshaded symbols)      NMWQCC (horizontal line)  
 Hexavalent Chromium (dashed green line, squares)      Detects (shaded symbols)      Non-Detects (unshaded symbols)

Note: Non-detect analyses plotted at the method detection limit or half the reporting limit (RL). Detections denoted by symbol and detection values greater than the RL denoted by shaded symbol.
