**GW - 004**

**2013 AGWMR**

**VOL 5 OF 5**

*North Eunice Gas Plant  
Lea County, New Mexico*

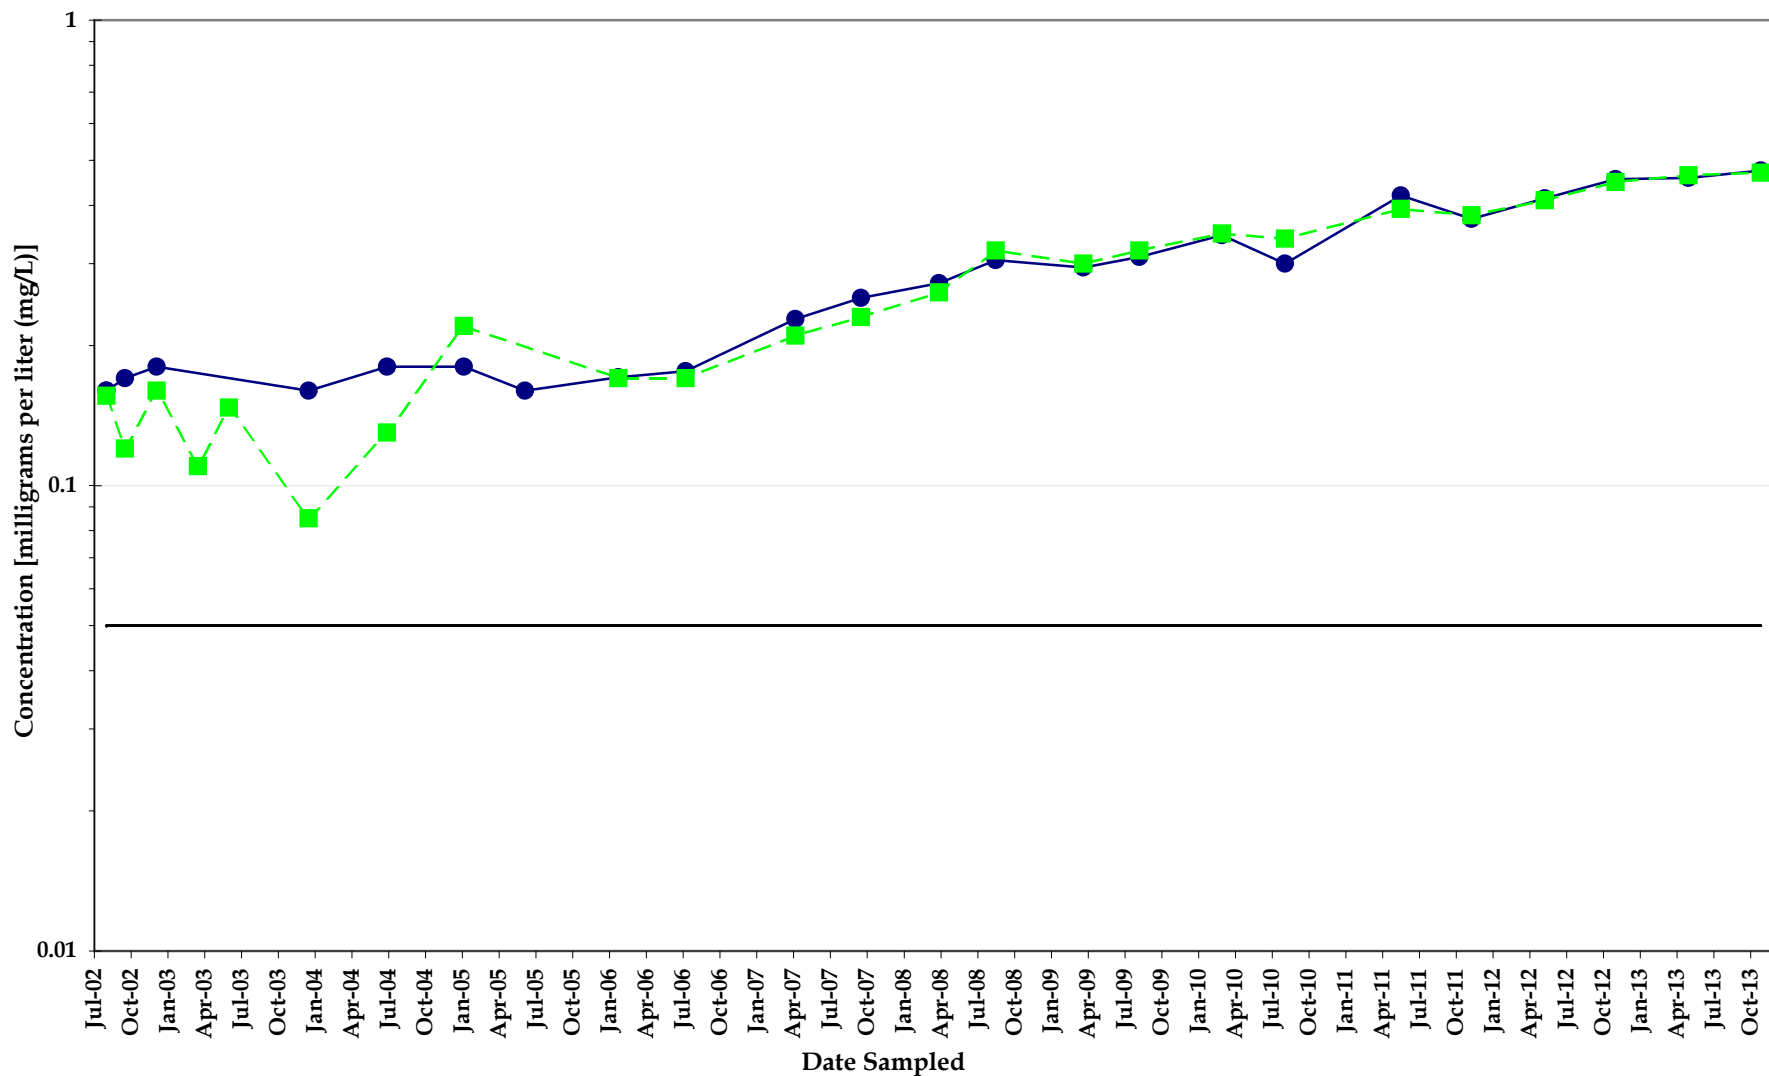
## Chromium Concentrations Monitoring Well MW048SA

Note: Non-detect analyses plotted at the method detection limit or half the reporting limit (RL). Detections denoted by symbol and detection values greater than the RL denoted by shaded symbol.

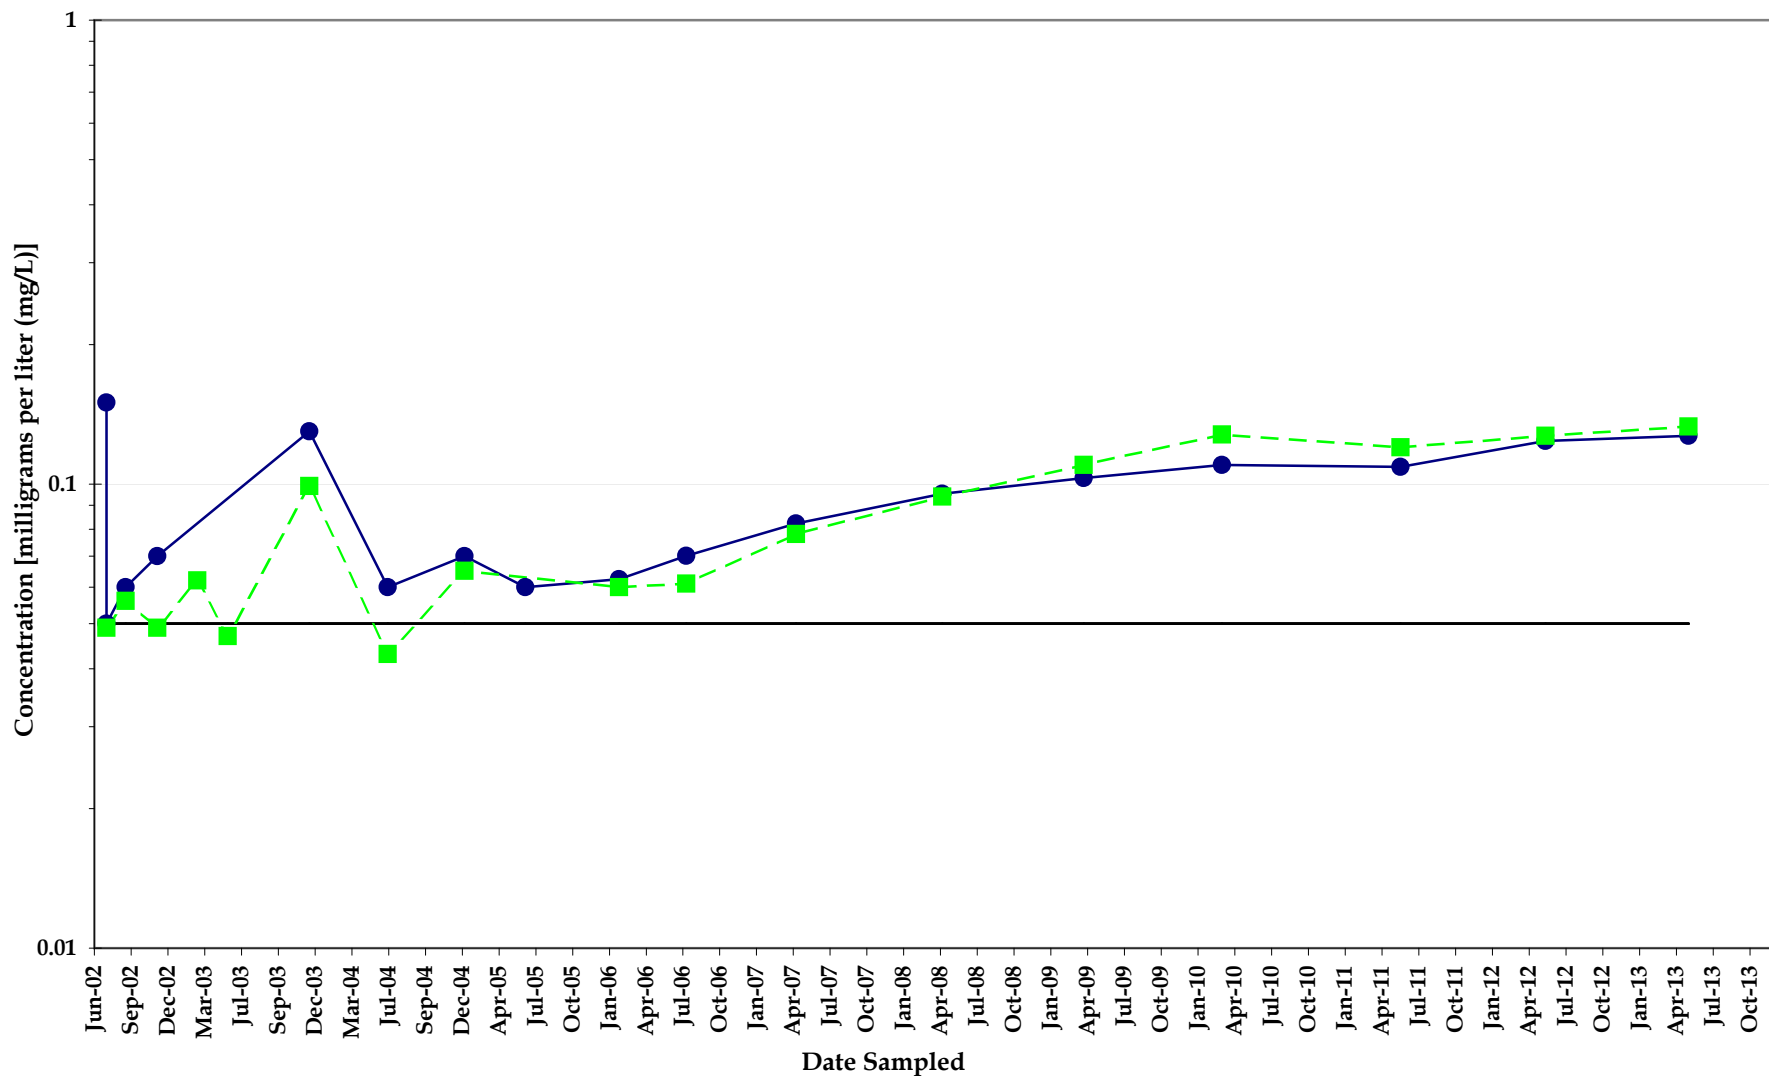
## Chromium Concentrations Monitoring Well MW049SA

Note: Non-detect analyses plotted at the method detection limit or half the reporting limit (RL). Detections denoted by symbol and detection values greater than the RL denoted by shaded symbol.

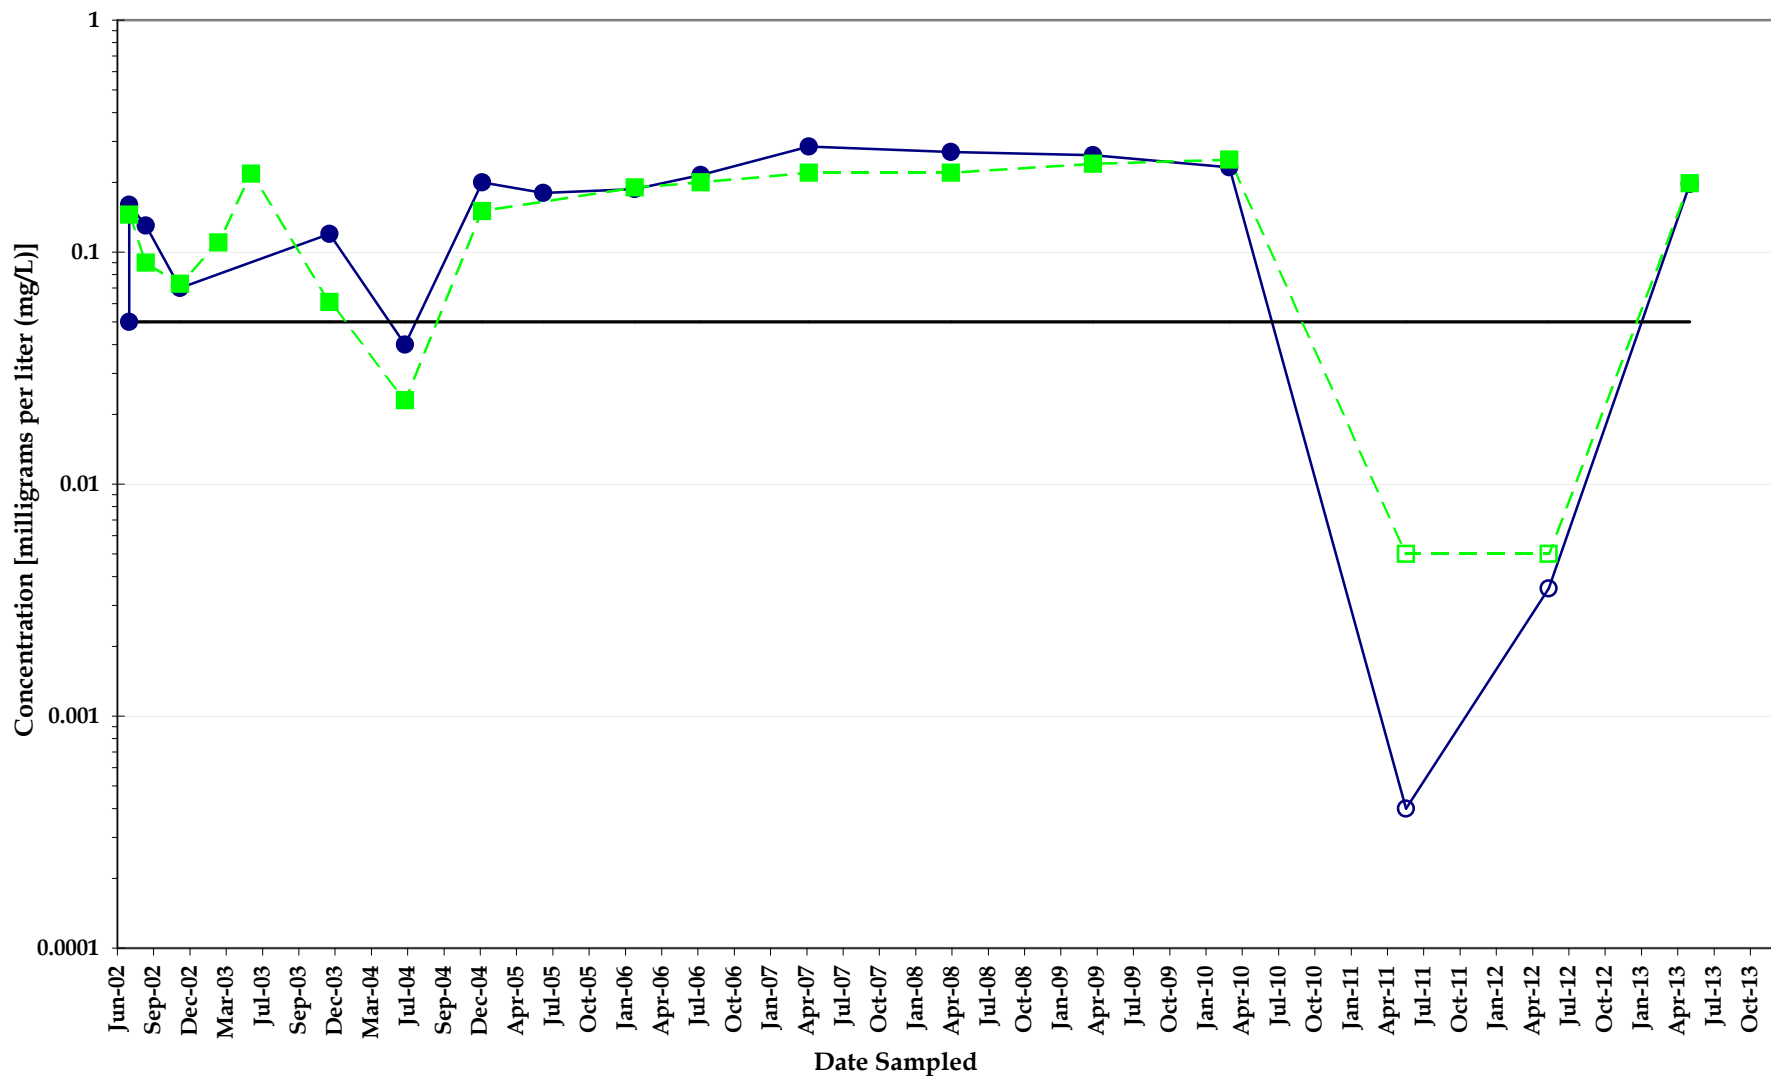
## Chromium Concentrations Monitoring Well MW050SA

Note: Non-detect analyses plotted at the method detection limit or half the reporting limit (RL). Detections denoted by symbol and detection values greater than the RL denoted by shaded symbol.

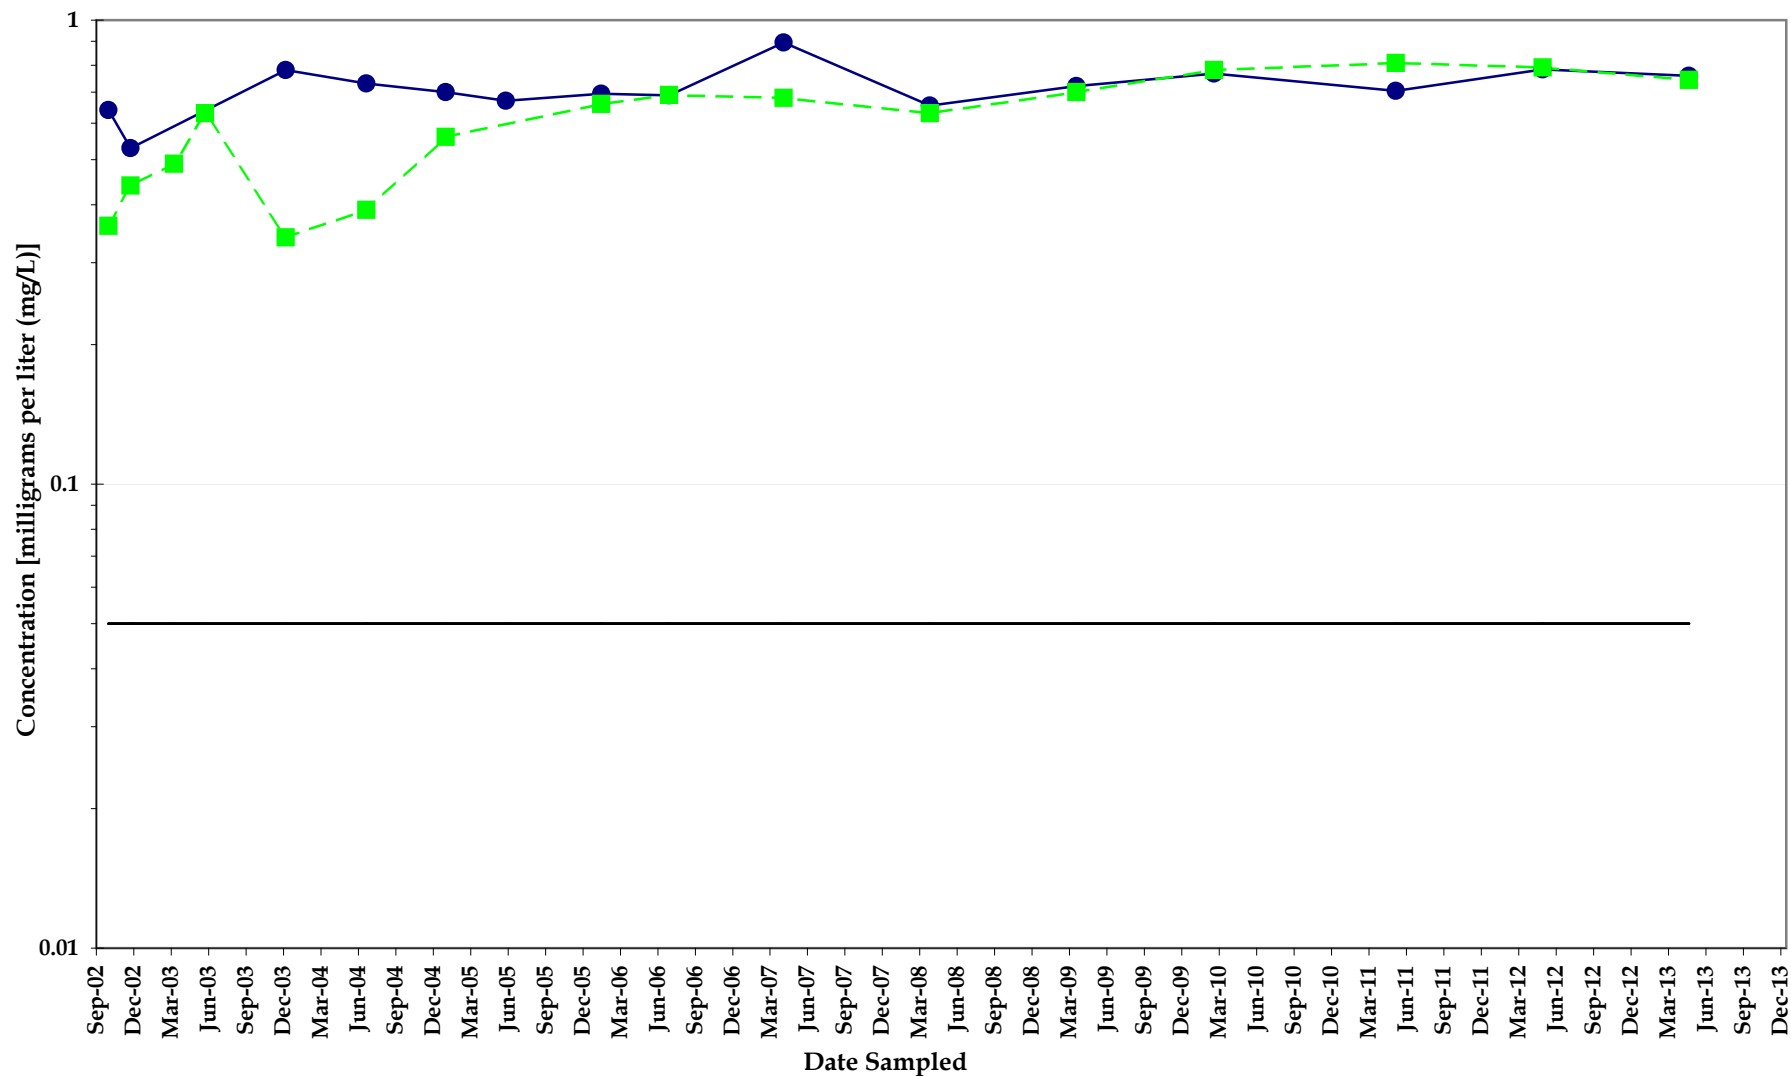
## Chromium Concentrations Monitoring Well MW051SA

Note: Non-detect analyses plotted at the method detection limit or half the reporting limit (RL). Detections denoted by symbol and detection values greater than the RL denoted by shaded symbol.

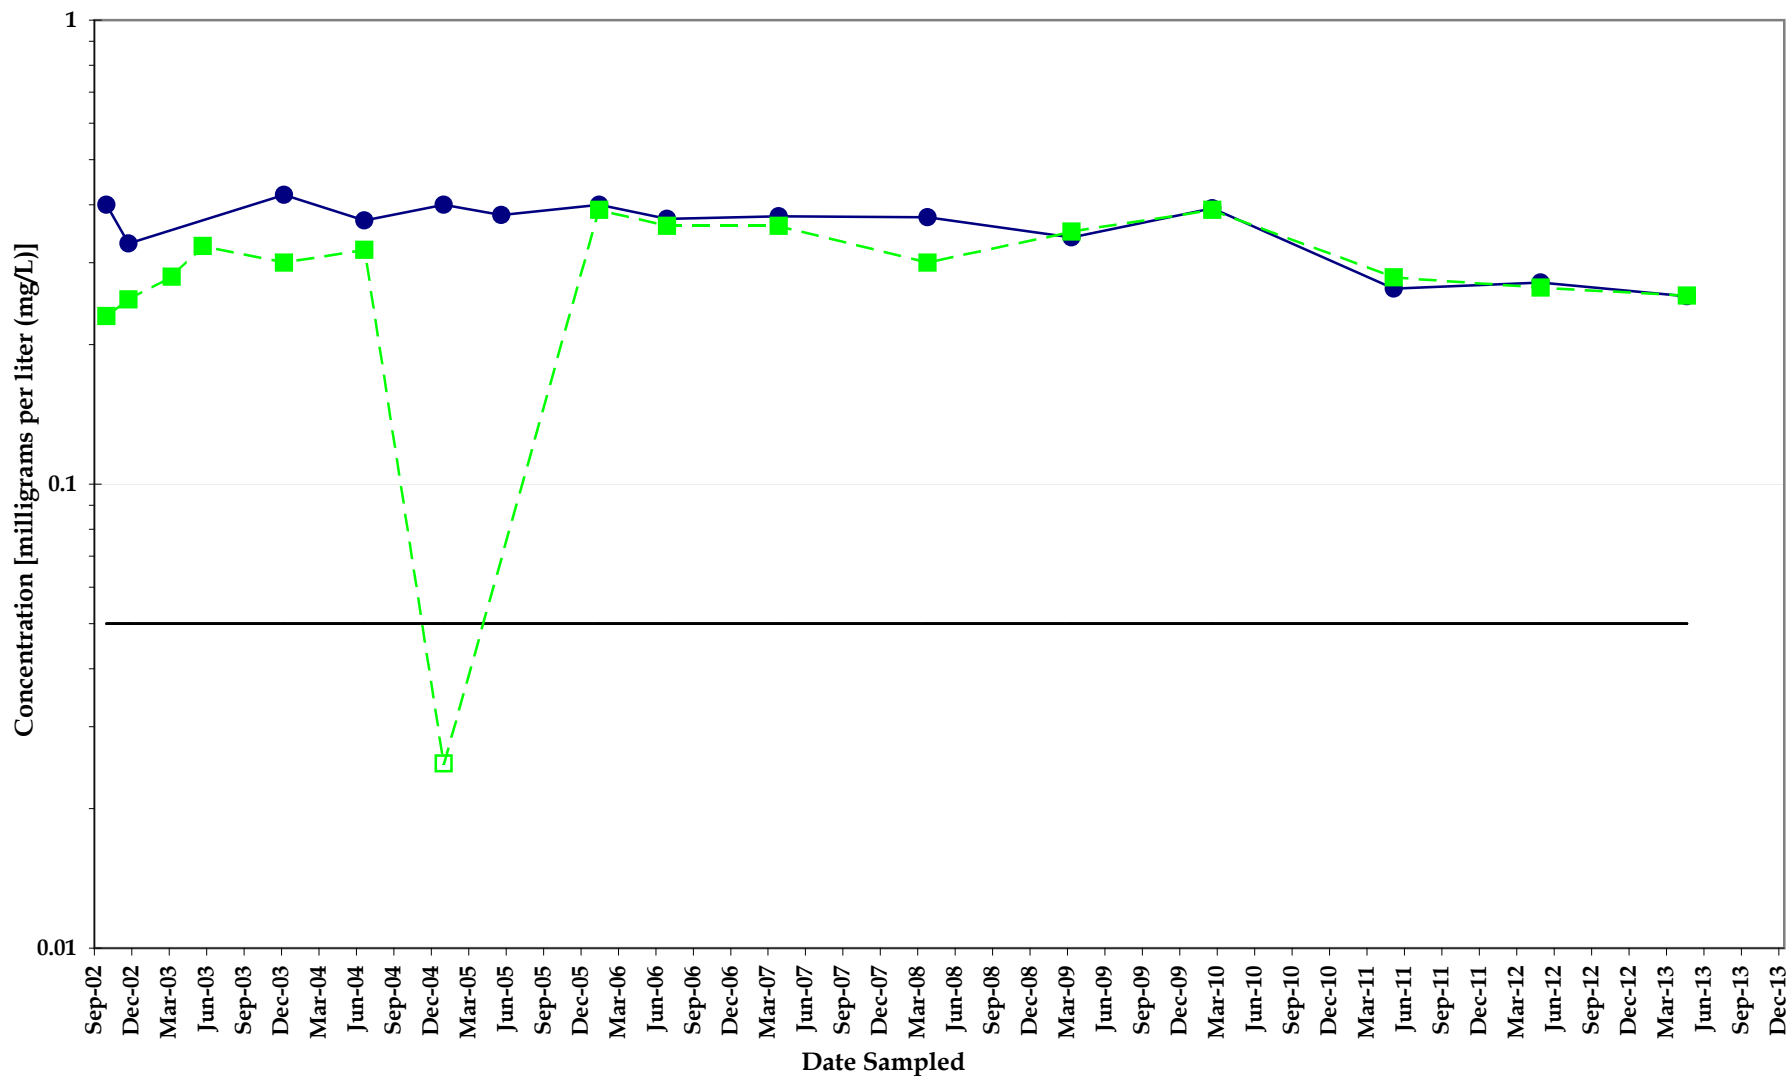
## Chromium Concentrations Monitoring Well MW052SA

Note: Non-detect analyses plotted at the method detection limit or half the reporting limit (RL). Detections denoted by symbol and detection values greater than the RL denoted by shaded symbol.

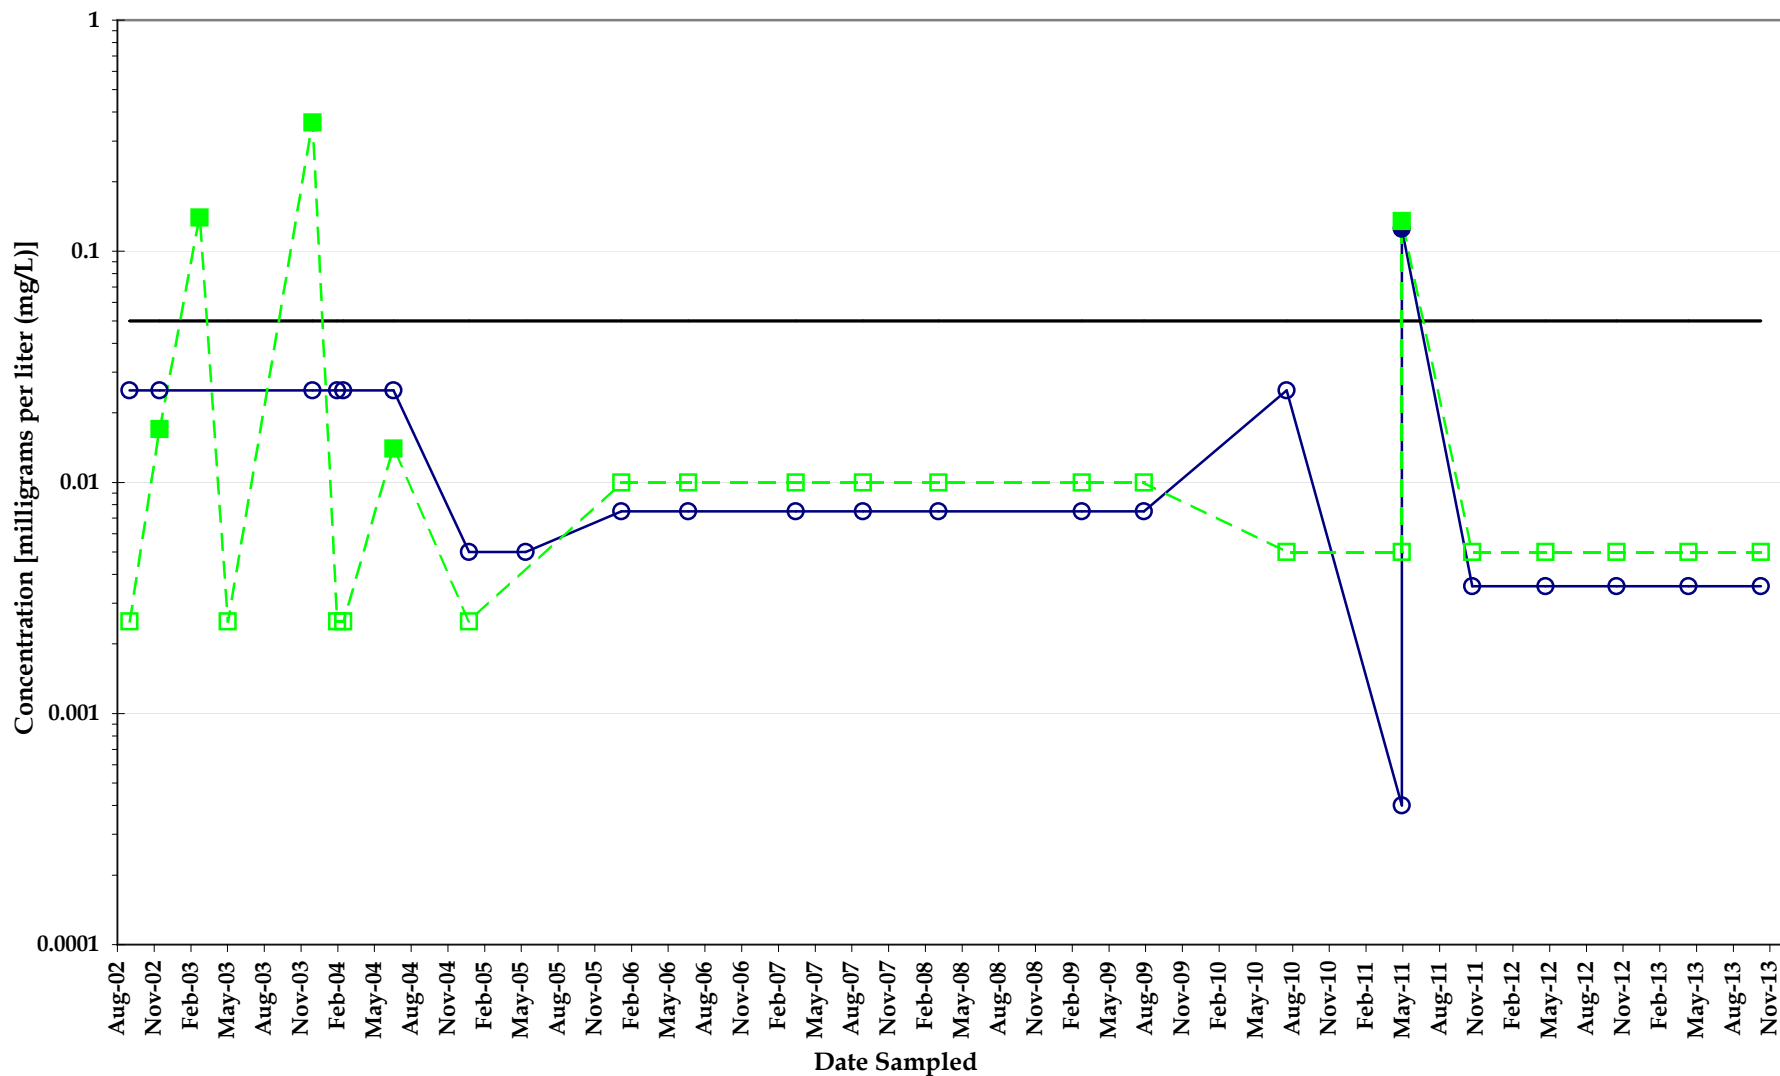
## Chromium Concentrations Monitoring Well MW053SA

Note: Non-detect analyses plotted at the method detection limit or half the reporting limit (RL). Detections denoted by symbol and detection values greater than the RL denoted by shaded symbol.

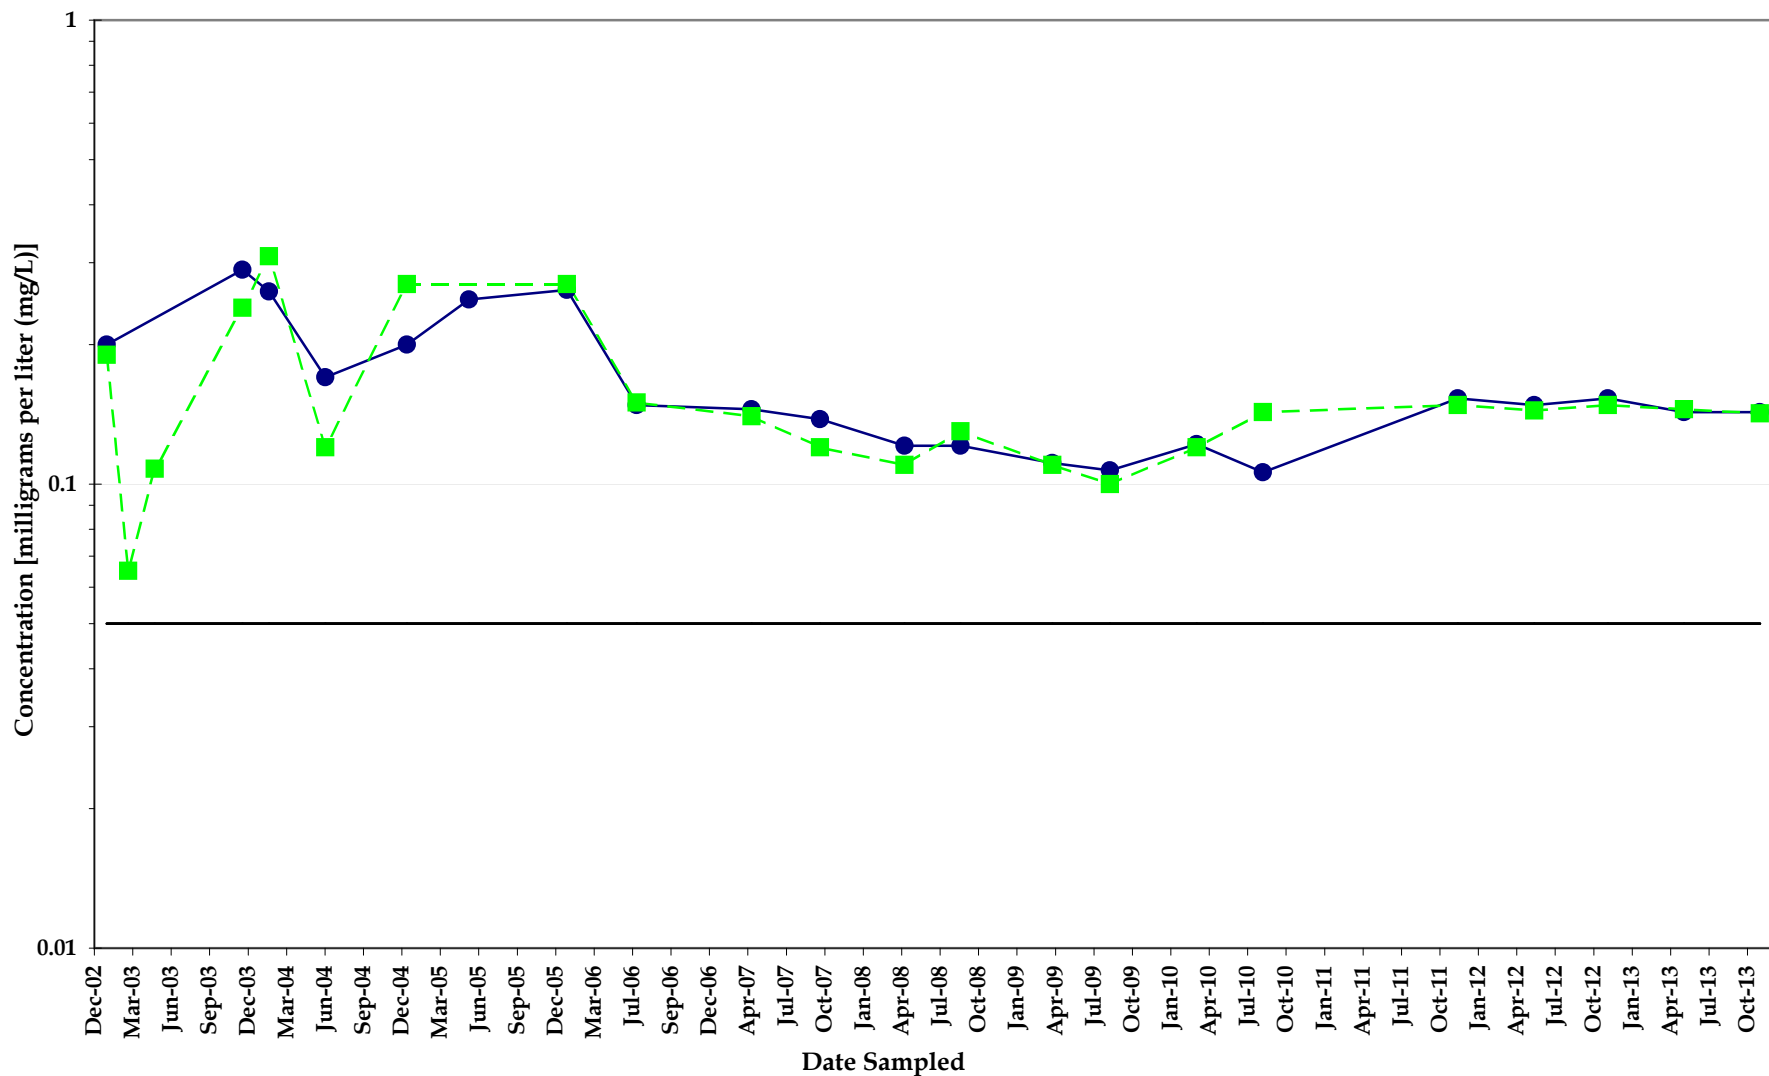
## Chromium Concentrations Monitoring Well MW054SA

Note: Non-detect analyses plotted at the method detection limit or half the reporting limit (RL). Detections denoted by symbol and detection values greater than the RL denoted by shaded symbol.

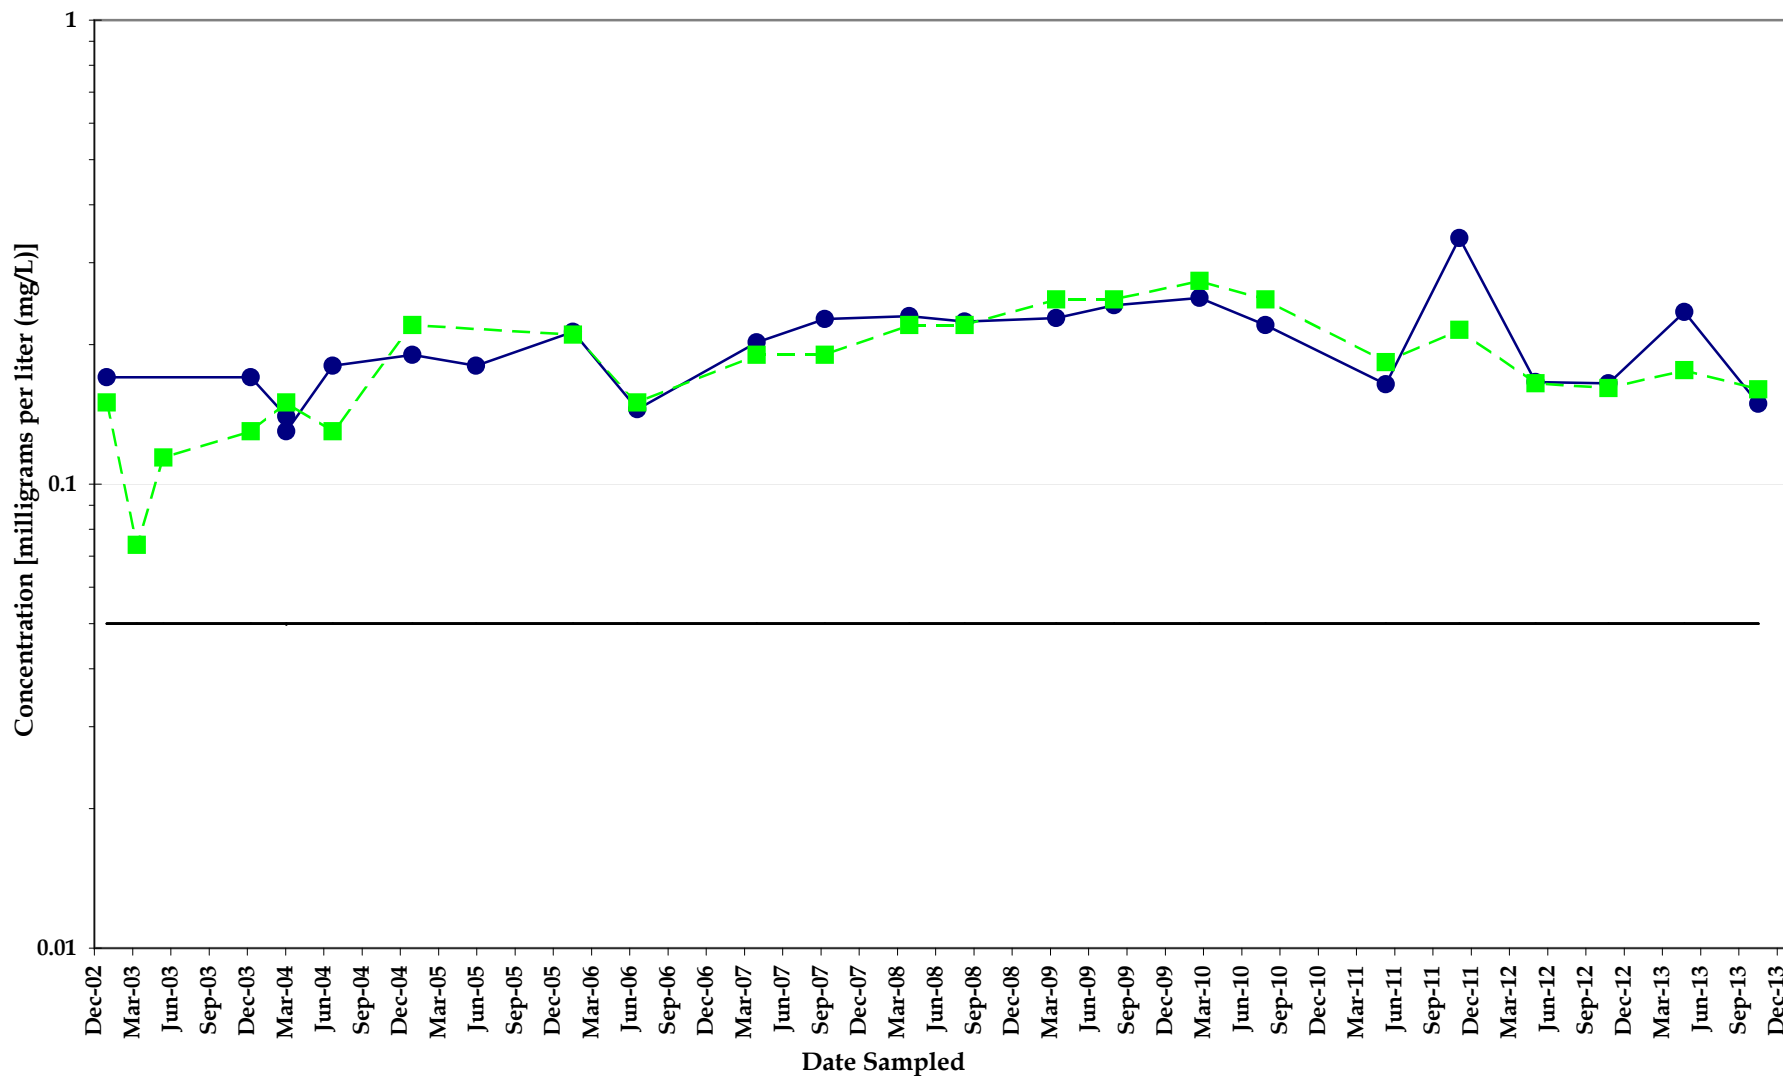
## Chromium Concentrations Monitoring Well MW055SA

Note: Non-detect analyses plotted at the method detection limit or half the reporting limit (RL). Detections denoted by symbol and detection values greater than the RL denoted by shaded symbol.

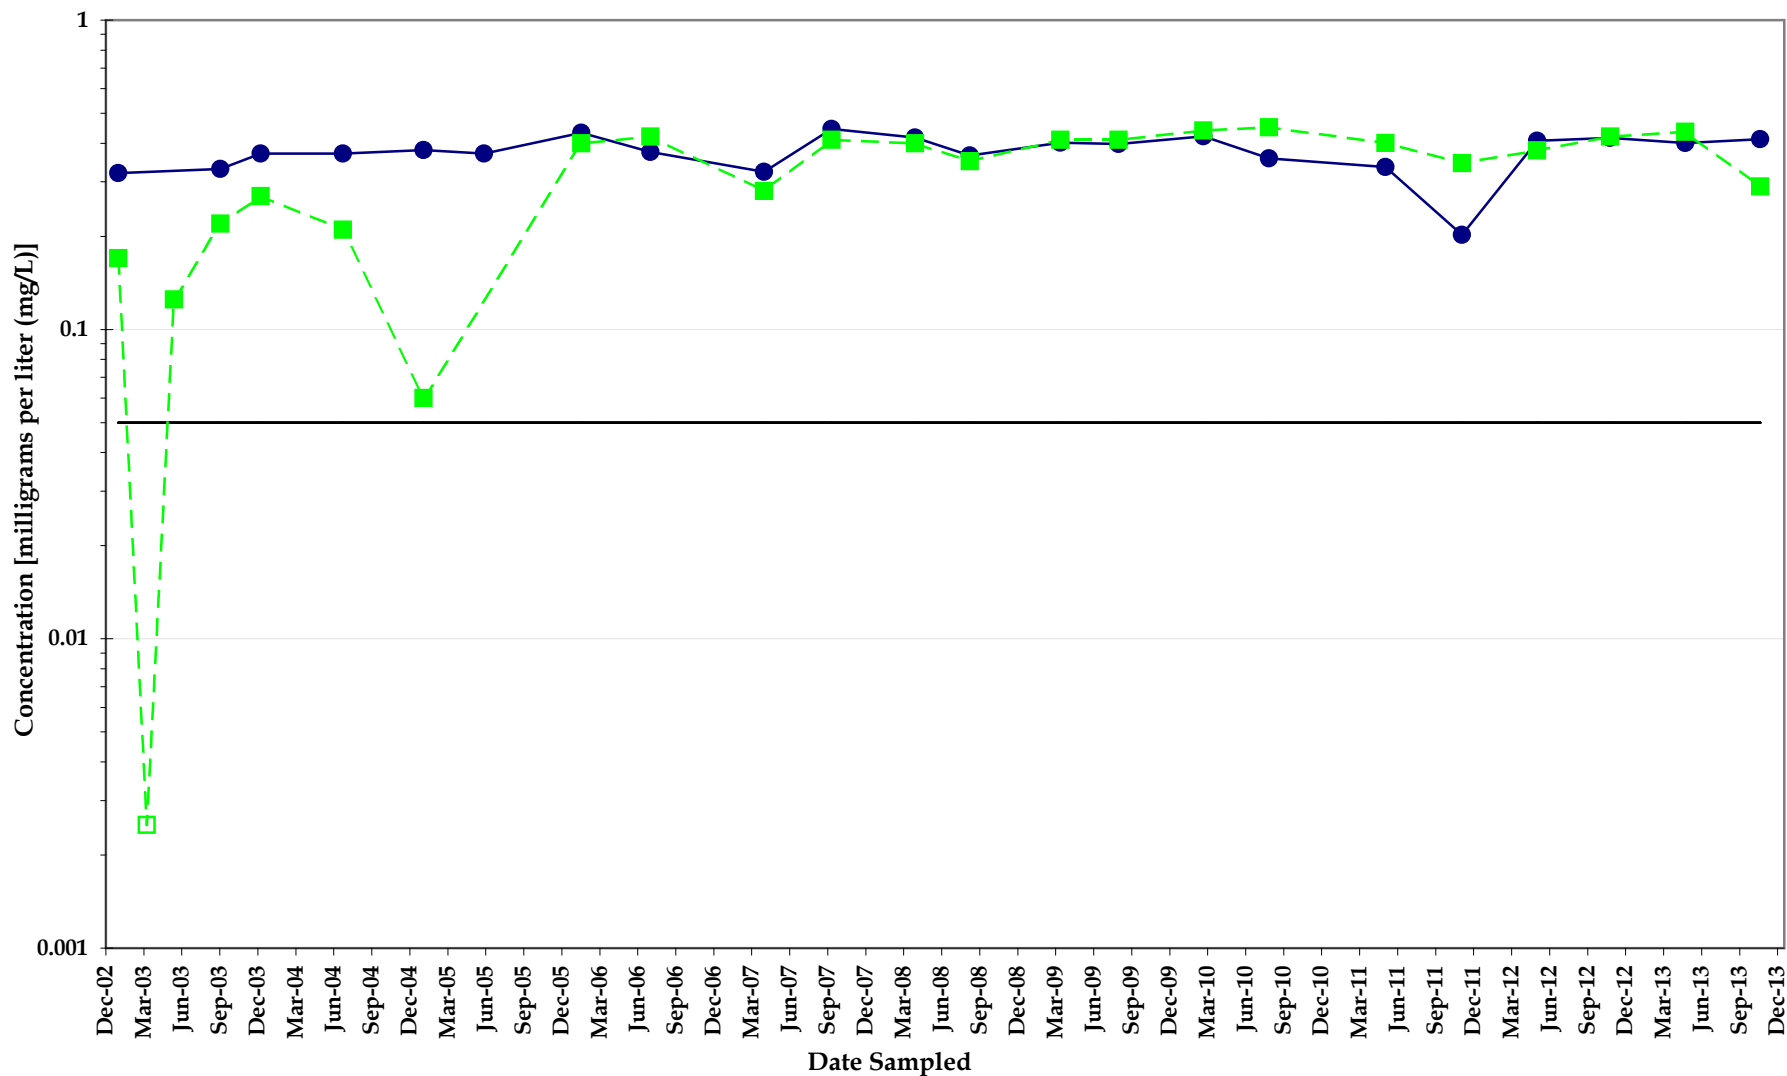
## Chromium Concentrations Monitoring Well MW056SA

Note: Non-detect analyses plotted at the method detection limit or half the reporting limit (RL). Detections denoted by symbol and detection values greater than the RL denoted by shaded symbol.

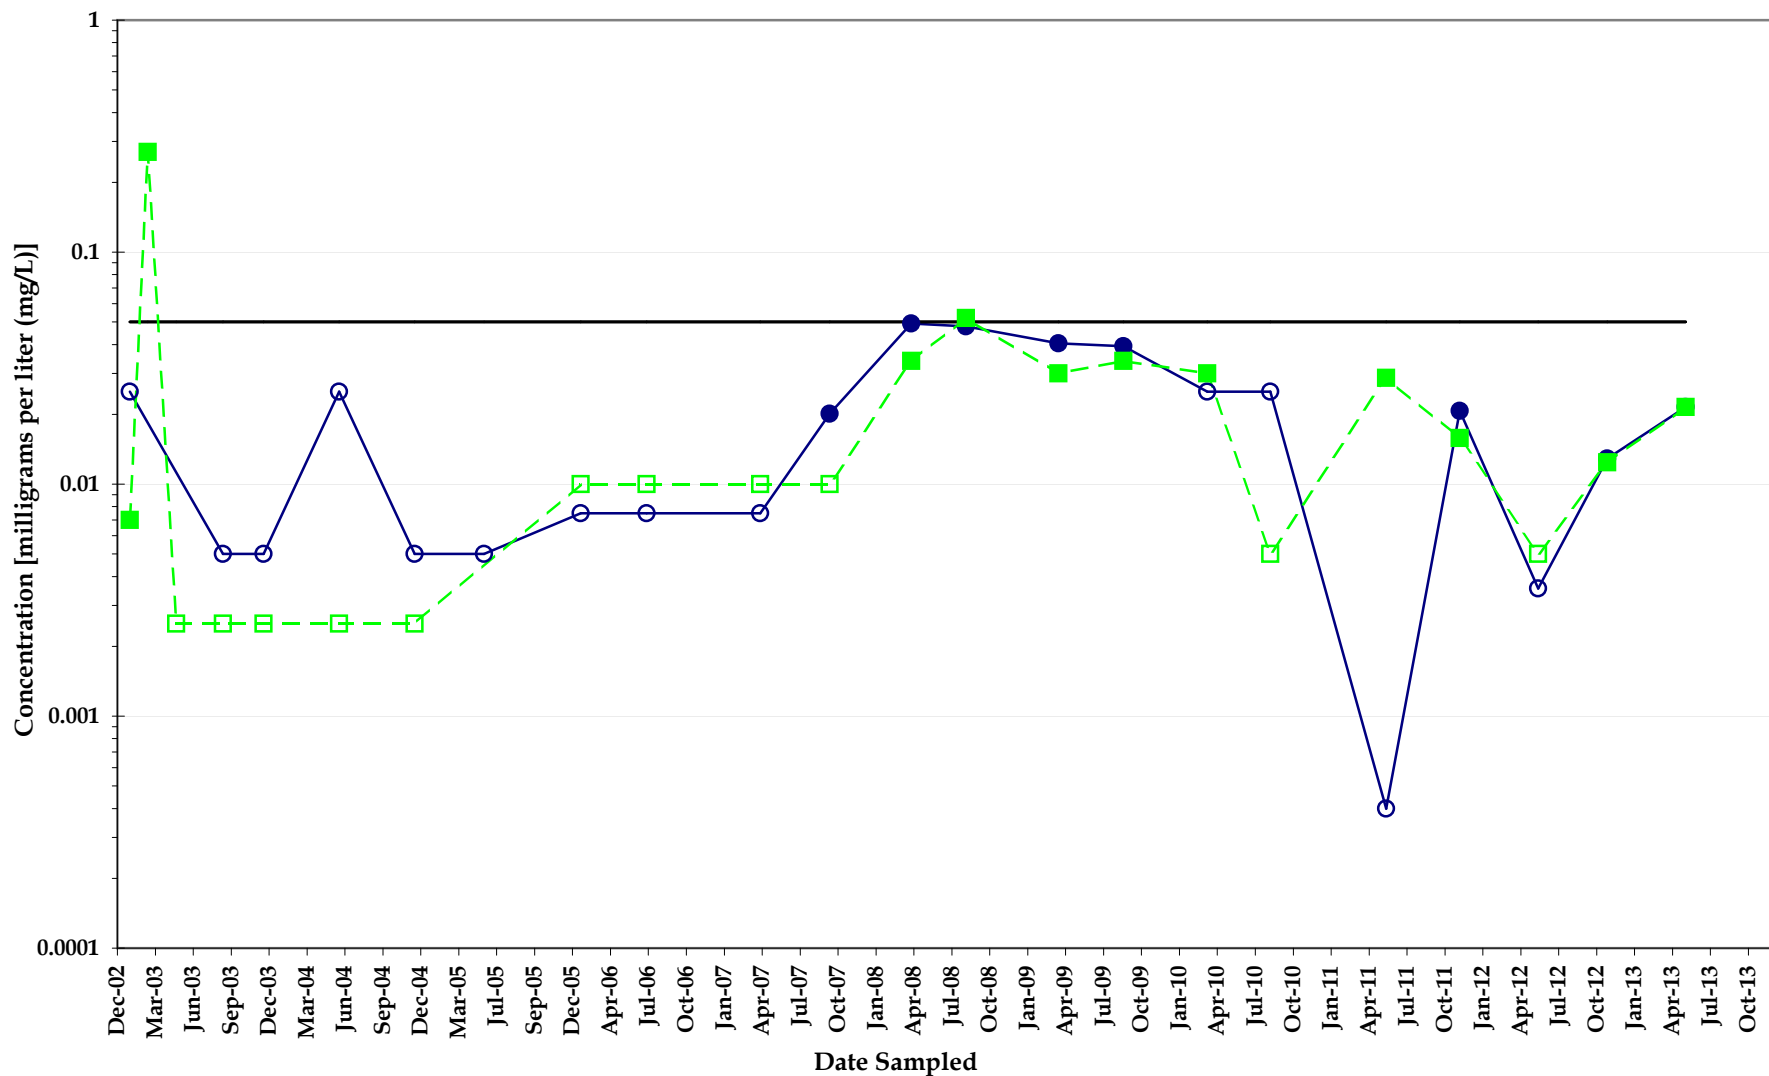
## Chromium Concentrations Monitoring Well MW057SA

Note: Non-detect analyses plotted at the method detection limit or half the reporting limit (RL). Detections denoted by symbol and detection values greater than the RL denoted by shaded symbol.

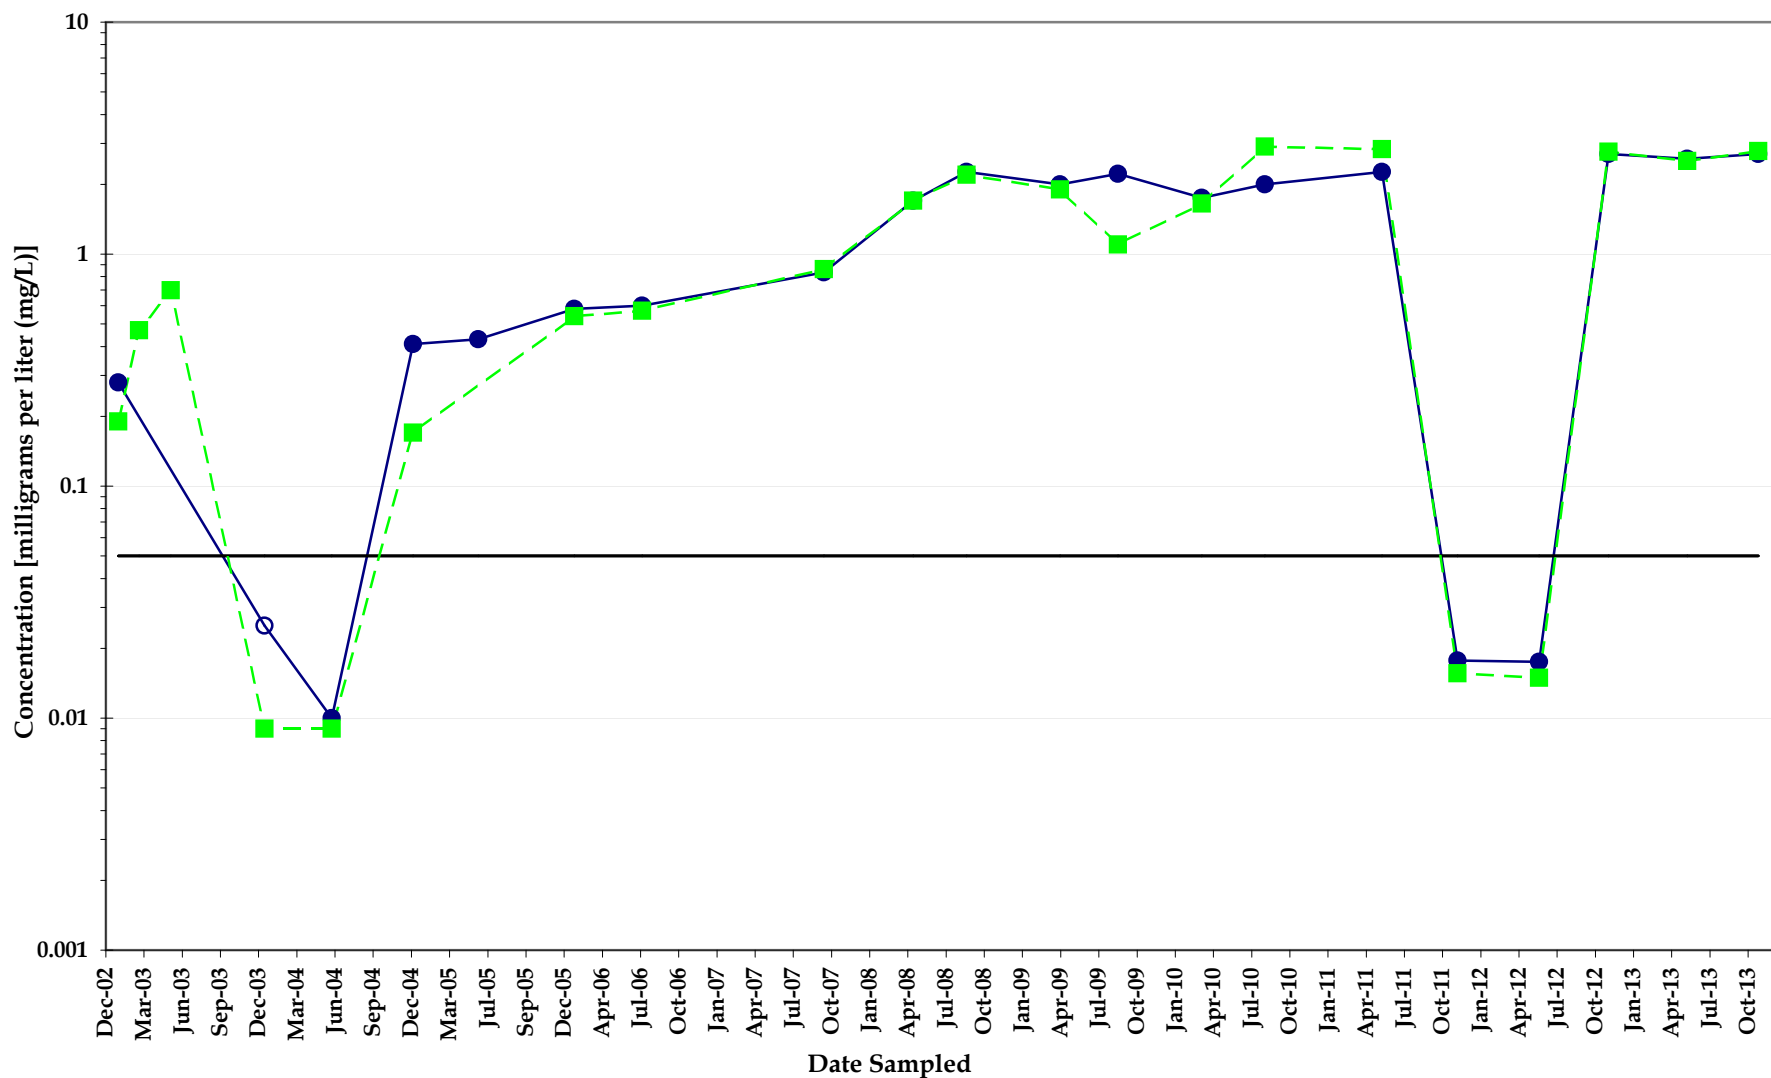
## Chromium Concentrations Monitoring Well MW058

Note: Non-detect analyses plotted at the method detection limit or half the reporting limit (RL). Detections denoted by symbol and detection values greater than the RL denoted by shaded symbol.
