**GW - 004**

**2013 AGWMR**

**VOL 5 OF 5**

*North Eunice Gas Plant  
Lea County, New Mexico*

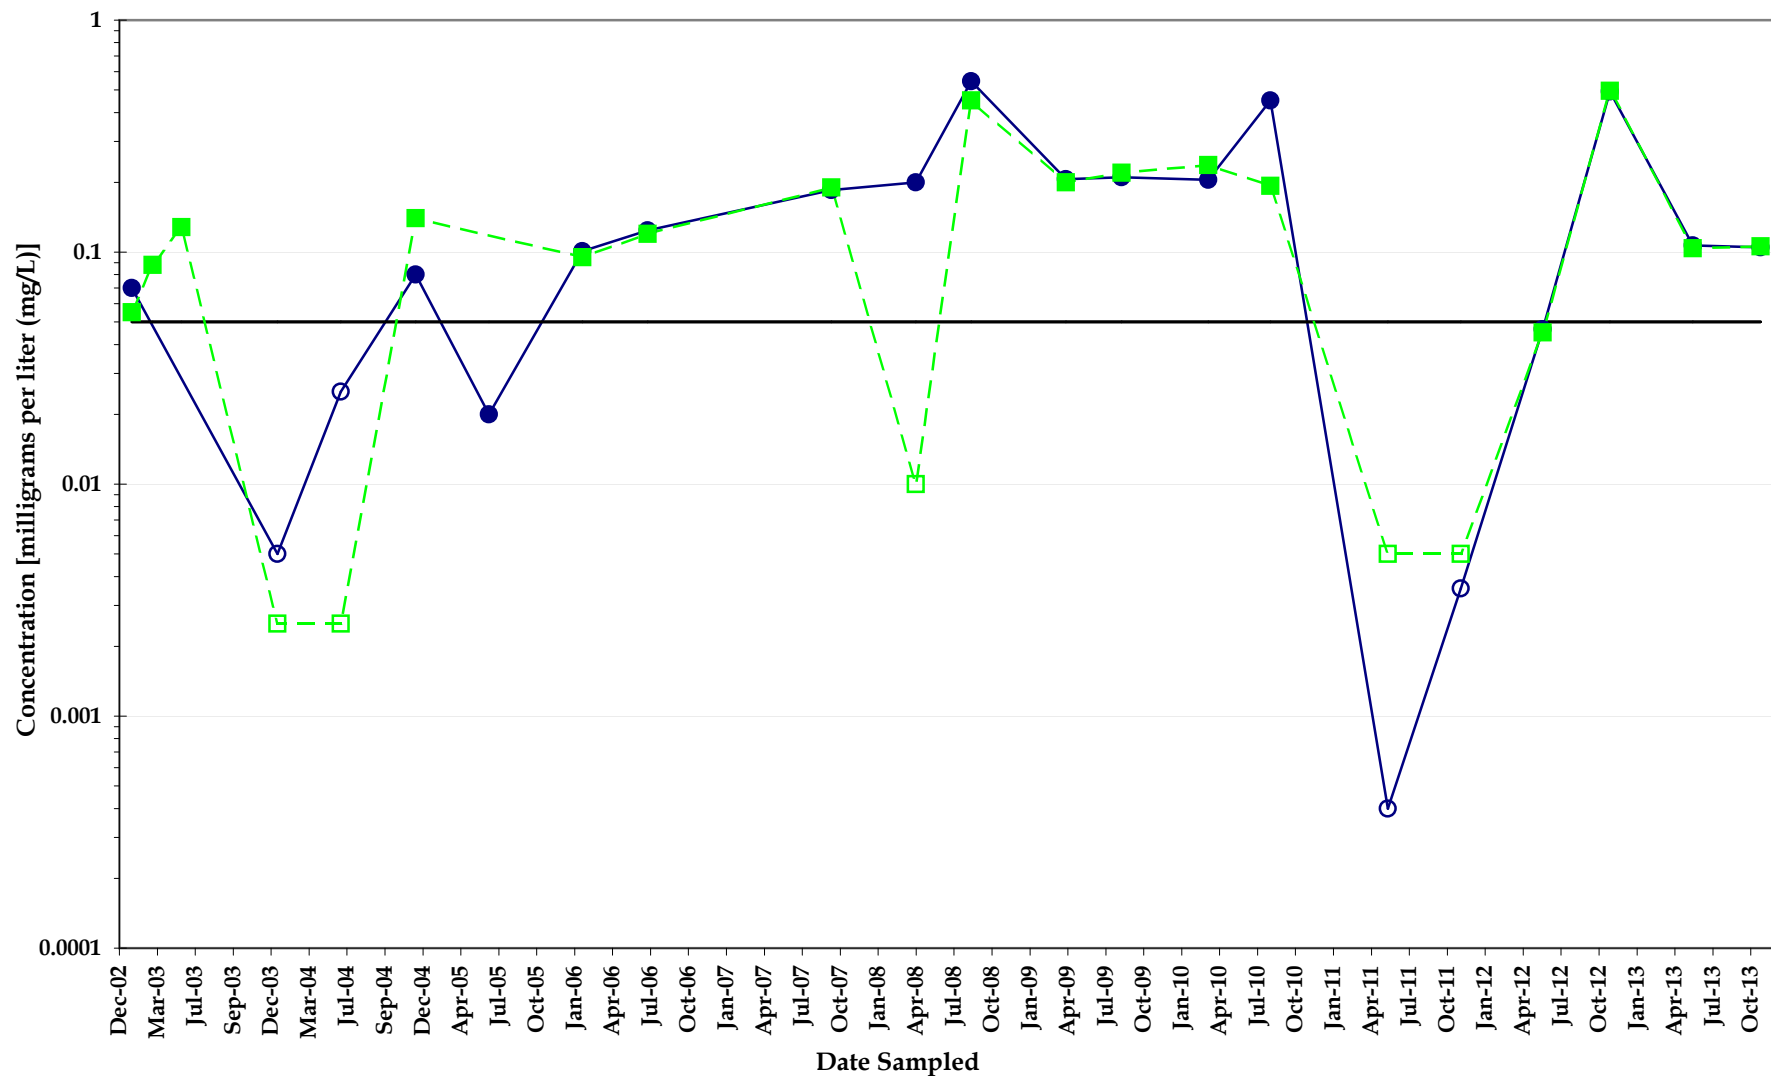
## Chromium Concentrations Monitoring Well MW059

Note: Non-detect analyses plotted at the method detection limit or half the reporting limit (RL). Detections denoted by symbol and detection values greater than the RL denoted by shaded symbol.

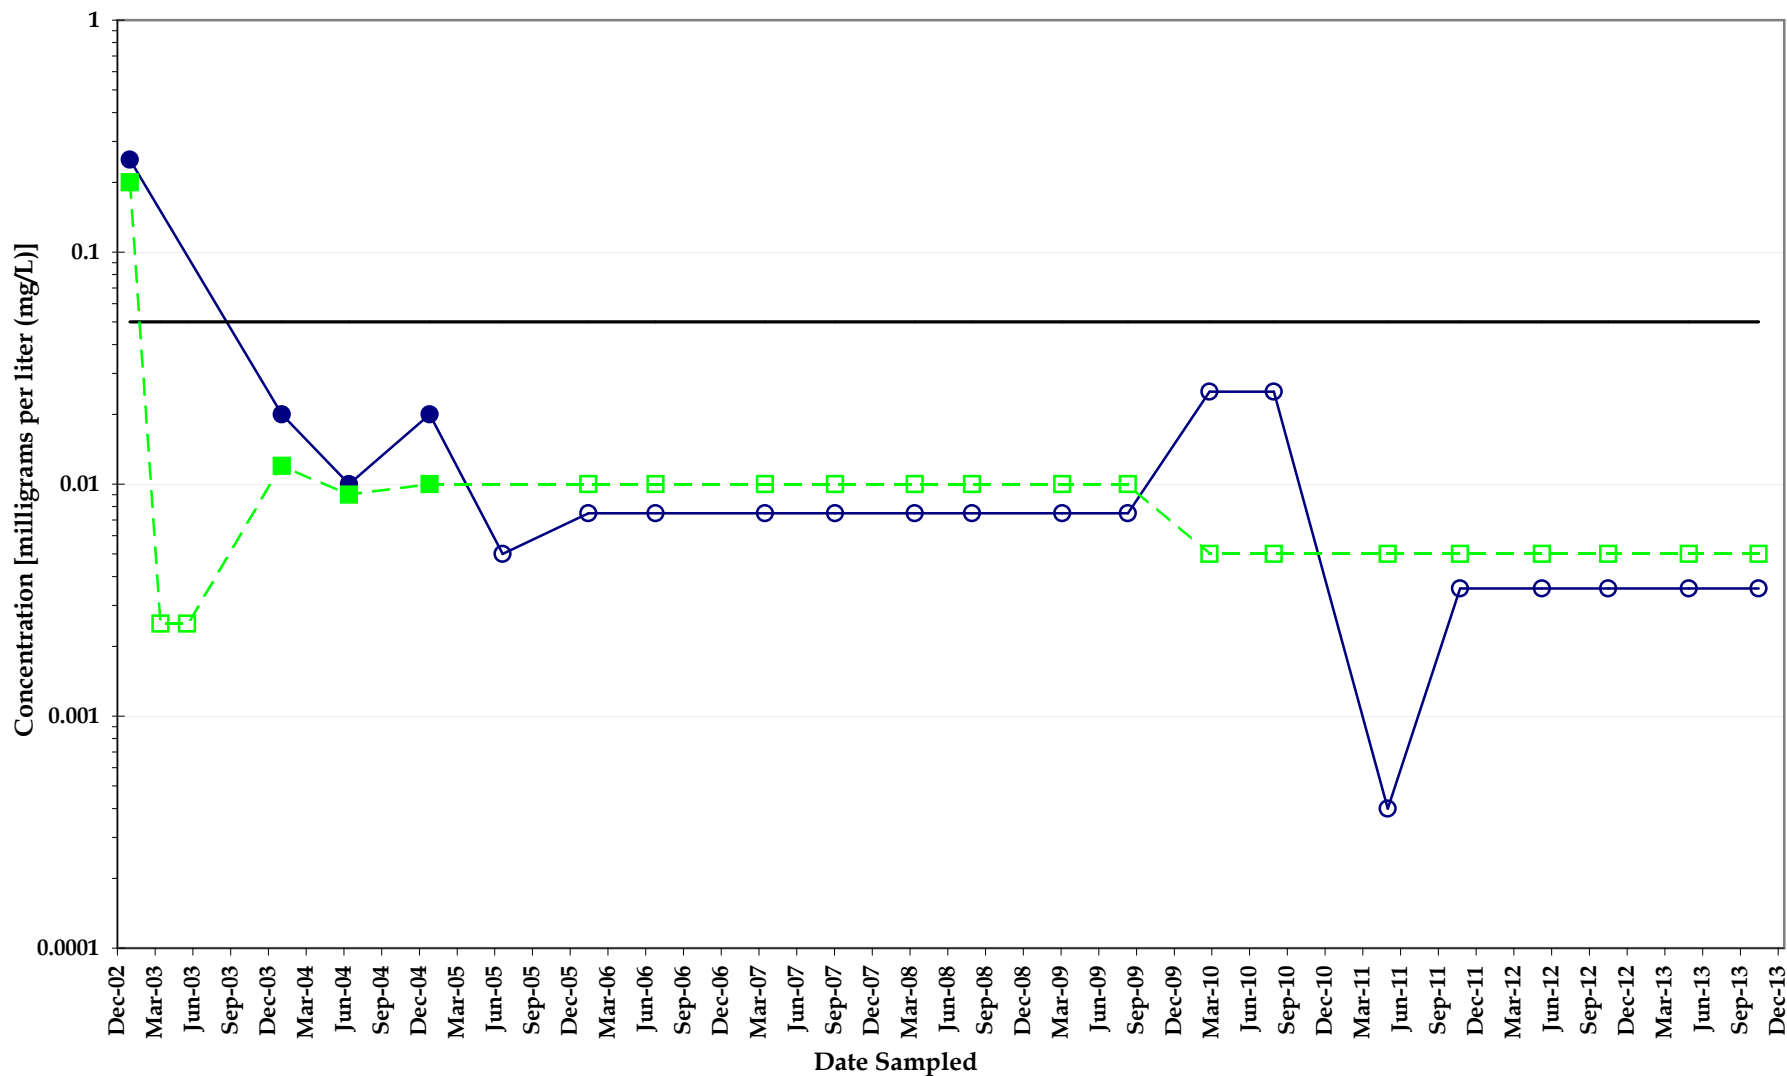
## Chromium Concentrations Monitoring Well MW060

Note: Non-detect analyses plotted at the method detection limit or half the reporting limit (RL). Detections denoted by symbol and detection values greater than the RL denoted by shaded symbol.

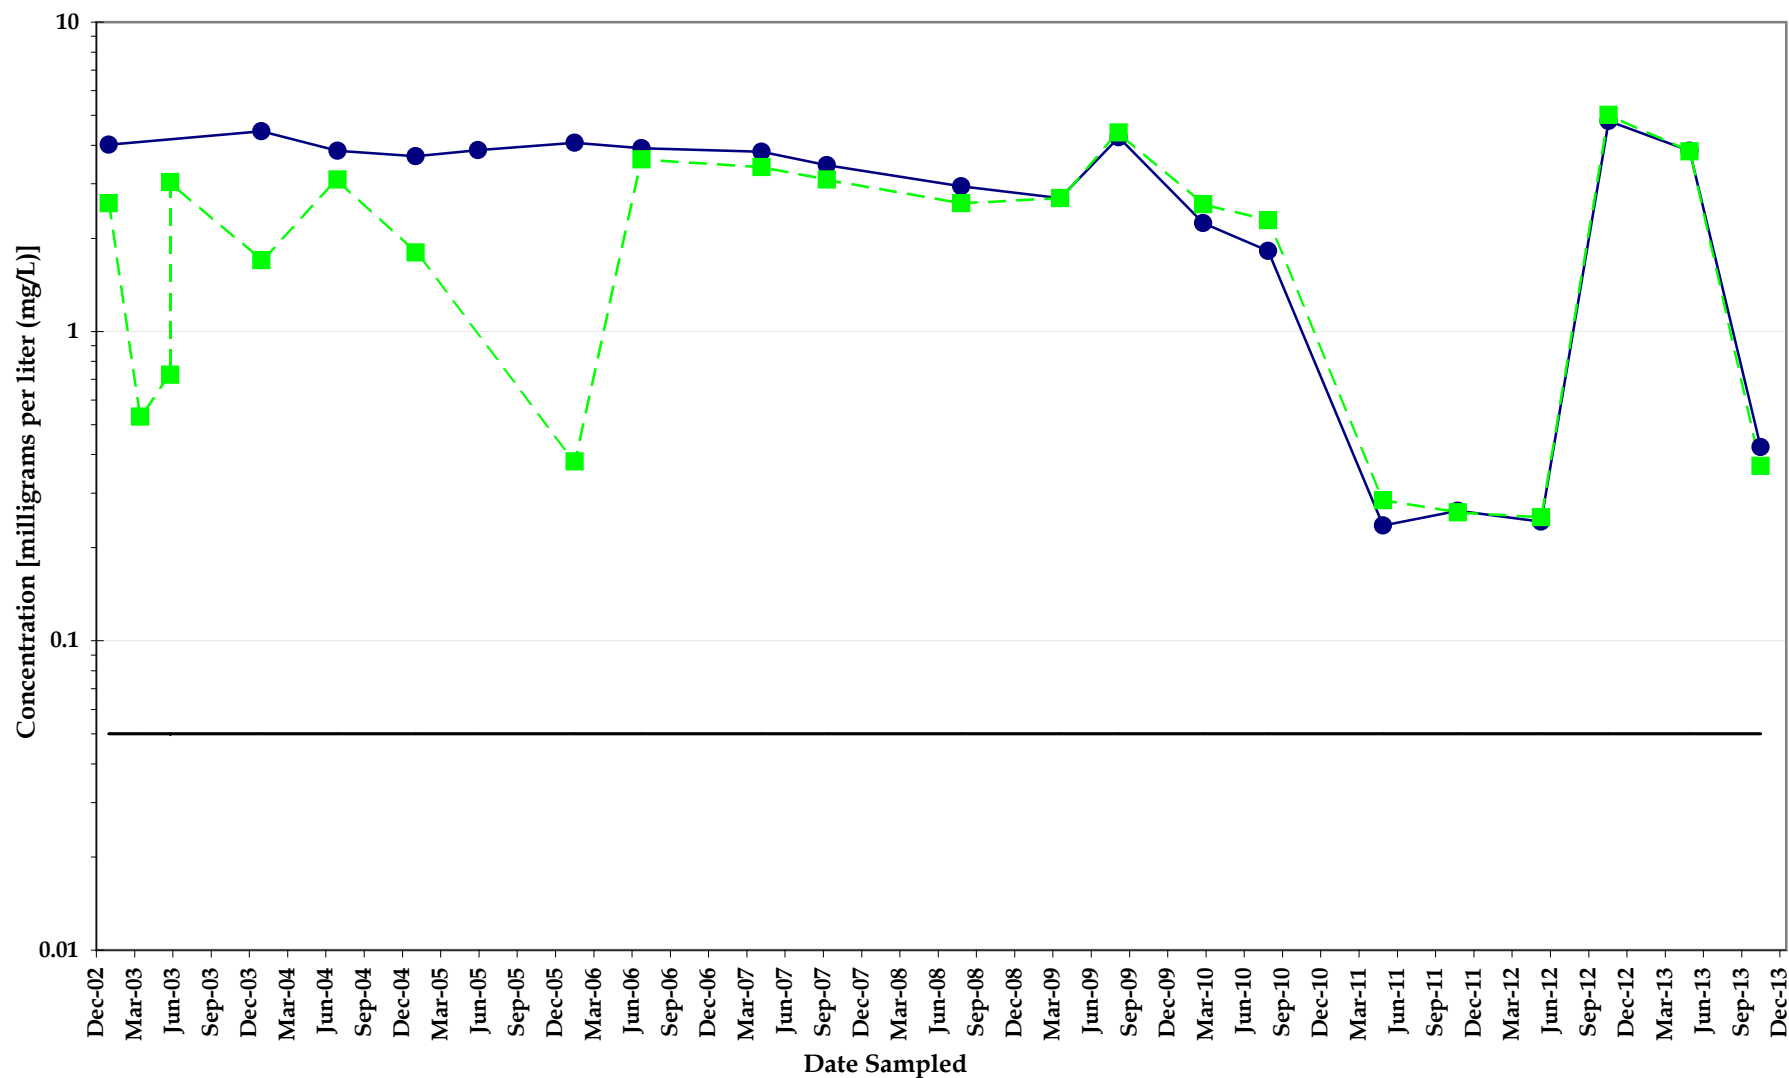
## Chromium Concentrations Monitoring Well MW061

— Chromium      ● Detects      ○ Non-Detects      — NMWQCC  
 - - - Hexavalent Chromium      ■ Detects      □ Non-Detects

Note: Non-detect analyses plotted at the method detection limit or half the reporting limit (RL). Detections denoted by symbol and detection values greater than the RL denoted by shaded symbol.

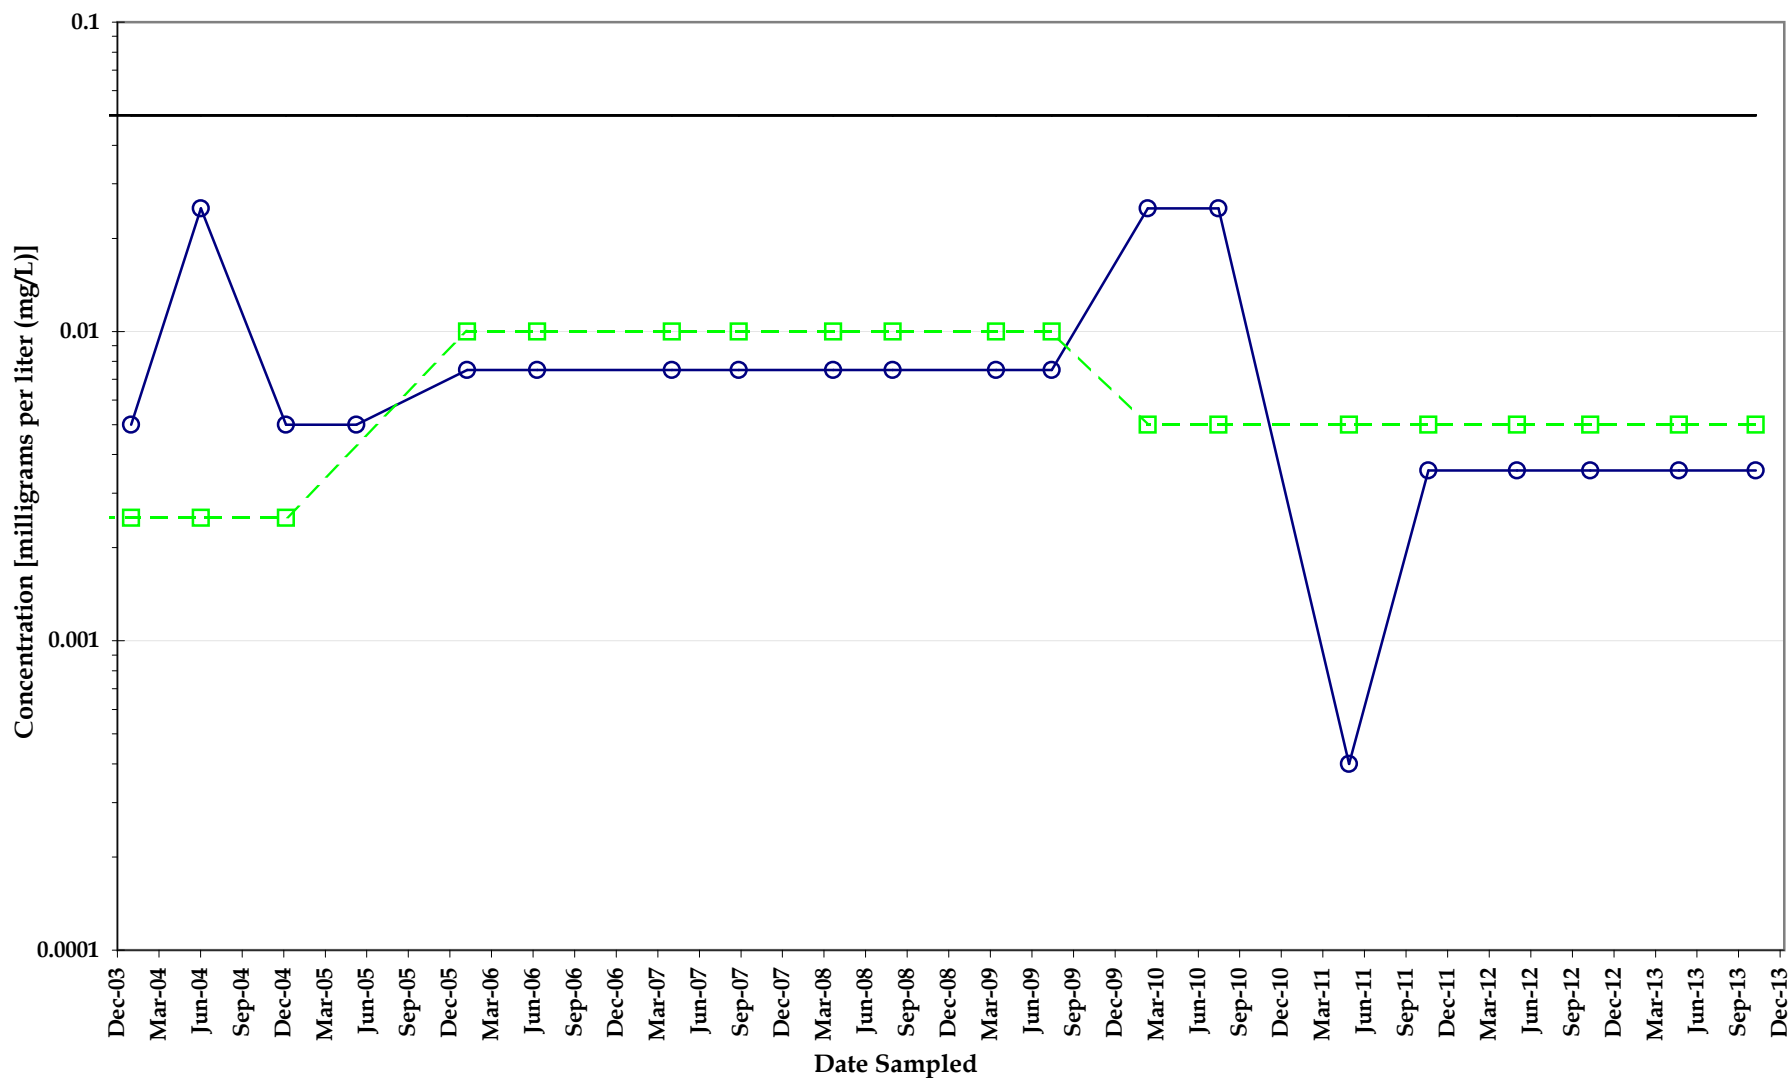
## Chromium Concentrations Monitoring Well MW062A

Note: Non-detect analyses plotted at the method detection limit or half the reporting limit (RL). Detections denoted by symbol and detection values greater than the RL denoted by shaded symbol.

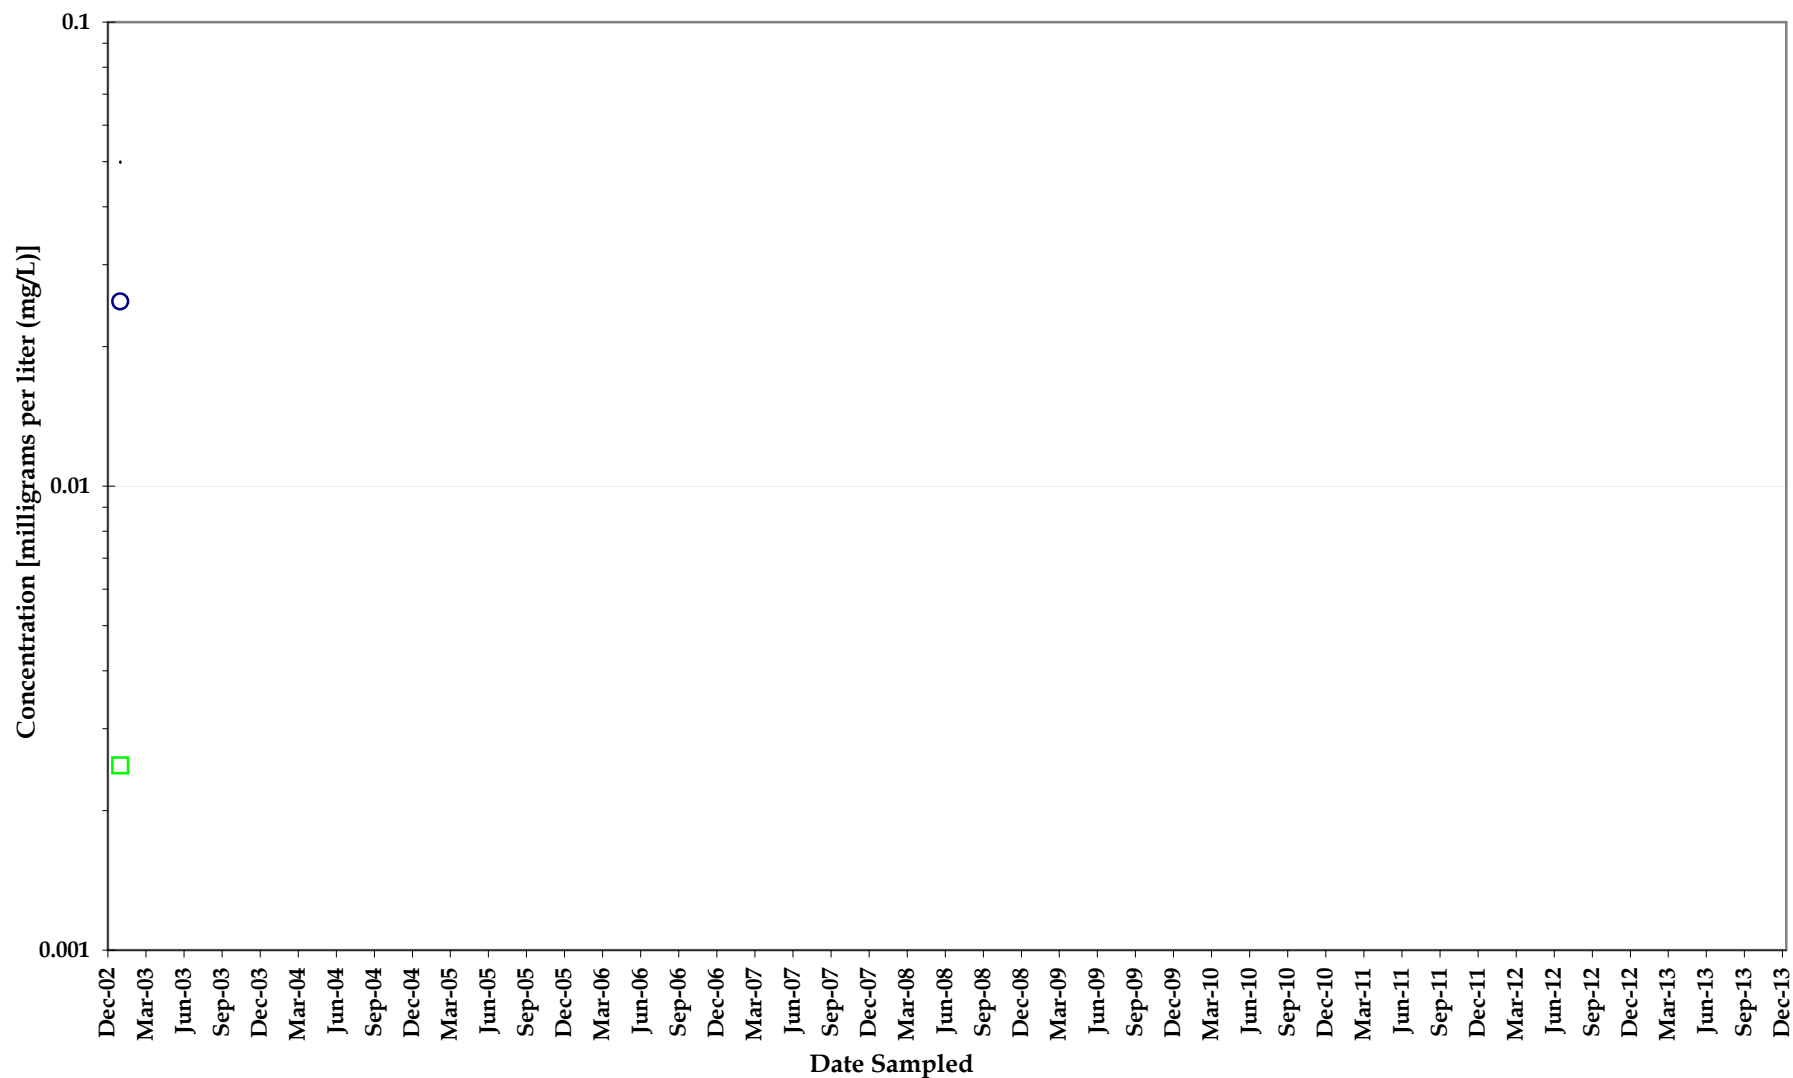
## Chromium Concentrations Monitoring Well MW062SA

Note: Non-detect analyses plotted at the method detection limit or half the reporting limit (RL). Detections denoted by symbol and detection values greater than the RL denoted by shaded symbol.

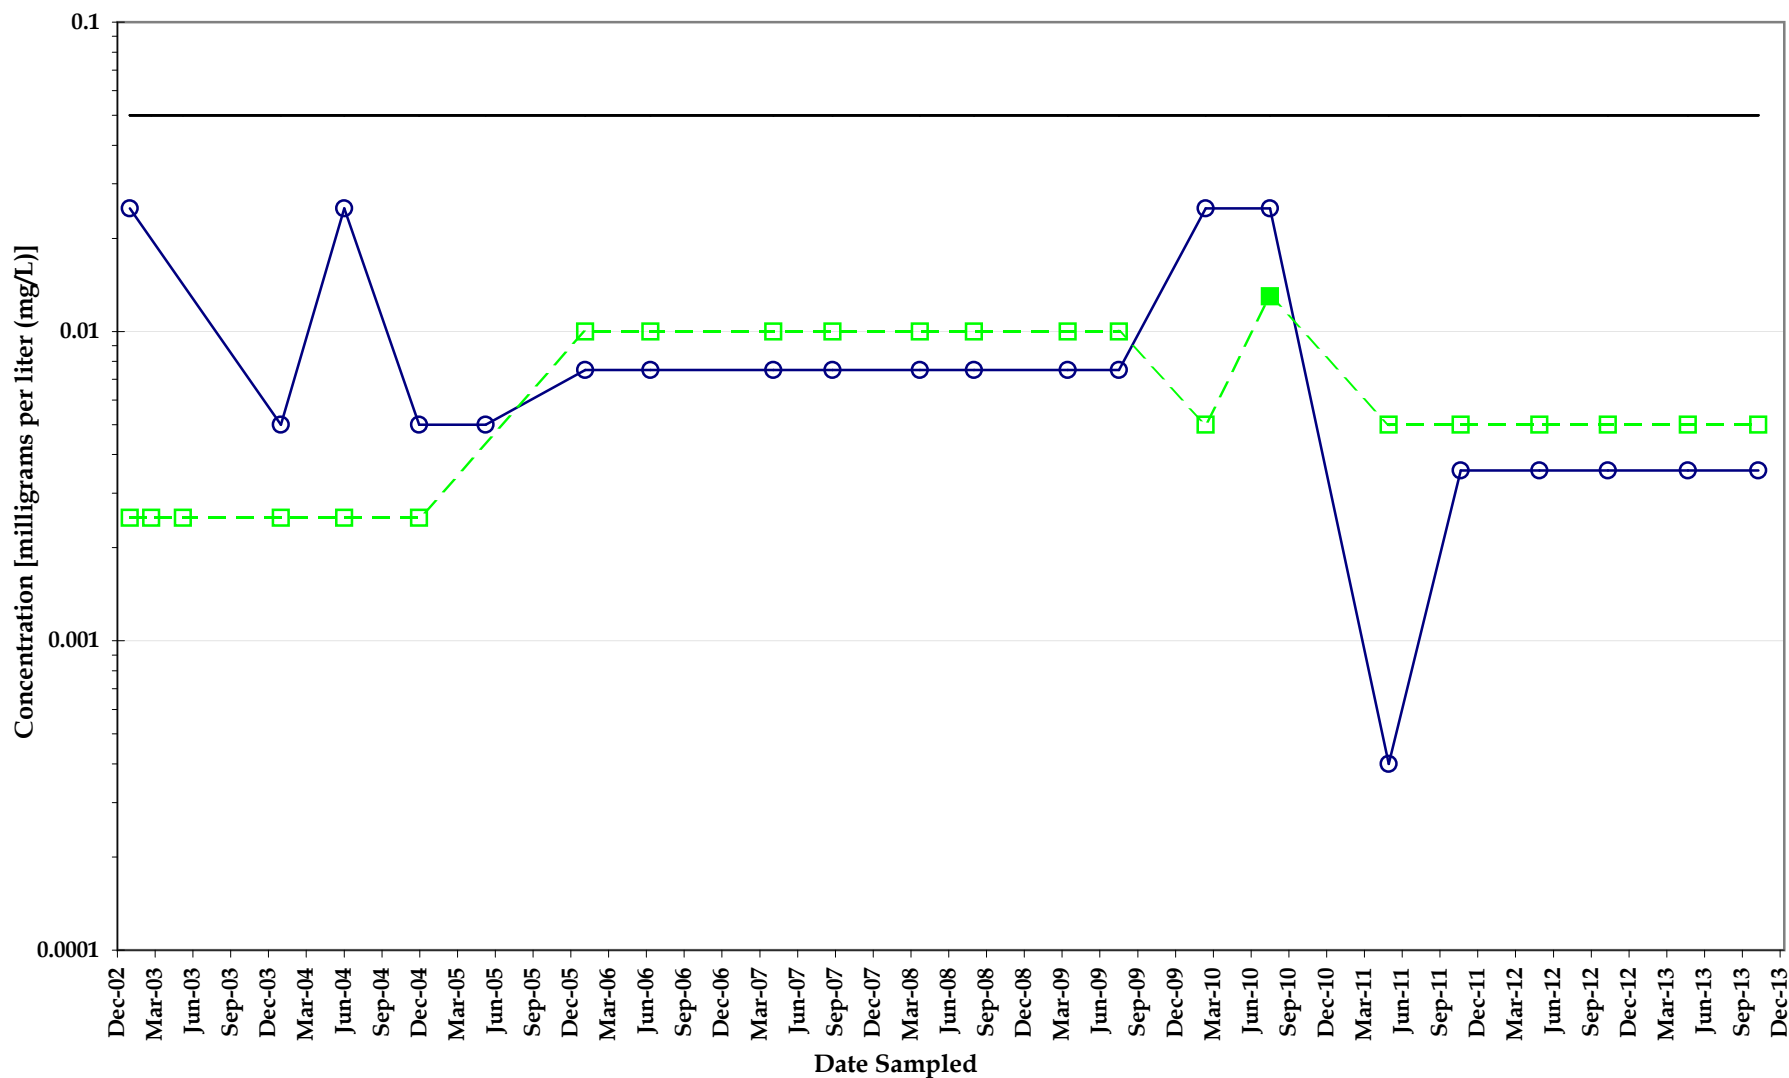
## Chromium Concentrations Monitoring Well MW063A

Note: Non-detect analyses plotted at the method detection limit or half the reporting limit (RL). Detections denoted by symbol and detection values greater than the RL denoted by shaded symbol.

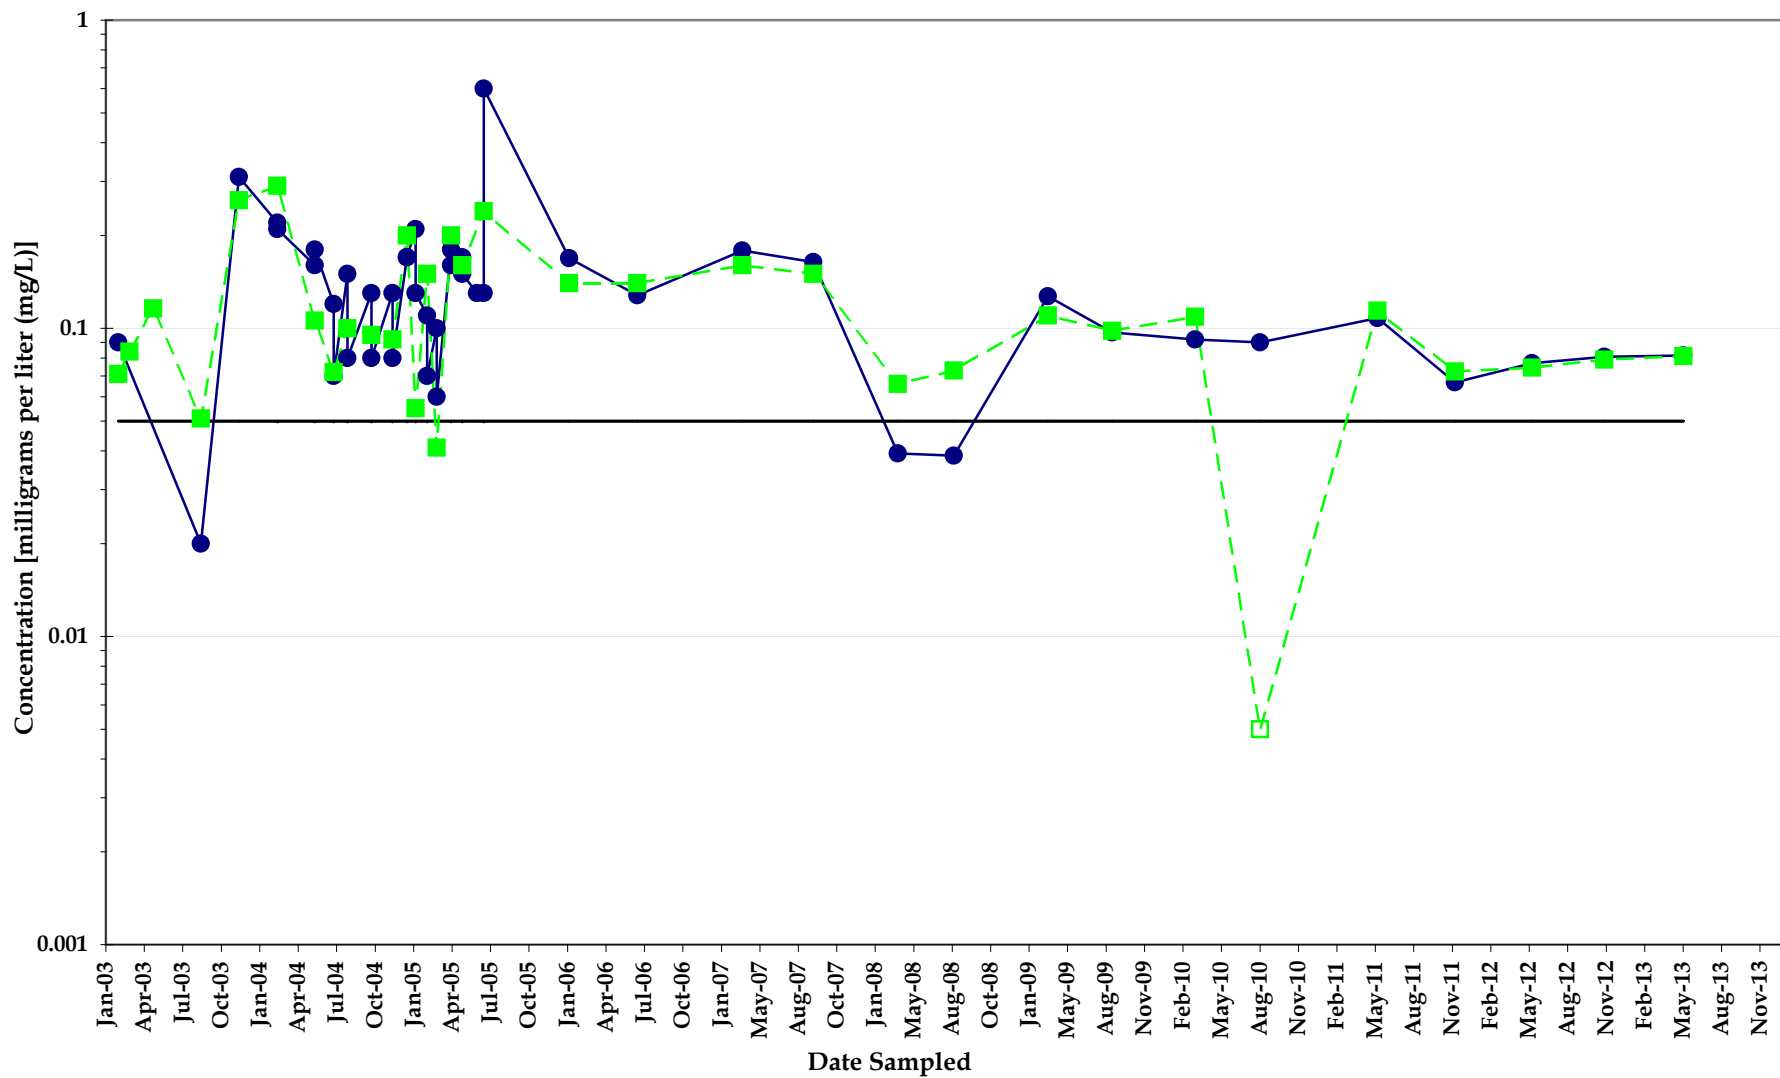
## Chromium Concentrations Monitoring Well MW064SA

Note: Non-detect analyses plotted at the method detection limit or half the reporting limit (RL). Detections denoted by symbol and detection values greater than the RL denoted by shaded symbol.

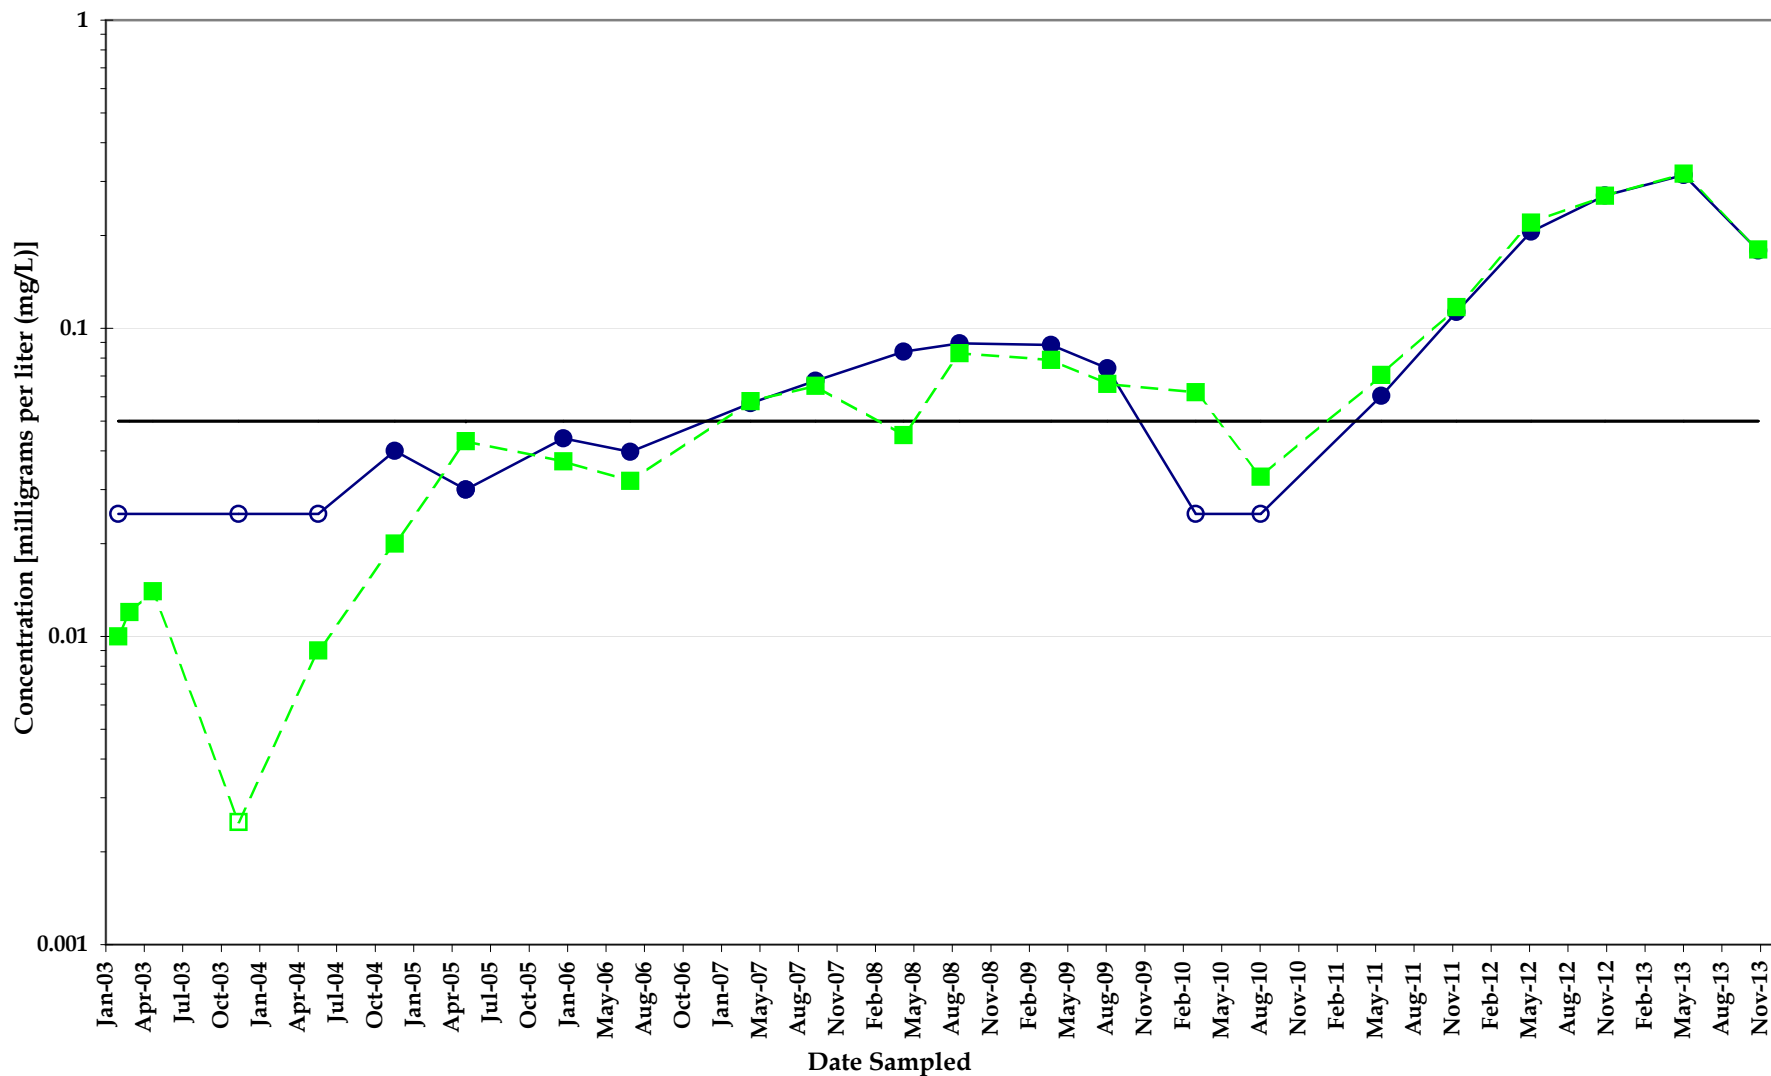
## Chromium Concentrations Monitoring Well MW065SA

Note: Non-detect analyses plotted at the method detection limit or half the reporting limit (RL). Detections denoted by symbol and detection values greater than the RL denoted by shaded symbol.

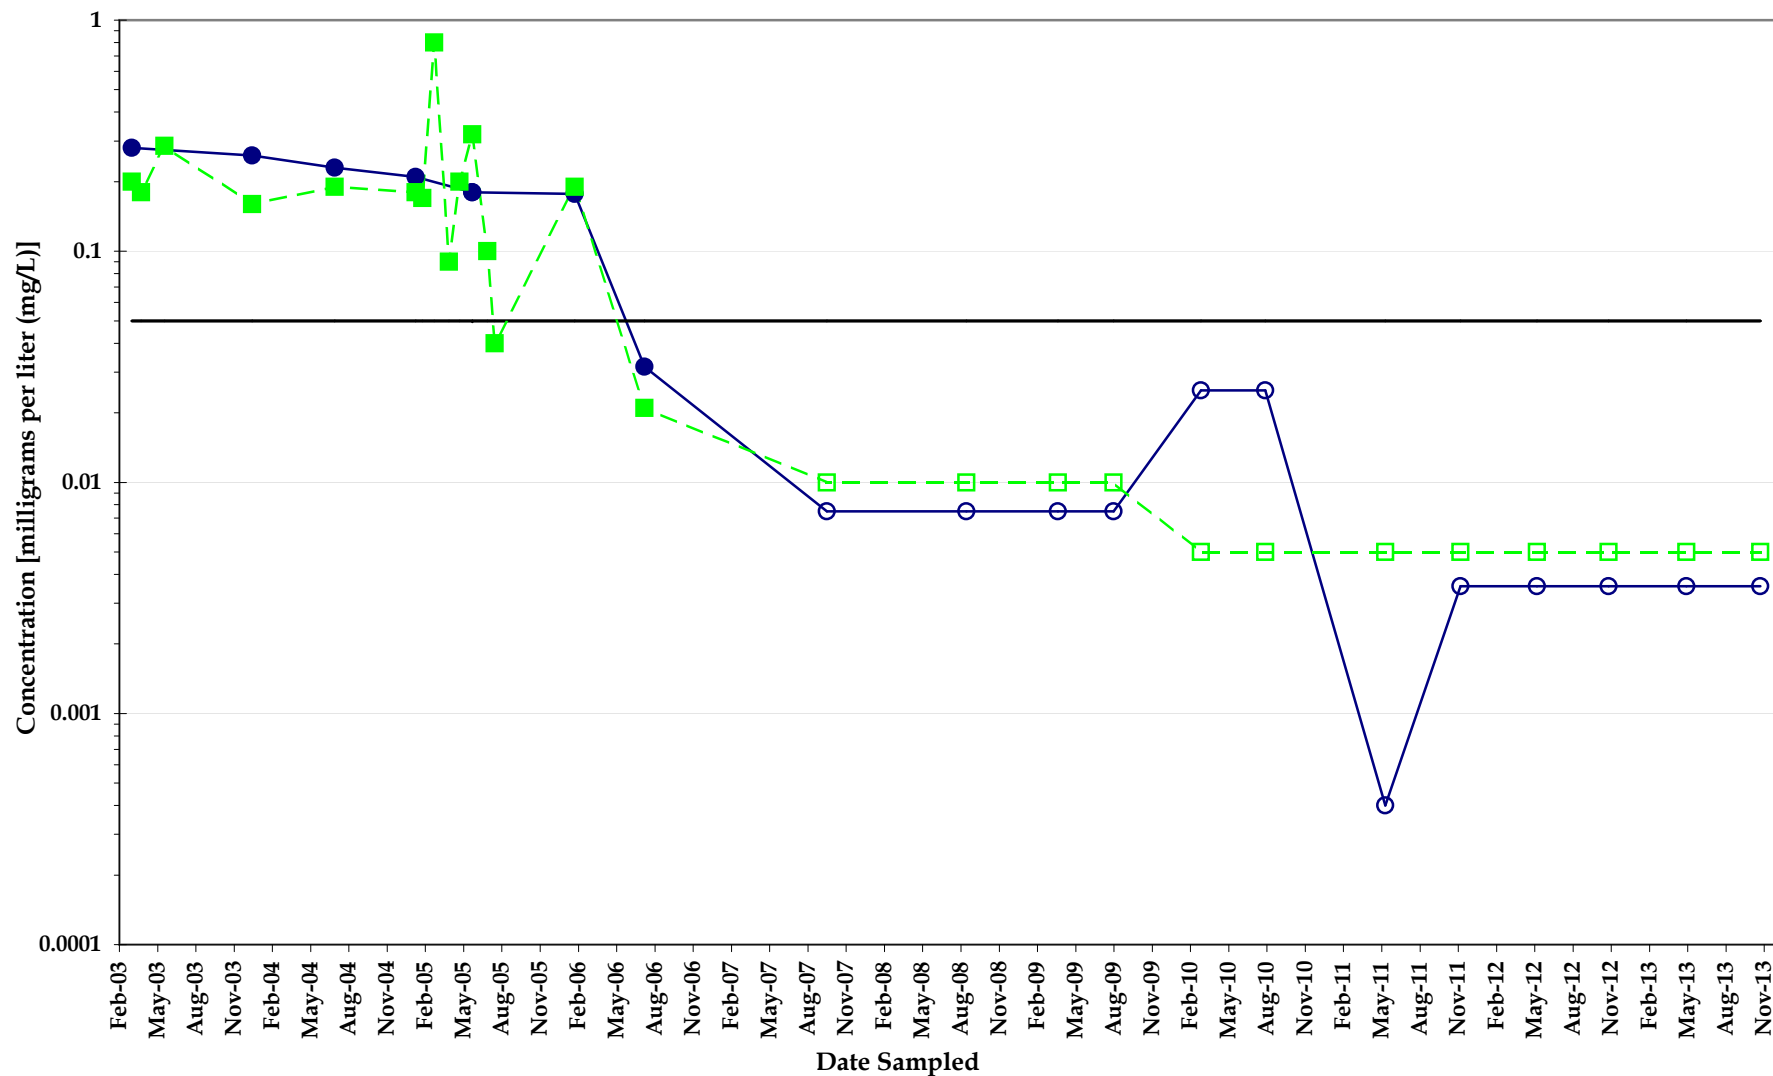
## Chromium Concentrations Monitoring Well MW066SA

Note: Non-detect analyses plotted at the method detection limit or half the reporting limit (RL). Detections denoted by symbol and detection values greater than the RL denoted by shaded symbol.

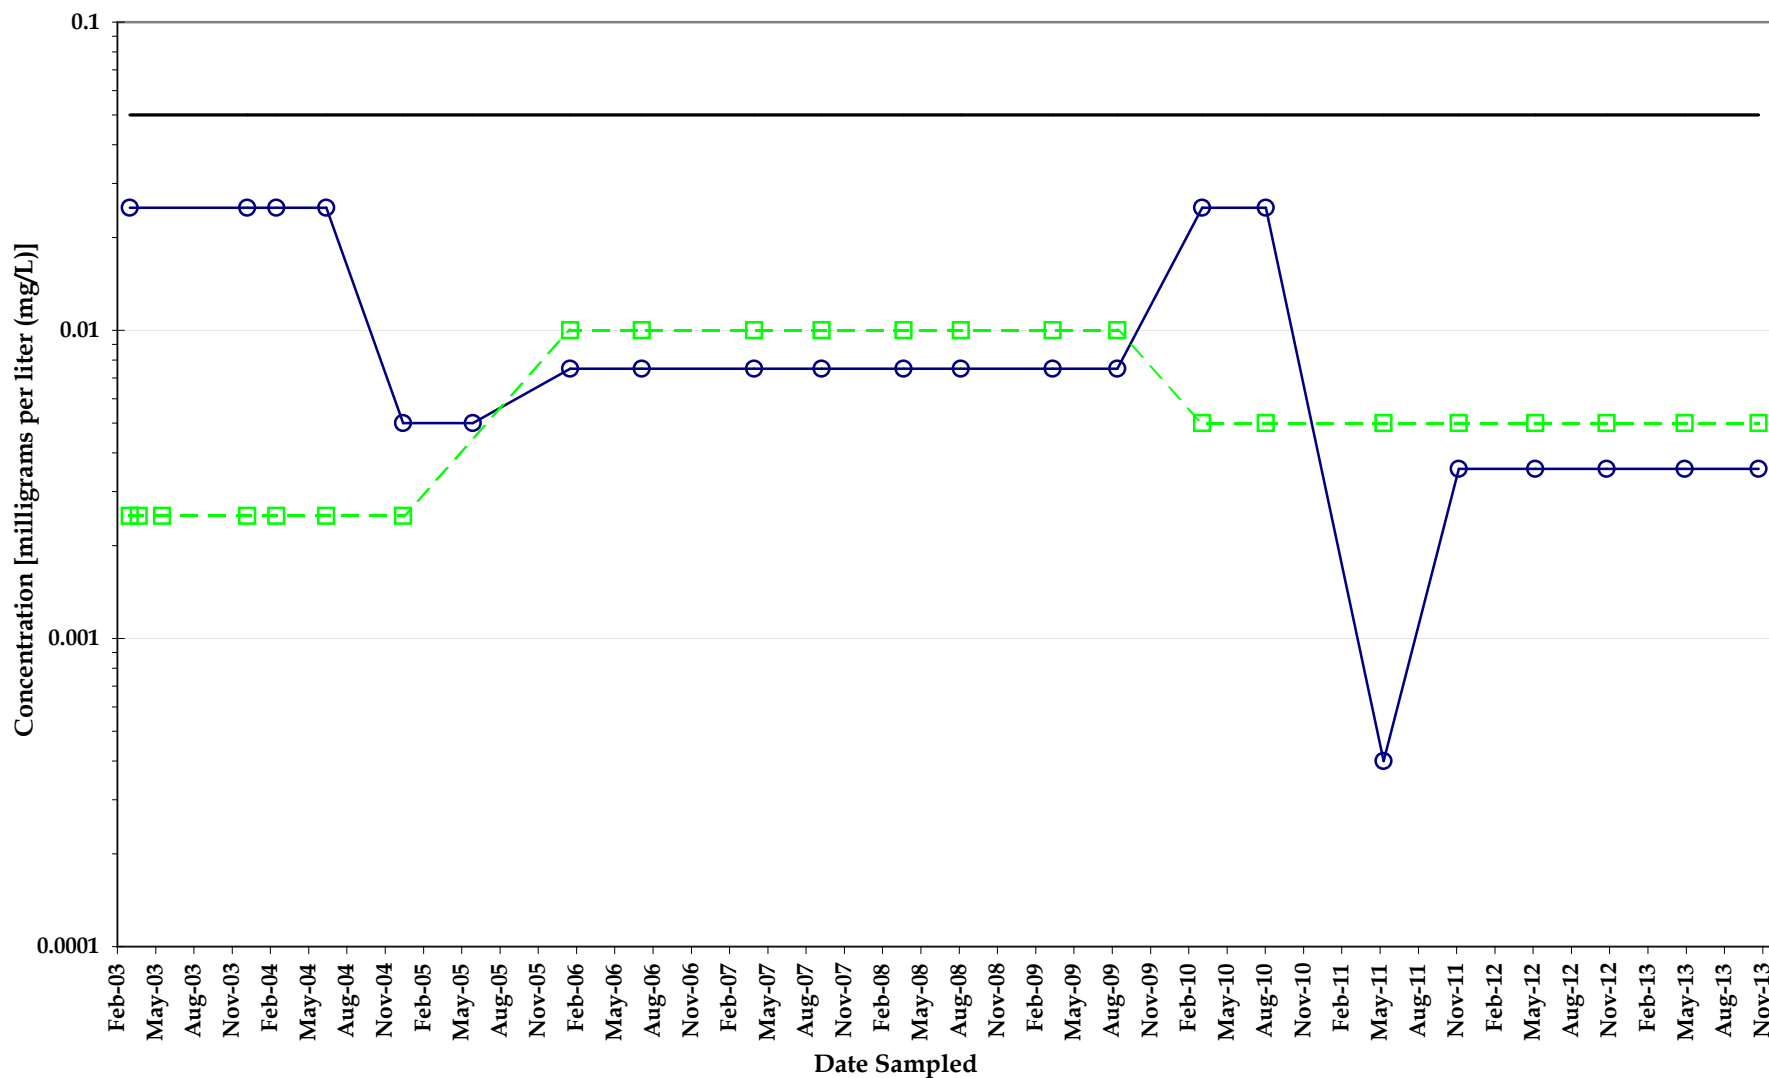
## Chromium Concentrations Monitoring Well MW067SA

Note: Non-detect analyses plotted at the method detection limit or half the reporting limit (RL). Detections denoted by symbol and detection values greater than the RL denoted by shaded symbol.

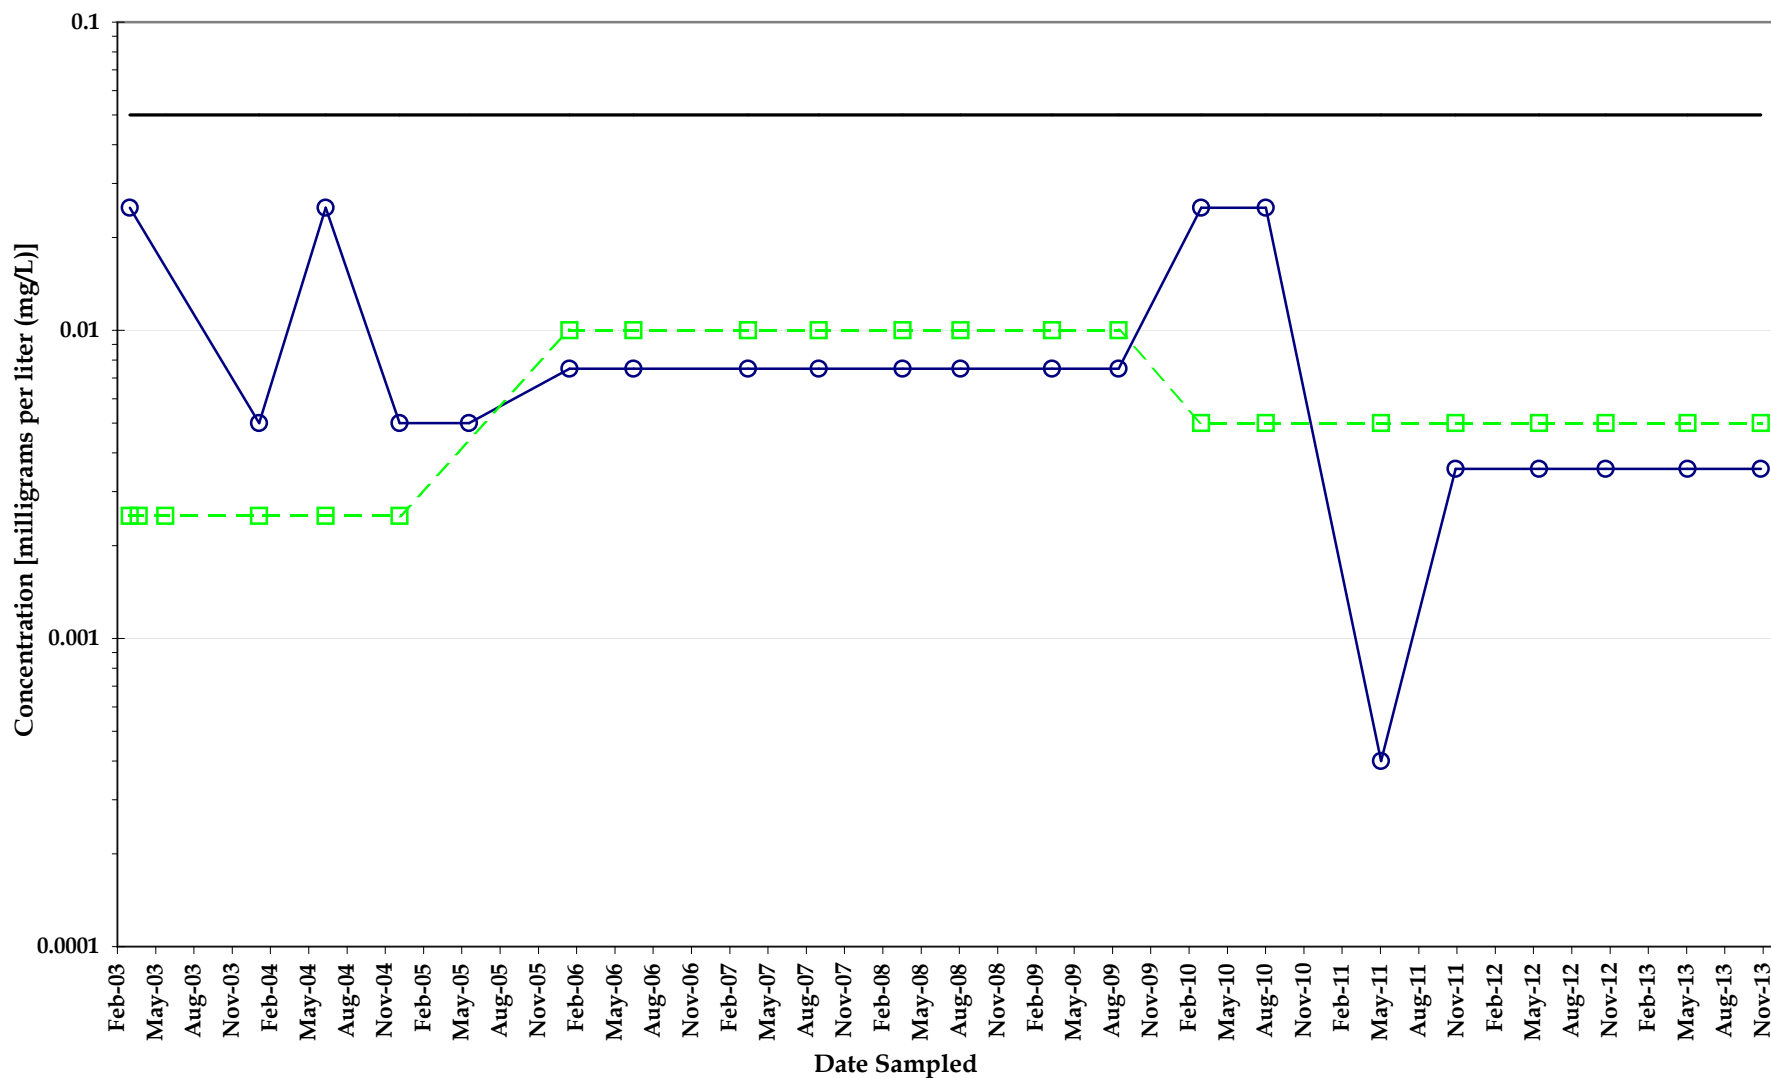
## Chromium Concentrations Monitoring Well MW068

Note: Non-detect analyses plotted at the method detection limit or half the reporting limit (RL). Detections denoted by symbol and detection values greater than the RL denoted by shaded symbol.
