**GW - 004**

**2013 AGWMR**

**VOL 5 OF 5**

*North Eunice Gas Plant  
Lea County, New Mexico*

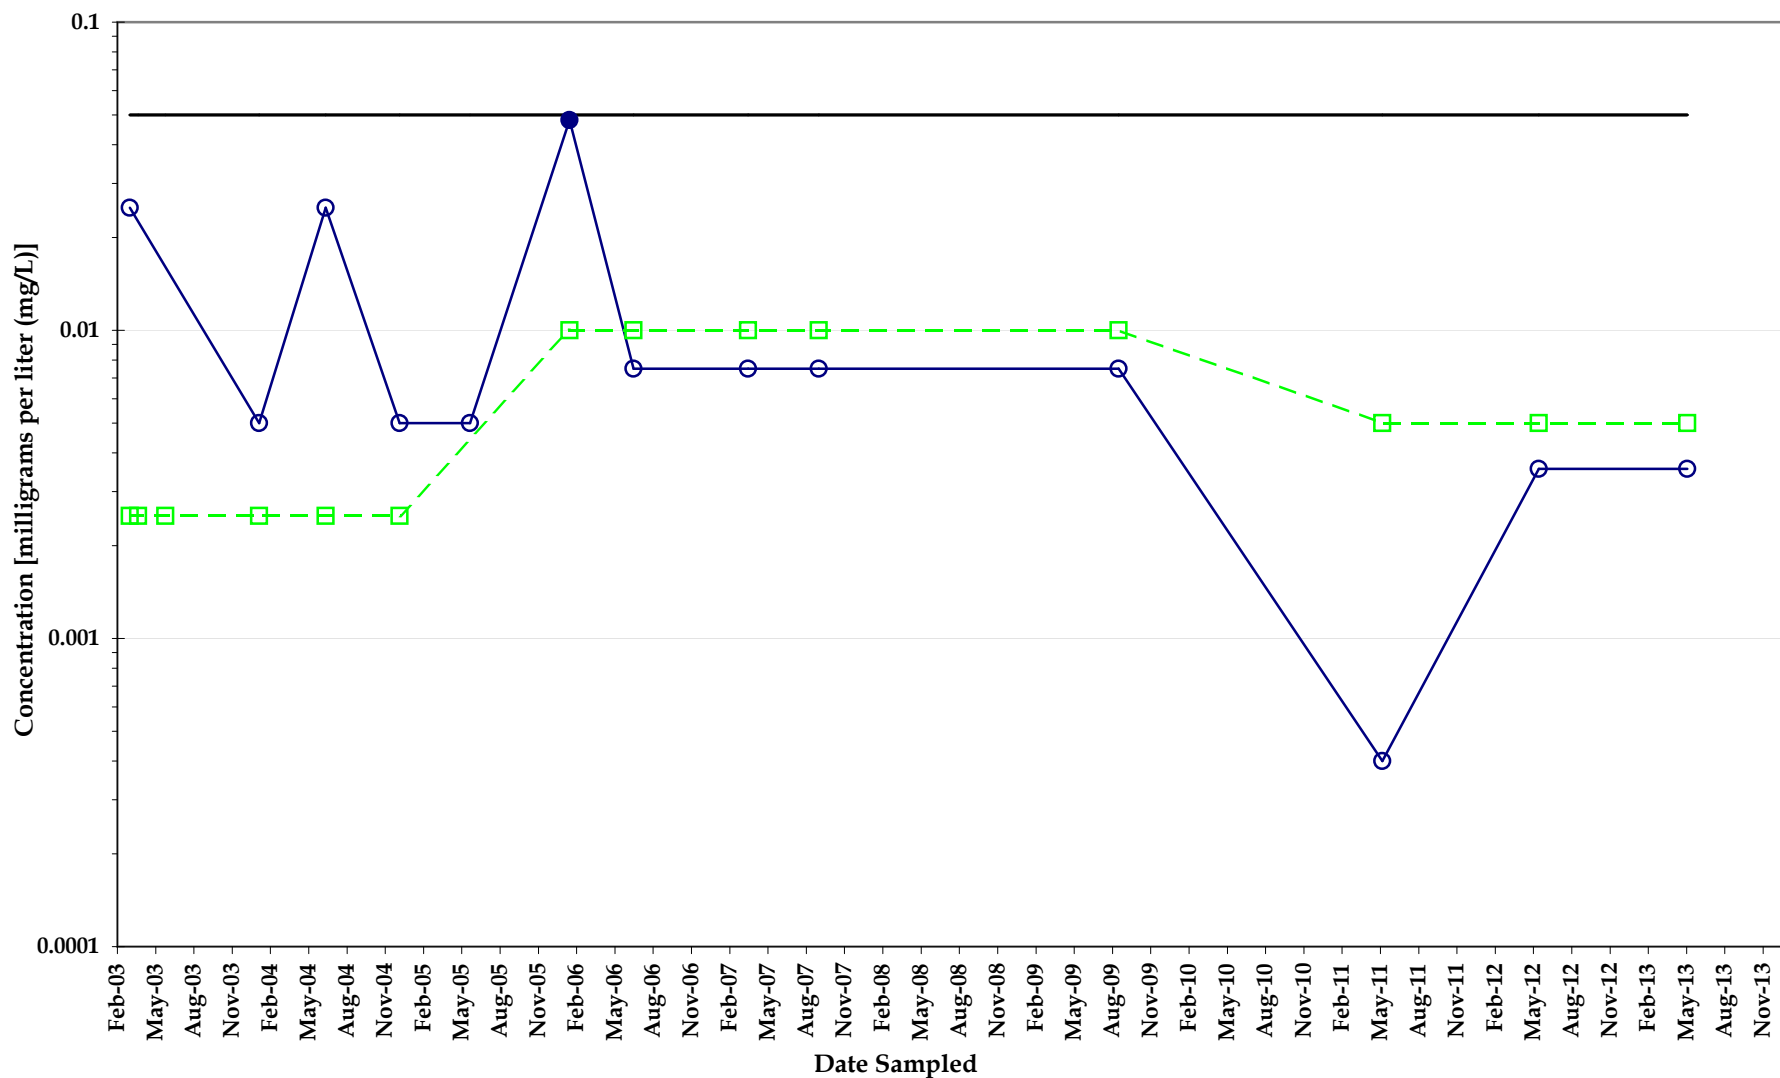
## Chromium Concentrations Monitoring Well MW069

Note: Non-detect analyses plotted at the method detection limit or half the reporting limit (RL). Detections denoted by symbol and detection values greater than the RL denoted by shaded symbol.

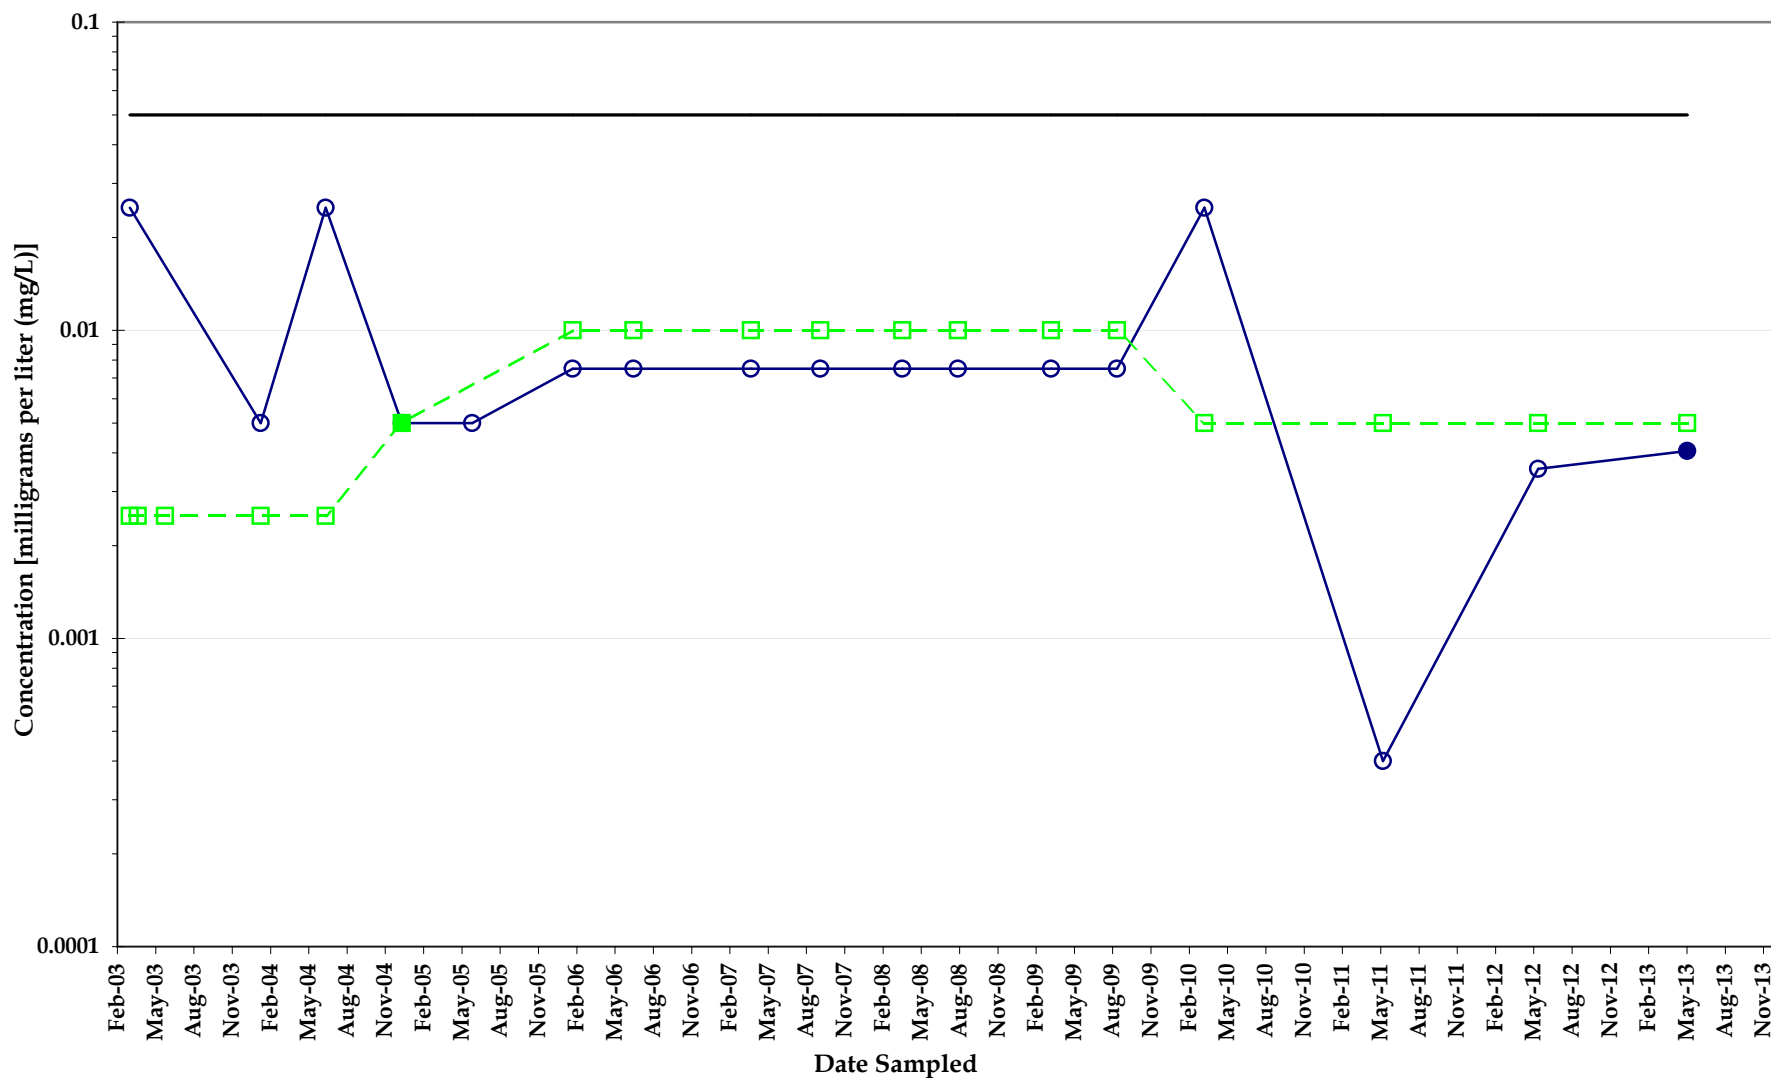
## Chromium Concentrations Monitoring Well MW070A

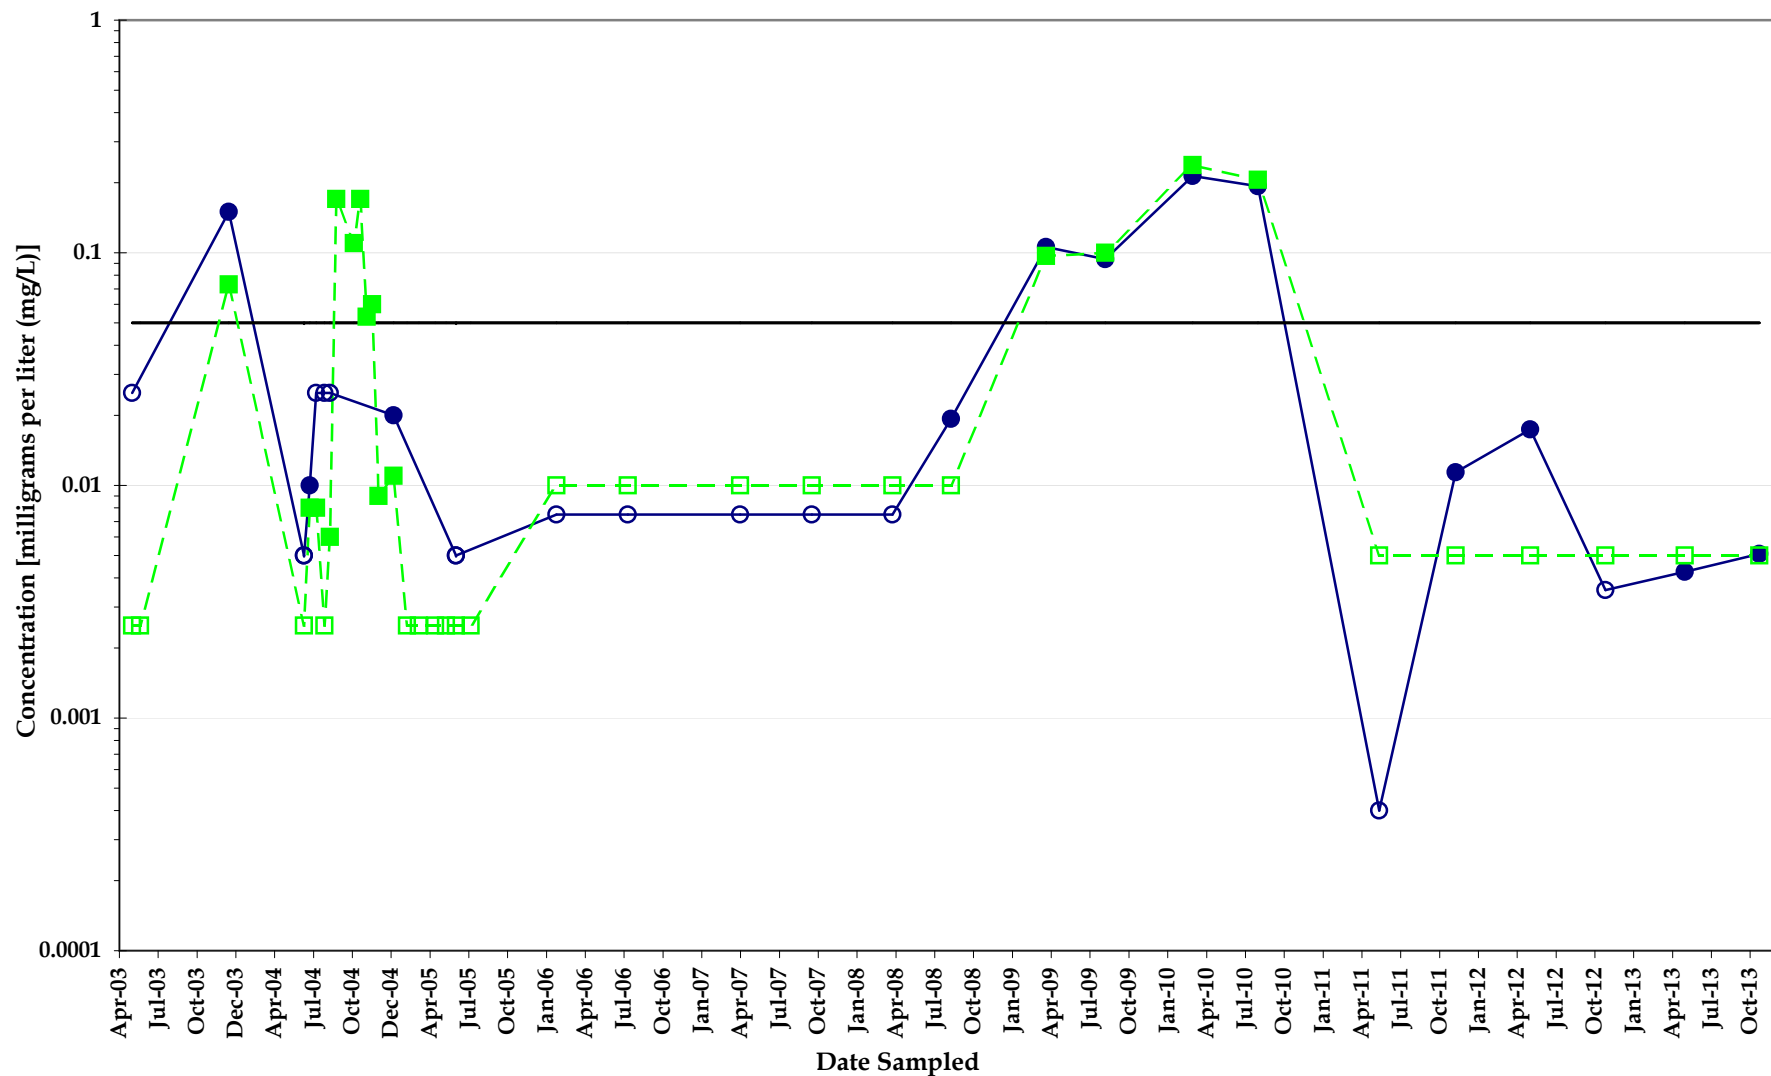
## Chromium Concentrations Monitoring Well MW071SA

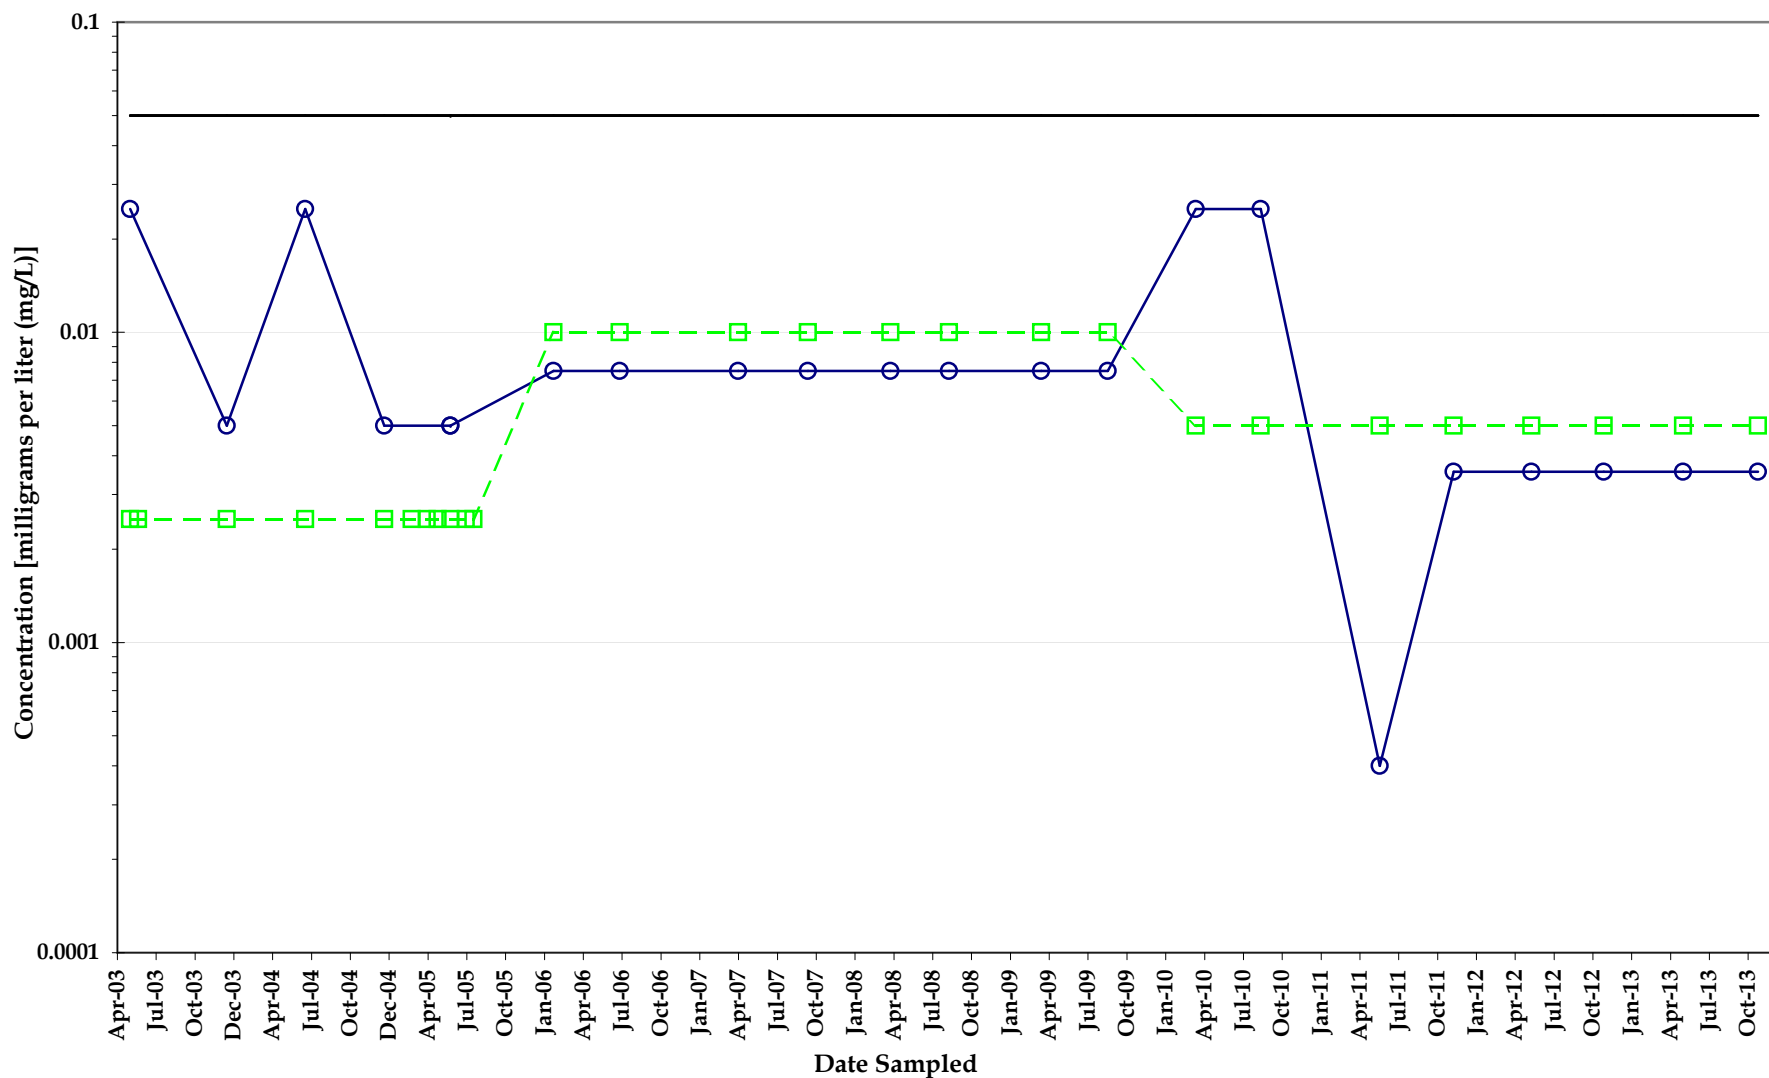
## Chromium Concentrations Monitoring Well MW072SA

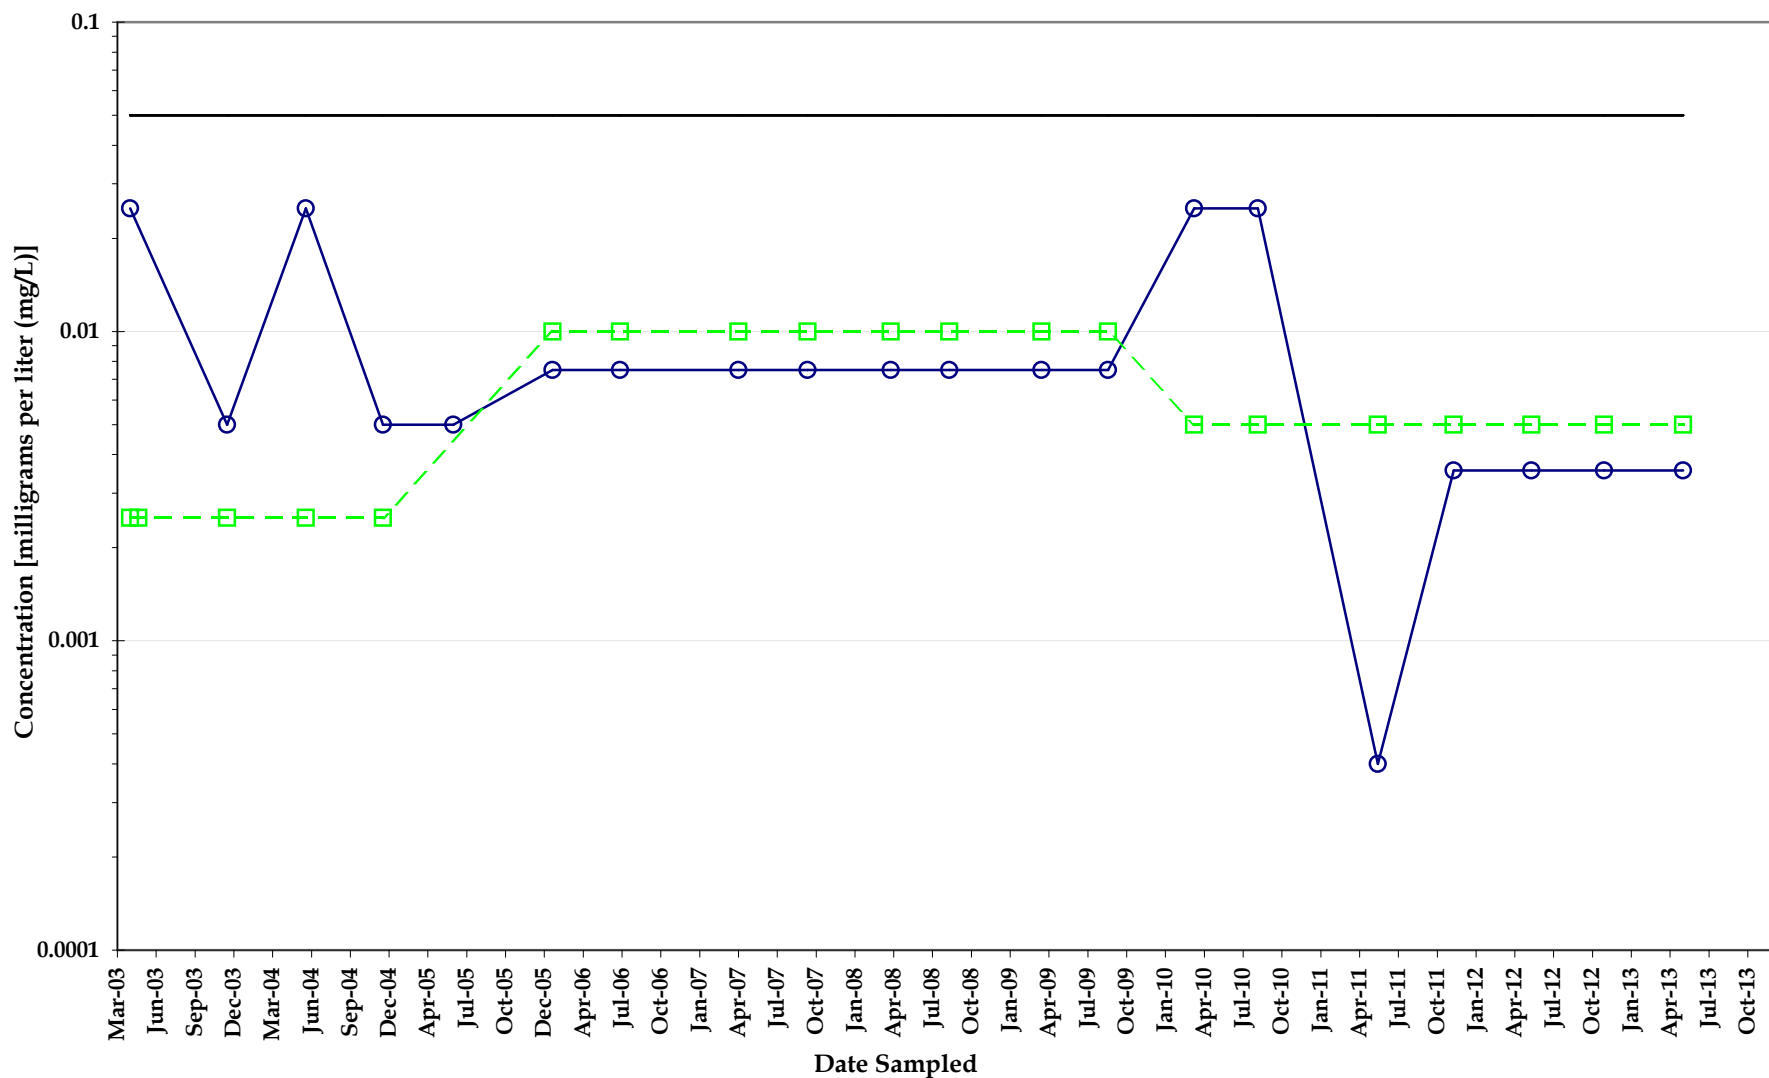
## Chromium Concentrations Monitoring Well MW073SA

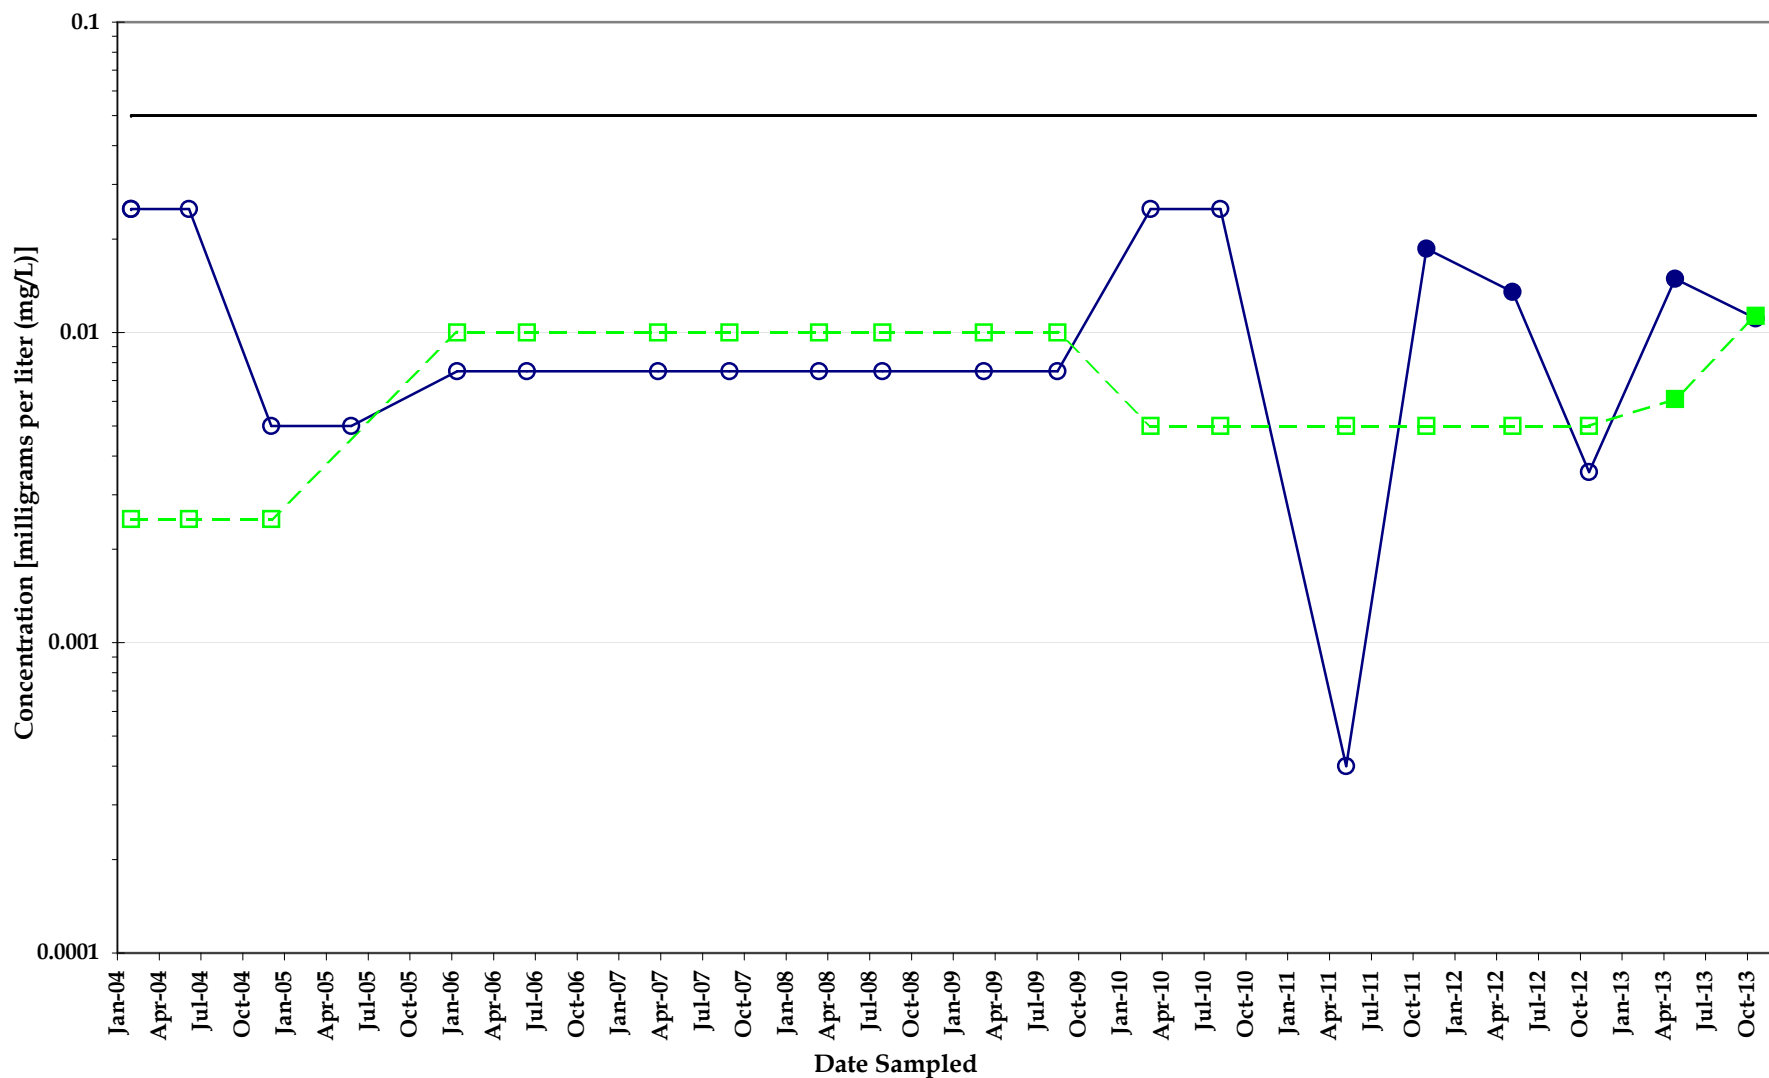
## Chromium Concentrations Monitoring Well MW074SA

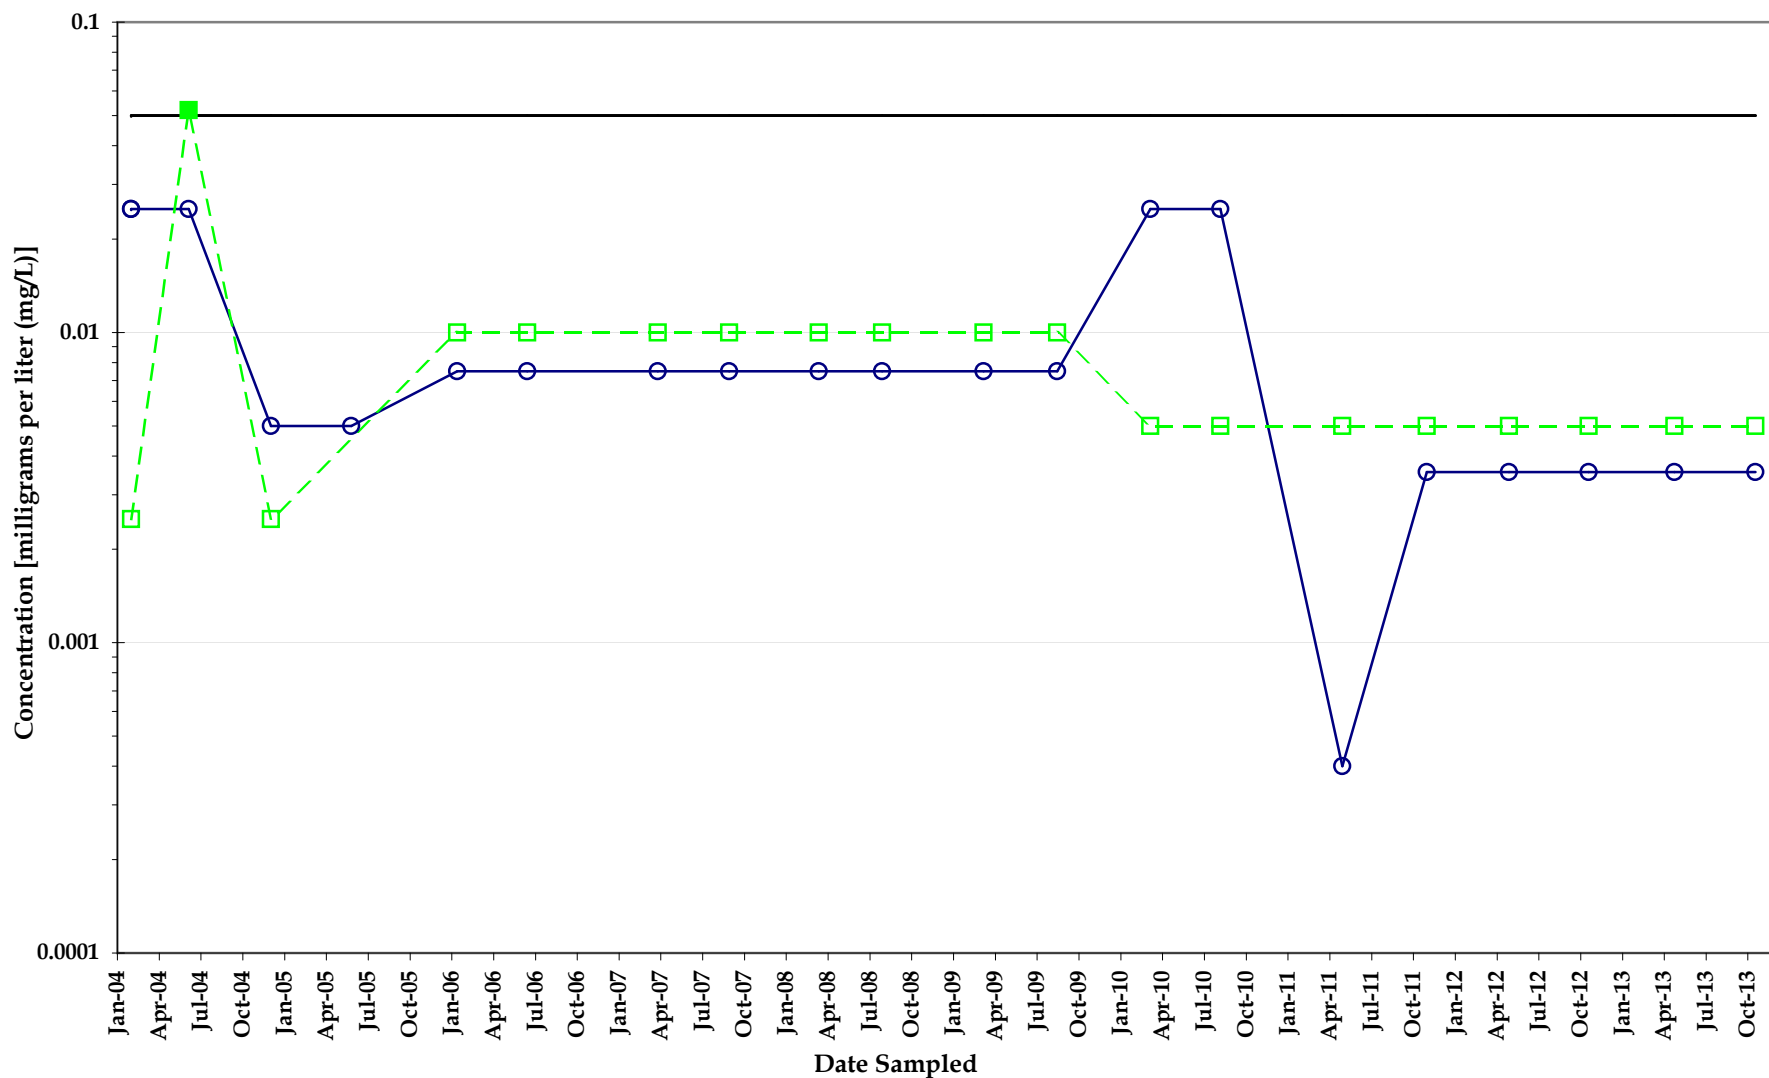
## Chromium Concentrations Monitoring Well MW075SA

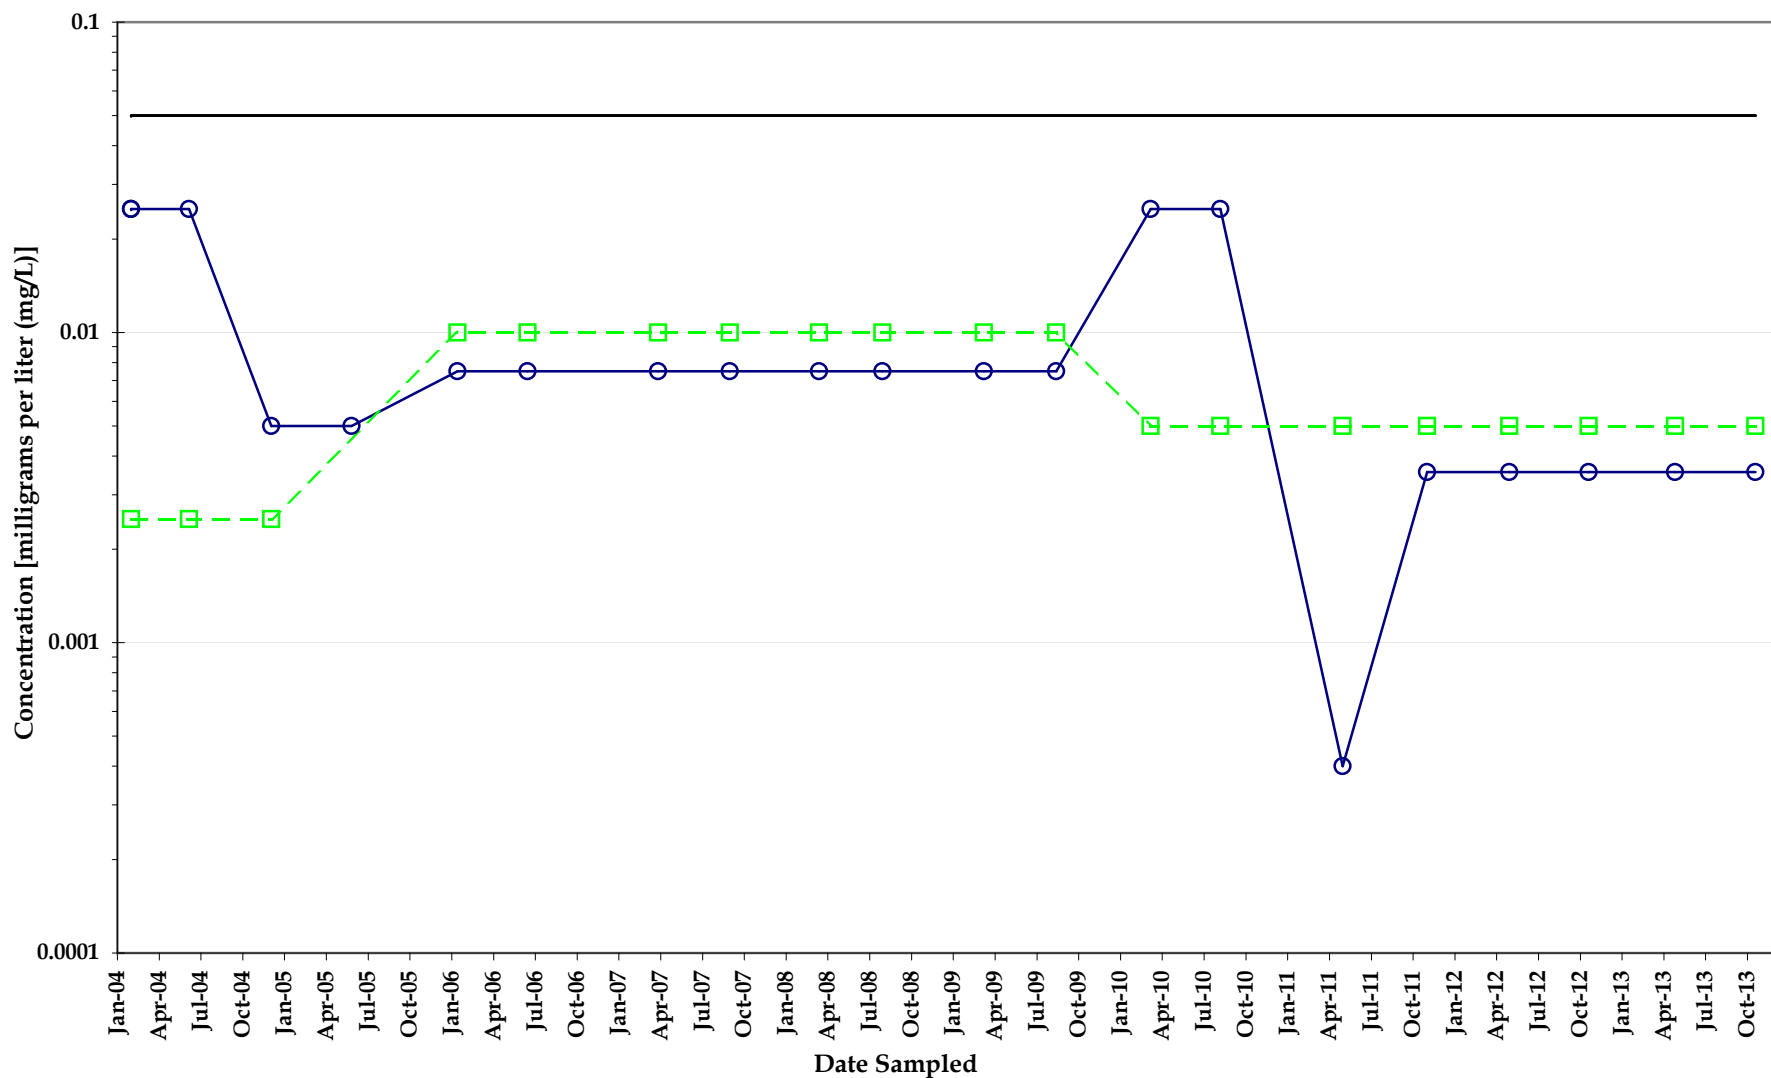
## Chromium Concentrations Monitoring Well MW076SA

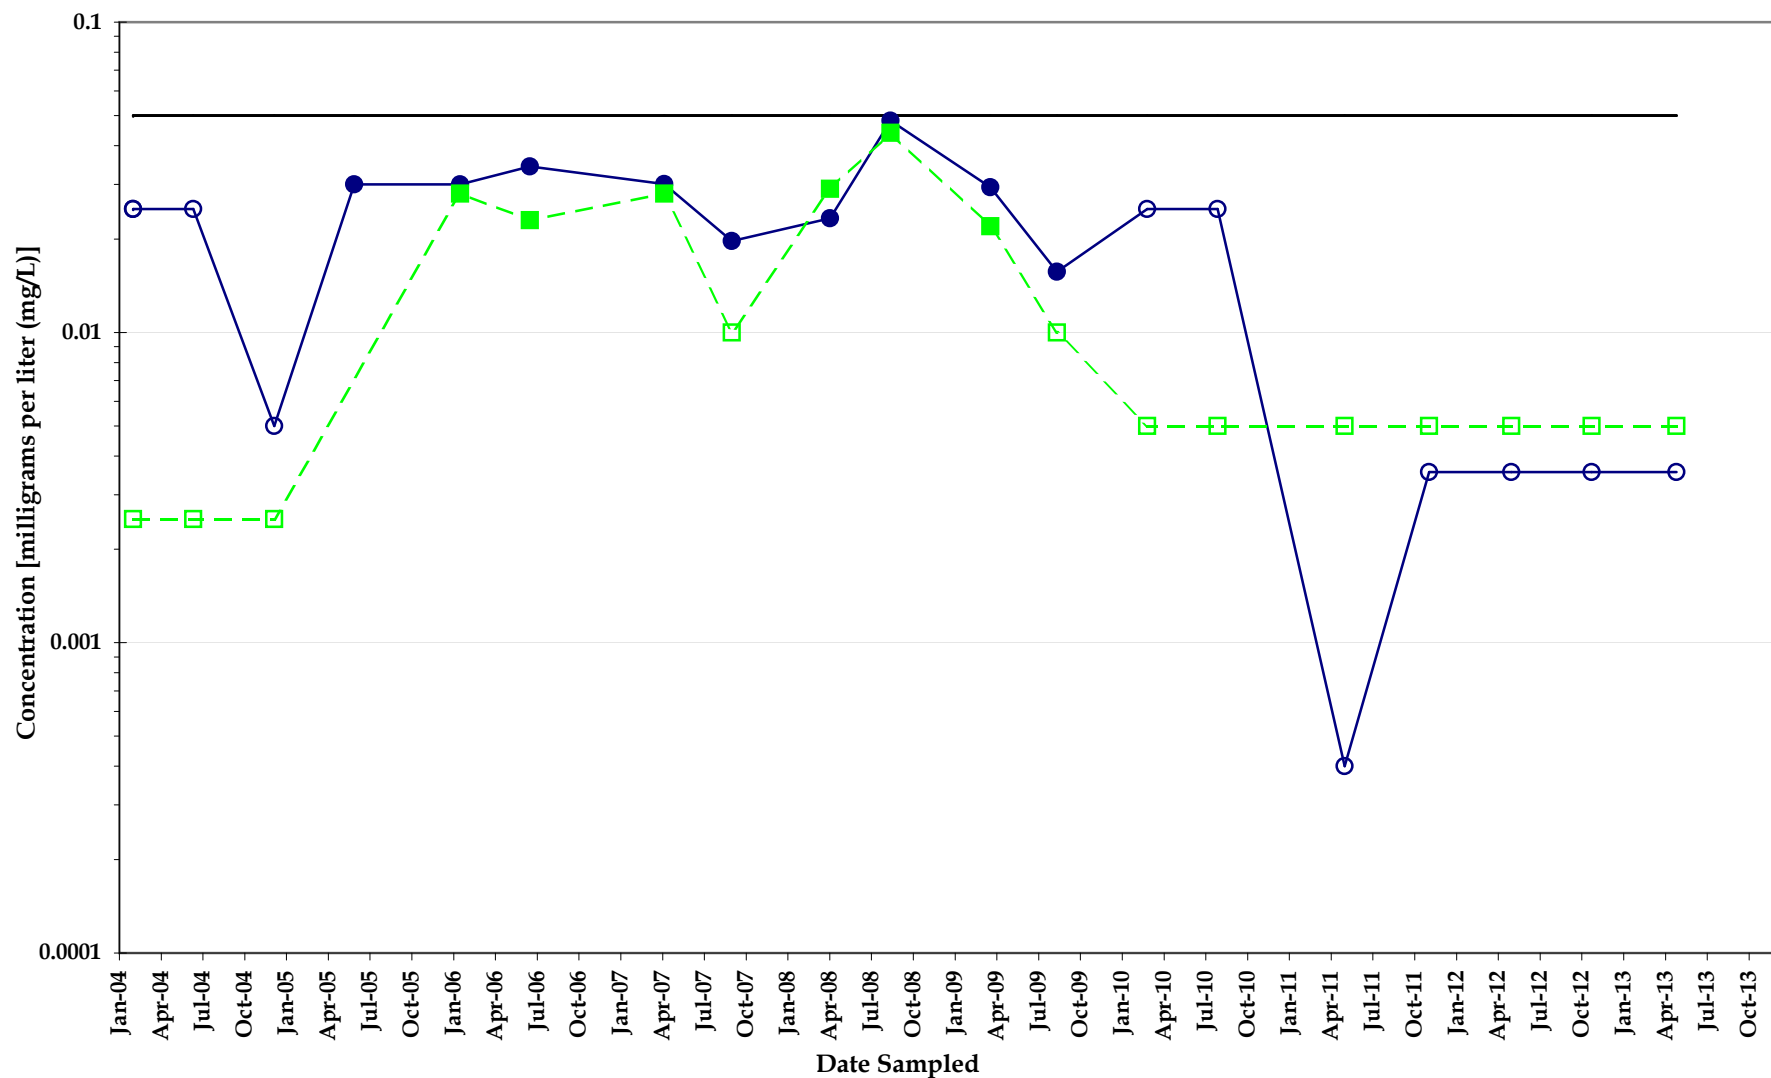
## Chromium Concentrations Monitoring Well MW077SA

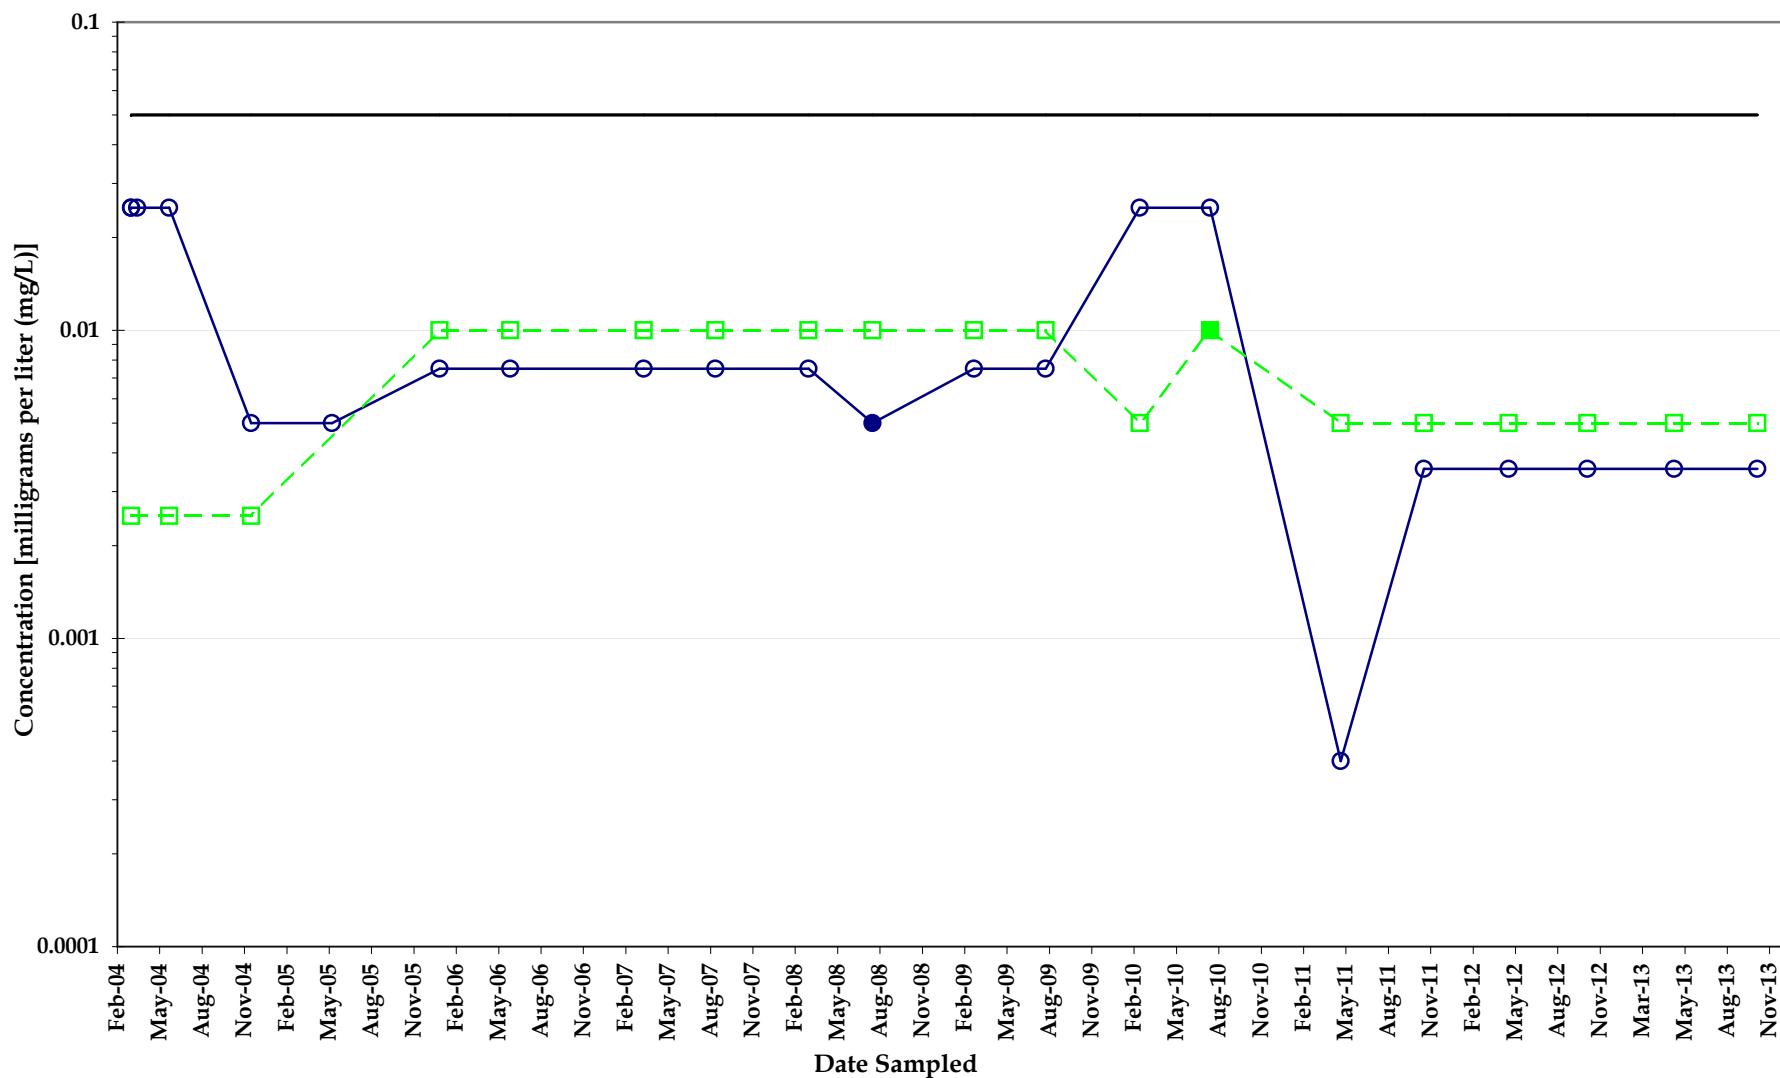
## Chromium Concentrations Monitoring Well MW078SA

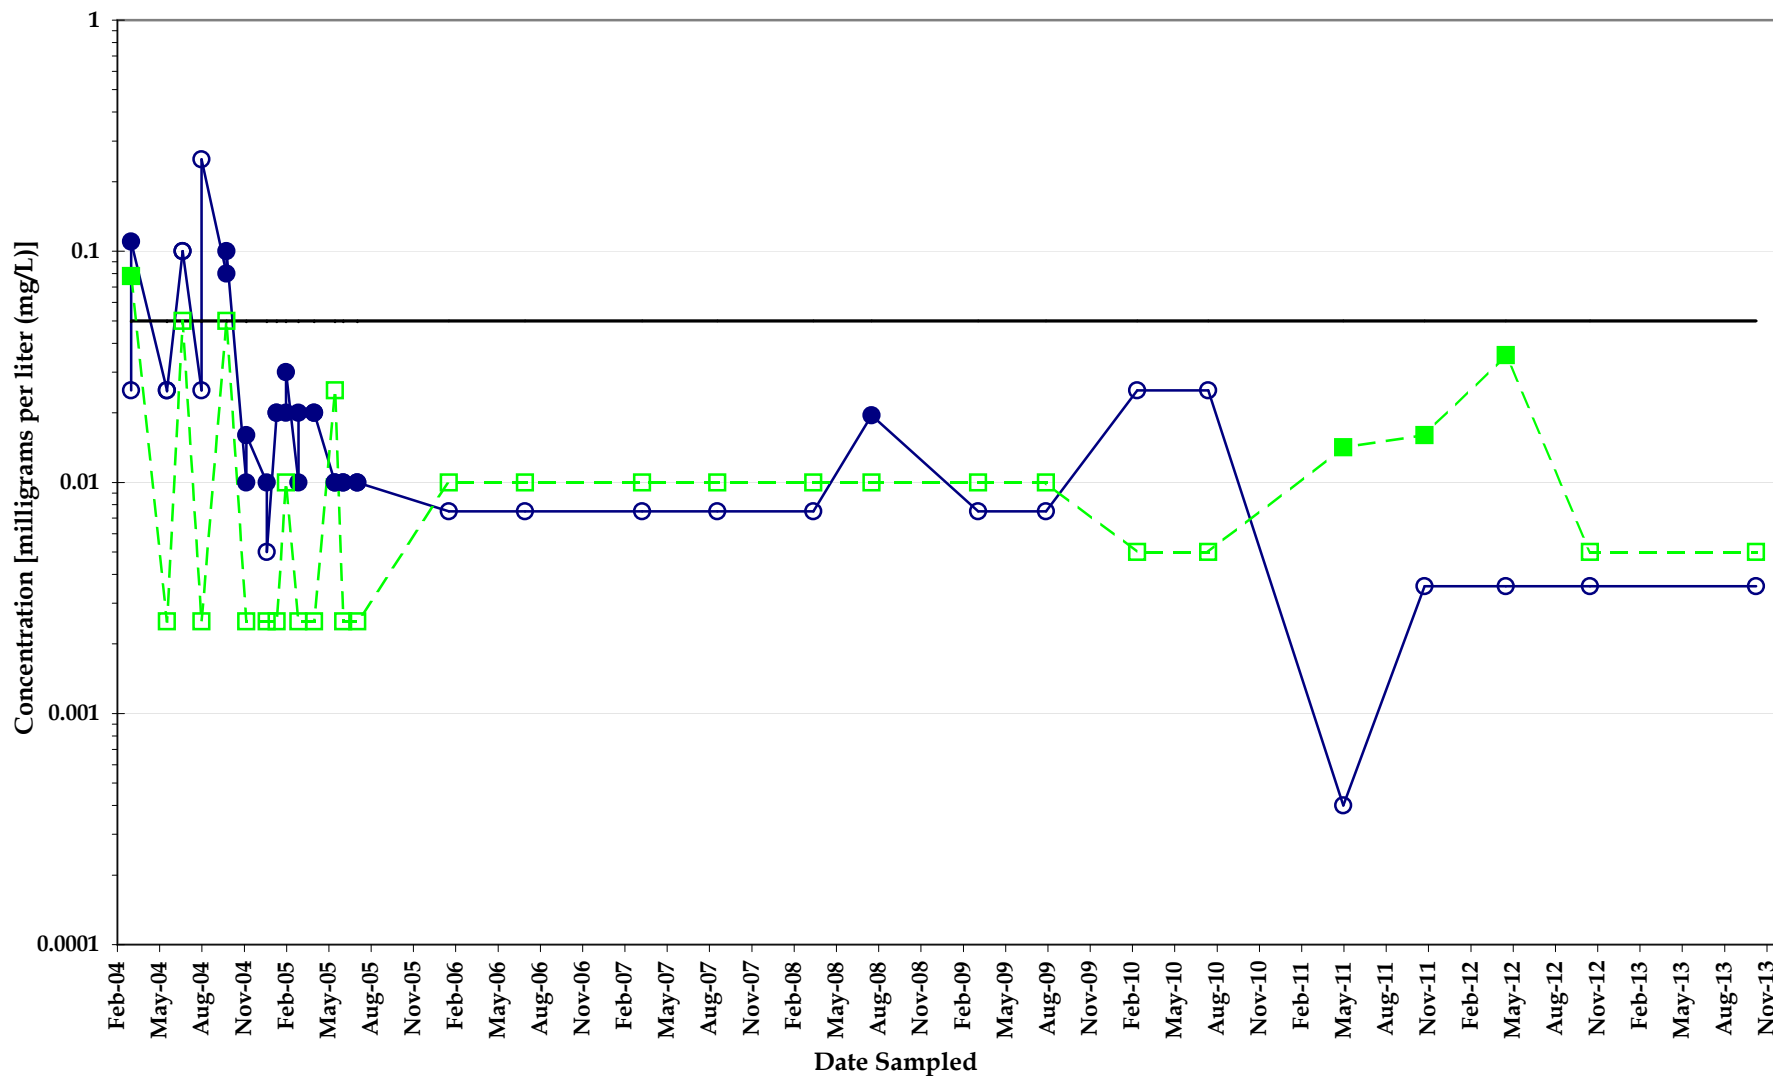
## Chromium Concentrations Monitoring Well MW079SA

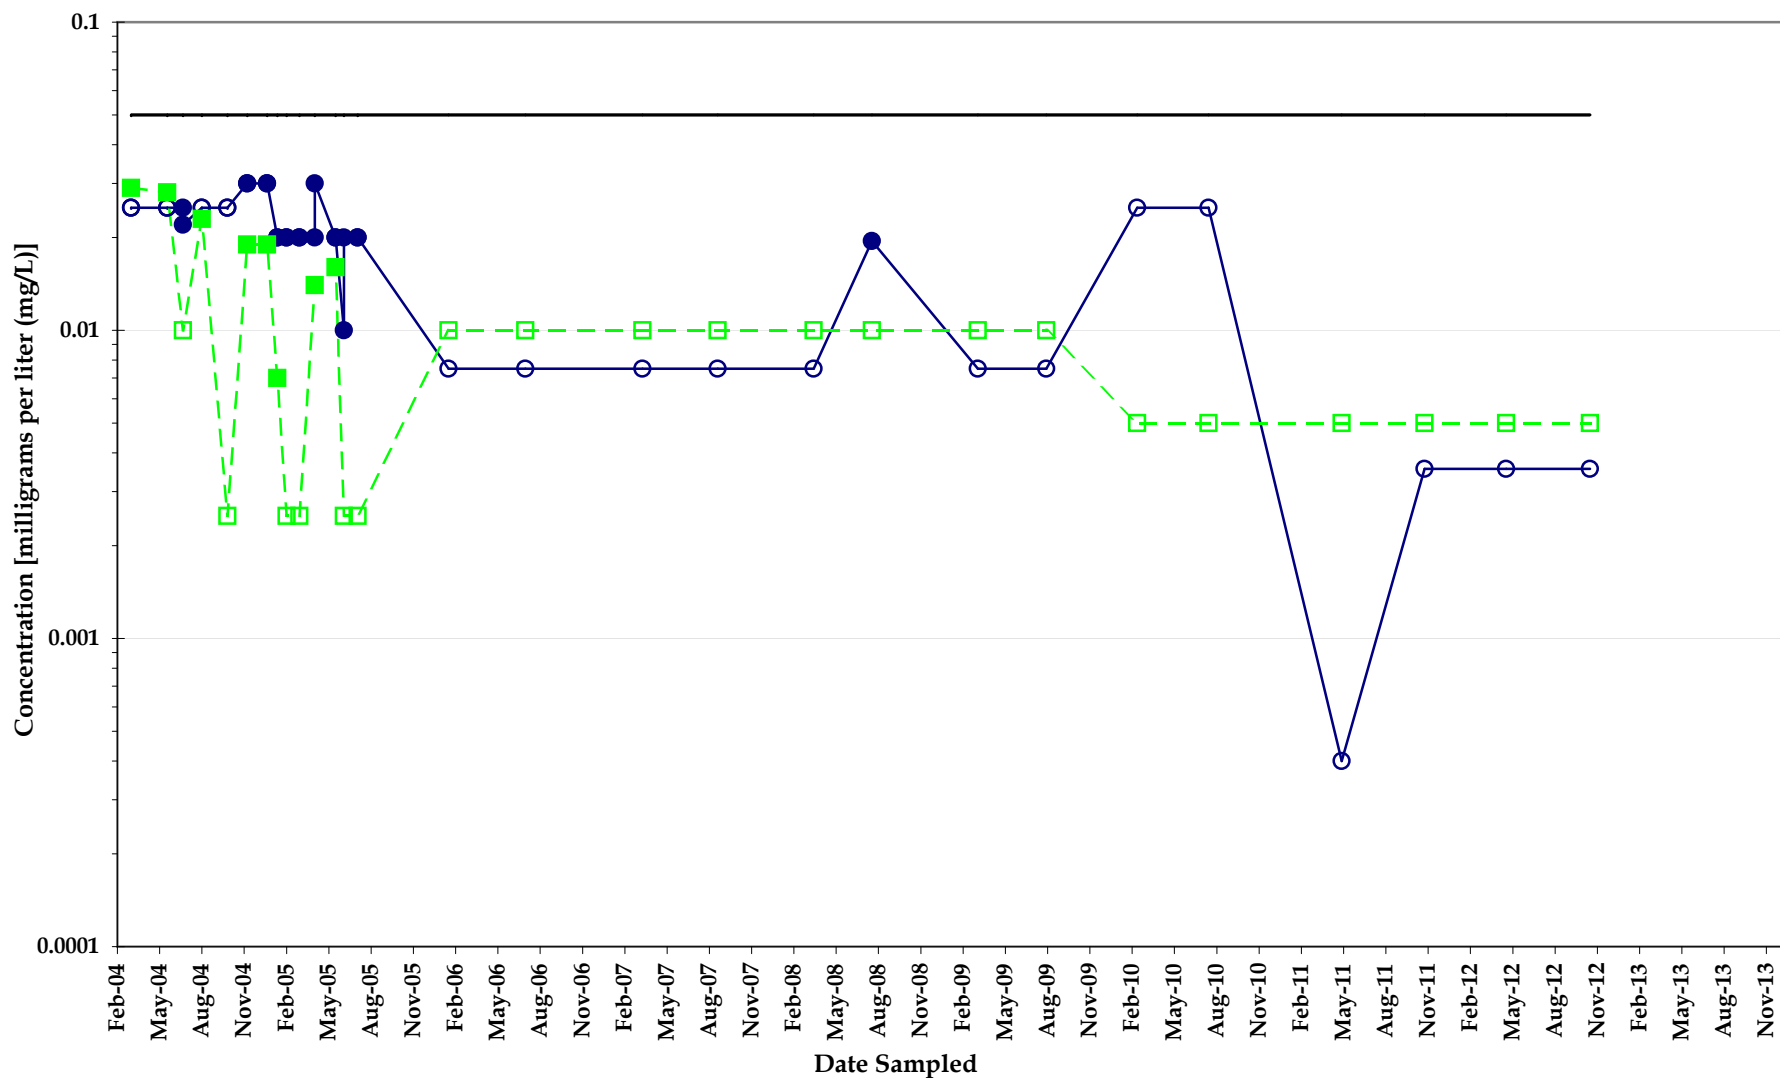
## Chromium Concentrations Monitoring Well MW080SA
