**GW - 004**

**2013 AGWMR**

**VOL 5 OF 5**

*North Eunice Gas Plant  
Lea County, New Mexico*

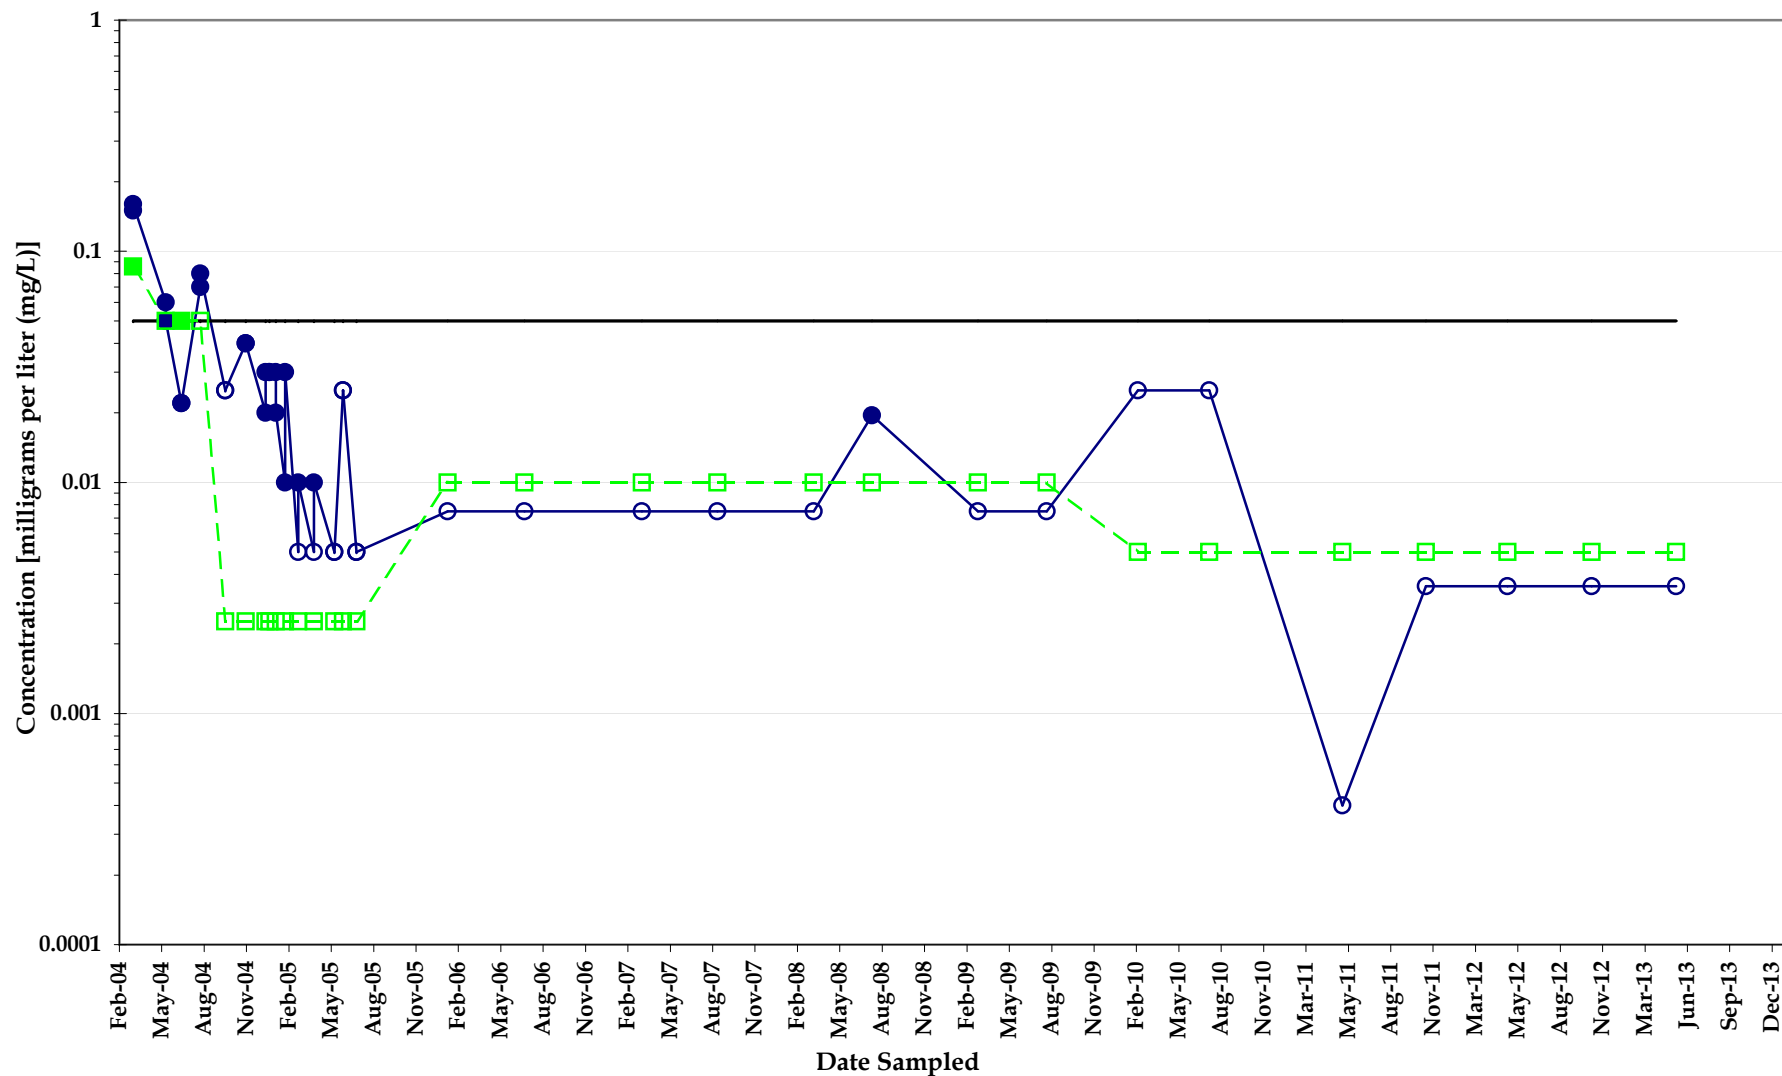
## Chromium Concentrations Monitoring Well MW081SA

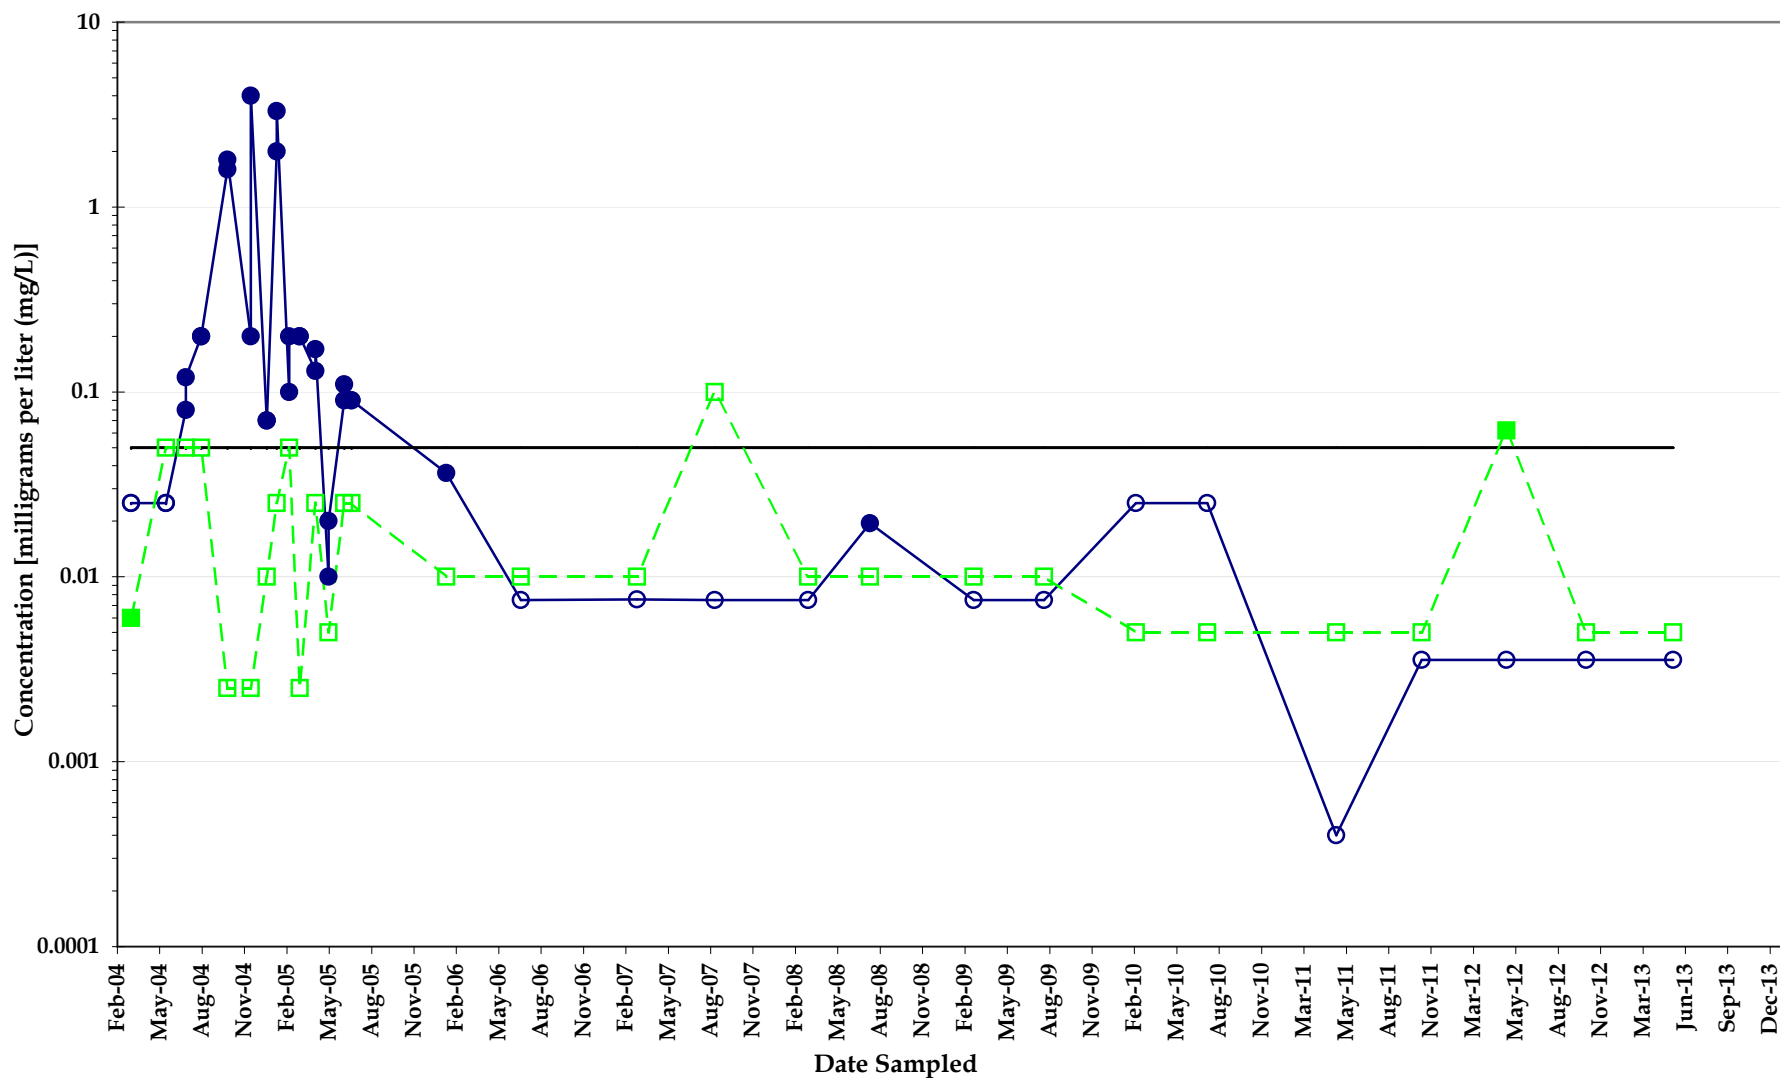
## Chromium Concentrations Monitoring Well MW082SA

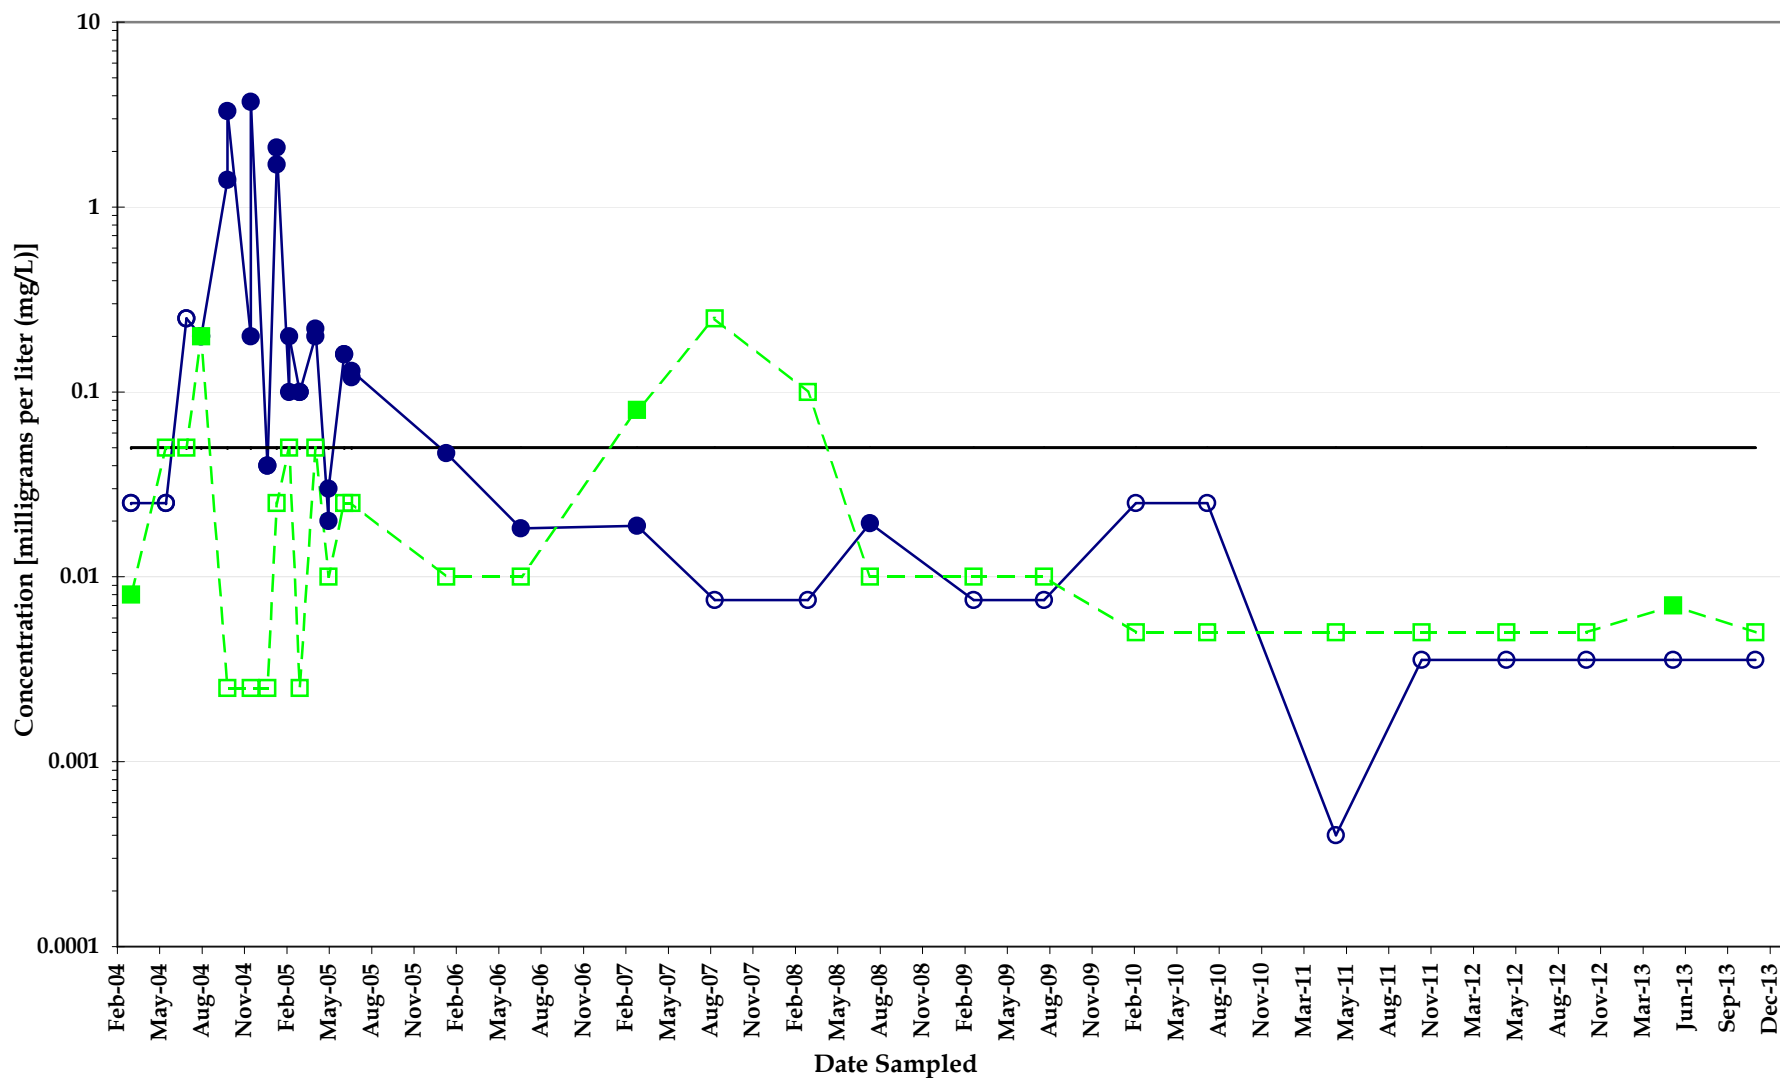
## Chromium Concentrations Monitoring Well MW083SA

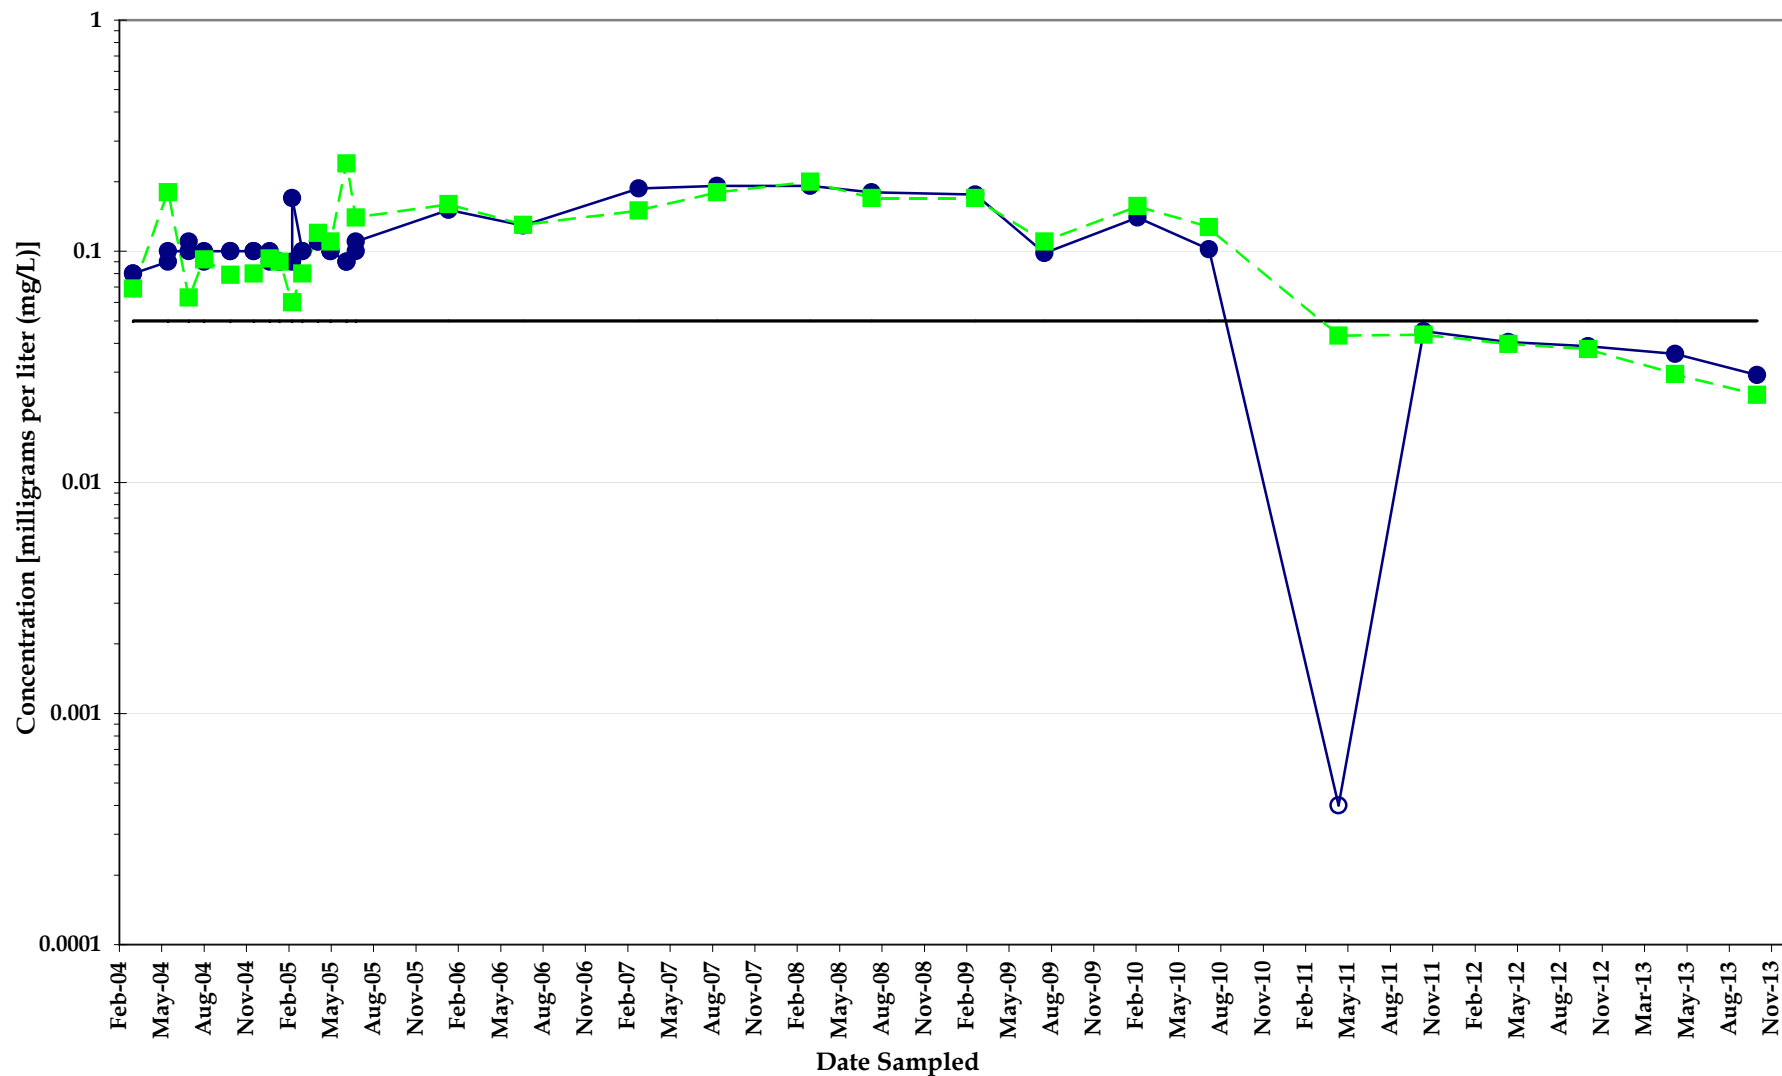
## Chromium Concentrations Monitoring Well MW084SA

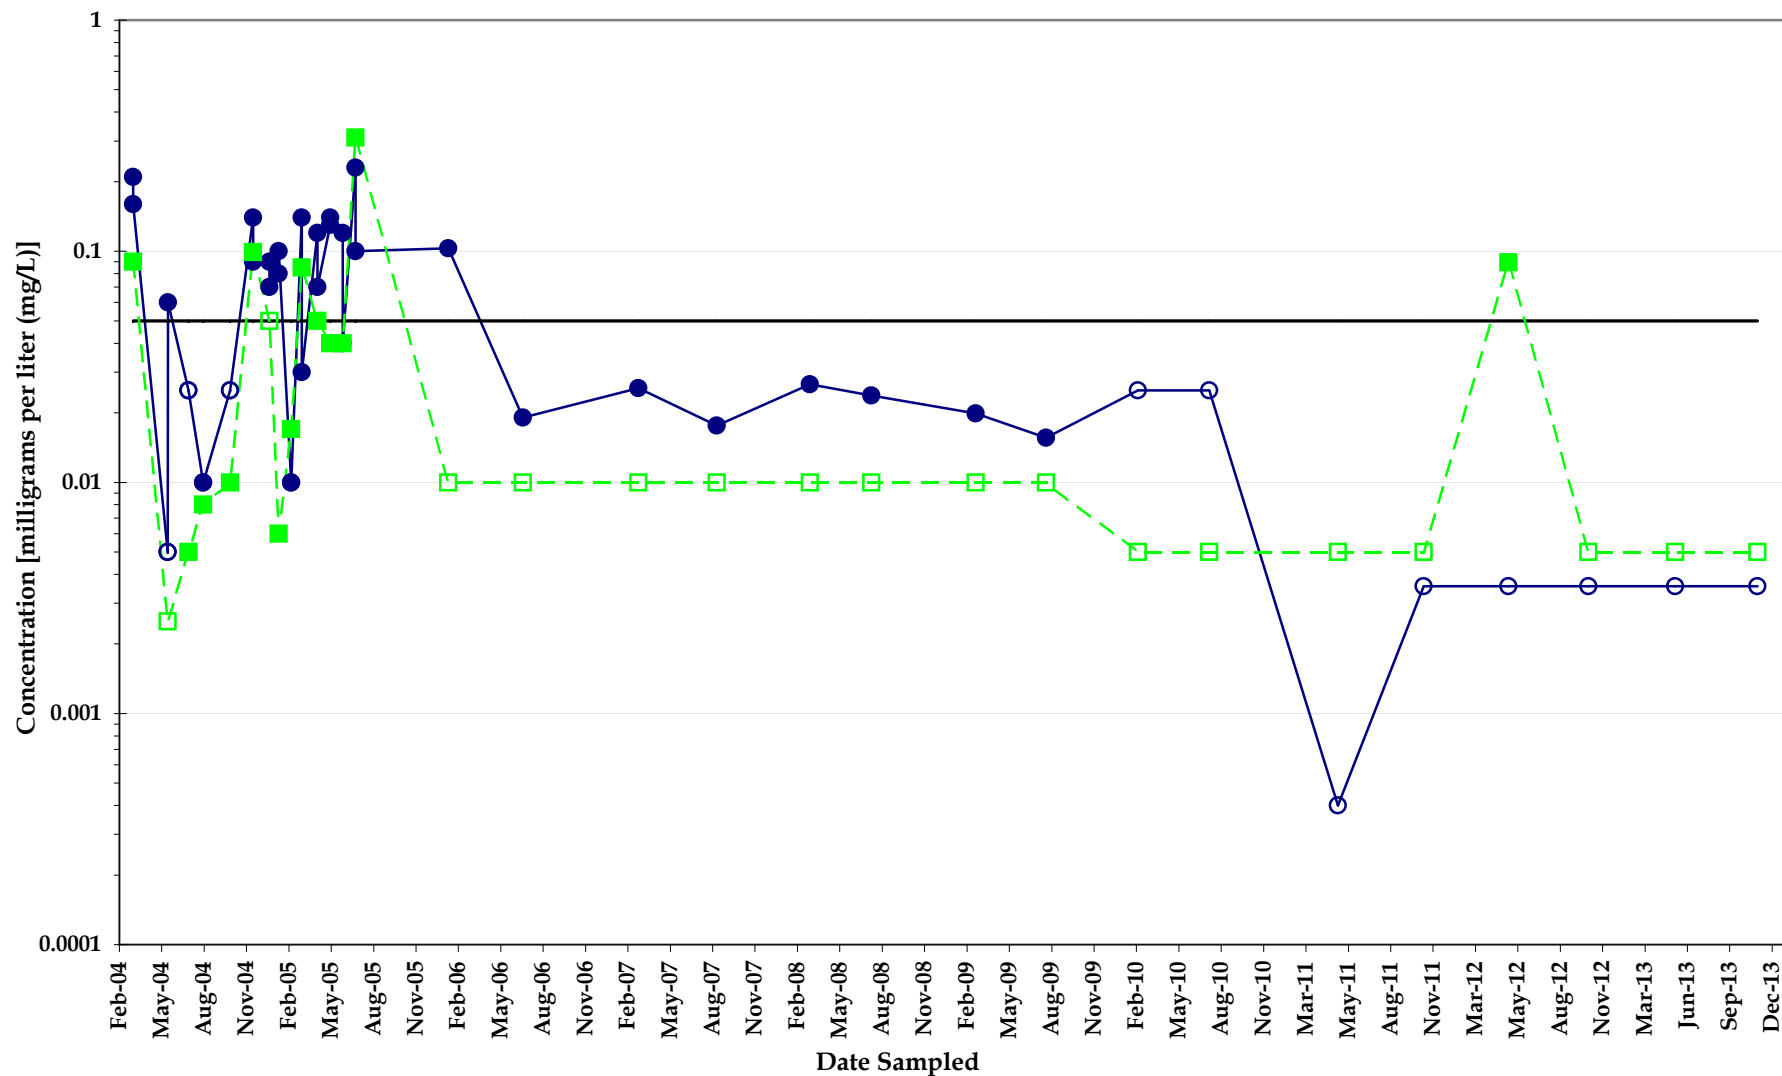
## Chromium Concentrations Monitoring Well MW085SA

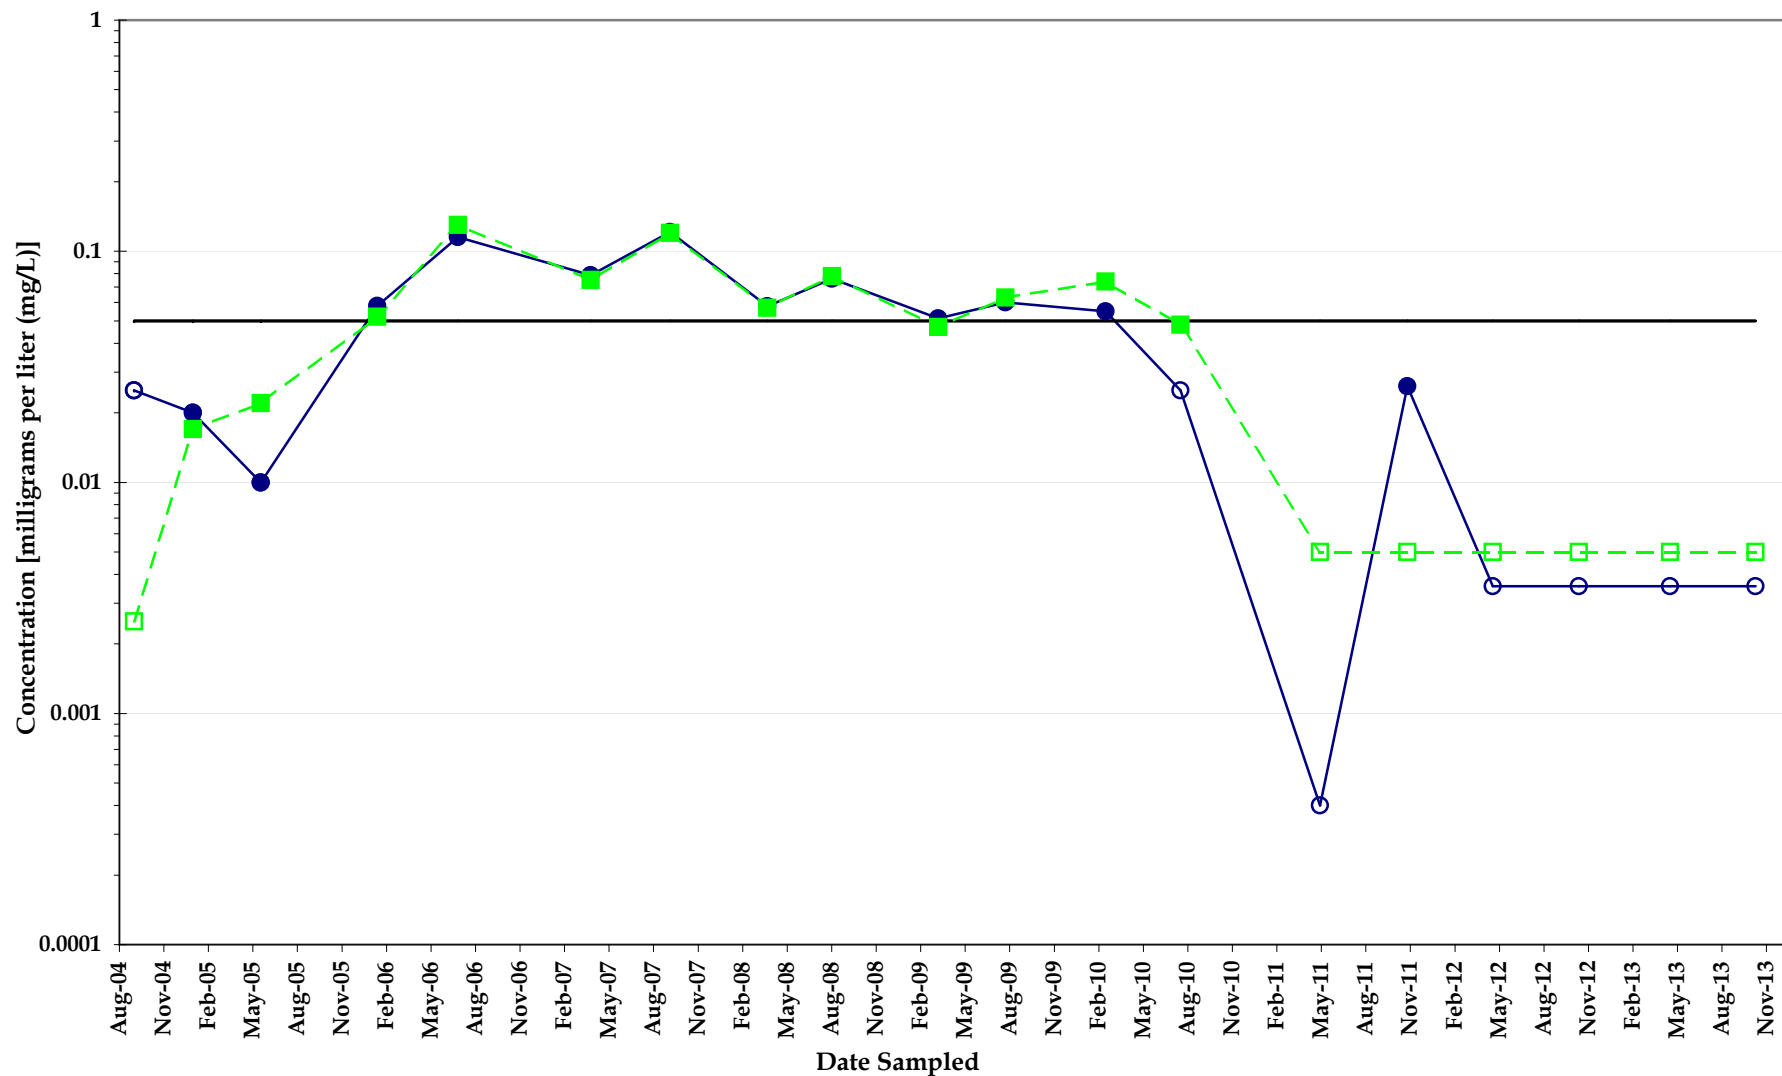
## Chromium Concentrations Monitoring Well MW086SA

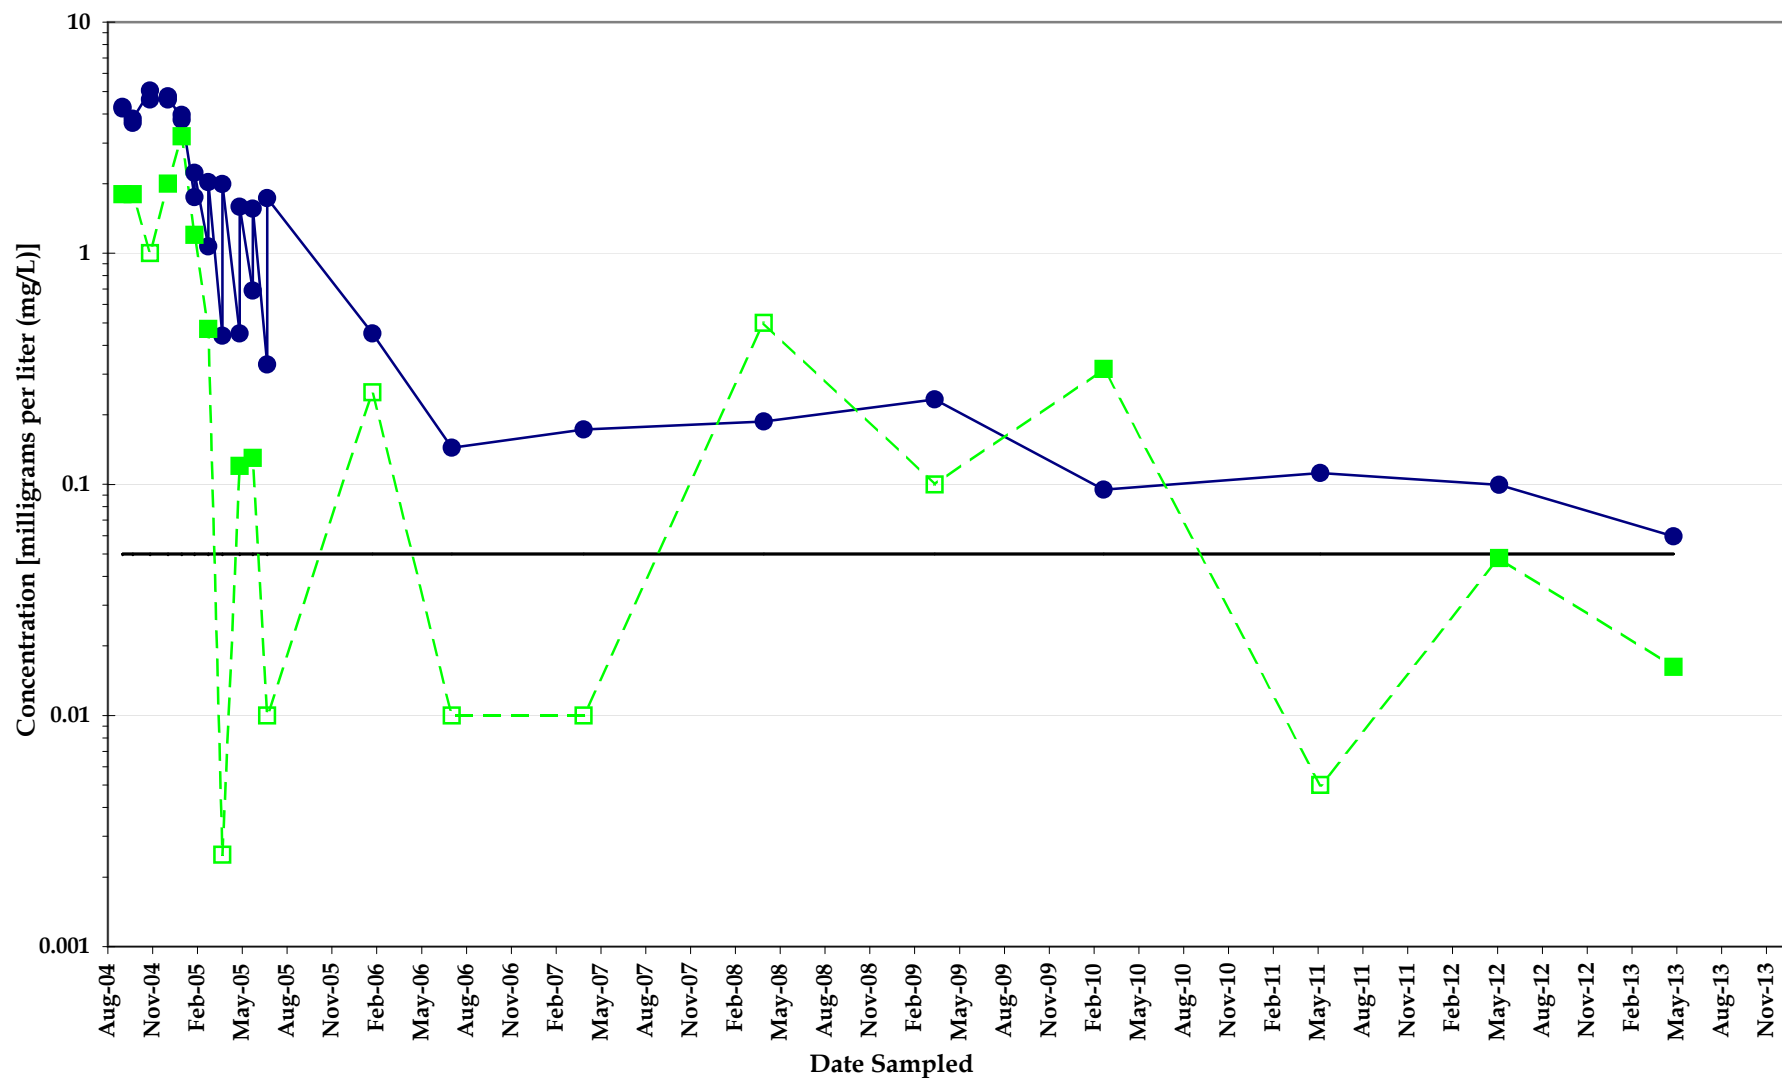
## Chromium Concentrations Monitoring Well MW087A

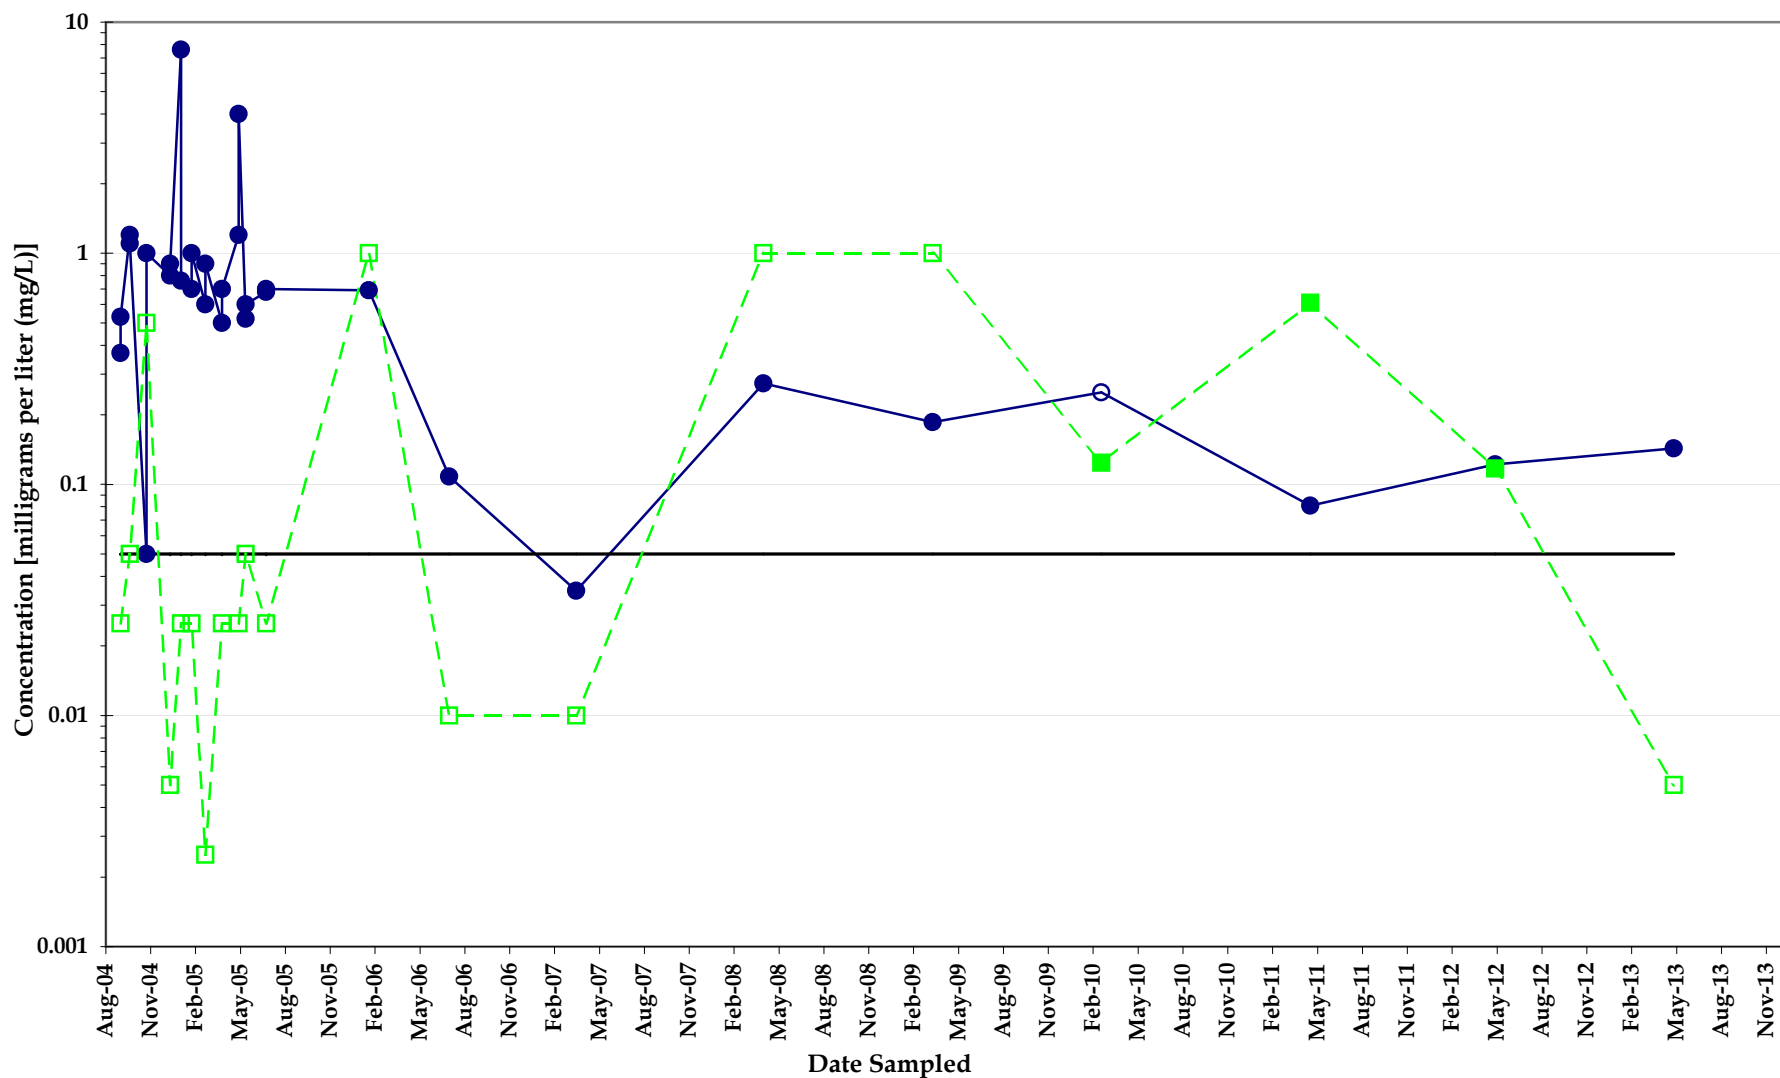
## Chromium Concentrations Monitoring Well MW088M

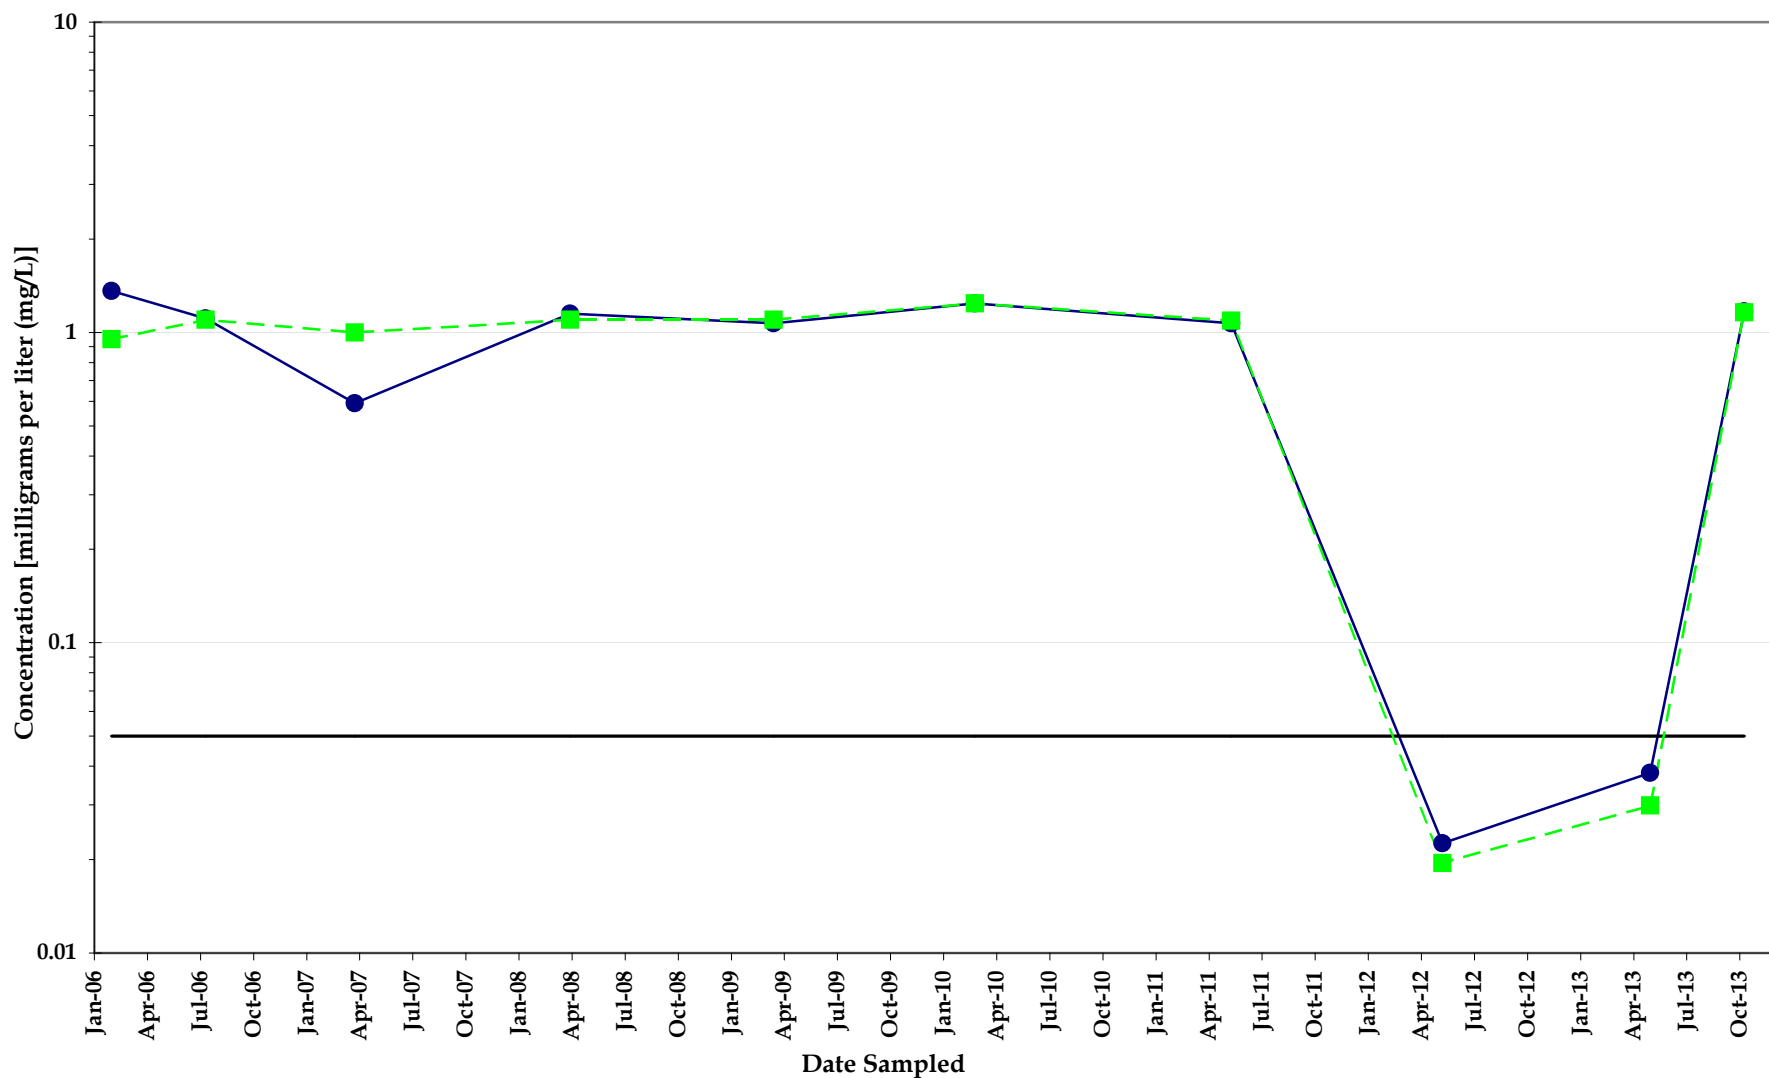
## Chromium Concentrations Monitoring Well MW089SA

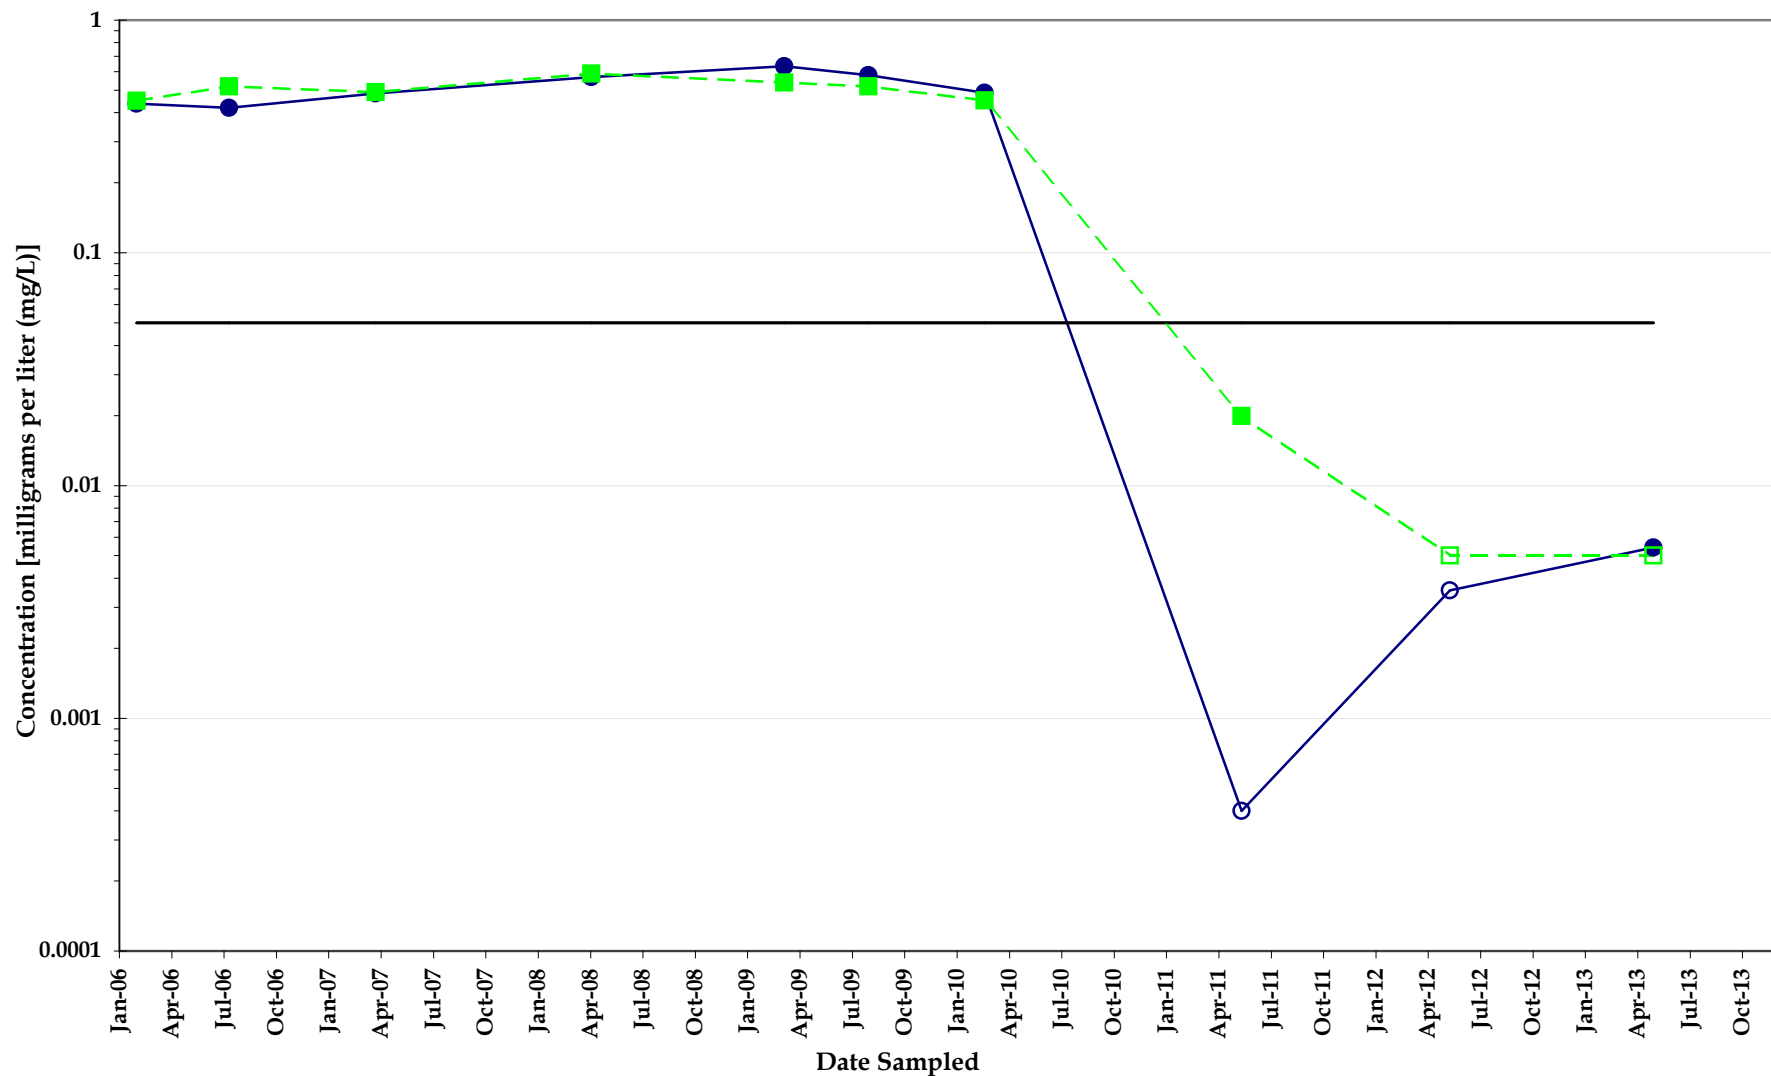
## Chromium Concentrations Monitoring Well MW090SA

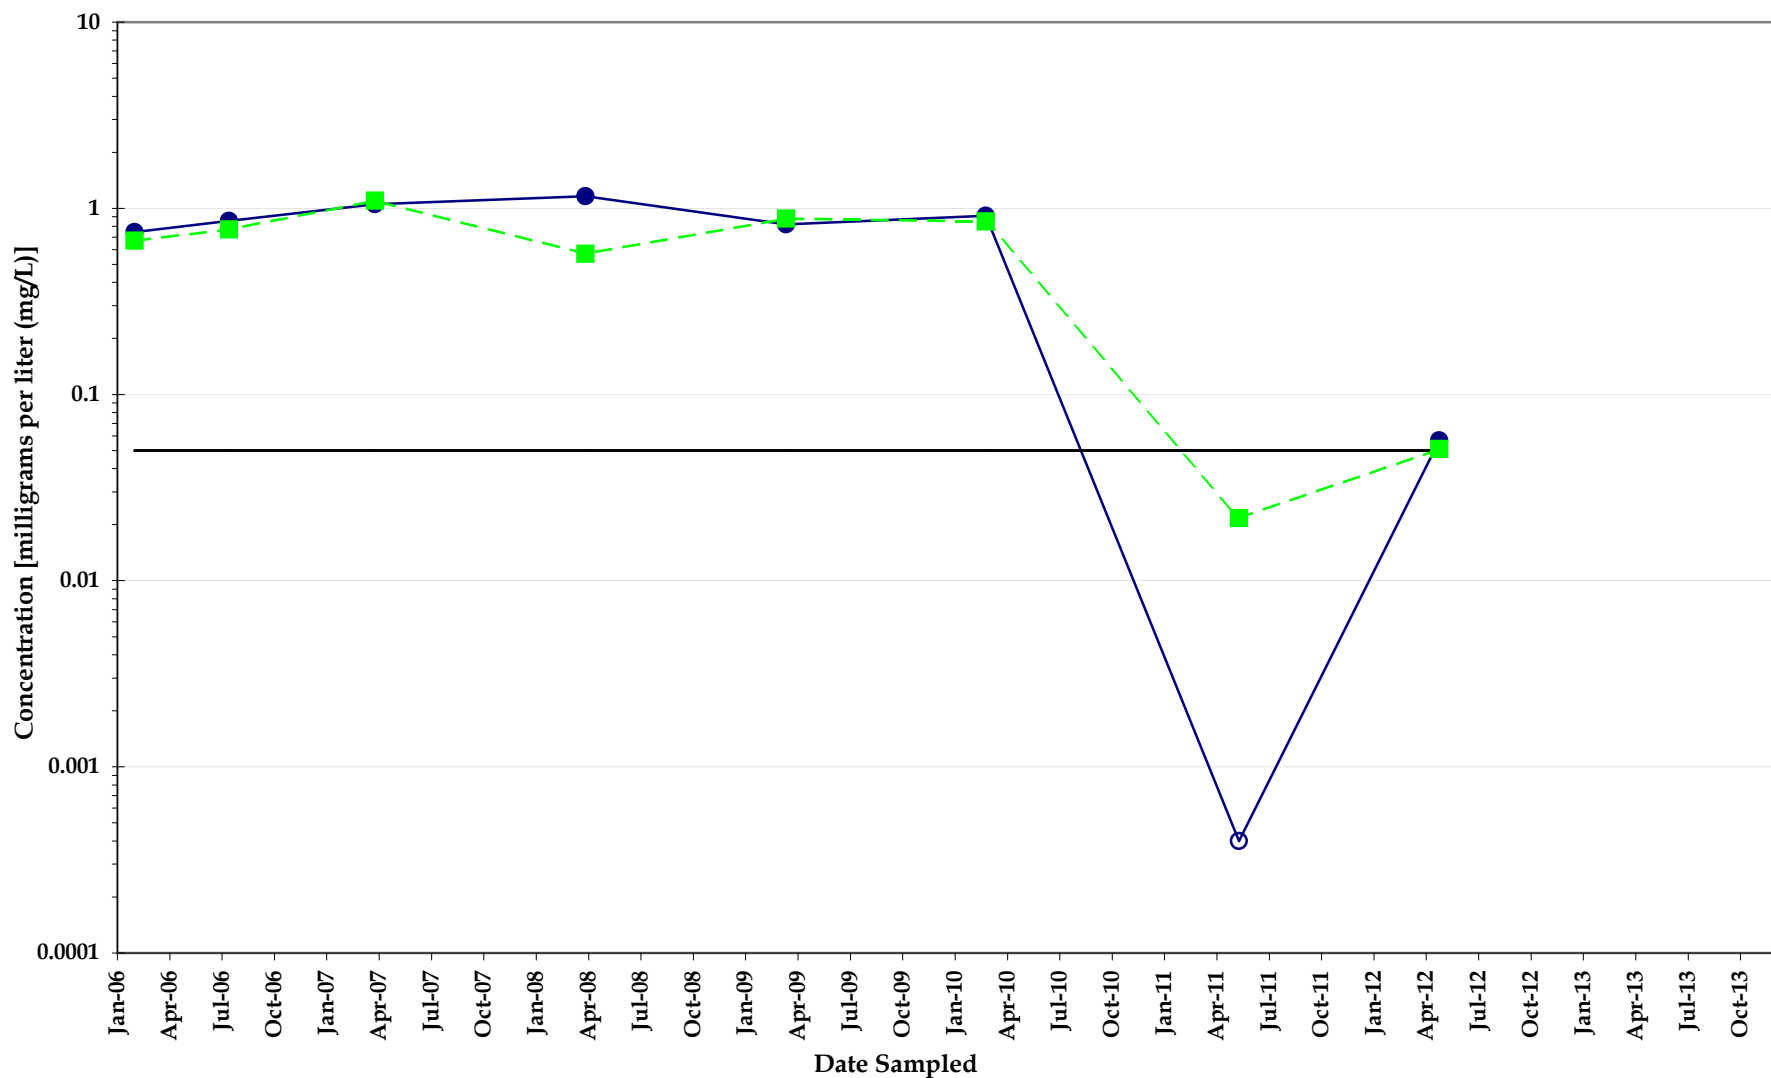
## Chromium Concentrations Monitoring Well MW091SA

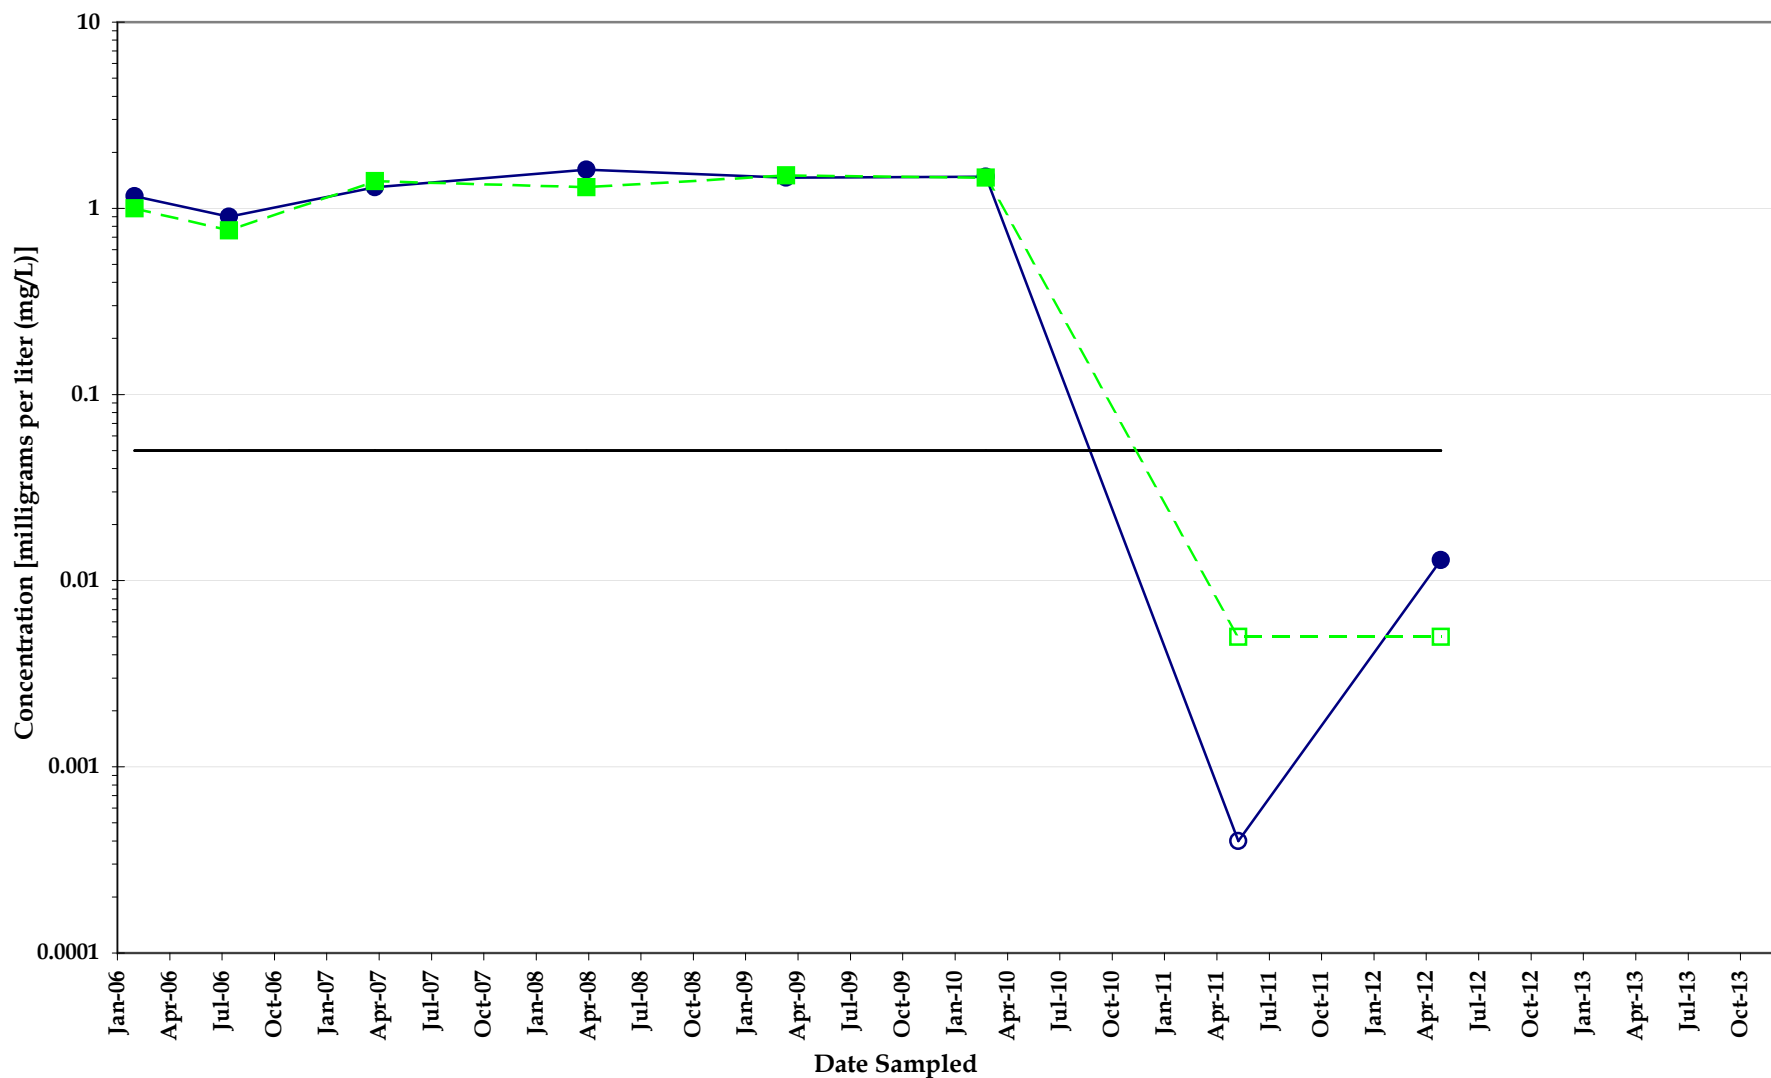
## Chromium Concentrations Monitoring Well MW092SA
