**GW - 004**

**2013 AGWMR**

**VOL 5 OF 5**

*North Eunice Gas Plant  
Lea County, New Mexico*

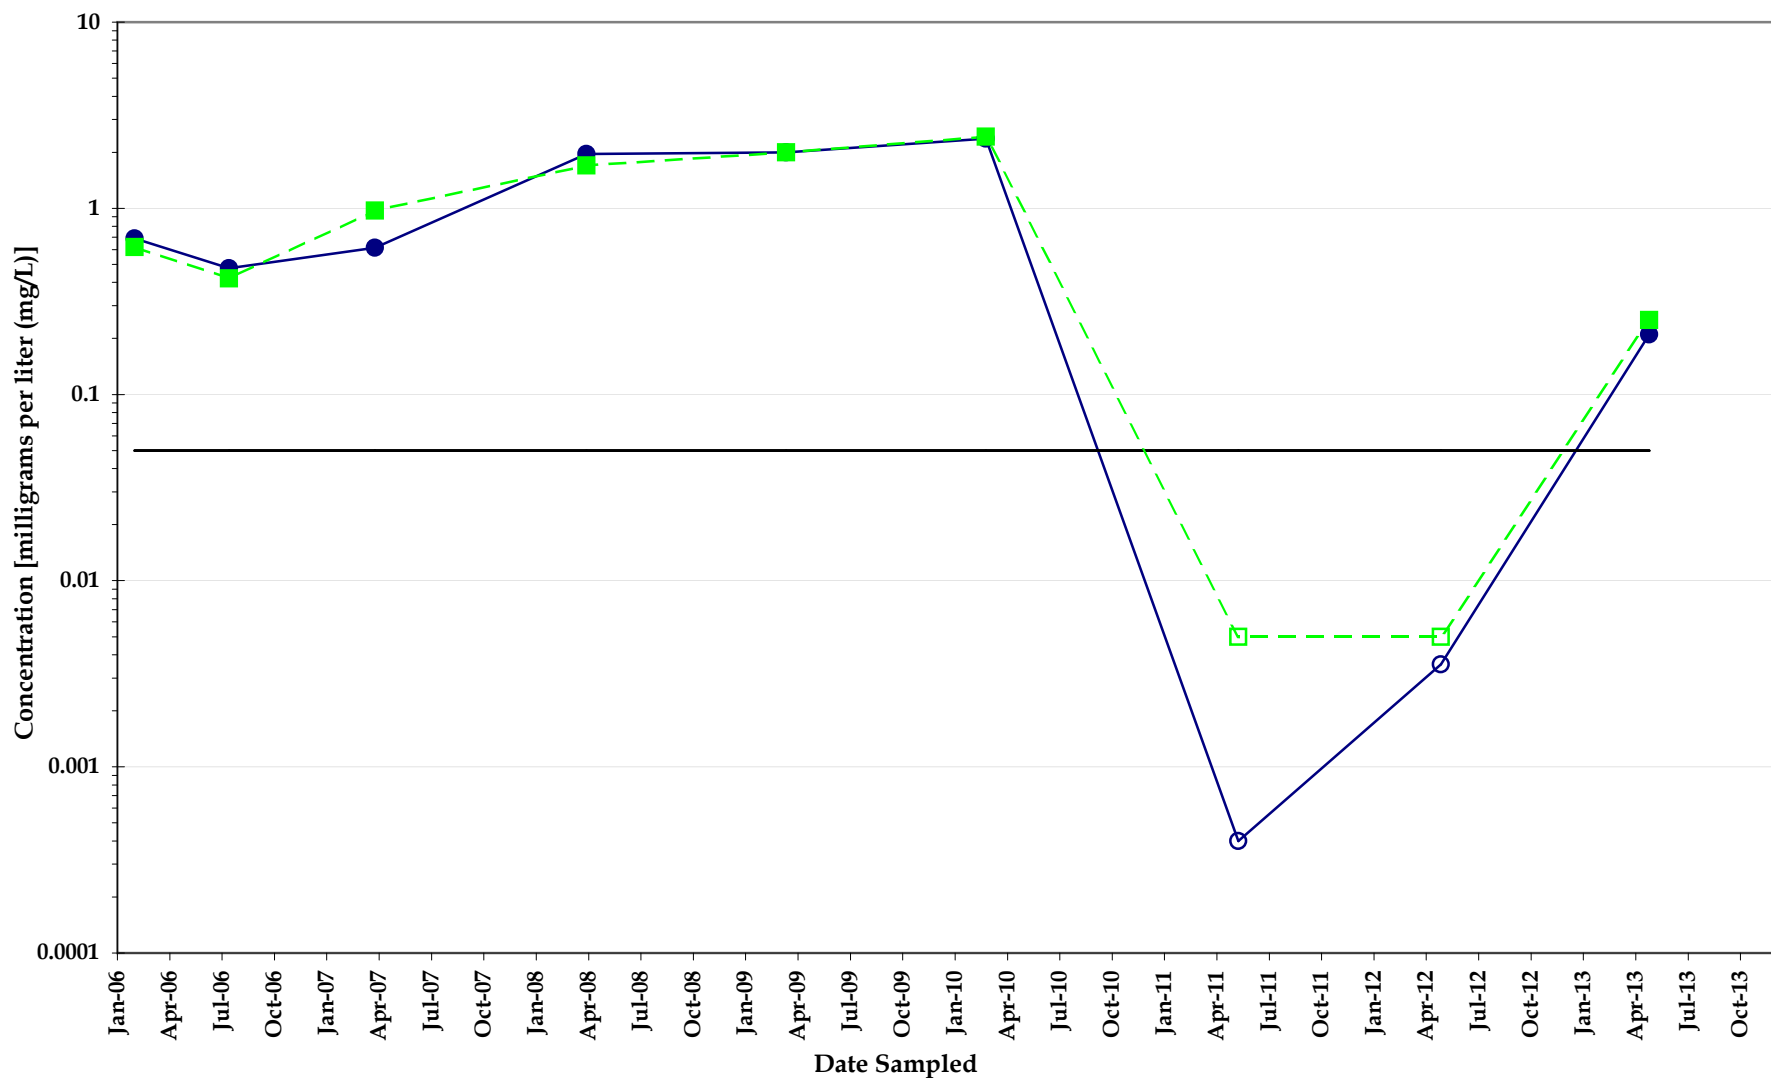
## Chromium Concentrations Monitoring Well MW093SA

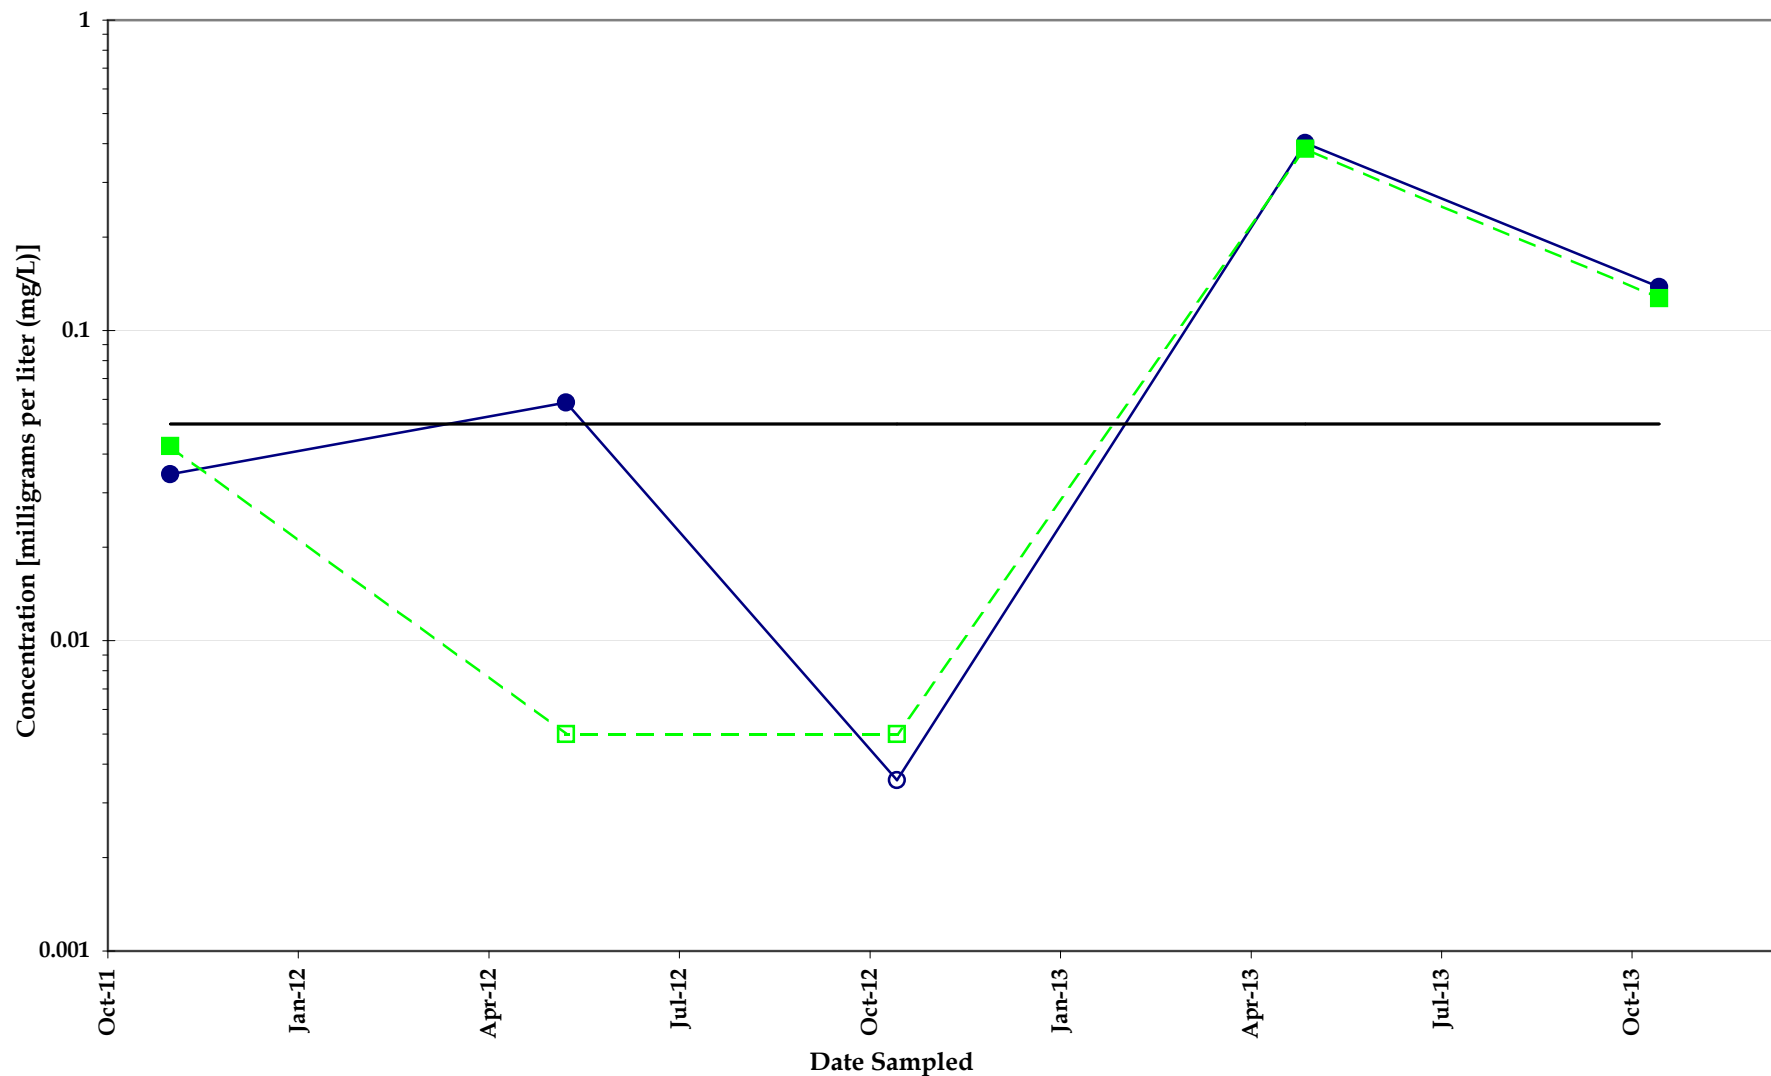
## Chromium Concentrations Monitoring Well MW094

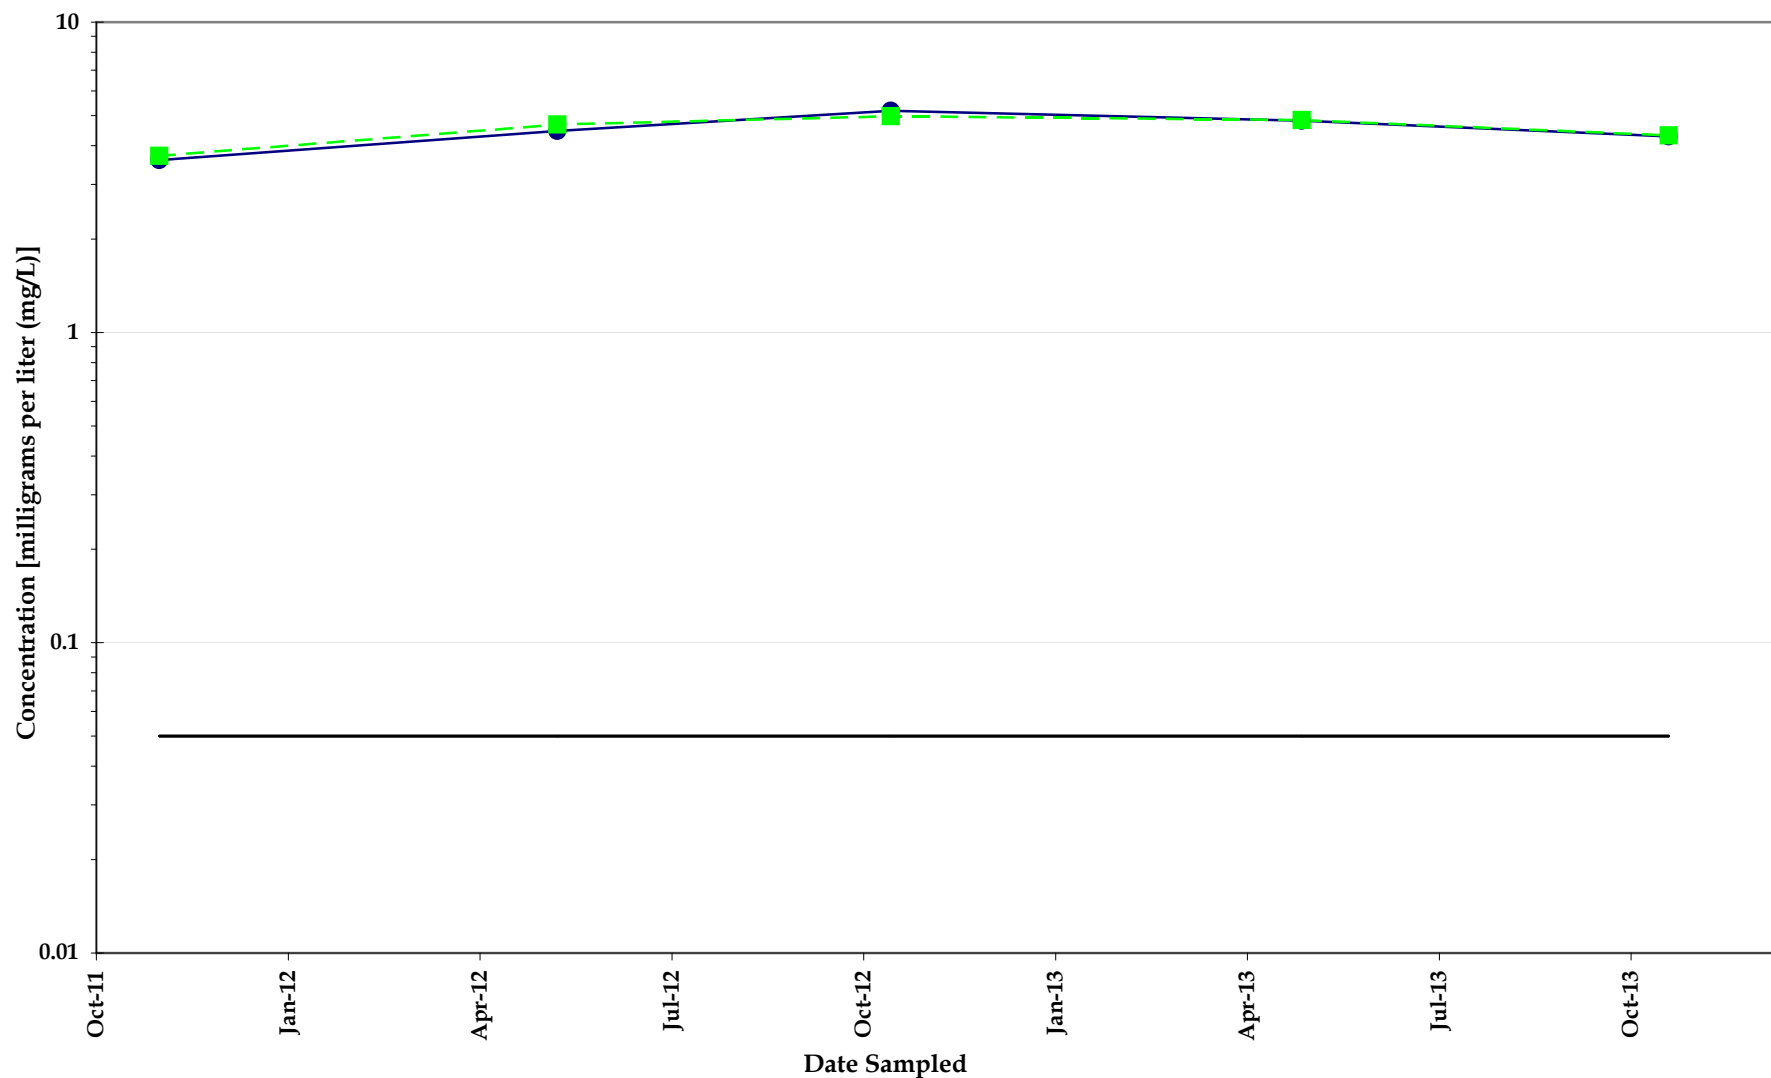
## Chromium Concentrations Monitoring Well MW095

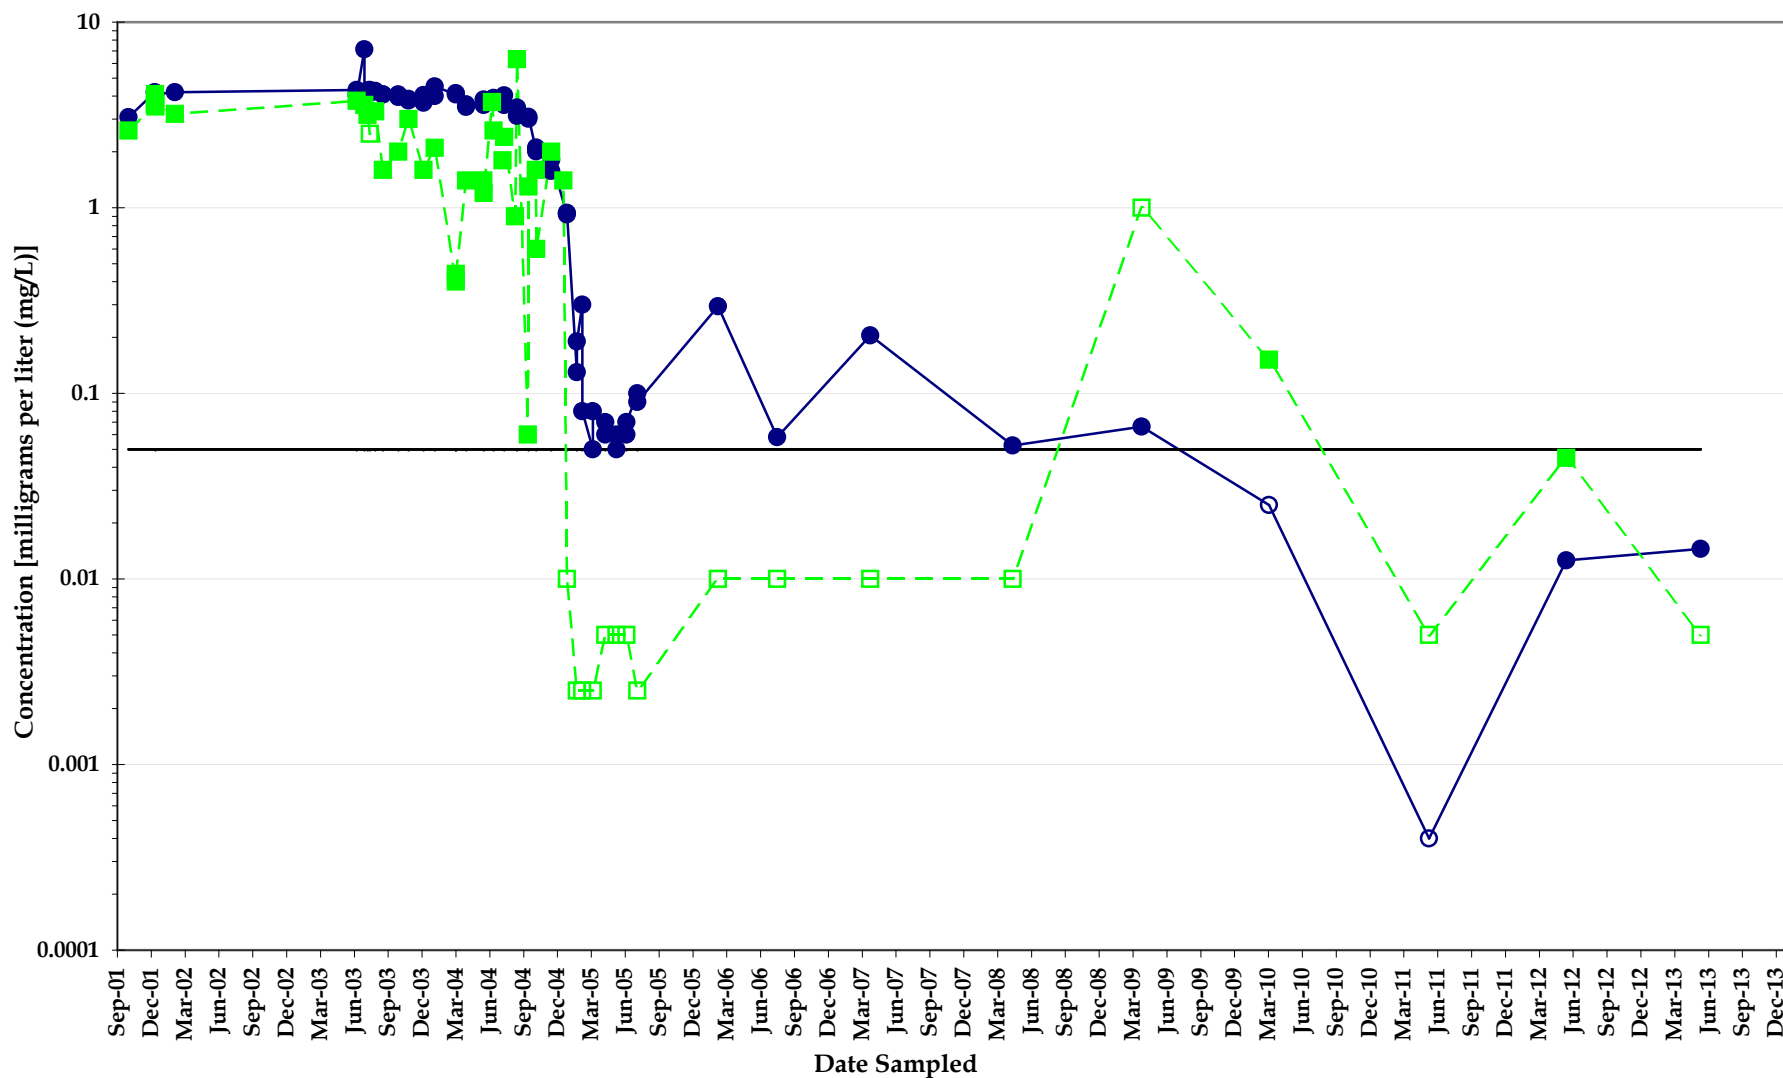
## Chromium Concentrations Monitoring Well RW002

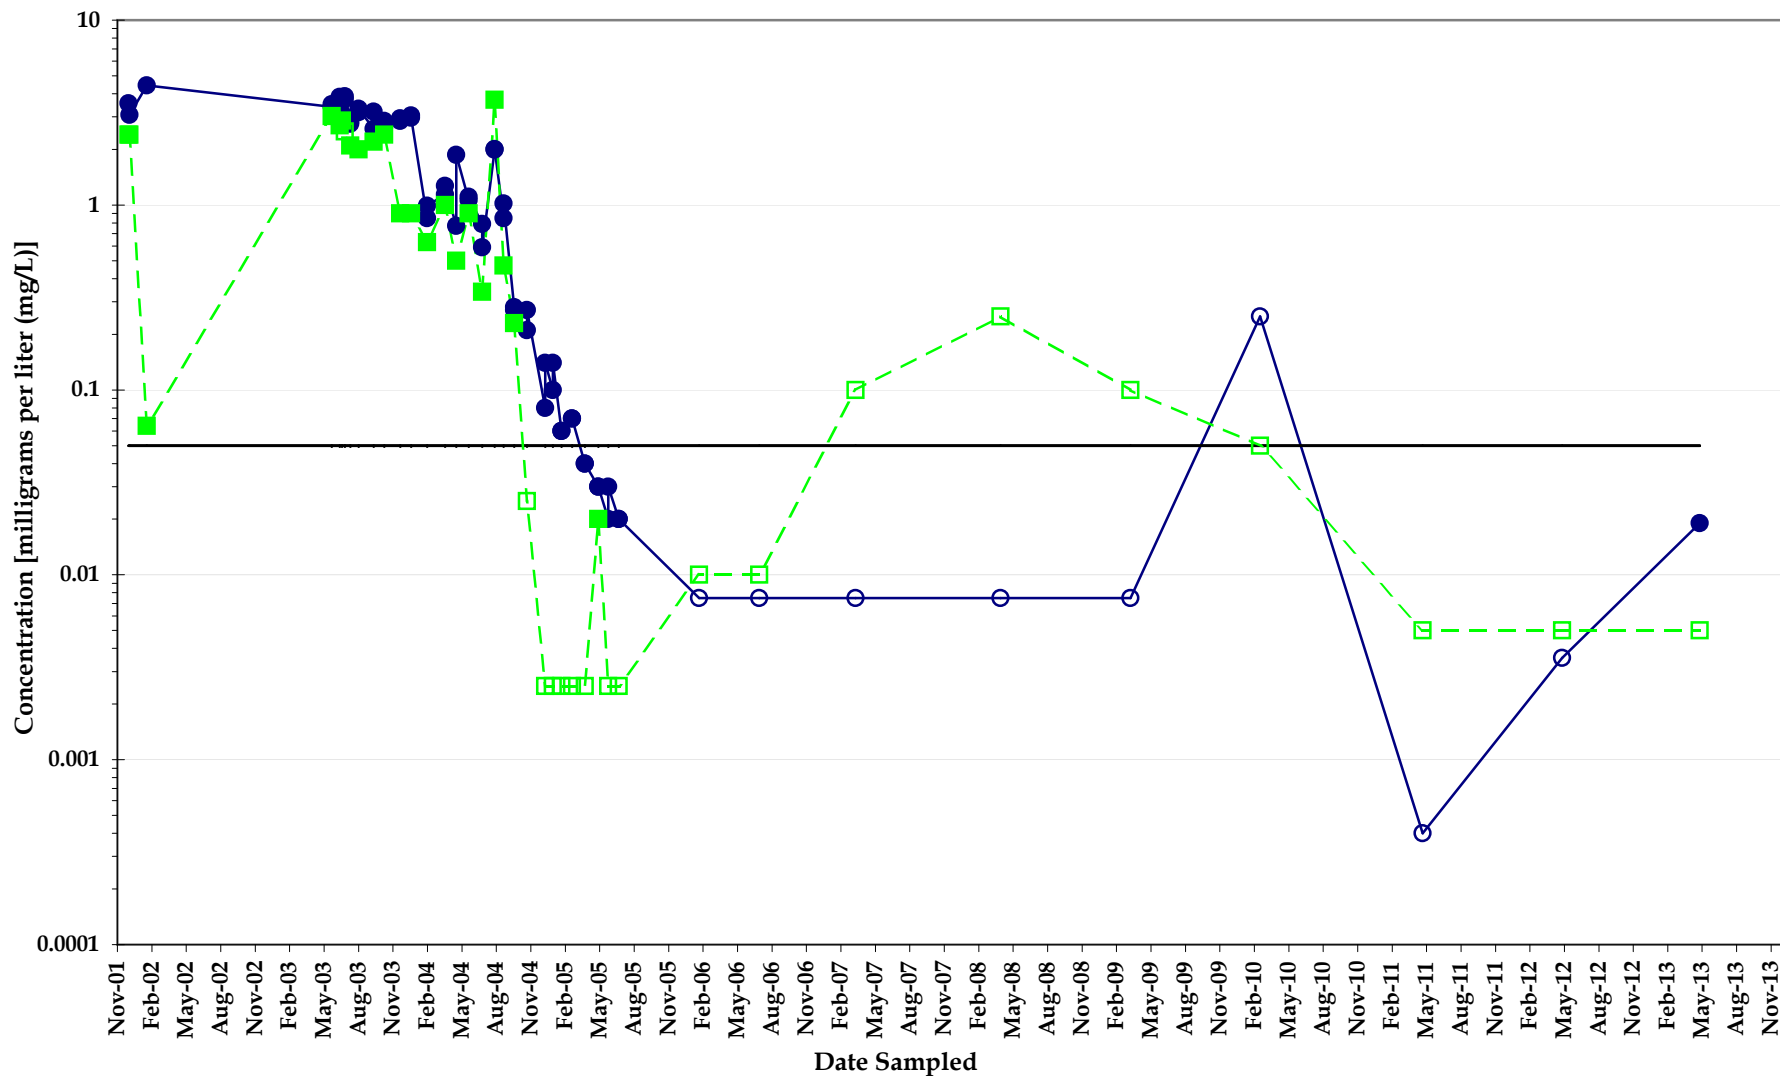
## Chromium Concentrations Monitoring Well RW003

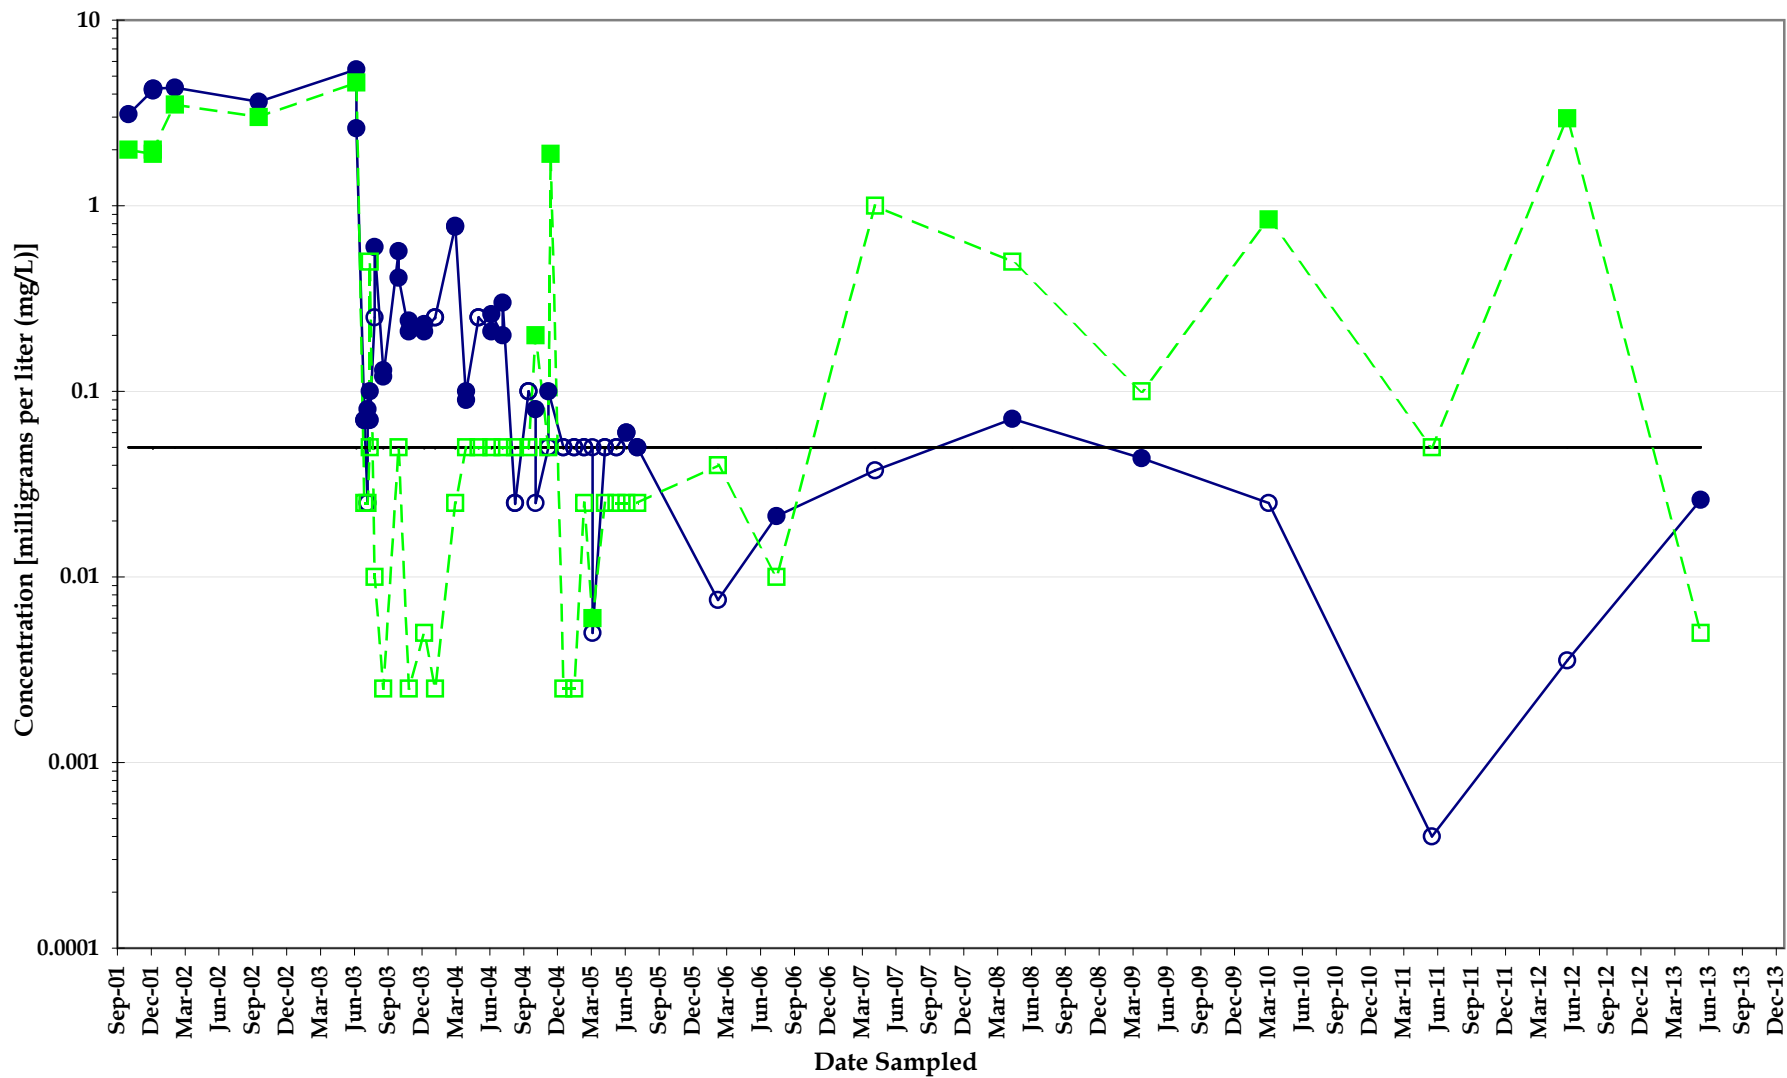
## Chromium Concentrations Monitoring Well RW004A

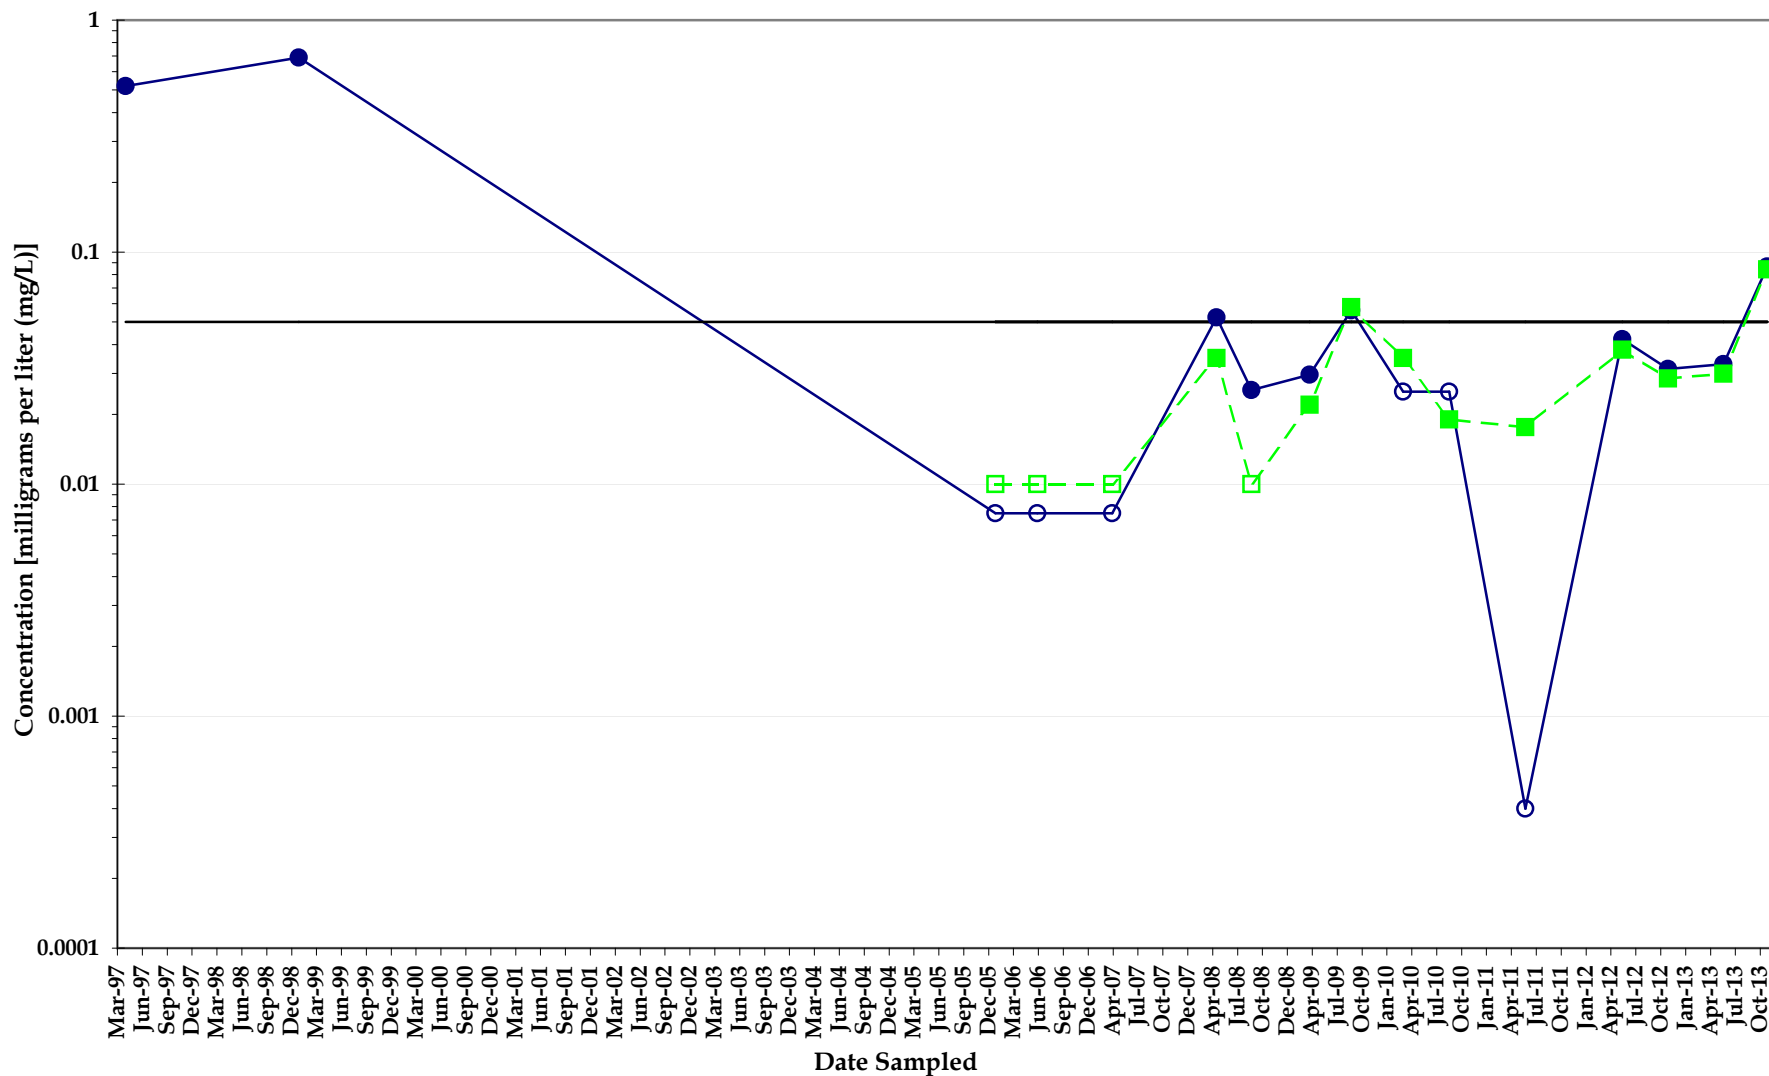
## Chromium Concentrations Monitoring Well WOODELLWW
