**AP - 111**

**N. DRAINAGE  
DITCH**

**RE: APPROVAL  
RESPONSE TO APPROVAL WITH MODIFICATIONS – COMMENT NO. 6  
[REVISED] INVESTIGATION REPORT NORTH DRAINAGE DITCH  
AND OW-29 & OW-30 AREAS  
WESTERN REFINING SOUTHWEST INC., GALLUP REFINERY  
EPA ID# NMD000333211  
HWB-WRG-18-008**

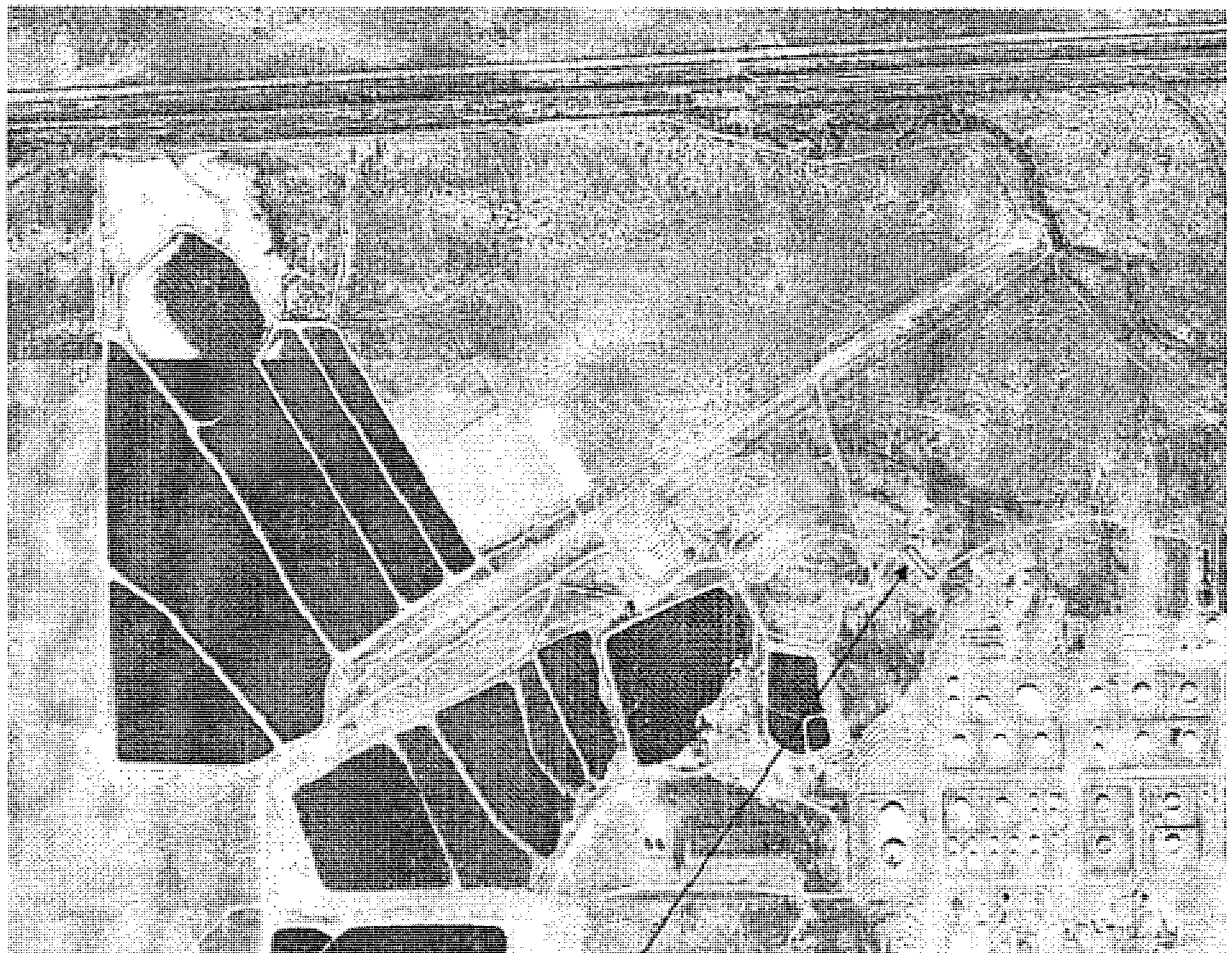
Approximate location of ditch – not to scale

Describe Cause of Problem and Remedial Action Taken.\* At approximately 1:30 pm on 10/19/2009, during a routine walk-through of arroyos and ditches in a field that lies immediately north of the hill on which the refinery is located, a ditch containing non-moving water was found to have some possible hydrocarbon staining – suspected from color of the water and smell of diesel.

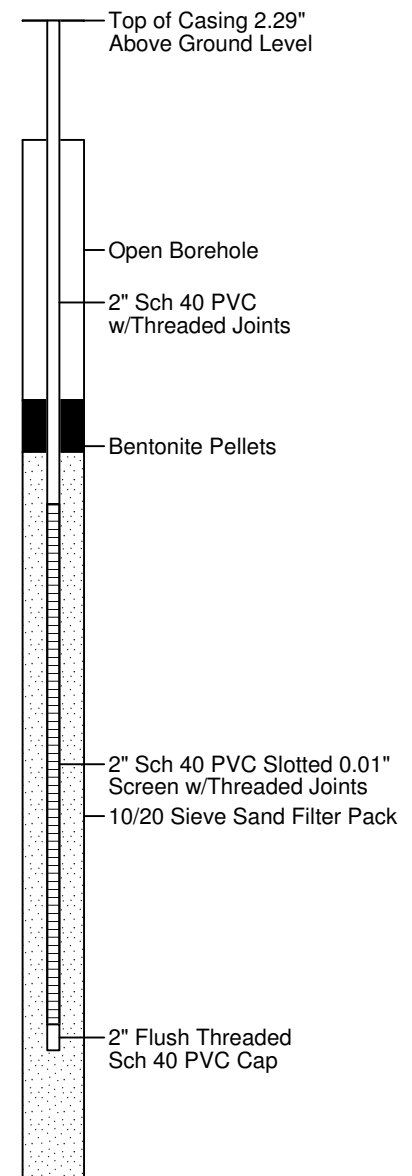
TEMP WELL NO. NDD-4

## Temporary Well Settings

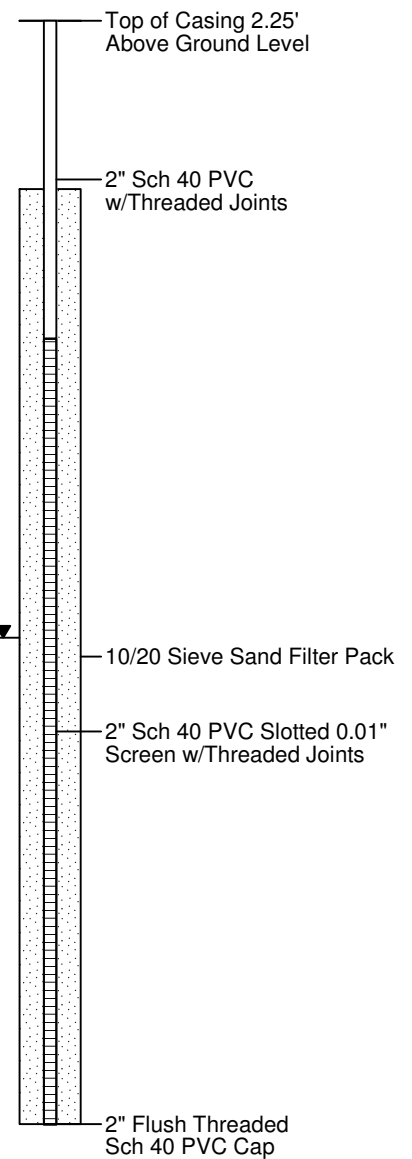
TEMP WELL NO. NDD-6

## Temporary Well Settings
