Volume II:
**Discharge Plan Application, Site Investigation
and Abatement Plan**

GIANT BLOOMFIELD REFINERY

Giant Refining Company

R.T. HICKS CONSULTANTS, LTD.

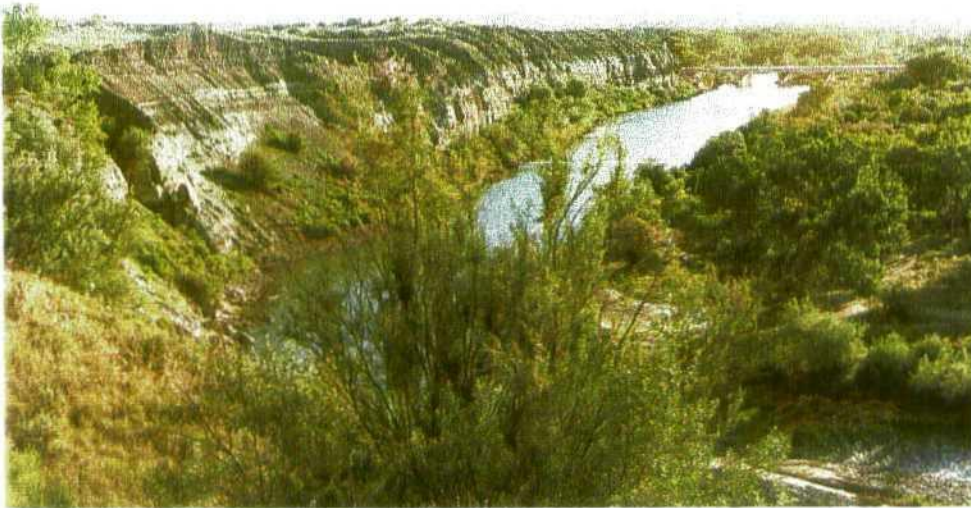
Figure 1: View looking west from Seep S-3 on Plate 4. The Nacimientto Formation forms the lower $\frac{3}{4}$ of the vertical cliff. The top of the cliff, on the left side of the photograph is what appears to be a cross section of a sand dune in the loess of the upper Jackson Lake Terrace. Below the dune is the 20-30 foot thick gravel unit.

As Plate 5 shows, the area south of the Refinery is mapped as Nacimiento Formation. The Nacimiento Formation forms a cliff more than 80 feet high along the south side of the San Juan River between NM Route 44

and the Refinery. With the exception of this dramatic exposure (see Figure 1), the Nacimientto Formation is generally covered by soil, aeolian sand or slope wash.

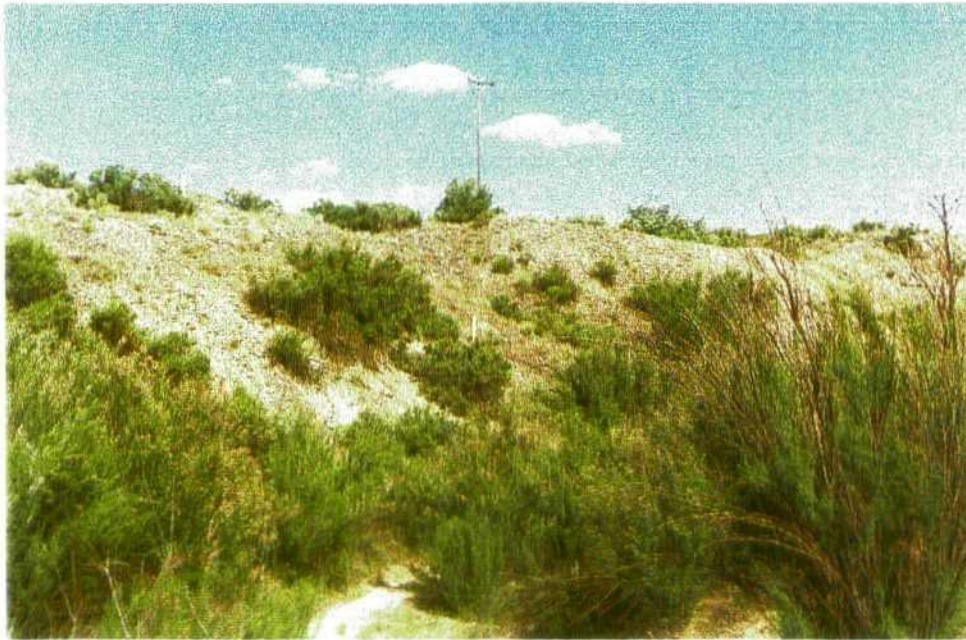
Figure 2: View looking north from Sullivan Road, east of the Refinery. Here, the unnamed arroyo has removed the Jackson Lake Terrace and scoured the Naciminto Formation. The white stake in the center of the photograph is about 5 feet below the contact between the two units.

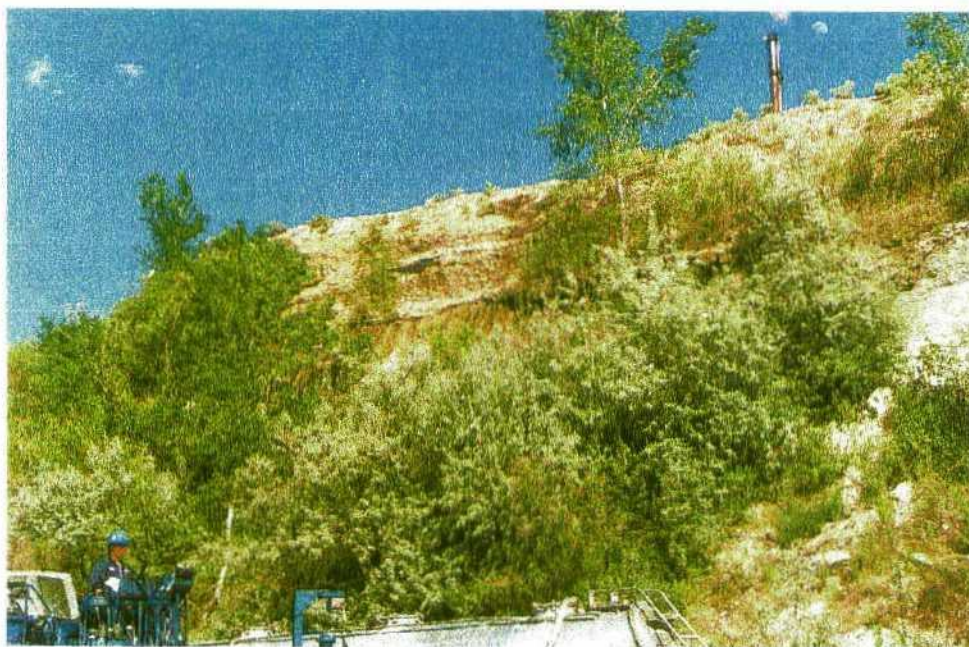
Figure 3: View looking south from San Juan River to Seep S-2; the Refinery flare is in the upper right corner. In the center of the photograph, the Jackson Lake Terrace gravel rests upon the underlying Nacimiento Formation. The Nacimiento Formation is wet by groundwater seeping from the gravel. Iron and hydrocarbon stains are evident on the Nacimiento Formation.

Leakage from Hammond Ditch has created several small surface water bodies within the Study Area. Along the cliff face between the Refinery and the San Juan River, water flows from numerous seeps. Figure 3 shows one seep (Seep #2 sampling point) flowing from the Jackson Lake Terrace exposure onto the underlying Nacimiento Formation. The Refinery flare is in the upper right side of the photograph. Small pools of water are common near the cliff face. On the western margin of the Study Area, an excavation near a pipeline exposes the upper portion of the Jackson Lake Terrace and the groundwater table. Within this excavation, a small ephemeral pool of surface water is present, typically during the irrigation season. This area, like other seeps and pools caused by Hammond Ditch leakage, contains cattails, phreatophytes and the associated ecosystem.
