# **REPORTS**

**RICE OPERATING COMPANY  
JUNCTION BOX FINAL REPORT**

H-32-1

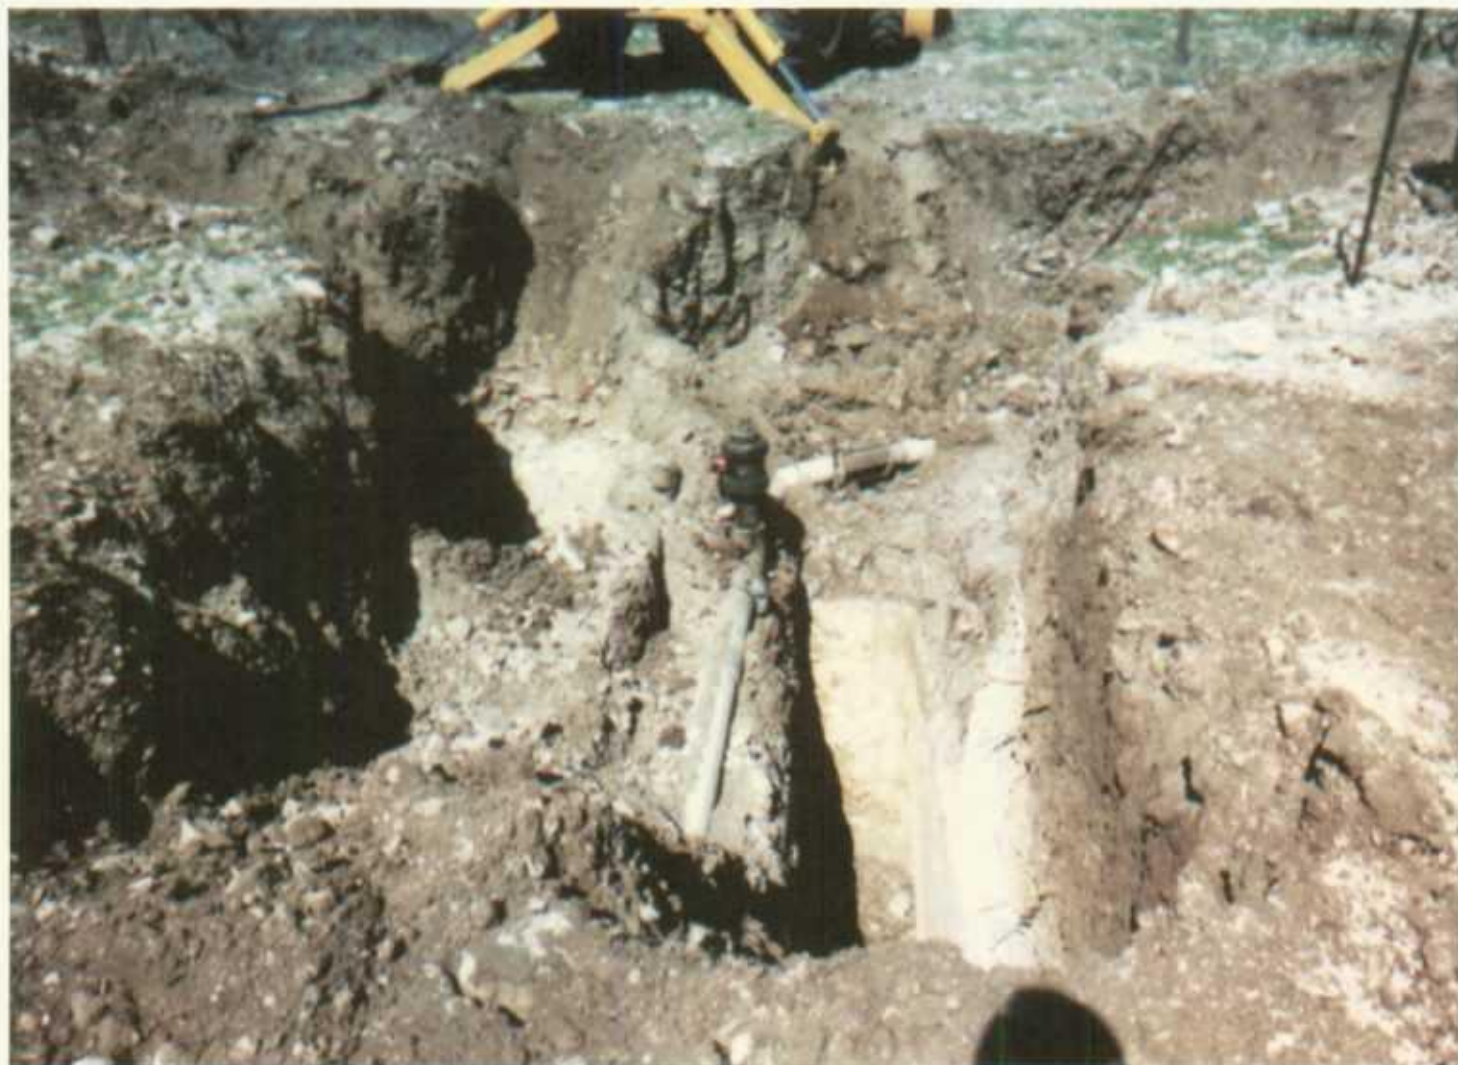
## EME H-32-1 Jet. Box Upgrade

Remediation

Vertical trench demonstrated TPH dropped from 9500 ppm @ 8' to 39 ppm @ 14' and chlorides dropped from 1250 ppm to 50 ppm. High impact soil was removed and hauled to permitted disposal facility. Installed a compacted clay liner and water proof junction box. Backfilled with clean soil.
