# FINAL REPORT

**RICE OPERATING COMPANY  
JUNCTION BOX FINAL REPORT**

| SWD SYSTEM | JUNCTION | UNIT | SECTION | TOWNSHIP | RANGE | COUNTY | BOX DIMENSIONS - FEET | | |
|---|---|---|---|---|---|---|---|---|---|
| Justis | B-26 | B | 26 | 25 S | 37 E | Lea | Length<br>7 | Width<br>5 | Depth<br>7 |

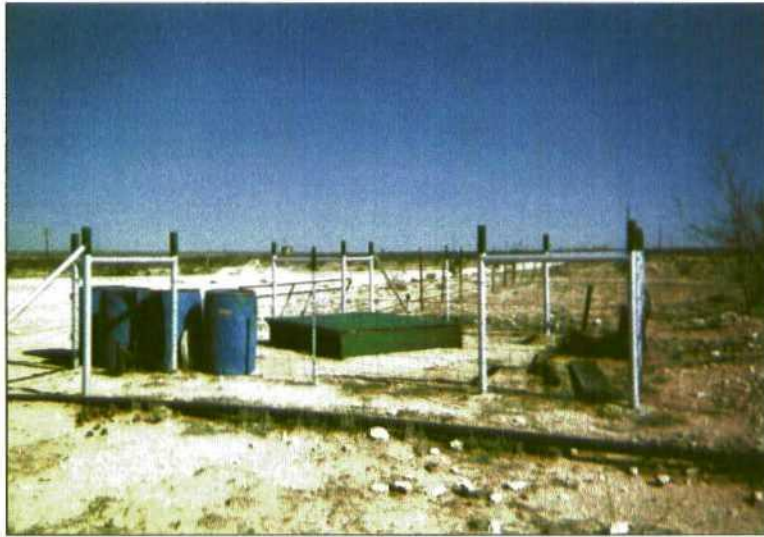
## Justis B-26 jet. with vent

Old box before NORM removal

impact below the box down to 22' where the concentration was 194 ppm. A hard sandstone layer was encountered just below 22' BGS. Chlorides diminished vertically at 8'. TPH was negligible in the lateral directions of 20' west, 17' east, 10' south, and 10' north. The chloride boundary was found at 20' west, 25' east, 10' south, and 10' north where concentrations were below 1000 ppm and a vertical decline was also found. A 20' x 35' x 22' excavation under the location was completed in September. A bottom composite sample at 22' BGS revealed 44.8 ppm TPH and 319 ppm chlorides. The wall composite yielded <10 ppm TPH and 153 ppm chlorides. The removed soil was landfarmed on location and backfilled into the excavation. The remediated soil tested 38.6 ppm TPH and 674 ppm chlorides, these concentrations should not threaten groundwater. A water-tight junction box has been built at this location.

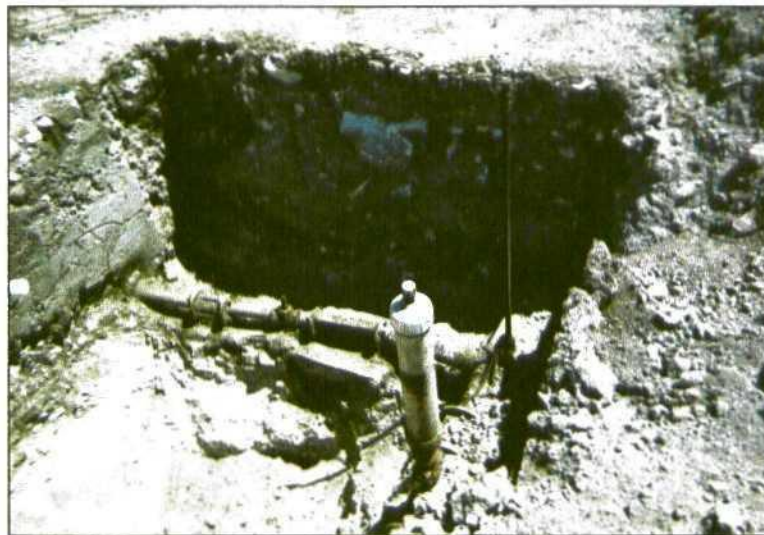
NORM Removal

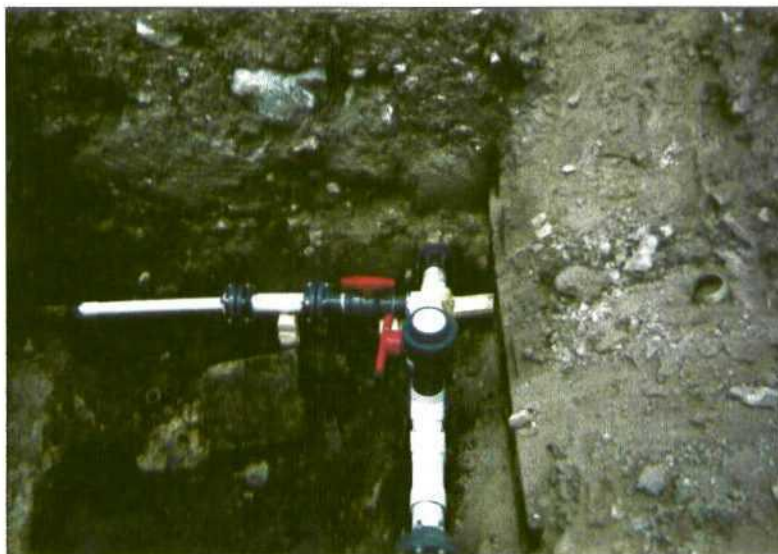
New Plumbing

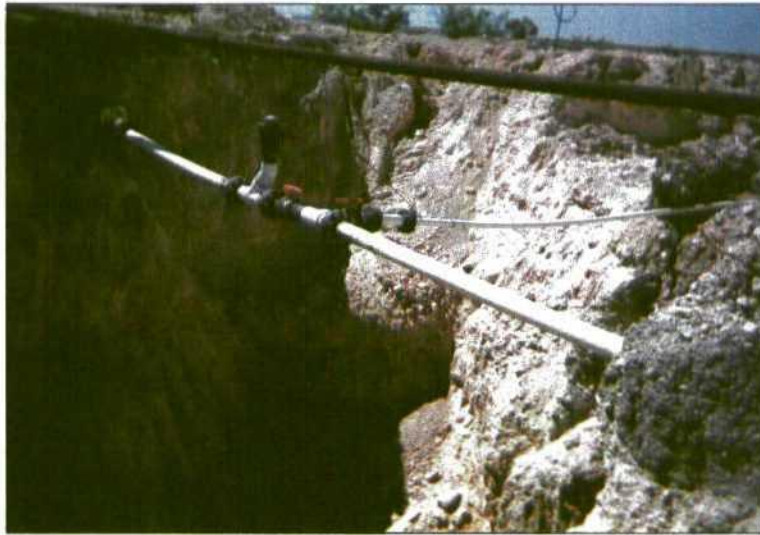
**Justis B-26 jct. with vent**

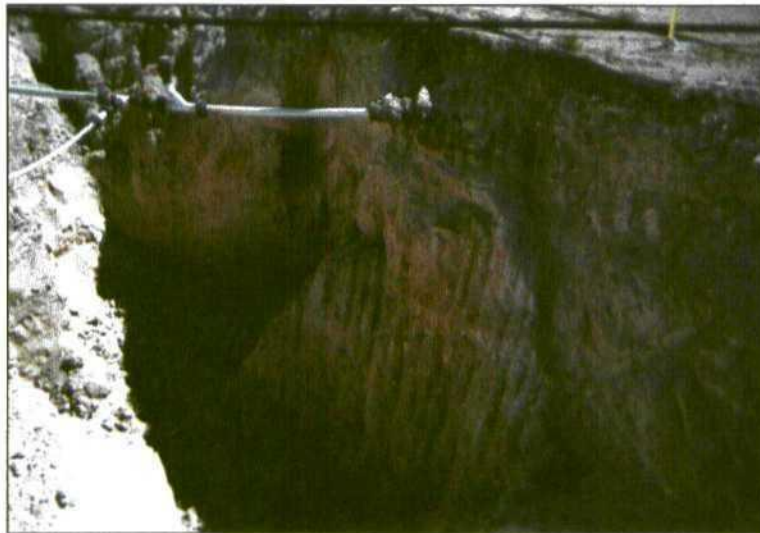
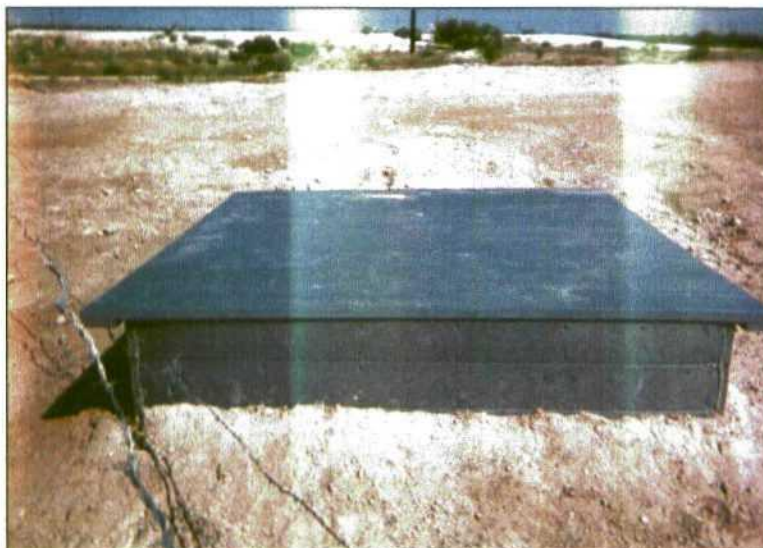
↓ Environmental Impact Excavation ↑

**New Junction Box**

B. 26  
Remediated
