Closure Report

Site Name:	Lentini 1 Federal Battery
Company:	Chevron USA
Legal Description:	U/L F, Section 1, T23S, R28E
County:	Eddy County, NM
GPS Coordinates:	N 32.33701 W-104.04275

Chevron, Lentini Federal 1 Battery

Leak date: 01/07/2018
Eddy County, NM
API# 30-015-27535

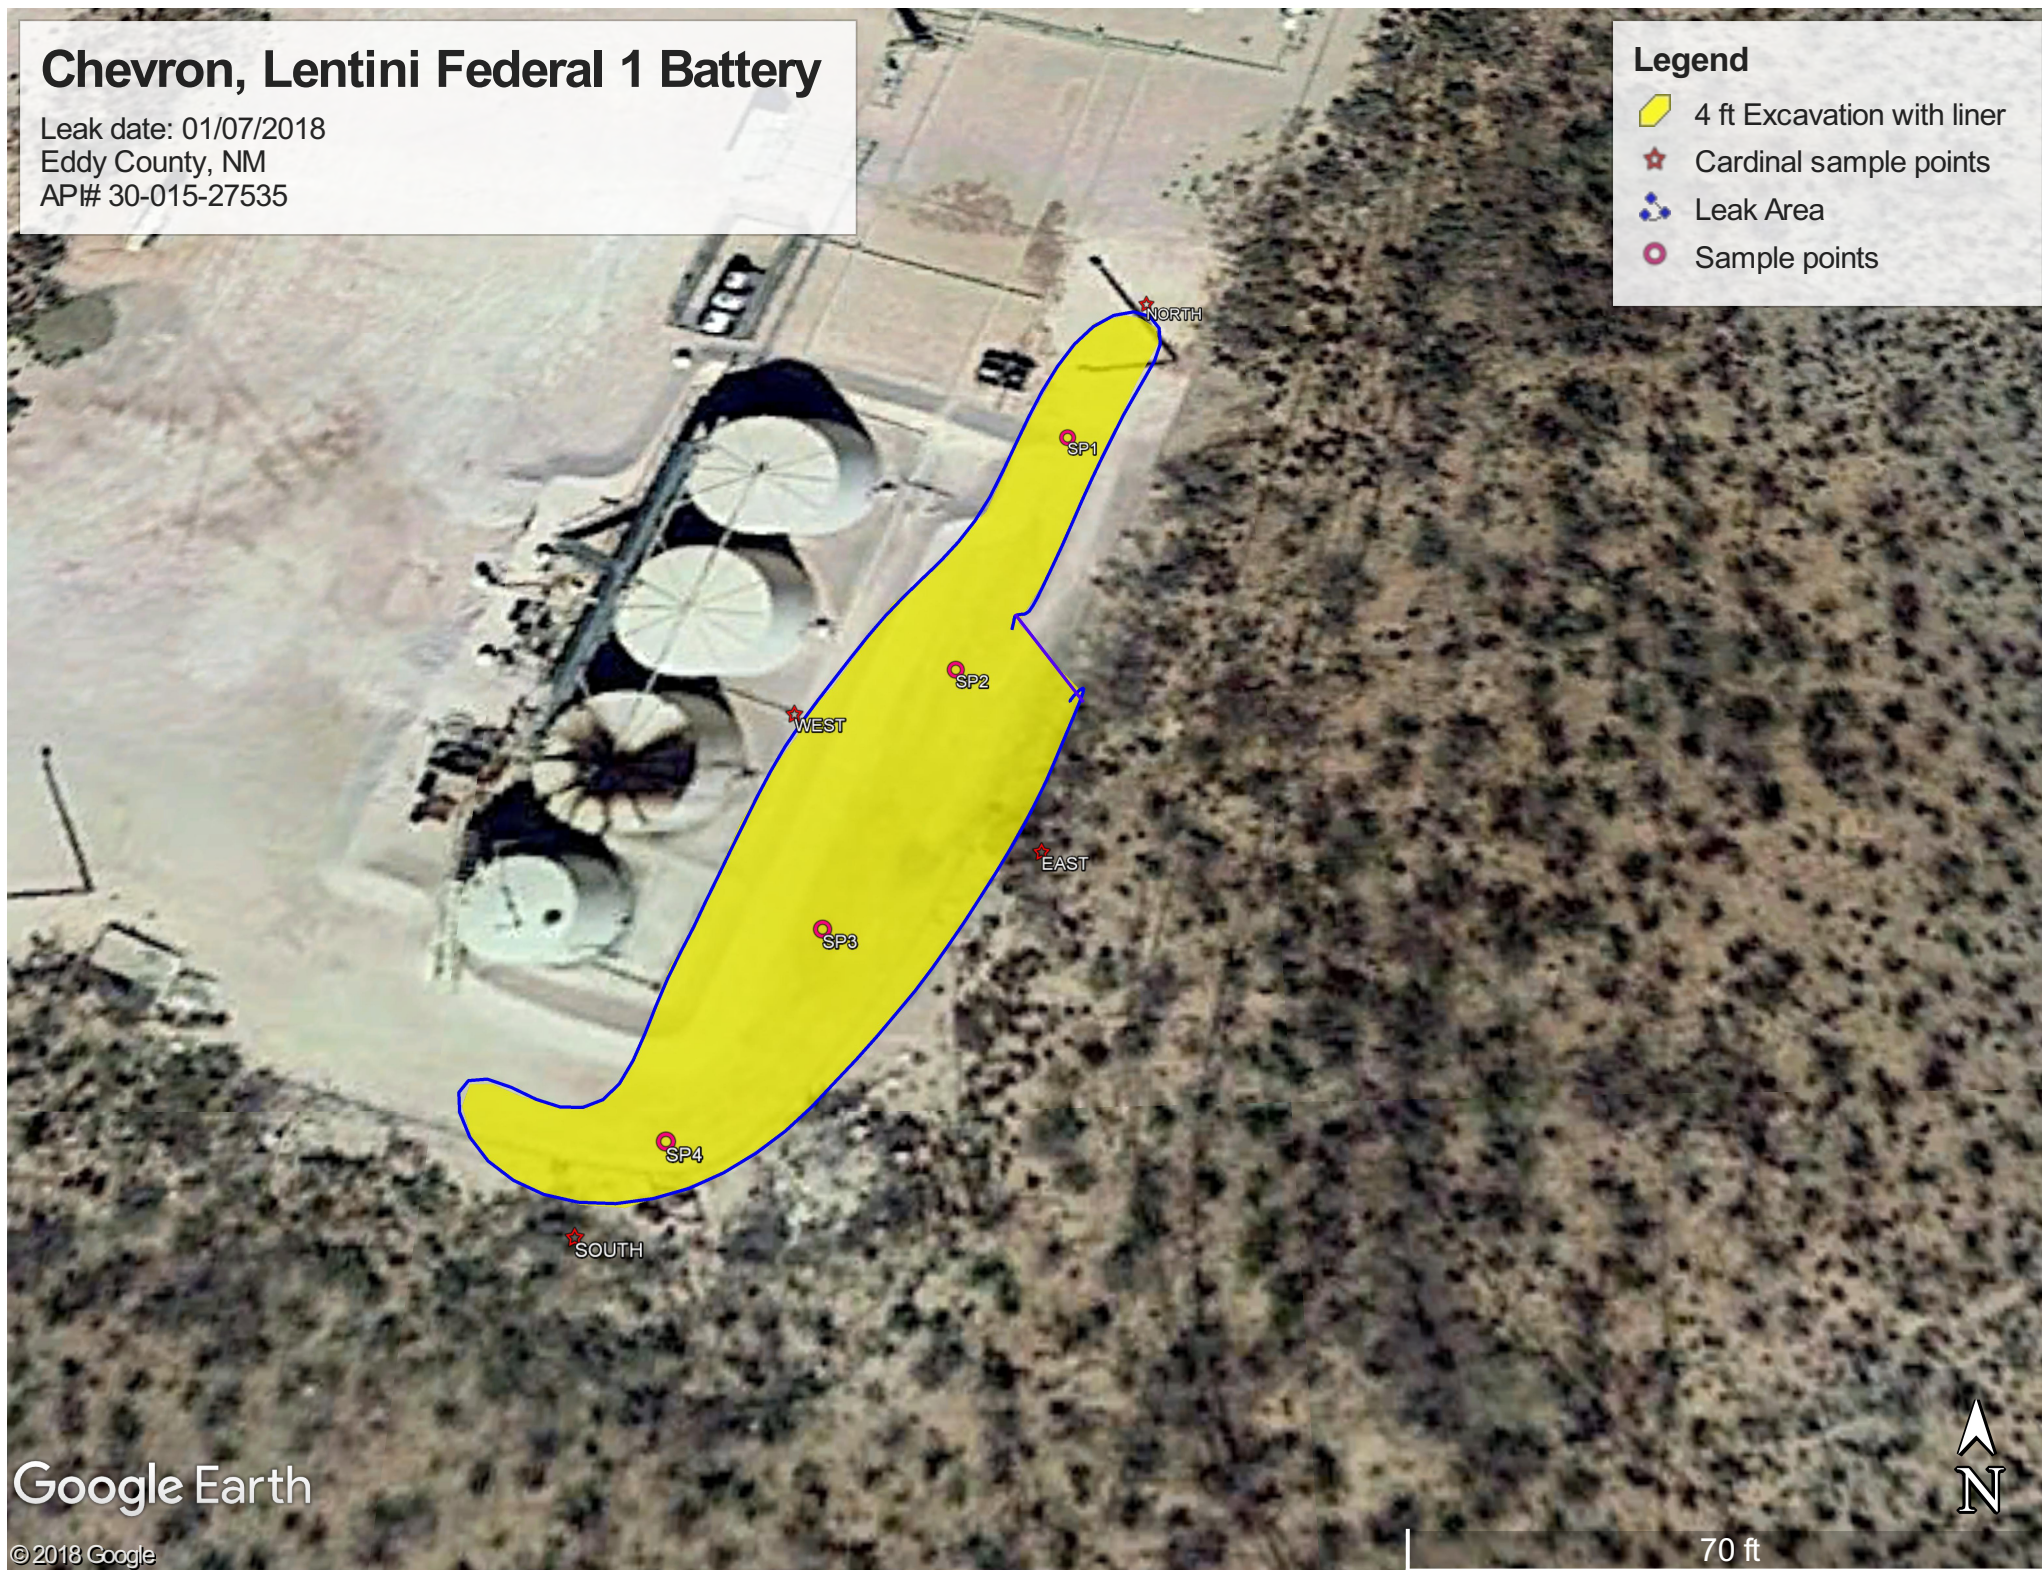
Legend

4 ft Excavation with liner
-

Cardinal sample points
-

Leak Area
-

Sample points

Chevron, Lentini Federal 1 Battery

SP1, N 32.33716 W-104.04267

SP2, N 32.33705 W-104.04272

SP3, N 32.33694 W-104.04277

SP4, N 32.33687 W-104.04283

NORTH, N 32.33723 W-104.04263

SOUTH, N 32.33683 W-104.04286

EAST, N 32.33698 W-104.04268

WEST, N 32.33703 W-104.04279

Remediation Parameters:	Excavated the entire leak area to a depth of 4 feet. Placed an impermeable liner in the excavated area. Backfilled the site with clean soil.	
Remediation Activities:	6/11/19 to 6/19/19	
Plan Sent to OCD:	6/20/18	Email from Cliff Brunson to Mike Bratcher
OCD Approval of Plan:	7/26/18	Email from Mike Bratcher to Cliff Brunson
Plan Sent to BLM:	6/20/18	Email from Cliff Brunson to Shelly Tucker
BLM Approval of Plan:	7/11/18	Email from Shelly Tucker to Cliff Brunson
