# Excavation Data

**LINN H E  
WEST B #58**

UL G SECTION 10  
T-17-S R-31-E  
EDDY COUNTY, NM

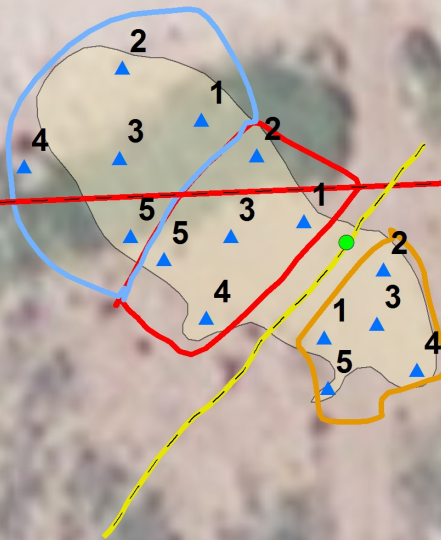
| 5 pt bottom composite of 6 inch scrape | Cl- | PID | GRO | DRO | B | T | E | X | BTEX |
| | <16 | 1.2 | <10 | <10 | <0.05 | <0.05 | <0.05 | <0.15 | <0.3 |
| 5 pt bottom composite of 1.5 ft excavation | Cl- | PID | GRO | DRO | B | T | E | X | BTEX |
| | <16 | 0.7 | <10 | <10 | <0.05 | <0.05 | <0.05 | <0.15 | <0.3 |
| 5 pt bottom composite of 4 ft excavation | Cl- | PID | GRO | DRO | B | T | E | X | BTEX |
| | <16 | 0.08 | <10 | <10 | <0.05 | <0.05 | <0.05 | <0.15 | <0.3 |
| 5 pt composite of spoil pile | Cl- | PID | GRO | DRO | B | T | E | X | BTEX |
| | 240 | 4.8 | <10 | 48.9 | <0.05 | <0.05 | <0.05 | <0.15 | <0.3 |
