RE: Corrective Action Plan

Mewbourne Oil Co. – Zircon Compressor Facility/State HL #1
N-1-19S-29E 660 FSL 1980 FWL
API No. 30-015-23065
IRP-3430

Release Notification and Corrective Action

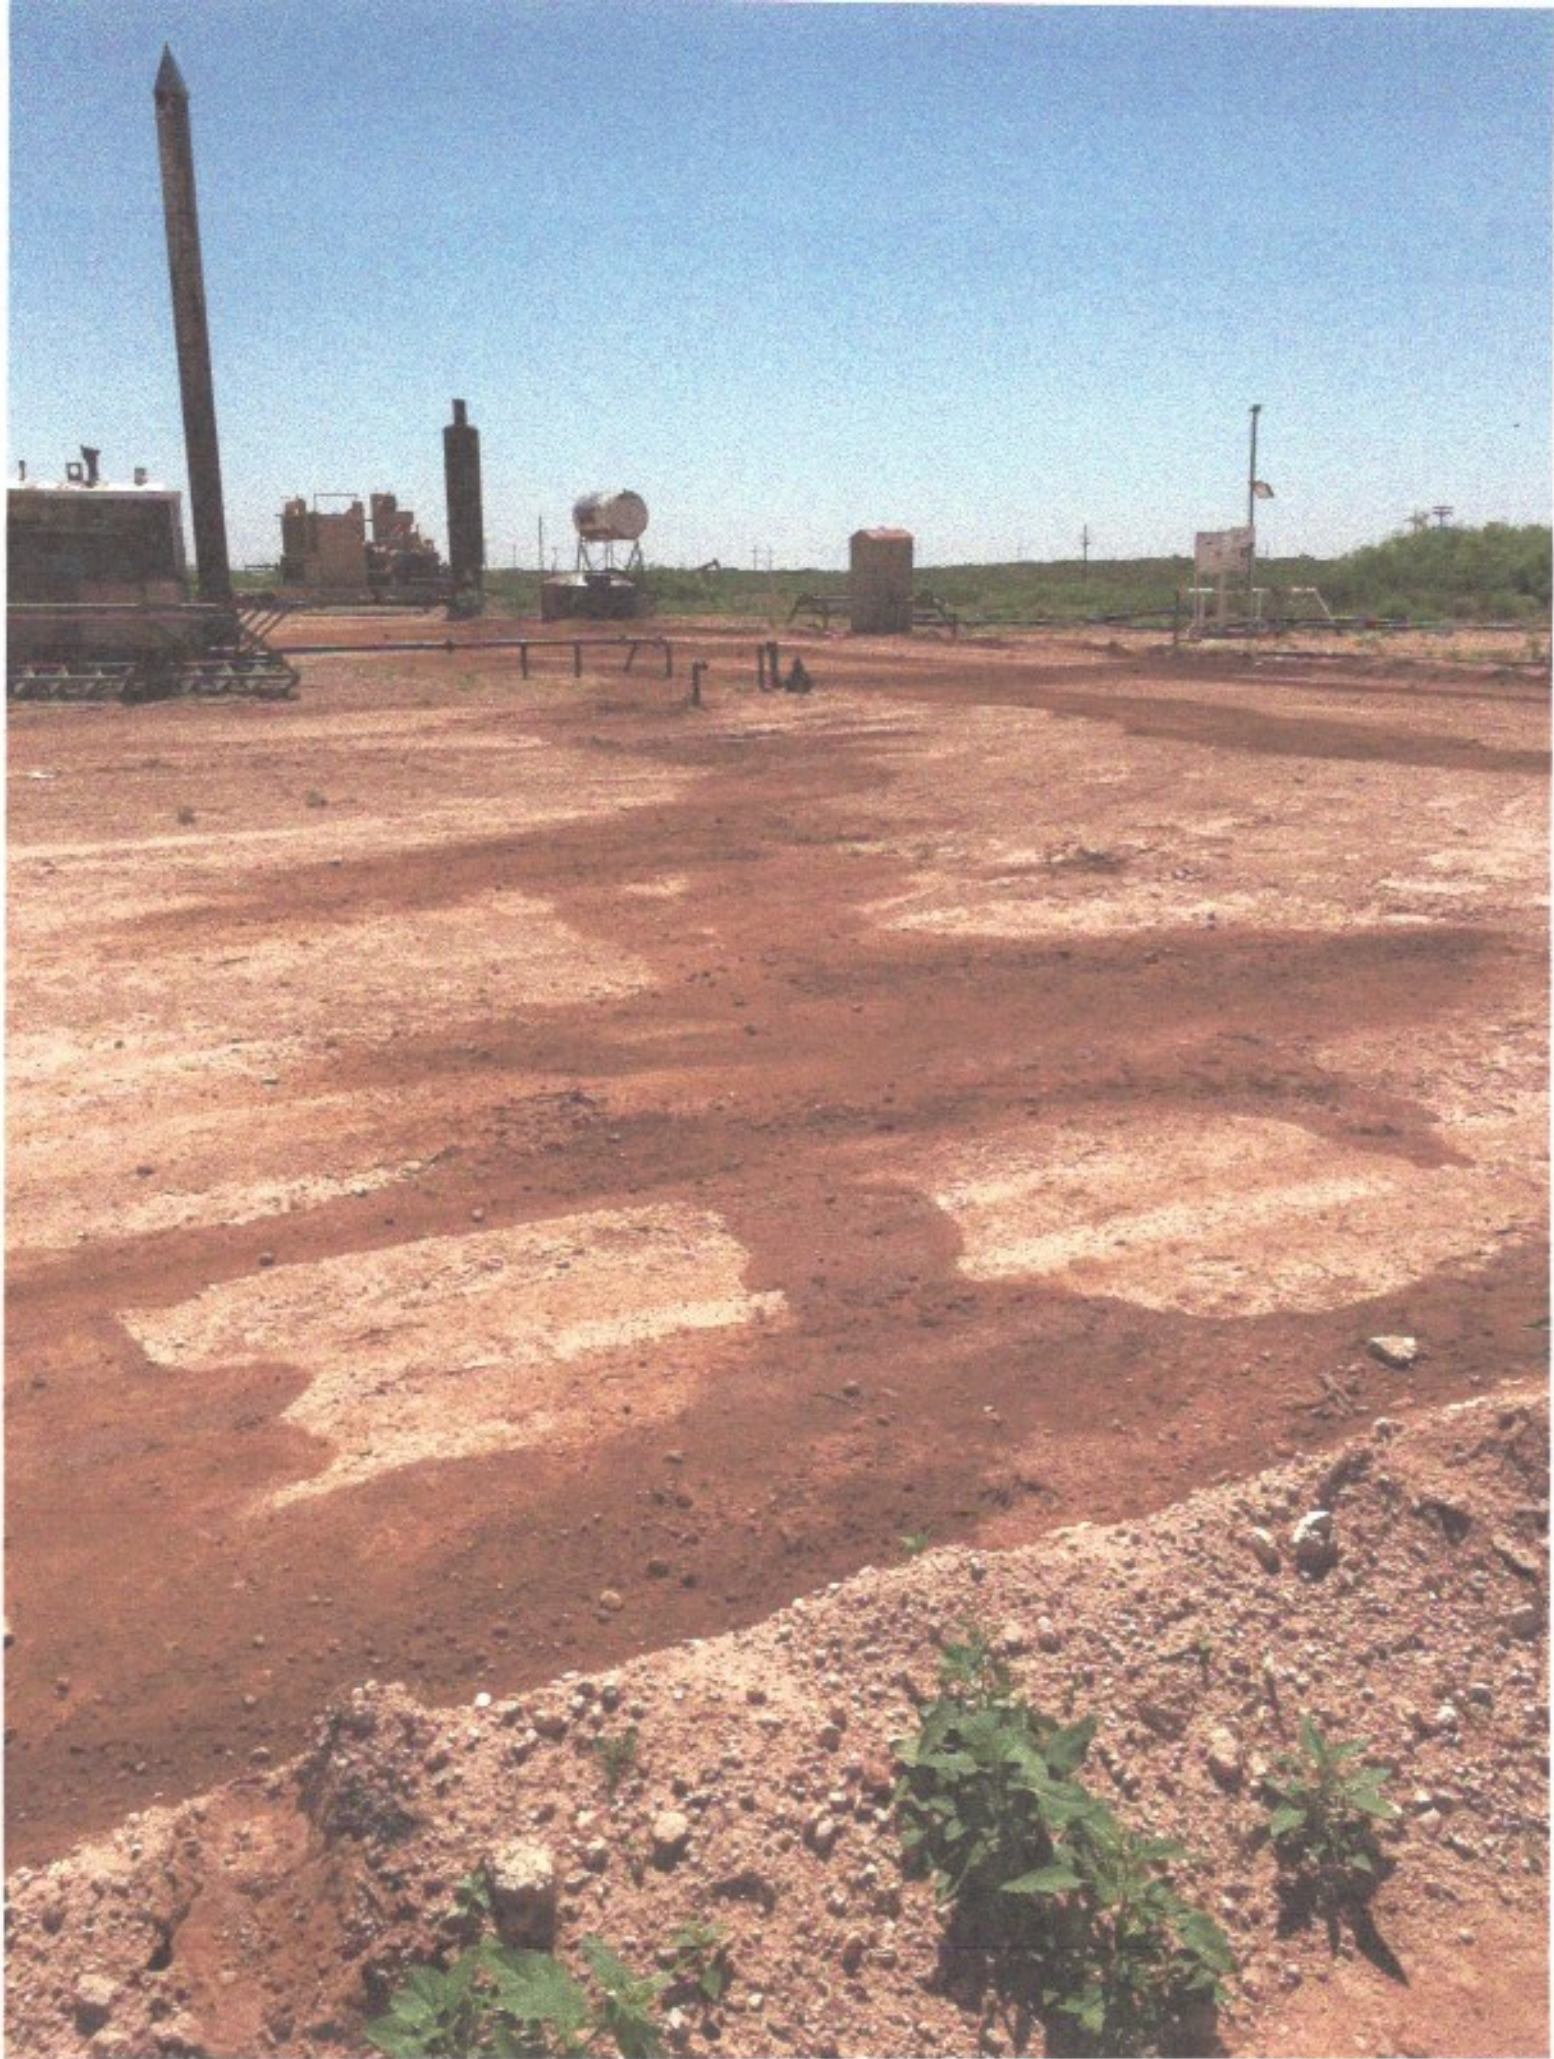
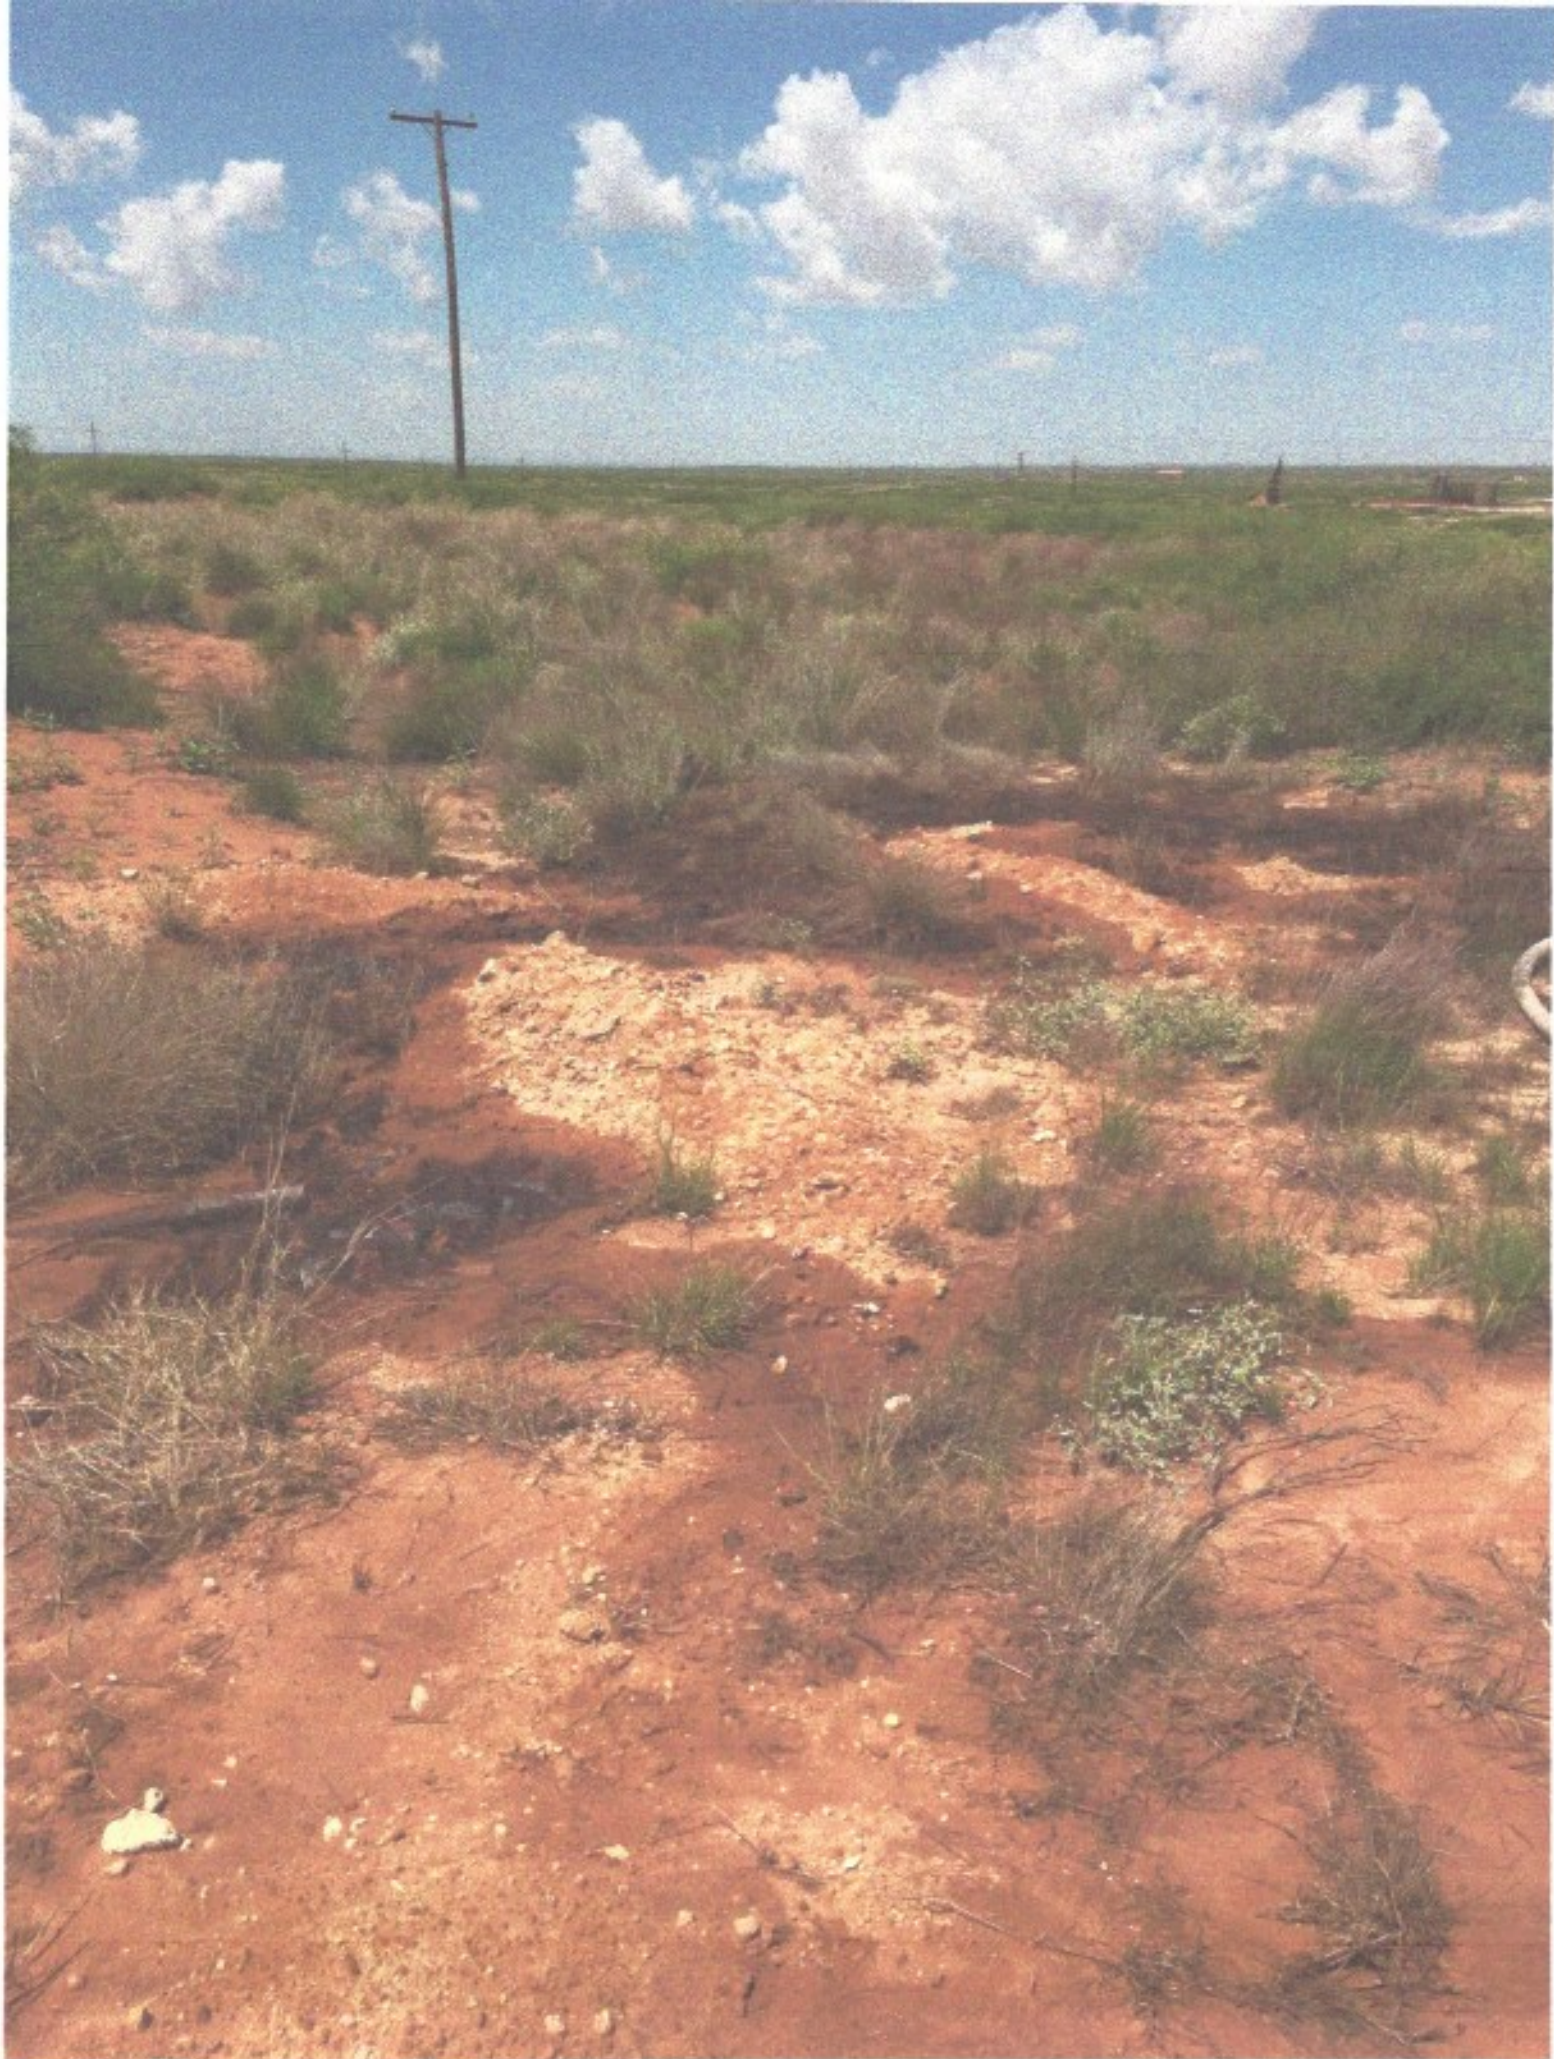
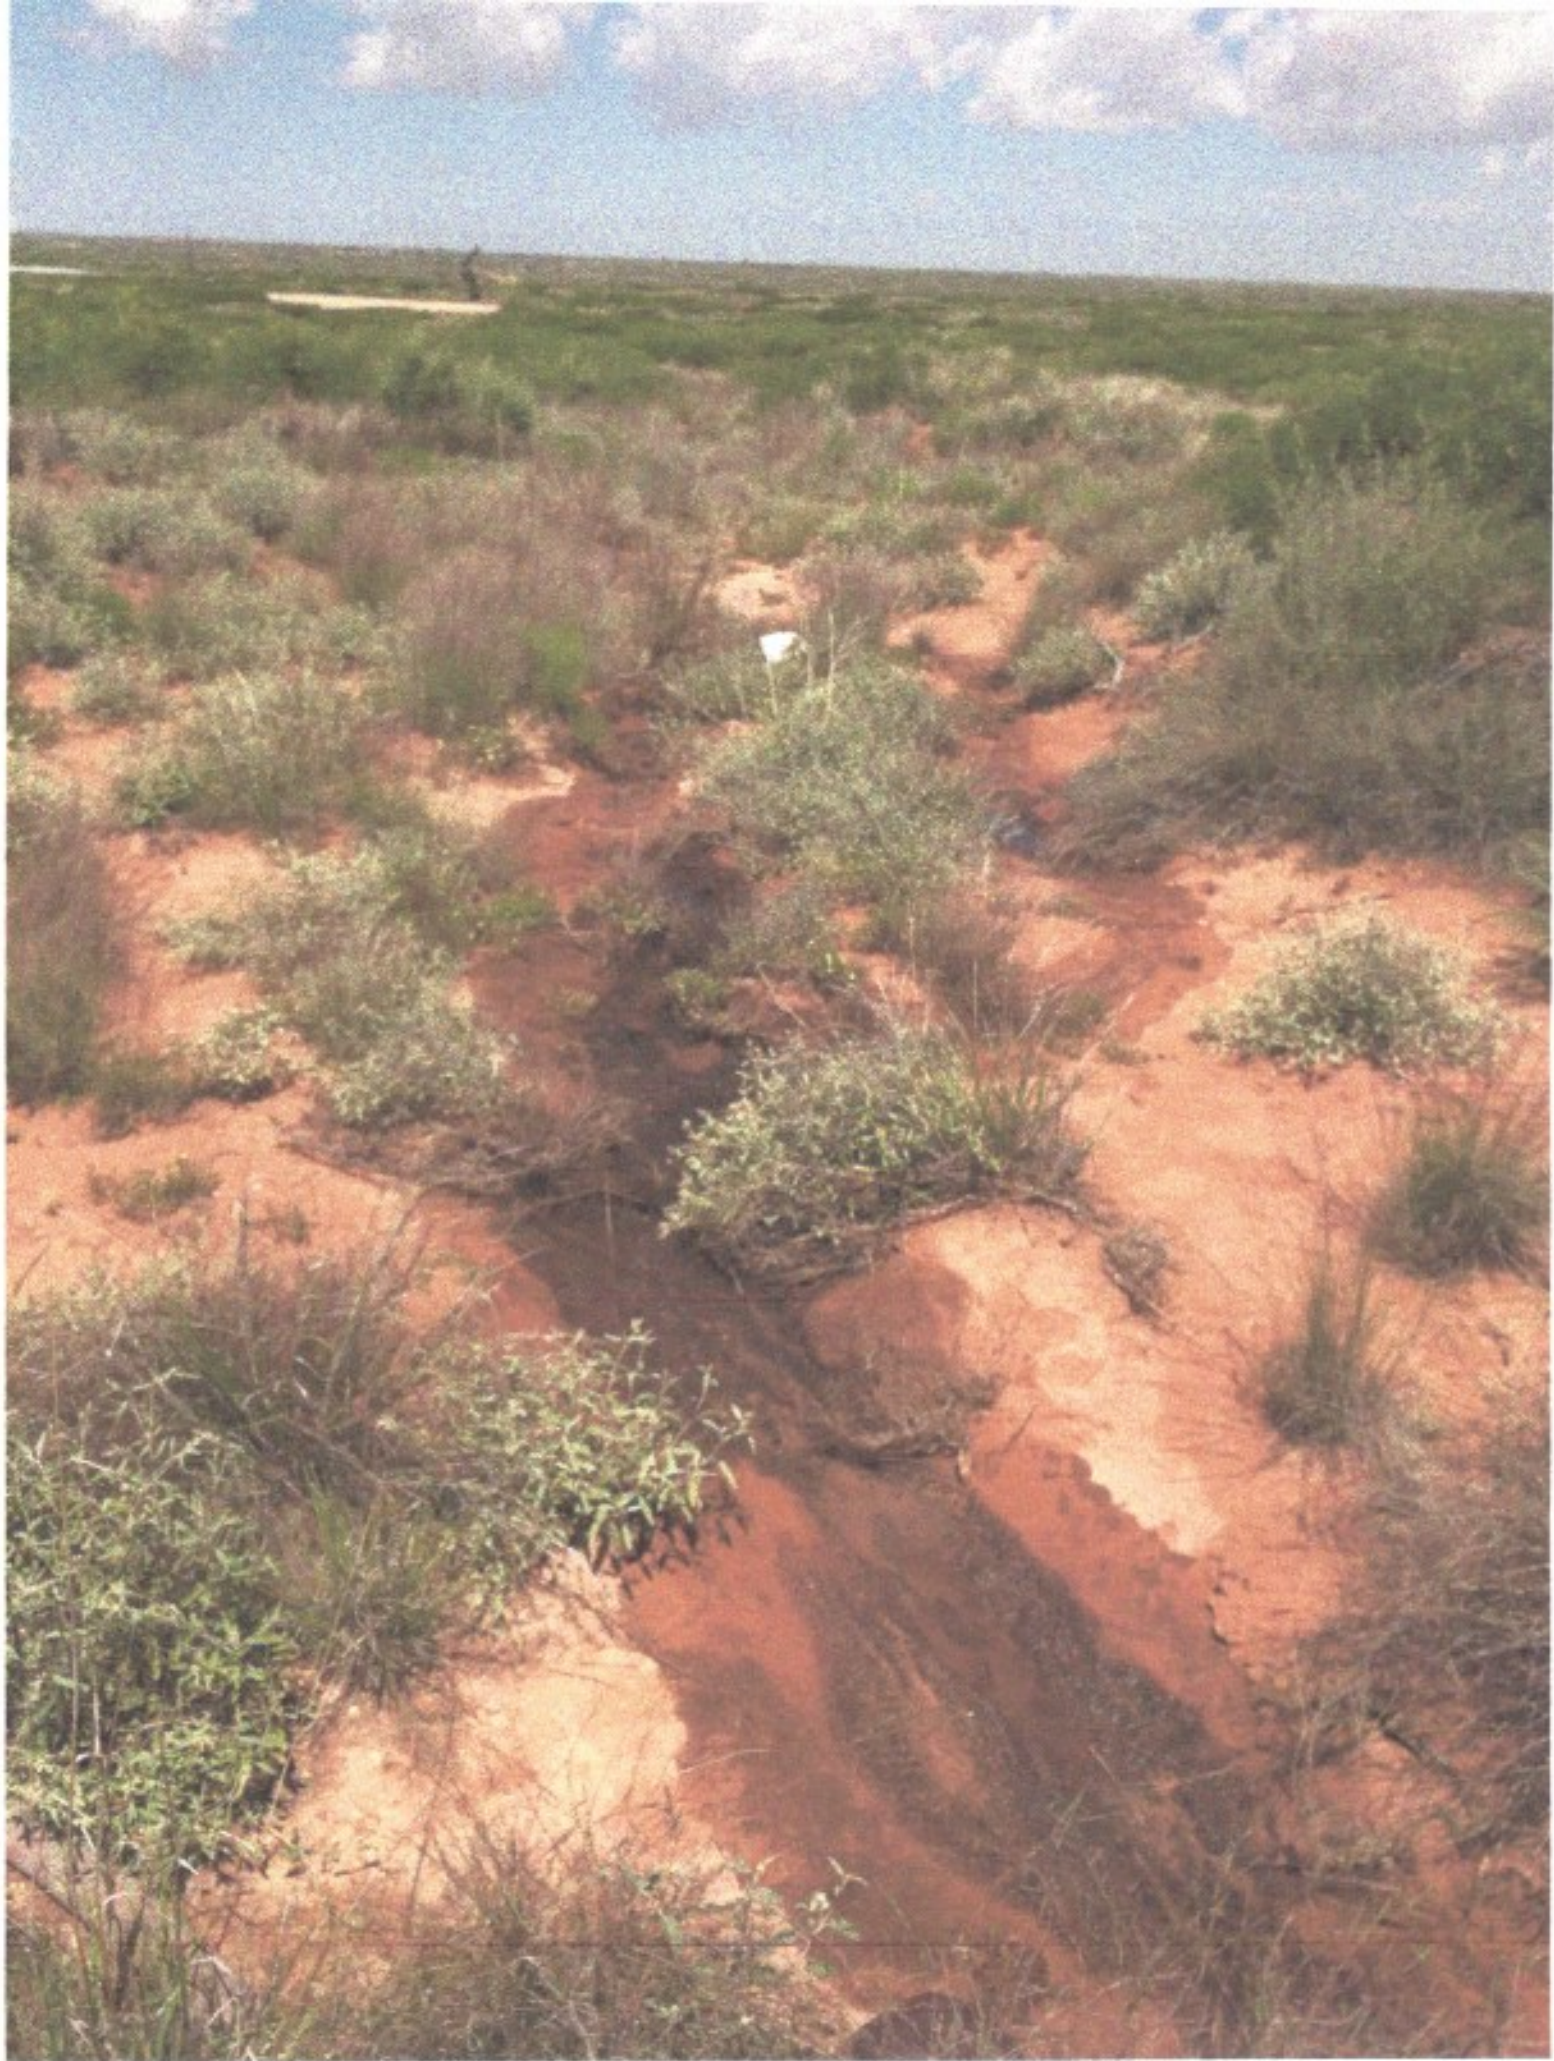
Exhibit C

In terms of a cleanup effort. With NMOCD's approval we would like to excavate the EA off of the location using a backhoe and hand shoveling removing the contaminated soil and stock piling on plastic at the location. On the location we intend to use a backhoe to remove the contaminated soil and load it as well as stockpiled soil onto trucks. This material will be taken to R360 for disposal. Pictures of the EA can be found in Exhibit C.

Leaked fluid affected the pad surface around the catch tank and also ran off location to the west an estimated 200 yards in to the pasture.
