Table 2: Summary of Chloride Field Screening Results

Cedar 32 State Com #1  
Sample Event  
11/3/16

Detailed Site and Sample Map  
 Young Deep Unit 32= Matador Resources  
 Maljamar, New Mexico

SUBJECT Cedar 32 Resample

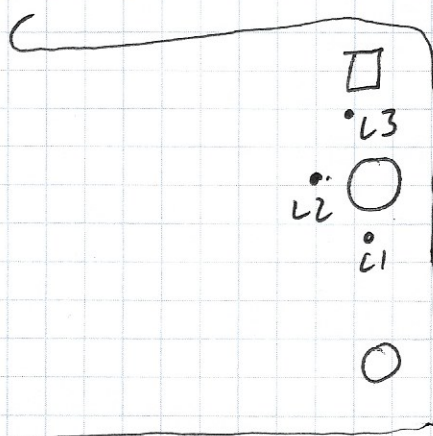
pipe is on south west of pad

Sample location is the east side of pad in tank battery

Samples take to 4' bys with gas power auger in the excavation area before
