Release Notification

| Site Name Rock Daisy Road Release | Site Type Pipeline ROW adjacent to SWD |

Terracon Consultants, Inc. (Terracon) is pleased to submit our Release Investigation and Remedial Action Plan (RAP) for the site referenced above. The Release Investigation and RAP were developed in accordance with the New Mexico Oil Conservation Division (NMOCD) regulations concerning response actions required for releases of crude oil and produced water. Based on the release investigation assessment, Terracon recommends the following actions be taken to achieve protection of fresh water and the environment in accordance with NMOCD regulations. Terracon developed the Release Investigation and RAP in general accordance with our proposal (PAR197270) dated July 20, 2019.

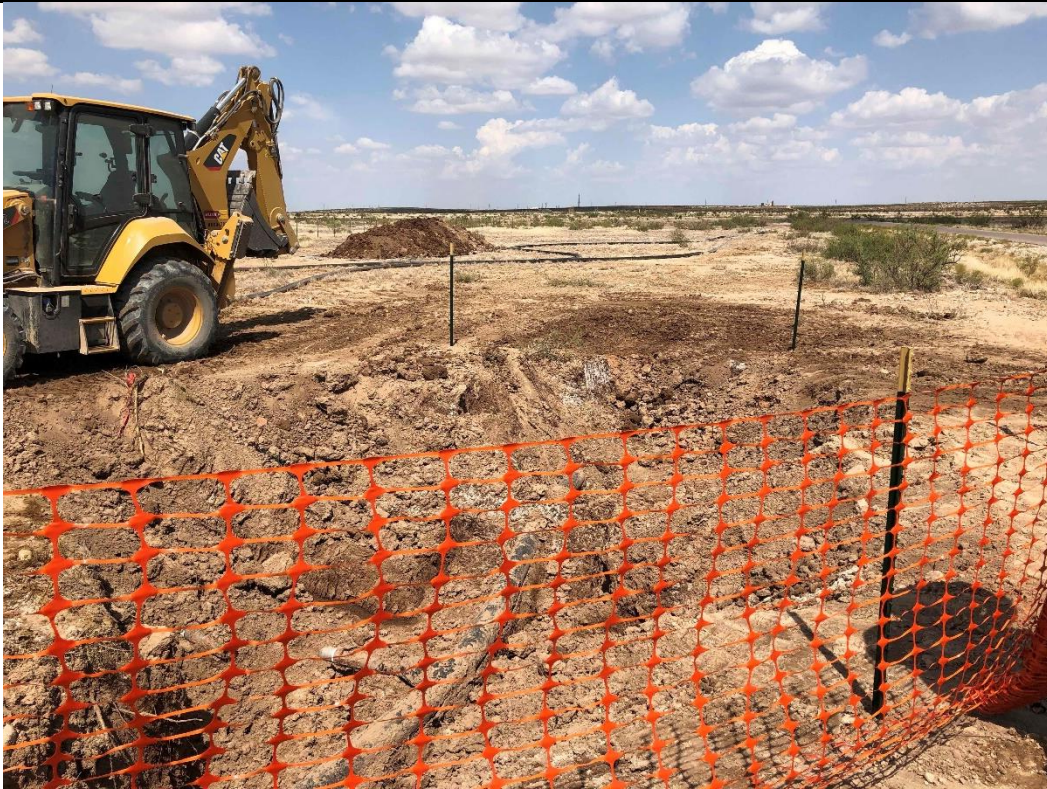
| Required Information | Site and Release information | |
|---|---|---|
| Discharge event | A legacy tie-in to the Spur SWD system from a Mewborn battery failed inside of the vertical access point. Specifically, the steel valve had corroded through. The site was excavated in order to remediate the leak and cap the abandoned line as well as tie in the active line. The fluid that released to ground was before the excavation was completed to access the line. Vacuum trucks were utilized in the open excavation to recover all remaining fluids. | |

**PHOTO 1:** View of release origin, facing northeast. 8/14/2019

| Required Information | Site and Release information | |
|---|---|---|
| Immediate corrective actions | Pipeline was shut in, and the pump along with the corroded valve was replaced and repaired. | |

Initial source elimination was accomplished by the Spur foreman shutting in the leaking line and replacing the malfunctioning pump and the corroded valve in the pipeline that failed. Spur enlisted Terracon to assess the impacted areas resulting from the release and develop a remediation plan of action.

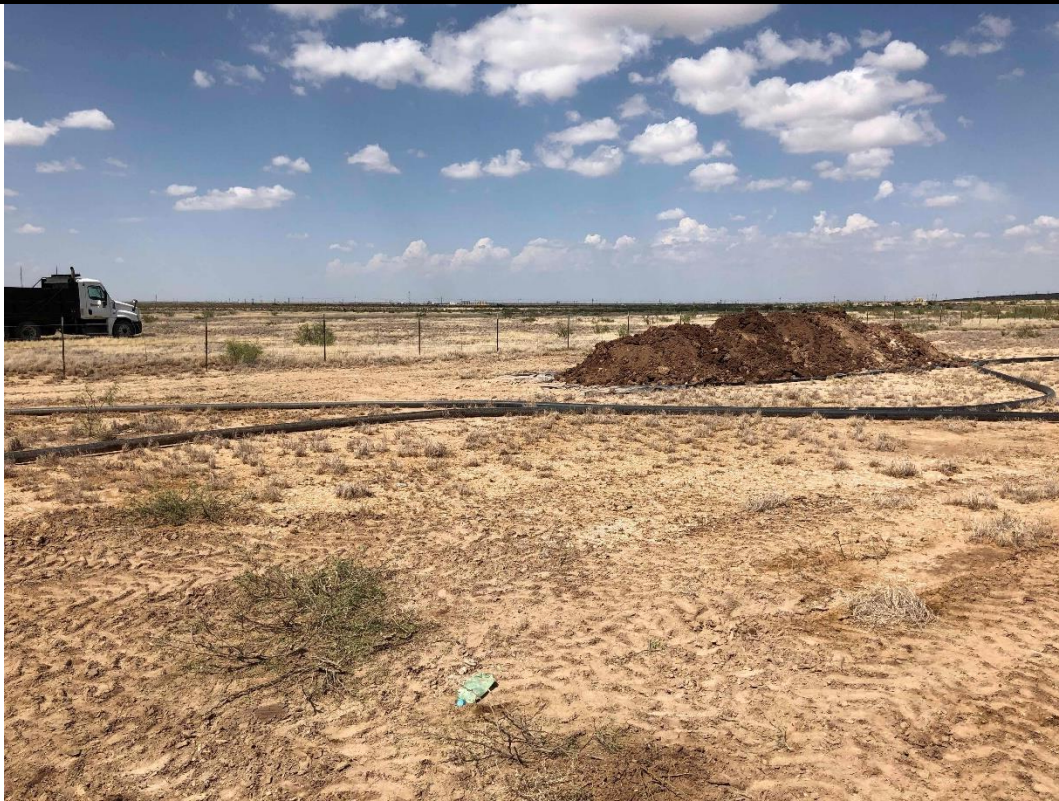
Based on the review of the above release investigation analytical results, the areas within the release margins exhibit concentrations of chloride in multiple locations and Total TPH in the stockpile (SP-1). Based on these exceedances above NMOCD RALs, Sections 9.0 and subsequent detail recommended remedial response actions to be implemented at the site.

**PHOTO 3:** View of stockpile, facing North. 8/14/2019

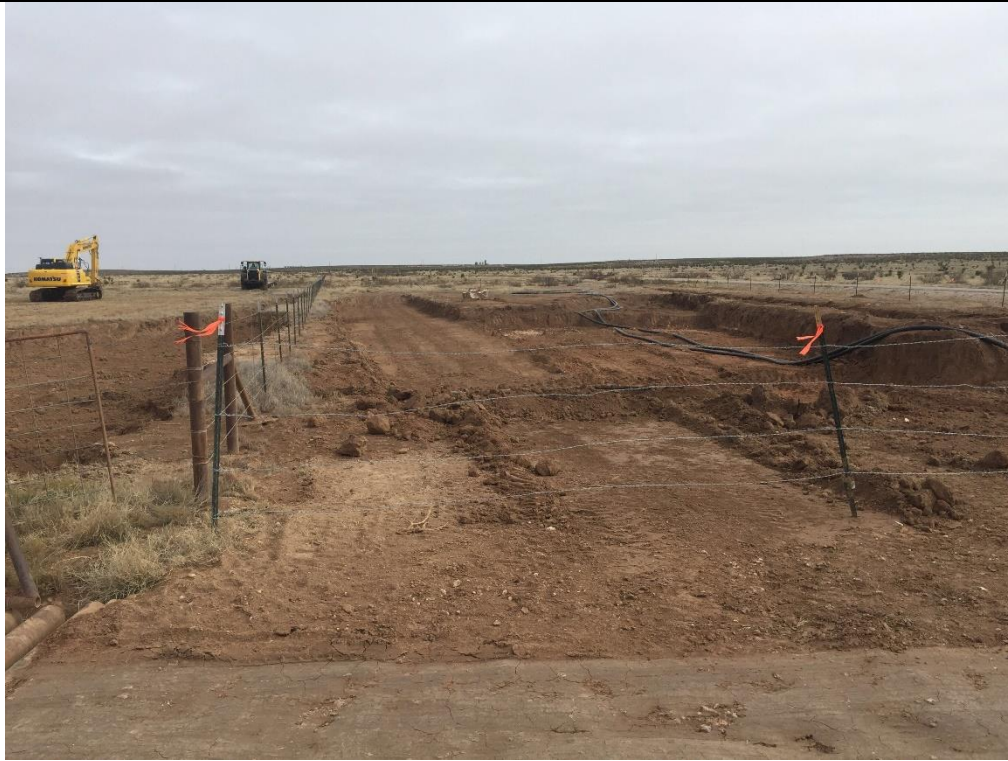
**PHOTO 11:** View of excavation, facing east. 11/08/2019

Following excavation to recommended Reclamation depths, horizontal delineation samples will be collected from the base and walls of the excavation to confirm the remaining levels of soil contaminants are below the desired NMOCD RALs. Based on the proximity of the analyzed samples to this restrictive layer and the magnitude of the concentrations being elevated above below 600 mg/kg, Terracon recommends hydro excavating the restrictive feature to wash out the residual presence of chlorides at this restrictive zone to ensure that concentrations are not elevated further at this restrictive interphase. Terracon will additionally include photo logs of the hydro excavating activities with the closure report.

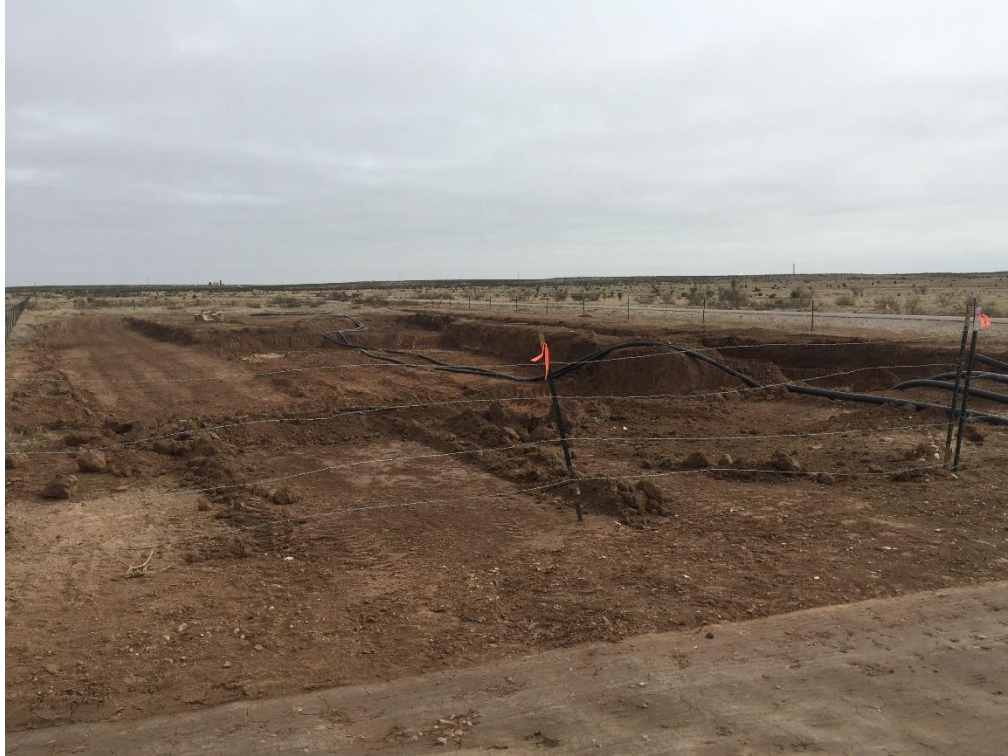
**PHOTO 12:** View of excavation, facing southeast. 11/08/2019

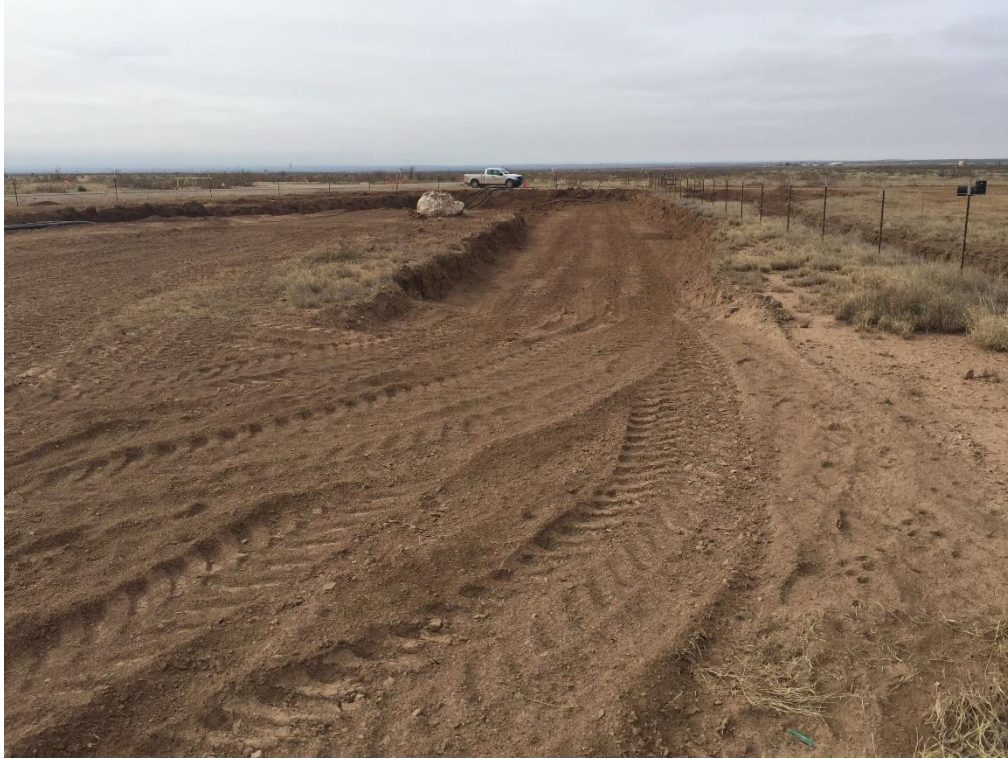
**PHOTO 13:** View of excavation, facing west. 11/08/2019

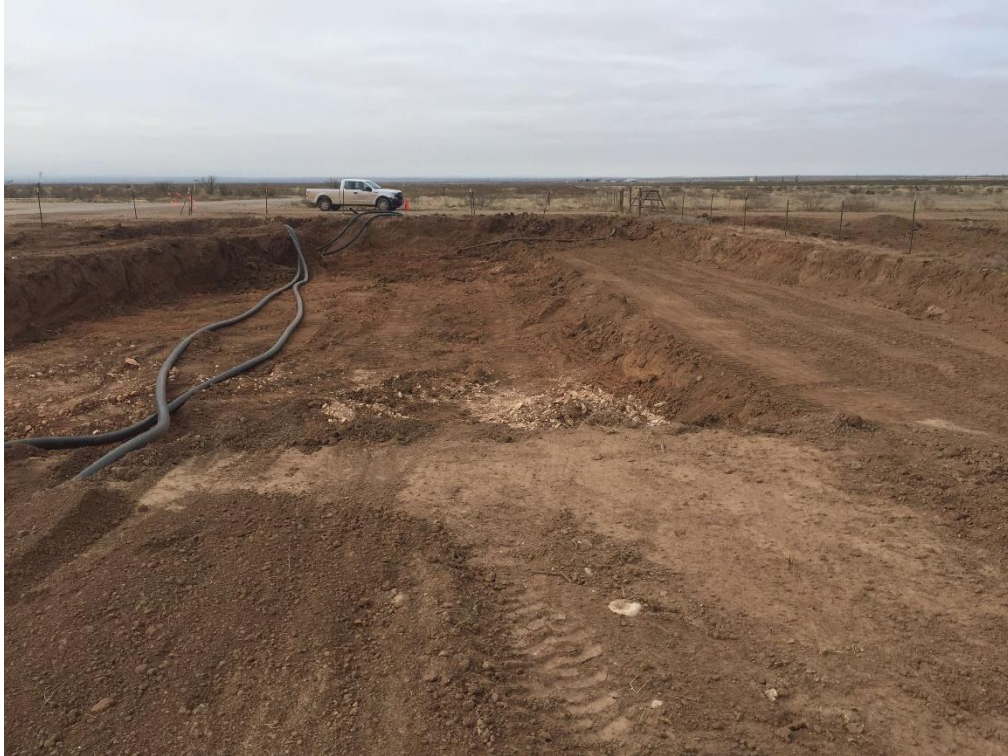
**PHOTO 14:** View of excavation, facing west. 11/08/2019

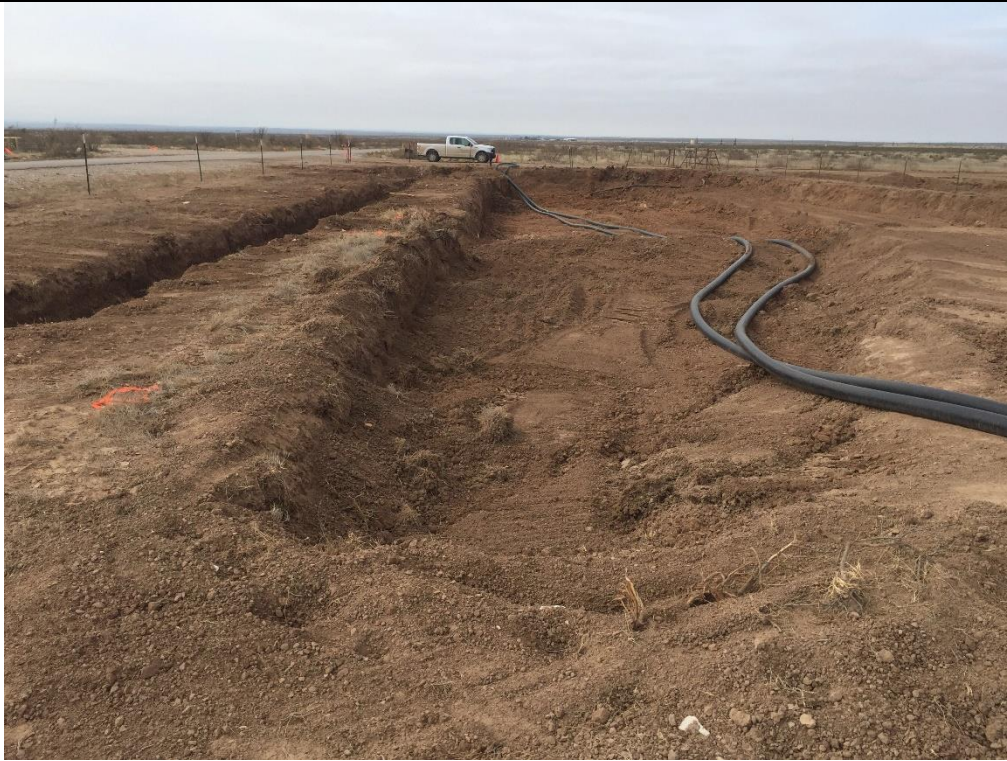
**PHOTO 15:** View of excavation, facing west. 11/08/2019

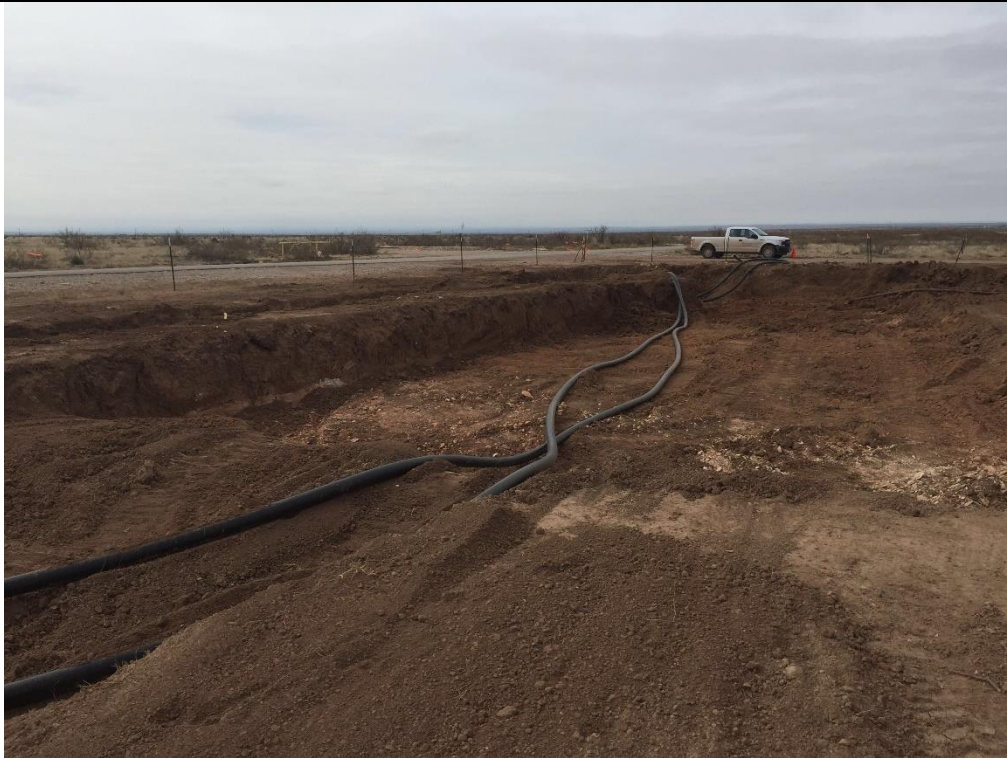
**PHOTO 16:** View of excavation, facing southwest. 11/08/2019

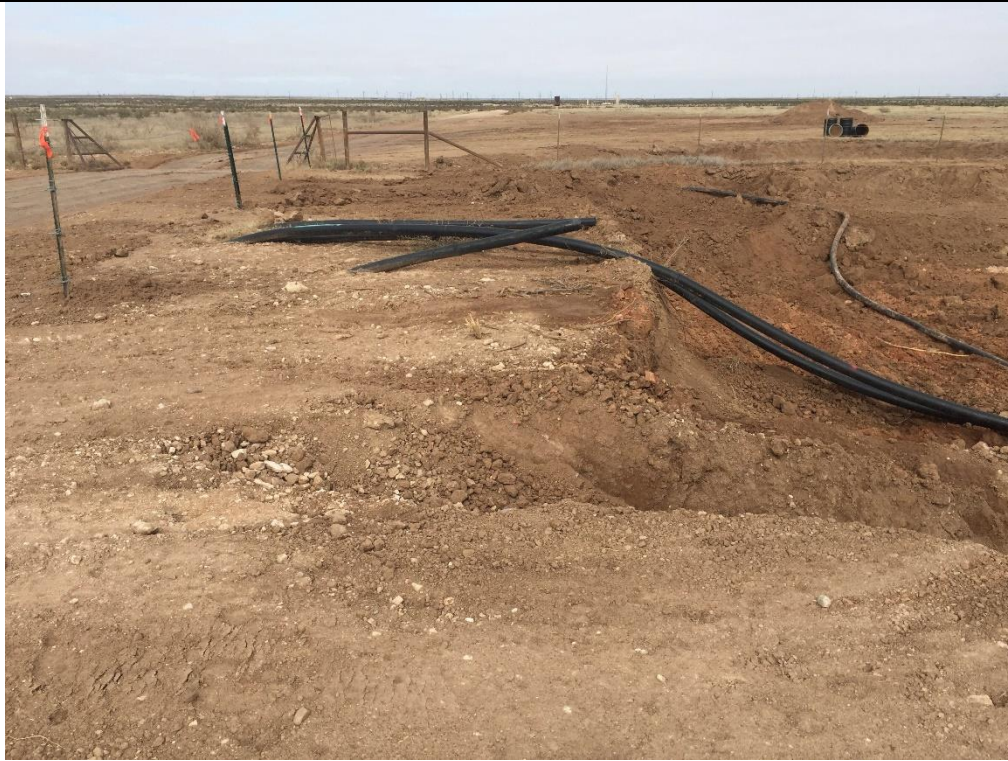
**PHOTO 17:** View of western portion of excavation, facing north. 11/08/2019

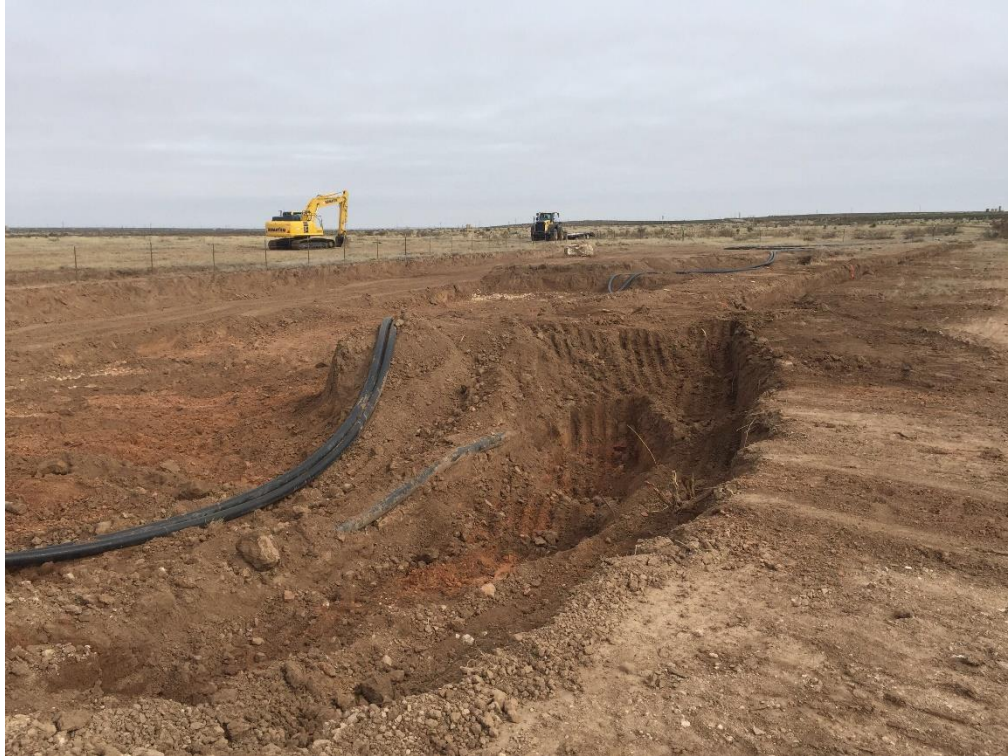
**PHOTO 18:** View of excavation, facing northeast. 11/08/2019
