# Closure of Release Investigation and Remedial Action Plan

Eddy State #2 SWD

July 17, 2020

Terracon Project No. AR197208

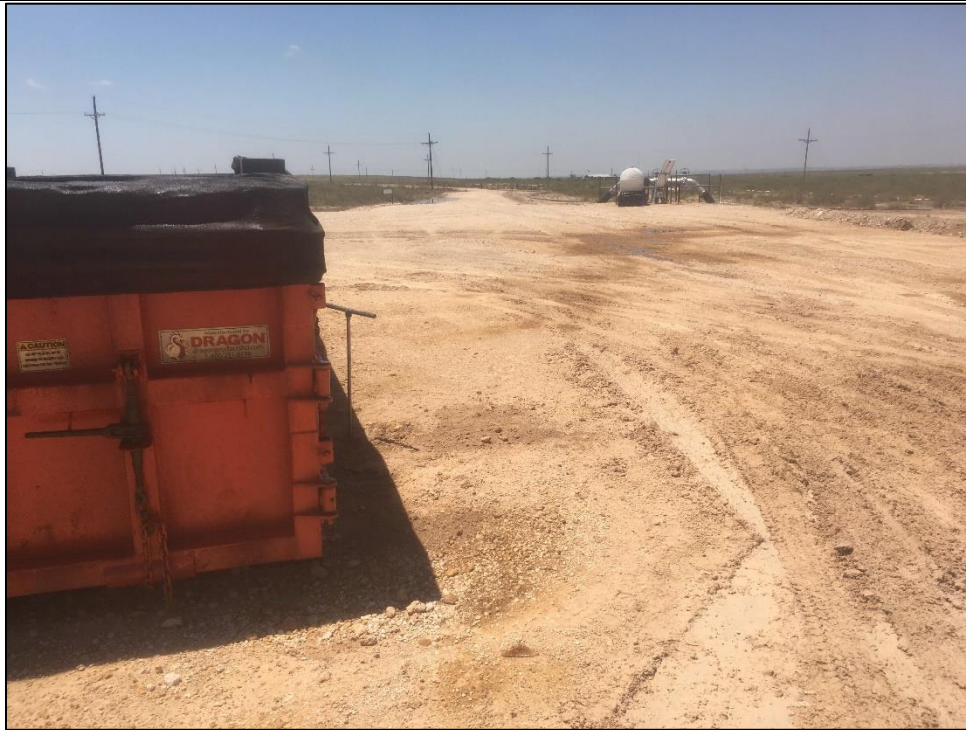
**PHOTO 1:** View of sight and HA-1 (non-reportable), facing south. 6/04/2019

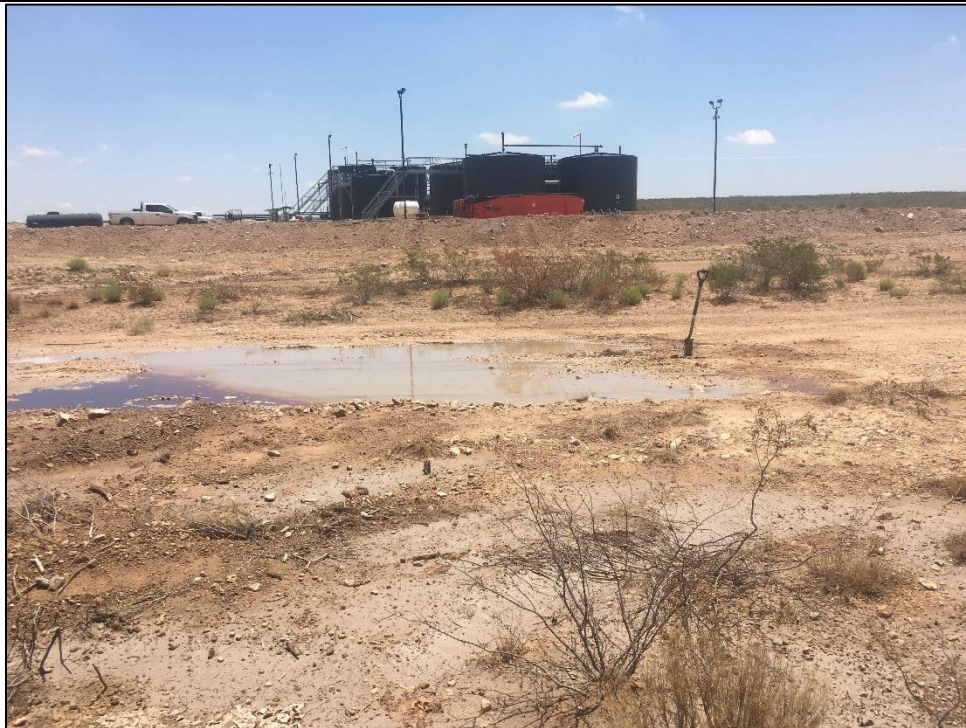
**PHOTO 2:** View of sight, standing water and HA-2 (non-reportable), facing east. 6/04/2019

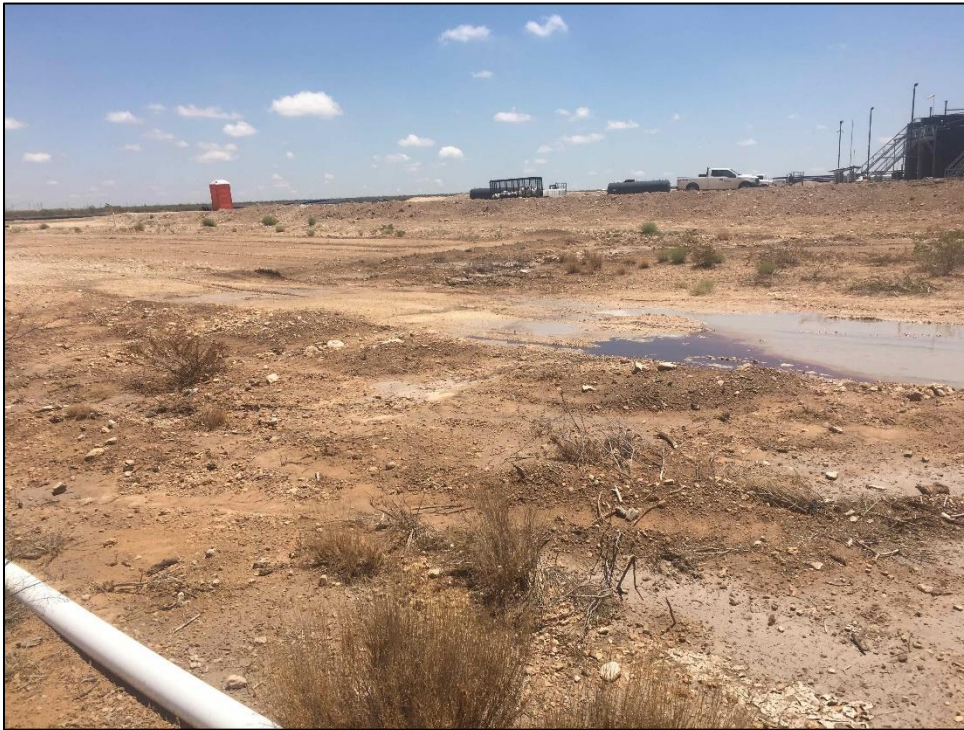
**PHOTO 3:** View of sight and staining (non reportable), facing northeast. 6/04/2019

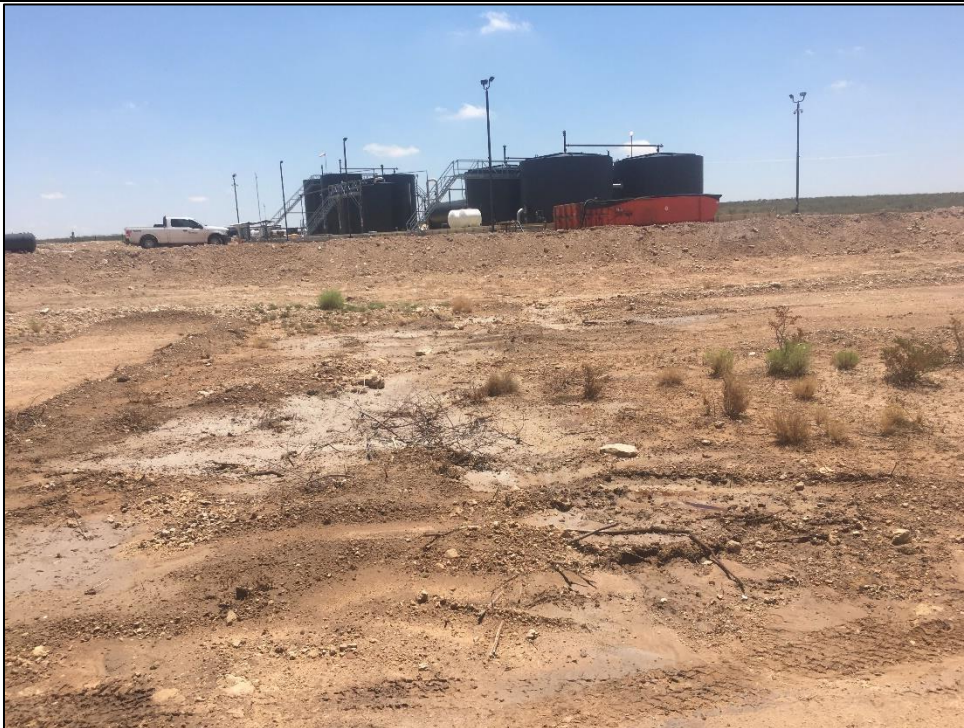
**PHOTO 4:** View of sight and staining (non-reportable), facing east. 6/04/2019

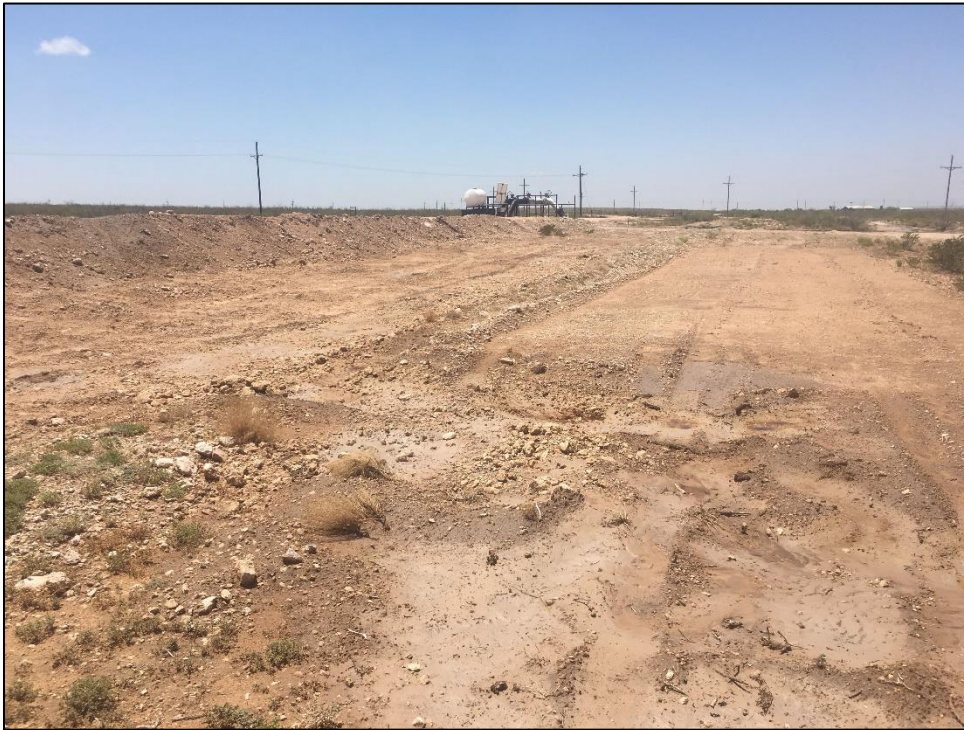
**PHOTO 5:** View of sight and staining (non-reportable), facing south. 6/04/2019

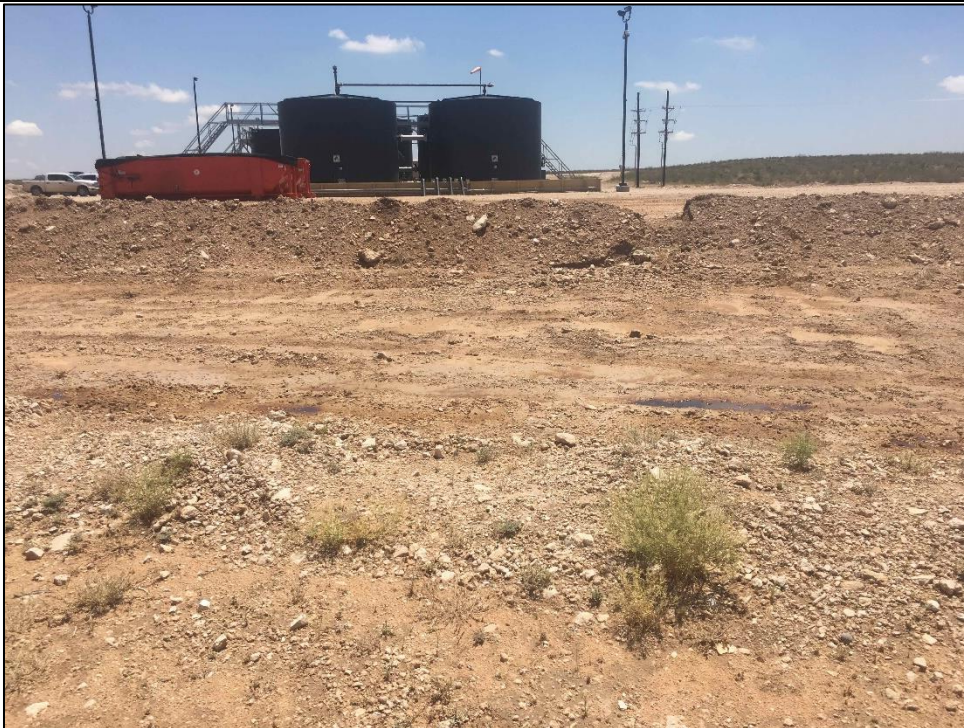
**PHOTO 6:** View of staining and flow path off pad (non-reportable), facing east. 6/04/2019

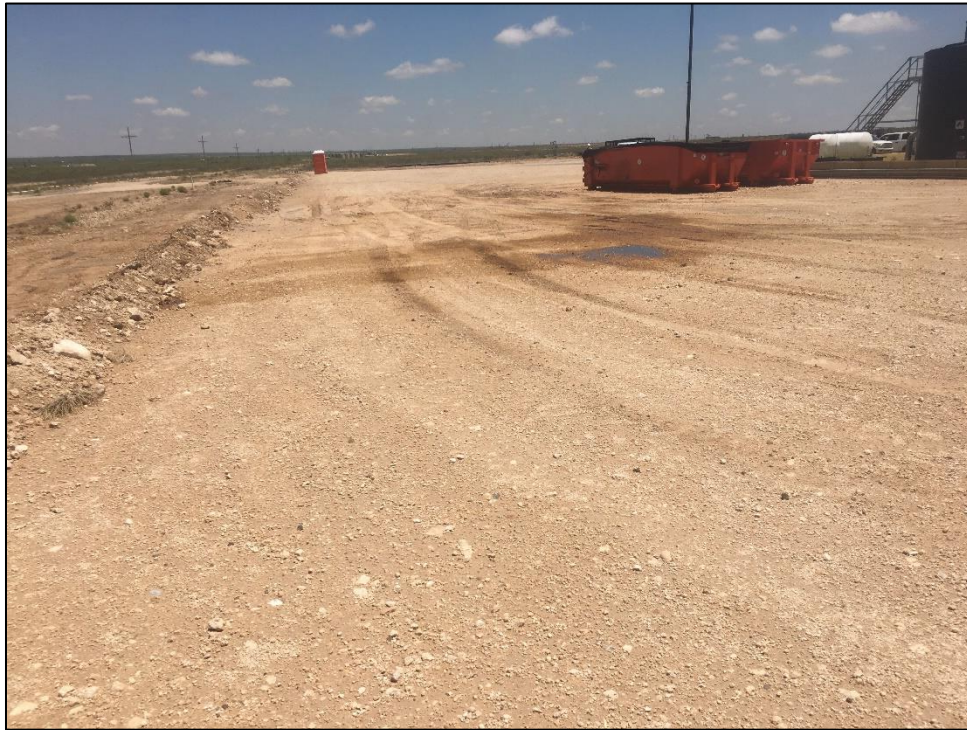
**PHOTO 7:** View of staining on pad (non-reportable), facing north. 6/04/2019

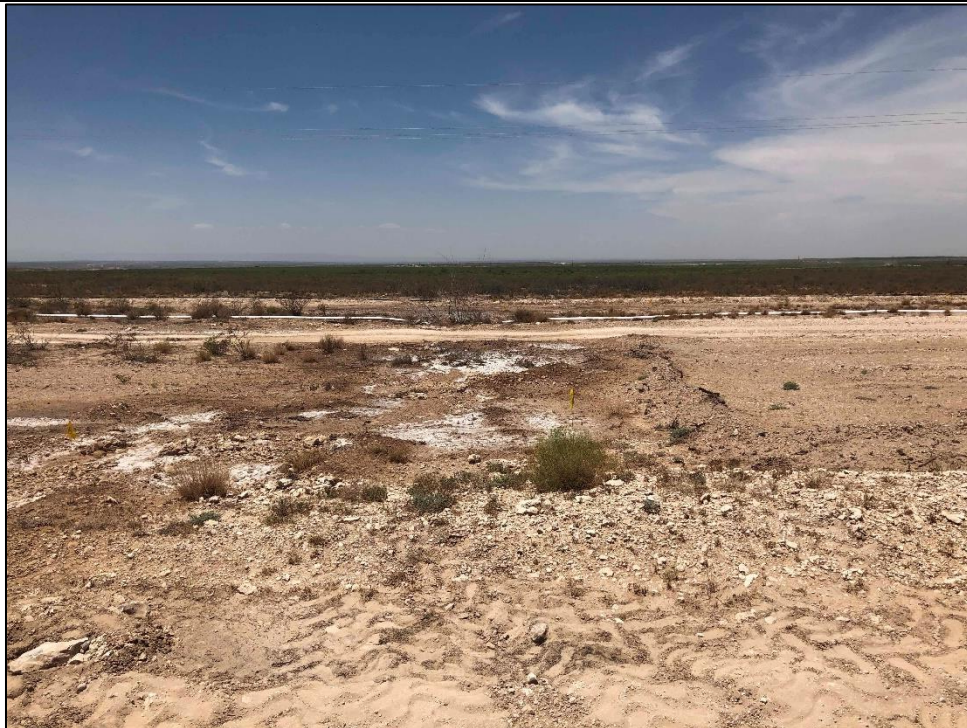
**PHOTO 8:** View of sight and flow path, facing west. 7/15/2019

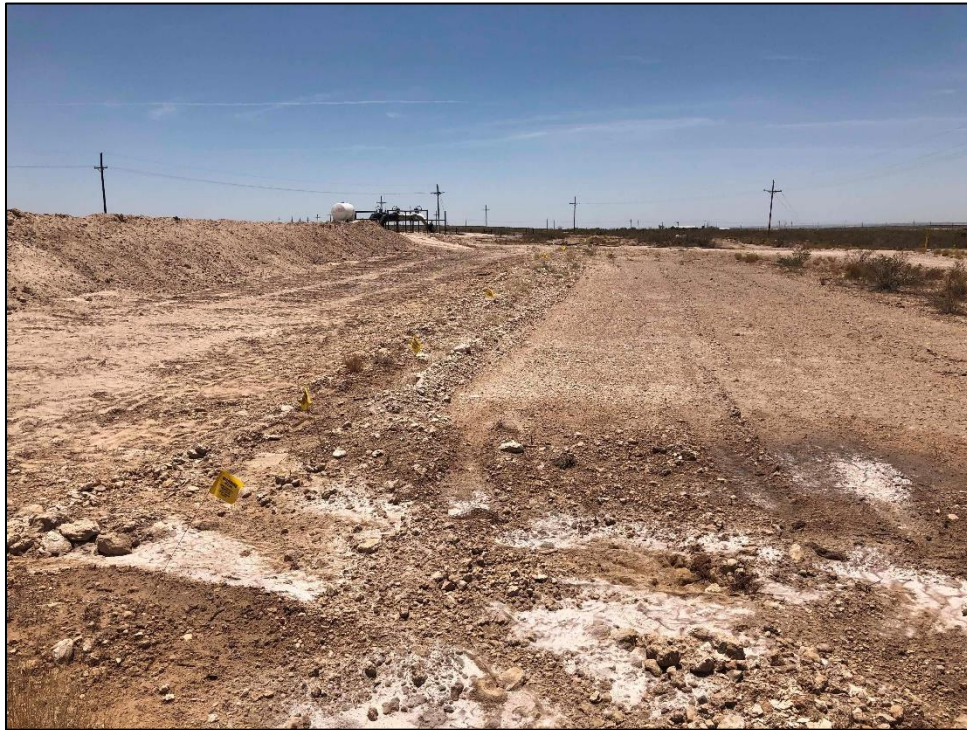
**PHOTO 9:** View of sight and staining, facing south. 7/15/2019

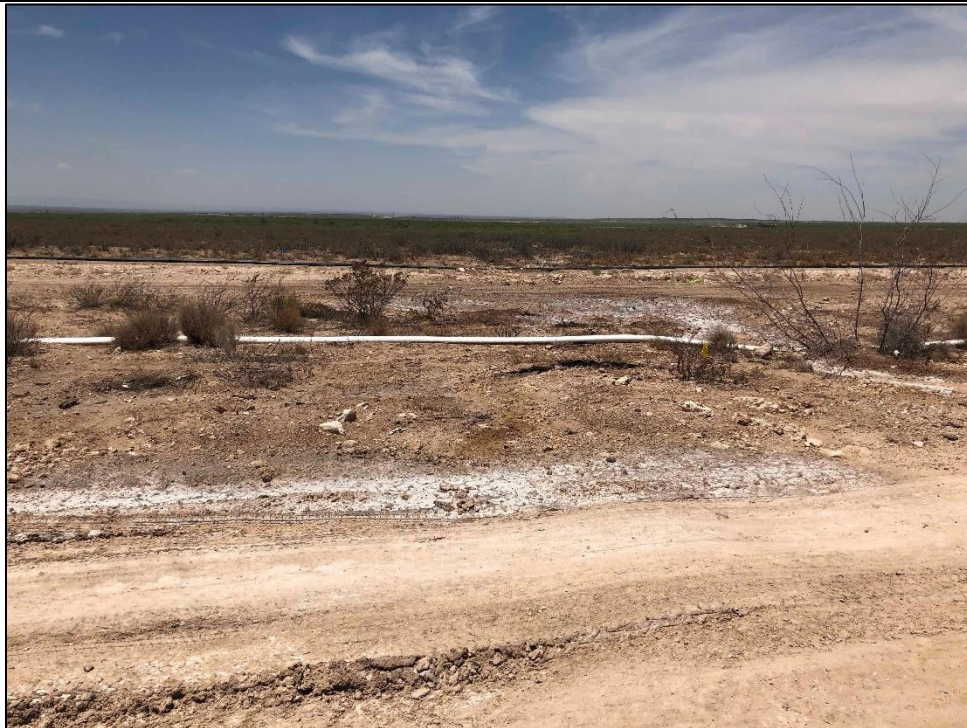
**PHOTO 10:** View of sight and staining, facing west. 7/15/2019

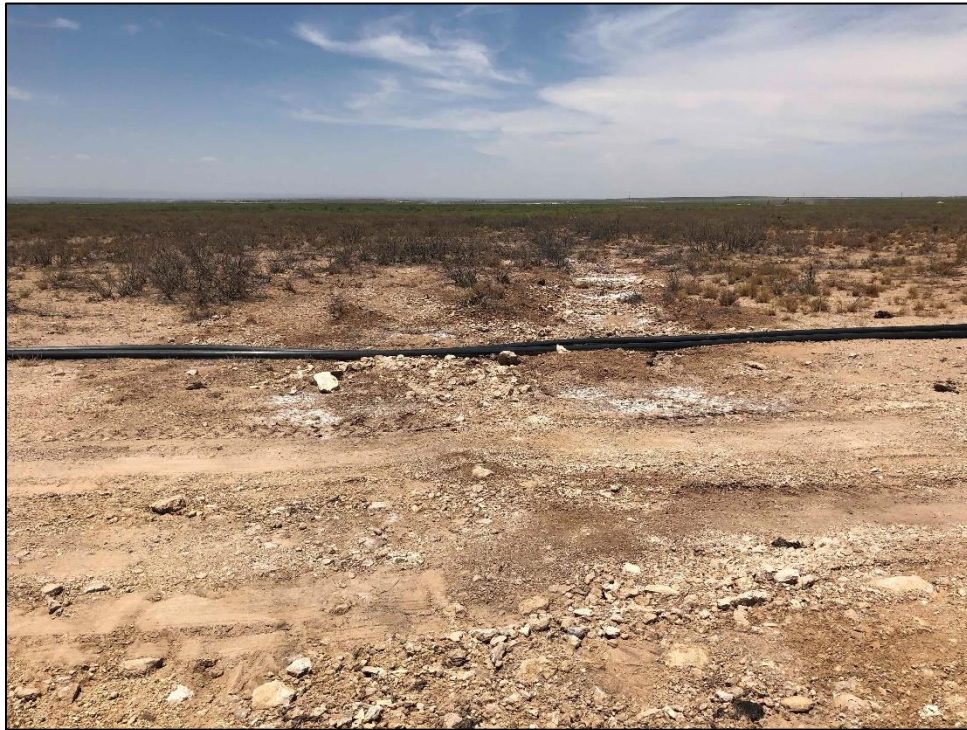
**PHOTO 11:** View of sight and staining going into drainage, facing west. 7/15/2019

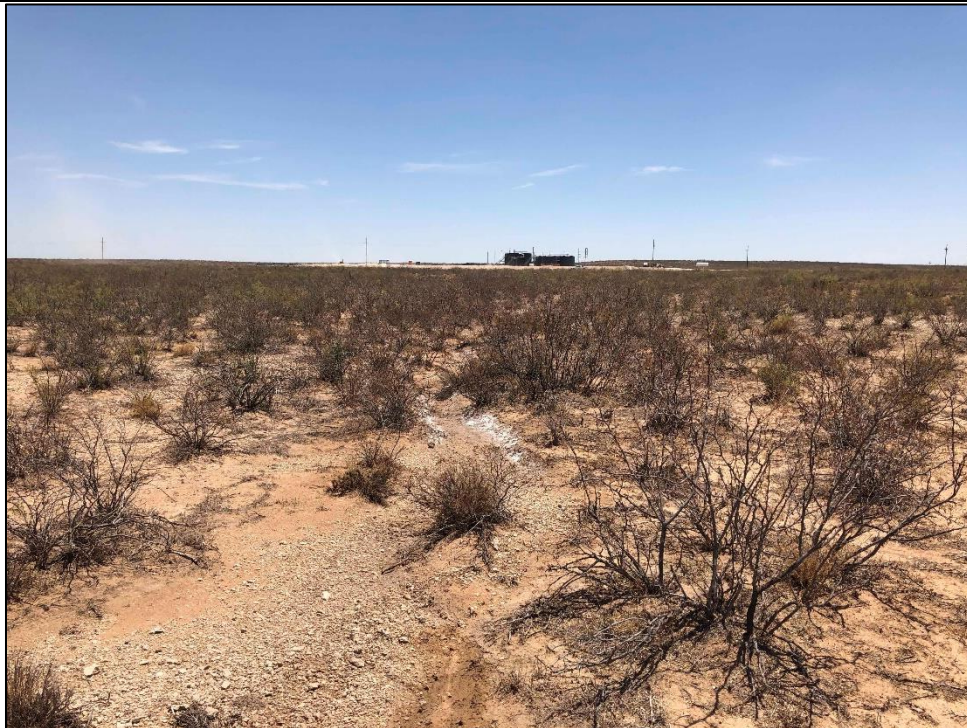
**PHOTO 12:** View of sight and staining end of spill, facing east. 7/15/2019

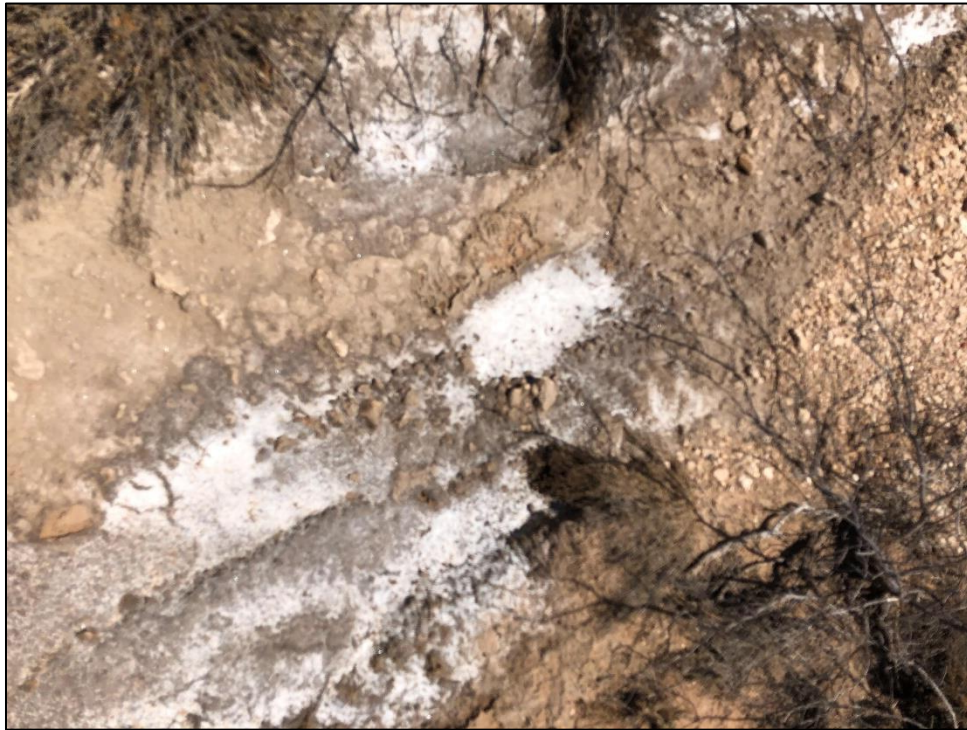
**PHOTO 13:** View of staining and width of flow path. 7/15/2019

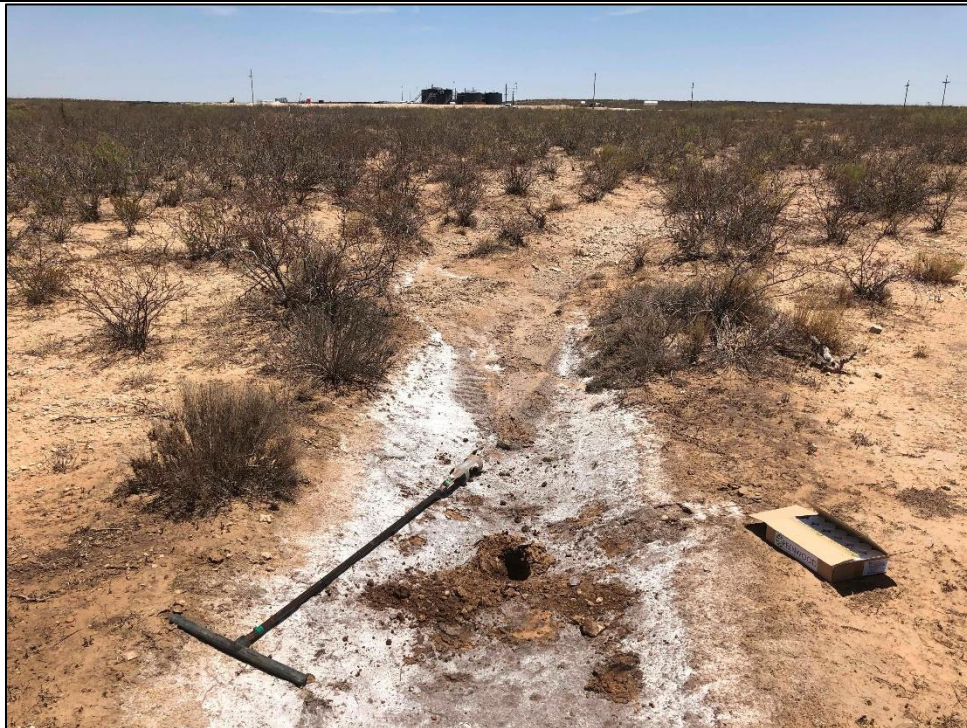
**PHOTO 14:** View of staining and HA-1, facing east. 7/15/2019

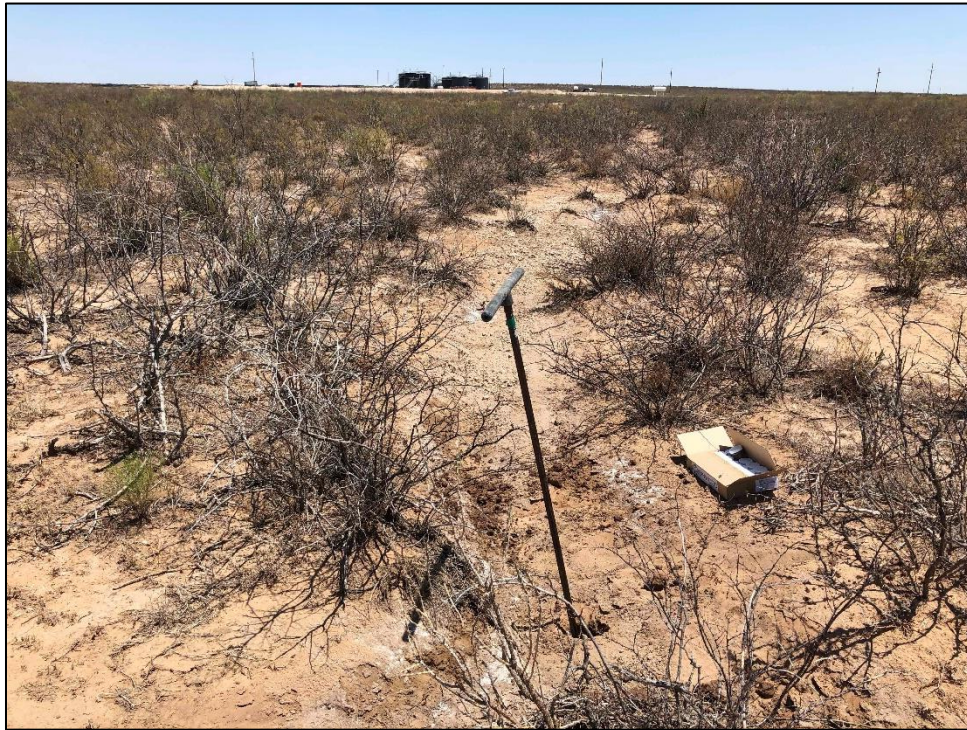
**PHOTO 15:** View of staining and HA-2, facing east. 7/15/2019

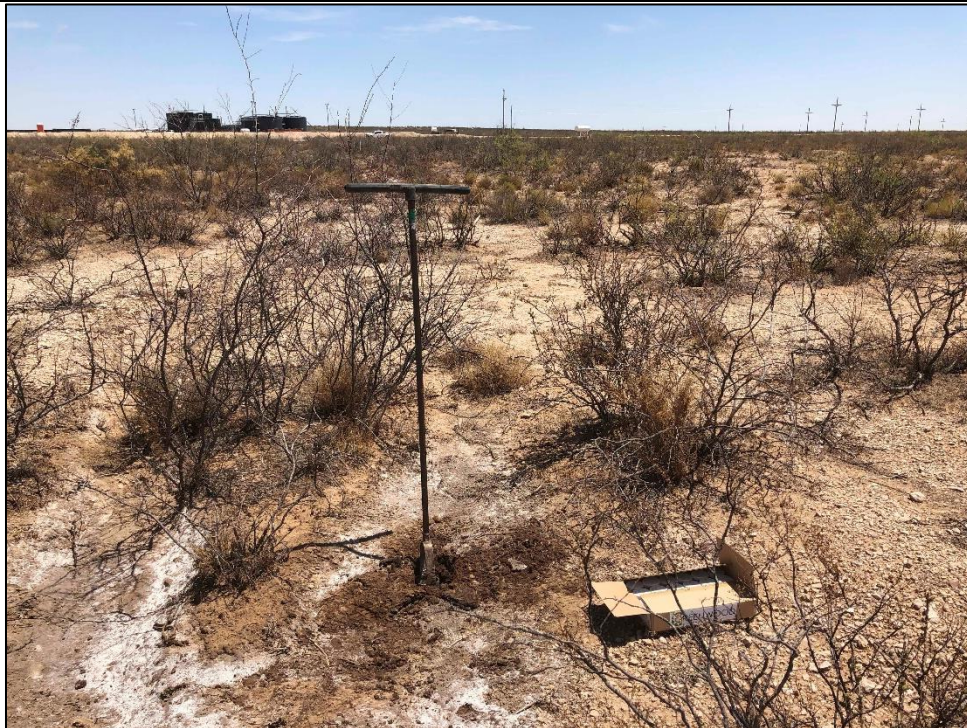
**PHOTO 16:** View of staining and HA-3, facing east. 7/15/2019

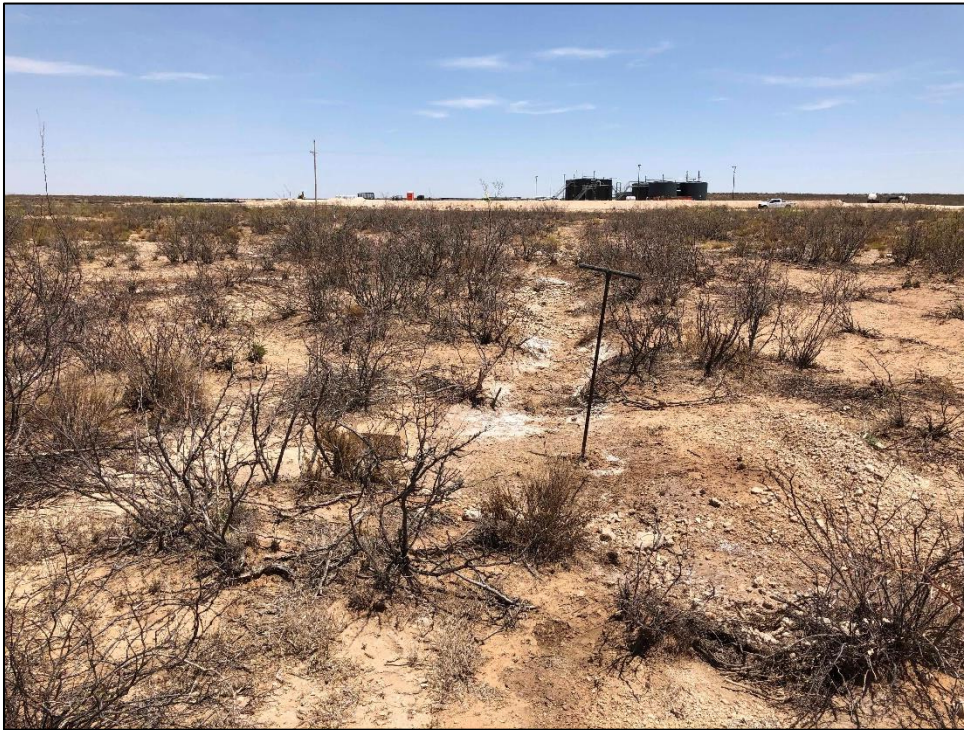
**PHOTO 17:** View of staining and HA-4, facing east. 7/15/2019

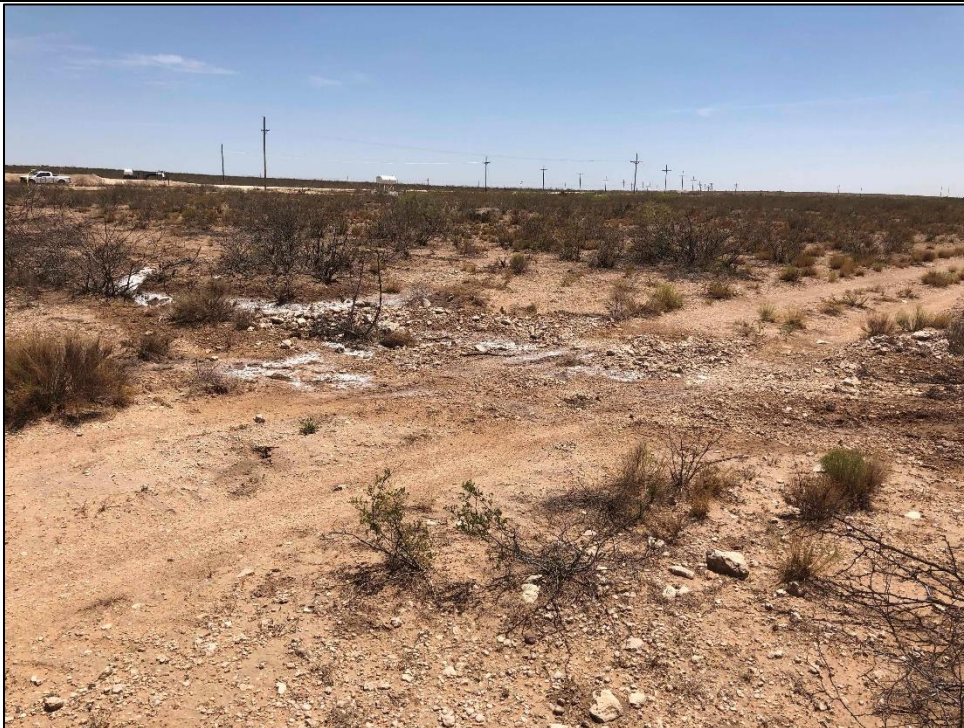
**PHOTO 18:** View of staining and flow path over rancher's road, facing southeast. 7/15/2019

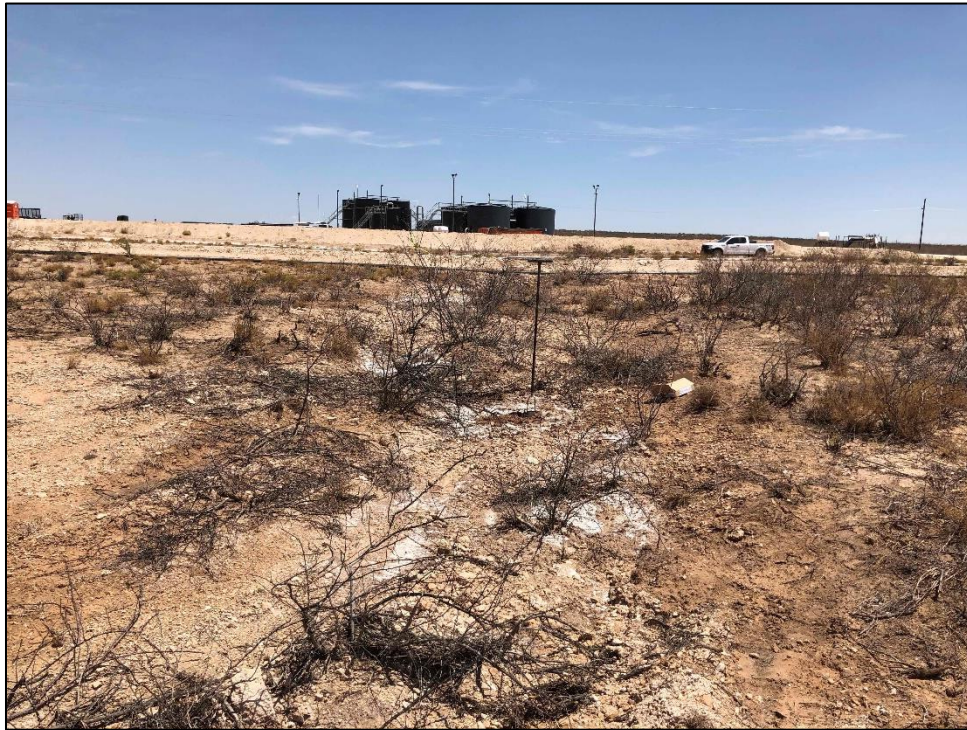
**PHOTO 19:** View of staining and HA-5, facing east. 7/15/2019

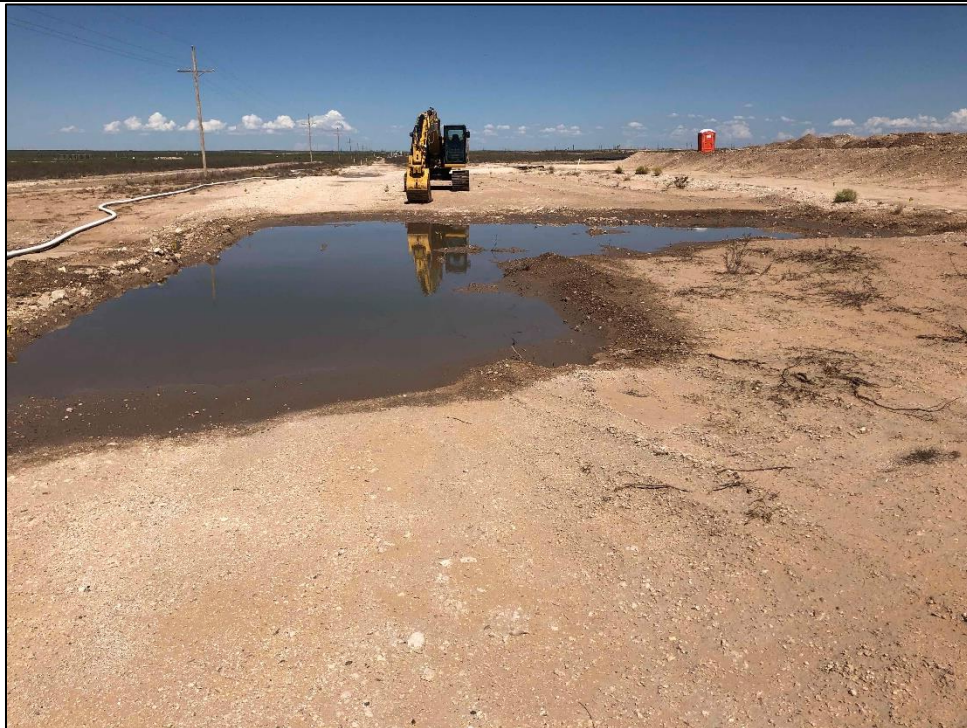
**PHOTO 20:** View of excavation full post rainfall, facing north. 9/26/2019

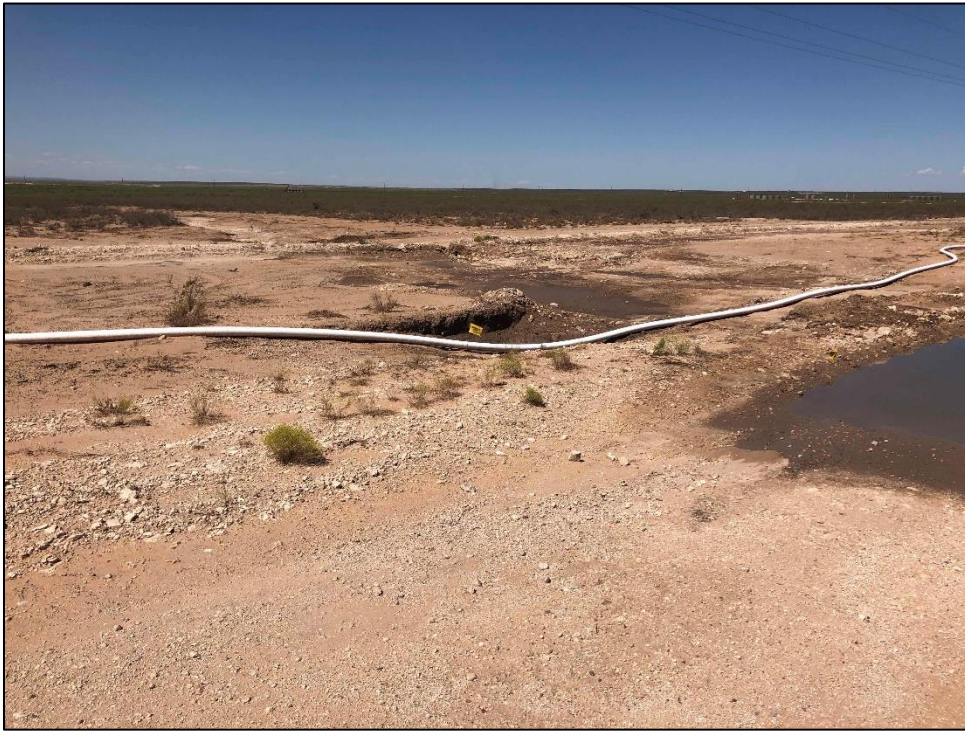
**PHOTO 21:** View of excavation going into natural drainage, facing northwest. 9/26/2019

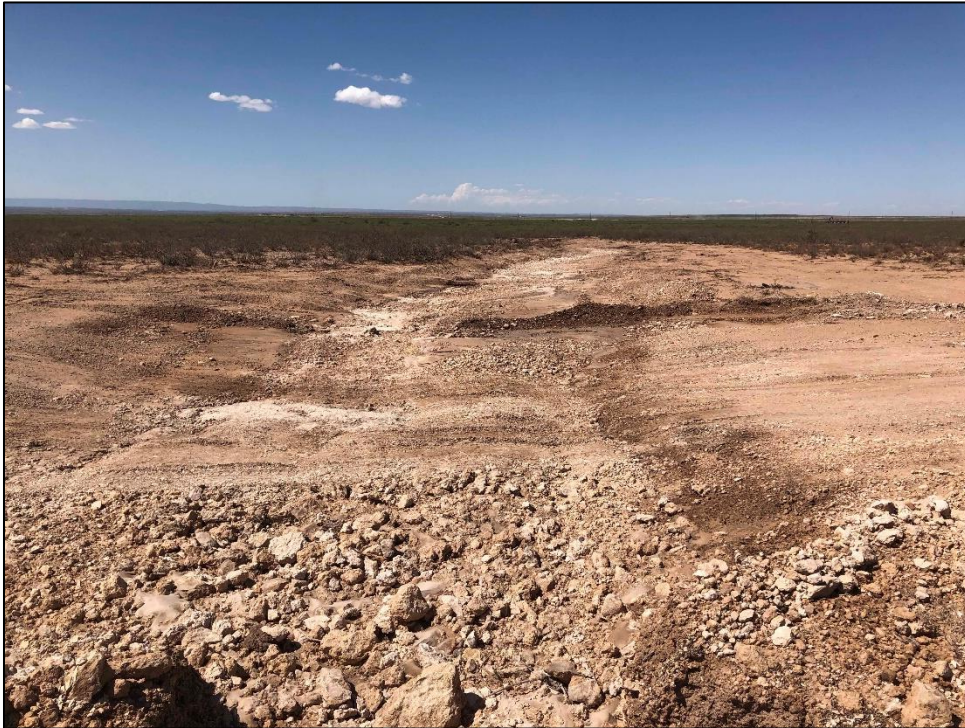
**PHOTO 22:** View of excavation in natural drainage area, facing west. 9/26/2019

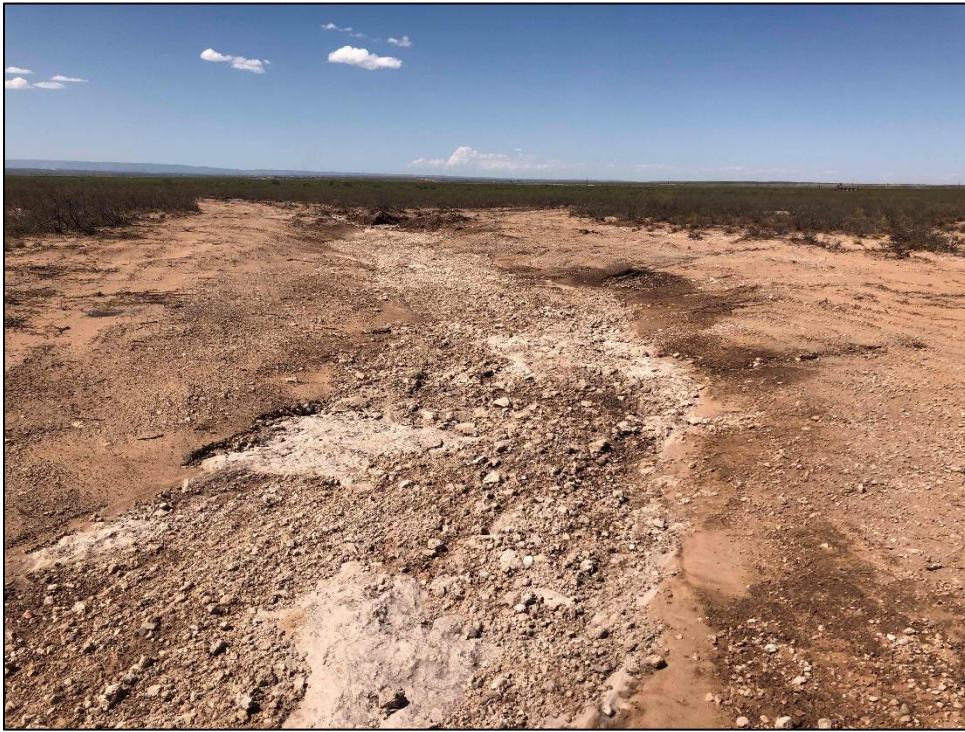
**PHOTO 23:** View of excavation from HA-4, facing west. 9/26/2019

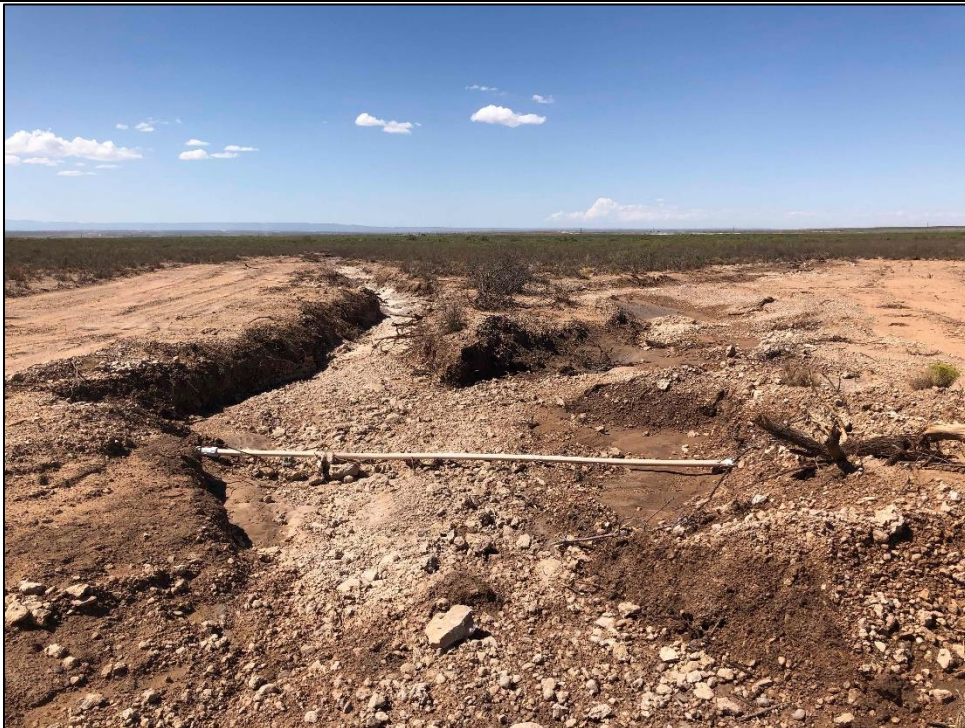
**PHOTO 24:** View of excavation, facing west. 9/26/2019

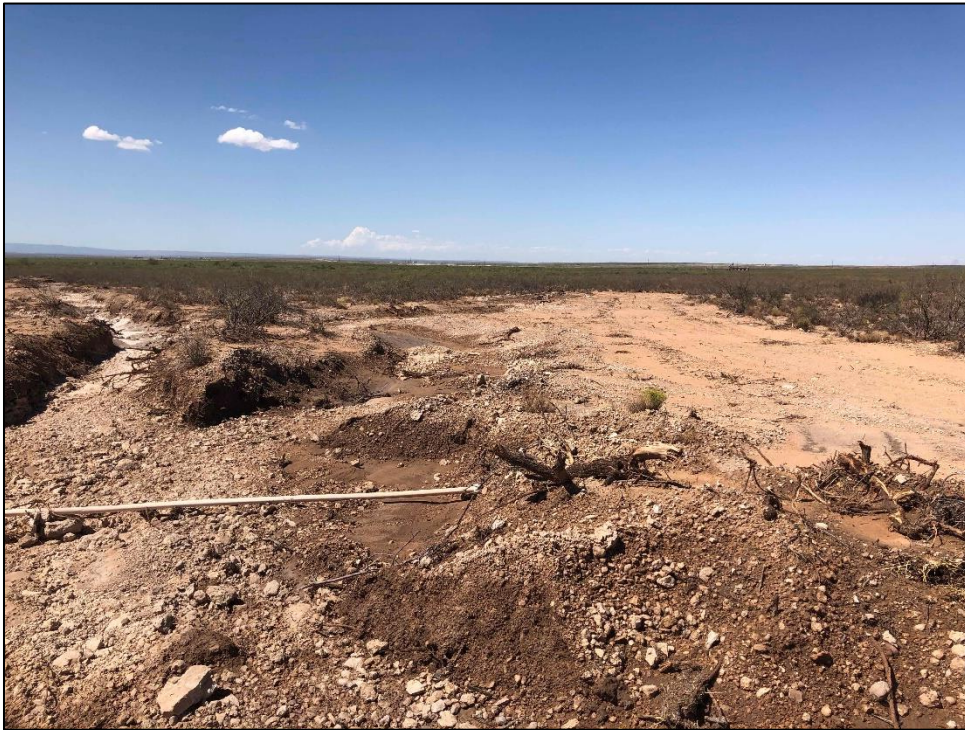
**PHOTO 25:** View of excavation toward HA-3, facing northwest. 9/26/2019

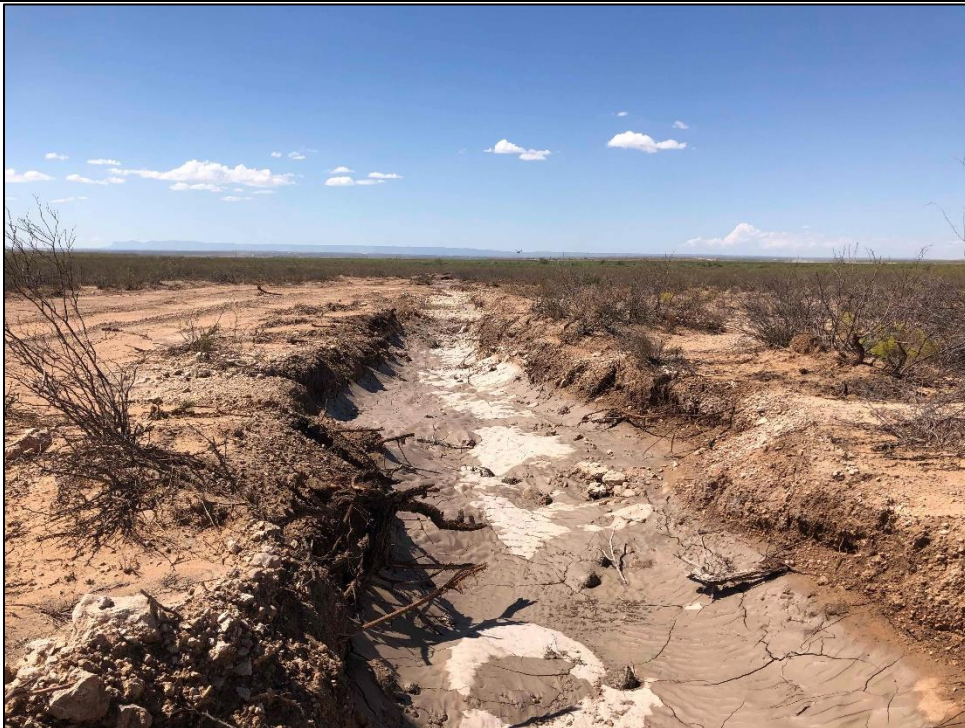
**PHOTO 26:** View of excavation on south fork, facing west. 9/26/2019

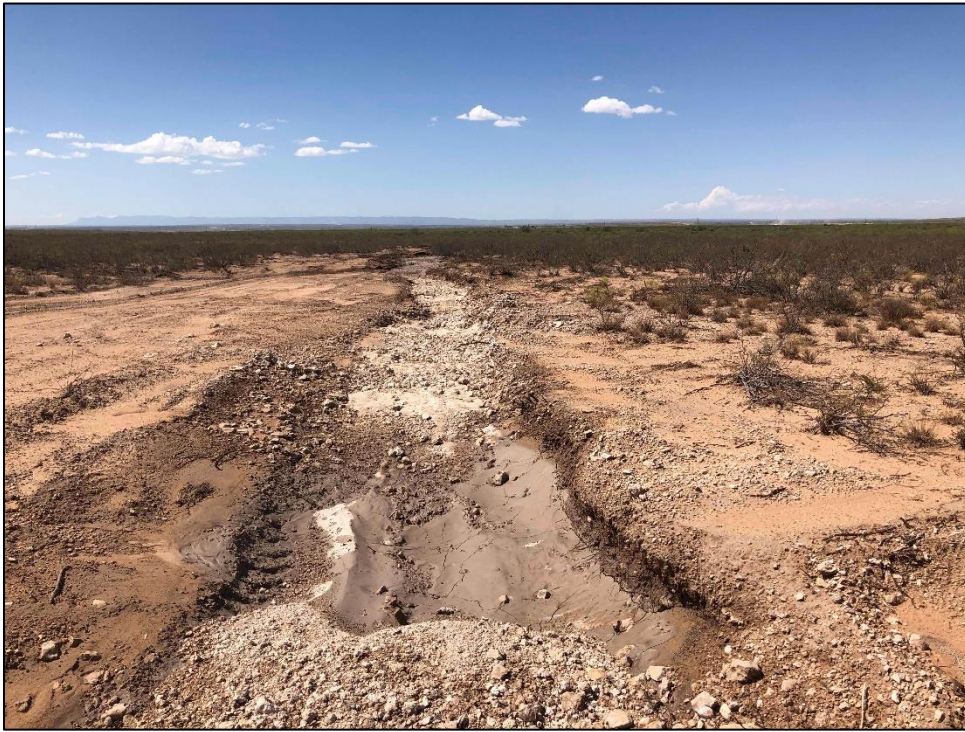
**PHOTO 27:** View of excavation on southern fork continued, facing west. 9/26/2019

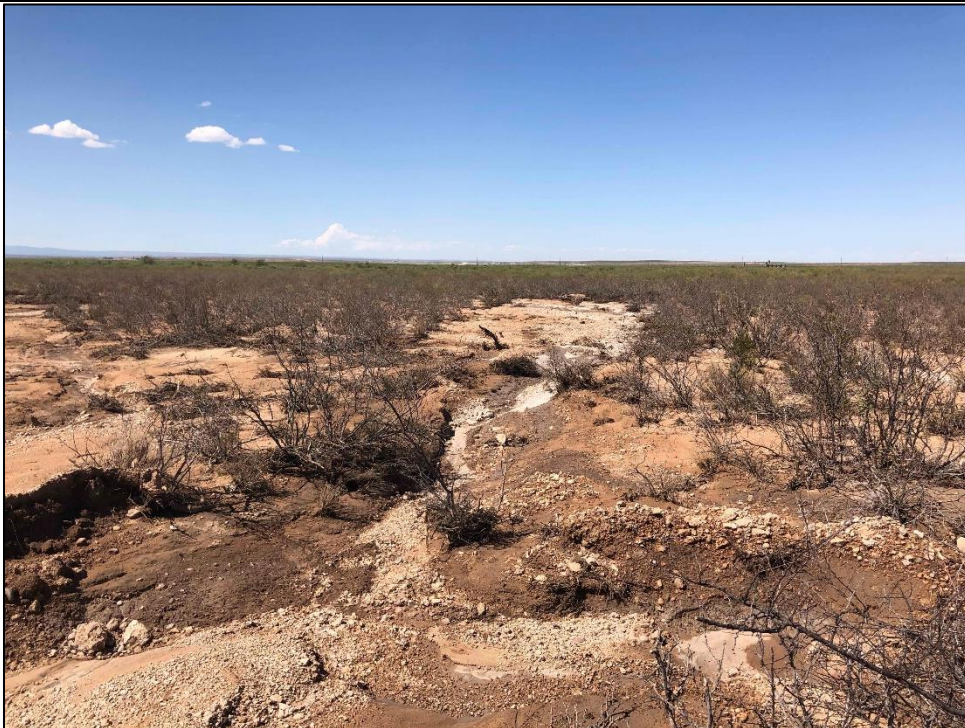
**PHOTO 28:** View of excavation facing HA-2, facing northwest. 9/26/2019

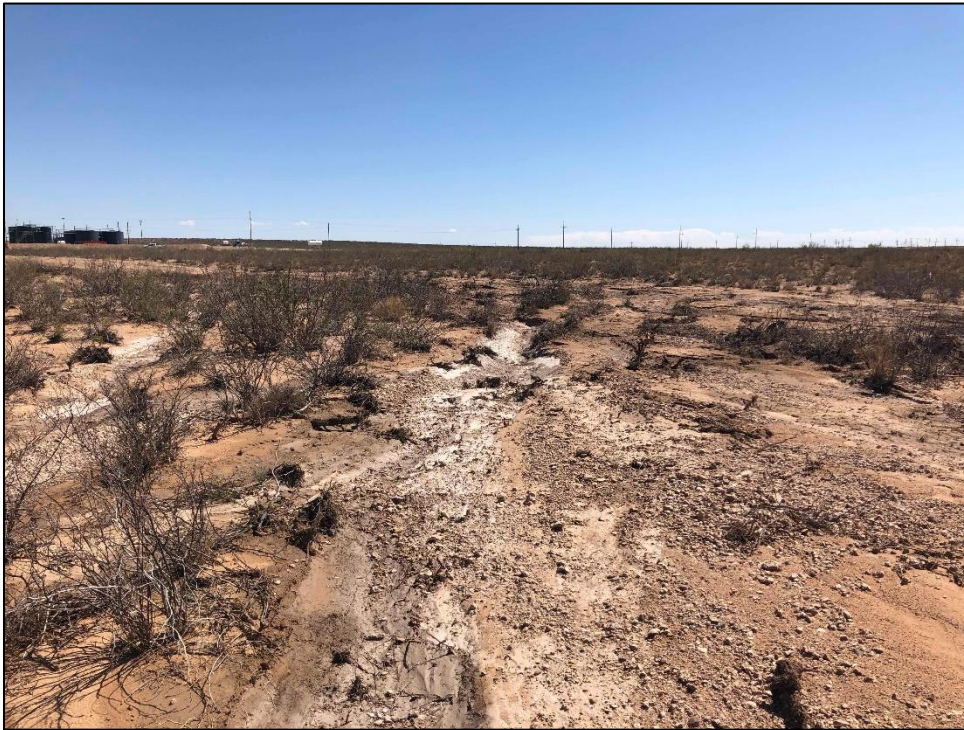
**PHOTO 29:** View of end of excavation facing HA-1, facing west. 9/26/2019

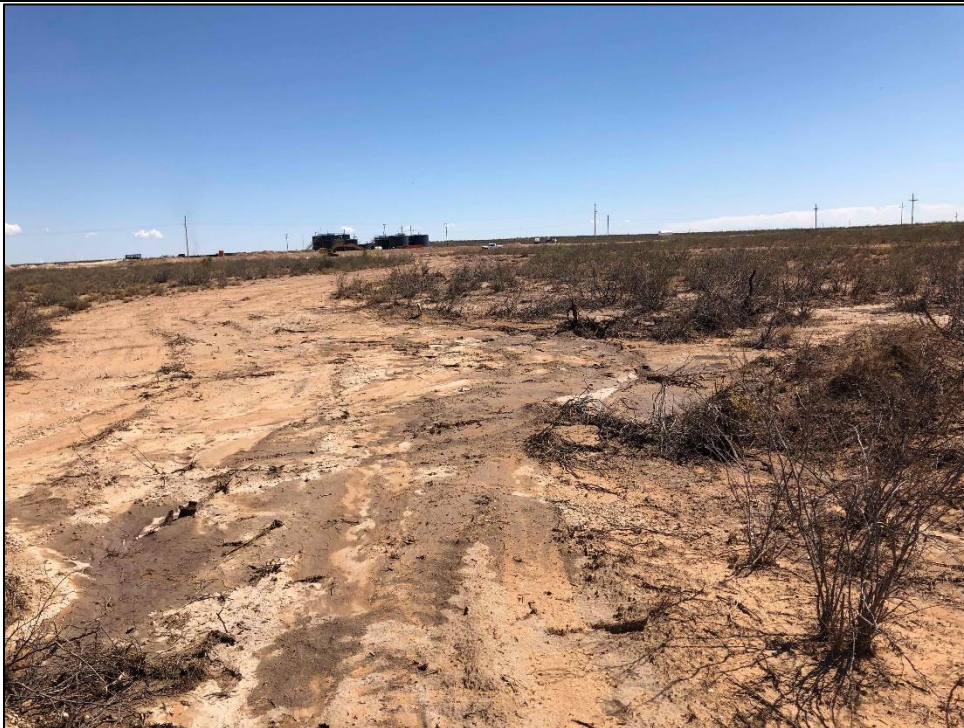
**PHOTO 30:** View of end excavation from HA-3, facing southeast. 9/26/2019

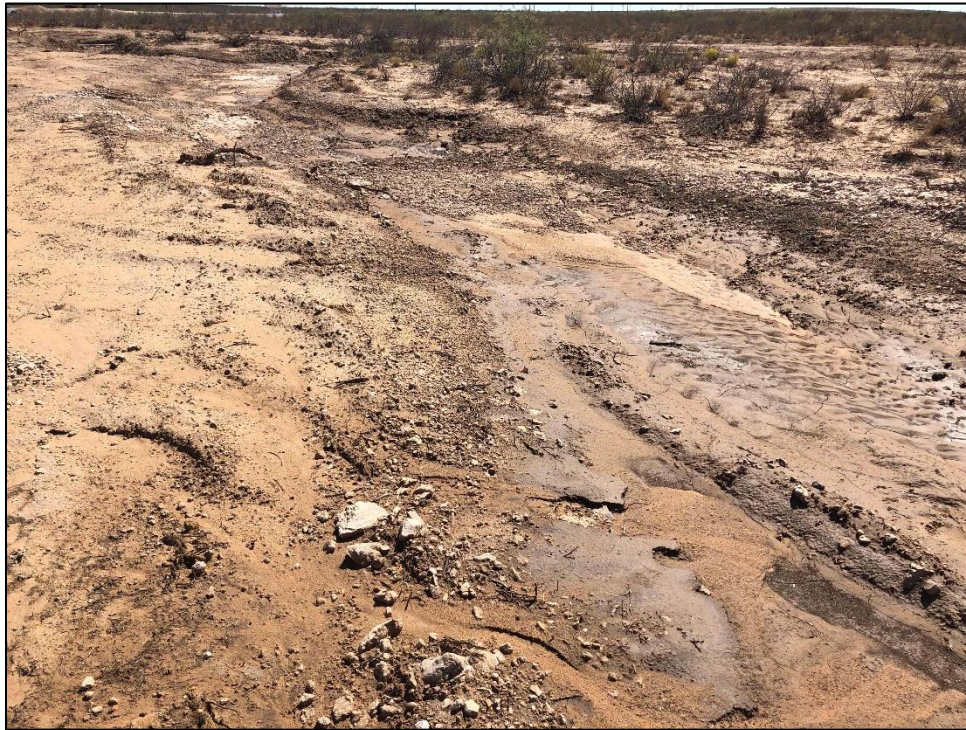
**PHOTO 31:** View of excavation from HA-2, facing southeast. 9/26/2019

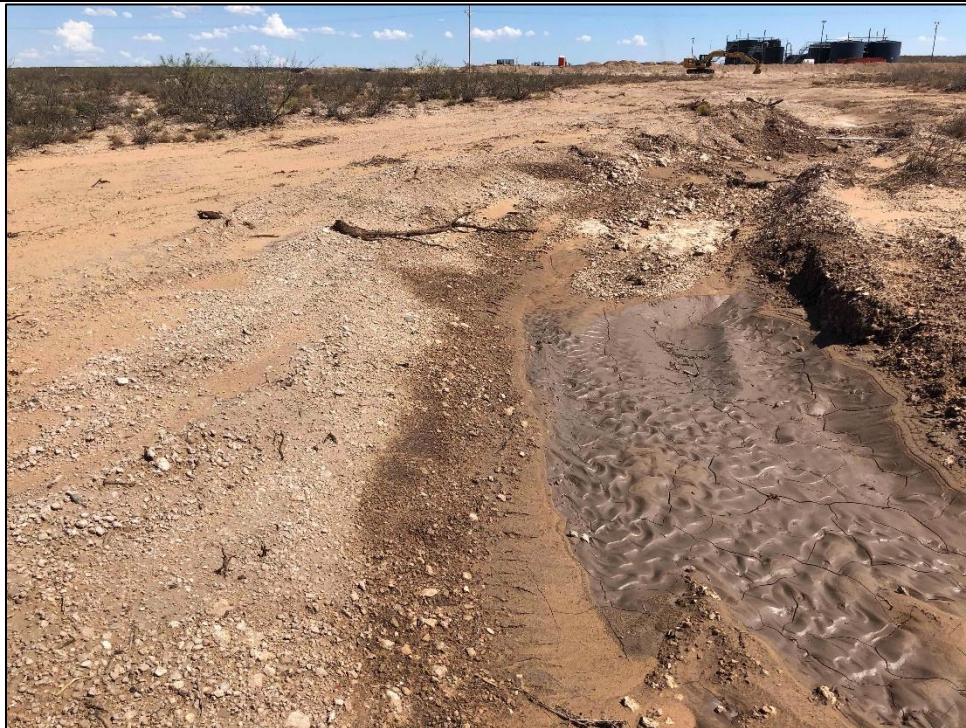
**PHOTO 32:** View of excavation facing HA-4, facing east. 9/26/2019
