# Closure of Release Investigation and Remedial Action Plan

Eddy State #2 SWD

July 17, 2020

Terracon Project No. AR197208

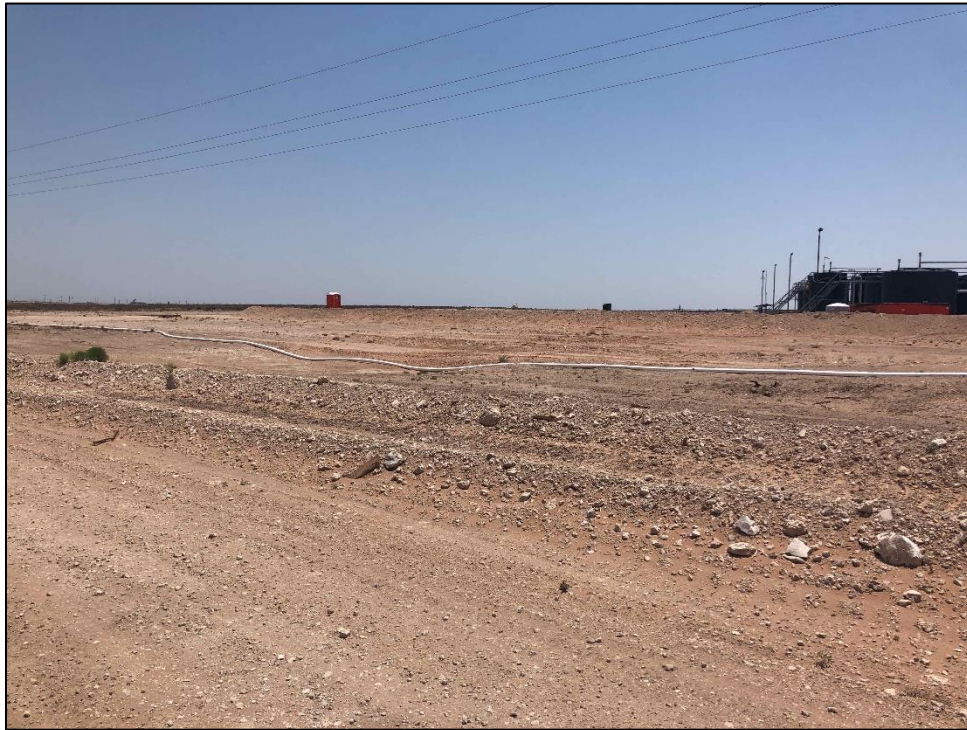
**PHOTO 33:** View of completed remediation, facing east. 6/22/2020

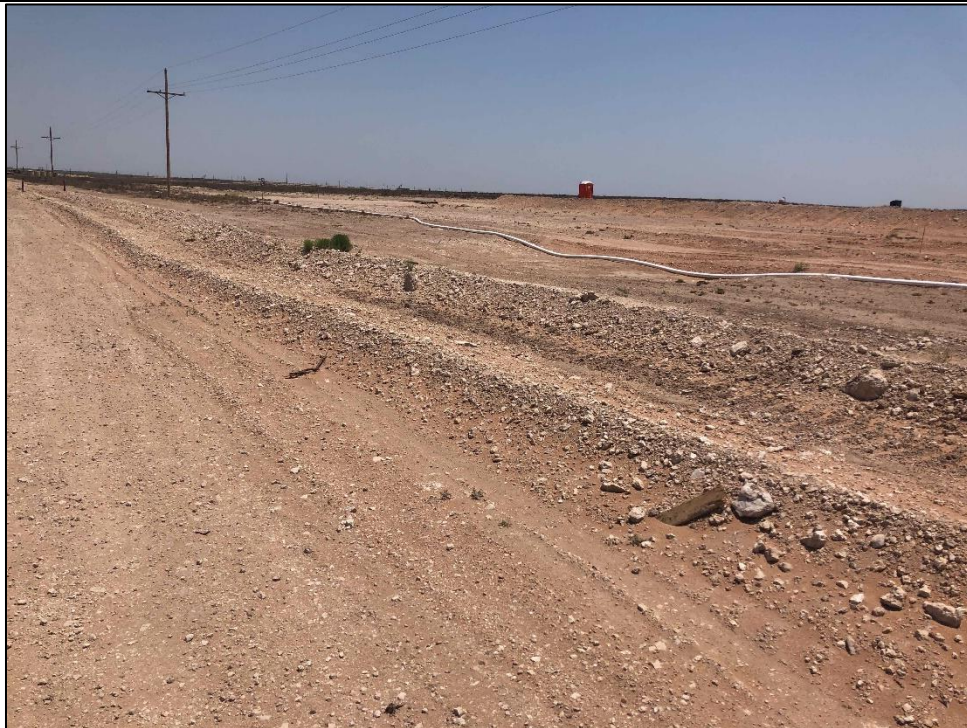
**PHOTO 21:** View of completed remediation, facing northeast. 6/22/2020

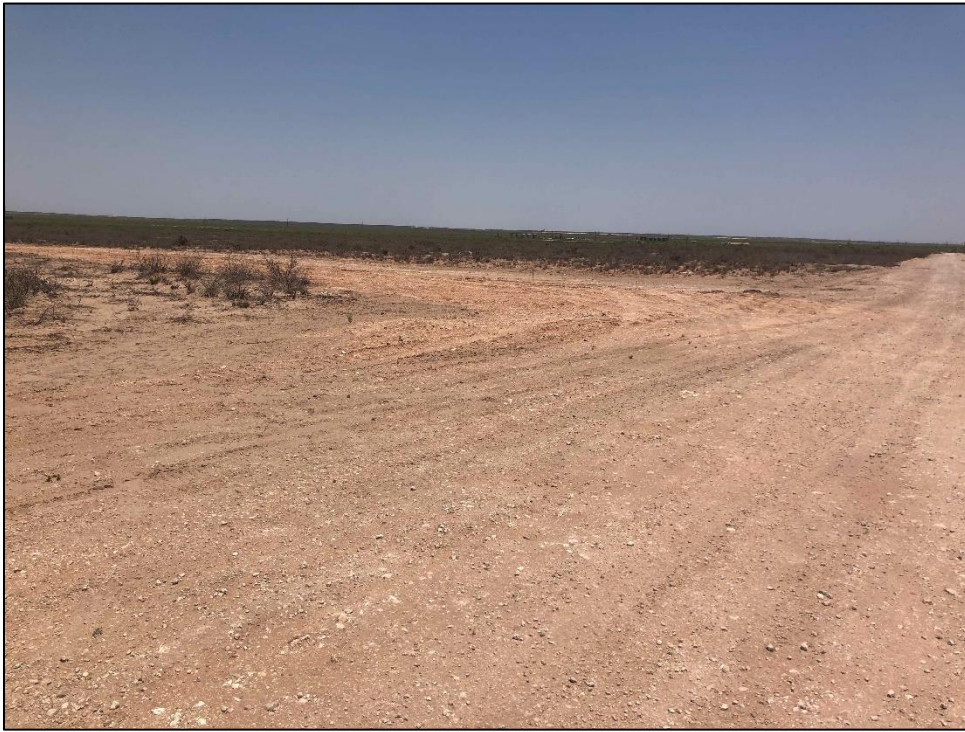
**PHOTO 22:** View of completed remediation in natural drainage area, facing north. 6/22/2020

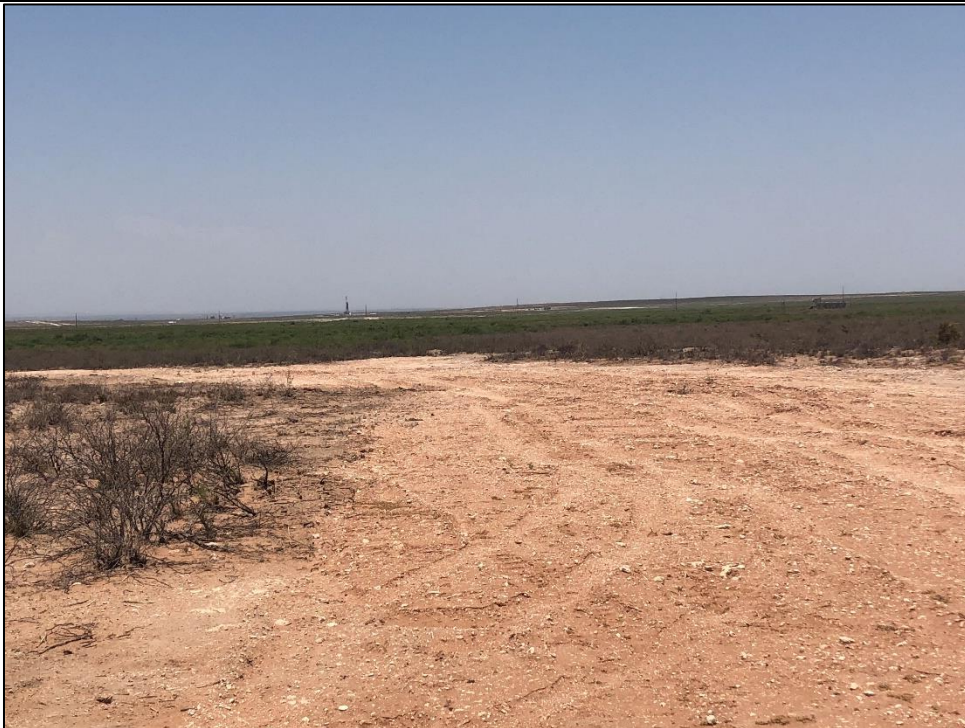
**PHOTO 23:** View of completed remediation in natural drainage area, facing west. 6/22/2020

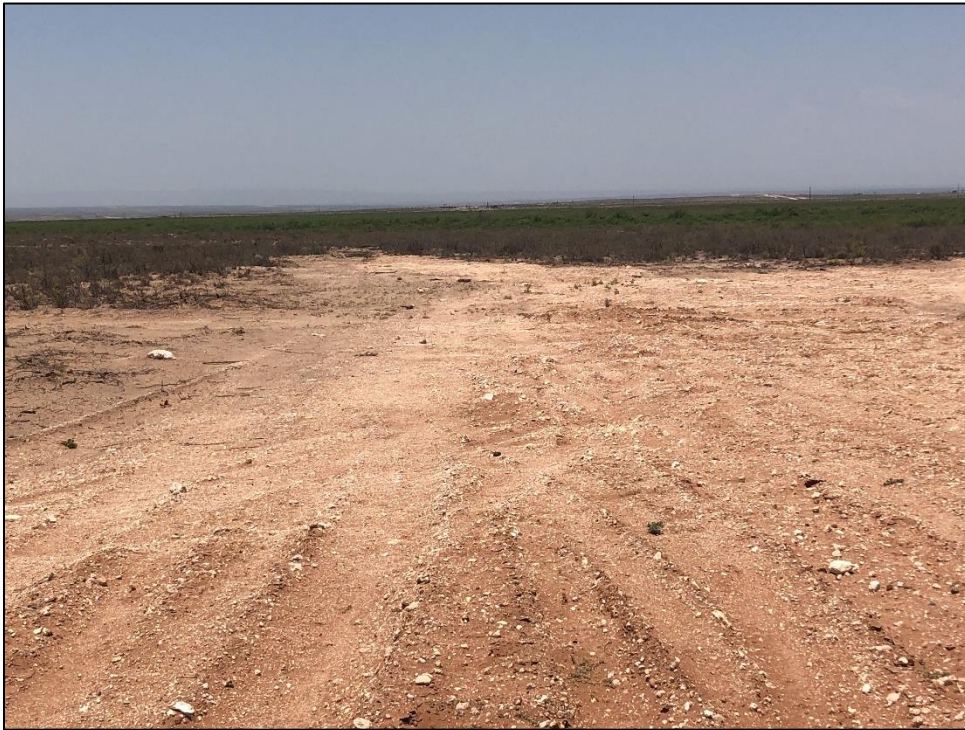
**PHOTO 24:** View of completed remediation toward HA-1, facing west. 6/22/2020

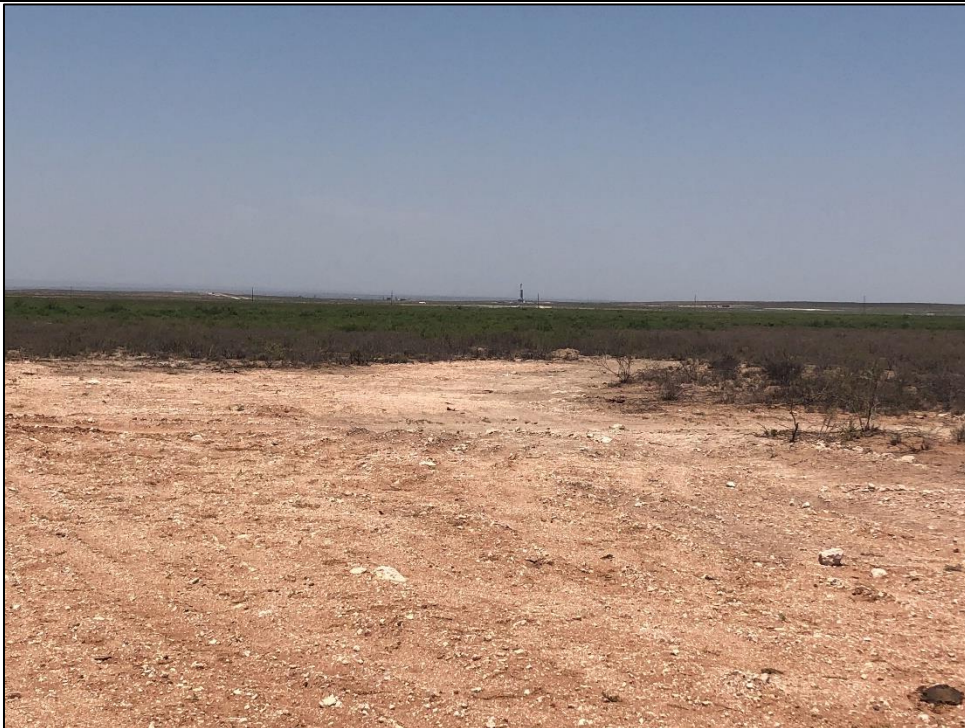
**PHOTO 25:** View of completed remediation toward HA-3, facing northwest. 6/22/2020

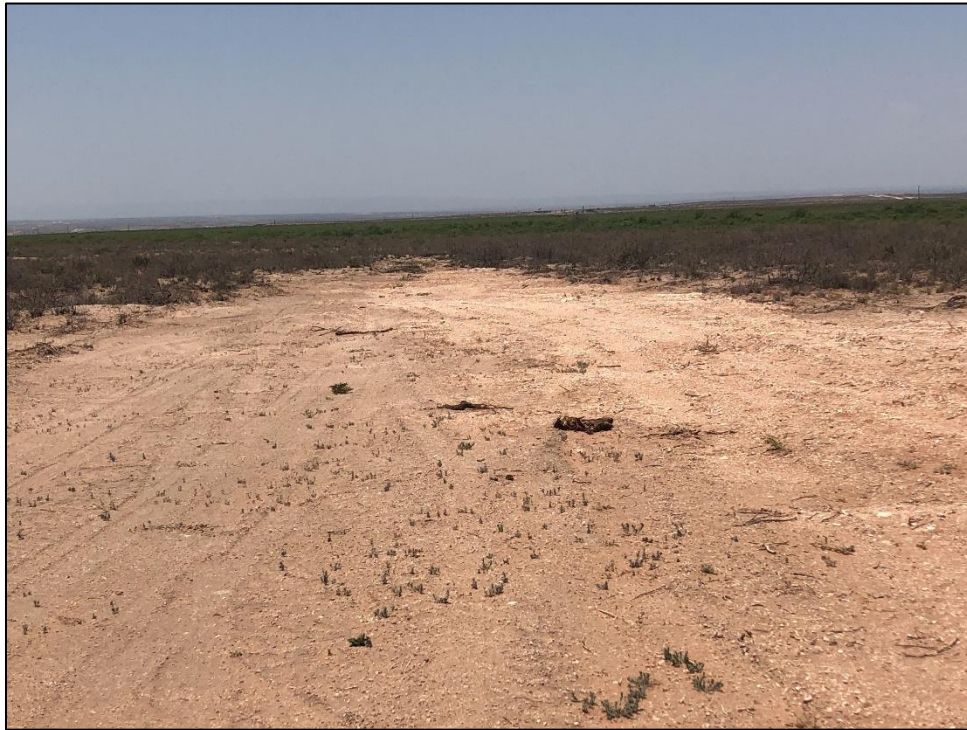
**PHOTO 26:** View of completed remediation toward HA-2, facing west. 6/22/2020

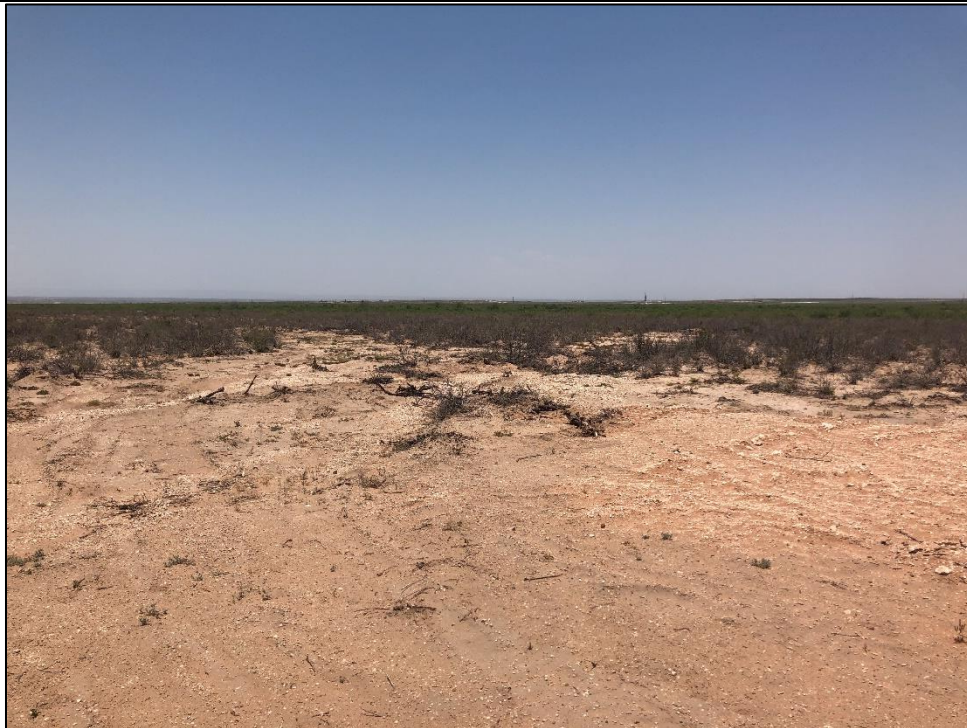
**PHOTO 27:** View of completed remediation toward HA-1, facing west. 6/22/2020

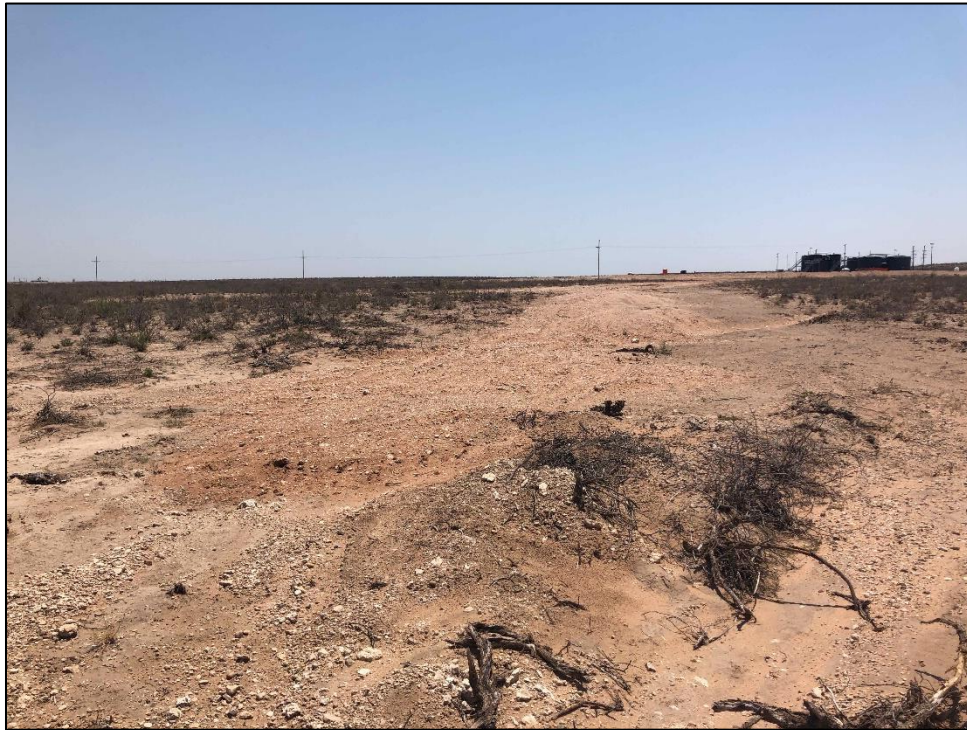
**PHOTO 28:** View of completed remediation from HA-1, facing east. 6/22/2020

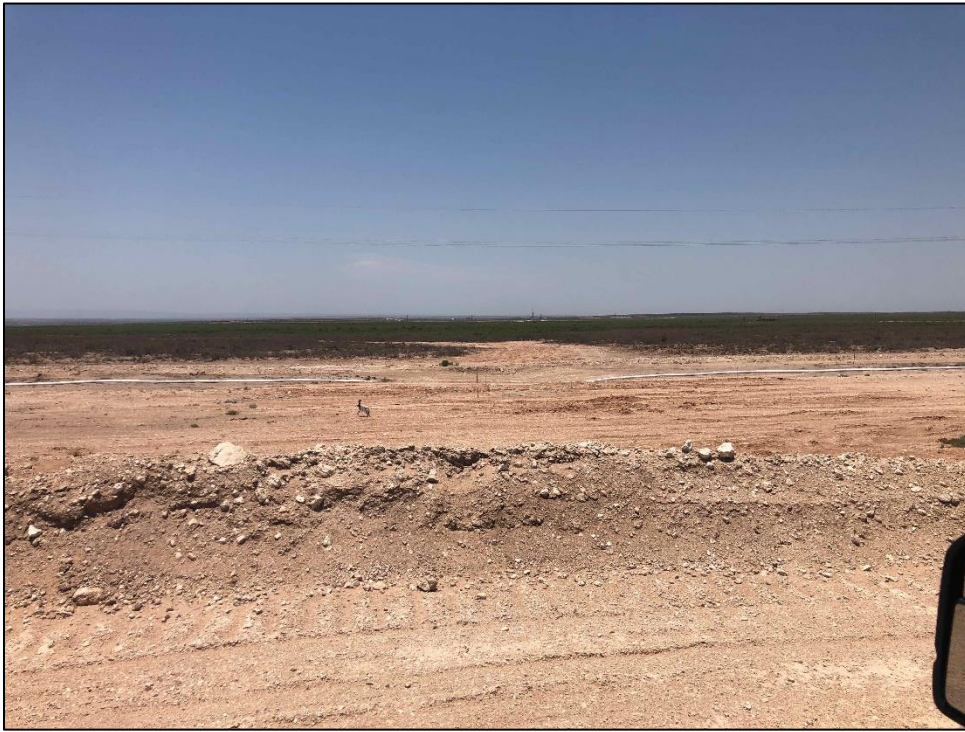
**PHOTO 30:** View of completed remediation, facing west. 6/22/2020
