**Maclaskey Oilfield Services, Inc.**

RE: Release of permit Monument Treating Plant

Regarding our phone conversation concerning the Bandera Monument Treating Plant closure, the following is an outline of the procedure, photo's and test results. Initially, surface equipment was removed and the area was then scrapped of the granite pea gravel mixed with slightly off colored soil on June 21, 2004. The soil area, (photo's 1, 2 & 3) appeared dry and unsaturated with no hydrocarbon odor. Approximately 84 yards of gravel with some soil was recovered and taken off site. Three areas were sampled and taken within the foot prints of each tank on July 16, 2004. Testing for total petroleum hydrocarbons test 418.1 was conducted by Cardinal Laboratories in Hobbs, New Mexico. The results dated July 19, 2004 are enclosed.

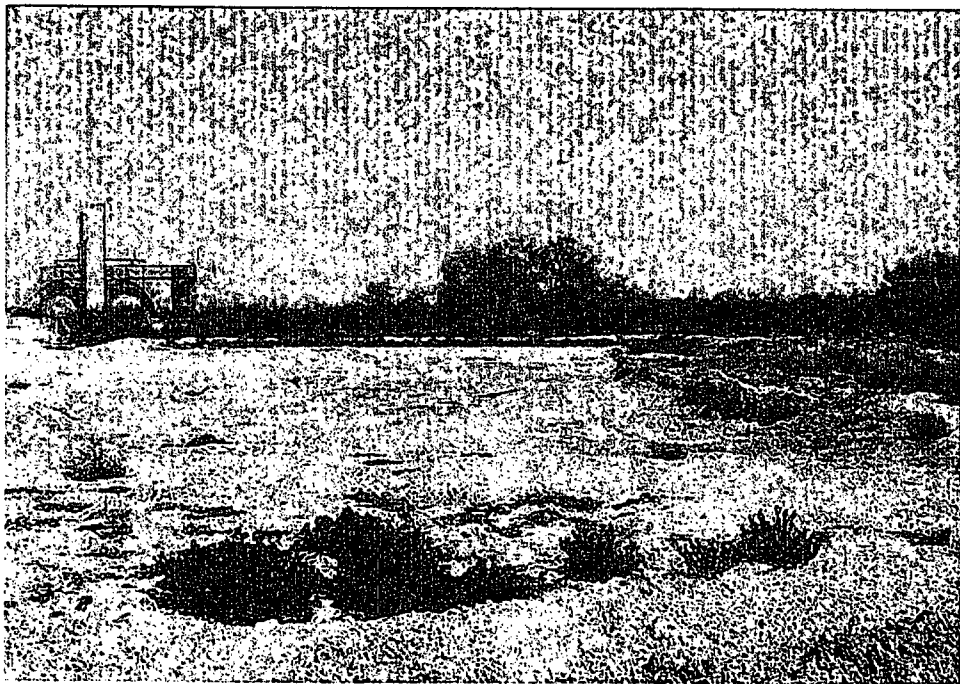
④

Upon receiving the test results, we removed an additional 72 yards of soil material within the impacted area on July 29, 2004, (photo's 4 & 5). Samples were then taken in the three areas within each tanks foot print area on August 27, 2004. The soil appeared dry,

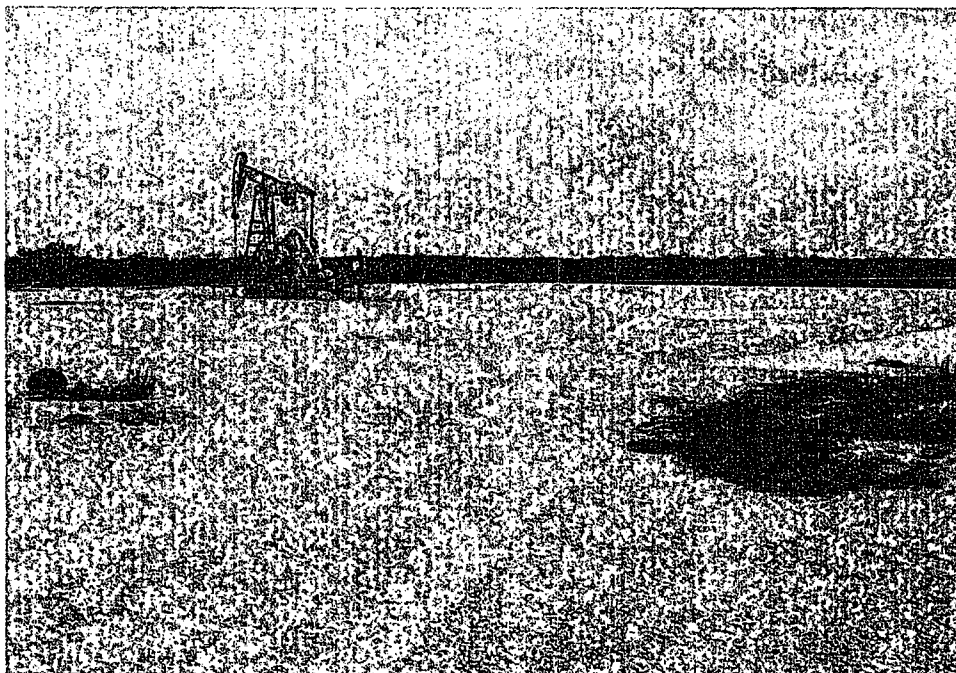
9

Final testing was done with the combined samples of the foot prints for BTEX. Cardinal Laboratories conducted the test dated September 16, 2004. The BTEX method test SW846-8260 results are enclosed. Upon receiving those results we re-leveled the area using the existing adjacent oil wells location pad from the west side to replace the pad on the east for servicing of the existing active oil well (photo 6). An overview of the location with pictures (photo 7), showing the inactive oil well dry hole marker looking to the south. Looking to the north with (photo 8) showing the adjacent wells, batteries and pipelines. Entering the location looking towards the southeast (photo 9).
