losure Report

Site Description						
Site Name:	JR Holt NCT A #6Y Battery					
Company:	Oxy Permian Ltd.					
Legal Description:	U/L G, Section 16, T24S, R37E					
County:	Lea County, NM					
GPS Coordinates:	N 32.21735° W 103.16608°

Release Data						
Date of Release:	03/28/2015					
Type of Release:	Oil and produced water					
Source of Release:	Vent line corroded					
Volume of Release:	15 bbls produced water, 8 bbls oil					
Volume Recovered:	Unknown

Soil Assessment and Remediation Work Plan

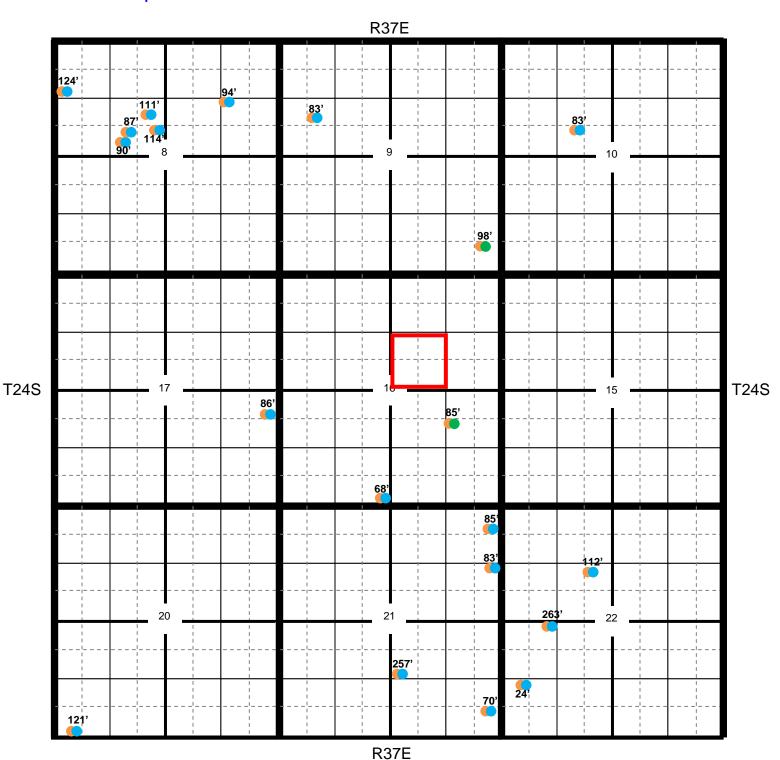
Trend Map 75'-100'

Groundwater Plot

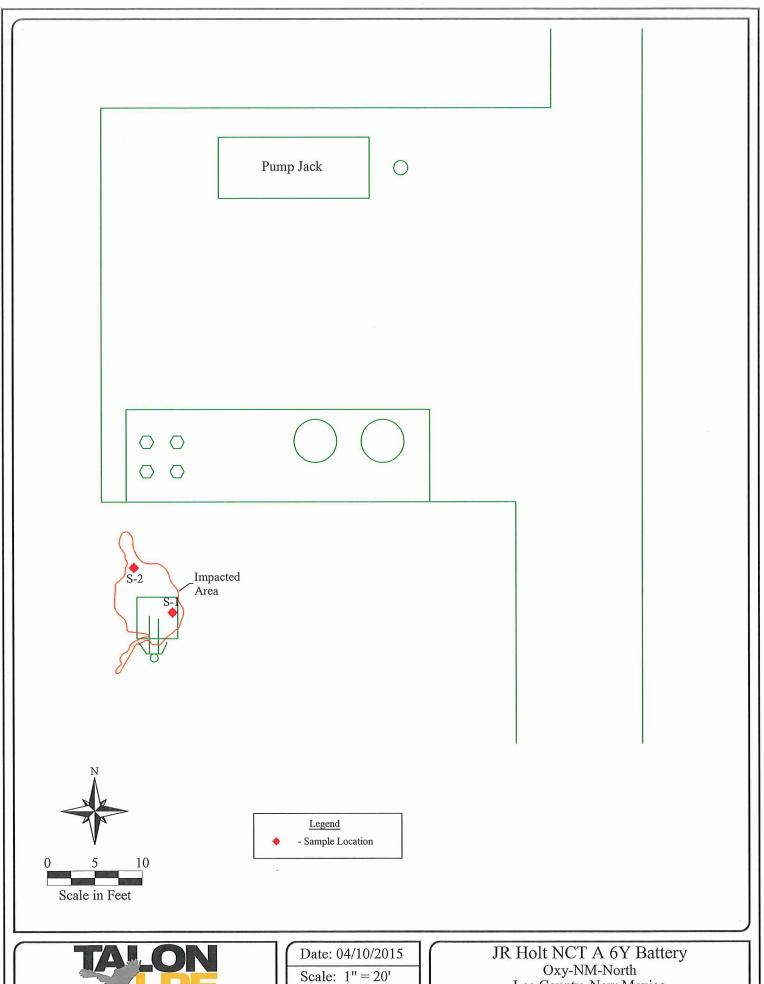
JR Holt NCT A 6Y Battery
Oxy-NM-North
Lea County, New Mexico Figure 1 - Site Plan

A vent line corroded causing a release of 23 barrels of mixed fluids which breached the containment berms. A vac truck was immediately called to the location, recovering an unknown amount of fluids. The impacted area was within the berms surrounding the vent and the flow path breaching the berms measuring approximately 20' x 20' in the pasture around surrounding the berm.

- The impacted area in the vicinity of S-1 will be excavated to a minimum depth of 3.5-feet bgs. Field PID readings will be used to guide the excavation. Once field results indicate that the impacted soil is below NMOCD Recommended Remedial Action Level's (RRAL's) a confirmation soil sample will be taken to insure all of the impacted material was removed.

- The impacted area in the vicinity S-2 will be excavated a minimum of 2.5-feet deep. Field PID readings will be used to guide the excavation. Once field results indicate that the impacted soil is below NMOCD Recommended Remedial Action Level's (RRAL's) confirmation soil samples will be taken to insure all of the impacted material was removed.
