Release Notification and Corrective Action

Name of Company EnergyQuest II, LLC	Contact Larry D. Davis	
Address 4526 Research Forest Dr, Ste 200, The Woodlands, TX 77381	Telephone No. 281.651.5201	
Facility Name STATE AO #2 and STATE C #1 & #2	Facility Type Oil & Gas flow lines from wells to co-mingled battery	
Surface Owner	Mineral Owner	API No.

1RP-4359

Photos of fire damage (July 2016) – State AO #2 and State C #1 & #2

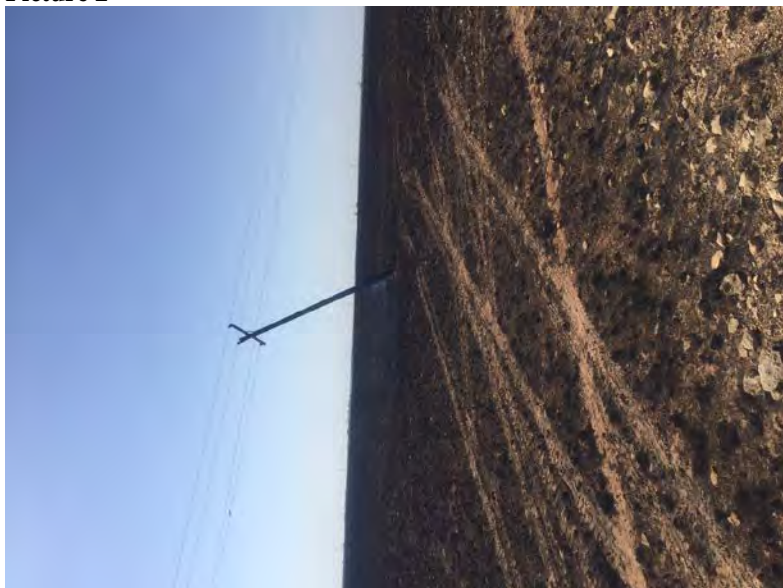
Picture 5 - Powerline pole on fire

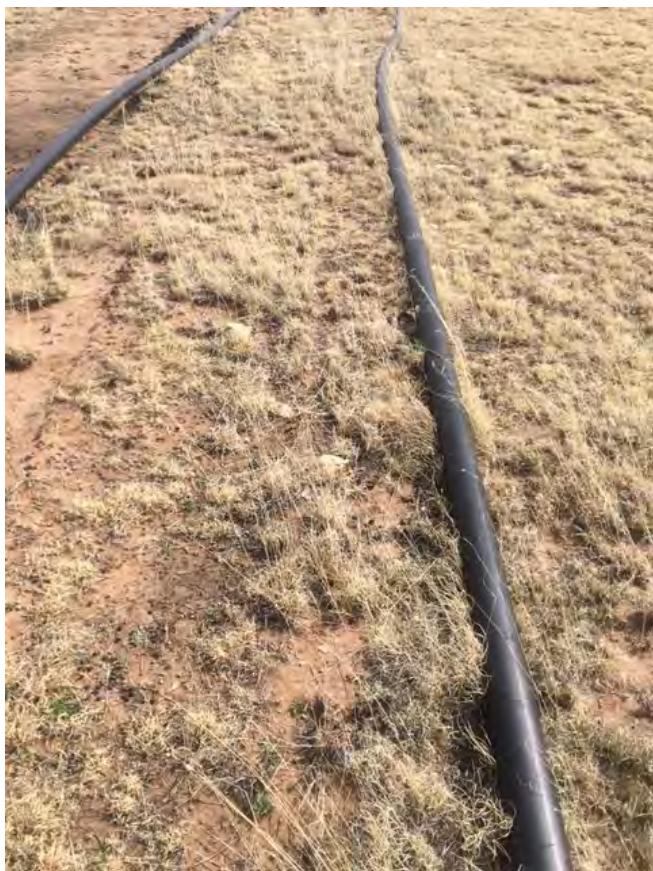
Picture 6 - February 2017

Photos of Vegetation Recovery (February 2017) - State AO #2 and State C #1 & #2

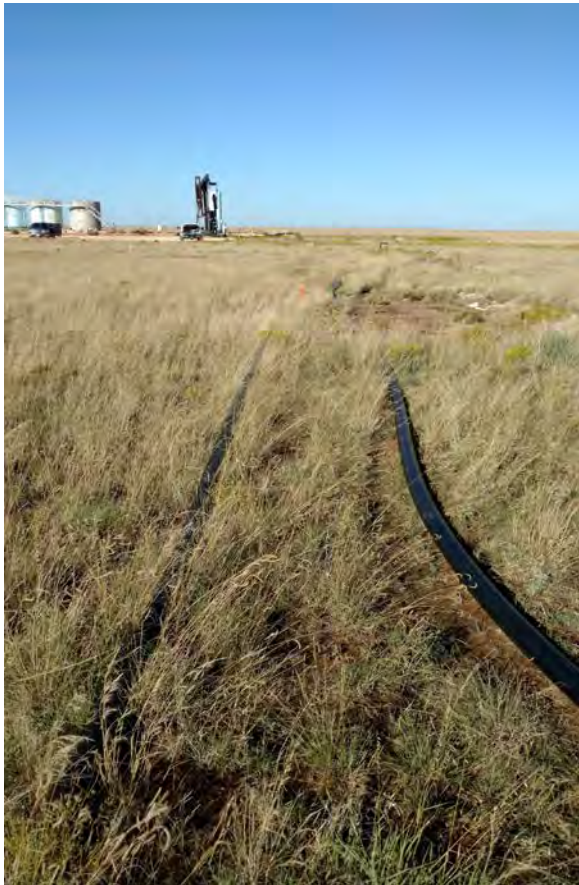
Picture 10 - October 2017

Photos of Vegetation Recovery (October 2017) - State AO #2 and State C #1 & #2
