Heidel, Samberson, Cox & McMahon
Epperson 16-Inch Pipeline (Release #1)
Lea County, New Mexico
NMOCD Ref. #: 1RP-4664

Analytical Report 579492
for
Trinity Oilfield Services & Rentals, LLC

Project Manager: Ben Arguijo
Epperson 16-Inch Pipeline (Release Site #1)

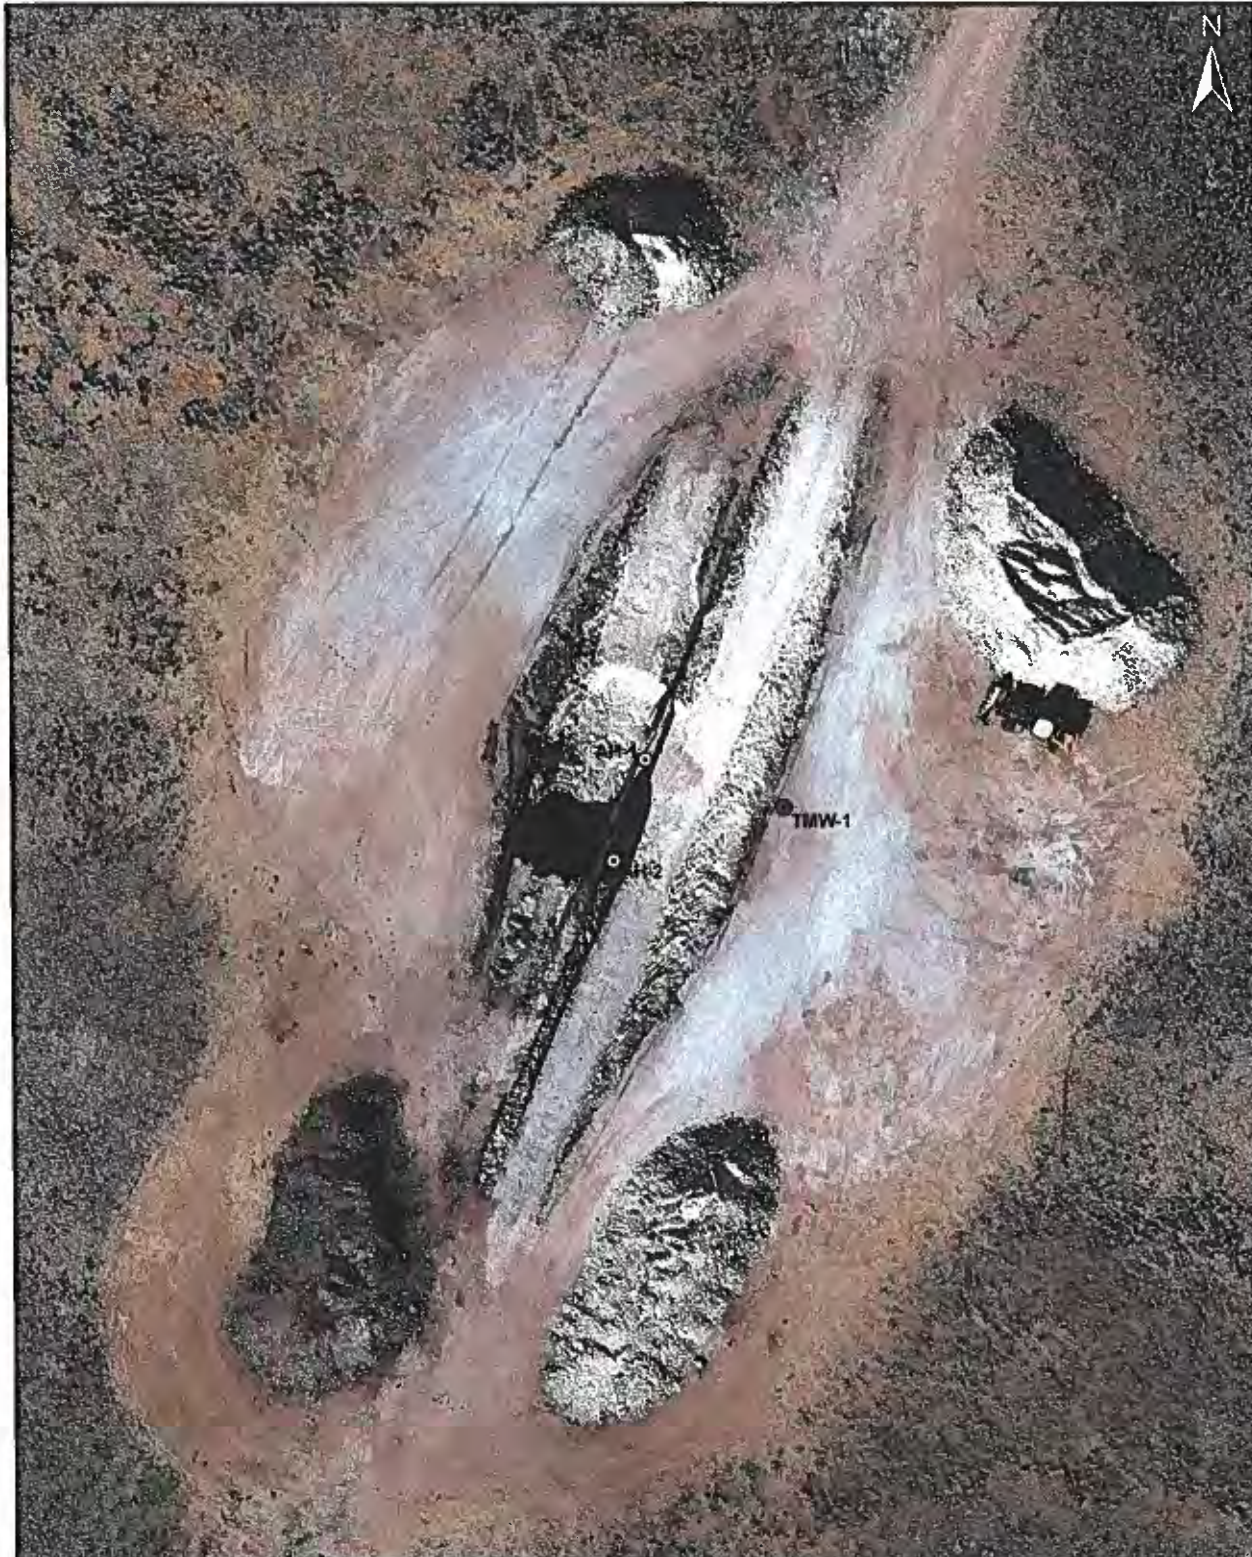
Figure 1 Aerial

- Auger Hole
- Temporary Monitor Well
