Marshall & Winston, Inc.
Loco Dinero 36 State 2H
Unit O-Sec. 28-T21S-R34E, Lea Co., NM
Produced Water Spill
Affected Surface Area – 12,495 sq. ft. / .29 acre
GPS Coordinates: N32.44395 W103.47352

OCD Case Number 1RP-5069

Release Notification and Corrective Action

Release Characterization / Delineation Plan

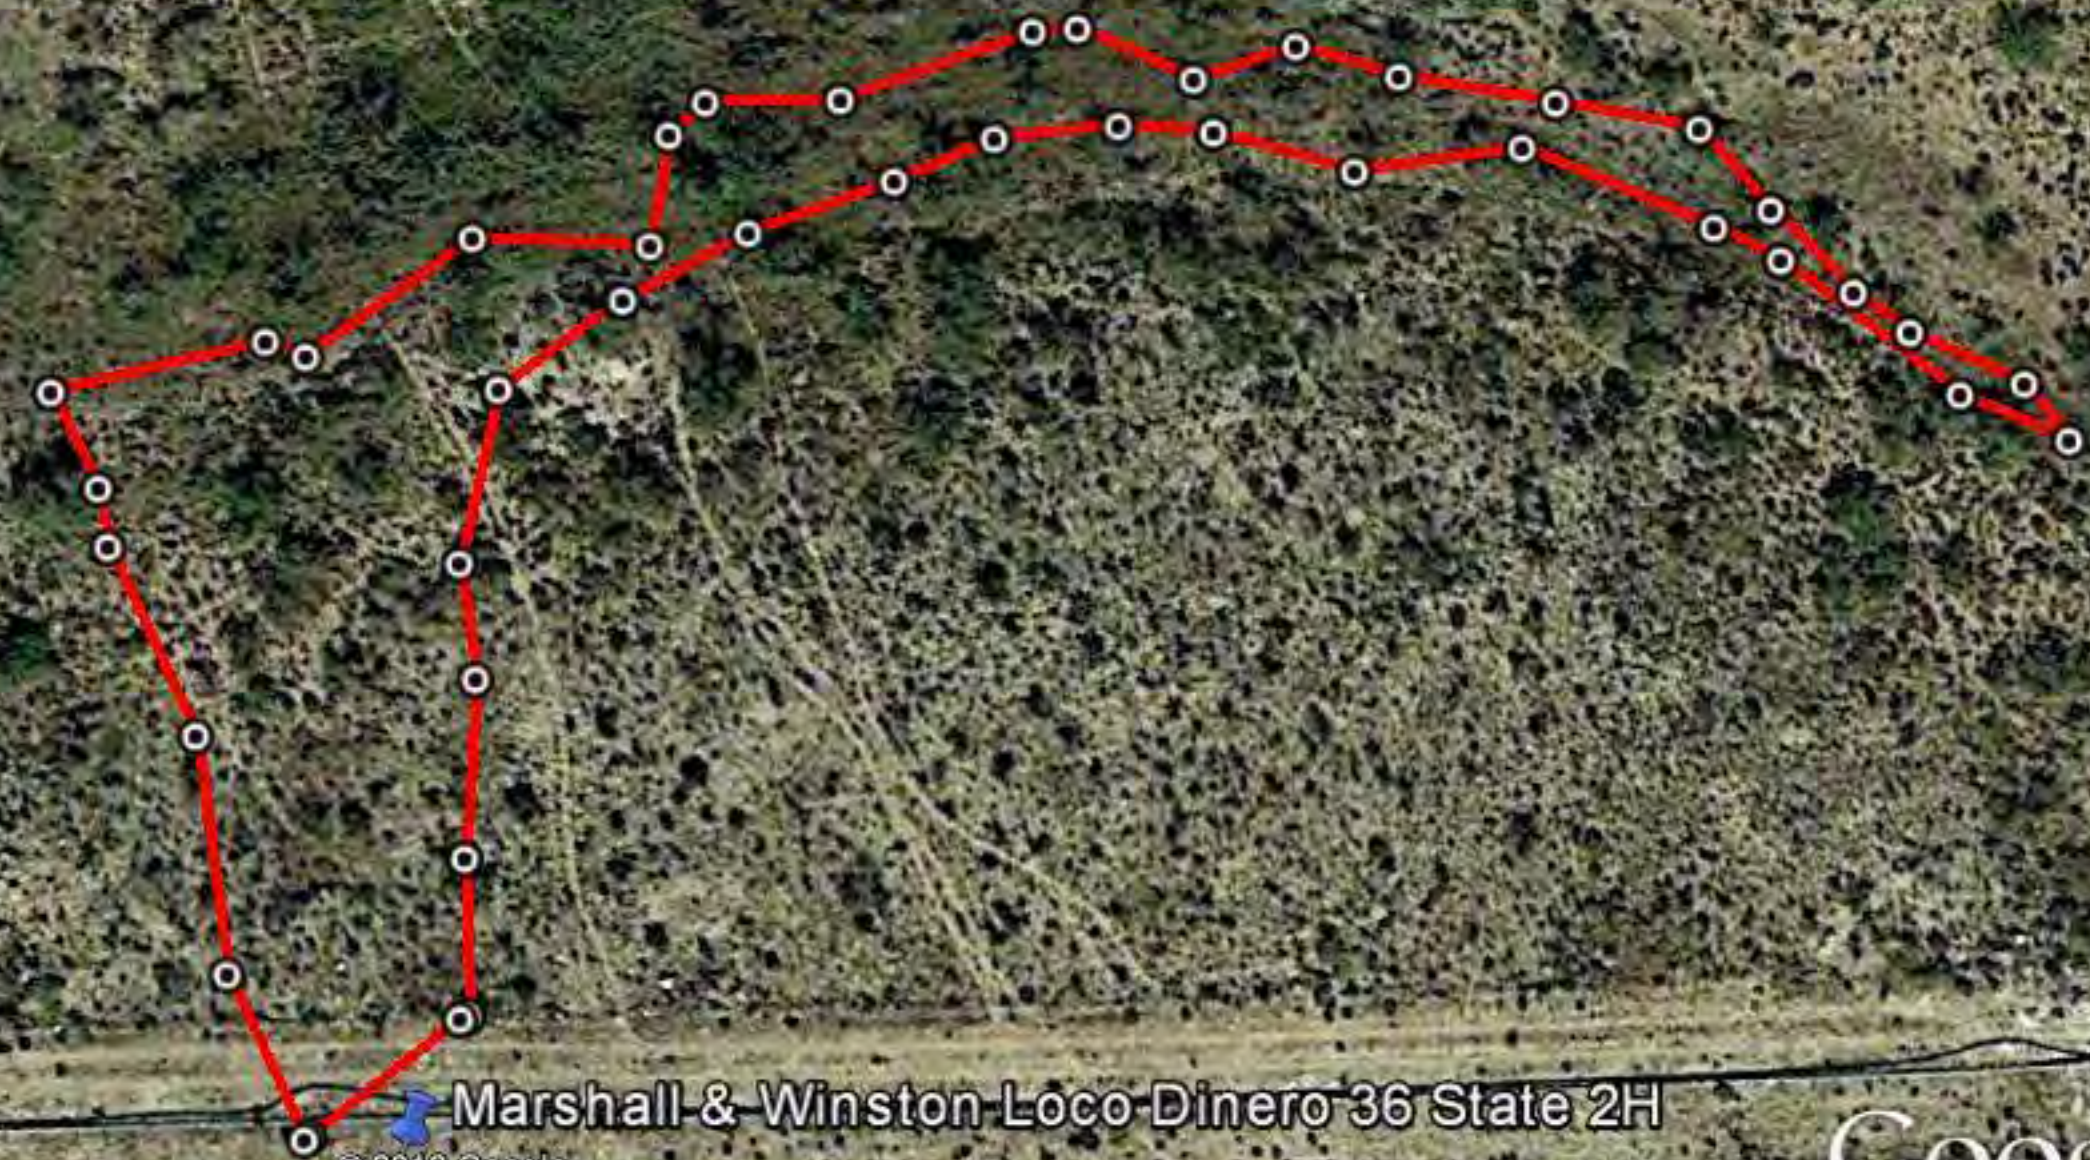
Marshall & Winston, Inc.
Loco Dinero 36 State 2H
Produced Water Spill
Affected Surface Area - 12,495 sq. ft. / .29 acre
GPS Coordinates: N32.44395
W103.47352

With the approval from the NMOCD, Marshall & Winston, Inc. and BCC, Inc. would like to begin delineating this site both horizontally and vertically to determine the extent of the impacted soils. On-site field testing for chlorides will be performed on the soil and the GPS coordinates for the sample locations will be recorded for our subsequent report. Once all delineation procedures have been completed, BCC, Inc. will submit an excavation plan for NMOCD's approval based on all of the field sampling data which was obtained. Once the approval is given and the excavation and disposal of the affected soil is complete, a set of bottom and sidewall soil samples will be pulled and laboratory tested for BTEX, TPH, and chlorides. A revegetation plan will also be submitted seeking the approval from both the NMOCD and the NMSLO.
