**JR OIL LTD. CO.
ENVIRONMENTAL SITE SUMMARY & SPILL REMEDIATION PLAN**

Site Name: Eaton B AC #1 **NM OCD Reference #:** 1RP-4591

Date/Time of Release: 1/15/2017, 5:00 AM **Type of Release:** Produced water & crude oil

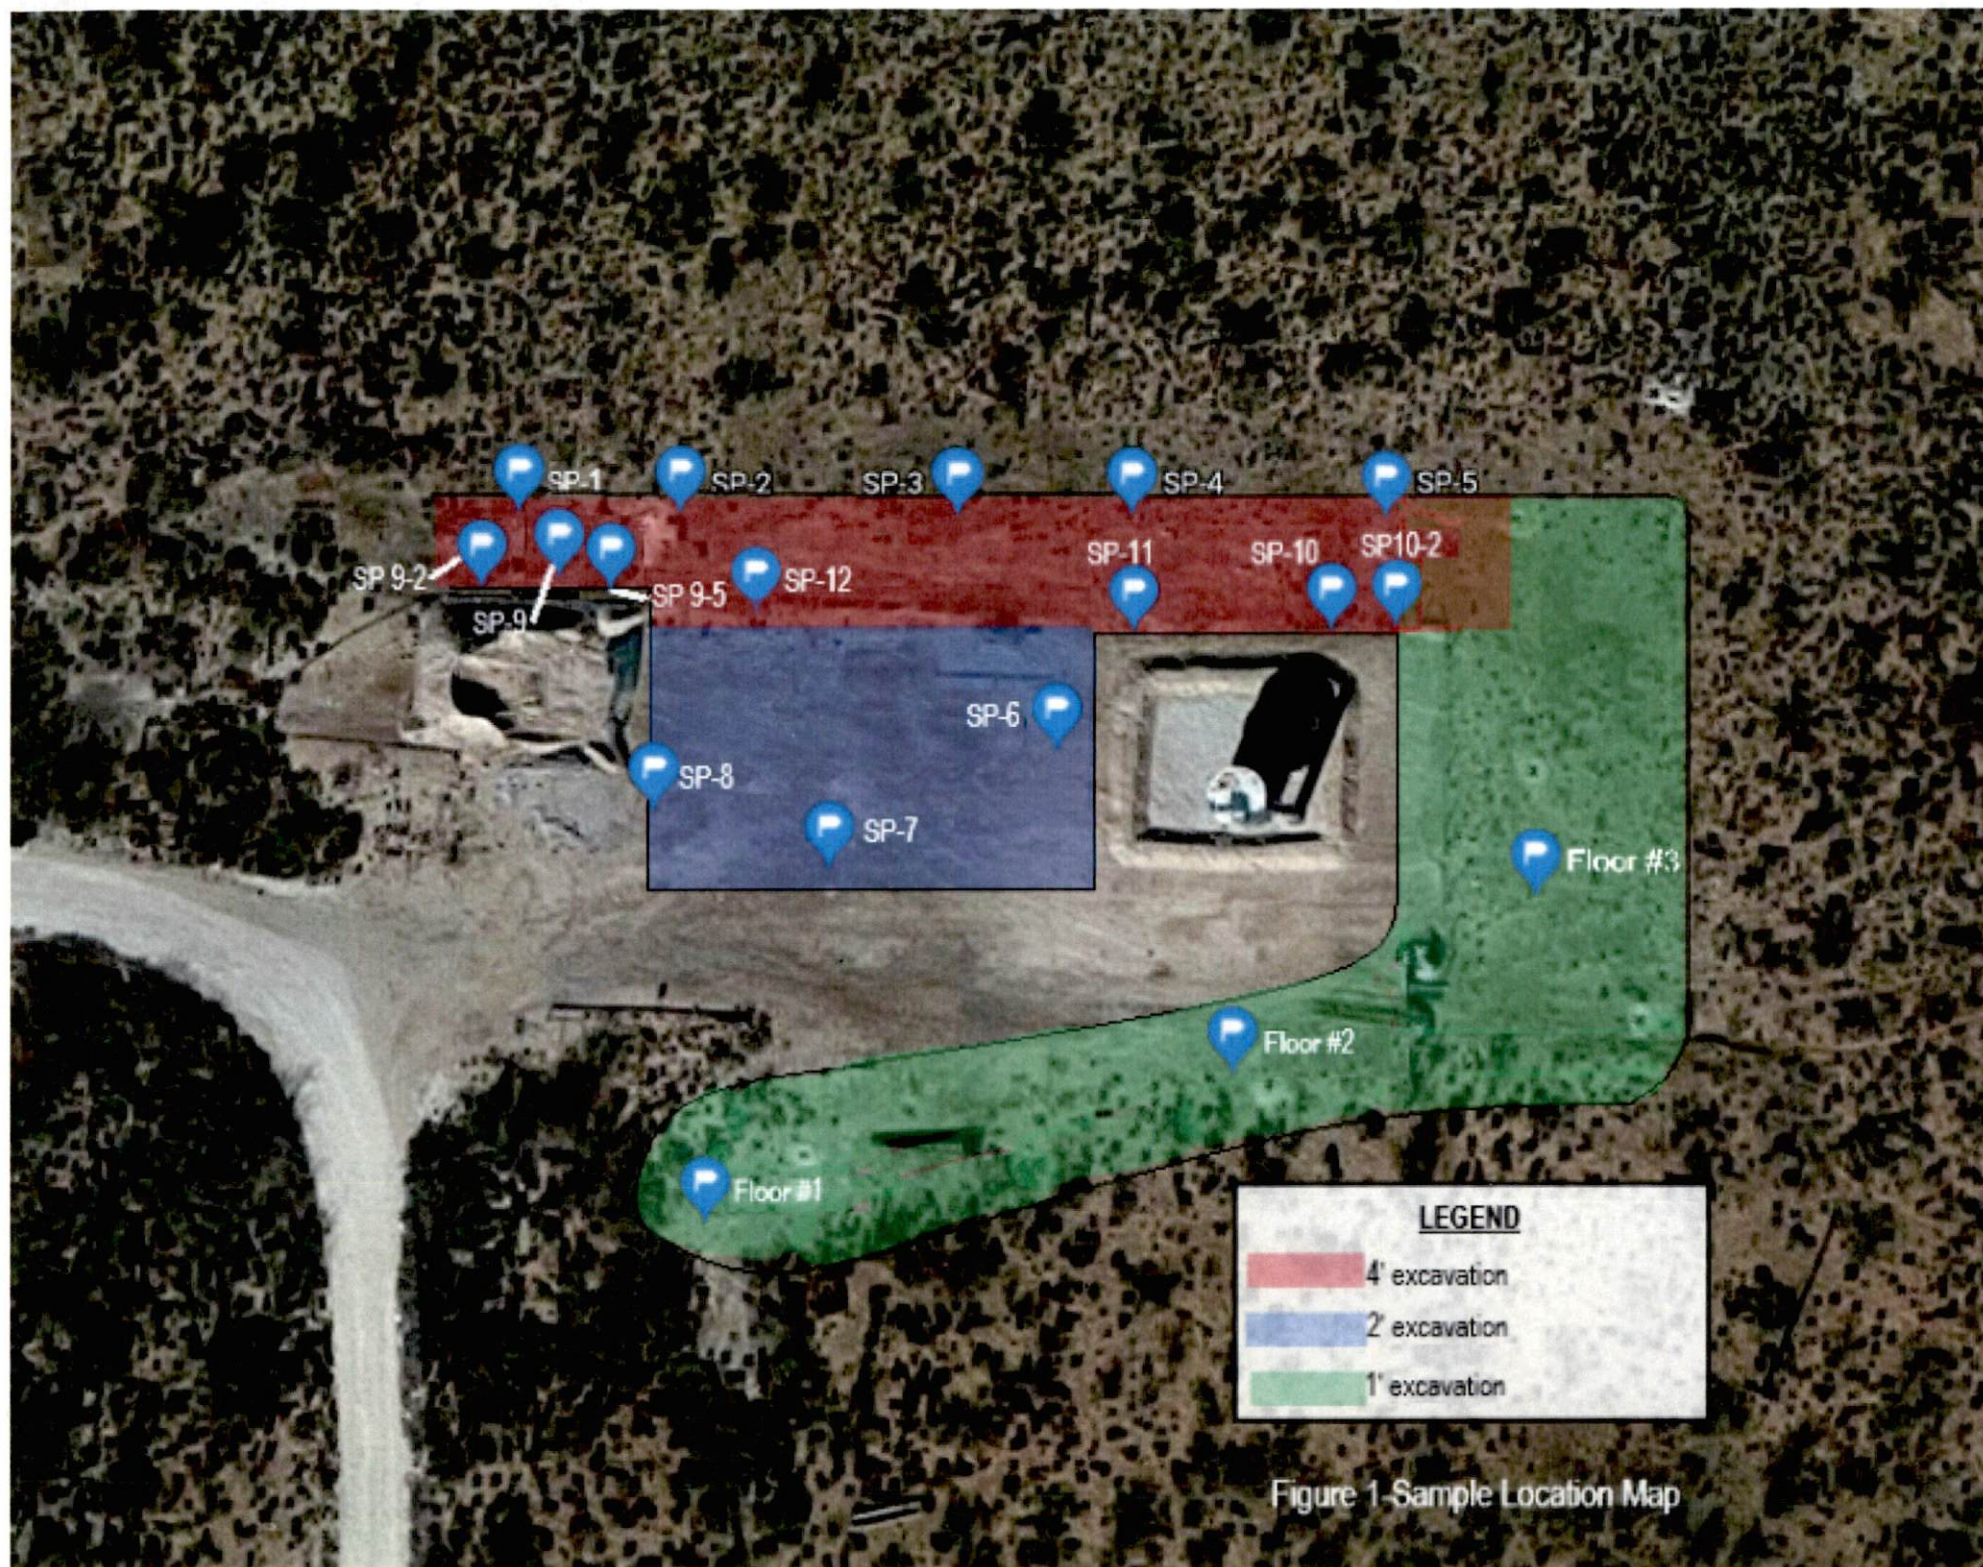
Figure 1 Sample Location Map

On March 15, 2018, soil samples were taken from two sites on the north wall (SP-1 and SP-2) and from the floor (Floor #1, 2, and 3) at the south and east areas.

On March 27, 2018, soil samples were taken at 50 foot intervals along sidewalls on North and Central excavations. SP #6, 9, 10, 11, 12 taken from this day returned high on Chlorides. SP #6, 10, and 11 are against the battery fence and SP #12 is in the center of a 4' excavation; therefore, these sample points were considered not actionable. SP #9 was considered actionable.

On April 9, 2018, 2' of sidewall was excavated at SP #9. Two more soil samples were taken from this location. SP #9-2 was taken 6' west and 2' south of SP #9. SP #9-3 was taken 6' east and 2' south of SP #9. SP 10-2 was taken 6' east of SP-10. SP #9-2 and #10-2 cleared.

On April 27, 2018, another 1' of sidewall was excavated from sample point #9. One more sample was taken from this area (Sample point #9-5) 6' East and 3' South of sample point #9.

SP-1	32° 08.854'N	-103° 06.911' W
SP-2	32° 08.855'N	-103° 06.903' W
SP-3	32° 08.855'N	-103° 06.892' W
SP-4	32° 08.855'N	-103° 06.885' W
SP-5	32° 08.855'N	-103° 06.875' W
SP-6	32° 08.847'N	-103° 06.888' W
SP-7	32° 08.843'N	-103° 06.897' W
SP-8	32° 08.845'N	-103° 06.904' W
SP-9	32° 08.853'N	-103° 06.912' W
SP-10	32° 08.850'N	-103° 06.873' W
SP-11	32° 08.851'N	-103° 06.885' W
SP-12	32° 08.853'N	-103° 06.902' W
Floor #1	32° 08.842'N	-103° 06.869' W
Floor #2	32° 08.836'N	-103° 06.881' W
Floor #3	32° 08.831'N	-103° 06.902' W
SP 9-2	32° 08.853'N	-103° 06.914' W
SP 9-5	32° 08.852'N	-103° 06.910' W
SP 10-2	6' East from SP-10

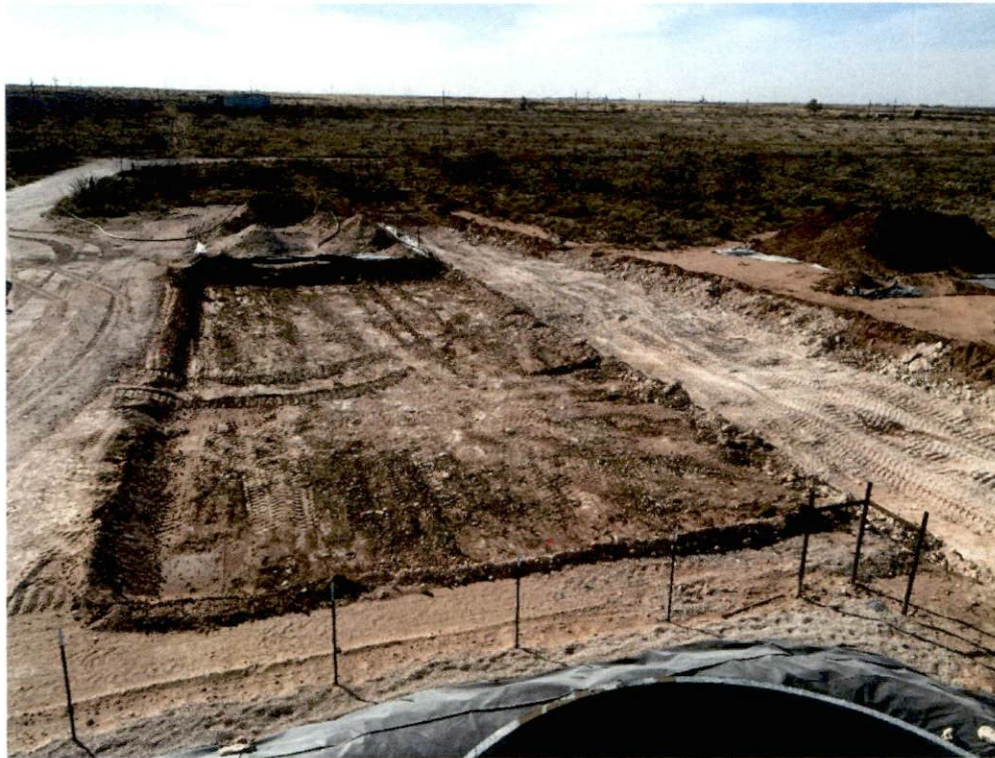
View facing West from the battery

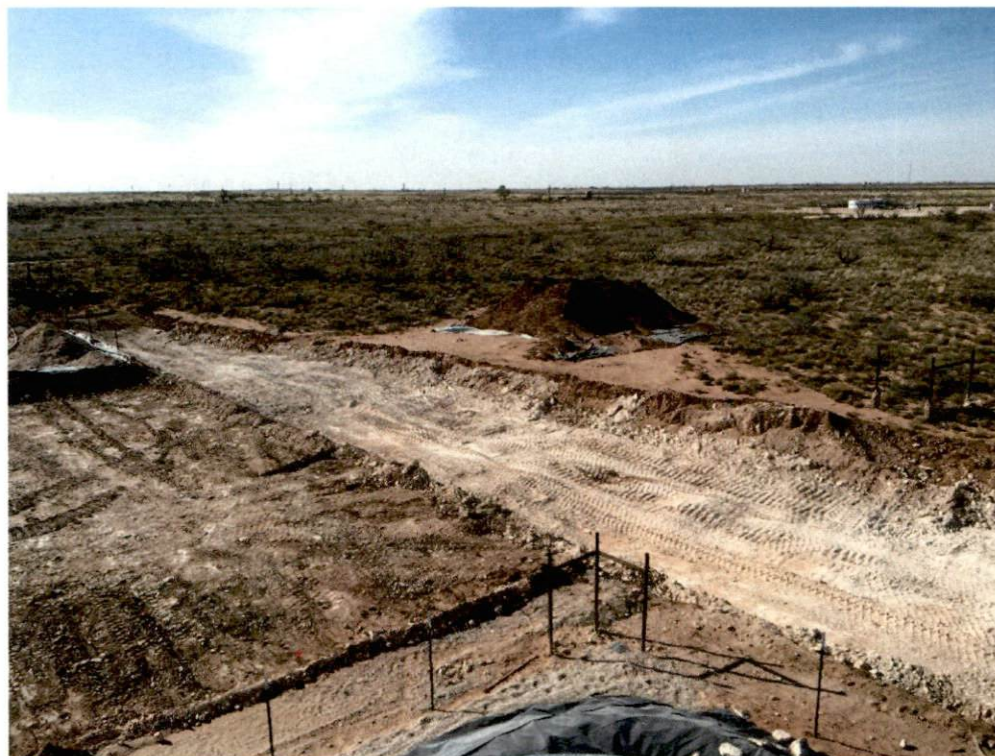
View facing Northwest from the battery

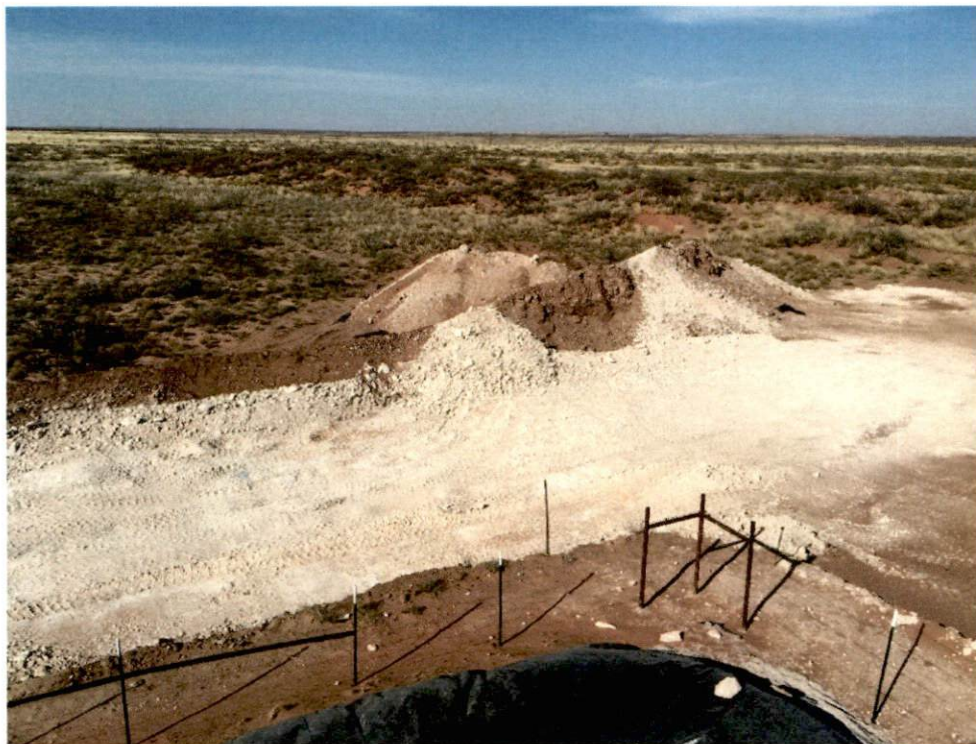
View facing Northeast from the battery

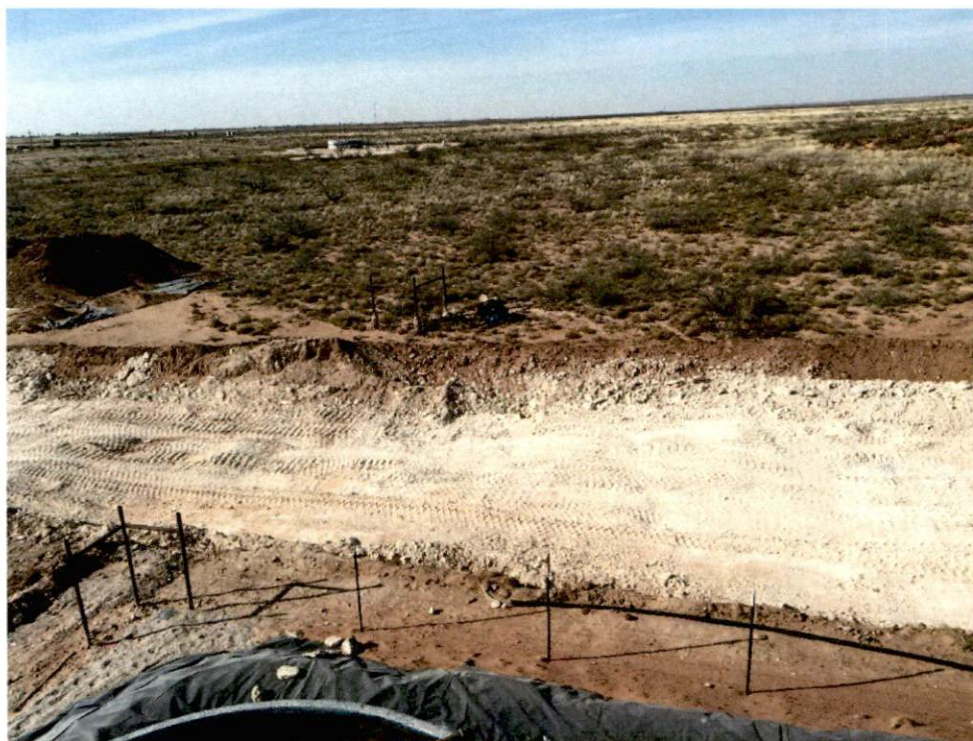
View facing North from the battery

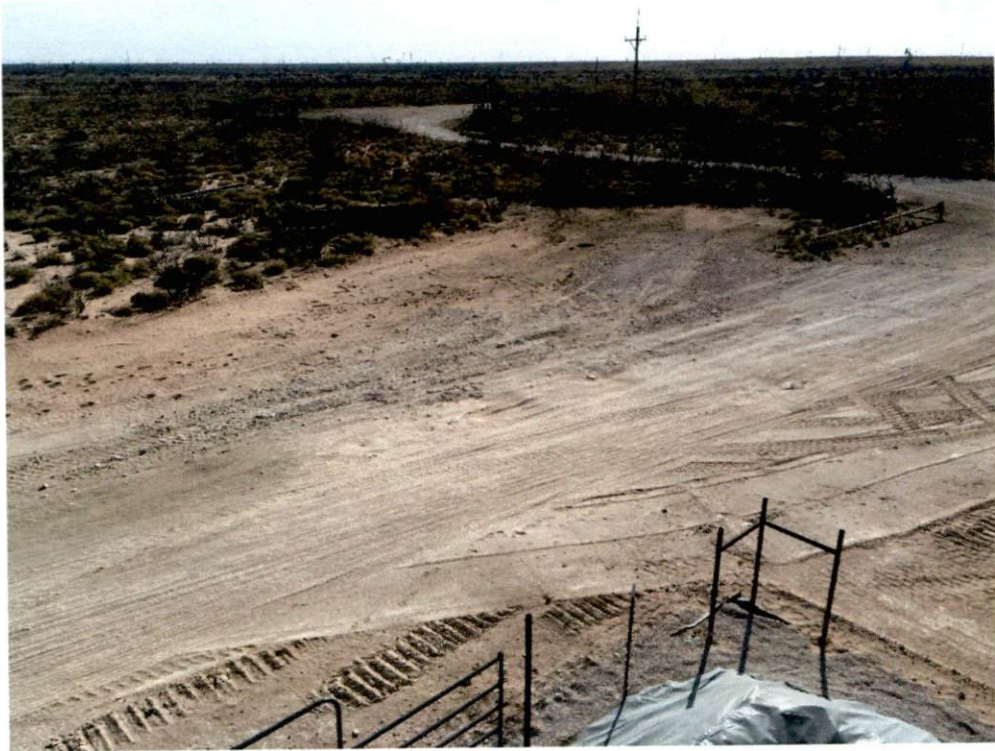
View facing Southwest from the battery

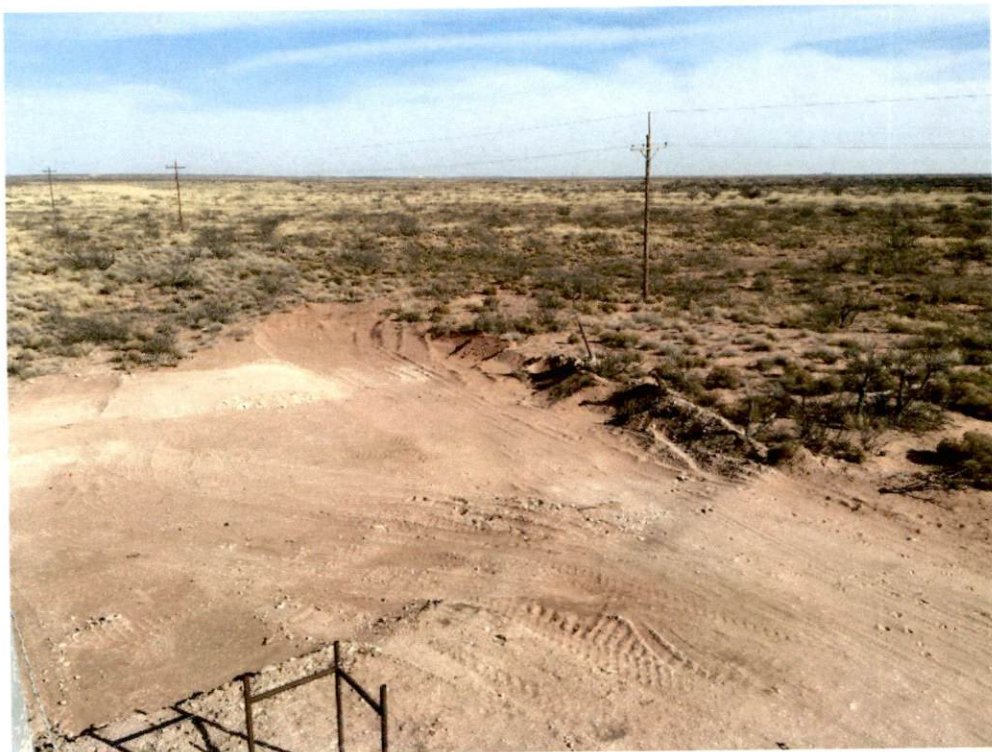
View facing Southeast from the battery

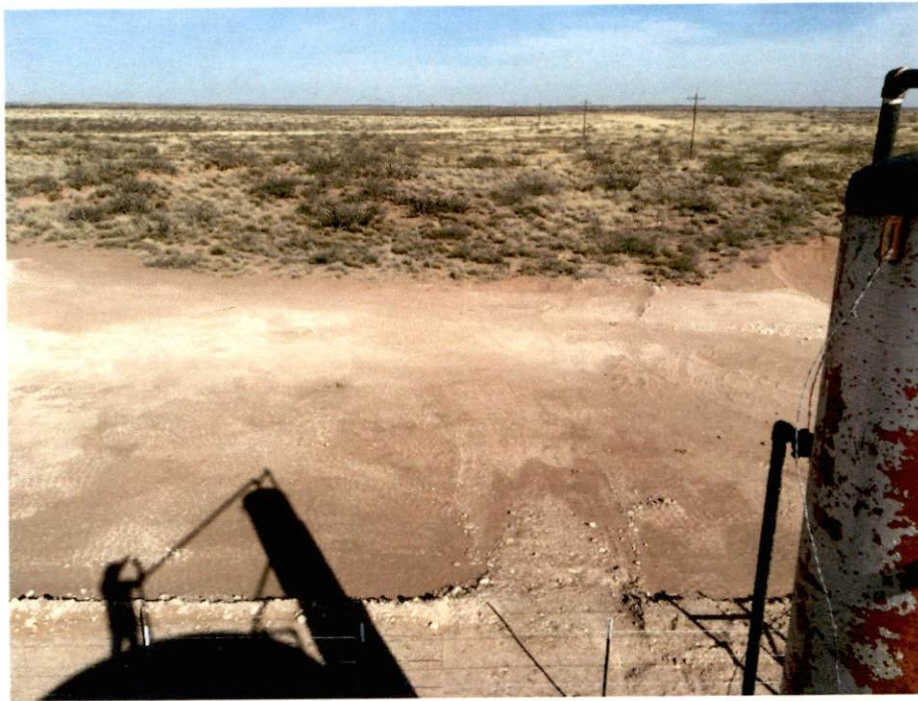
View facing East from the battery
