Release Notification and Corrective Action

Name of Company: Chevron USA, Inc.	Contact: Amy Barnhill
Address: 6301 Deauville Blvd., Midland, TX 79706	Telephone No.: 432-687-7108
Facility Name: R E COLE "A" TB #7	Facility Type: Central Tank Battery

1RP-4433

TANK BATTERY #7

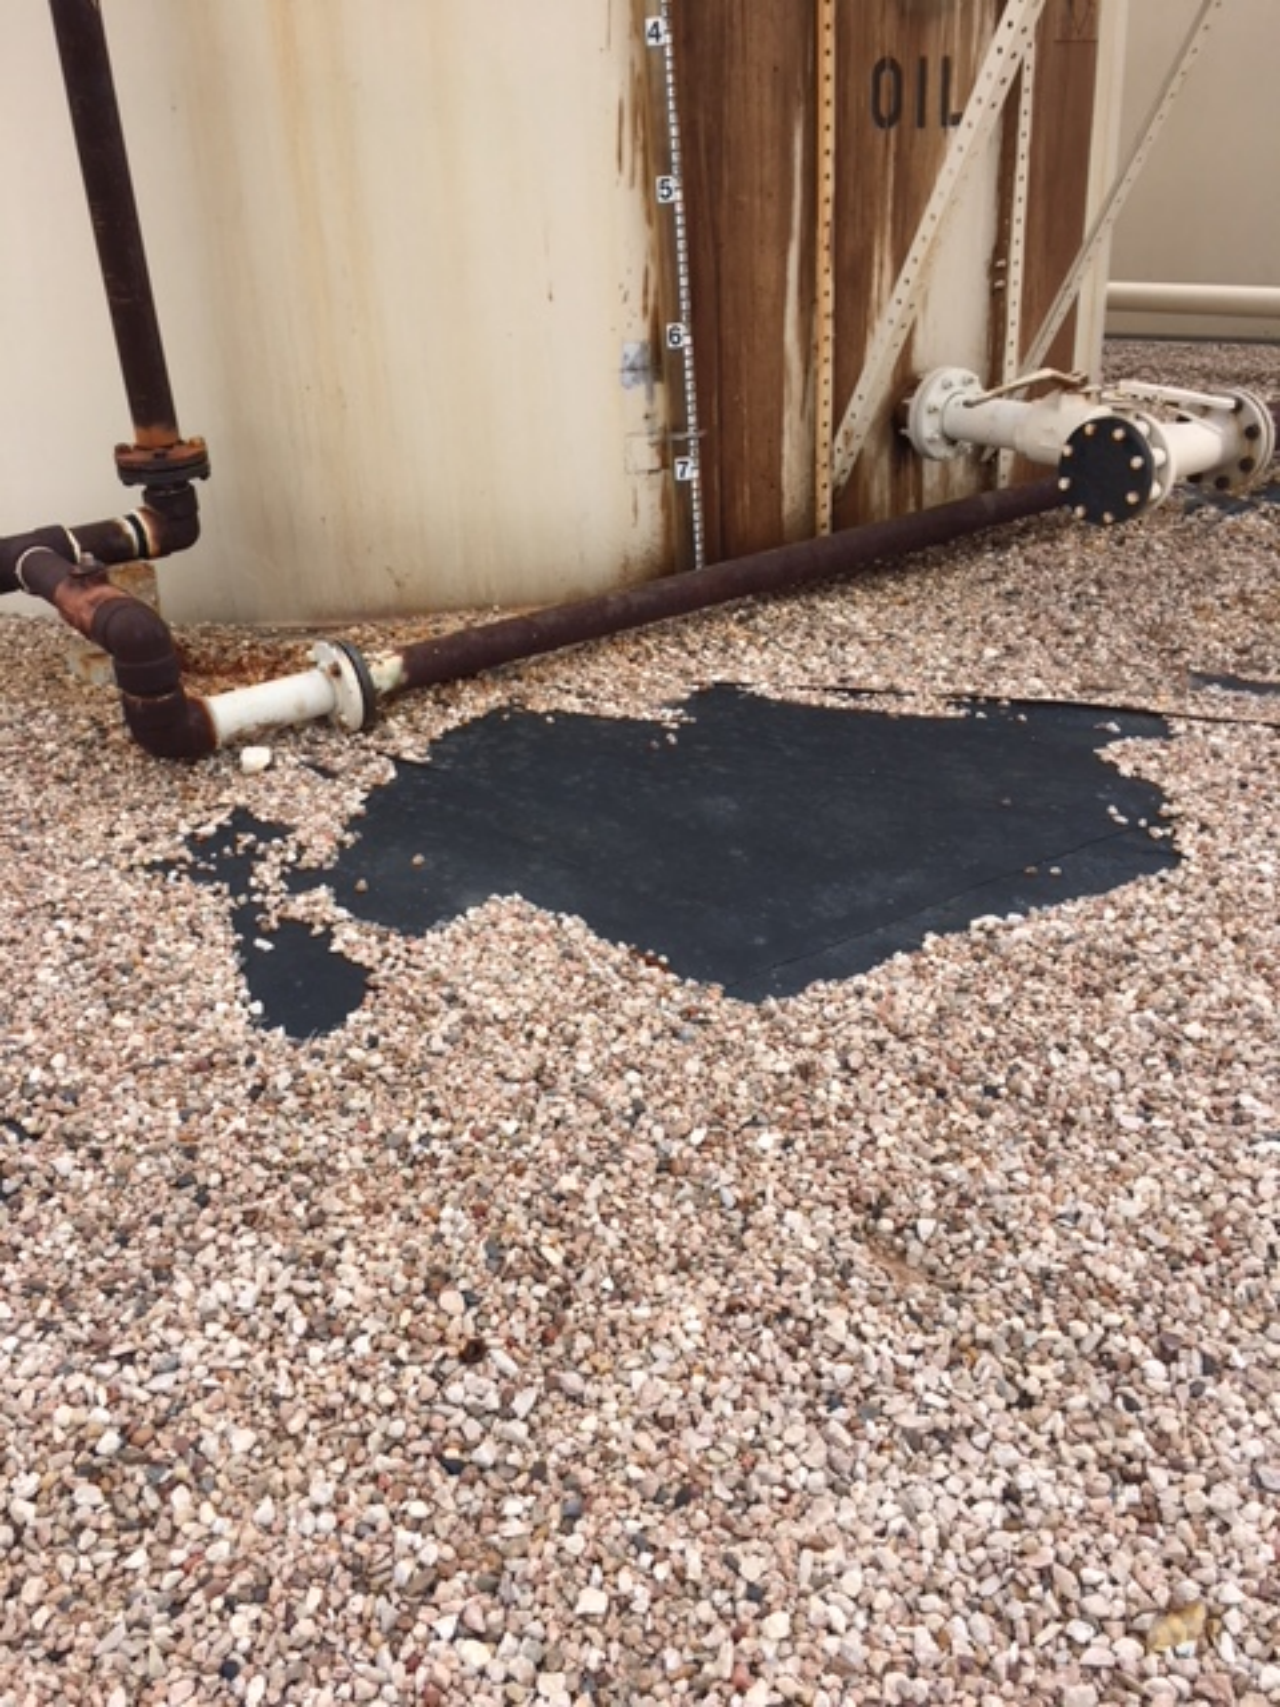
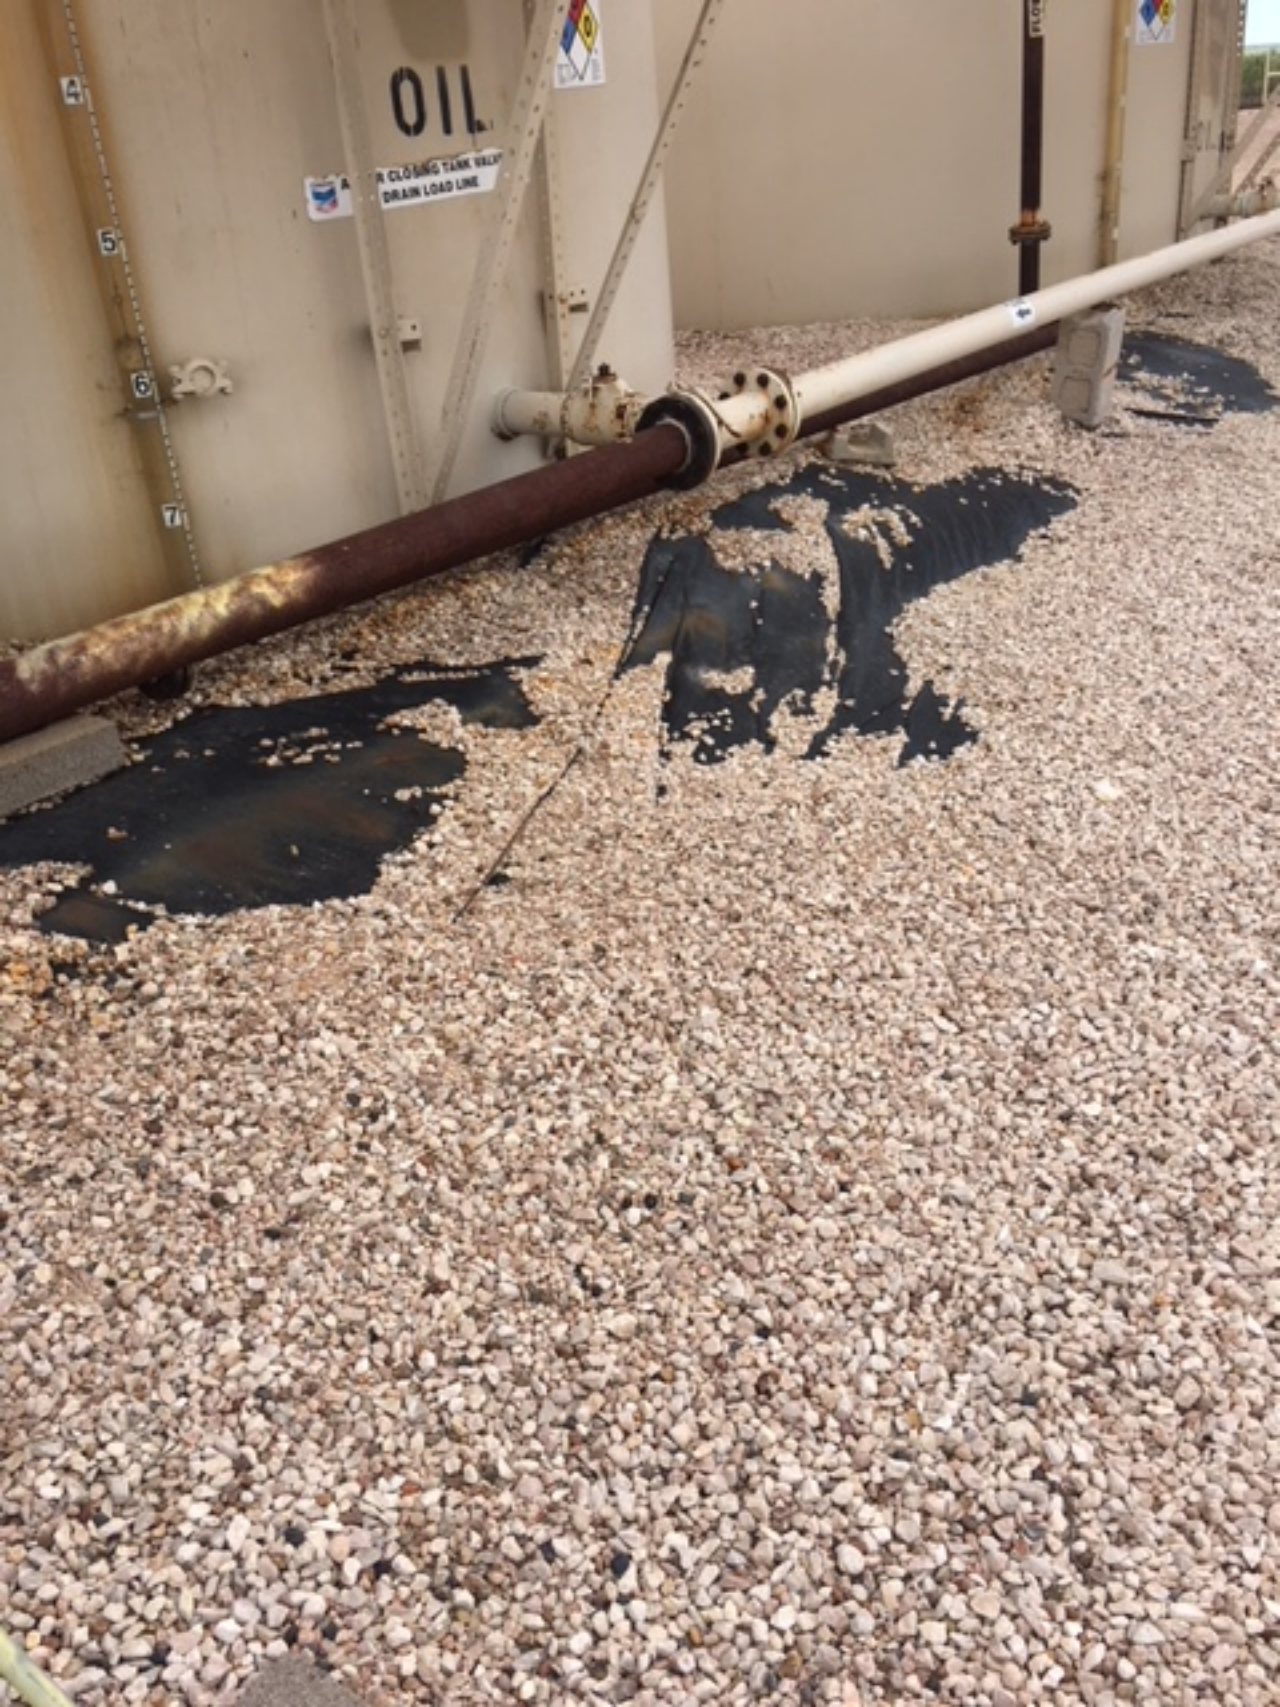
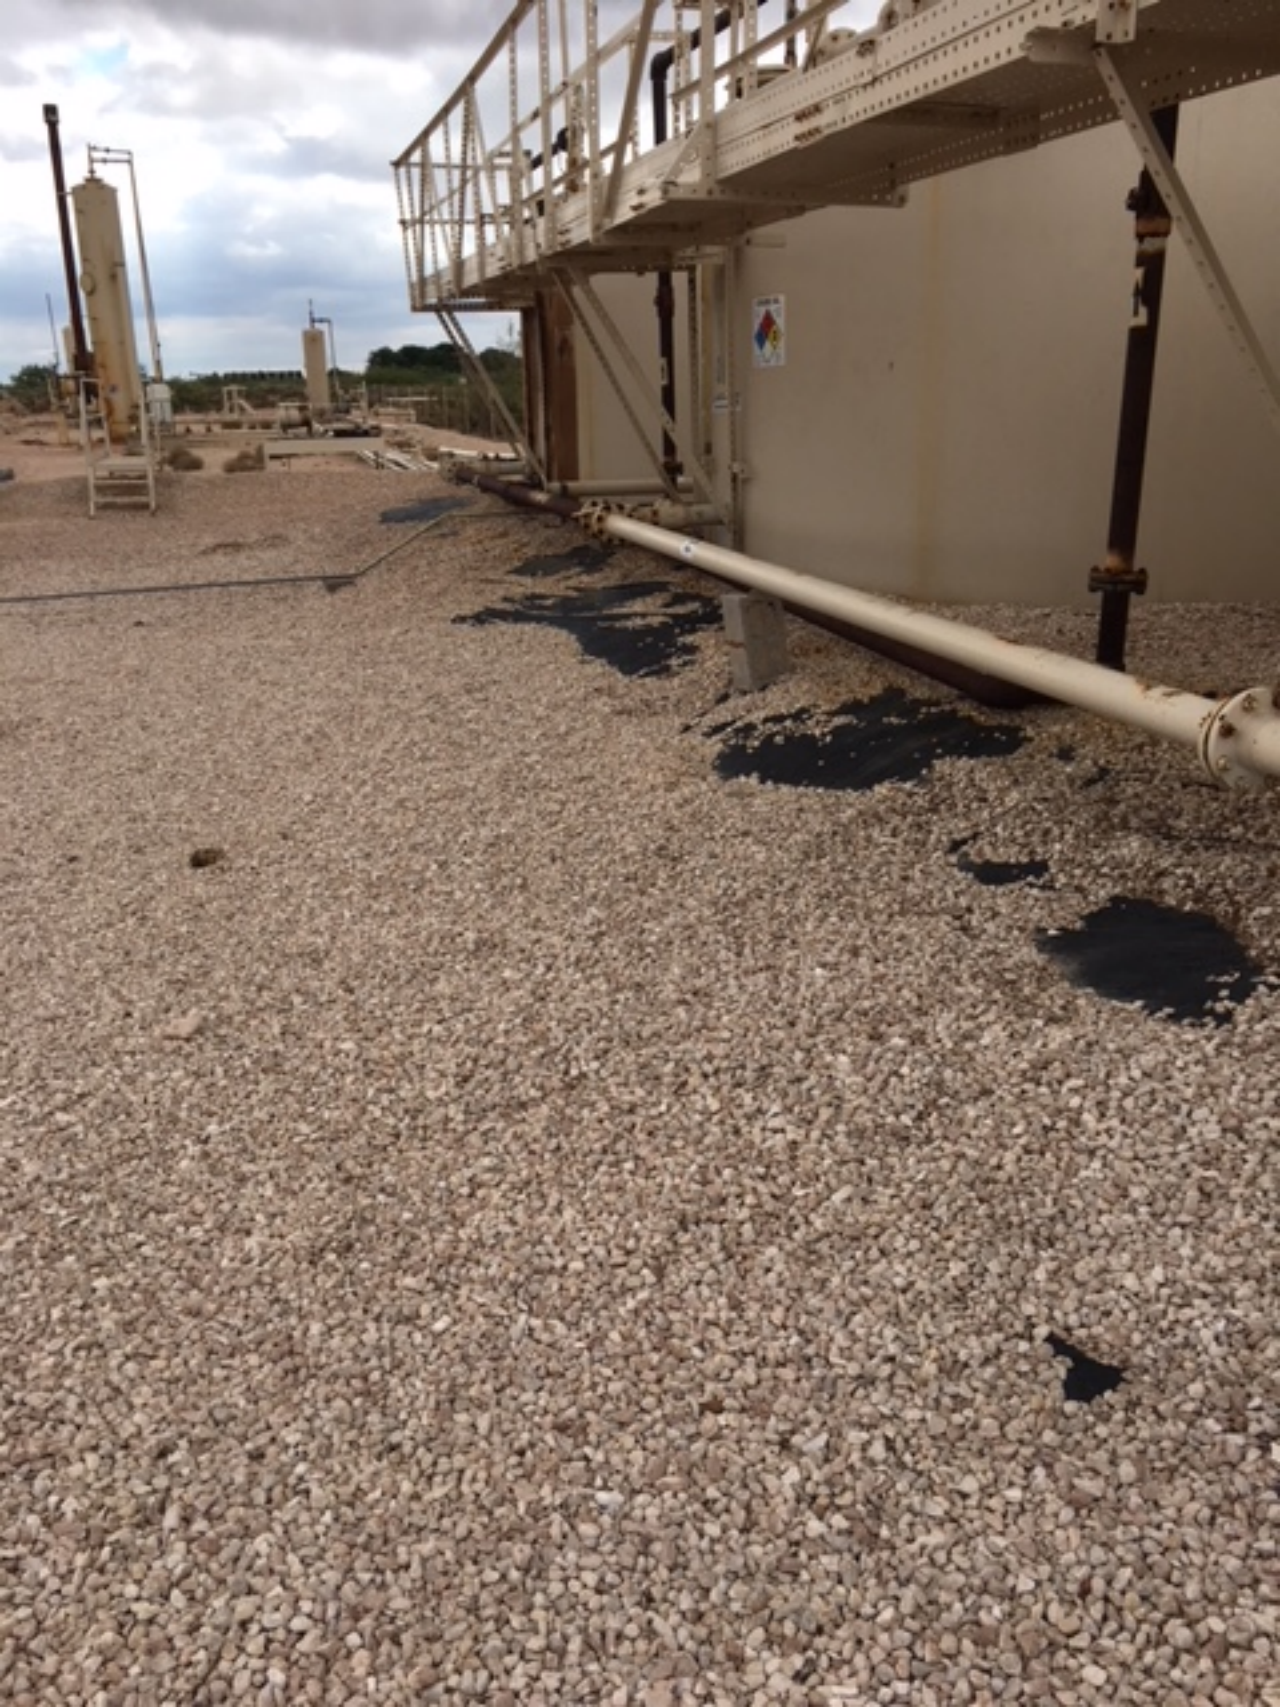
All in secondary, lined containment. Recovered all the fluid, there is gravel/dirt on top of the plastic liner and was cleaned with microbial product (Gator).
