**Release Notification and Corrective Action**

Name of Company Devon Energy Production Company	Contact Aaron Pina, Production Foreman
Address 6488 Seven Rivers Hwy Artesia, NM 88210	Telephone No. 575-748-3371
Facility Name Mean Green 23 Fed 1H Battery	Facility Type Battery

# Mean Green 23 Fed 1H Battery

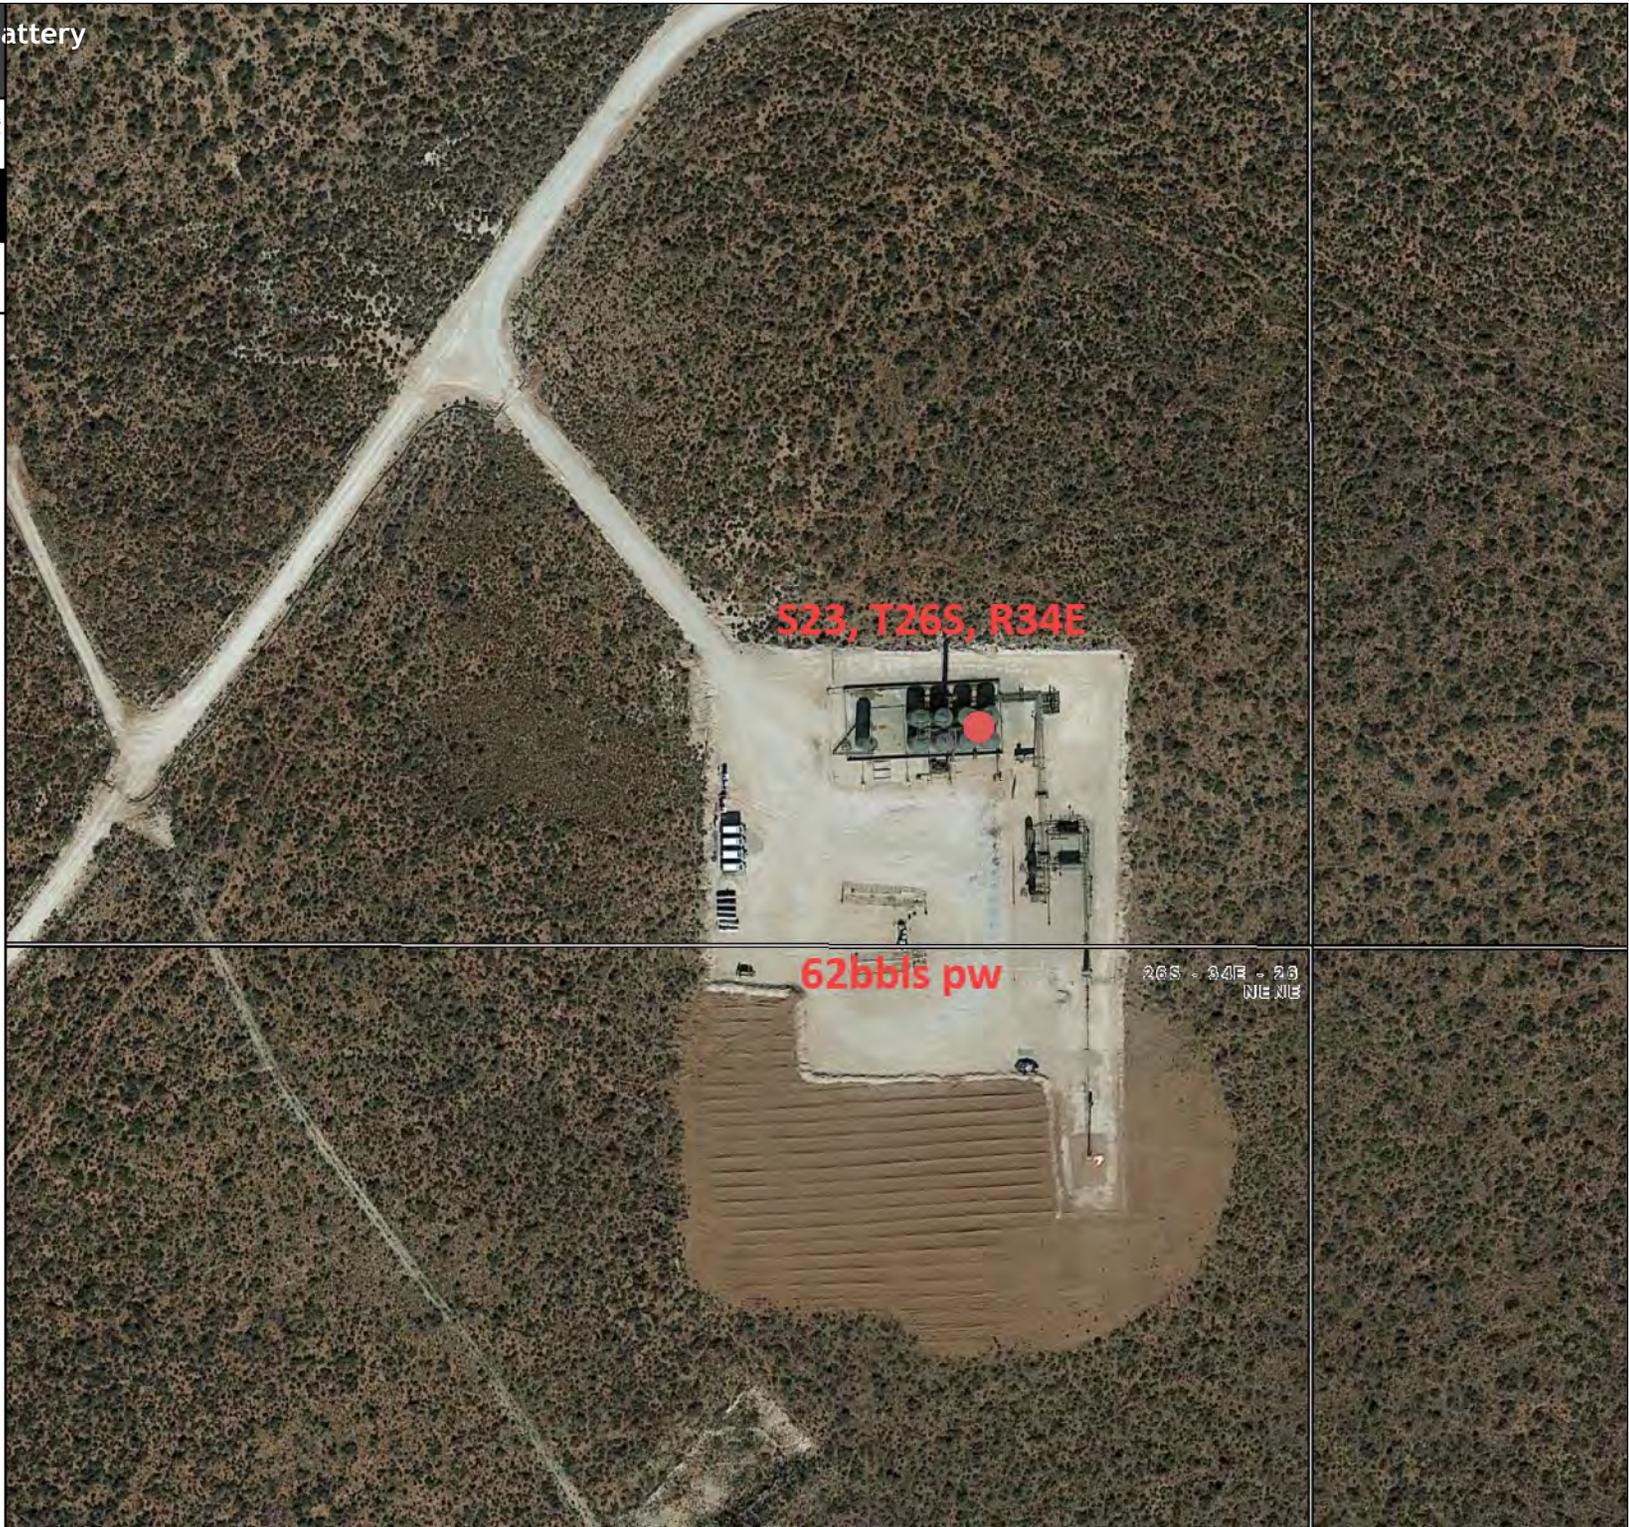
62bbbs PW\_7.27.18

62bbbs pw
